2005 Annual Inspection Report for the Weldon Spring, Missouri, Site

February 2006

Office of Legacy Management

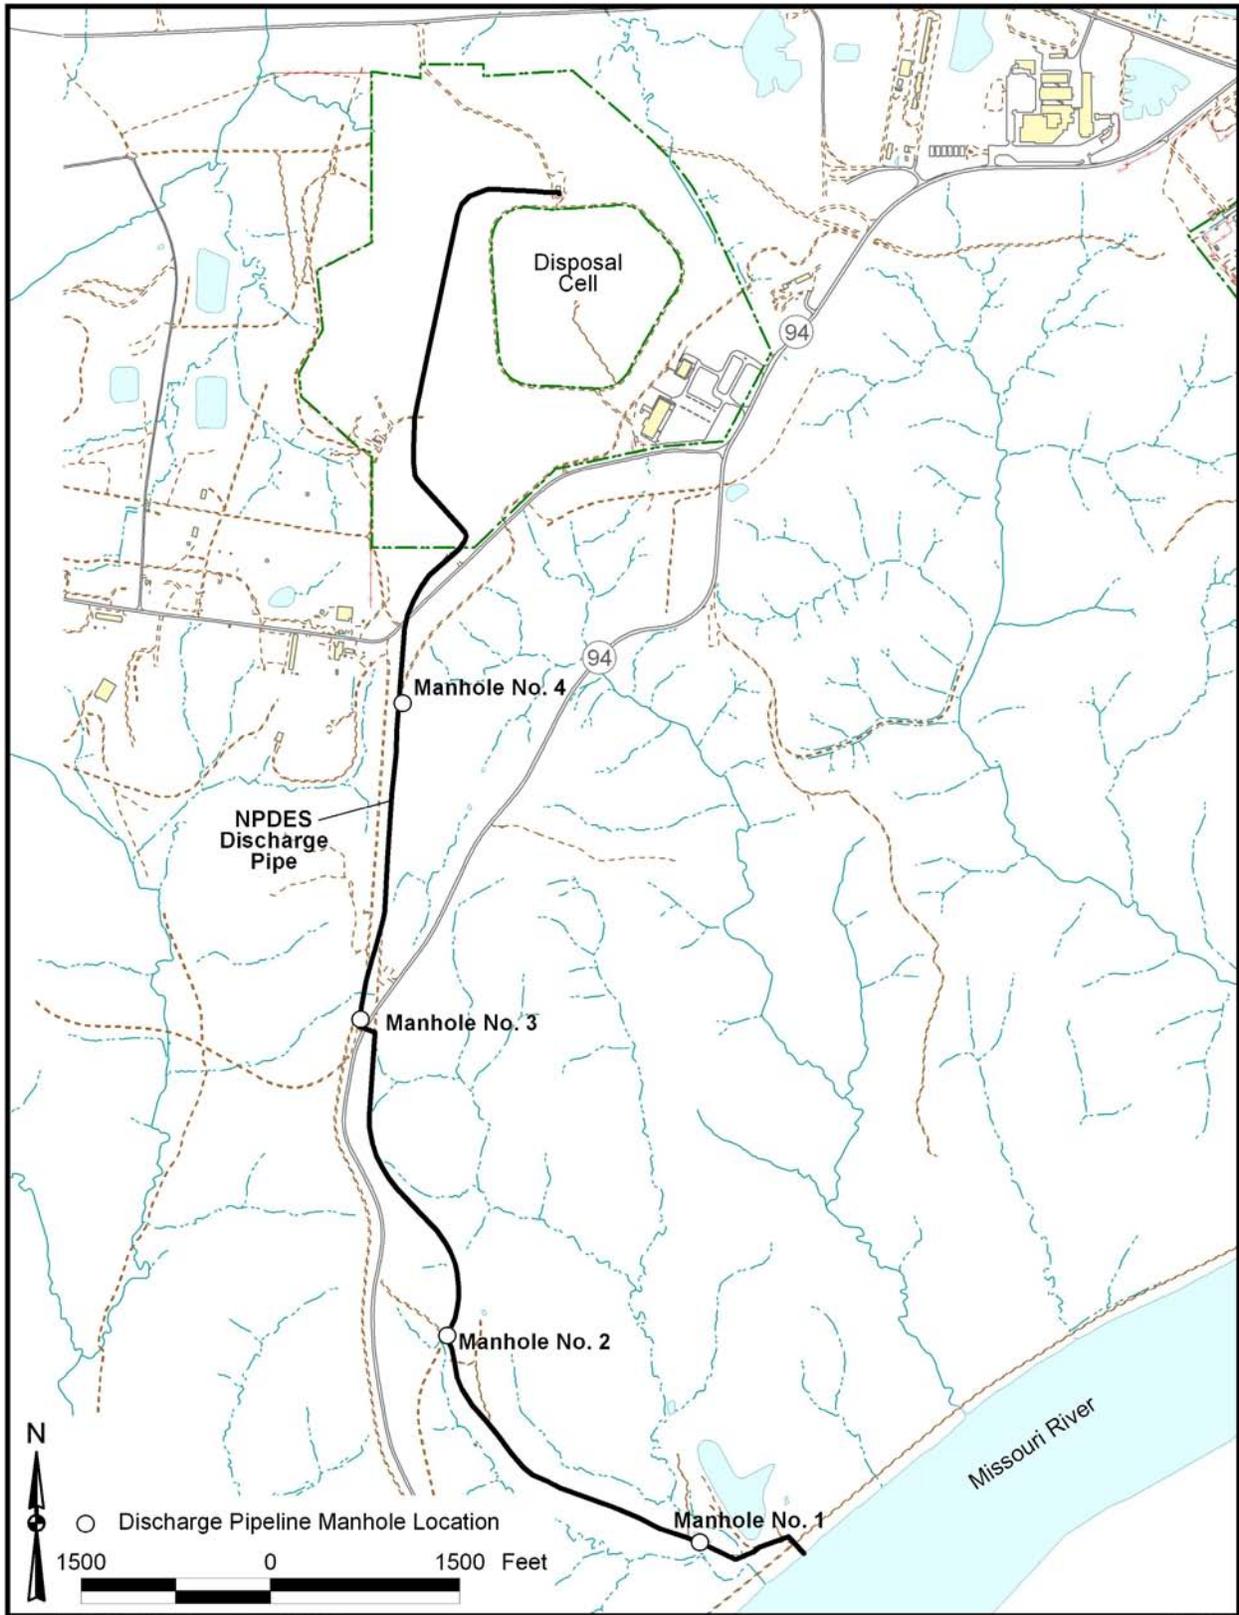
Figure 6. NPDES Discharge Pipeline Between the LCRS Support Building at the Missouri River, Weldon Spring, Missouri, Site

Inspection Results: The pipeline area was inspected. GPS surveying equipment was used to establish the locations of the manholes and cleanouts. A map of the pipeline, indicating the manhole locations, is shown in [Figure 6](#). It was noted that there were no on-site disturbances of the pipeline and there were no apparent disturbances in the area of the pipeline or manholes in the off-site areas.

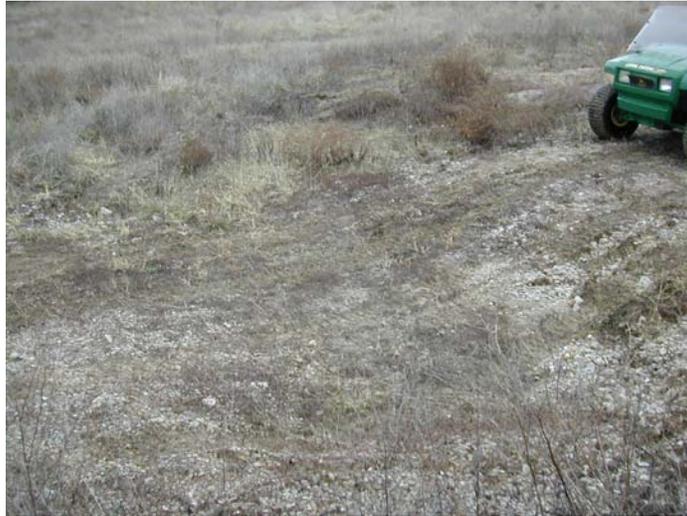
Photo 1. Depression area in the prairie east of the disposal cell.

Approximately one week after the official inspection, a depression area was noted in the prairie approximately 150 feet from the disposal cell on the north side (Photo 1). The location of the depression is shown in Figure 4. It was determined this was an area of past trenching and is most likely settlement caused by inadequate compaction of the soil at the completion of trenching. The area will be evaluated to determine the best course of action to address the area.

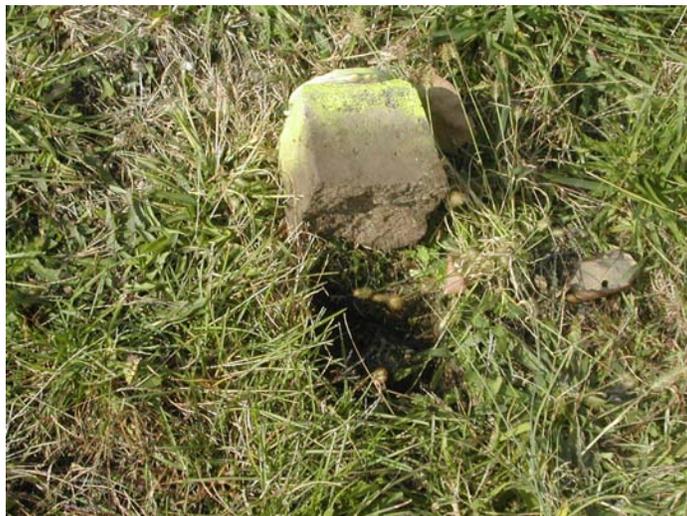
Photo 3. Groundwater restriction boundary WS-46. Monument has been broken off.

1. **Finding:** The boundary monument WS-46 was broken off.

Corrective Action: Coordinate repair of the monument.

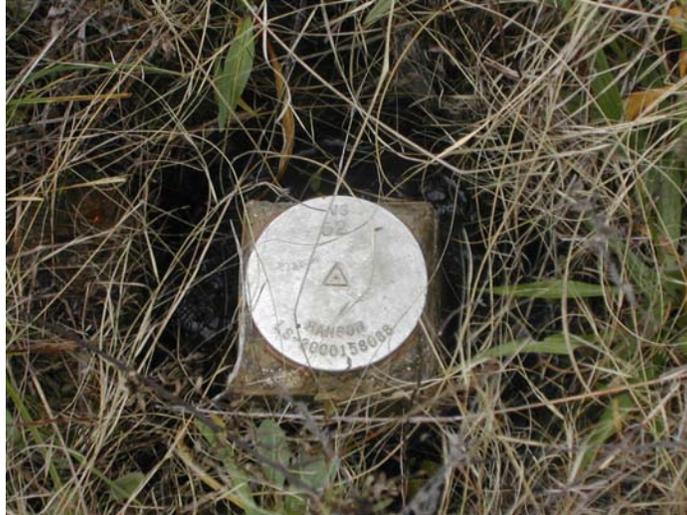
Photo 4. Groundwater restriction boundary monument WS-52. Has been dug around sides.

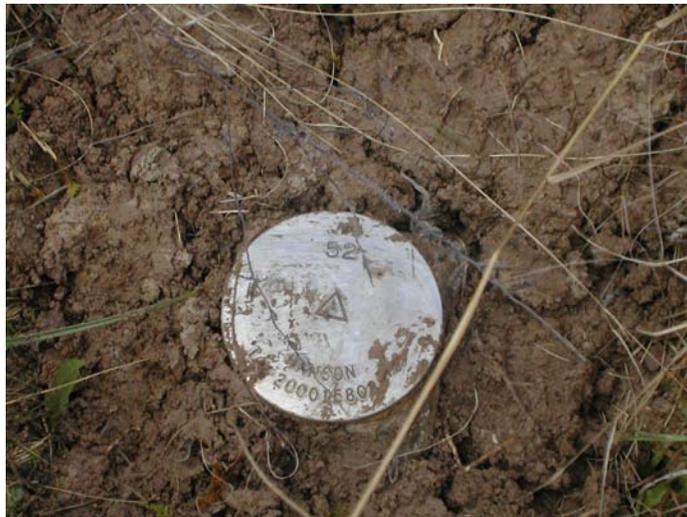
Photo 5. Groundwater restriction boundary monument WS-52. Dirt was replaced around monument.

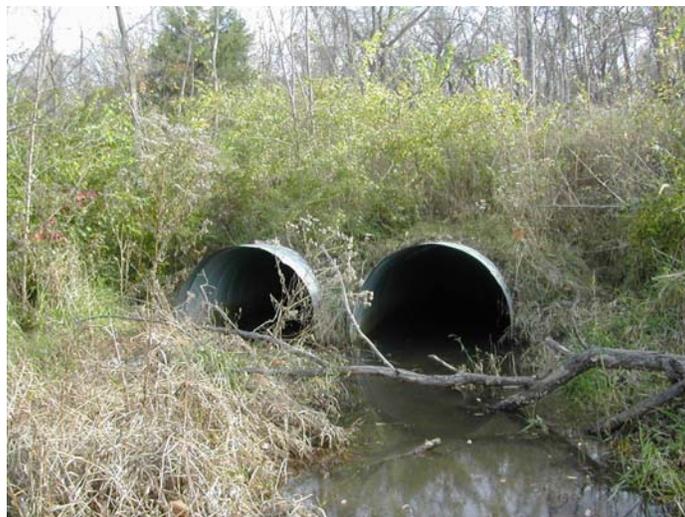
Photo 9. Outlet end of Highway D Culverts.

Inspection Results: The Highway D culverts were inspected (Photo 9). During the 2003 and 2004 annual inspection the area where the outlet side of the culvert passes beneath the ditch between Highway D and the north end of the culvert had eroded on top, exposing the culverts. The Missouri Department of Transportation (MoDOT) had been notified of this condition and been sent a copy of the inspection reports. Prior to the 2005 inspection, MoDOT had been in contact with the site and stated that they were going to address the culvert. They later contacted the site and stated that they had placed gravel on the culvert. It was noted during this inspection that gravel had been placed on top of the area covering the exposed culverts (Photo 10). This effort appears to have stabilized the areas so as to minimize additional erosion. Concrete had also been placed on the outside and middle of the culverts on the inlet side to minimize erosion in those areas (Photo 11).

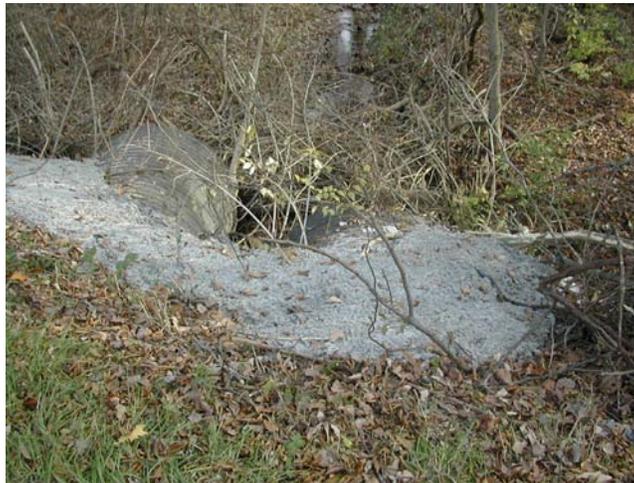
Photo 11. Inlet side of Highway D Culverts. Concrete had been placed on outside and in the middle of culverts.

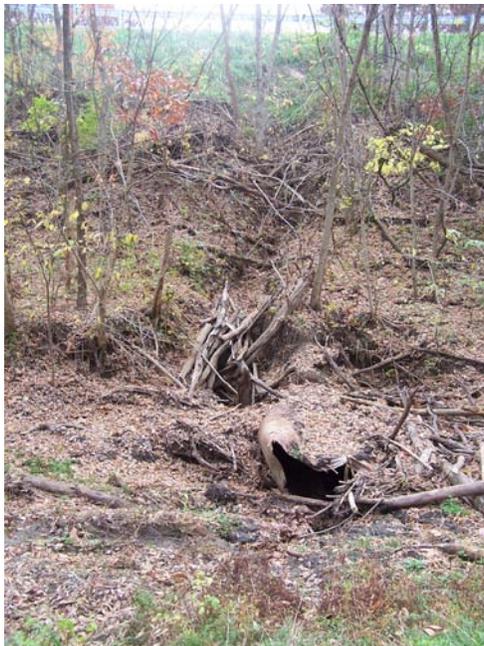
Photo 12. Highway 94 culvert inlet in the Southeast Drainage.

Inspection Results: The State Route 94 culvert was inspected. During the 2003 and 2004 inspections the upstream end of the culvert was substantially blocked with debris. The MoDOT had also been notified of this condition. During the 2005 inspection it was noted that the area had been cleared of debris (Photo 12).

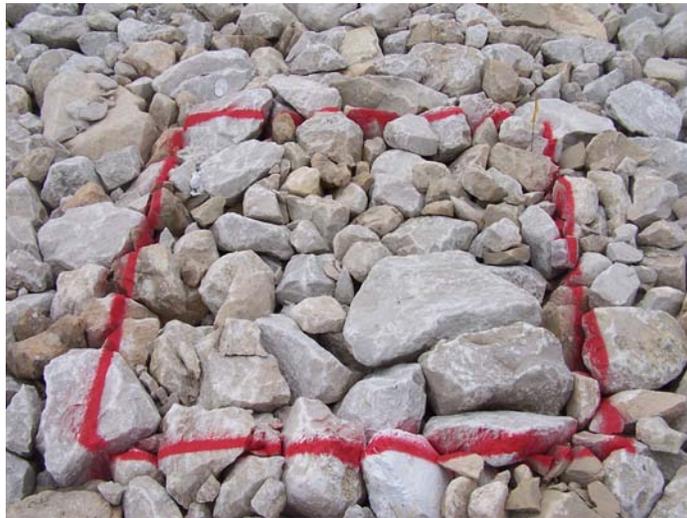
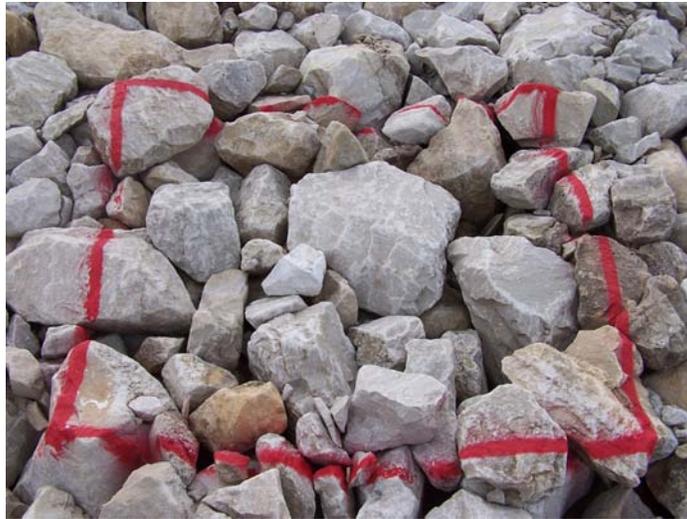
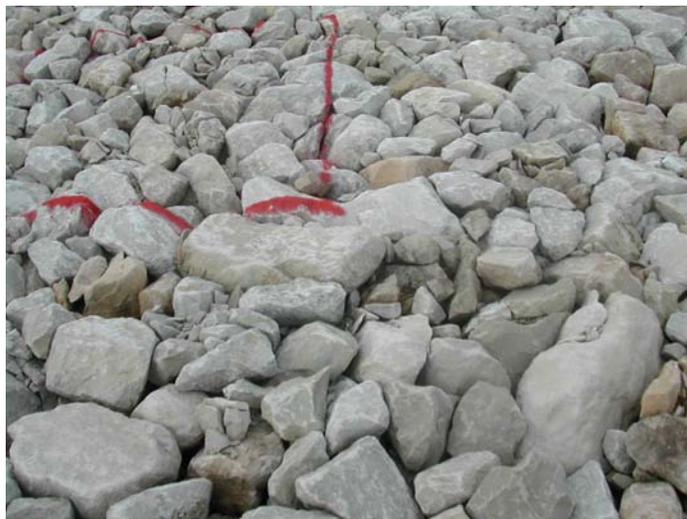
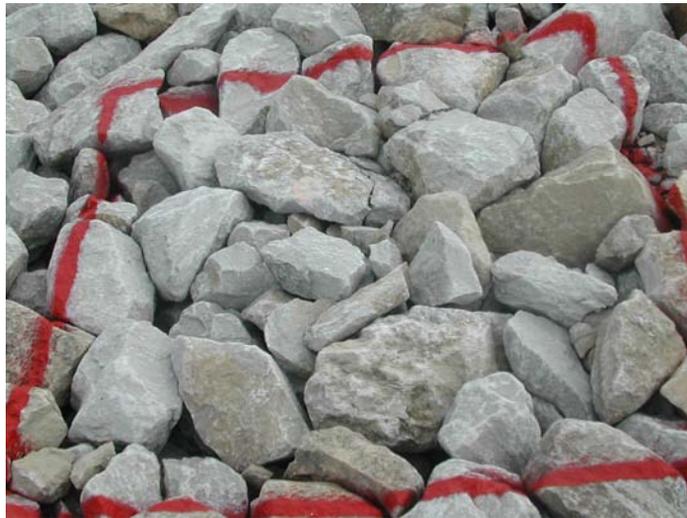
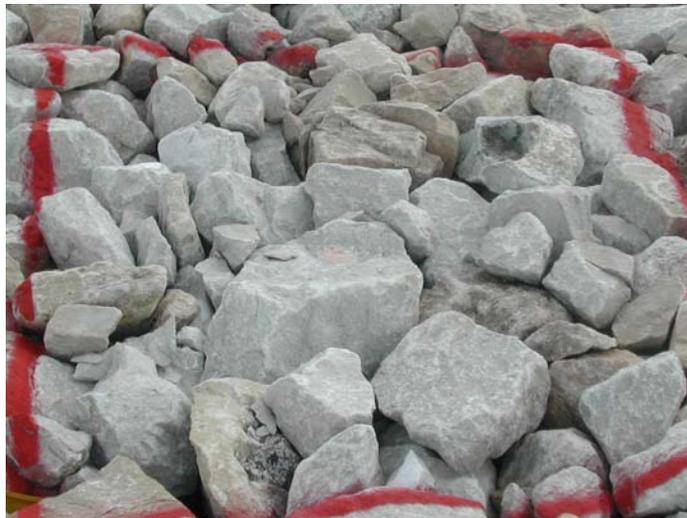
The disposal cell was inspected in accordance with the LTS&M Plan and the annual inspection checklist. The cell was divided into ten transects ([Figure 7](#)). The inspectors separated into two groups and walked five transects each; one group also walked along the grade break at the top of the side slopes and along the cell perimeter. The inspectors looked for depressions, shifts of cell plane vertices, and other indications of settlement. Other items for inspection were vegetation, wet areas, apron drains, guardrail, and the stairs. A GPS unit was used during the 2003 inspection to map five areas chosen for rock degradation review ([Figure 7](#)). The inspectors took photographs of these and compared them to photographs from the previous inspection of the same areas and observed no rock degradation. These areas are shown in Photos 13 through 17.

Photo 13. Cell cover rock test plot TP1; north edge of north facet.

Photo 14. Cell side slope rock test plot TP2; bottom of north side slope.

Photo 15. Cell cover rock test plot TP3; northeast ridgeline.

Photo 16. Cell cover rock test plot TP4; lower west side slope.

Photo 17. Cell cover rock test plot TP5; located on upper west side.

Remarks The 5 Rock Degradation Test Plot areas are photographed and inspected/observed annually. Photos are included in the inspection report. The rock does not appear degraded.

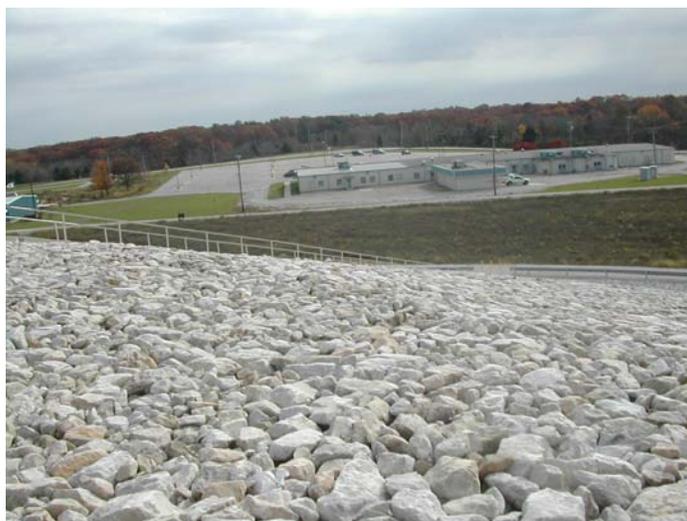
A few small shallow depressions on the cell cover and along the grade break were noted during the inspection. It appeared that the depressions ranged up to approximately 2 or 3 inches deep. The majority of these areas had been identified during the previous inspection(s). A few additional areas were noted on the northeast and southwest corners of the cell (Photo 18). The area identified as a depression by the aerial survey was located by GPS and it was observed that a slight depression exists in this area (Photo 19). These slight depressions are not unexpected for a disposal cell of this type and are not a cause for concern. They will continue to be monitored.

Photo 18. View from top looking SW towards admin bldg. Slight bulge.

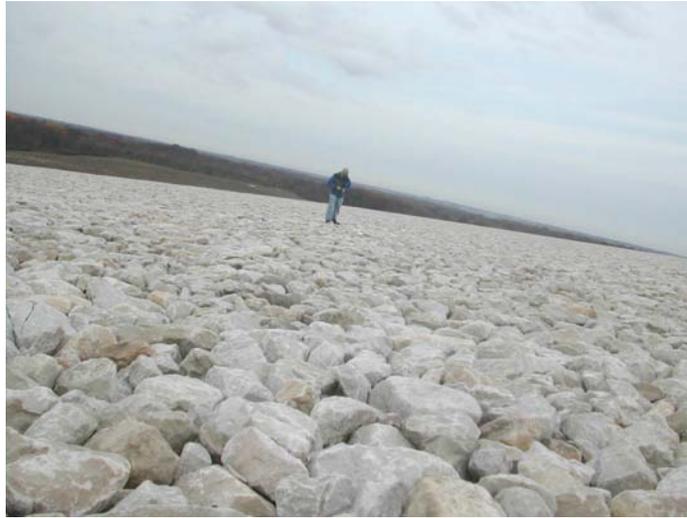
Photo 19. Slight depression area shown on aerial survey on southwest side looking northwest.

4. **Finding:** A few additional small depressions were observed on the disposal cell.

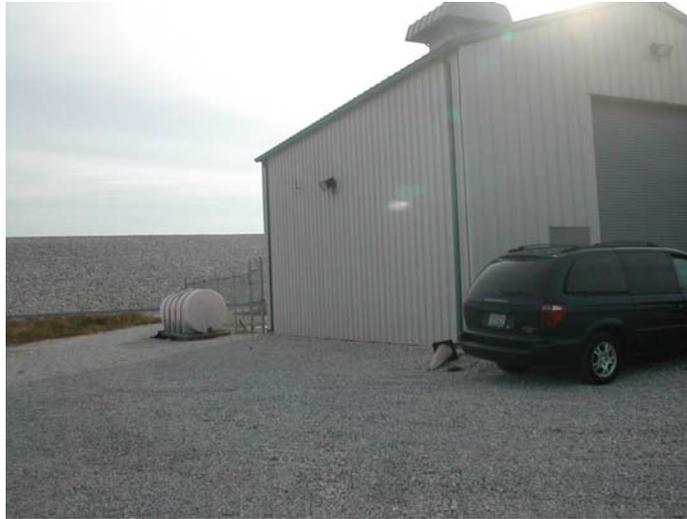
Photo 20. Outside Train 3 LCRS Building.

Operations of the LCRS were discussed with site personnel and the system was inspected (Photo 20). The fences and doors were locked and in good condition. The system was functioning as designed. The LCRS data and documentation were reviewed during the document review period of the inspection and the following information was checked and verified that it was available: sampling data, LCRS flow rates, action leakage rate information, “burrito” system flow rates, and leachate data. As required by the LTS&M Plan, the leachate production rates, analytical results, and disposal information are provided in [Appendix C](#).

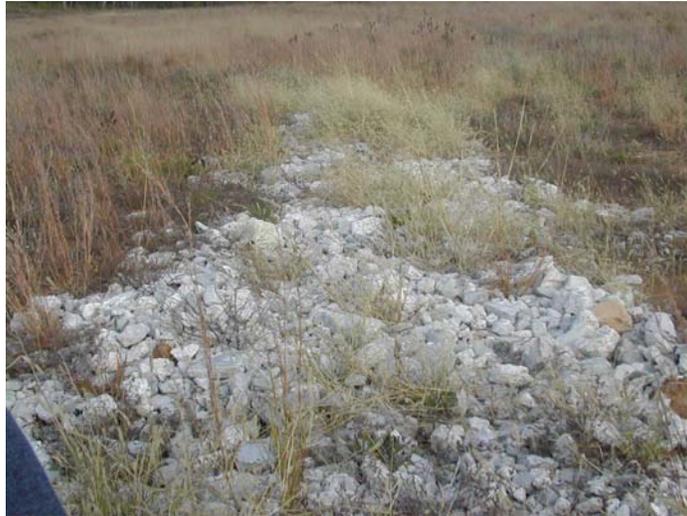
Photo 22. Erosion control repairs.

During the 2004 inspection, erosion areas were identified on the north and northwest sides of the disposal cell. These areas were repaired during June 6-8, 2005. A total of 32 rock boxes were constructed to prevent erosion from continuing. These rock boxes were filled with 2-inch rock and topped with 3-6 inch rock to ensure the rock would stay in place during high precipitation events. An additional 17 loads (approximately 255 tons) of 3-6 inch rock was delivered and

placed in the ditches/swales. The filled ditches provide well-drained channels for water to flow freely and no additional erosion should occur (Photo 22). A discussion of the repairs was held during the inspection and a few of the areas were inspected and found to be in good condition.

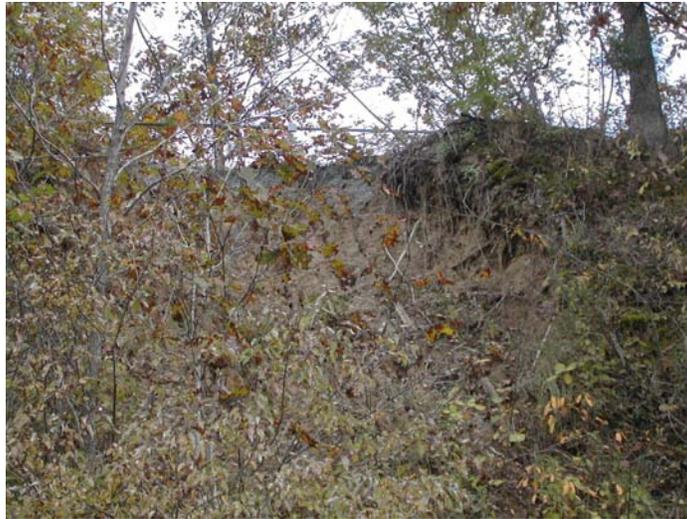
Photo 23. Walls of Quarry Proper.

Erosion areas were observed along some of the high walls of the Quarry during the inspection (Photo 23). These areas will continue to be monitored in the future.

2. **Quarry Area** Location shown on site map Erosion not evident
 Areal extent _____ Depth _____
 Remarks Some erosion of the high walls of the quarry was observed.
This will be monitored.

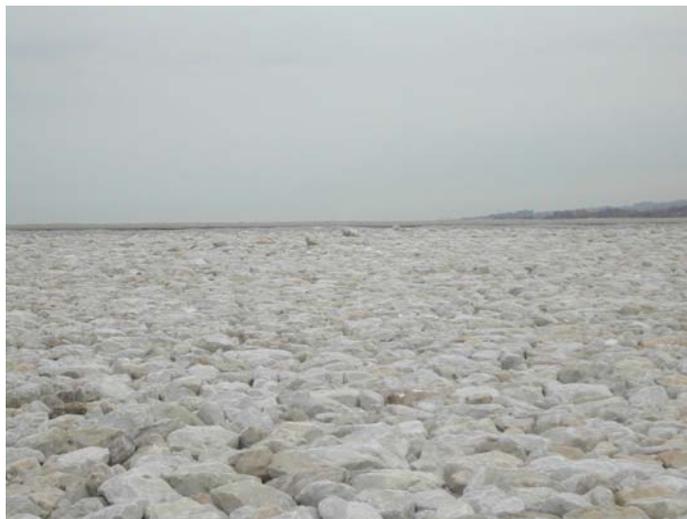
Photo 24. Rocks disturbed on top of cell.

The small area of surface disturbance that was noted at the base of the side slope near the northwest corner of the cell during the 2004 inspection was re-evaluated and determined to not exist. This area of disturbance was initially identified by the presence of different-colored side slope rocks present on top of the toe apron. Upon further inspection, it was apparent that a small area of the side slope had not slipped to rotate the rocks.

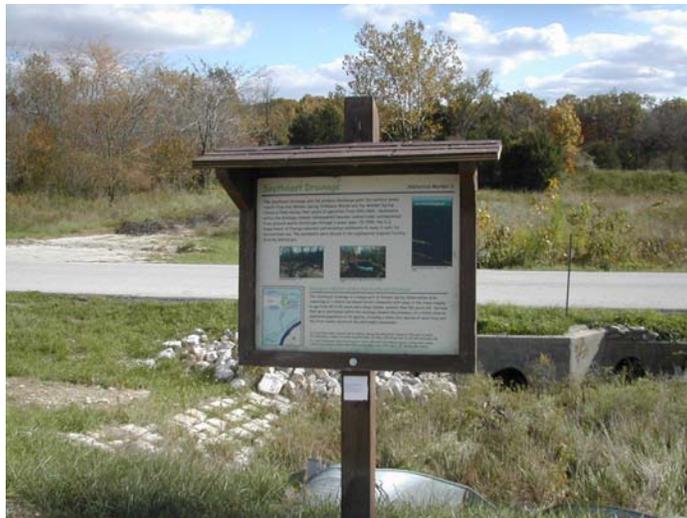
Photo 26. Historical Marker #3.

The four information plaques on top of the cell were generally in good condition. The faces of the bronze plaques have been scratched and a repair kit was purchased to repair the scratches. The pedestal on the south side of the viewing platform was eroded under the southeast corner (Photo 25). The historical markers were inspected prior to the inspection on October 27, 2005, and found to be in good condition. Photos were taken of each marker. Marker #3 is shown in Photo 26.
