2010 Annual Inspection Report for the Weldon Spring, Missouri, Site

January 2011

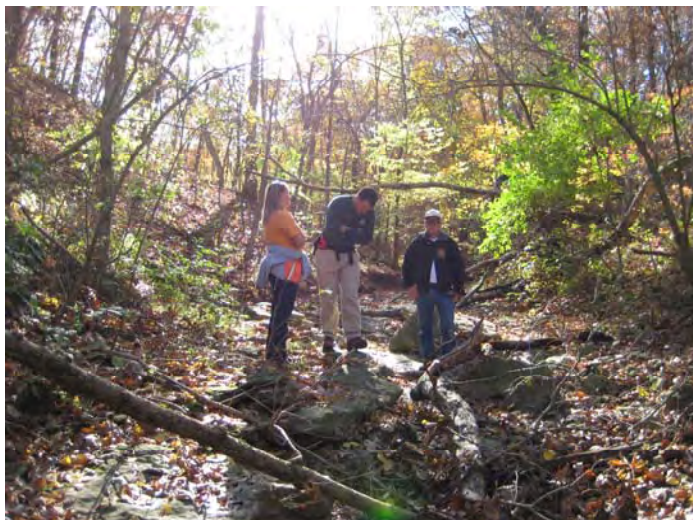
Photo 3. Southeast drainage.

Inspection Results: The inspectors walked down the entire Southeast Drainage (Photo 3) and no indications of residential use, construction, or any other activity that would indicate non-recreational use of the area were observed. The springs also were inspected and no indications of residential, commercial, or agricultural use of the springs were observed. Both of the springs were observed to be flowing. Current land use remains consistent with planned institutional controls.

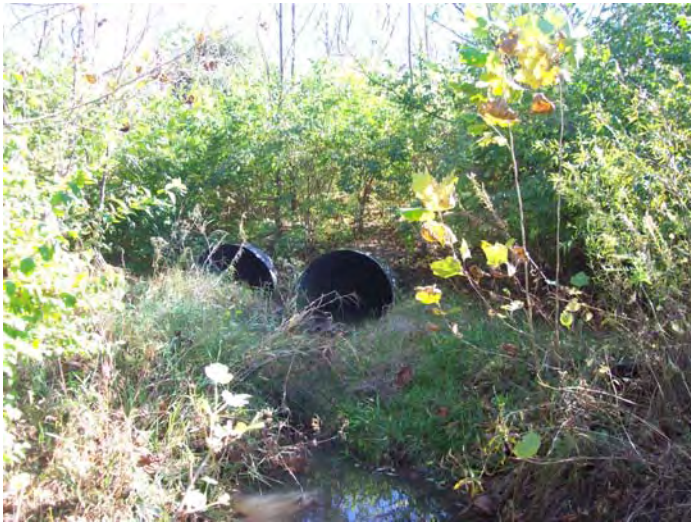
Photo 4. Highway D culverts outlet.

Inspection Results: The Highway D culverts were inspected (Photo 4). No disturbance or changes were noted. It was noted that MoDOT plans to widen the shoulders on Hwy. D next spring, therefore, DOE has agreed to work with MoDOT and assist in removing the contaminated culverts and soil in this area. Coordination is underway regarding this activity.

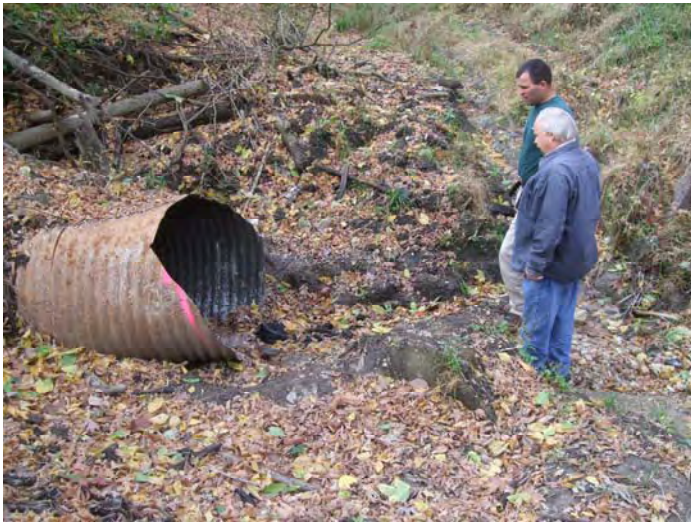
Photo 5. Culvert under Highway 94.

Inspection Results: The State Route 94 culvert was inspected and it was noted that Stoller representatives had cut off a portion of the culvert (Photo 5) in August 2010 at the request of MoDOT. The culvert pieces that were removed are stored in a container in a Conex box behind the LCRS building.

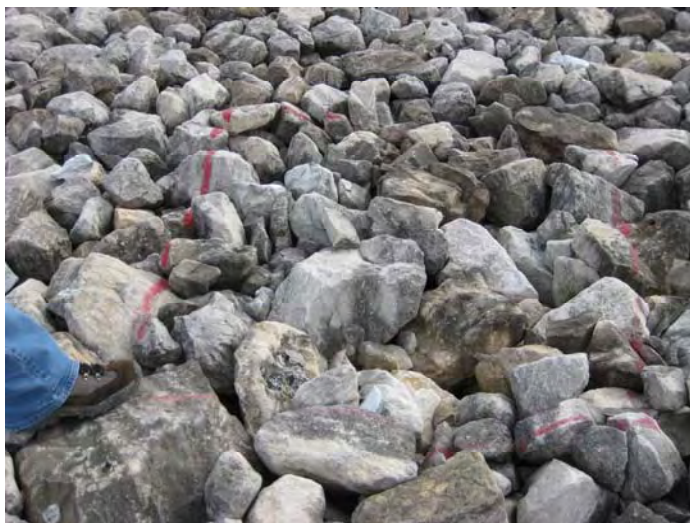
Photo 21. Cell cover test plot TP5; located on lower west side.

Remarks *The 5 rock degradation test plots were compared to previous years photos. The rocks had not changed or degraded. ~~So~~ The rocks in Test Plot #5 had been disturbed with 3 rocks being removed.*

4. Recommendation: Place signs on the disposal cell stating that video surveillance is in use or similar type action. This is in response to vandalism on the disposal cell, including disturbance of Test Plot #5.

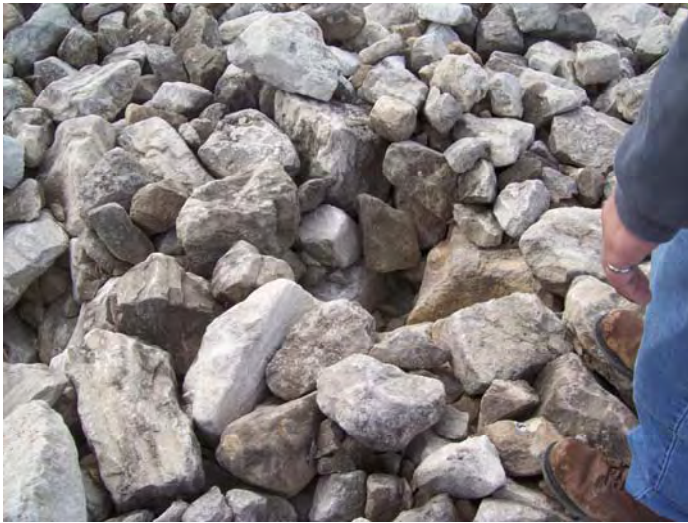
Photo 22. Disposal cell, small hole dug into rock.

2. **Vandalism** Location shown on site map Vandalism noted Yes No
Remarks Rocks were moved to form a small hole on the disposal cell along Transect #5
Rocks were removed from Test Plot #5
The Plaques on top of the cell have been vandalized

Remarks *The inspectors walked the 10 transects. Noted 2 additional minor depressions which will be put on map. Hole dug near transect 5. Aerial survey was performed in May 2010. Was discussed during inspection. Aerial survey indicated general settlement. No major changes*

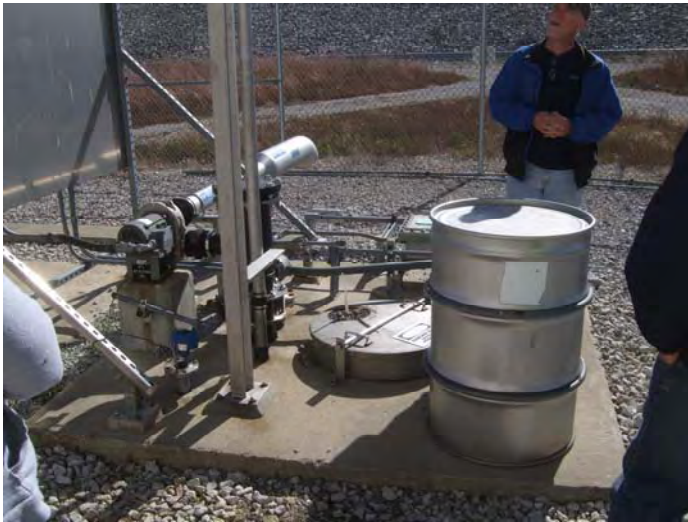
Photo 23. LCRS Sump.

Operations of the LCRS were discussed with site personnel and the system was inspected (Photo 23). The fences and doors were locked and in good condition. The system was functioning as designed. The LCRS data and documentation were reviewed during the document review period of the inspection and the following information was checked and verified that it was available: sampling data, LCRS flow rates, action leakage rate information, “burrito” system flow rates, and leachate data. As required by the LTS&M Plan, the leachate production rates, analytical results, and disposal information are provided in Appendix D.

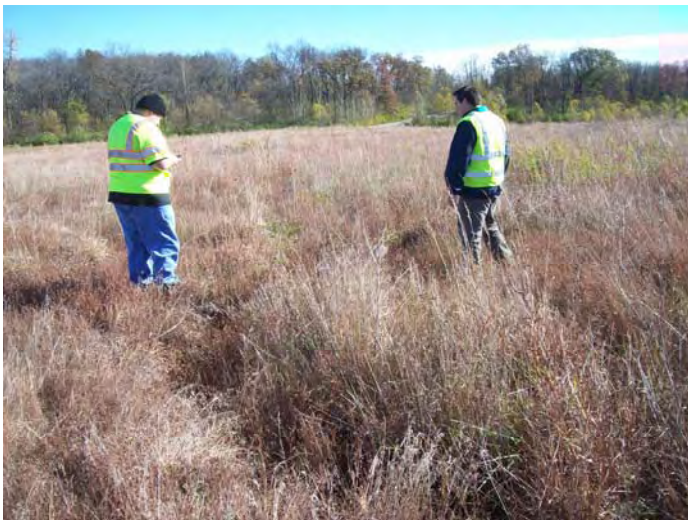
Photo 24. Erosion areas north of the disposal cell, showing vegetative growth.

It was noted during the 2010 inspection that vegetation had taken over some of the worse erosion areas located on the north side of the disposal cell considerably (Photo 24).

6. Recommendation: Continue to monitor and evaluate erosion on the Chemical Plant Site.
