2011 Annual Inspection Report for the Weldon Spring, Missouri, Site

January 2012

Legacy
Management

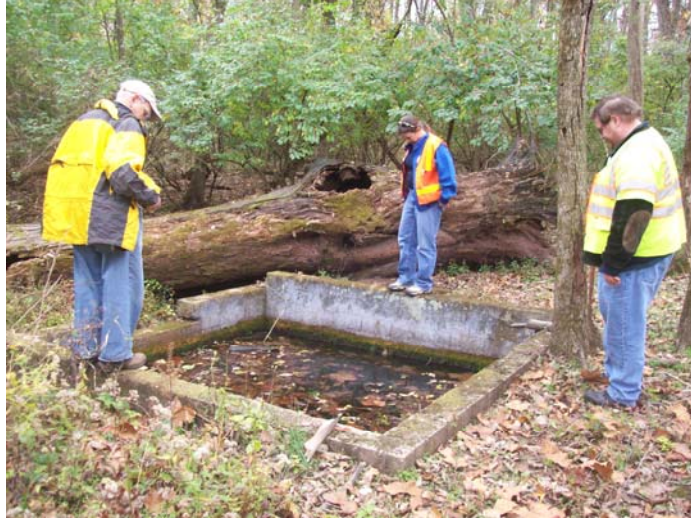
Photo 1. Burgermeister Spring.

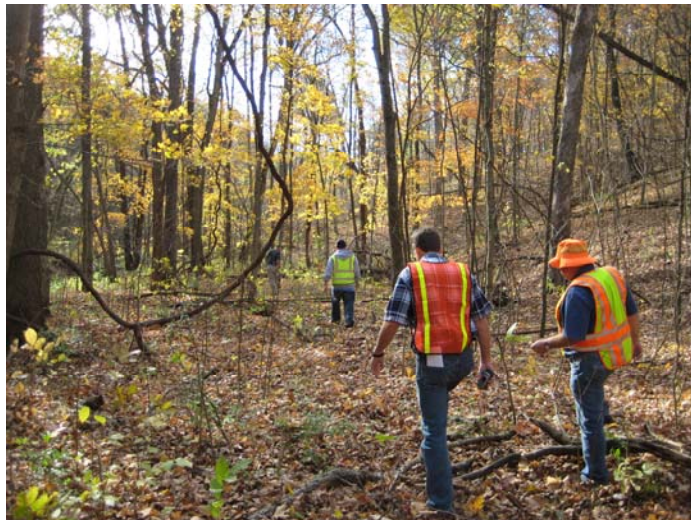
Inspection Results: The inspectors walked down the entire Southeast Drainage (Photo 2) and no indications of residential use, construction, or any other activity that would indicate non-recreational use of the area were observed. The springs also were inspected and no indications of residential, commercial, or agricultural use of the springs were observed. Both of the springs were observed to be flowing. A large tree is partially covering Spring 5304 and the spring is no longer a ponded area. Current land use remains consistent with planned institutional controls. Monitoring well MW-4026 needed painting. It was noted that erosion is occurring under the culvert which crossed under the Hamburg Trail. John Vogel of MDC noted this issue during the inspection as they are responsible for maintenance of the Hamburg Trail under a formal agreement between DOE and MDC.

Photo 2. Southeast Drainage.

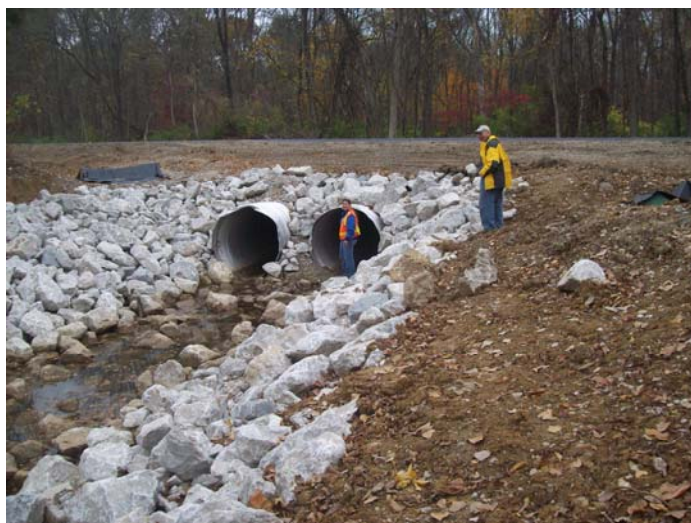
Inspection Results: The Highway D culverts were inspected (Photo 3). The culverts were replaced in August 2011. The culverts which had fixed contamination were removed by DOE in coordination with MoDOT during a road construction project. Confirmatory soil sampling conducted after culvert removals indicated that no radiological contamination existed over the stipulated action level of 1.5 times background activity levels. The culvert sections were relocated to a temporary staging area located on DOE property and will be disposed of at a low-level radiological disposal facility. These new culverts will no longer be inspected by DOE and will be removed from the LTS&M Plan and the checklist.

Photo 3. Hwy. D culverts outlet.

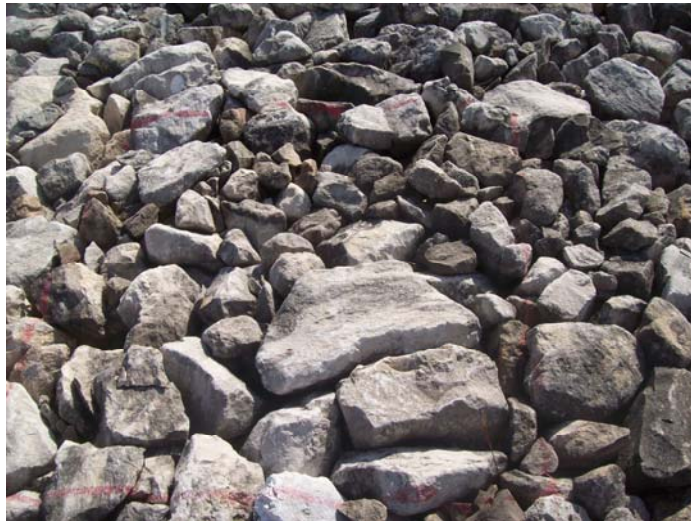
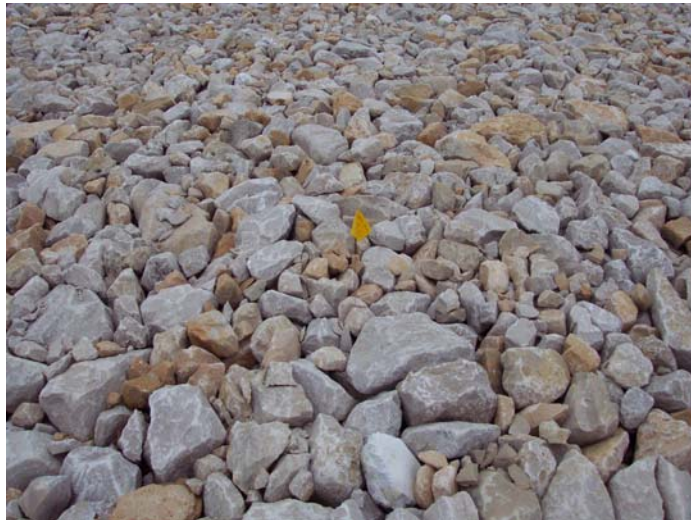
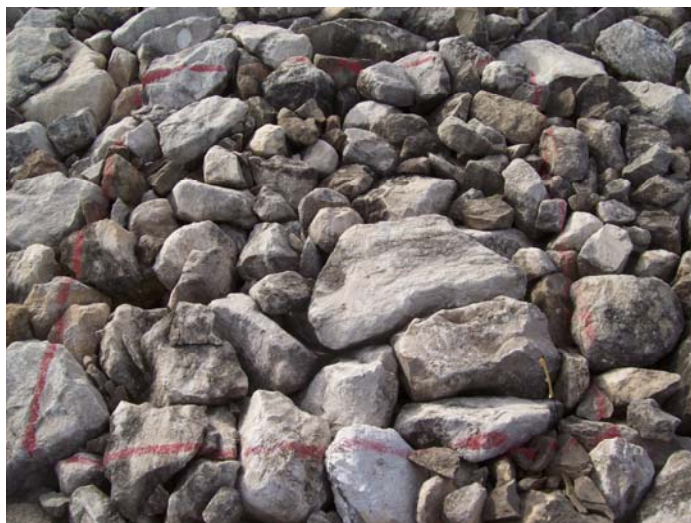
Photo 4. 2011-Cell cover test plot TP1; north edge of north facet.

Photo 5. 2003-TP1; north facet of the disposal cell cover.

Photo 6. 2010-Cell cover test plot TP1; north edge of north facet.

Remarks The 5 rock degradation test plots were compared to previous years photos. The rocks had not changed or degraded. New Test Plot # 6 was established and photographed as a baseline. Need to repaint the areas

2. Recommendation: Repaint Rock Degradation Test Plots

Action: Repaint Rock Degradation Test Plots

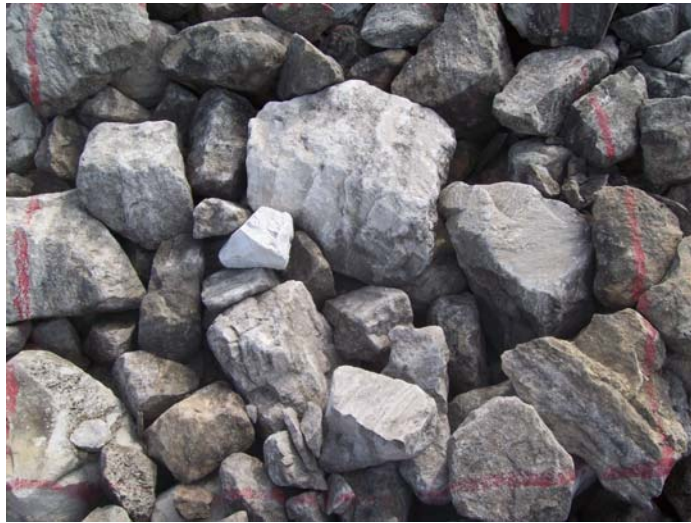
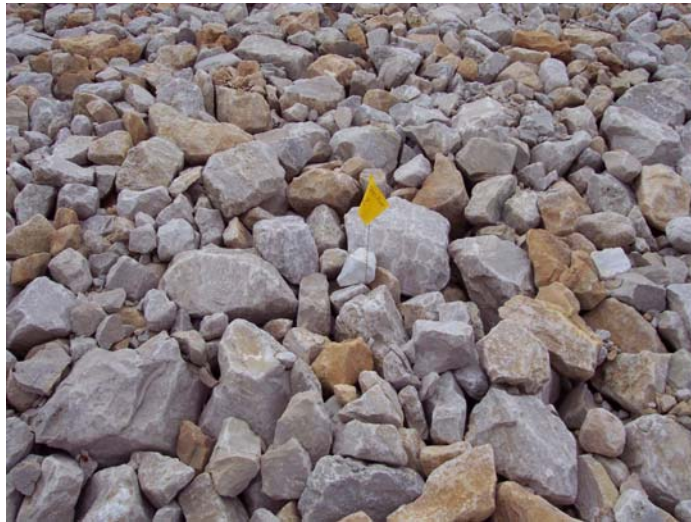
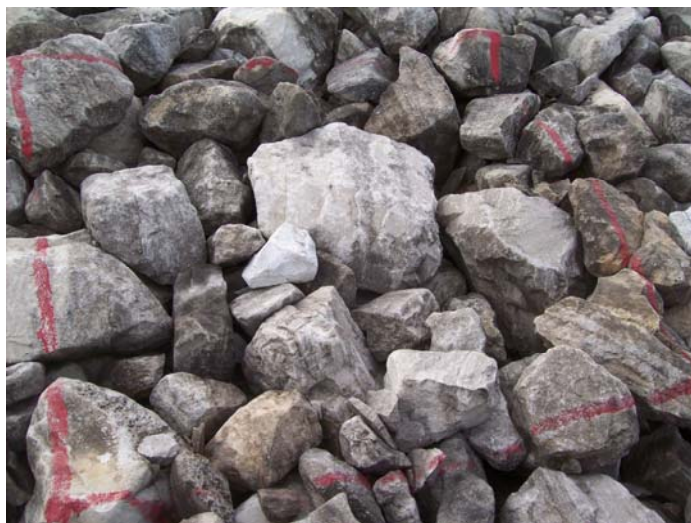
Photo 7. 2011-Cell cover test plot TP2; bottom of north side slope.

Photo 8. 2003-TP2; foot of north side slope of disposal cell.

Photo 9. 2010-Cell cover test plot TP2; bottom of north side slope.

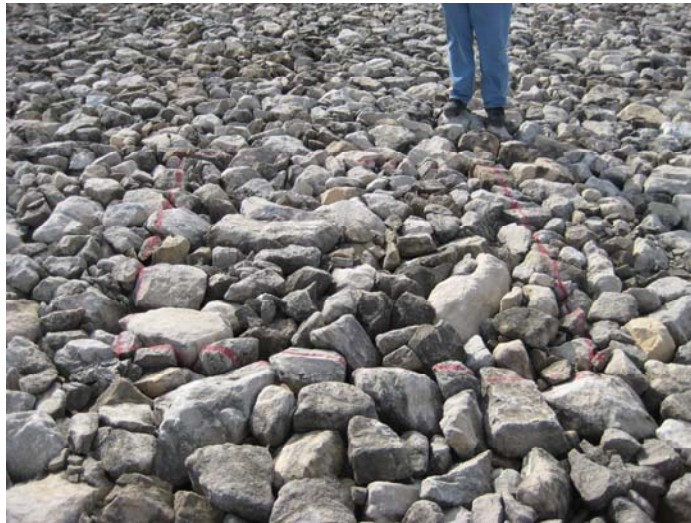
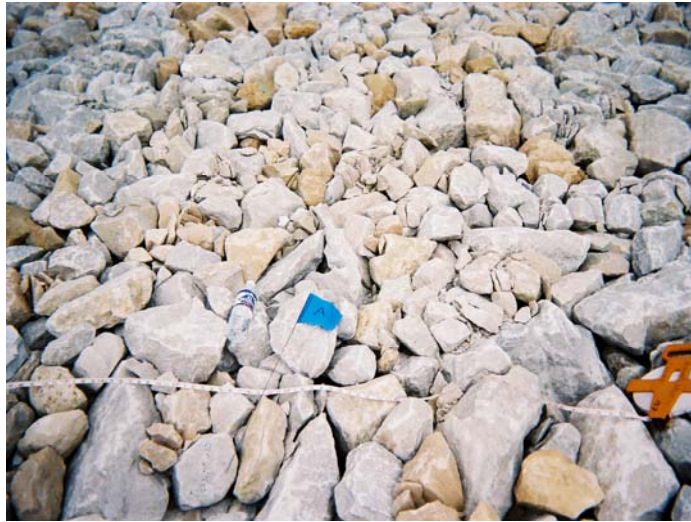
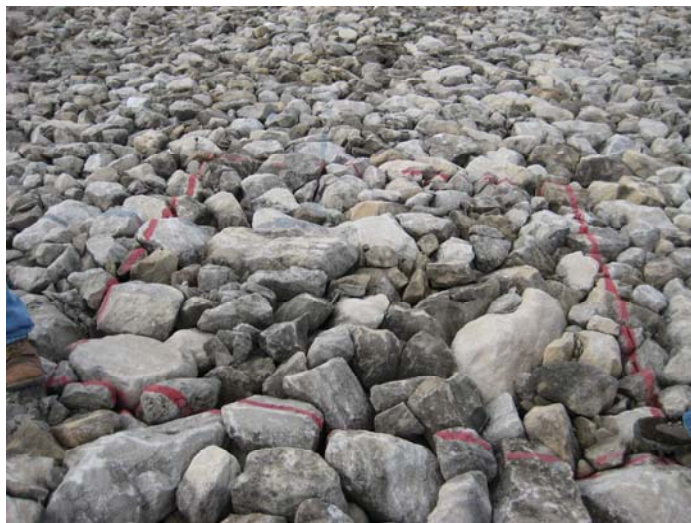
Photo 10. 2011-Cell cover test plot TP3; northeast ridgeline.

Photo 11. 2003-Cell cover test plot TP3; northeast ridgeline.

Photo 12. 2010-Cell cover test plot TP3; northeast ridgeline.

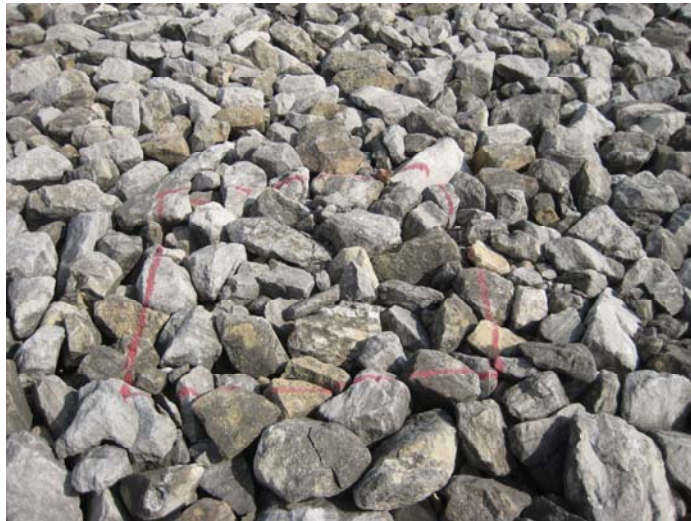
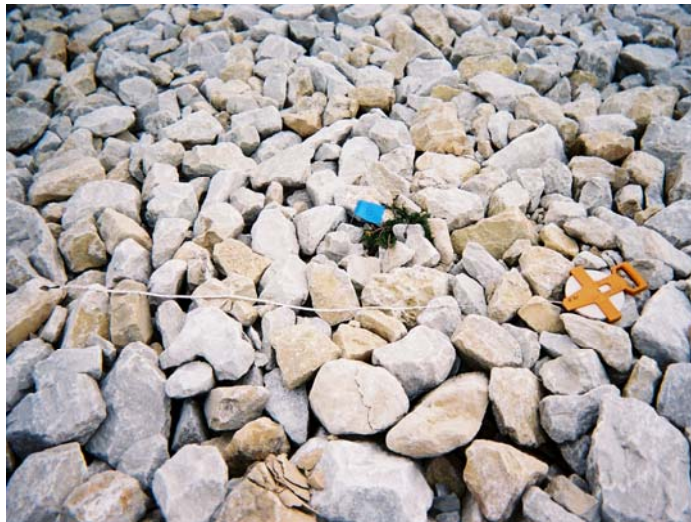
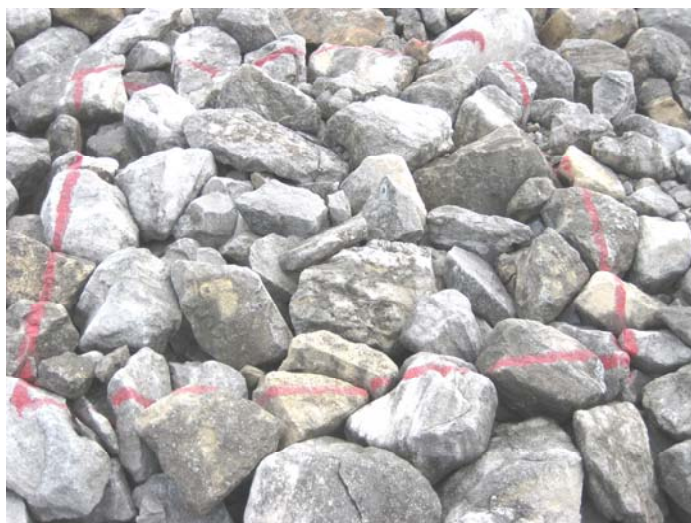
Photo 13. 2011-Cell cover test plot TP4; located on upper west side.

Photo 14. 2003-Cell cover test plot TP4; located on upper west side.

Photo 15. 2010-Cell cover test plot TP4; located on upper west side.

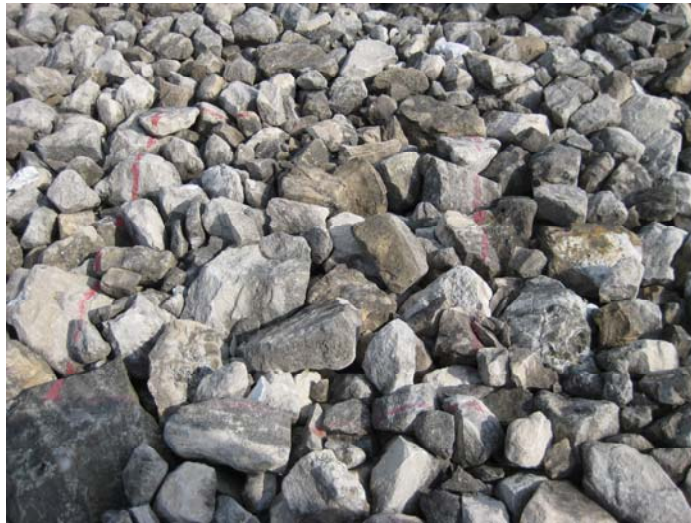
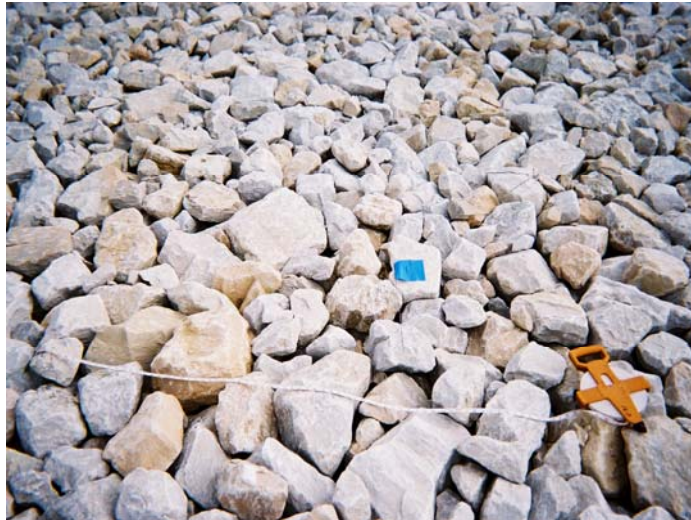
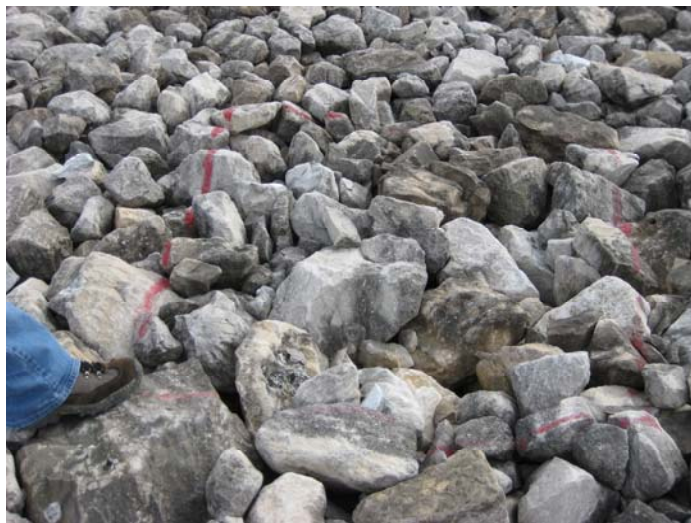
Photo 16. 2011-Cell cover test plot TP5; located on lower west side.

Photo 17. 2003-Cell cover test plot TP5; located on lower west side.

Photo 18. 2010-Cell cover test plot TP5; located on lower west side.

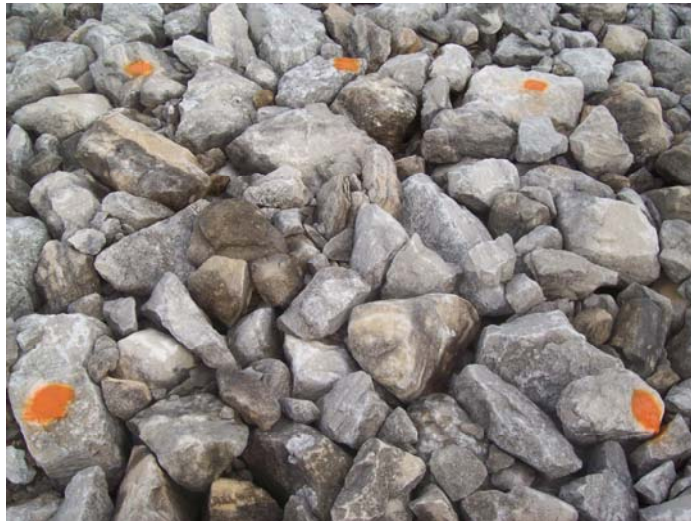
during the 2010 inspection. A new test plot (Test Plot #6) had been marked during 2011 in response to a request from MDNR during the 2010 inspection. This new plot is located on the southern face of the disposal cell (Figure 7). A photograph was taken during the inspection as a baseline (Photo 19). It was noted during the inspection that the painted lines around the test plots had faded a great deal and it was recommended that the lines be repainted.

Photo 19. Cell cover test plot TP6; located on upper south side.

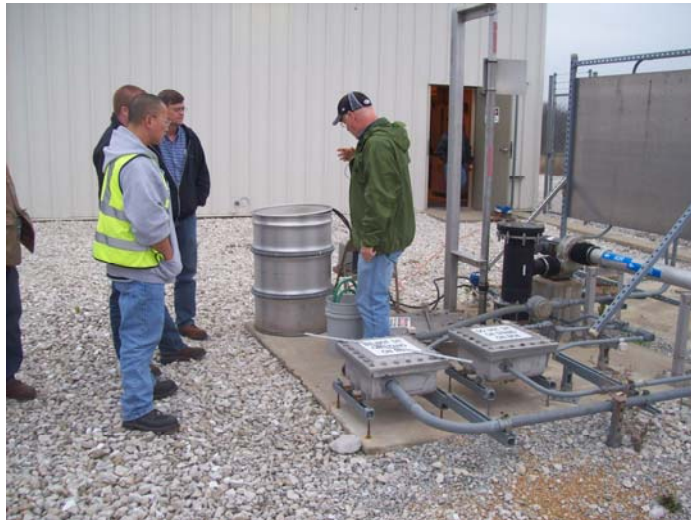
Operations of the LCRS were discussed with the inspection participants, the LCRS data and the SOARS system was presented, and the system was inspected (Photo 20). The fences and doors were locked and in good condition. The system was functioning as designed. As required by the LTS&M Plan, the leachate production rates, analytical results, and disposal information are provided in Appendix D. It was requested to provide the leachate reports to MDNR and EPA and to copy them on the monthly emails which include a summary of the leachate data each month.

Photo 20. Sump outside LCRS Building.
