**Monticello, Utah, National
Priorities List (NPL) Sites
Federal Facility Agreement
(FFA) Quarterly Report:
April 1–June 30, 2022**

July 2022

U.S. DEPARTMENT OF
ENERGY

Legacy
Management

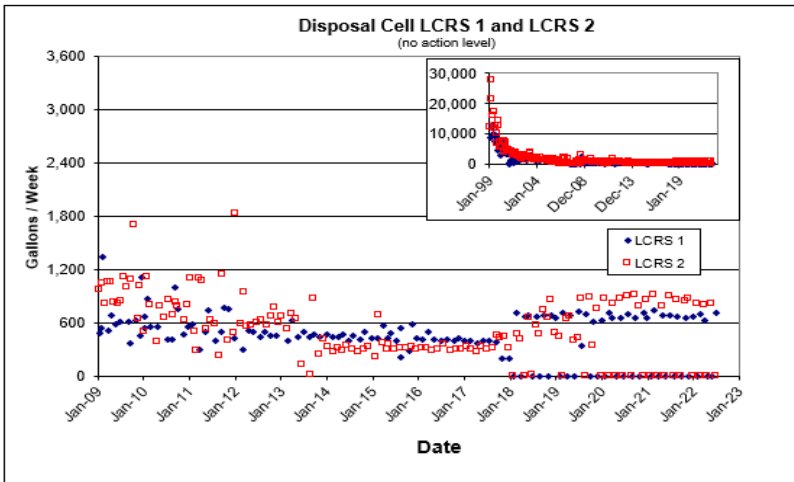
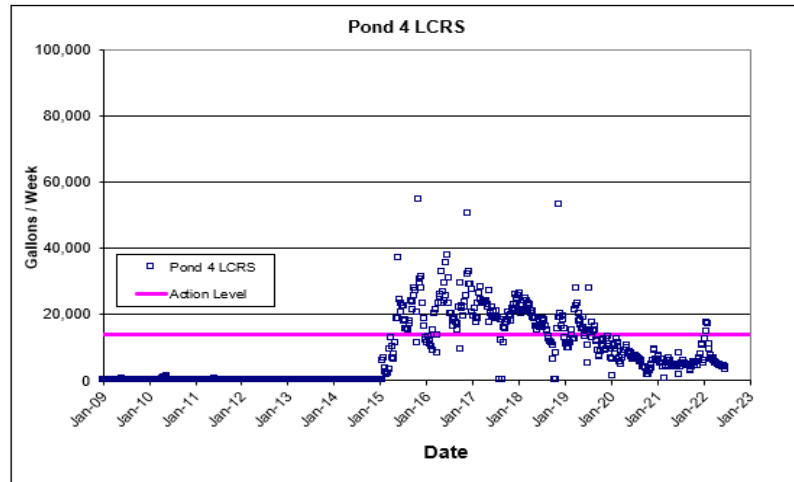
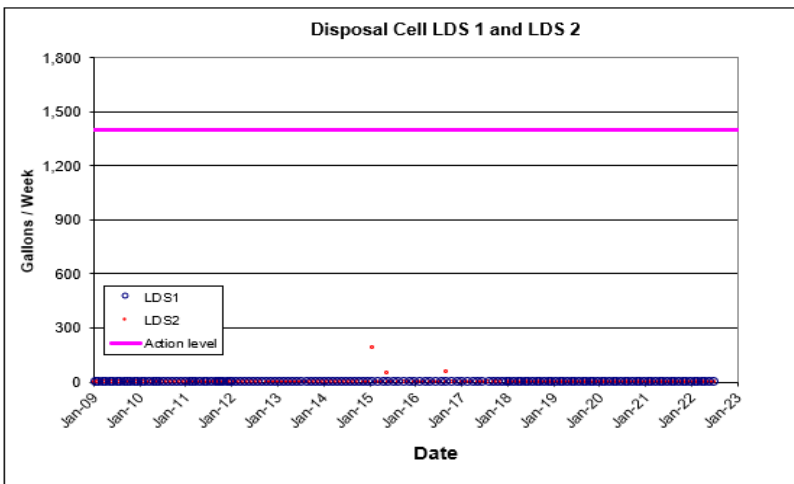
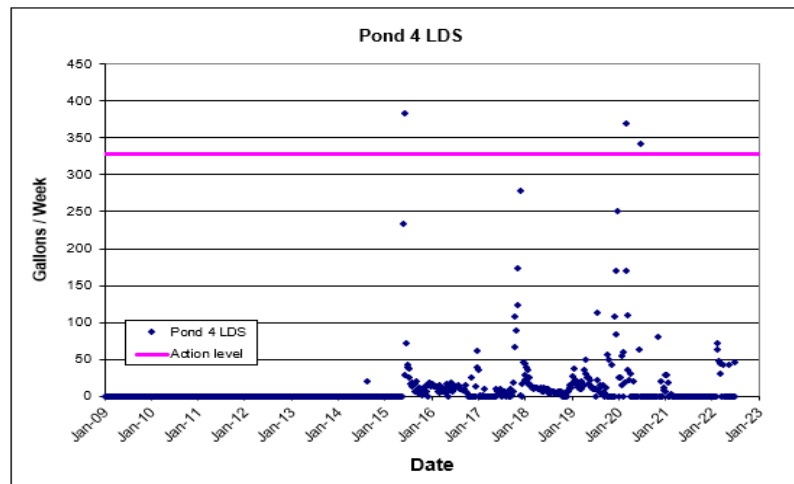
Graphs Showing Performance History for Disposal Cell and Pond 4 LCRS and LDS

- Leachate production from the disposal cell was approximately 510 gallons per week combined for sumps LCRS 1 and LCRS 2. There is no action level for the disposal cell LCRS. See Appendix B for a graphical depiction of leachate production history.

- The disposal cell LDS continues to receive no water; therefore, the disposal cell LDS action level was not exceeded. See Appendix B for a graphical depiction of leachate production history.

- Findings for the Pond 4 LCRS and LDS this period are as follows:
 - Water collection at the Pond 4 LCRS continued but did not exceed the action level this quarter (see Appendix B).
 - Water collection in the Pond 4 LDS remained below the action level (see Appendix B).
