**Monticello, Utah, National
Priorities List (NPL) Sites
Federal Facility Agreement
(FFA) Quarterly Report:
July 1–September 30, 2022**

December 2022

Legacy
Management

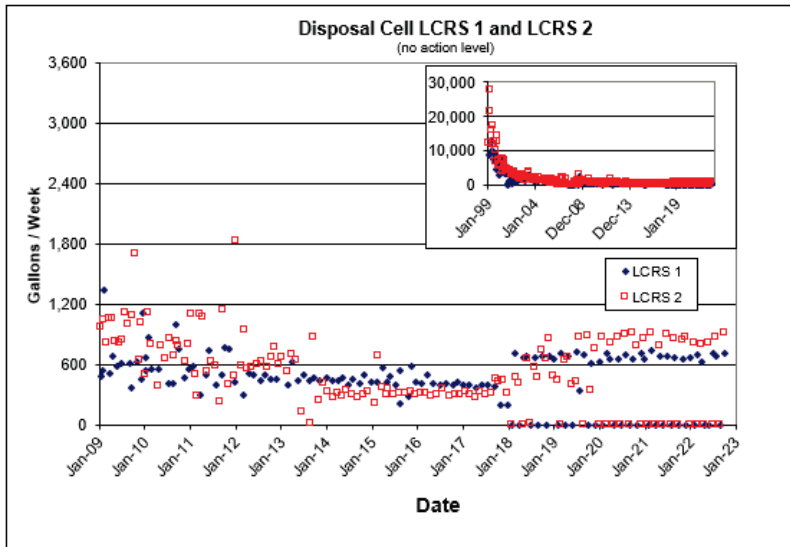
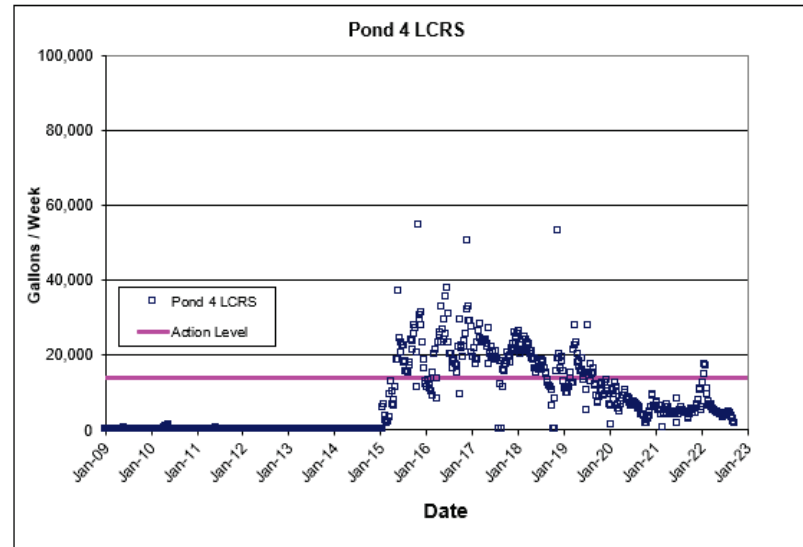
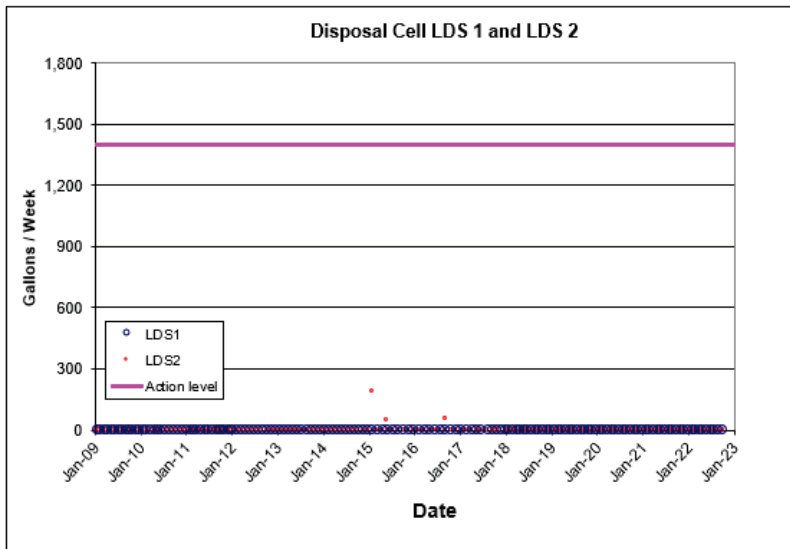
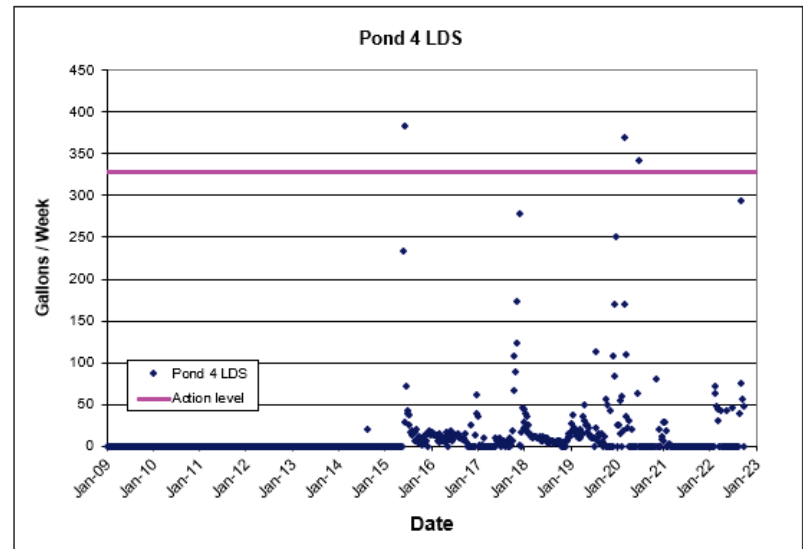
Graphs Showing Performance History for Disposal Cell and Pond 4 LCRS and LDS

- Leachate production from the disposal cell was approximately 1060 gallons per week combined for sumps LCRS 1 and LCRS 2. There is no action level for the disposal cell LCRS. See Appendix B for a graphical depiction of leachate production history.

- The disposal cell LDS continues to receive no water; therefore, the disposal cell LDS action level was not exceeded. See Appendix B for a graphical depiction of leachate production history.

- Findings for the Pond 4 LCRS and LDS this period are as follows:
 - Water collection at the Pond 4 LCRS continued but did not exceed the action level this quarter (see Appendix B).

- Water collection in the Pond 4 LDS remained below the action level (see Appendix B).
