**Long-Term Surveillance Plan  
for the  
DOE Bluewater (UMTRCA Title II) Disposal Site  
Near Grants, New Mexico**

July 1997

Prepared for  
U.S. Department of Energy  
Grand Junction Office  
Grand Junction, Colorado

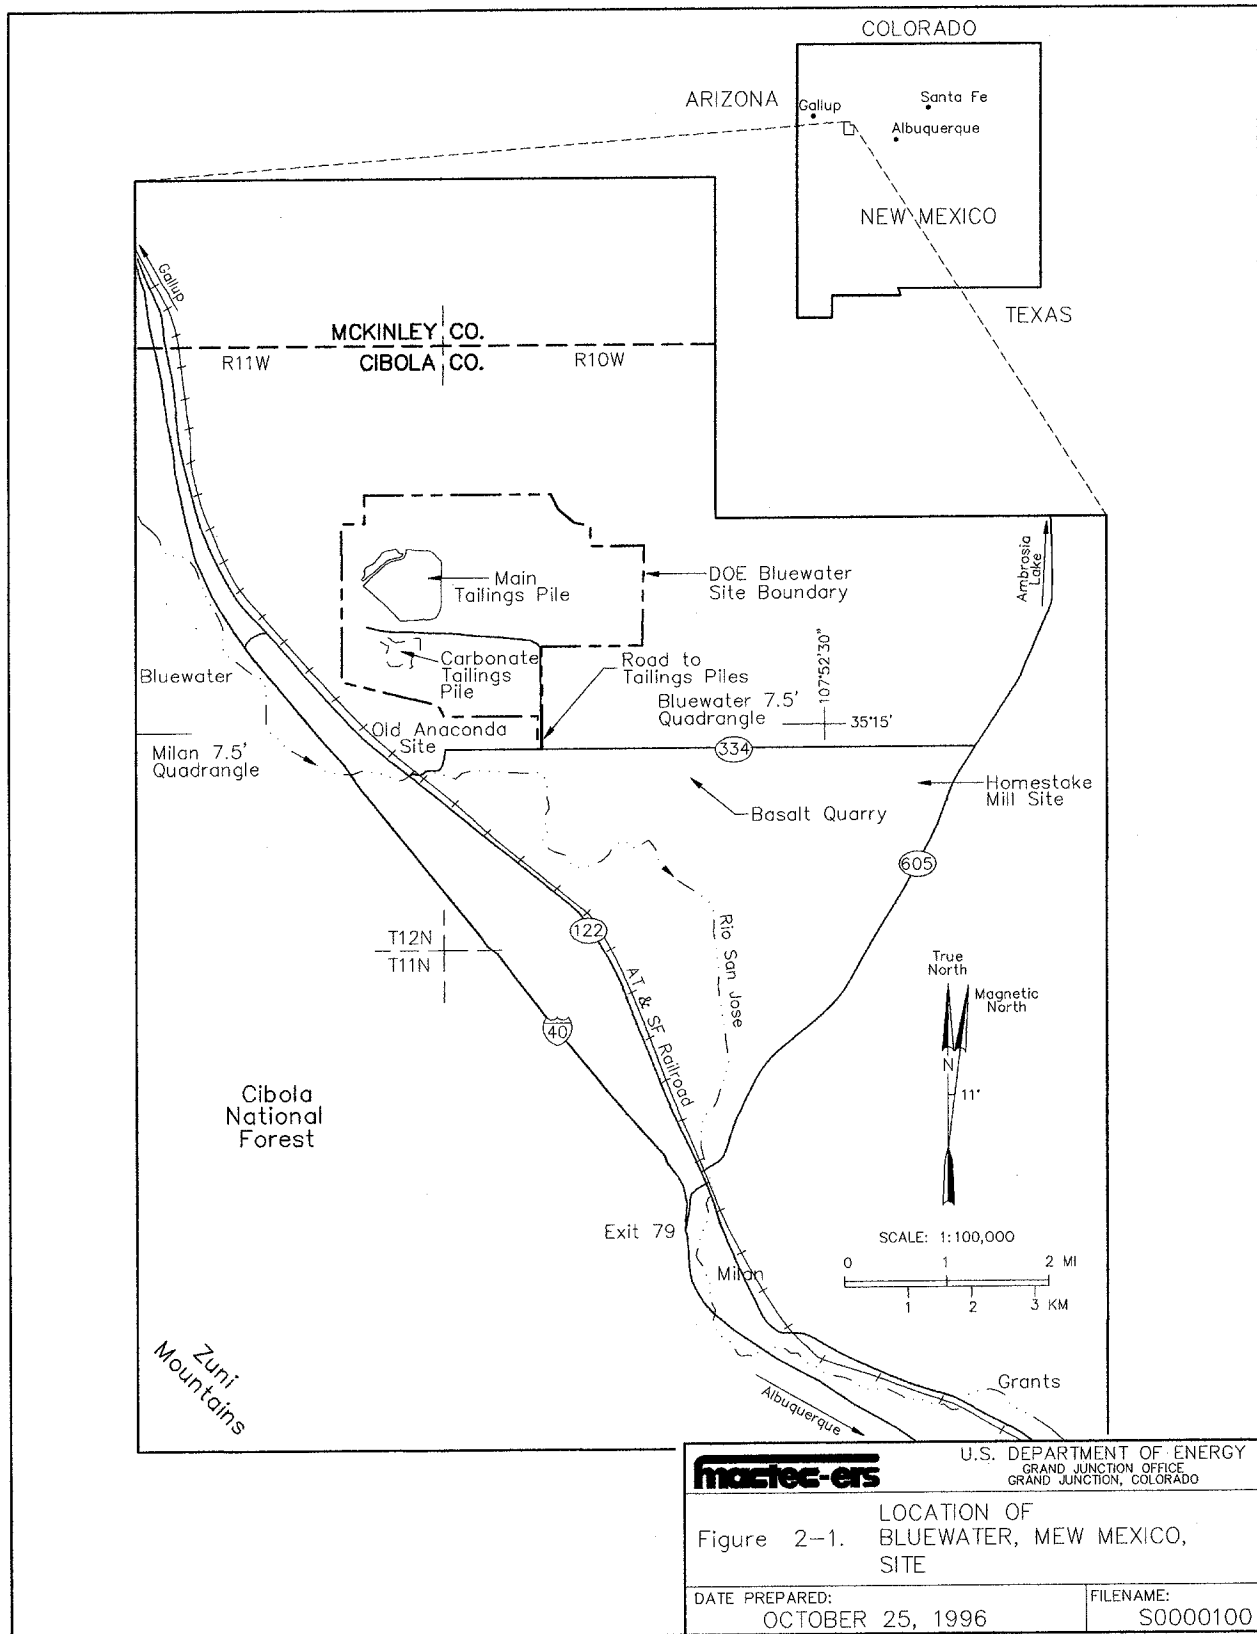
Figure 2-1. Location of Bluewater, New Mexico, Site

The Bluewater site is in the north-central part of Cibola (formerly Valencia) County in west-central New Mexico. The site is about 9 air miles (mi) (15 kilometers [km]) northwest of Grants, the county seat, and about 1.5 mi (2.4 km) northeast of the village of Bluewater. Between the village of Bluewater and the site is the transportation corridor containing Interstate 40, State Highway 122 (old U.S. Highway 66), and the main line of the Atchison, Topeka, and Santa Fe (AT&SF) Railroad. The location of the site is shown in Figure 2-1.

The Bluewater site at 35° 15-17' N and 107° 55-57' W is in the broad northwest-trending Grants-Bluewater Valley, which contains the southeasterly flowing Rio San Jose (Figure 2-1). The site property boundary is in the south-central part of the U.S. Geological Survey Bluewater 1:24,000-scale topographic map. The site encompasses approximately 3,300 acres (1,330 hectares [ha]) and is in Sections 7, 8, 17, 18, and 19, Township (T) 12 North (N), Range (R) 10 West (W), and in Sections 12, 13, and 24, T 12 N, R 11 W, New Mexico Principal Meridian. A legal description of the site property boundary is given in Appendix A. All real estate correspondence and instruments are maintained and filed by the Property Management Branch, DOE Albuquerque Operations Office. Access directions to the site from the Grants-Milan area to the southeast are shown in Table 2-1.

The site property is enclosed by a 4-strand barbed-wire fence that meets highway fence specifications. Steel T-posts are set on 16 ft (5 m) centers. The site entrance gate is at the southeast corner of the site along State Highway 334 (Figures 2-1 and 2-2). The site access road goes north from the gate along a DOE property easement about 0.25 mi (0.4 km) long to reach the main site property. No prior notification or permission from property owners adjacent to the site is necessary for access to the site. The entrance gate is locked and a key is held by the DOE-GJO Project Manager, who should be contacted for access to the site (Table 2-2).

In January 1986, Anaconda changed its name to ARCO Coal Company and later that year, the NRC assumed regulatory authority over the site. In 1987, houses were removed from the old Anaconda housing area south of the mill site (Figure 2-1). In November 1986, ARCO submitted a Reclamation Plan for the mill facilities to the NRC for review and approval. In early 1989, while the Reclamation Plan was undergoing NRC review, the NRC revised its slope stabilization and rock specifications, which in turn required modifications to the Plan. ARCO revised the *Reclamation Plan, Bluewater Mill* and resubmitted the three-volume Plan to the NRC in March 1990 (ARCO 1990b). The NRC approved the Reclamation Plan in August 1990.

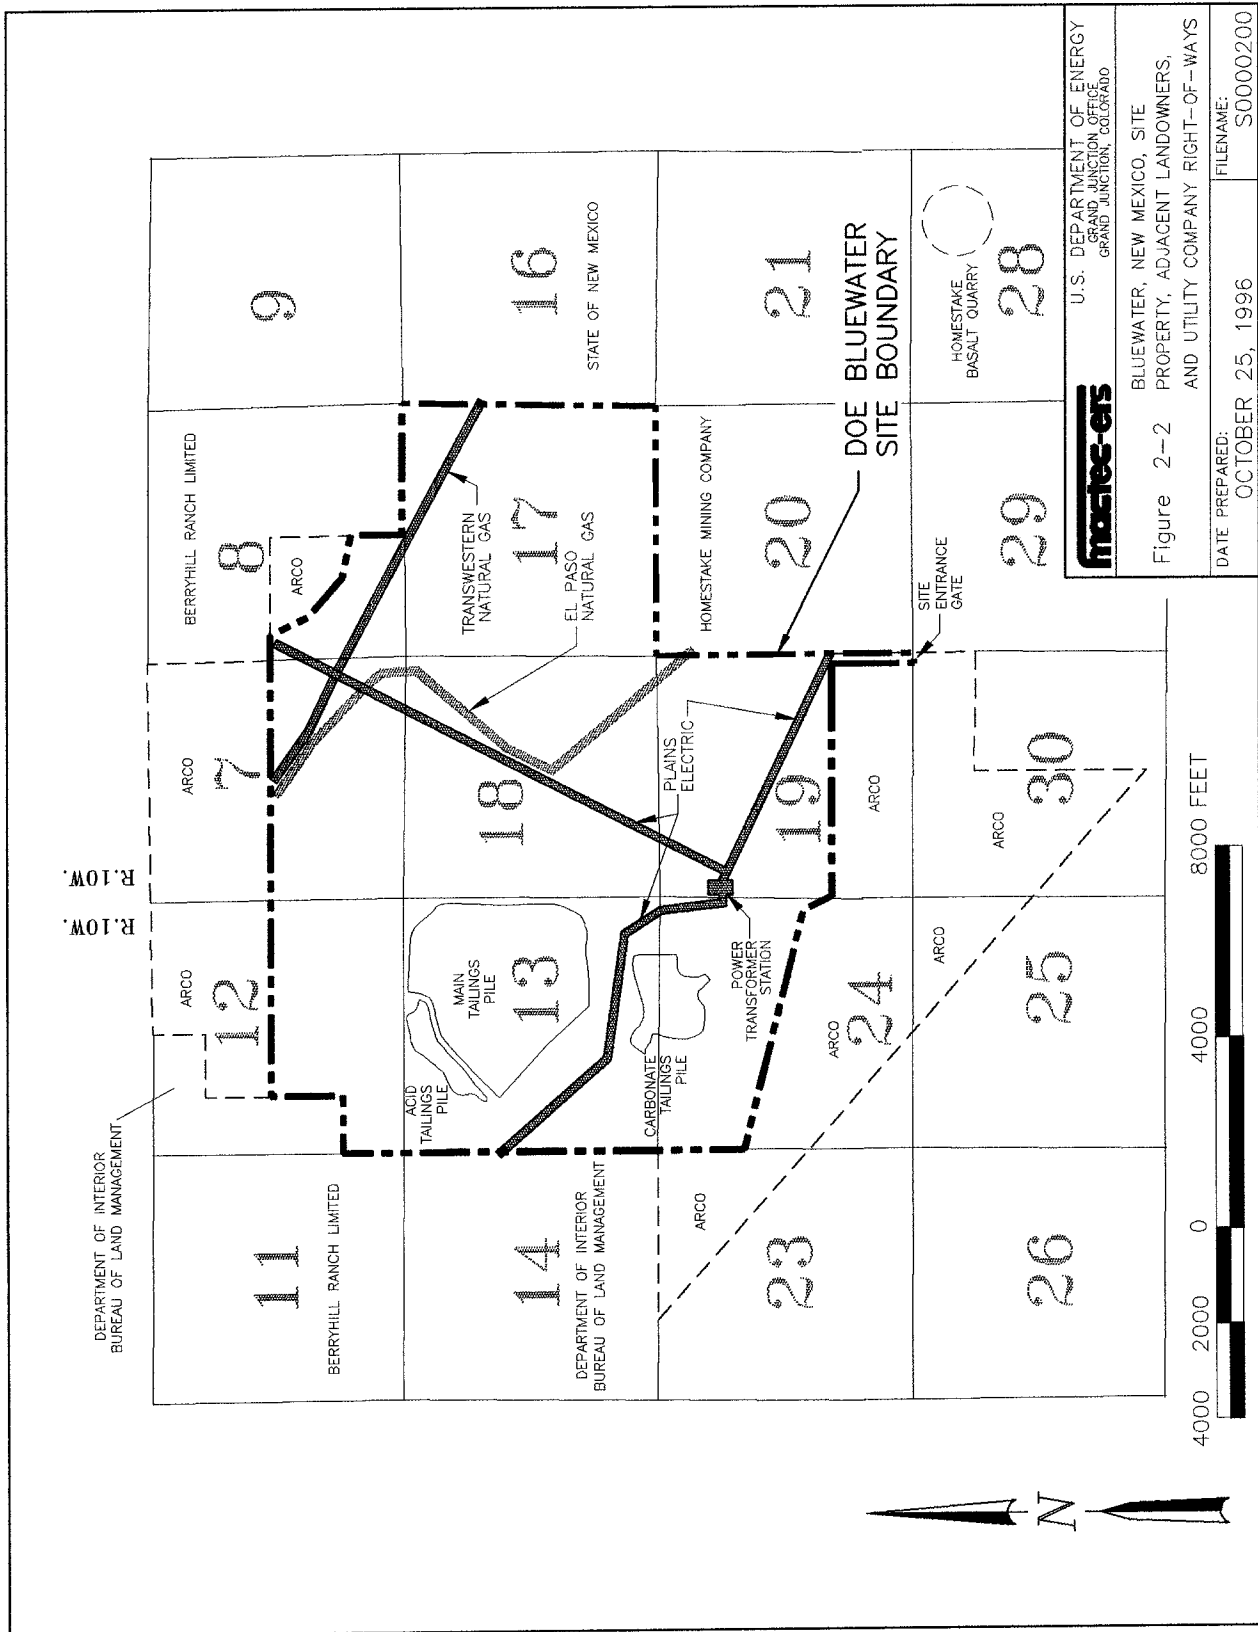
Figure 2-2. Bluewater, New Mexico, Site Property, Adjacent Landowners, and Utility Company Right-of-Ways

Several utility company right-of-ways pass across the site property (Figure 2-2). The legal description of each utility company right-of-way across the property is given in Appendix C. These right-of-way corridors are delineated by stock fence where they pass across the site property. Where each right-of-way intersects the site property fence, a vehicle access gate has been constructed in the site property fence. These gates are locked and a key to each lock is kept by the appropriate utility company. Where access roads inside the site property intersect a utility company right-of-way, two vehicle access gates have been constructed to allow travel across the right-of-ways. Gates at these crossings are locked and have the same key as the entrance gate. The Plains Electric Generation and Transmission Cooperative, Inc., in addition to its power line right-of-way, also has a tract 330 by 660 ft (100 by 200 m) that contains a power transformer station along its right-of-way in the south part of the site. The legal description of this tract is given in Appendix C. A chain-link fence about 7 ft (2.2 m) high has been constructed on the boundary of the power transformer station property tract.

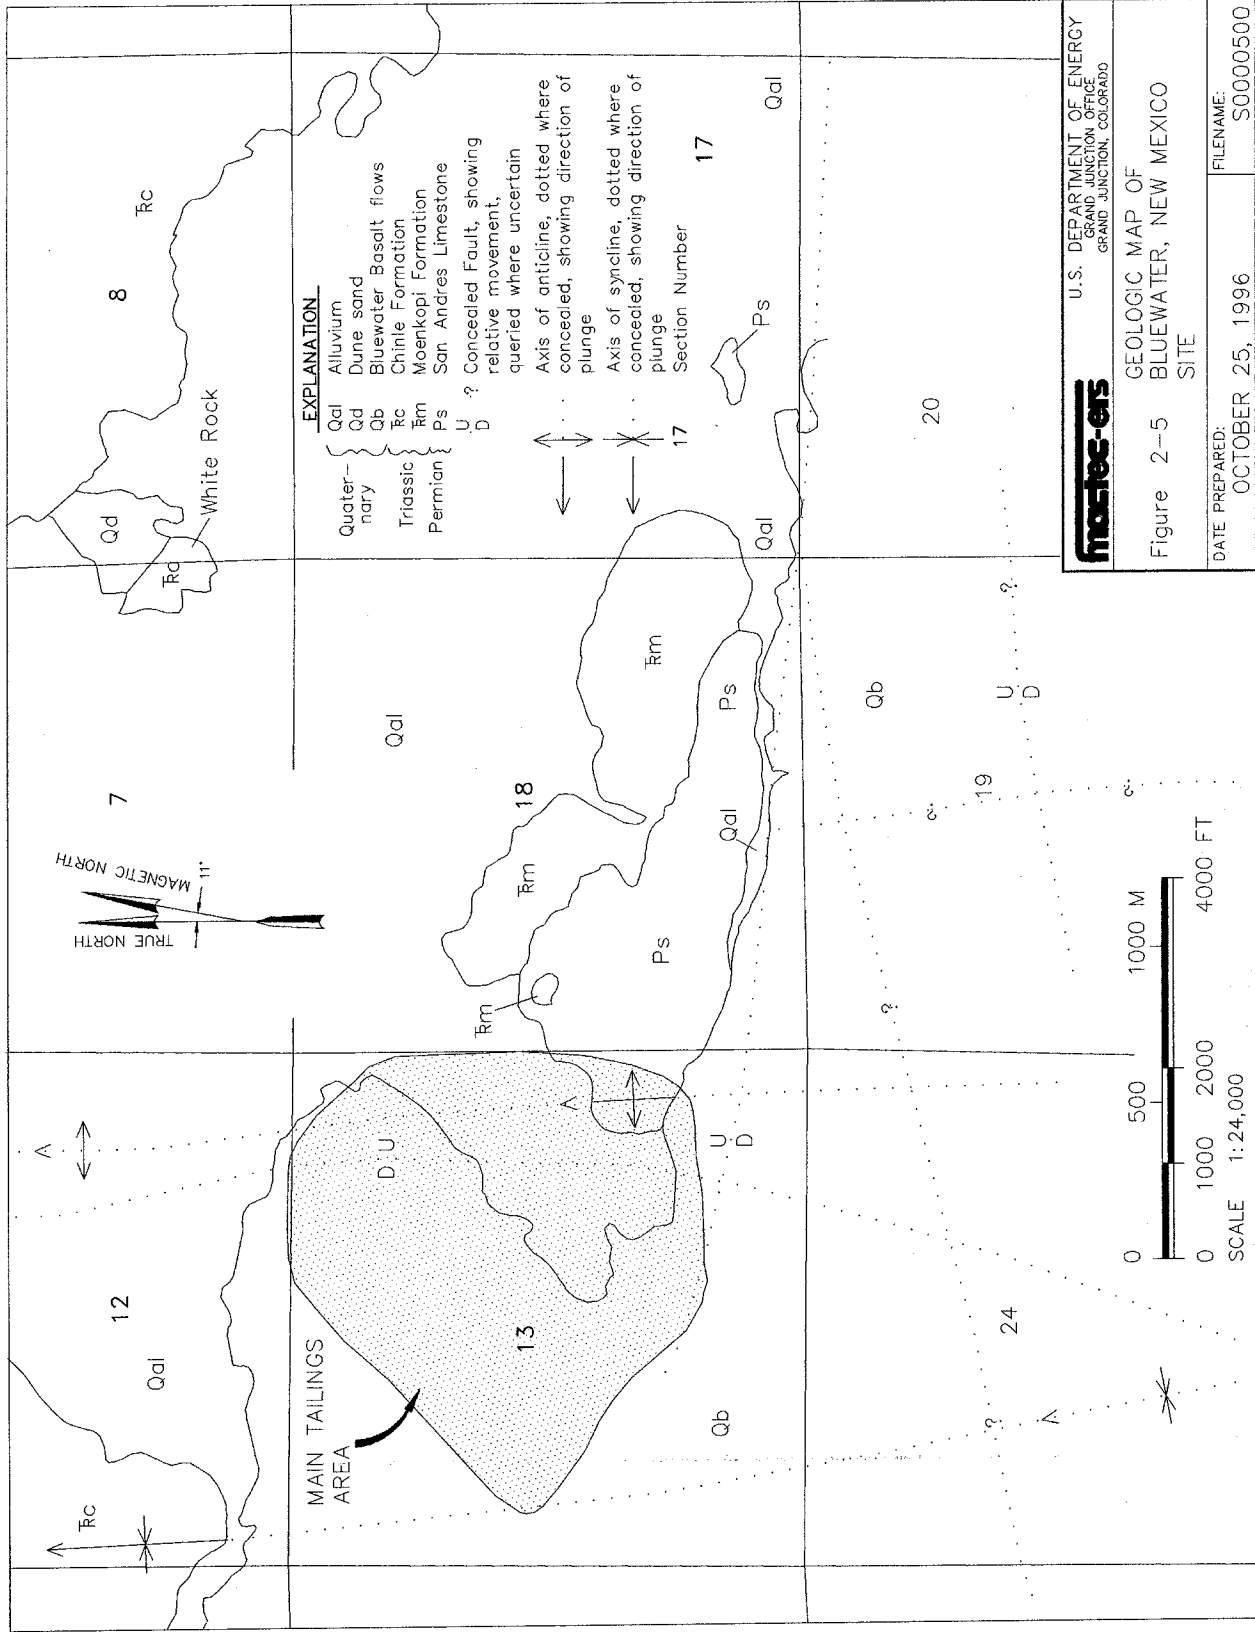
Figure 2-5. Geologic Map of Bluewater, New Mexico, Site

Geology of the Bluewater site is shown in Figure 2-5, which has been compiled and modified from the *Geologic Map of the Bluewater Quadrangle, Valencia and McKinley Counties, New Mexico* (Thaden and Ostling 1967) and from the geologic map, Plate 1, in *Geology and Ground-Water Resources of the Grants-Bluewater Area, Valencia County, New Mexico* (Gordon 1961). The following discussion of

geologic conditions at the site is summarized mainly from the section on "Geology and Geoseismicity" in Volume II of *Licensing Documentation* prepared by Dames and Moore (ARCO 1981).

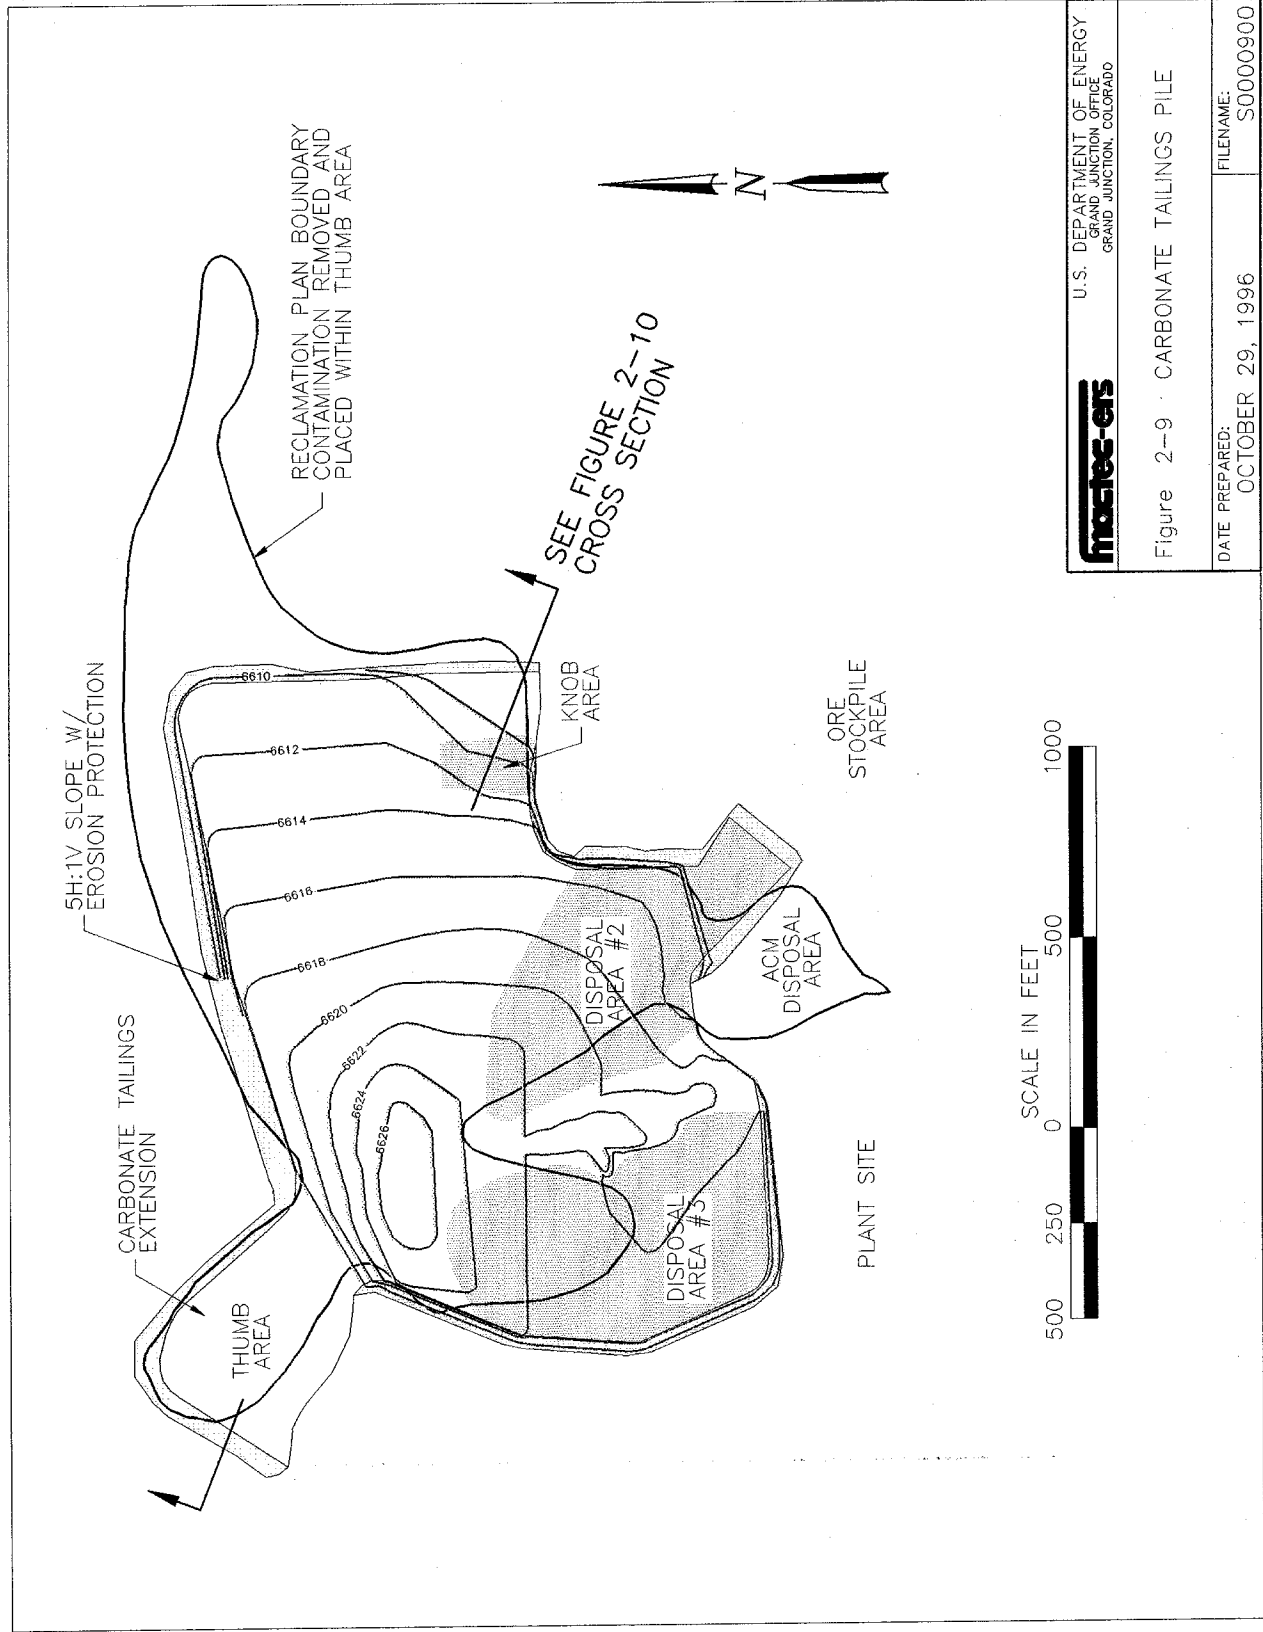
Figure 2-9. Carbonate Tailings Pile

The carbonate tailings pile contains tailings generated from the carbonate leach process that were deposited just northeast of the plant site from 1953 to late 1955. The carbonate pile shown in Figure 2-9 includes disposal areas no. 2 and no. 3, both of which were used for disposal of mill building debris, evaporation pond liner, and other rubble. Disposal area no. 2 is in the south part of the carbonate pile and disposal area no. 3 is in the southwest part of the pile. A typical cross section through the carbonate pile is shown in Figure 2-10.

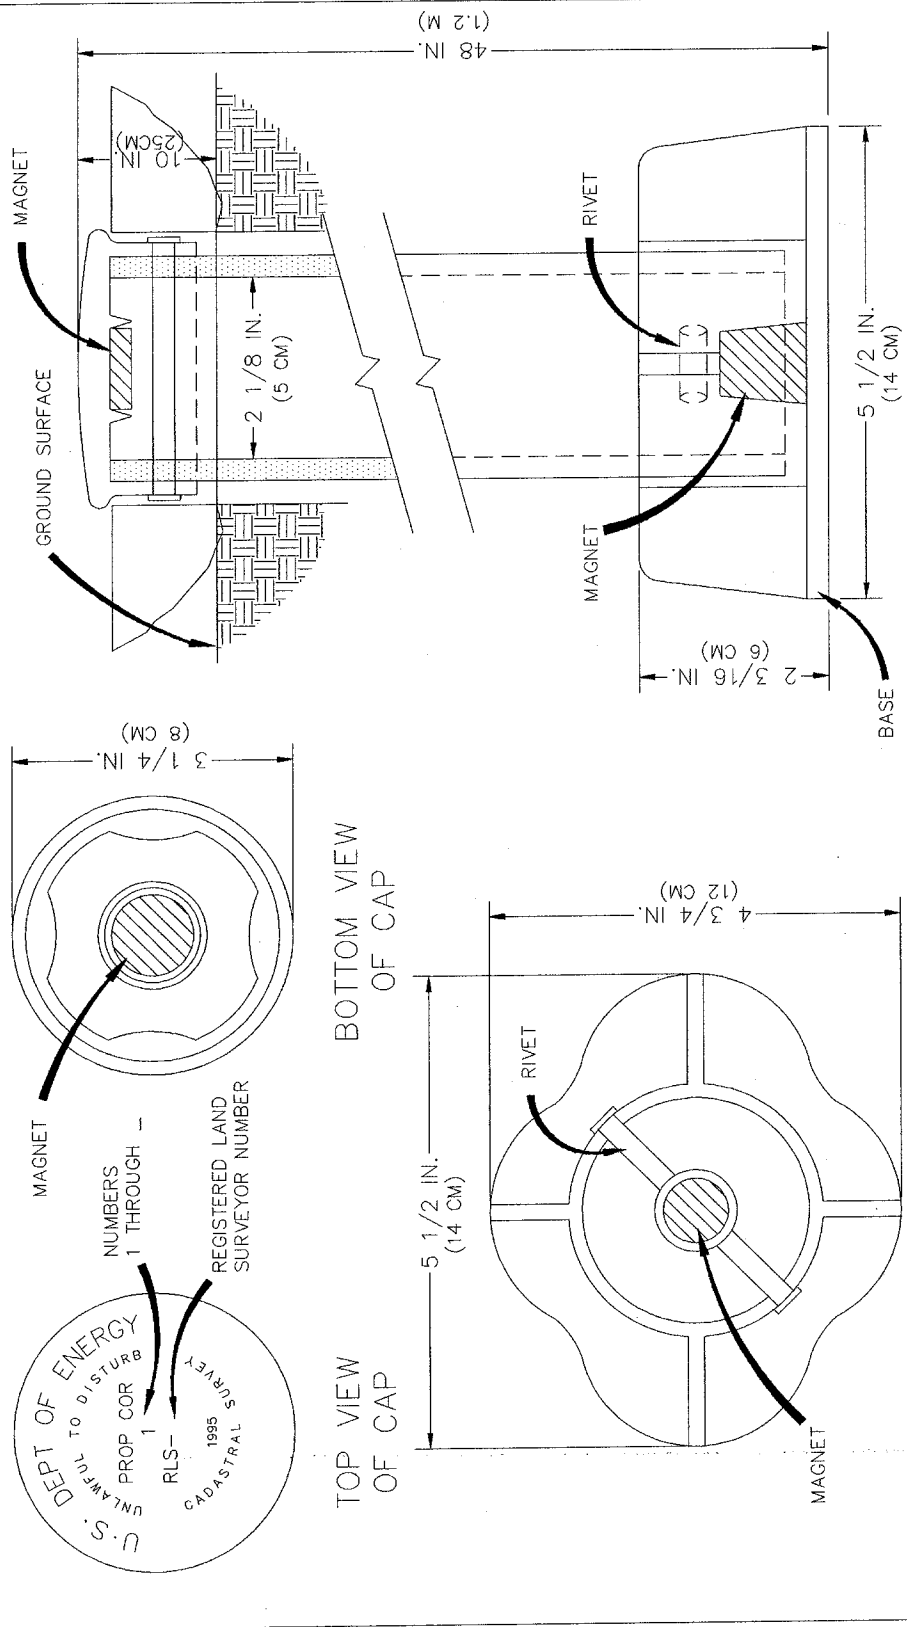
Figure 2-11. Boundary Monument at Bluewater, New Mexico, Site

Bernsten Federal aluminum survey monuments, Model A-1, were used for the 24 boundary monuments (Figure 2-11). Ceramic magnets are epoxied into the cap and base of each monument and are vertically oriented so that the monument can easily be found if it becomes buried. The monuments are set with the base 38 in. (97 cm) below ground surface and 10 in. (25 cm) above ground surface (Figure 2-11).

BERNTSEN FEDERAL ALUMINUM BOUNDARY MONUMENT, MODEL A-1, STANDARD LOGO CAP

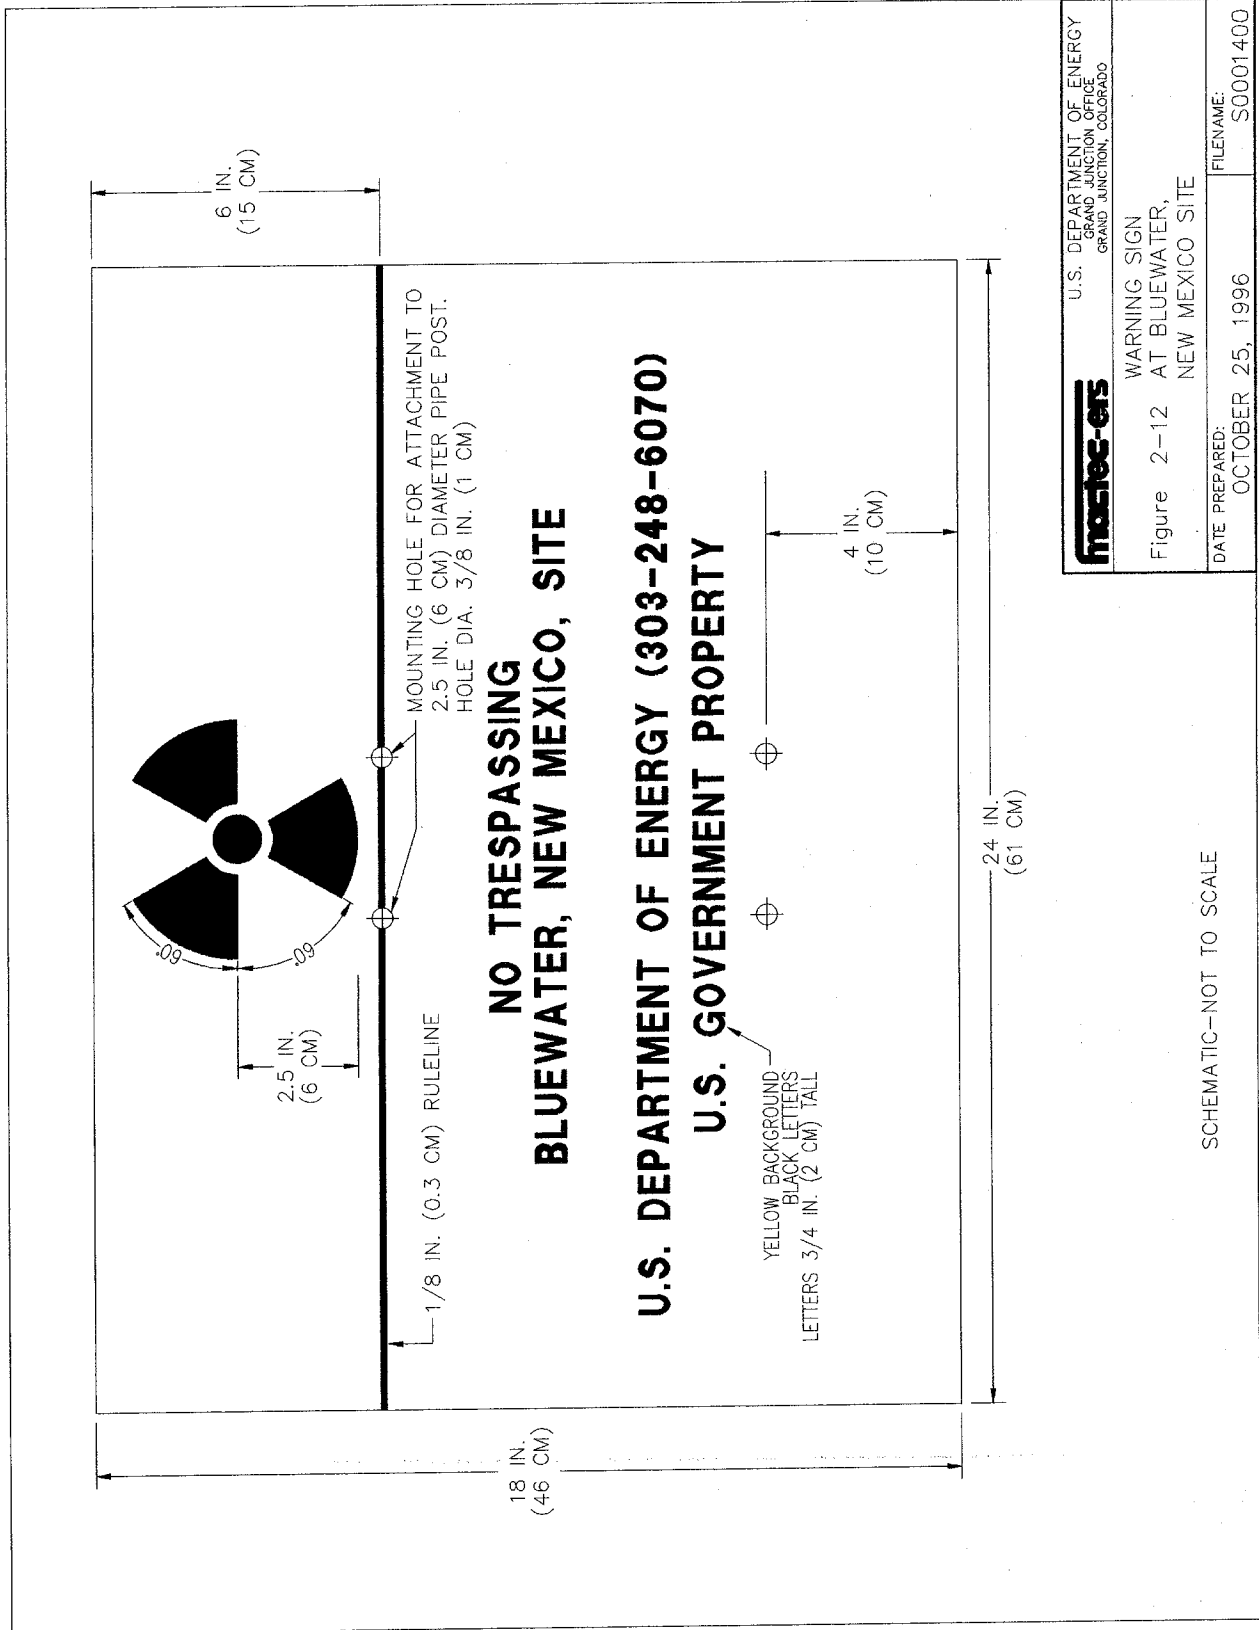
Figure 2-12. Warning sign at Bluewater, New Mexico, Site.

Warning signs are posted at various places around the site property: at the entrance gate, other vehicle access gates, and around the tailings piles and other disposal areas. These warning signs inform the public of the name, function, and ownership of the site (Section 2.6). The signs are attached at a height of about 5 ft (1.5 m) above ground to 2.5-inch (in.) (5.5 centimeters [cm]) diameter pipe (posts) set in concrete. Sign posts are placed approximately 5 ft (1.5 m) inside the fence when set along the site perimeter. Warning signs are similarly placed on posts around the main tailings area, the carbonate tailings area, and other disposal areas. These signs are placed no more than 500 ft (152 m) apart and about 100 ft (31 m)

from the edge of each radioactive material disposal area. These warning signs provide sufficient warning to persons approaching the areas of buried radioactive material. Human intrusion and vandalism are expected to be minor because of the remoteness of the site, sparse population of the area, and land use (mainly cattle grazing) of surrounding land. Additional security is considered unnecessary.

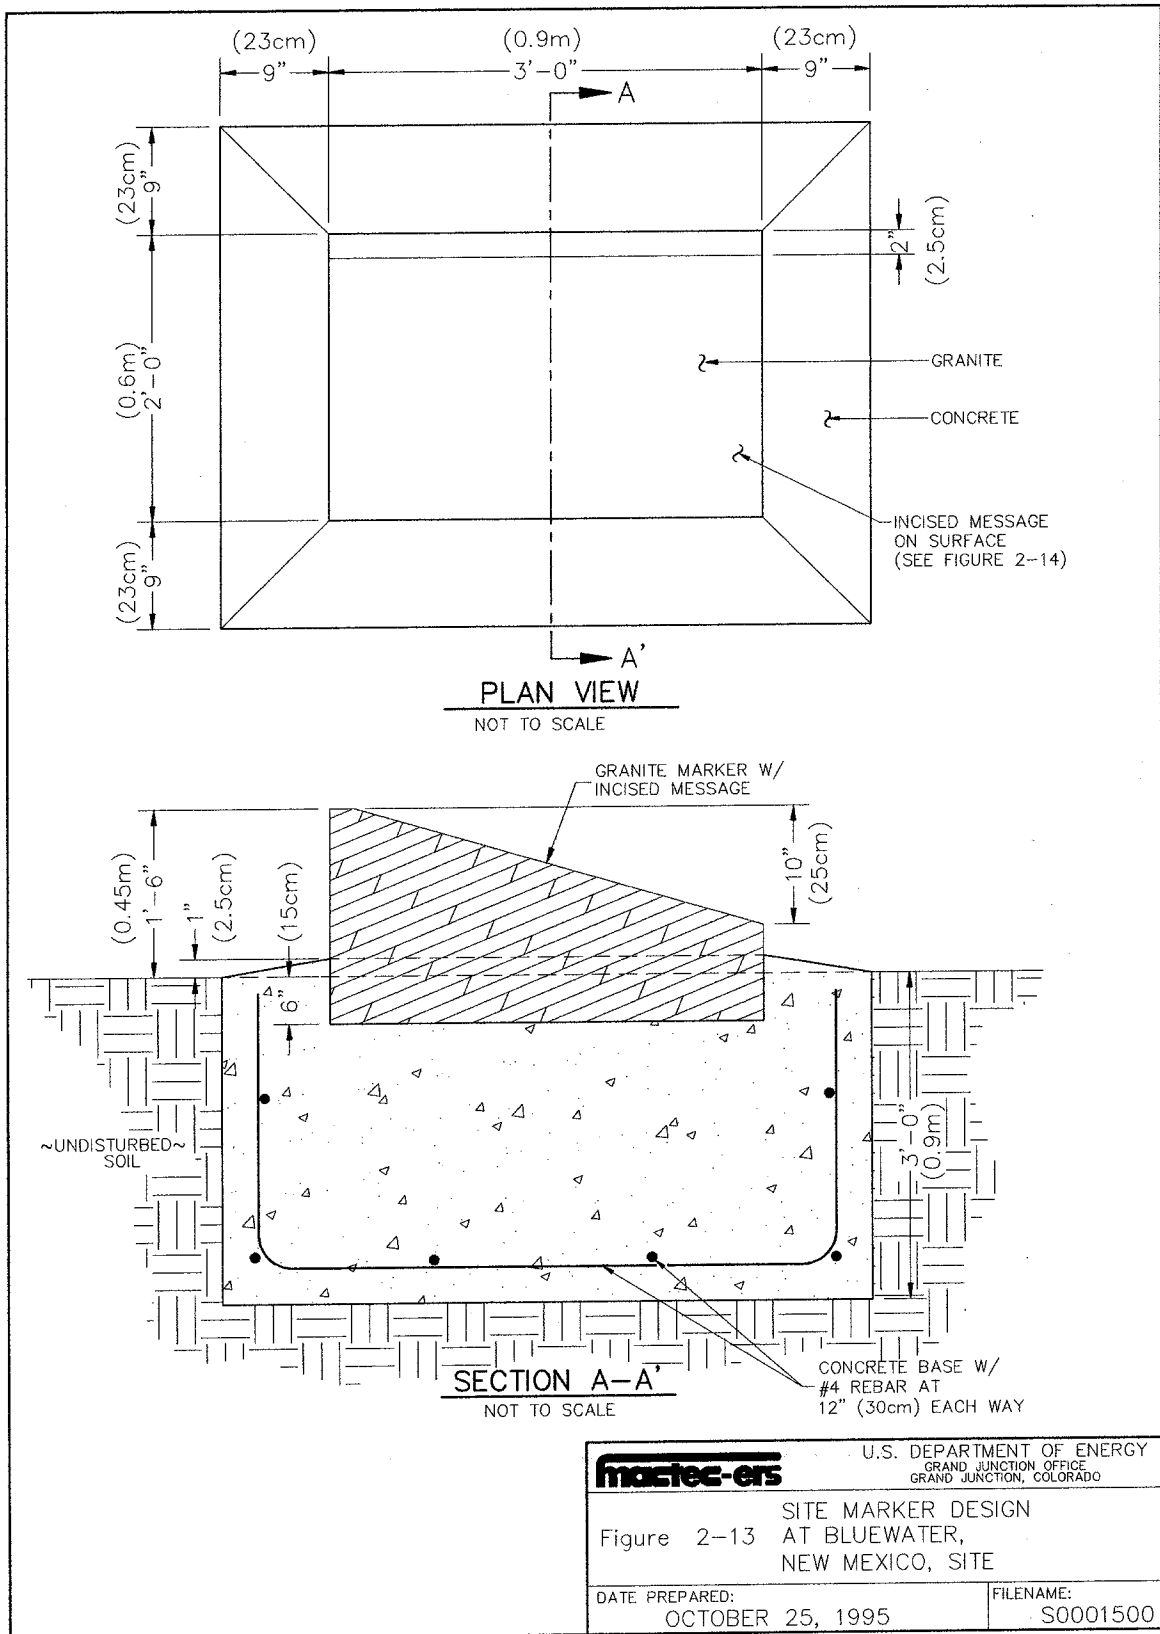
Figure 2-13. Site Marker Design at Bluewater, New Mexico, Site

The inscription on the site marker identifies the general locations of the tailings piles within the site property, the date of closure, the tonnage of tailings, and the curies of radioactivity of radium-226. The international symbol for radiation is also inscribed in the marker at the position of each tailings disposal area (Figure 2-14).

TONS OF TAILINGS: MAIN TAILINGS 22,881,000  
CARBONATE TAILINGS 1,307,000

RADIOACTIVITY: MAIN TAILINGS 11,200 Curies, Ra-226  
CARBONATE TAILINGS 1,130 Curies, Ra-226

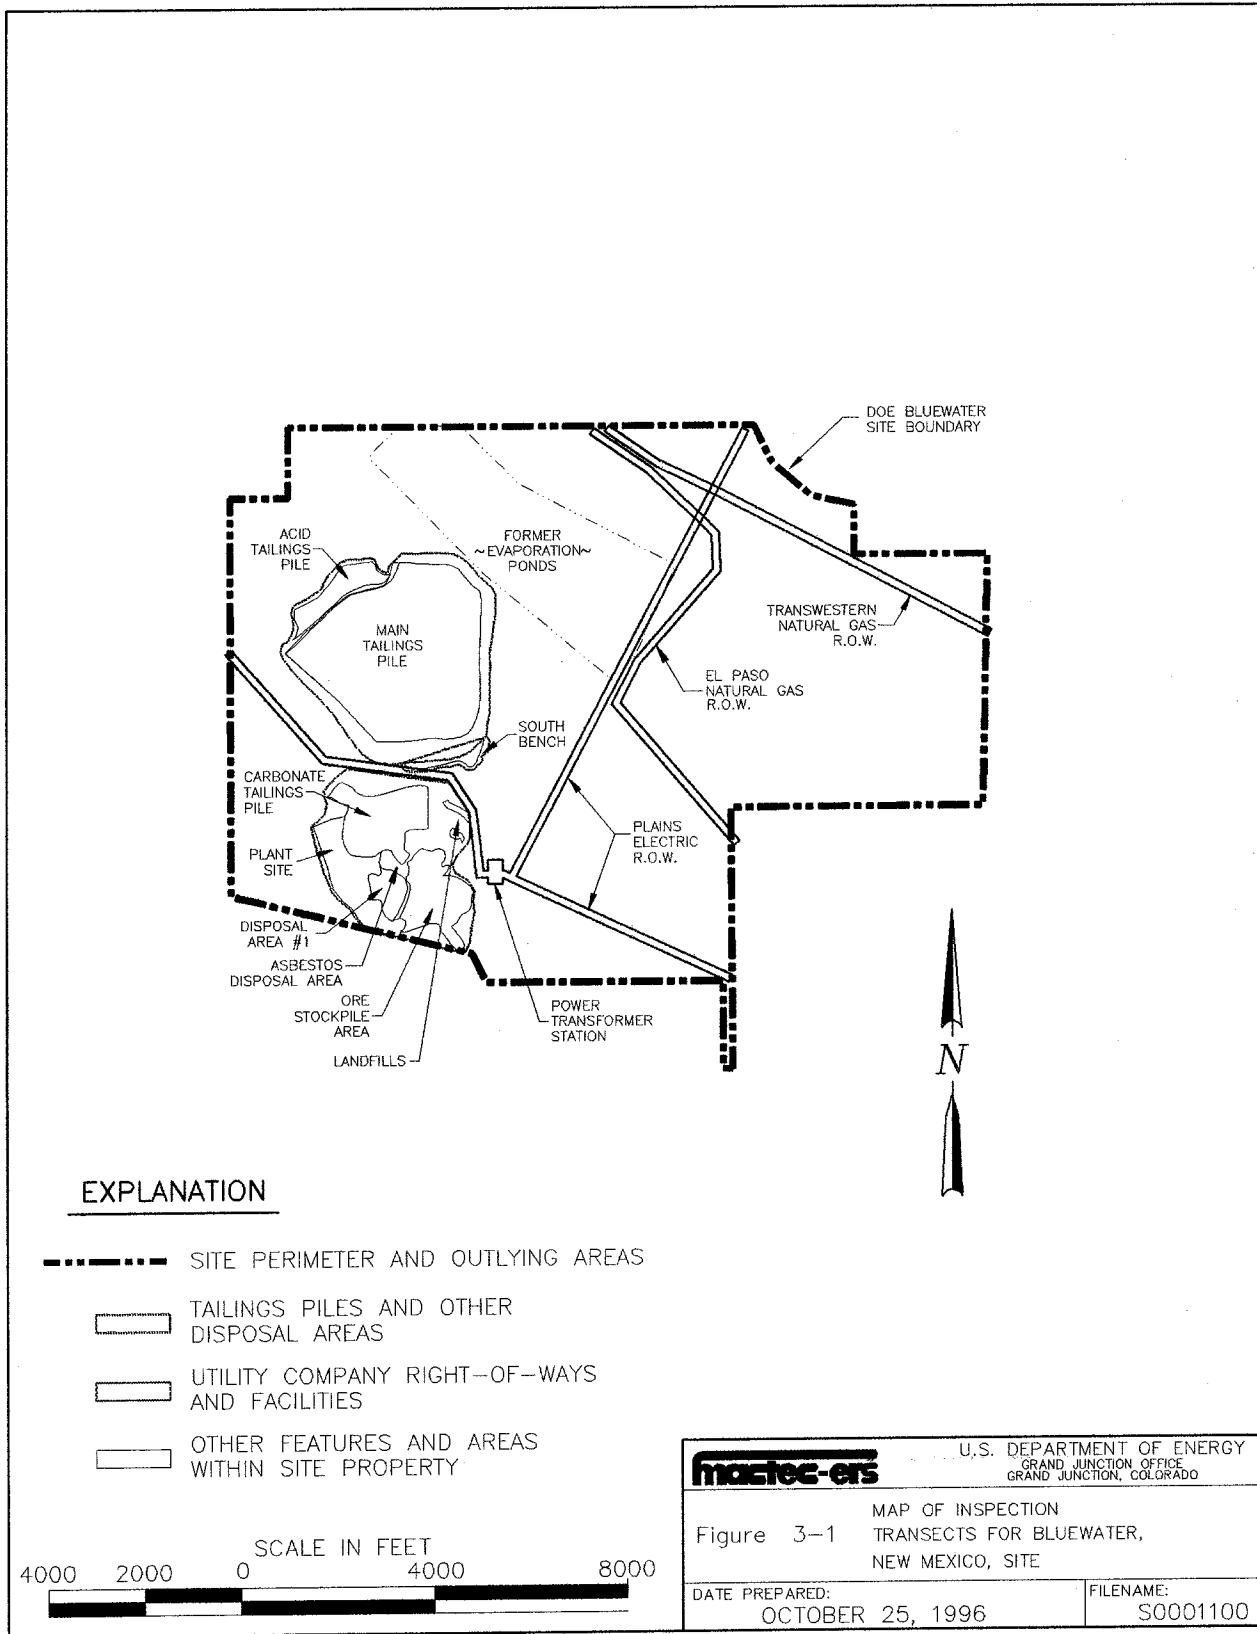
Figure 3-1. Map of Inspection Transects for Bluewater, New Mexico, Site

The area within each transect will be generally inspected for evidence of slumping, settlement, wind or water erosion, and human, plant, or animal intrusion. The condition of disposal area cover and riprap and the health and success of revegetation efforts will be evaluated. Within each transect, the condition of specific site-surveillance features (Section 2.6), such as the site marker, warning signs, monitor wells, and boundary monuments, will be individually inspected for change, deterioration, and other effects such as vandalism. The entire perimeter fence will be inspected for integrity and deterioration.
