**Annual Performance Report  
April 2010 Through March 2011  
for the  
Shiprock, New Mexico, Site**

**January 2012**

**U.S. DEPARTMENT OF  
ENERGY**

Legacy  
Management

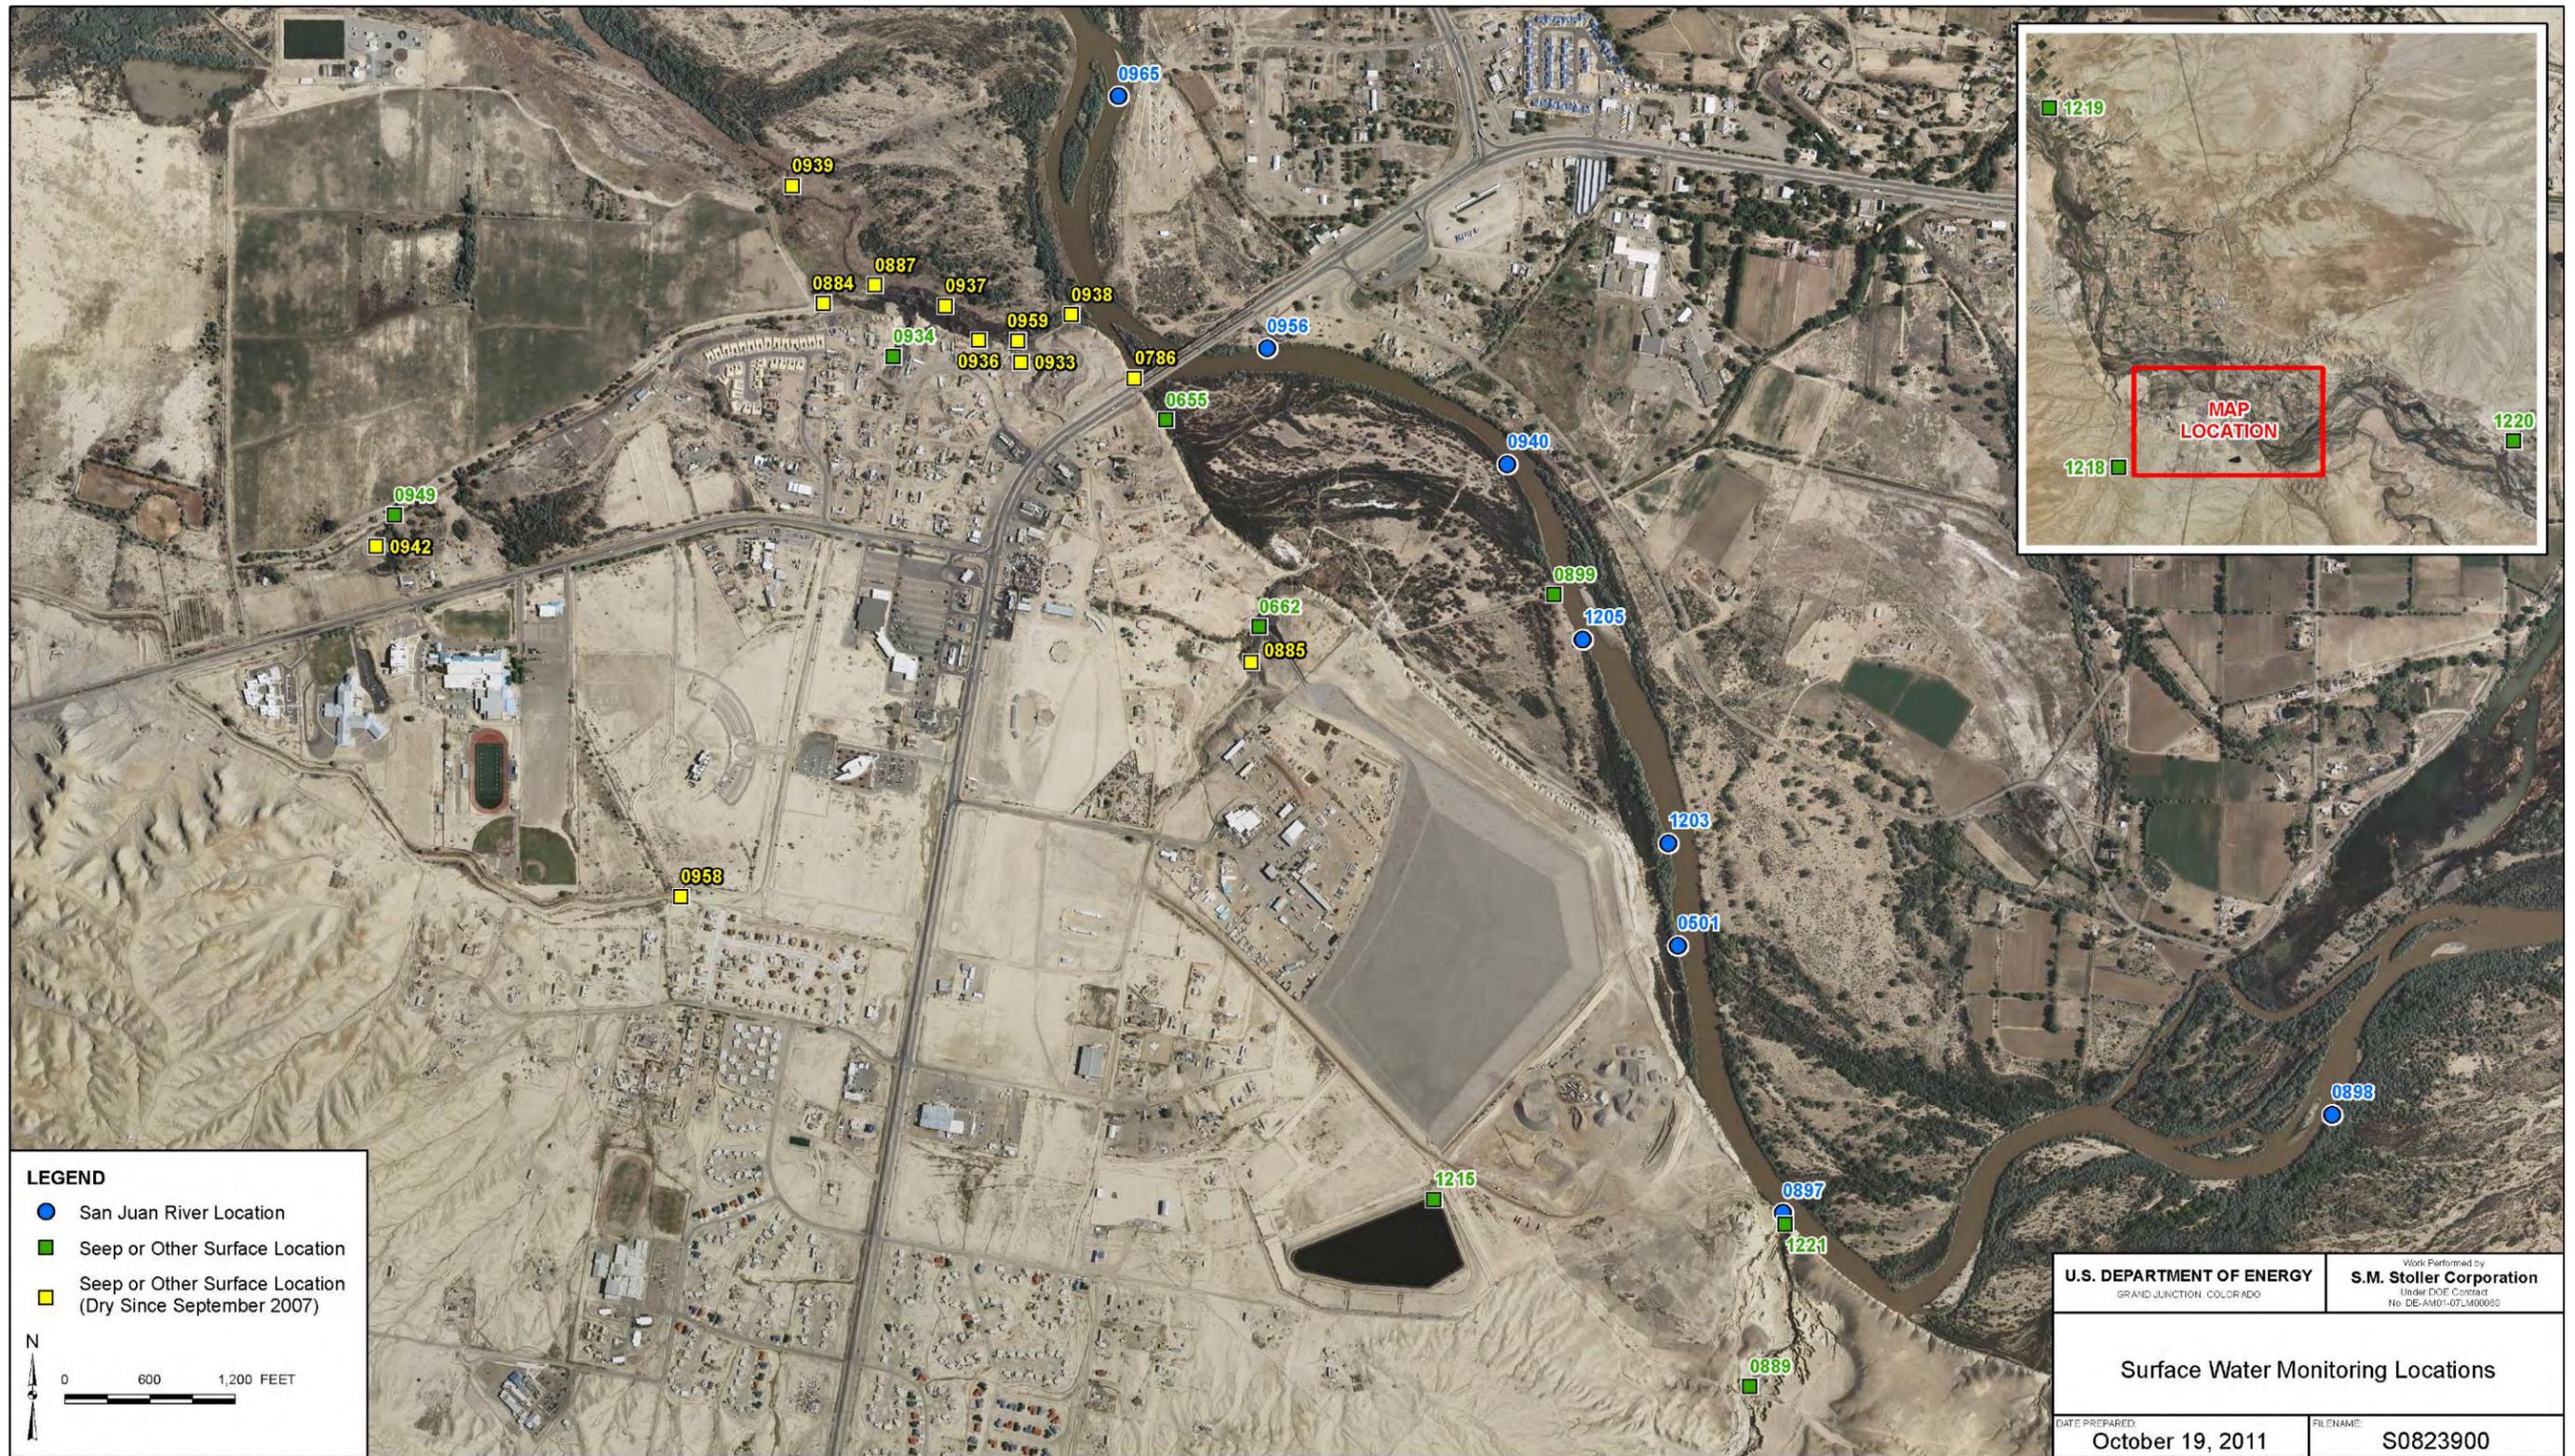
Figure 3. Shiprock Site Surface Water Monitoring Locations

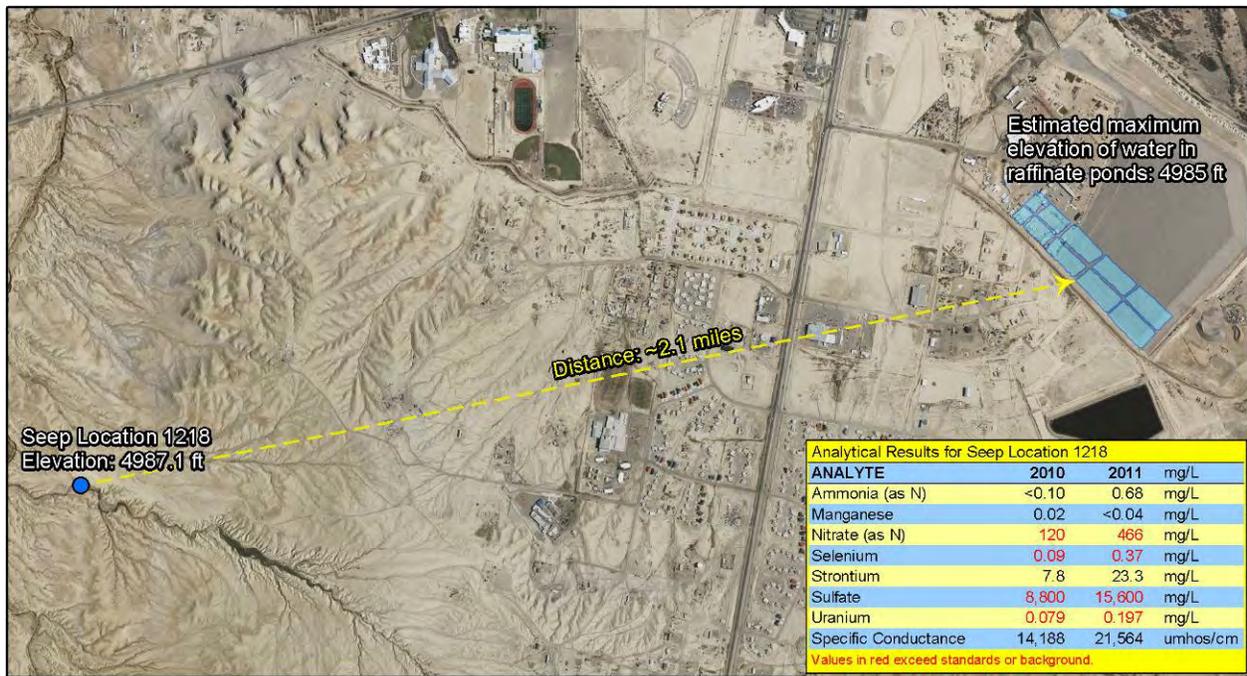
Figure 4. Surface (Seep) Location 1218: Location (Zoom View) and Results

- Location 1218 (sometimes referred to as “Washing Machine” [WM] Draw)<sup>4</sup>, which is approximately 2 miles southwest of the site (also see Figure 4). The elevation where water from location 1218 seeps from the ground—4987.1 feet (ft) above mean sea level (amsl)—is 2 ft higher than the highest possible water elevations in the mill site raffinate ponds during milling years (4985 ft amsl<sup>5</sup>), which indicates that it was very likely not influenced by the former mill. The highest groundwater elevations currently observed in the alluvial system overlying the Mancos Shale in the vicinity of the mill site are on the order of 4945 ft amsl.

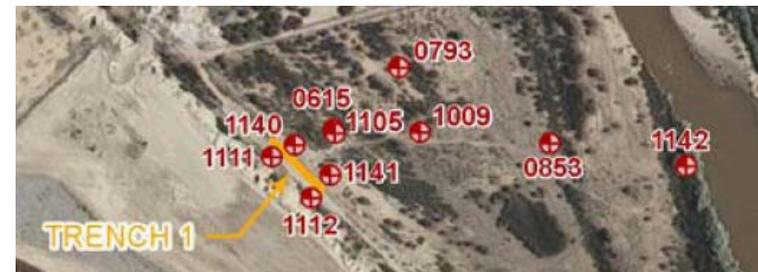
Trench 1 Area Wells (adapted from Figure 21)

In these sparkline diagrams, red markers denote maximum (max) concentrations and green markers denote minima (min); black markers denote the most recent (current) March 2011 measurement. The x-axis is hidden but corresponds to the Feb-00 to Mar-11 date range noted above each plot. Vertical (y-) axis scales are automatic for each individual well, so magnitudes should not be compared across wells (instead refer to summary statistics).

Figure 23. Summary of Uranium Concentration Trends in All Floodplain Wells

Figure 23 plots temporal data for uranium in all floodplain wells, using the well group categories shown in Figure 22. This figure is a compendium of sparklines, which are simple condensed plots intended as a big-picture overview. Essentially, this figure combines data that might require 10 graphs to present adequately. In all individual plots, the *x*-axis is hidden but corresponds to a common date scale—January 2000 through March 2011 (so newly installed wells are clearly apparent). Individual data points are not plotted except for minimum and maximum concentrations (denoted by green and red markers, respectively<sup>8</sup>) and the most recent result (black markers, which in some cases is the minimum historical measurement). In all cases, the *y*-axis is condensed (scales are not common), so magnitudes of temporal trends are somewhat masked. However, the main point illustrated in Figure 23 is that, in general, uranium concentrations in most floodplain wells have decreased since the baseline period (e.g., see trends for well 1089 area). This is most apparent for the Trench 1 and well 1089 areas. Exceptions are found in wells located on the disposal cell side of Trenches 1 and 2, in wells with lower-magnitude beginning uranium concentrations (e.g., northwest floodplain area wells), and in other wells where there have been recent increases (e.g., in central floodplain well 0857).

To expand upon the simplified global schematic in Figure 23, subsequent (area-specific) plots (e.g., Figures 24 through 27) better capture the changes in concentrations of uranium and other COCs in selected floodplain wells. The following discussion focuses on those areas exhibiting the most pronounced trends and that are most indicative of remediation “performance” on the floodplain.

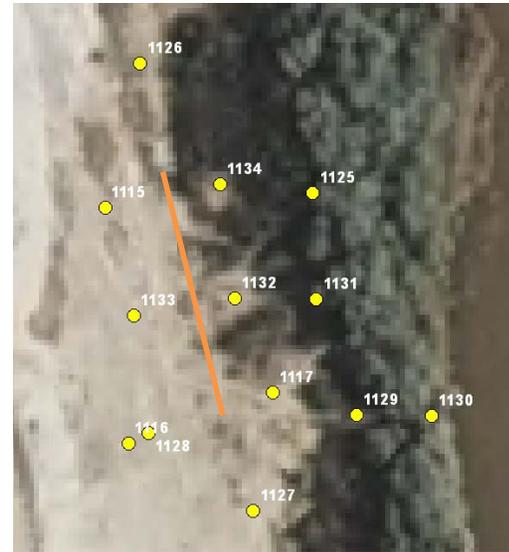
Trench 2 Area Wells

Figure 26. Uranium, Nitrate, and Sulfate Trends in the Well 1089 Area

Note:  
 Similar to the format shown for Trench 1, in each plot legend, wells are listed in general order of increasing distance from the disposal cell (and decreasing distance to the San Juan River).

Figure 26 plots uranium, nitrate, and sulfate concentrations in well 1089 area wells. Although decreases are not of the magnitude and consistency as those shown in Figure 24, decreases are still evident. For example, in a comparison of baseline (2000–2003) to current conditions, average sulfate concentrations decreased by nearly 10,000 mg/L. For all COCs, concentrations in well 1008 have been erratic (also see DOE 2011d).
