Postclosure Inspection Report for the Tonopah Test Range and Nevada Test and Training Range, Nevada, Sites for Calendar Year 2023

August 2024

**U.S. DEPARTMENT OF
ENERGY**

**Legacy
Management**

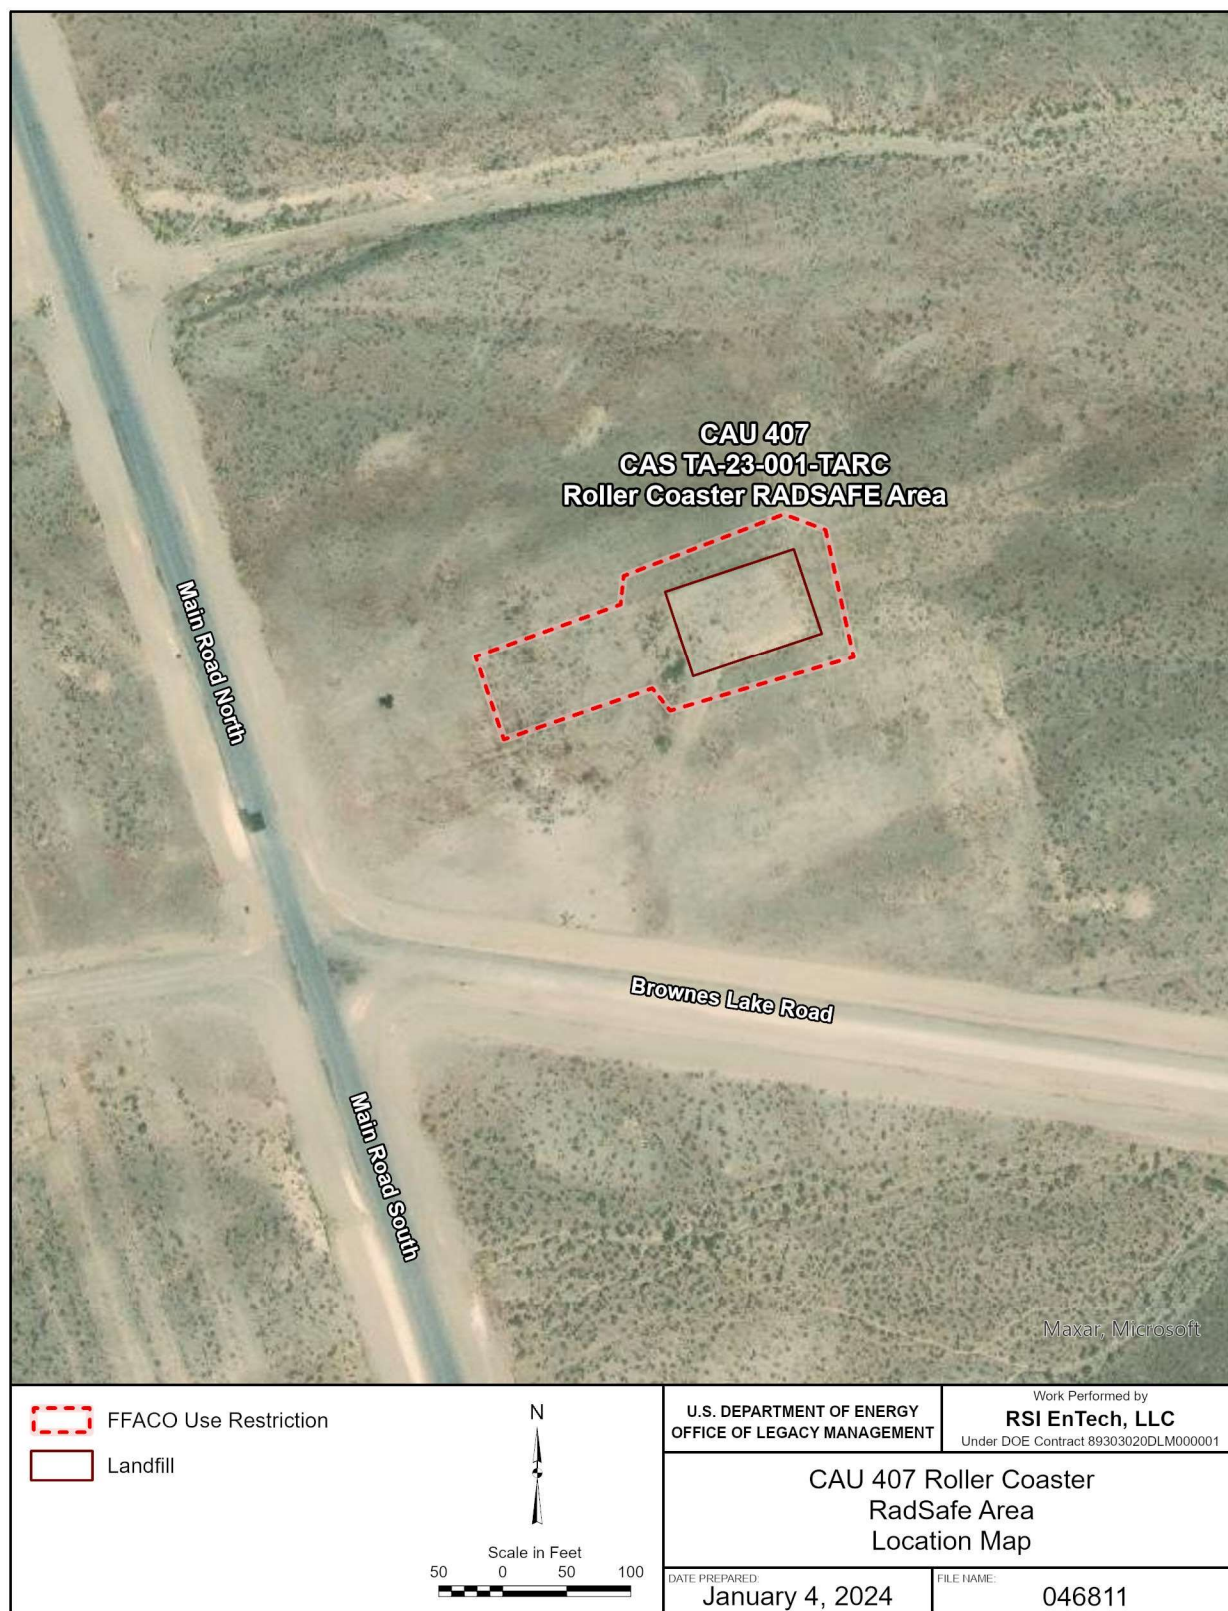
Figure 2. Roller Coaster RadSafe Area

Visual inspections were conducted according to the postclosure requirements for CAU 407, Roller Coaster RadSafe Area (TTR), CAS TA-23-001-TARC, Roller Coaster RadSafe Area, as described in the CAU 407 UR (DOE/EMNV 2019a). The site is shown in Figure 2 in Appendix A. The visual inspection was conducted on May 31, 2023. All signs were legible. One sign was loose and hung to the ground. The sign was repaired during the inspection. The top strand of the wire fence was loose and hung to the ground. The strands were reattached to the T-posts during the inspection. Erosion on the east side of cover was observed. This erosion could potentially damage cover. Area will be monitored for potential maintenance in future site inspections. During time of inspection no maintenance was required. No other repair or maintenance needs were observed.

Two signs were loose and were rehung during the inspection. The top strand of the wire fence was loose and hung to the ground and was reattached to the T-post. No other repair or maintenance needs were identified, and no recommendations are proposed at CAS TA-23-001-TARC, Roller Coaster RadSafe Area.

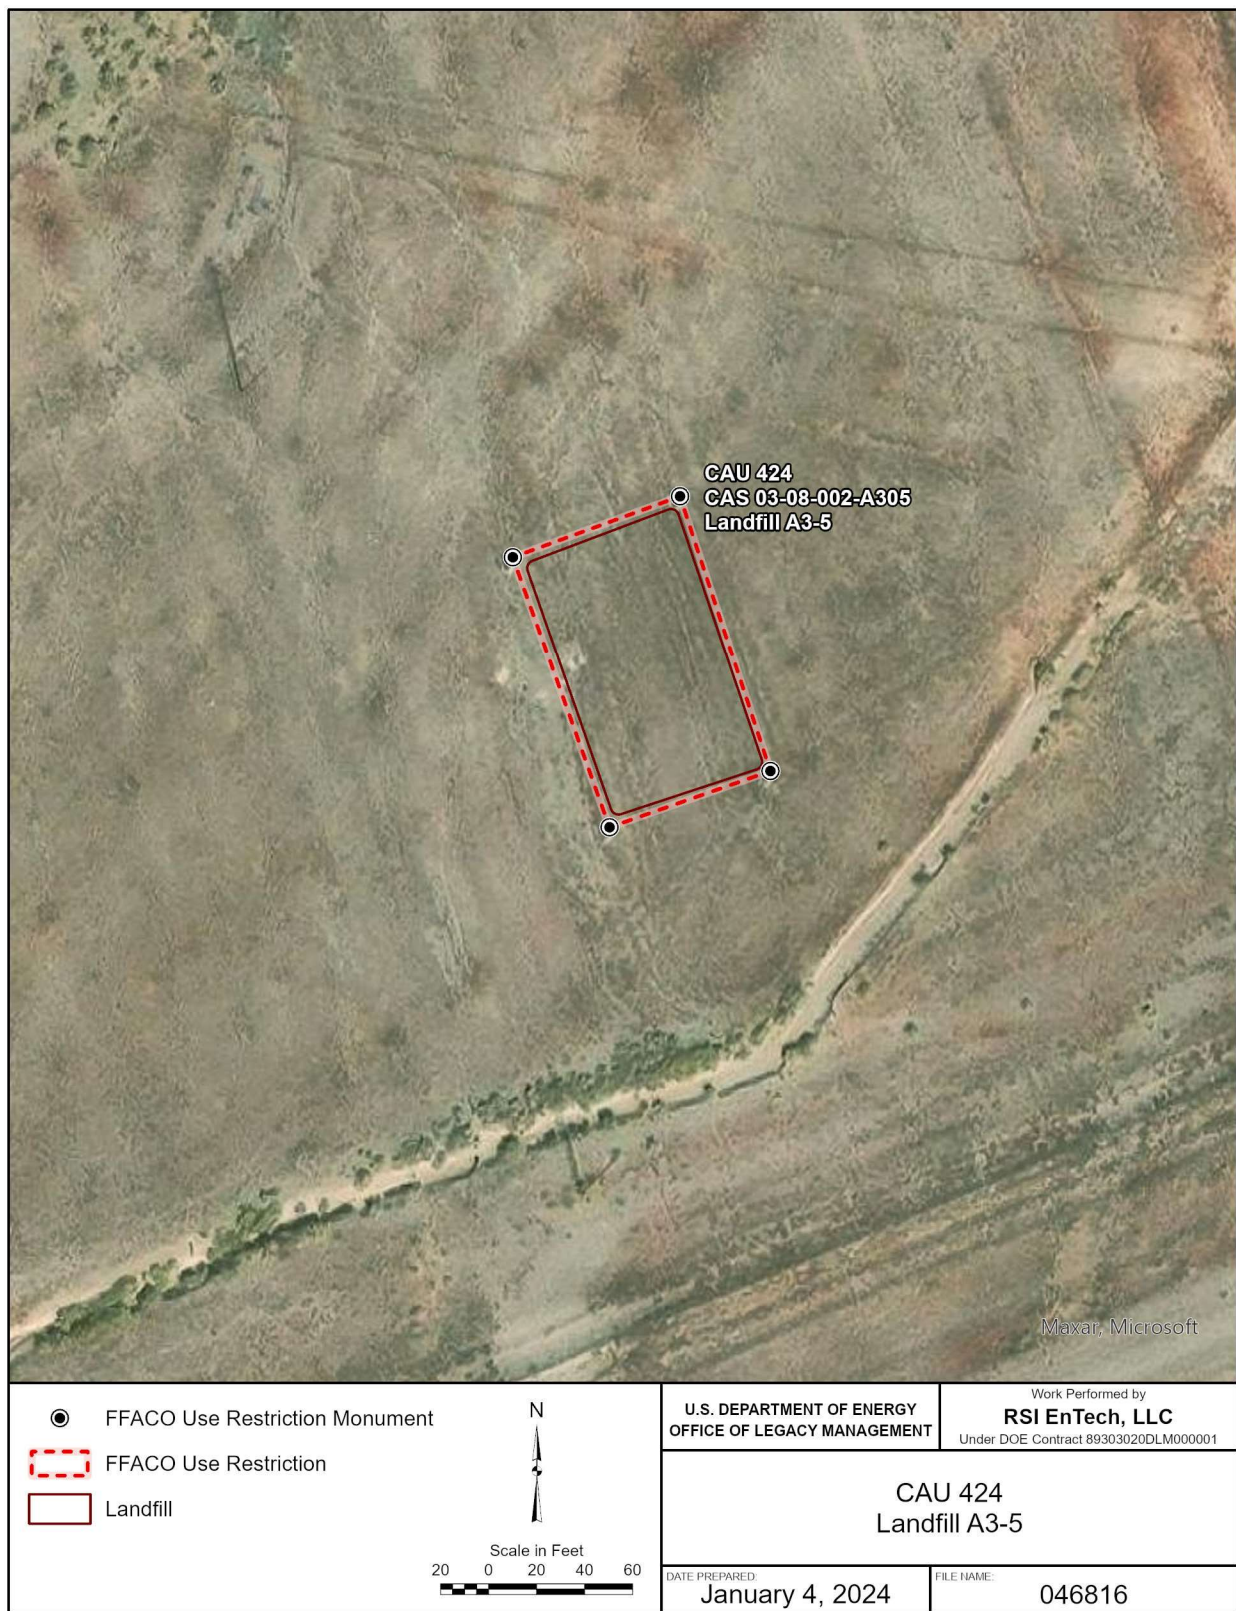
Figure 7. CAU 424, Landfill A3-5

Landfill Cell A3-5 (CAS 03-08-002-A305): All signs, monuments, and survey markers were in good condition. All monuments had warning signs. No repair or maintenance needs were observed. A survey marker, not previously seen, was identified during inspection. The marker was a 1-foot × 1-foot red triangle spraypainted on the ground. The triangle also had a 2-inch × 2-inch gold survey marker placed in the center. Further communication with site officials confirmed that the survey marker was from a survey conducted by the U.S. Air Force. The marker does not indicate future excavation at the cell. The site is shown in Figure 7 of Appendix A.

Landfill Cell A3-5 (CAS 03-08-002-A305): No repair or maintenance needs were identified, and no recommendations are proposed. The red survey marker was utilized for a survey by the USAF. The presence of the marker does not affect Landfill Cell A3-5.

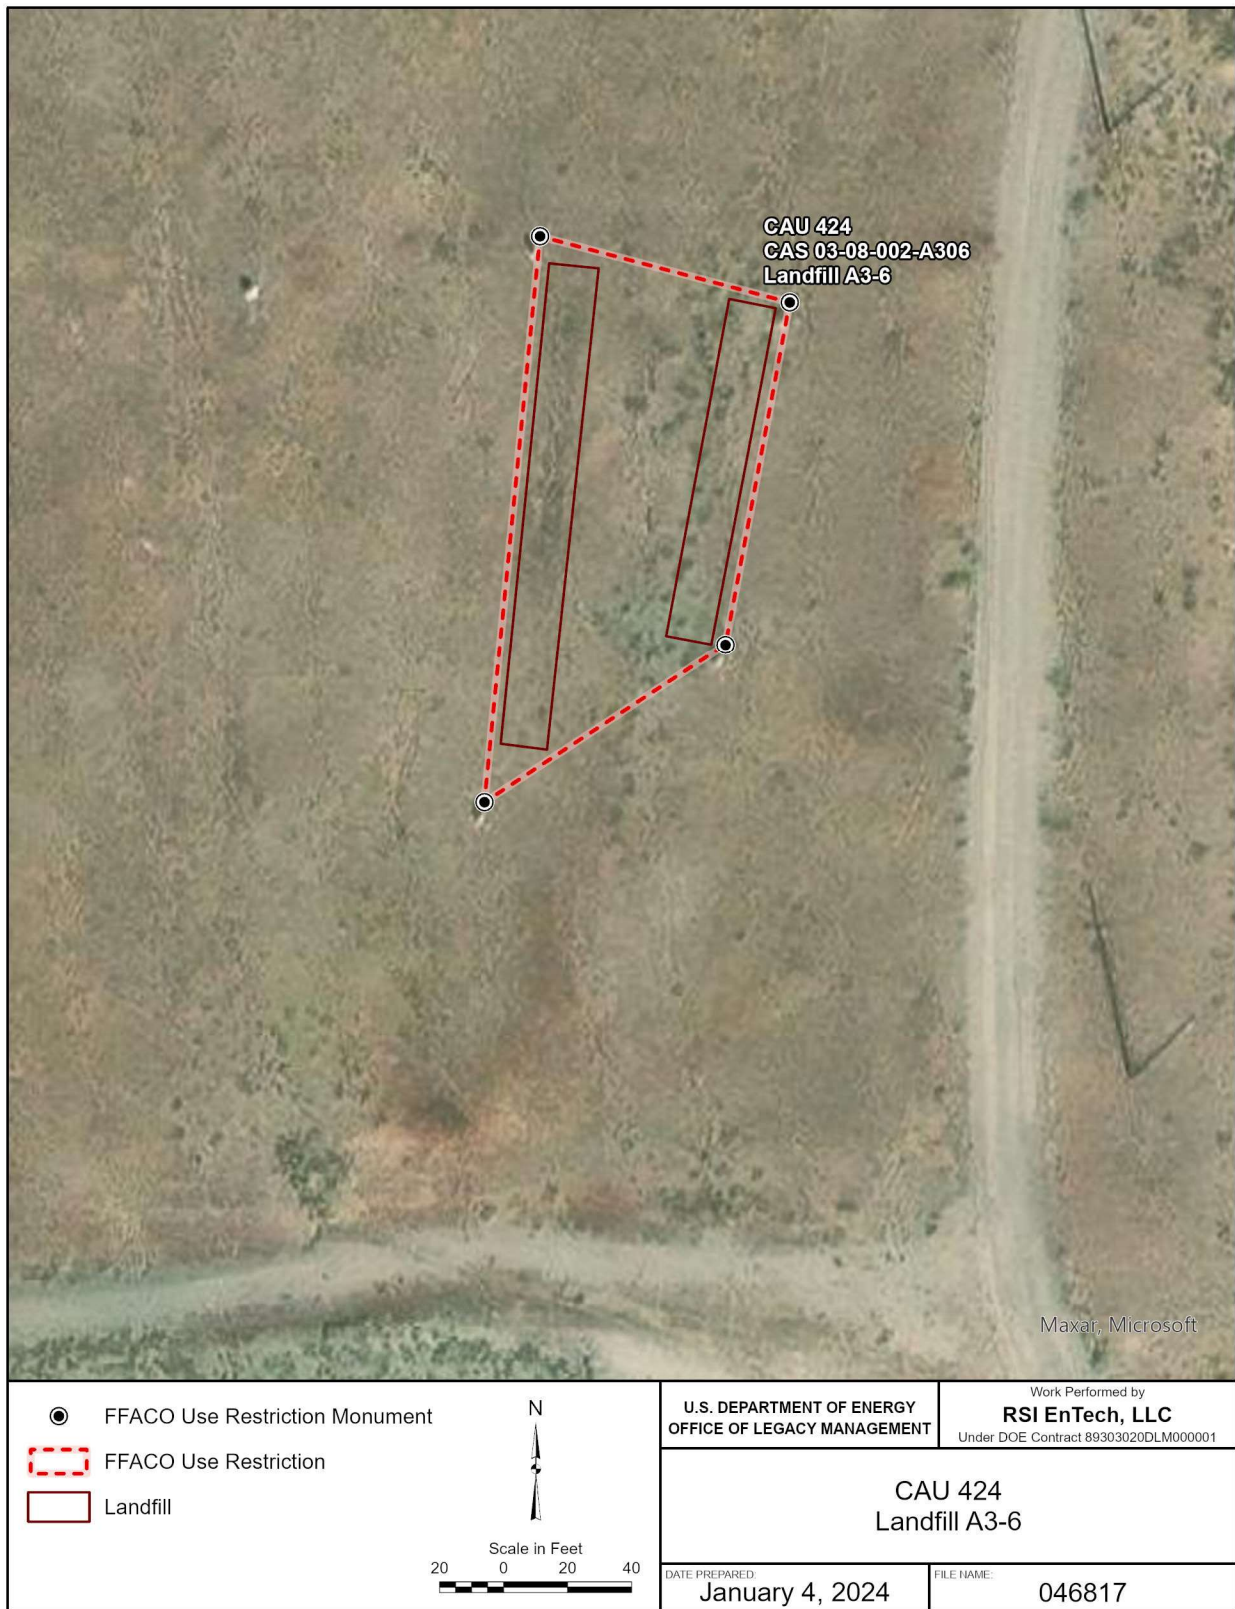
Figure 8. CAU 424, Landfill A3-6

Landfill Cell A3-6 (CAS 03-08-002-A306): All signs, monuments, and survey markers were in good condition. All monuments had warning signs. Small animal burrows were present onsite but were not on the landfill cell. No repair or maintenance needs were observed. The site is shown in Figure 8 of Appendix A.

Landfill Cell A3-6 (CAS 03-08-002-A306): Small animal burrows were observed near the cell. They do not represent inherent risk or damage to the cell. No repair or maintenance needs were identified, and no recommendations are proposed.
