# **2011 Inspection and Annual Site Status Report for the Site A/Plot M, Cook County, Illinois Decontamination and Decommissioning Program Site**

## **Summary**

Site A/Plot M was inspected on April 26, 2011. The site, located within a county forest preserve with significant tree and grass cover, was in good condition. No cause for a follow-up inspection was identified.

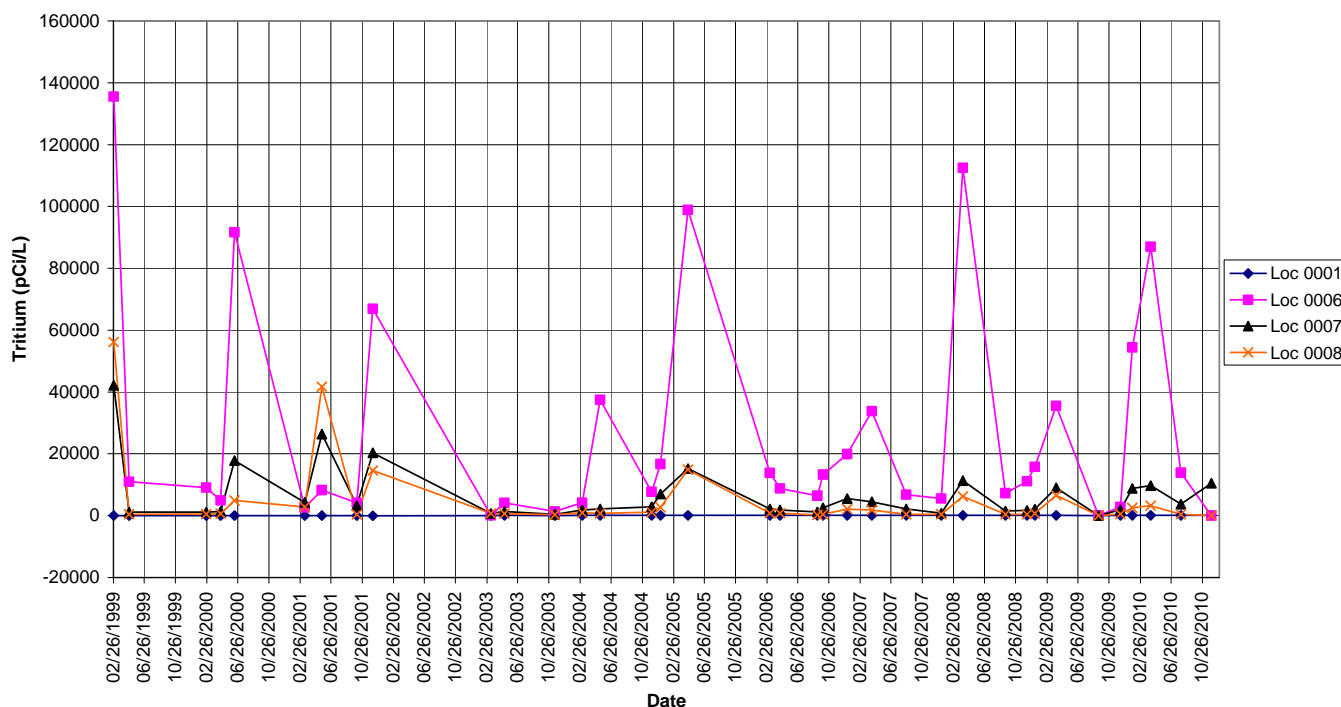
Figure 1. Tritium Activities in Surface Water at Site A/Plot M, Cook County, Illinois

Tritium levels exceeded the State of Illinois standard of 20,000 picocuries per liter (pCi/L) at seep location 0006 which is located just downgradient of Plot M. Seep activities at location 0006 ranged from 13,900 to 87,000 pCi/L (Figure 1).

**Site A/Plot M Decommissioned Reactor (SAM01)  
Tritium Concentration, Plot M, Surface Water**

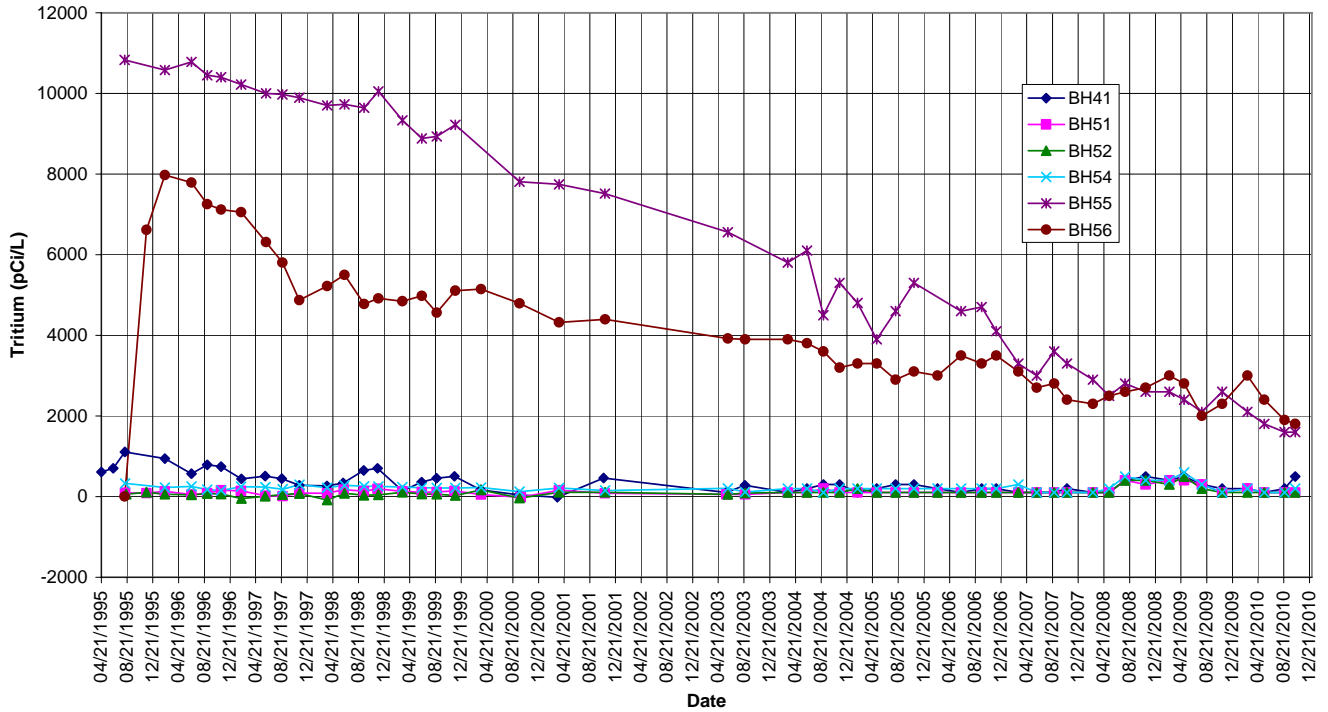
Figure 2. Tritium Activities in Groundwater in the Glacial Drift at Site A, Cook County, Illinois

In 2010, tritium was detected in the groundwater at Site A in all six monitoring well locations completed in the glacial drift. None exceeded the standard of 20,000 pCi/L. Activities ranged from non-detect (less than 100 pCi/L) to 3,000 pCi/L (Figure 2).

**Site A/Plot M Decommissioned Reactor (SAM01)  
Tritium Concentration, Site A, Glacial Drift**

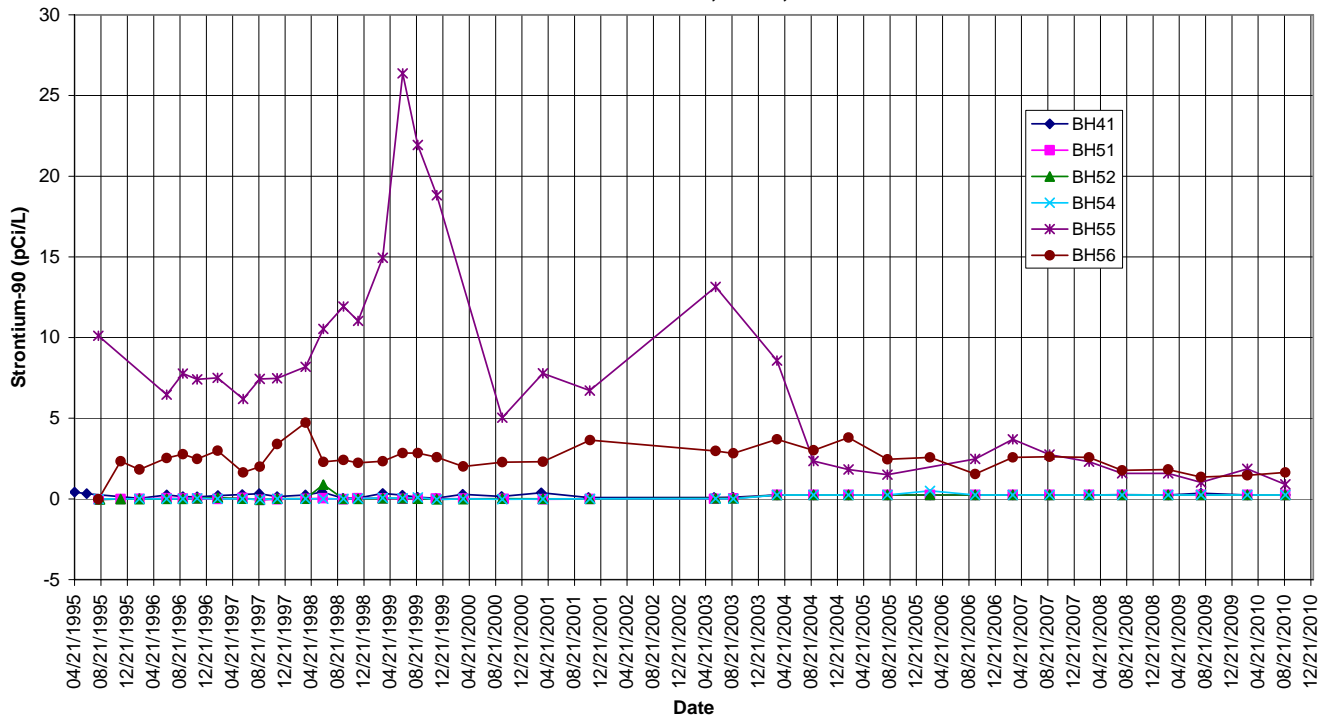
Figure 3. Strontium-90 Activities in Groundwater in the Glacial Drift at Site A, Cook County, Illinois

In 2010, strontium-90 was detected in the groundwater at Site A in two of the six monitoring well locations completed in the glacial drift. Activities ranged from non-detect (less than 0.25 pCi/L) to 1.87 pCi/L, but none exceeded the State of Illinois standard of 8 pCi/L (Figure 3).

**Site A/Plot M Decommissioned Reactor (SAM01)  
Strontium-90 Concentration, Site A, Glacial Drift**

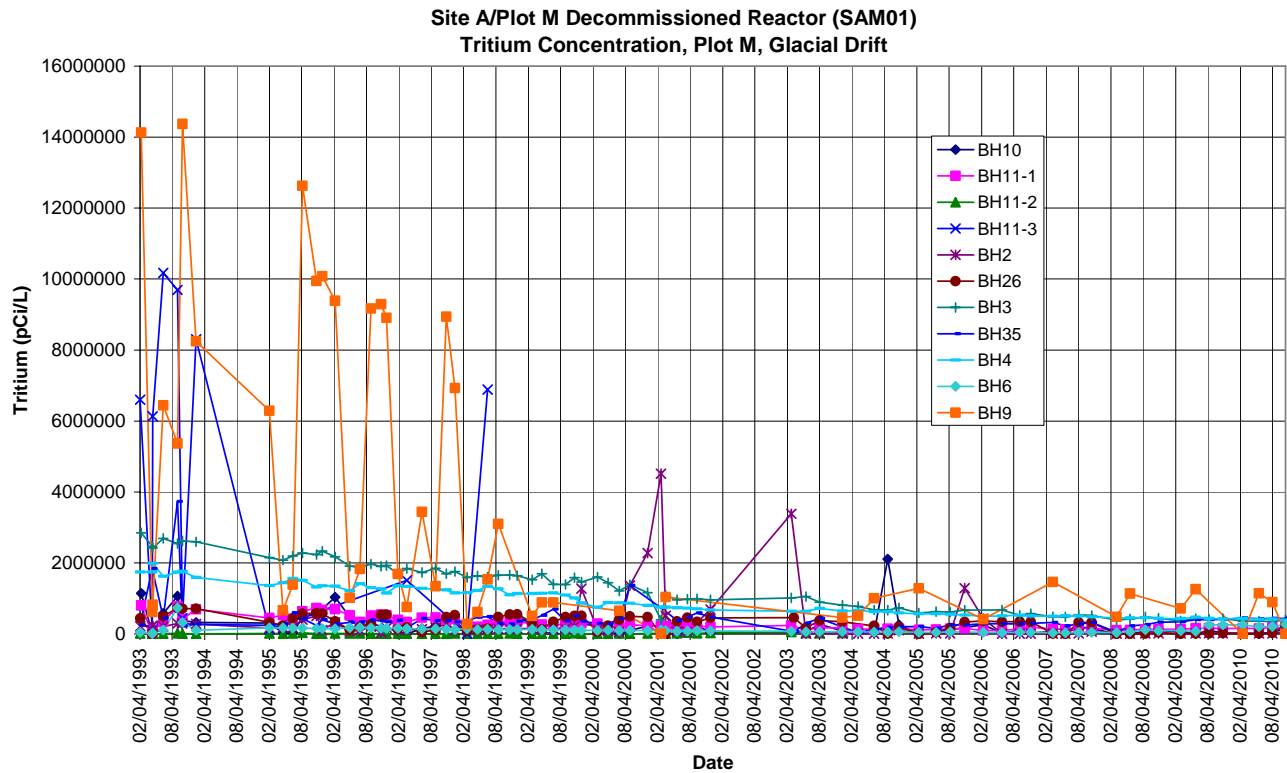
Figure 4. Tritium Activities in Groundwater in the Glacial Drift at Plot M, Cook County, Illinois

In 2010, tritium was detected in the groundwater at Plot M at all nine monitoring wells completed in the glacial drift. Tritium concentrations ranged from 5,700 pCi/L to 1,142,000 pCi/L (Figure 4). The highest reading was taken at BH9 on May 18, 2010. BH9 was dry in two of the four sampling attempts in 2010.

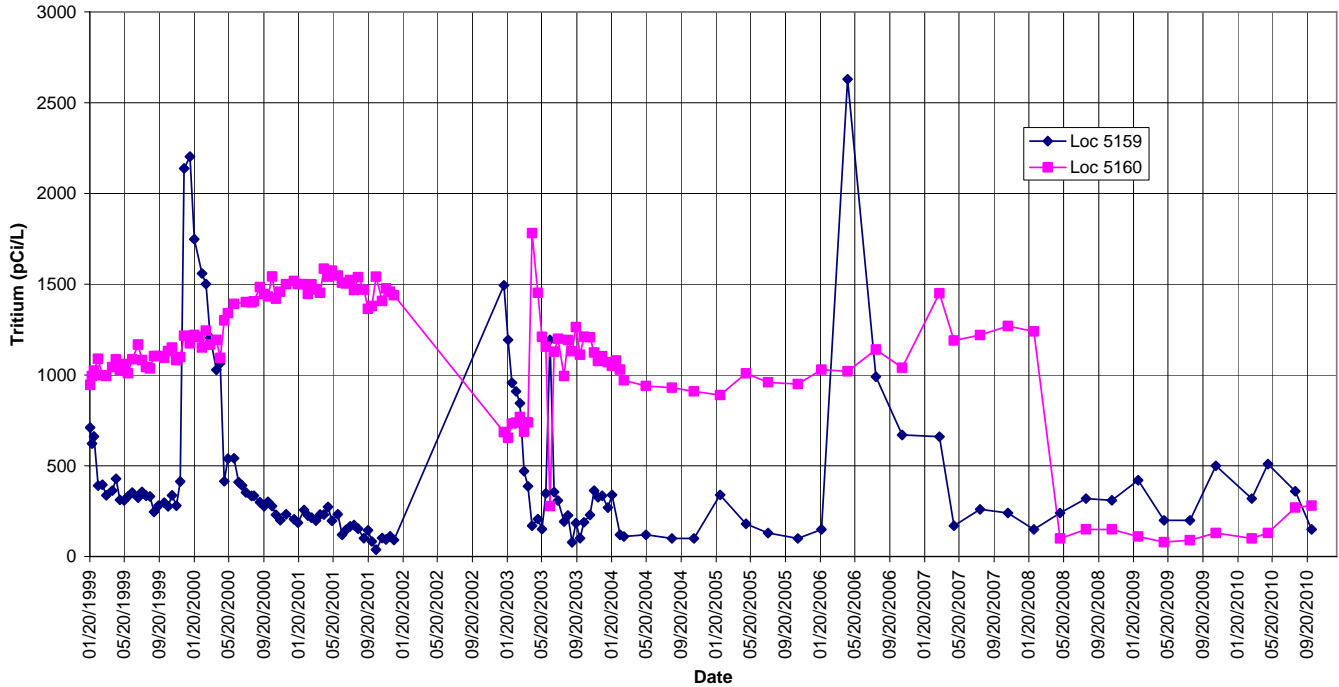
Figure 5. Tritium Activities in Groundwater in the Picnic Wells, Site A/Plot M, Cook County, Illinois

In 2010, tritium was detected in the groundwater at the picnic wells at the Red Gate Woods picnic area. Activities ranged from non-detect (less than 100 pCi/L) to 510 pCi/L (Figure 5). None exceeded the standard of 20,000 pCi/L.

**Site A/Plot M Decommissioned Reactor (SAM01)  
Tritium Concentration, Picnic Wells, Dolomite Bedrock**

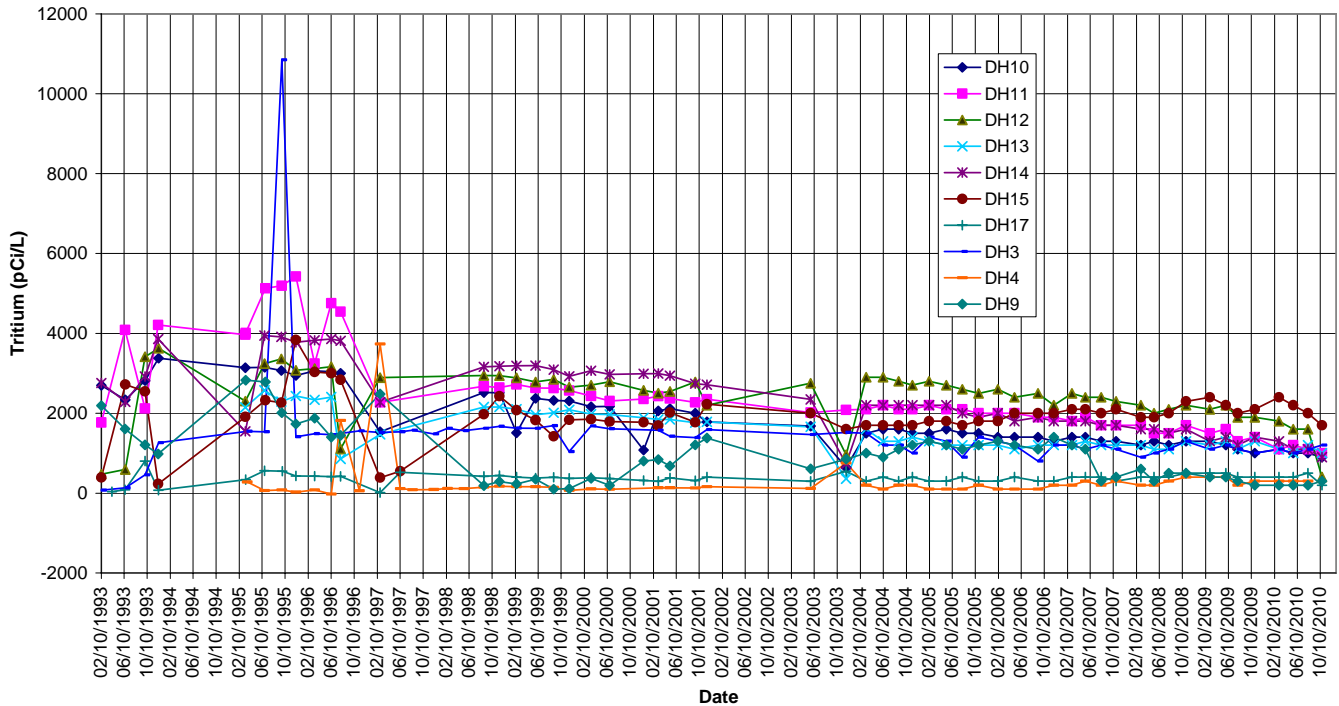
Figure 6. Tritium Activities in Groundwater in the Dolomite Bedrock, Site A/Plot M, Cook County, Illinois

In 2010, tritium was detected in the groundwater at all ten monitoring wells completed in the dolomite bedrock north of Plot M. Activities ranged from 100 pCi/L to 2,400 pCi/L (Figure 6). Tritium is no longer sampled for in the dolomite bedrock beneath Site A. Monitoring stopped in 2004 after approximately 30 years of sampling failed to detect tritium

Site A/Plot M Decommissioned Reactor (SAM01)  
Tritium Concentration, Plot M, Dolomite Bedrock

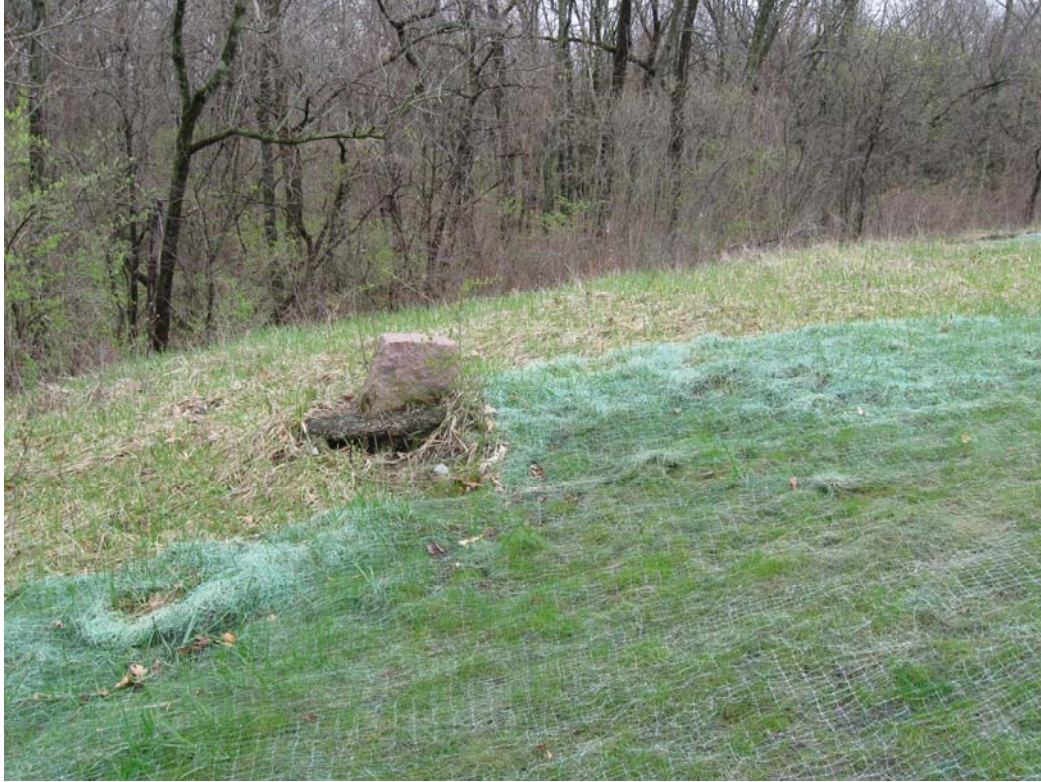
Erosion on top of the grass covered mound at Plot M (identified in previous inspections) was repaired in 2010 by ANL. Two areas were fixed: one north of the site marker and one west of the site marker. The area north of the site marker was approximately 31 feet by 12 feet, by 2 feet deep, and was impacting monitoring well BH9, and one of the Plot M corner markers. The erosion west of the site marker was approximately 13 feet by 3 feet by 1 foot deep, and was close to one of the Plot M corner markers. Both areas have been restored to pre-erosion conditions using top soil. Inspection photo PL-8 shows the regraded surface next to monitoring well BH9 and photo PL-1 shows the regraded surface next to the corner marker that was impacted by the erosion. The apparent cause of the erosion (bikers and pedestrians) has yet to be resolved. It is recommended that DOE work with ANL and the Forest Preserve to find a solution to eliminate the apparent cause of the erosion.

1. Erosion on top of the mounded earth cover at Plot M has been repaired, and the earth cover is in good condition (PL-1 and PL-2). The apparent cause of the erosion (bikers and pedestrians) has yet to be resolved (page 1).

SAM 4/2011. PL-1. Erosion repair at Plot M.

**Recommendation:** It is recommended that DOE work with ANL and the Forest Preserve to find a solution to eliminate the apparent cause of the erosion.

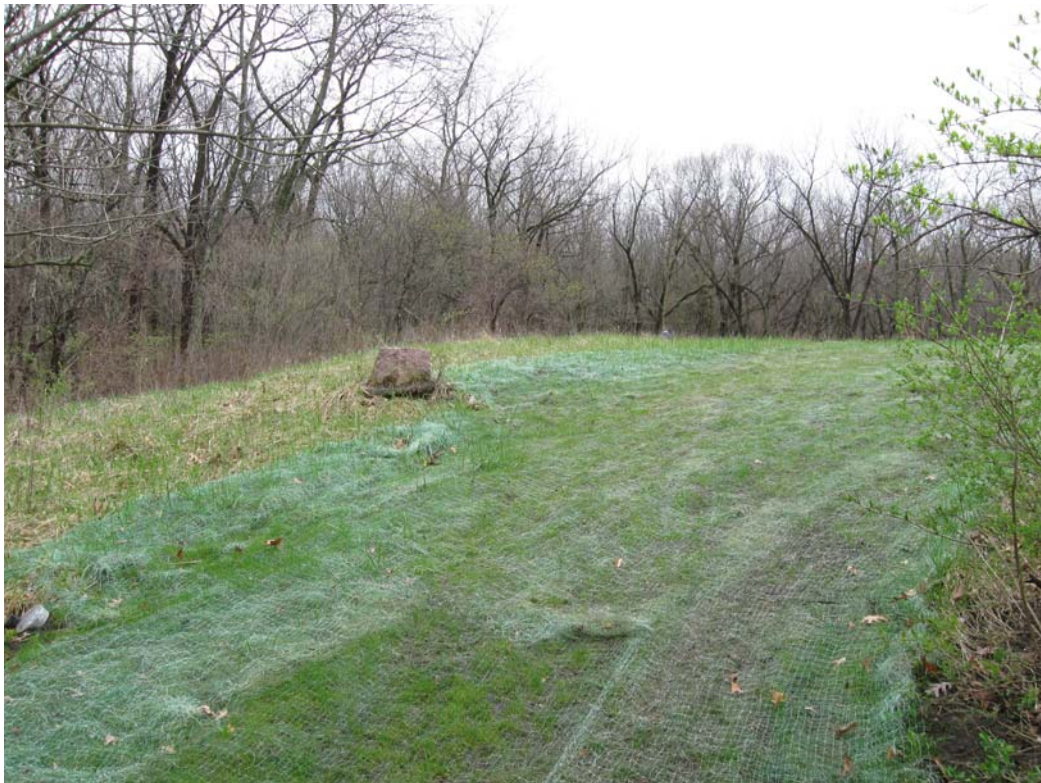
SAM 4/2011. PL-2. Erosion repair at Plot M.

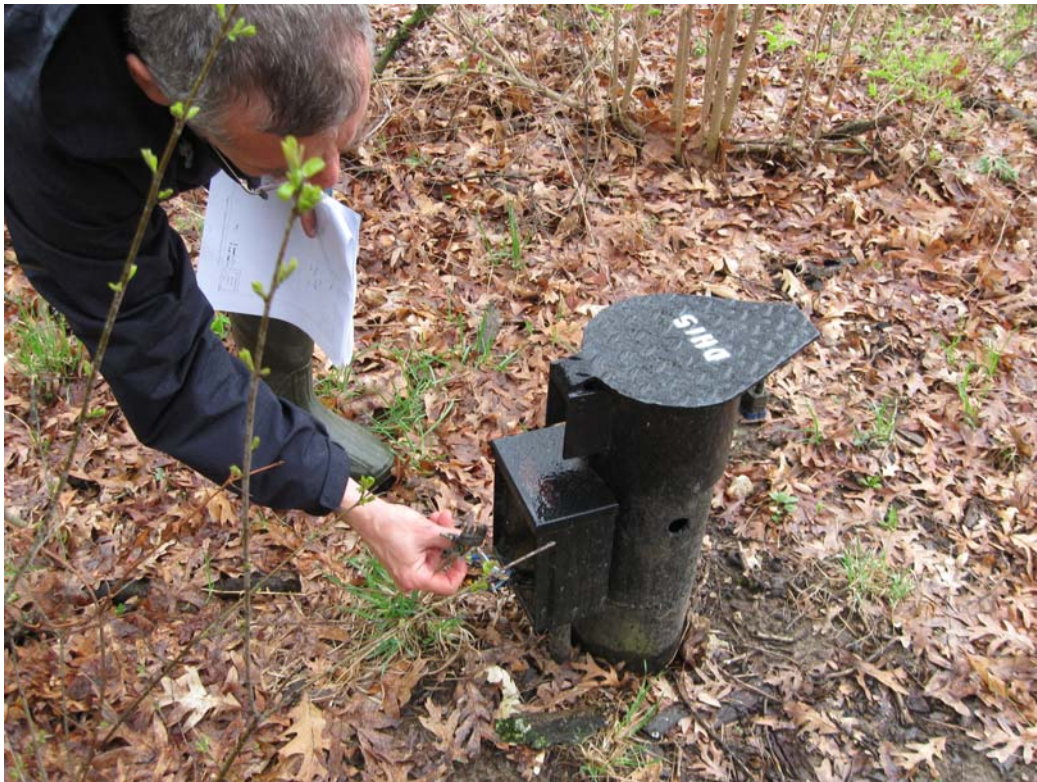
4. A panel on the well head of monitoring well DH15 is missing, and wires are exposed to the public (page 4).

SAM 4/2011. PL-3. Wires protruding from monitoring well DH15.

**Recommendation:** It is recommended that the cover be replaced, or the wires removed.

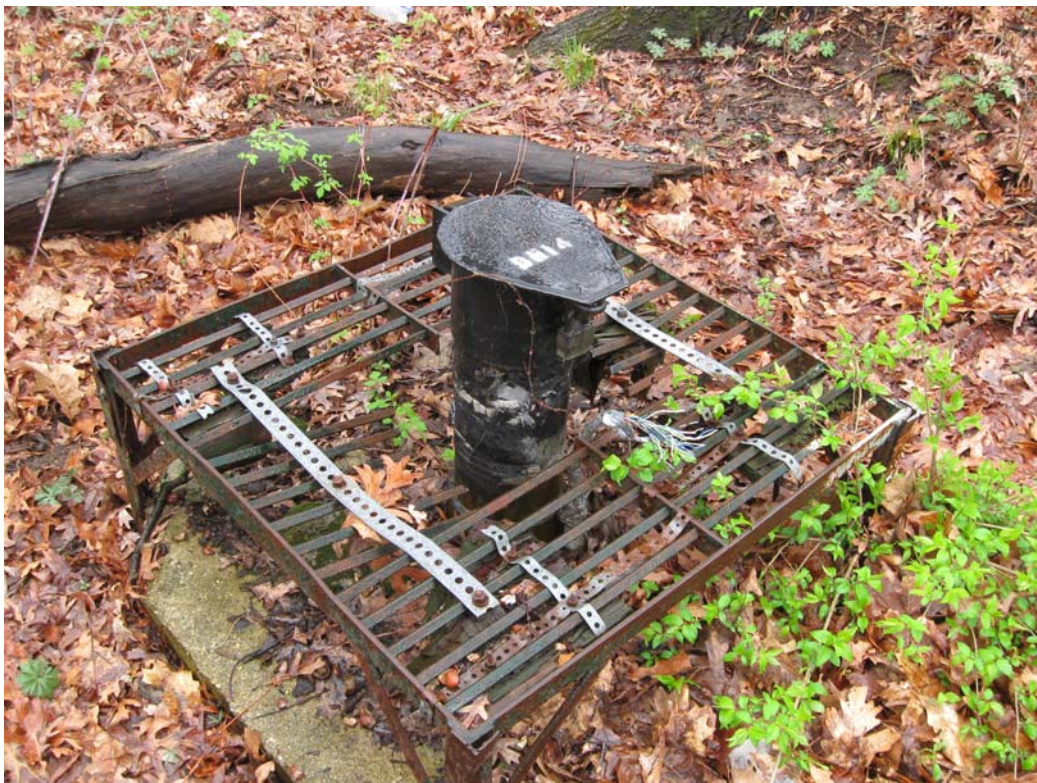
Monitoring wells at Plot M and north of Plot M were secured with locks and identified with a well number on the outer casing. No monitoring wells were opened during the inspection. ANL personnel visit the wells quarterly for sampling, ensure well security, and perform required maintenance at that time. A couple of minor maintenance issues remained in two of the ten wells north of Plot M. A panel on the well head of monitoring well DH15 is missing, and wires are exposed to the public (PL-3). It is recommended that the cover be replaced, or the wires removed. Metal grating remains around monitoring well DH14 that could present a tripping hazard to the public and some wires are also exposed at the wellhead (PL-4). It is recommended that the metal grating and wires be removed.

5. Metal grating is present around monitoring well DH14 that could present a tripping hazard to the public, and some wires are also exposed at the wellhead (page 4).

SAM 4/2011. PL-4. Wires and grate at monitoring well DH14.

**Recommendation:** It is recommended that the metal grating and exposed wires be removed.

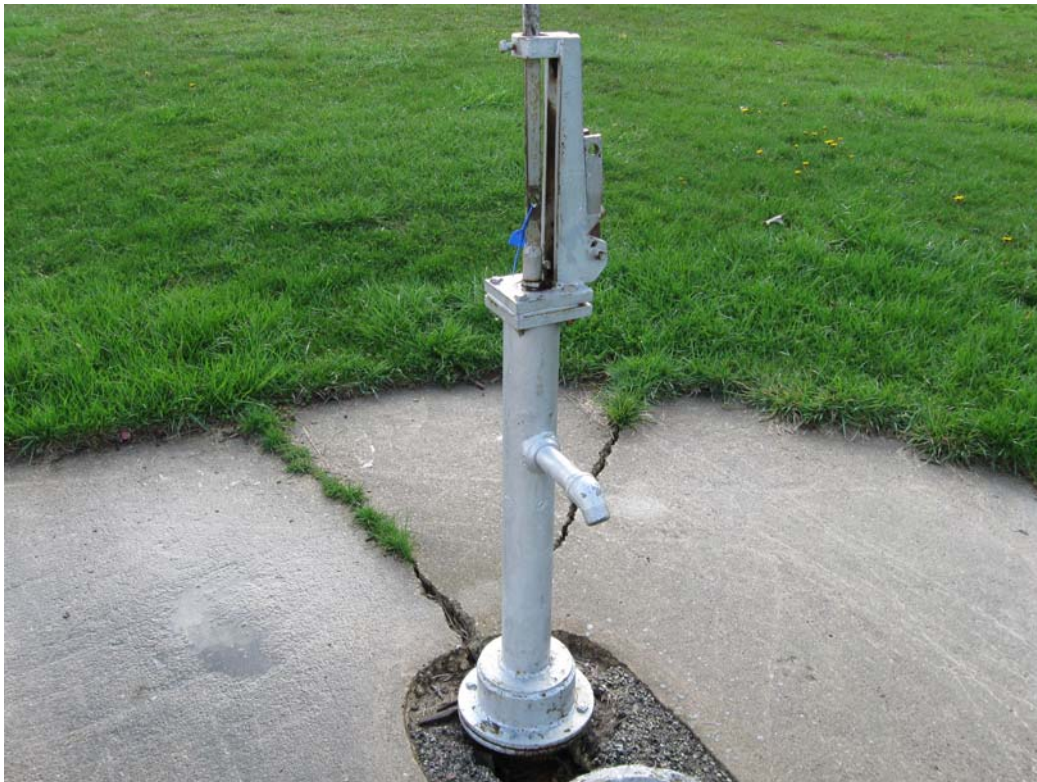
Inspectors met at the Red Gate Woods parking area and reviewed the Plan of the Day and the Job Safety Analysis. Inspectors noted that the pump handles remained off the picnic wells and that a portable restroom remained in place (PL-5). The handles were removed from the pumps years ago to prevent use of the well due to fecal coliform in the water. The fecal coliform originated from a nearby permanent restroom facility, which was removed and replaced with a portable restroom.

SAM 4/2011. PL-5. Disabled drinking water well at Red Gate Woods.

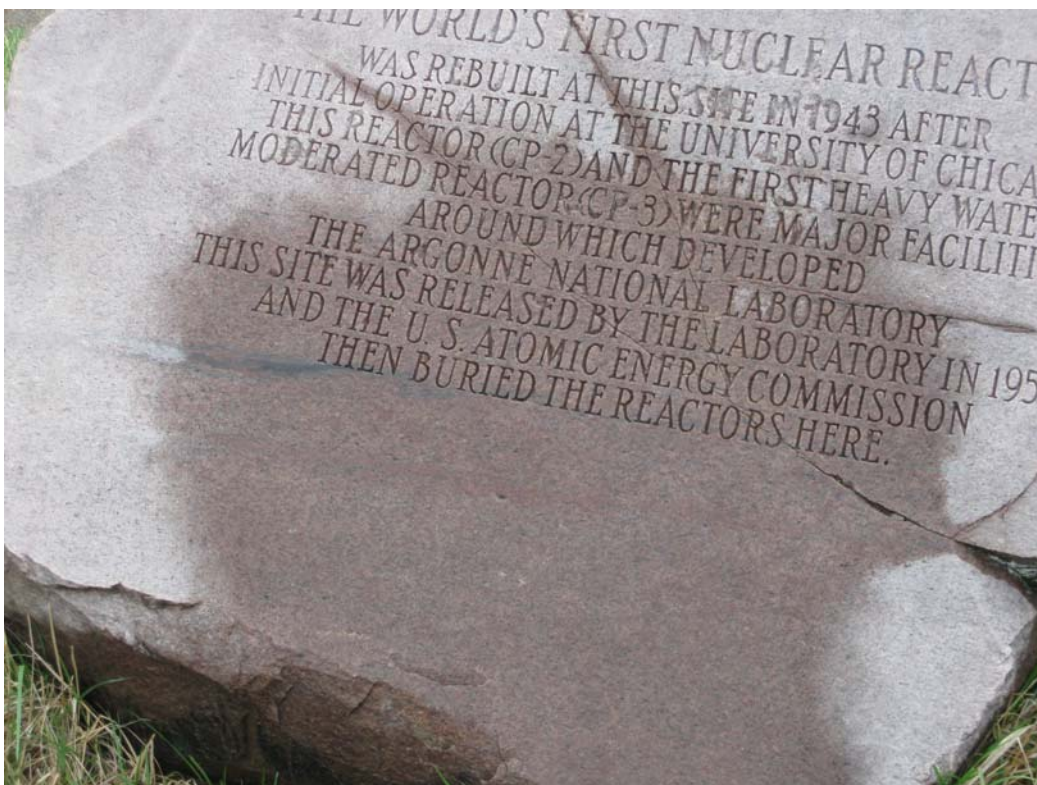
Inspectors drove to Site A, walked to the center of the area, examined the site marker and walked around the perimeter of the site. The site and marker were in good shape (PL-6).

SAM 4/2011. PL-6. Site marker for Site A.

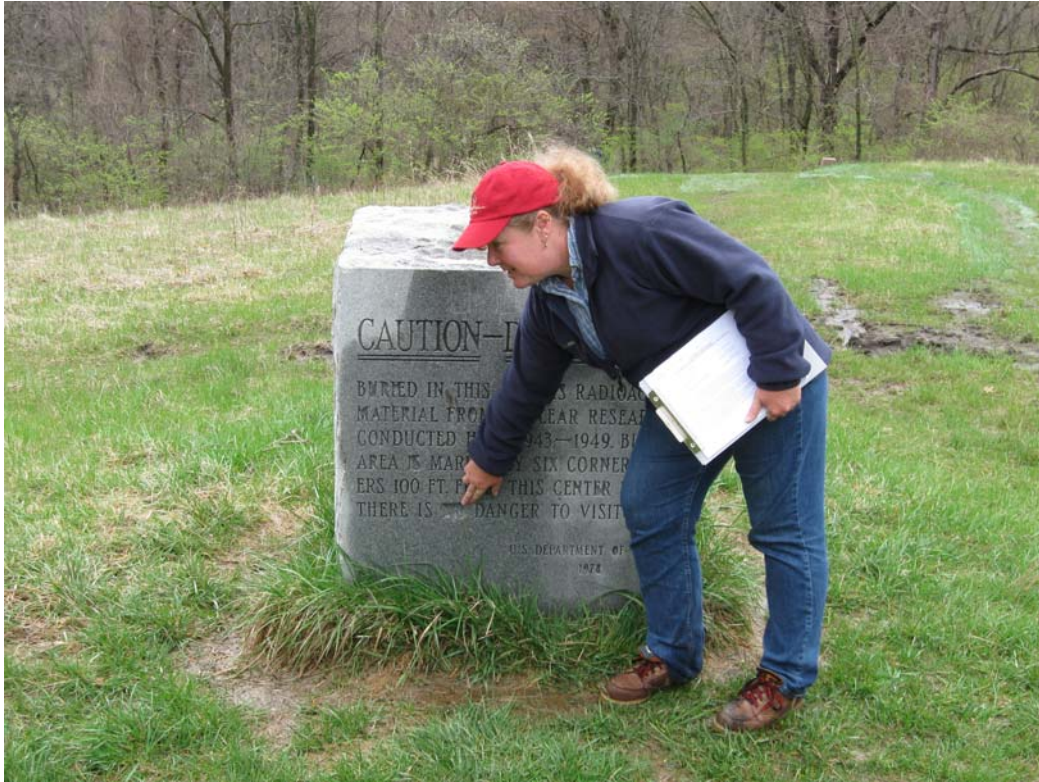
The Plot M site marker was unchanged from last year's inspection. It was in good shape, with the exception of some minor vandalism that occurred several years ago. Some words on the marker are chiseled off (PL-7). All Plot M corner markers were located and found to be in good shape.

SAM 4/2011. PL-7. Site marker for Plot M.

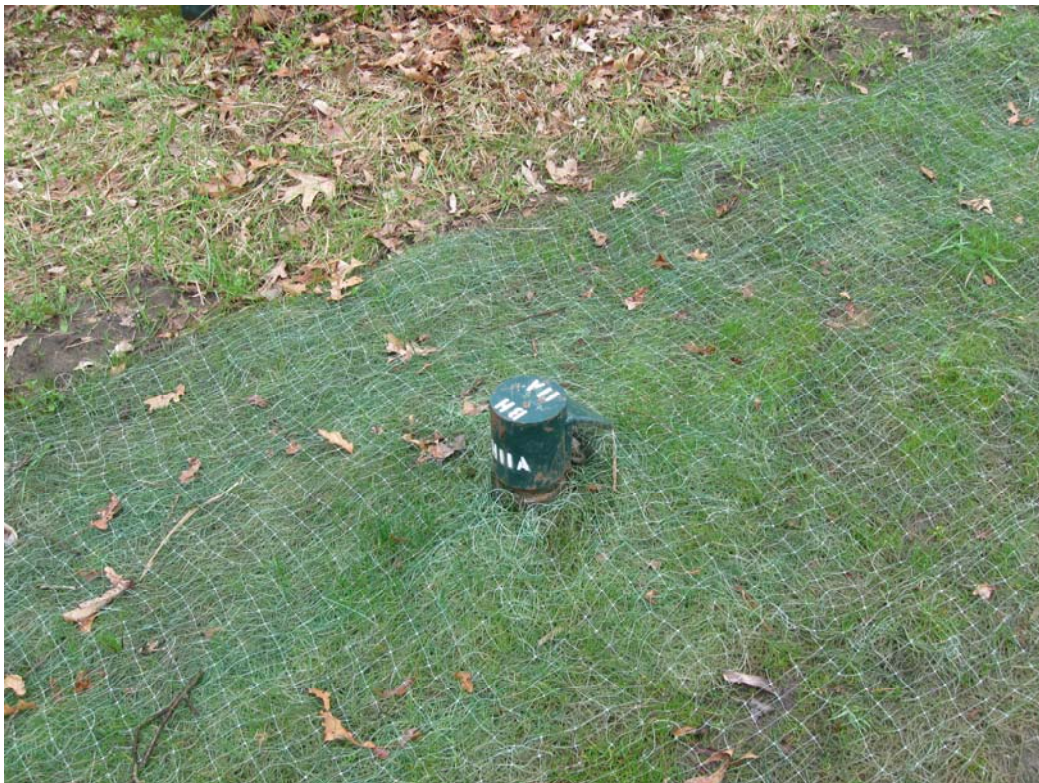
SAM 4/2011. PL-8. Erosion repair at Plot M, near Monitoring Well BH9.

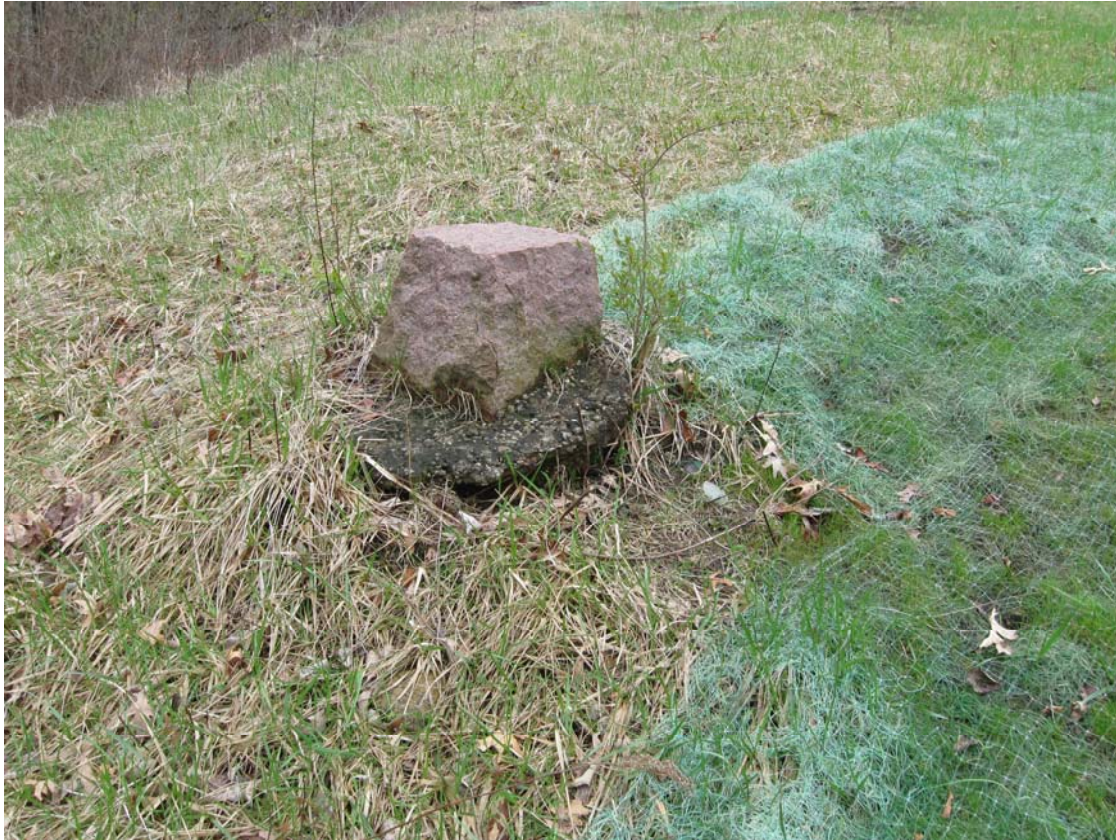
SAM 4/2011. PL-9. Erosion repair next to corner marker at Plot M.
