2012 Inspection and Annual Site Status Report for the Site A/Plot M, Cook County, Illinois Decontamination and Decommissioning Program Site

The annual site inspection for Site A/Plot M was conducted on May 9, 2012. The former reactor site was found to be in good condition and as a result, no follow-up inspection was deemed necessary.

2012 ANNUAL INSPECTION DRAWING
SITE A/PLOT M DECOMMISSIONED REACTOR
COOK COUNTY, ILLINOIS

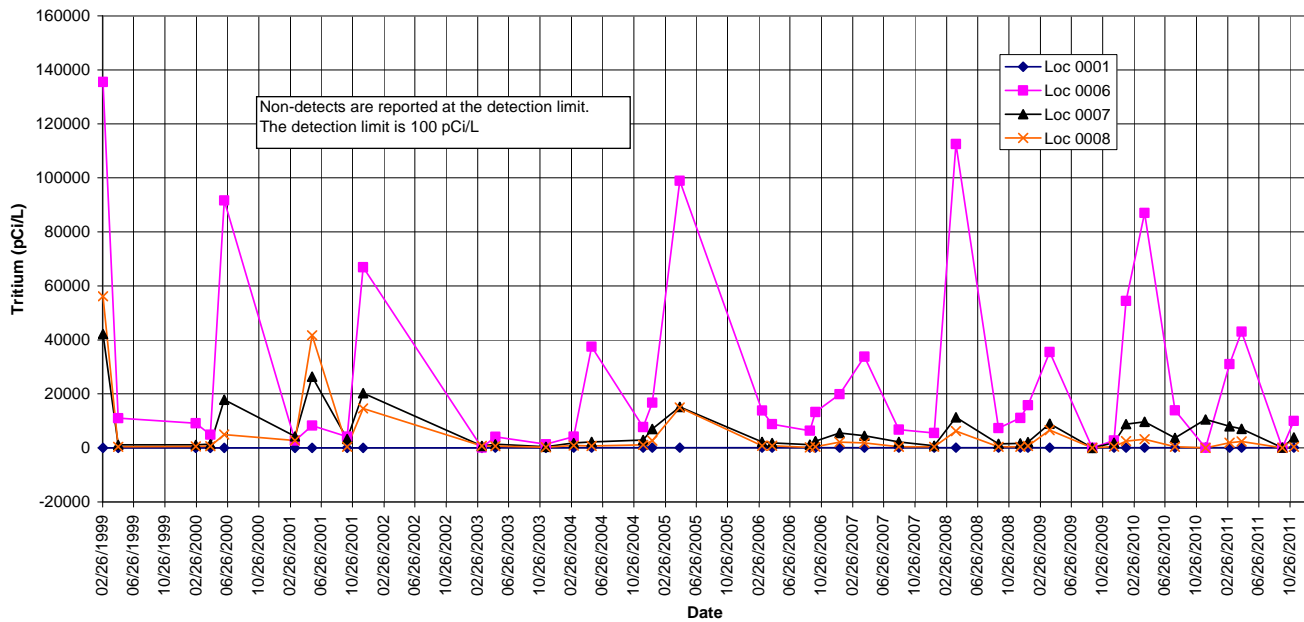
Figure 1. Tritium Activities in Surface Water at Site A/Plot M, Cook County, Illinois

Tritium levels exceeded the State of Illinois standard of 20,000 picocuries per liter (pCi/L) at seep location 0006 which is located just downgradient of Plot M. Seep activities at location 0006 ranged from 10,000 to 43,000 pCi/L (Figure 1). Seep locations 0006 and 0008 were dry on September 26, 2011.

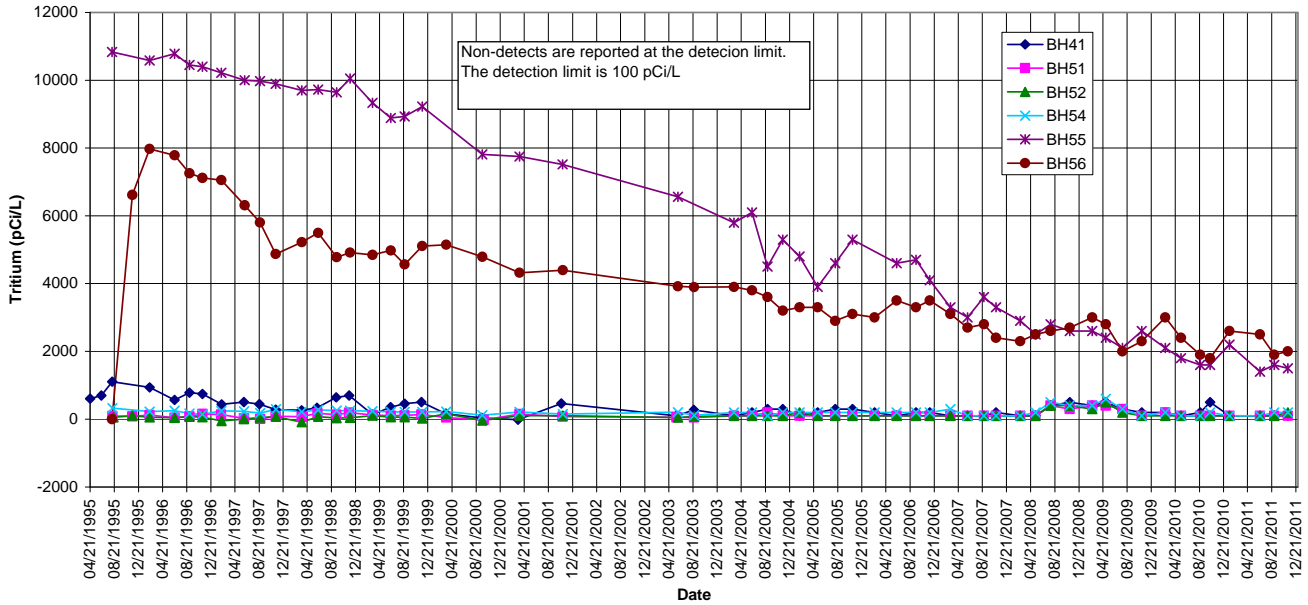
Figure 2. Tritium Activities in Groundwater in the Glacial Drift at Site A, Cook County, Illinois

In 2011, tritium was detected in the groundwater at Site A in five of the six monitoring well locations completed in the glacial drift. Tritium was not detected in monitoring well B51. None exceeded the standard of 20,000 pCi/L. Activities ranged from non-detect (less than 100 pCi/L) to 2,600 pCi/L (Figure 2).

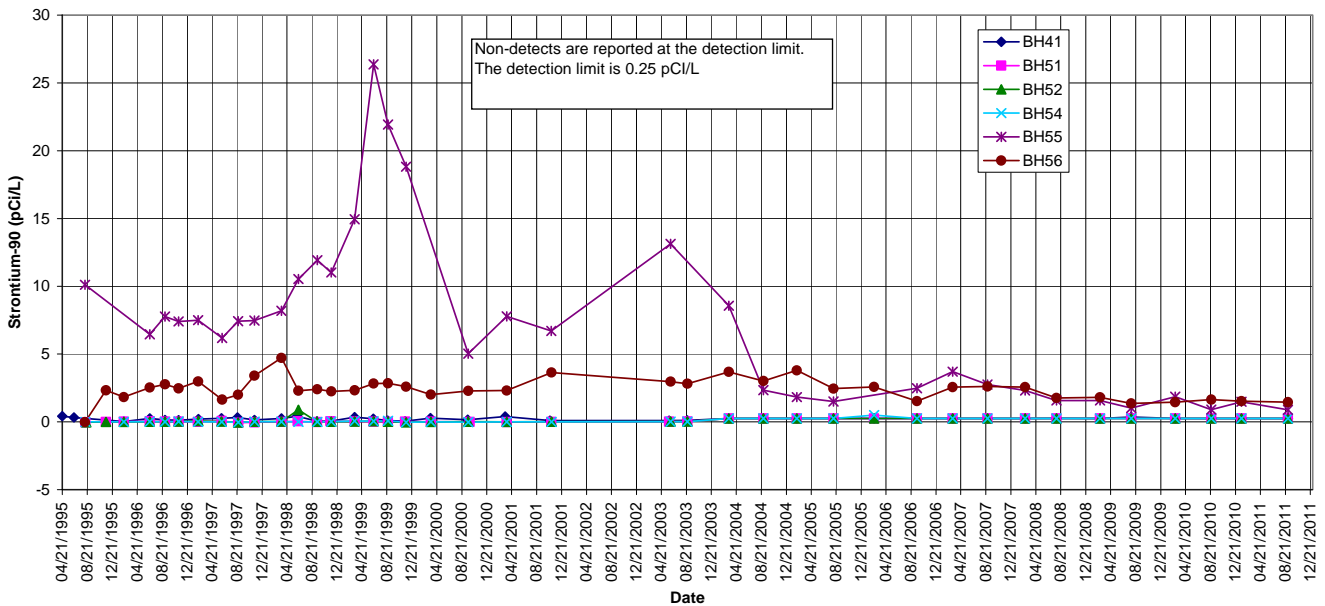
Figure 3. Strontium-90 Activities in Groundwater in the Glacial Drift at Site A, Cook County, Illinois

In 2011, strontium-90 was detected in the groundwater at Site A in two of the six monitoring well locations completed in the glacial drift. Activities ranged from non-detect (less than 0.25 pCi/L) to 1.54 pCi/L, but none exceeded the State of Illinois standard of 8 pCi/L (Figure 3).

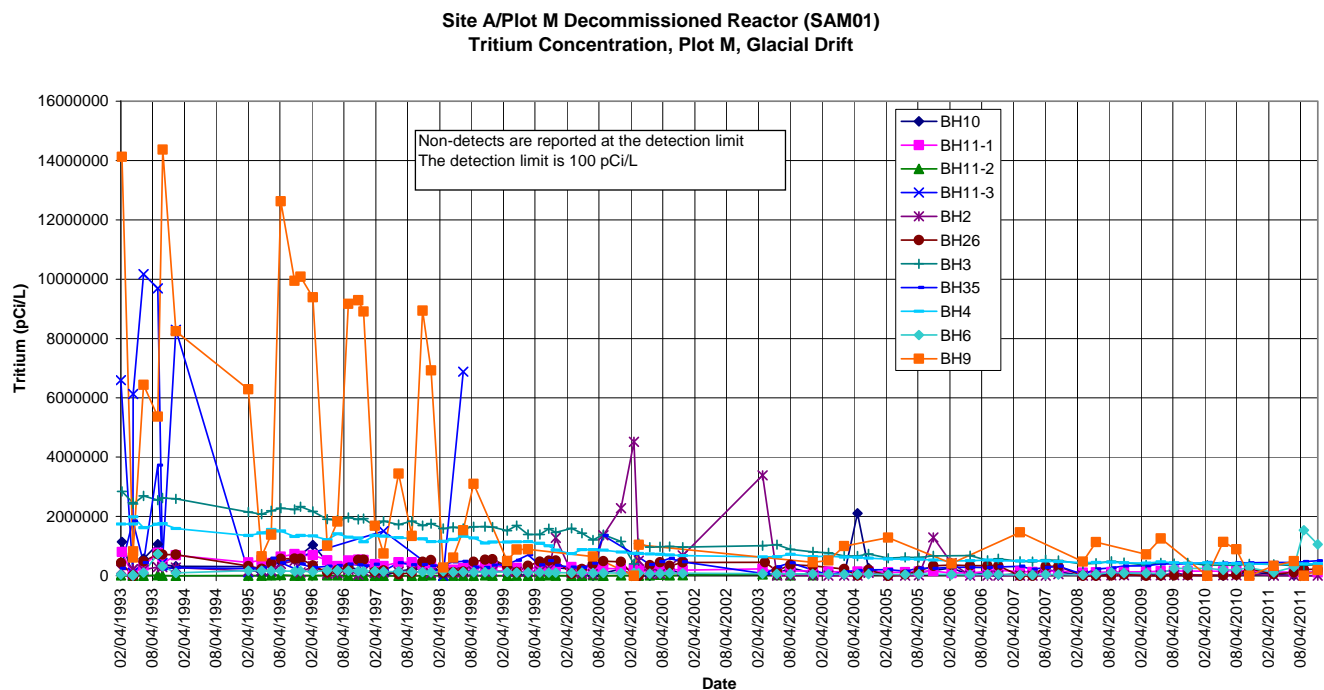
Figure 4. Tritium Activities in Groundwater in the Glacial Drift at Plot M, Cook County, Illinois

In 2011, tritium was detected in the groundwater at Plot M at all nine monitoring wells completed in the glacial drift. Tritium concentrations ranged from 7,200 pCi/L to 1,534,000 pCi/L (Figure 4). The highest concentration was at BH6 on August 24th. Well BH9 was dry during one of the four sampling attempts in 2011 (August 24th).

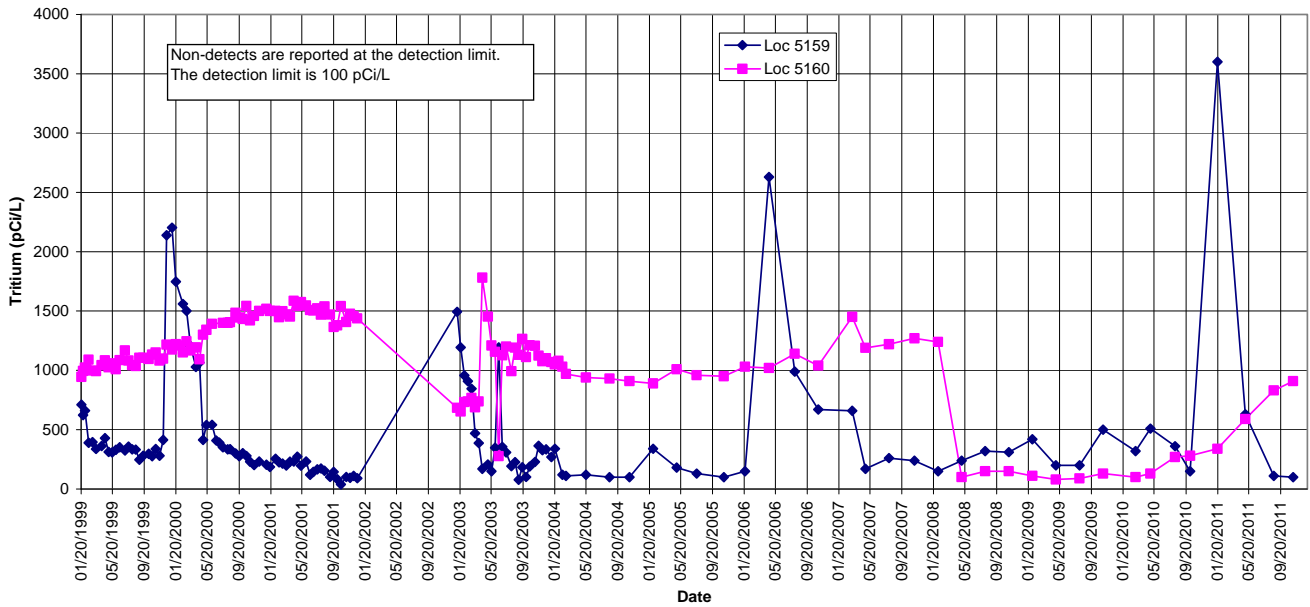
Figure 5. Tritium Activities in Groundwater in the Picnic Wells, Site A/Plot M, Cook County, Illinois

In 2011, tritium was detected in the groundwater at the picnic wells at the Red Gate Woods picnic area. The January 19th sample from Picnic Well 5159 had the highest concentration of tritium ever measured at the well (3,600 pCi/L). Activities for the two picnic wells ranged from non-detect (less than 100 pCi/L) to 3,600 pCi/L (Figure 5). None exceeded the State of Illinois standard of 20,000 pCi/L.

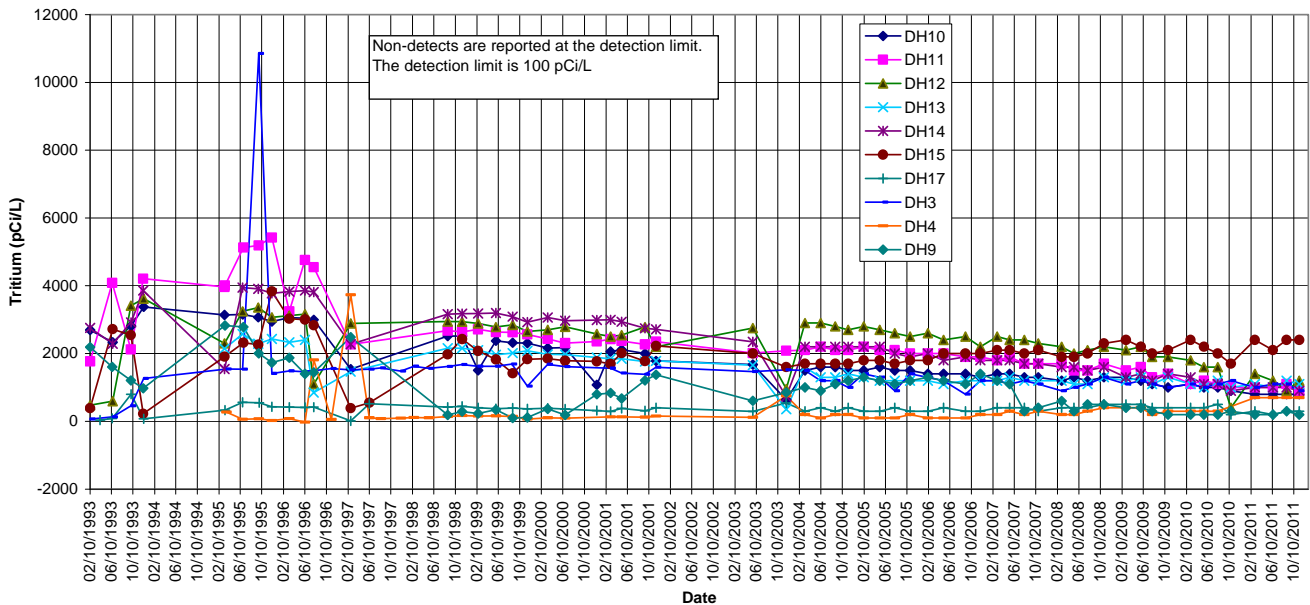
Figure 6. Tritium Activities in Groundwater in the Dolomite Bedrock, Site A/Plot M, Cook County, Illinois

In 2011, tritium was detected in the groundwater at all ten monitoring wells completed in the dolomite bedrock north of Plot M. Activities ranged from 200 pCi/L to 2,400 pCi/L (Figure 6). Tritium is no longer a constituent of concern in the dolomite bedrock beneath Site A. Monitoring was stopped in 2004 after approximately 30 years of sampling failed to detect tritium

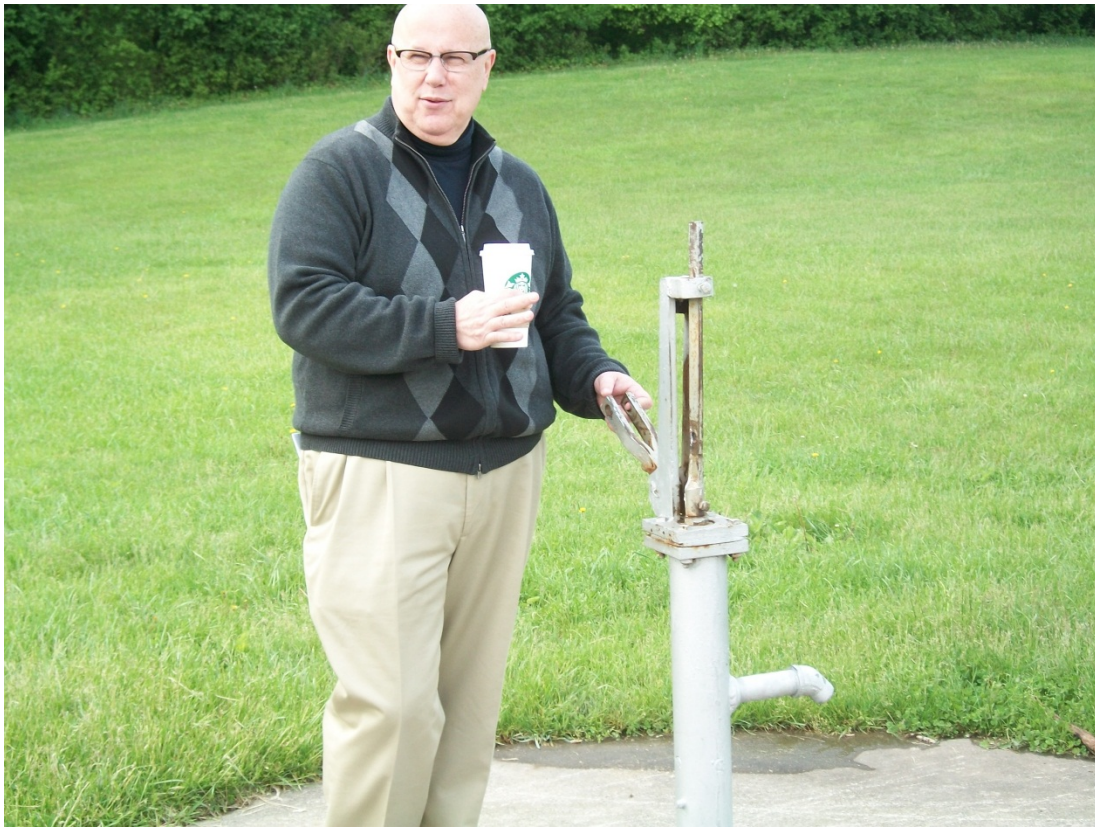
Inspectors met at the Red Gate Woods parking area and reviewed the Plan of the Day and the Job Safety Analysis. Inspectors noted that the pump handles remained off the picnic wells and that a portable restroom remained in place (PL-1). The handles were removed from the pumps years ago to prevent use of the well due to fecal coliform in the water. The fecal coliform originated from a nearby permanent restroom facility, which was removed and replaced with a portable restroom.

SAM 5/2012. PL-1. Picnic well 5160.

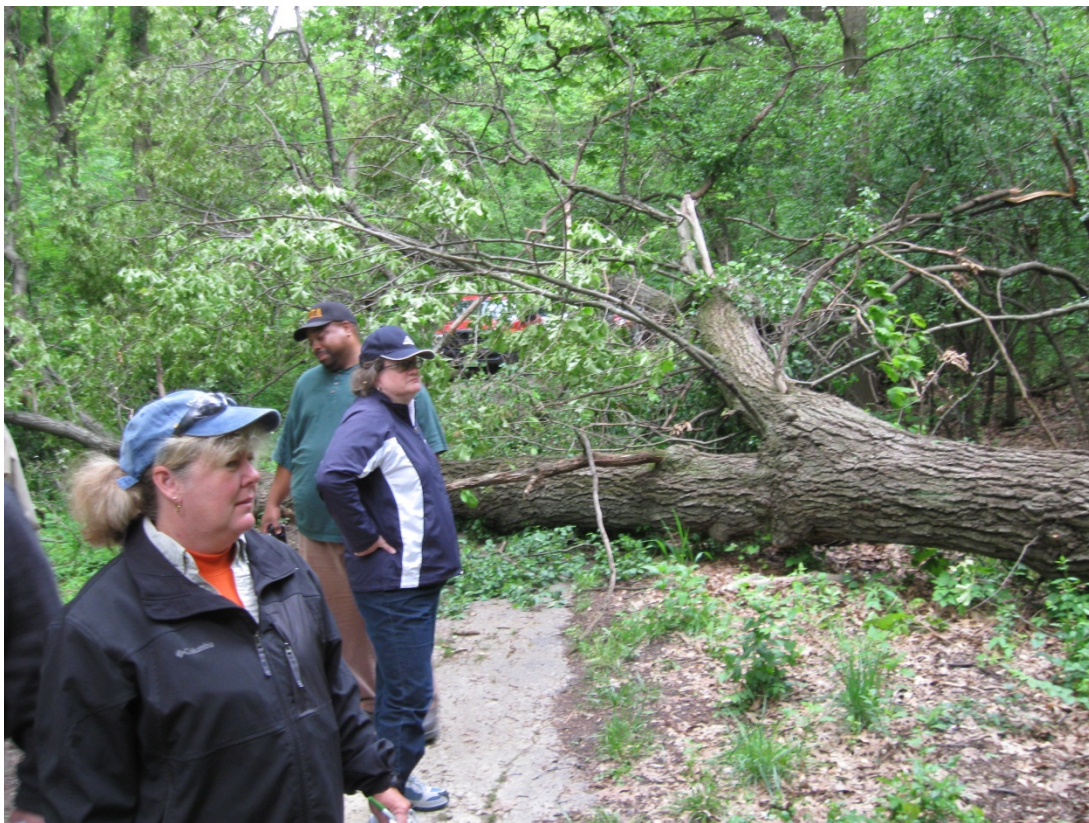
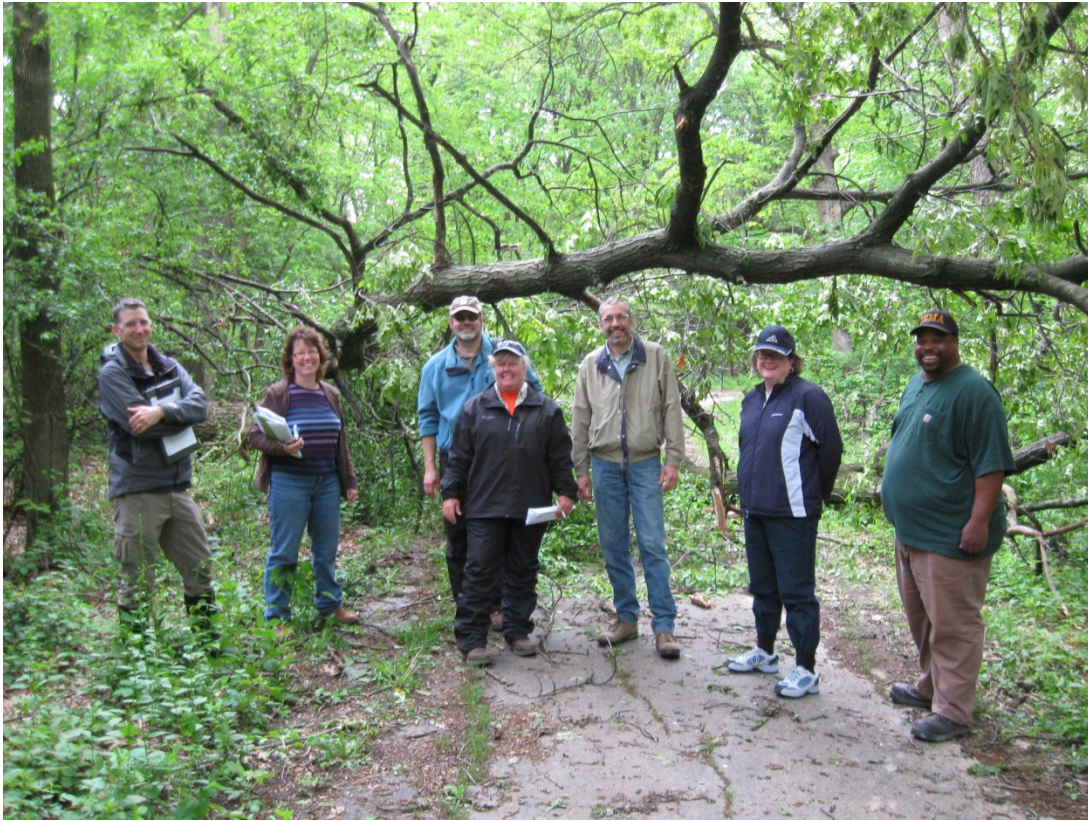
Inspectors could not drive to Site A this year due to a recently downed tree blocking the access road (PL-2, PL-3). ANL will work with forest preserve personnel to have the tree removed from the access road. Inspectors walked to Site A, examined the site marker, and walked around the perimeter of the site. The site and marker were in good condition (PL-4).

SAM 5/2012. PL-2. Fallen tree blocking access road to Site A.

SAM 5/2012. PL-3. Fallen tree blocking access road to Site A.

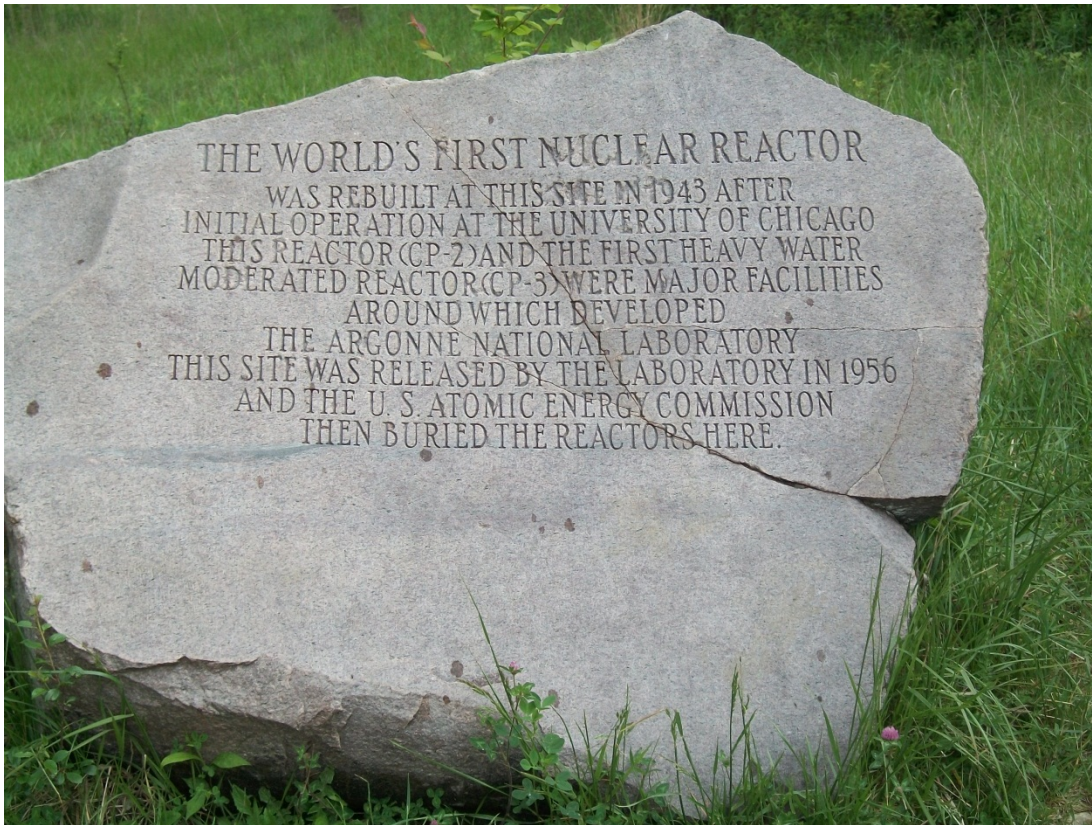
SAM 5/2012. PL-4. Site marker at Site A.

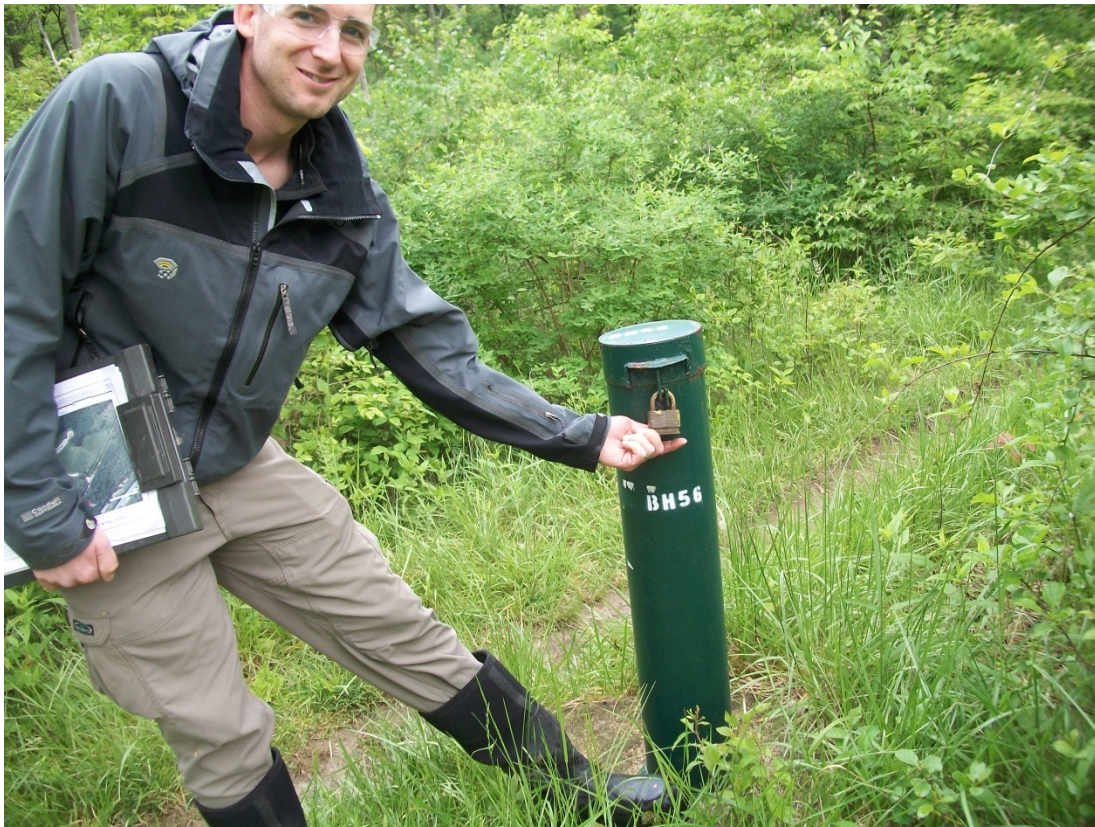
Monitoring wells at Site A were observed to be secured with locks and identified with a well number on the outer casing (PL-5). ANL personnel monitor the wells quarterly, ensure well security, and perform required maintenance.

SAM 5/2012. PL-5. Monitoring well BH56.

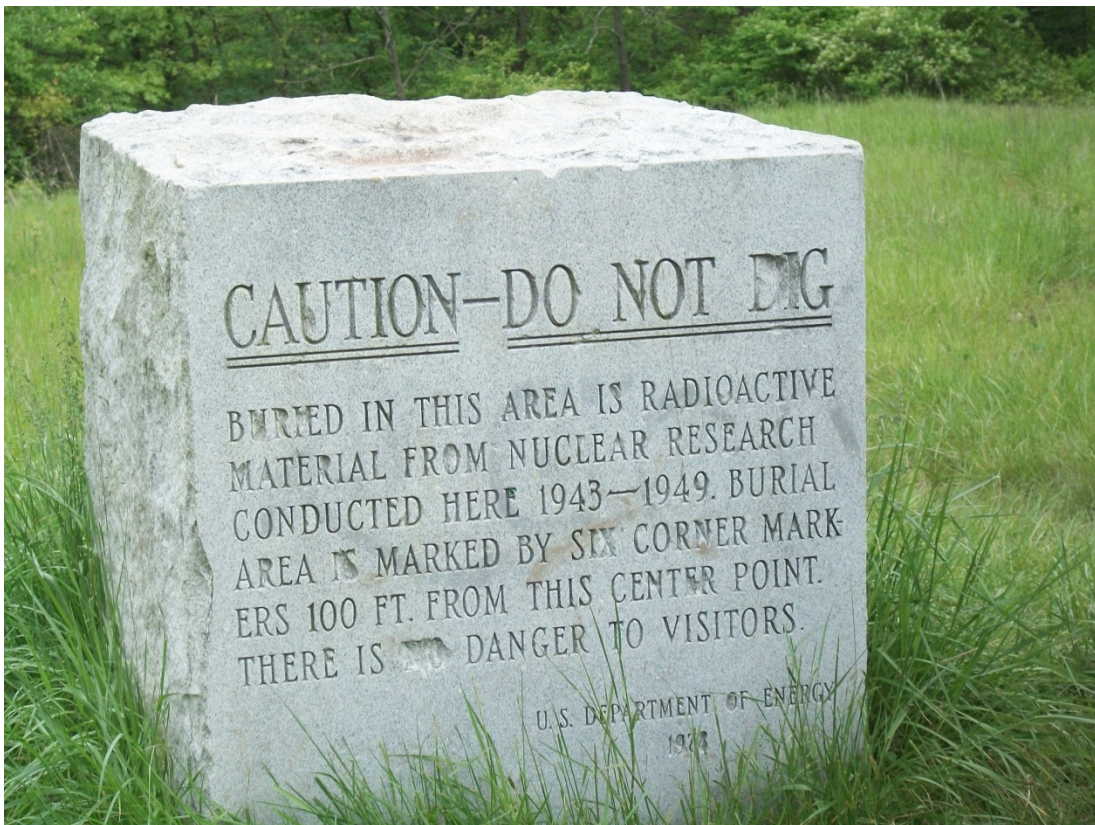
The Plot M site marker was unchanged from the inspection last year. It was in good condition, with the exception of some minor vandalism that occurred several years ago. Some words on the marker are chiseled off (PL-6). All Plot M corner markers were located and were in good condition (PL-7).

SAM 5/2012. PL-6. Site marker at Plot M.

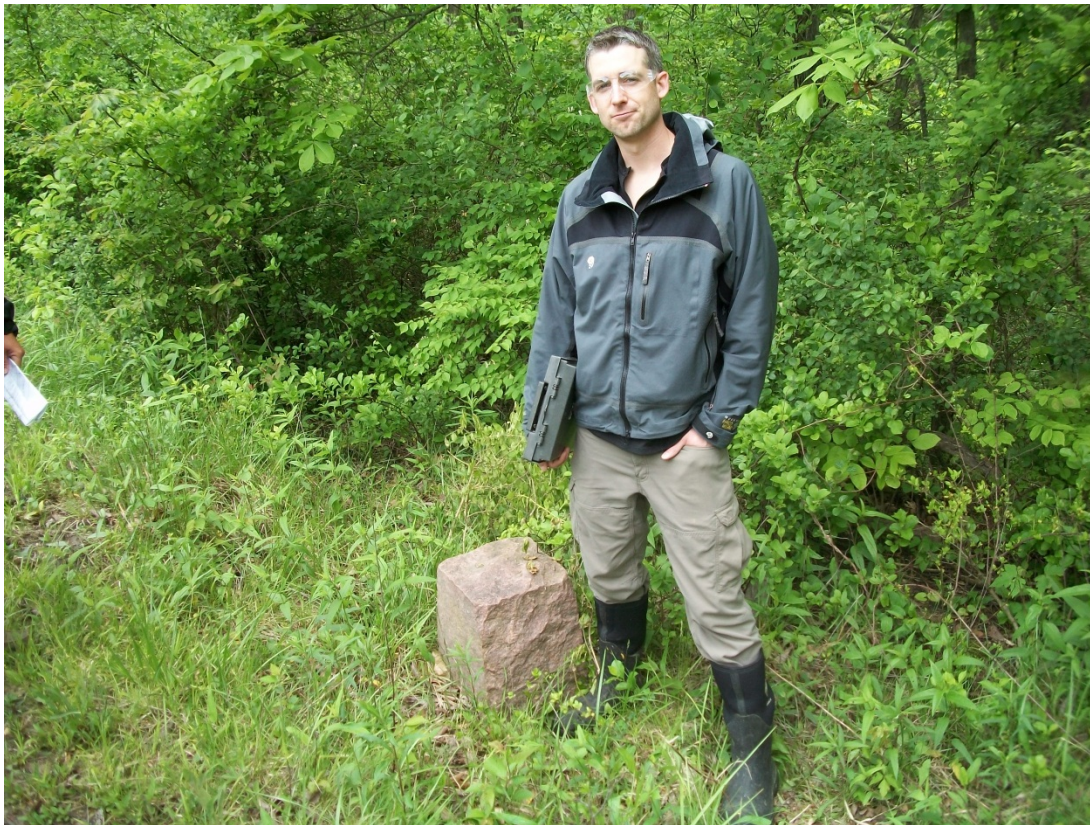
SAM 5/2012. PL-7. One of six corner markers at Plot M.

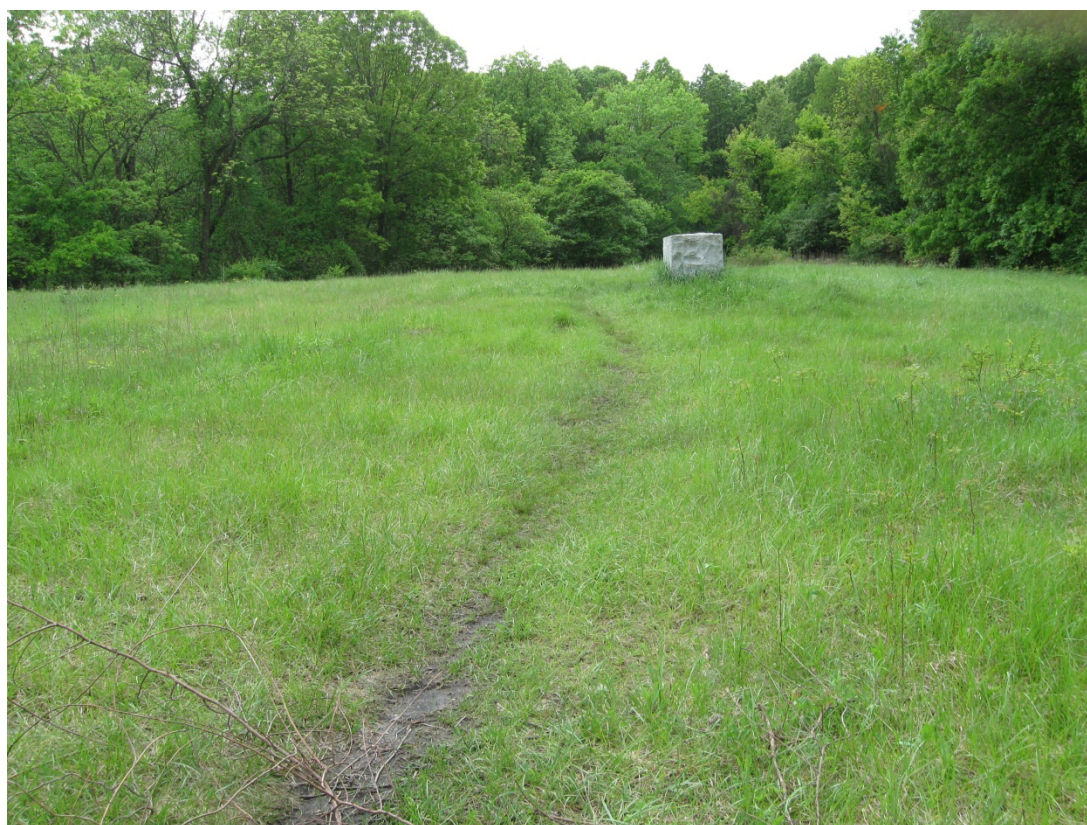
site marker. The area north of the site marker was approximately 31 feet by 12 feet, by 2 feet deep. The erosion west of the site marker was approximately 13 feet by 3 feet by 1 foot deep, and was close to one of the Plot M corner markers. The erosion was caused by visitors riding their bicycles across the grass covered mound. Both areas were restored to pre-erosion conditions using top soil. It was noted during this year's inspection that ruts are returning to the mound cover due to continued bicycle travel across the mound (PL-8). It is recommended that as erosion occurs due to bicycle pathways the resulting ruts be monitored then filled with top soil and seeded accordingly.

4. It was noted during the inspection this year that ruts are returning to the Plot M mound cover due to continued bicycle travel across the cover (pages 1 and 4).

SAM 5/2012. PL-8. New ruts on top of Plot M due to bicycle traffic.

Recommendation: It is recommended that as erosion occurs due to bicycle pathways the resulting ruts be monitored then filled with top soil and seeded accordingly.

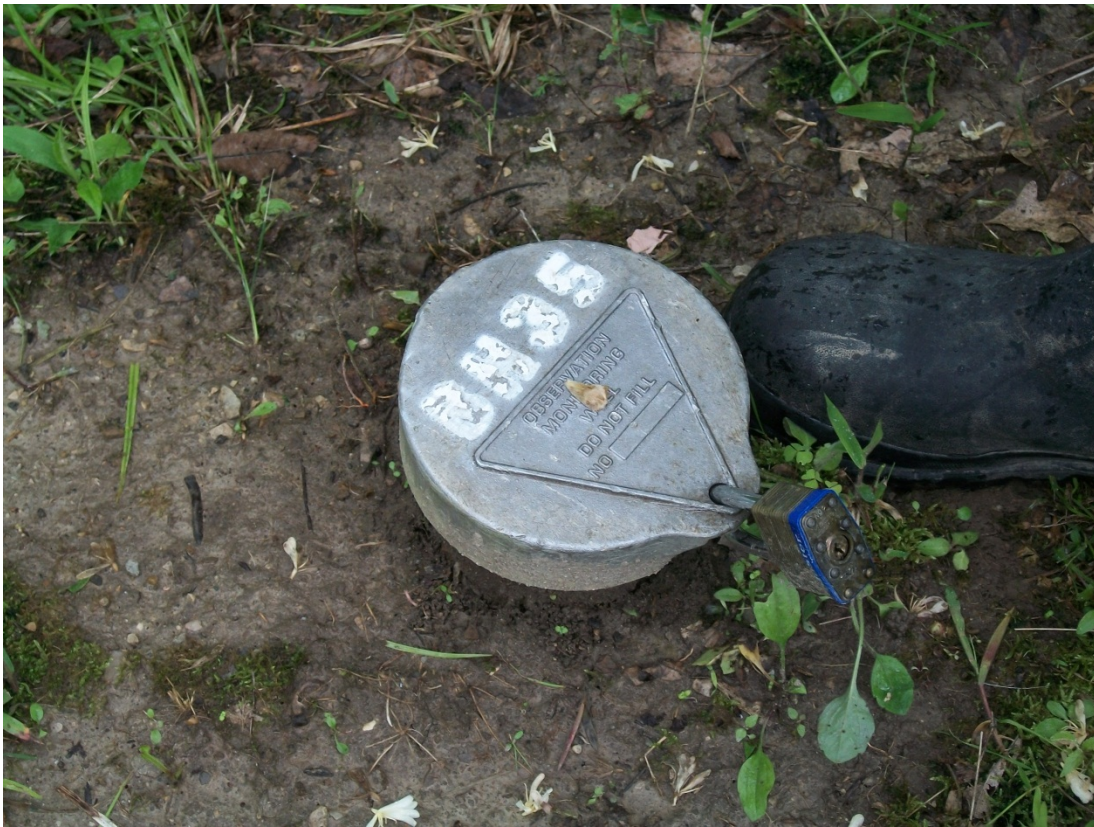
Monitoring wells at Plot M and north of Plot M were observed to be secured with locks and identified with a well number on the outer casing (PL-9). ANL personnel monitor the wells quarterly, ensure well security, and perform required maintenance.

SAM 5/2012. PL-9. Monitoring well BH35.

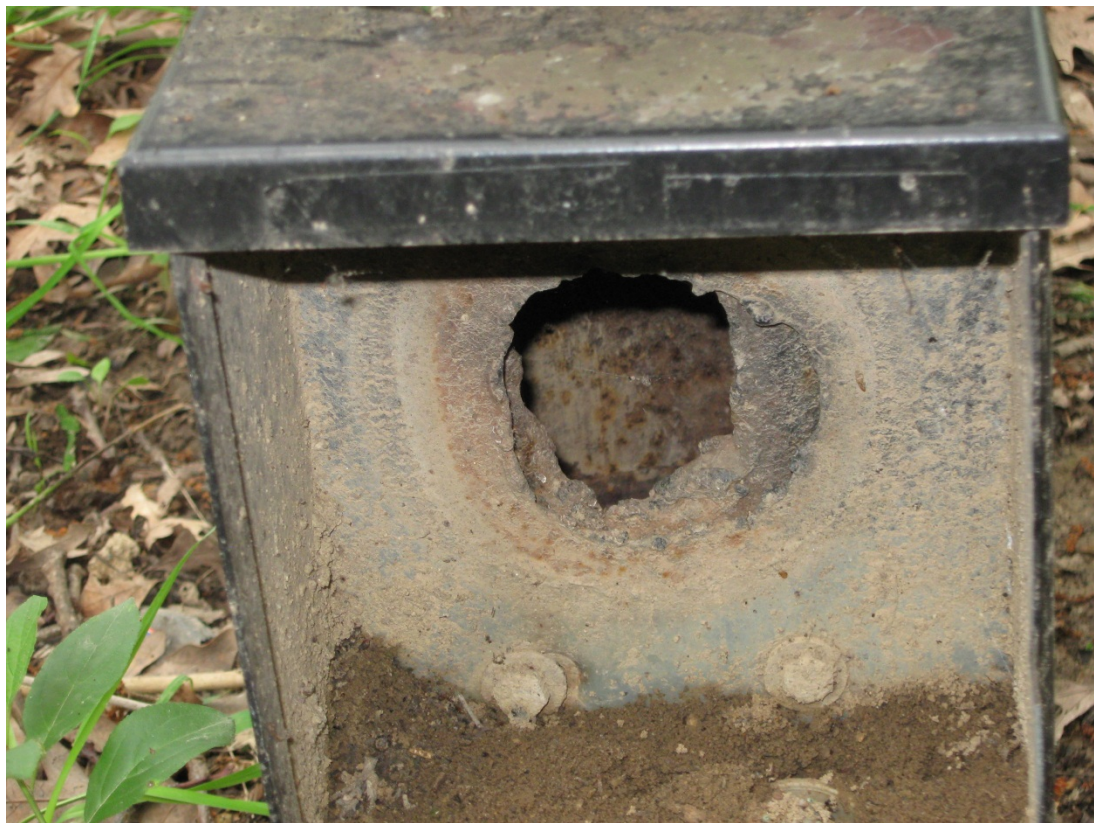
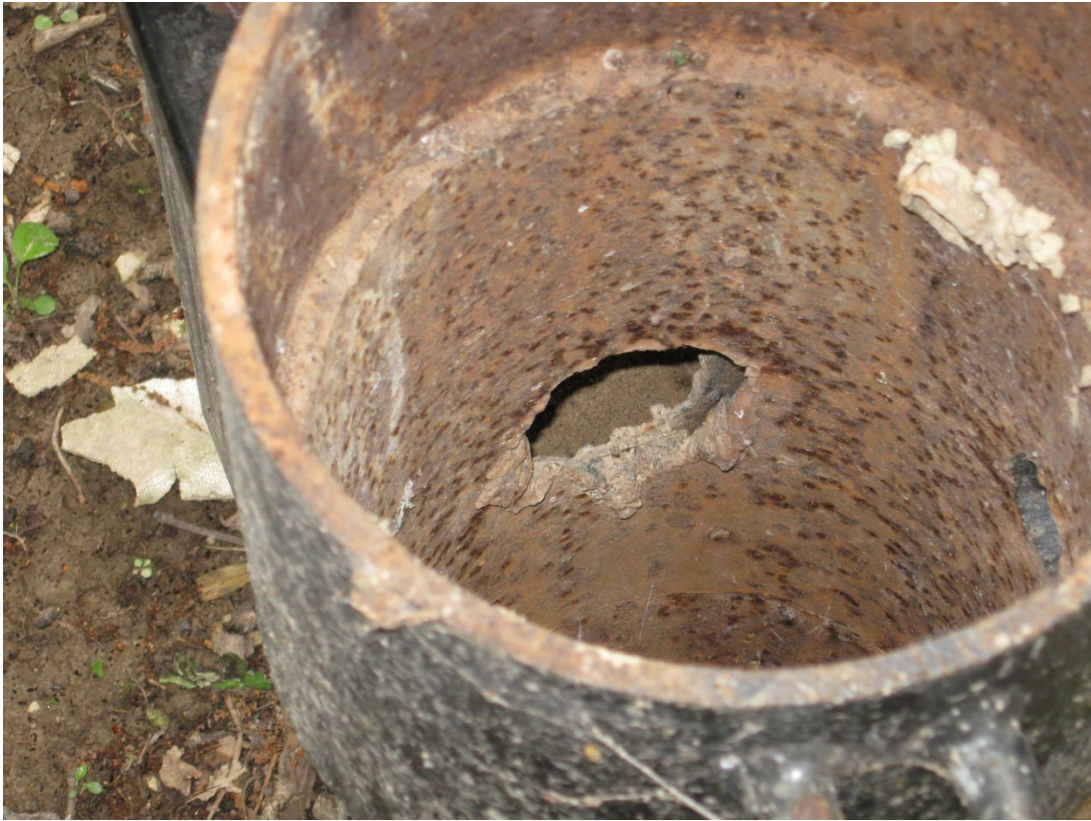
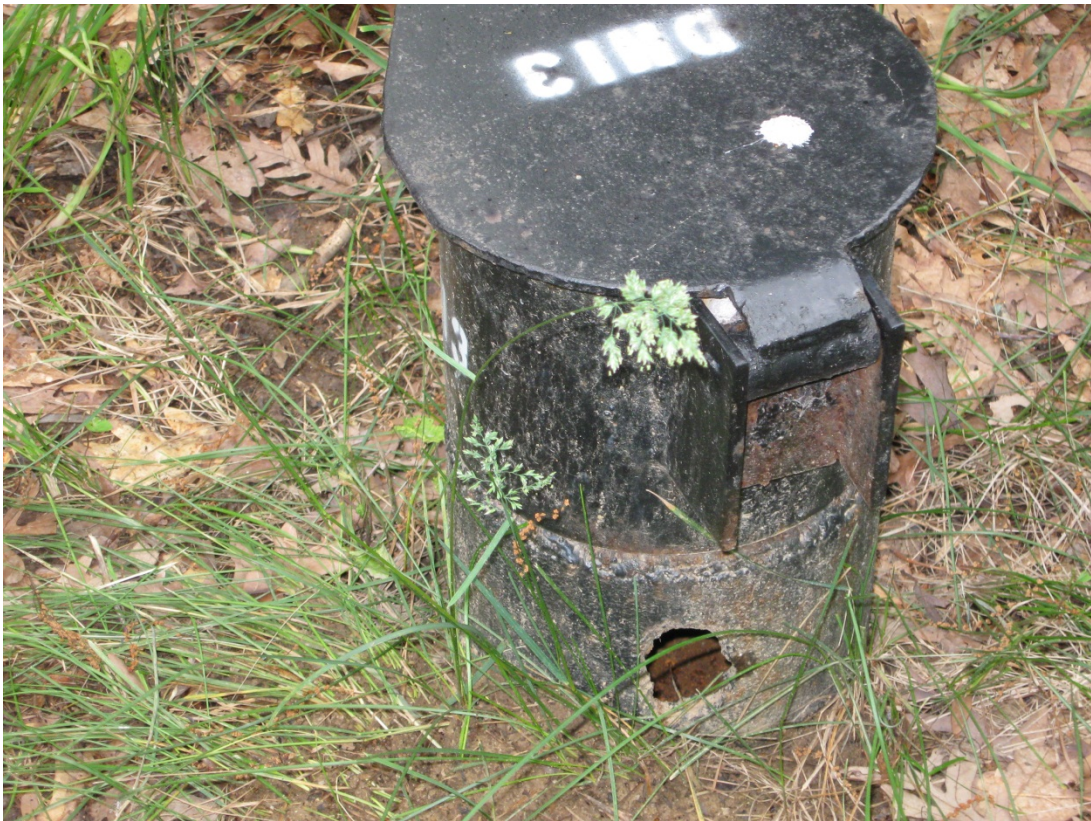
Some minor well maintenance items from previous inspections had been addressed. Specifically, at monitoring wells DH15 and DH14 some exposed wires were removed; a metal grate tripping hazard was removed from monitoring well DH14. Addressing these items though, inadvertently led to some additional minor maintenance needs at these wells. The openings through which the wires protruded from the well casing left holes in the casings that allow access to the wells even when the well heads are locked. These holes need to be patched. They are present at monitoring wells DH13 and DH15 (PL-10, PL-11, and PL-12). It is recommended that these holes be patched to maintain well head security.

1. The protective casings at monitoring wells DH13 and DH15 have holes in them where wires used to protrude from the casings (pages 1 and 4).

SAM 5/2012. PL-10. Hole in casing of monitoring well DH15.

SAM 5/2012. PL-11. Hole in casing of monitoring well DH15.

SAM 5/2012. PL-12. Hole in casing of monitoring well DH13.

Recommendation: It is recommended that these holes be covered to maintain proper security of the wells.
