2013 Inspection and Annual Site Status Report for the Site A/Plot M, Cook County, Illinois Decontamination and Decommissioning Program Site

Summary

ANNUAL INSPECTION CONDUCTED
 APRIL 10, 2013

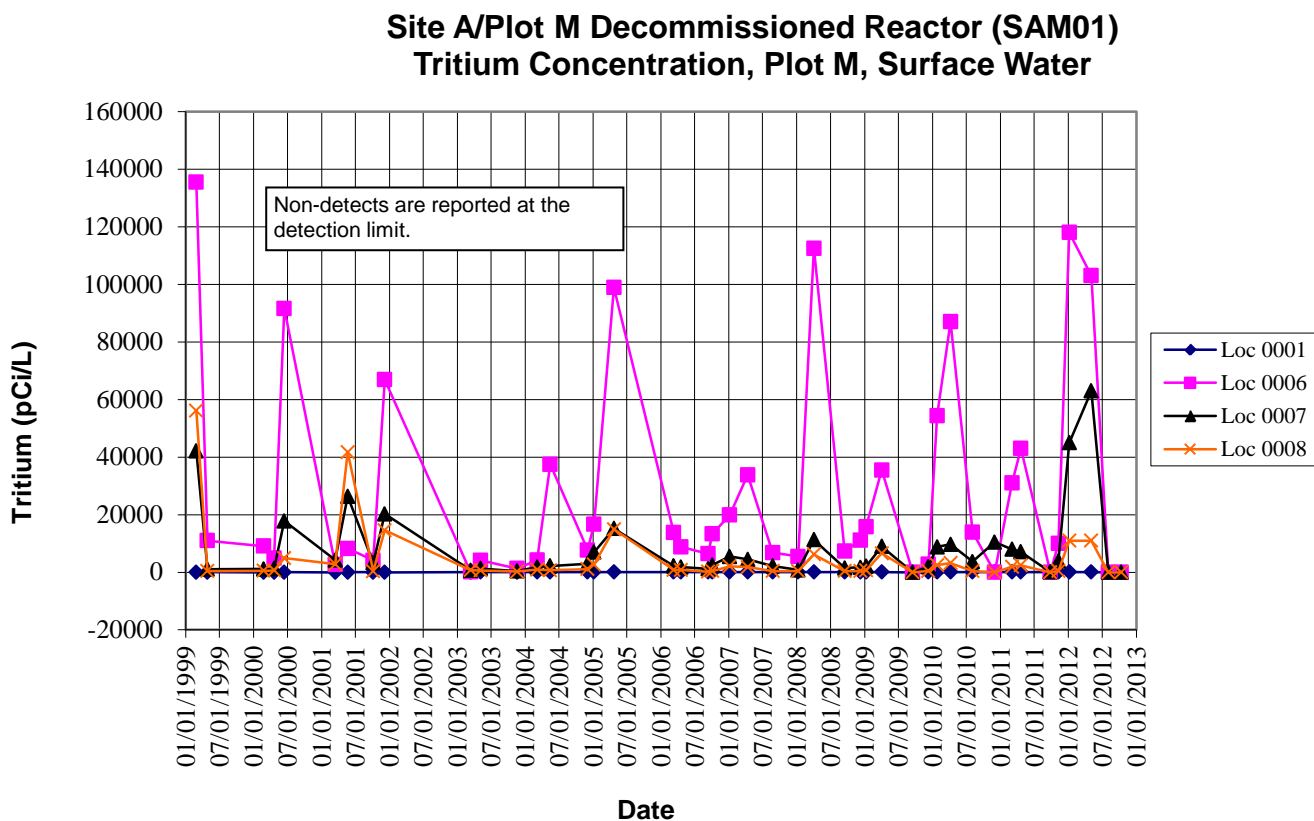
Figure 1. Tritium Activities in Surface Water at Site A/Plot M, Cook County, Illinois

Tritium levels exceeded the State of Illinois standard of 20,000 picocuries per liter (pCi/L) at seep location 0006. Seep activities at location 0006 ranged from 103,000 to 118,000 pCi/L (Figure 1). The 118,000 pCi/L activity is the highest activity measured at this location since 1999.

Tritium levels at intermittent stream sampling location 0007 also exceeded the State of Illinois standard of 20,000 pCi/L during the first and second quarters of 2012. Activities at location 0007 ranged from 45,000 to 63,000 pCi/L (Figure 1).

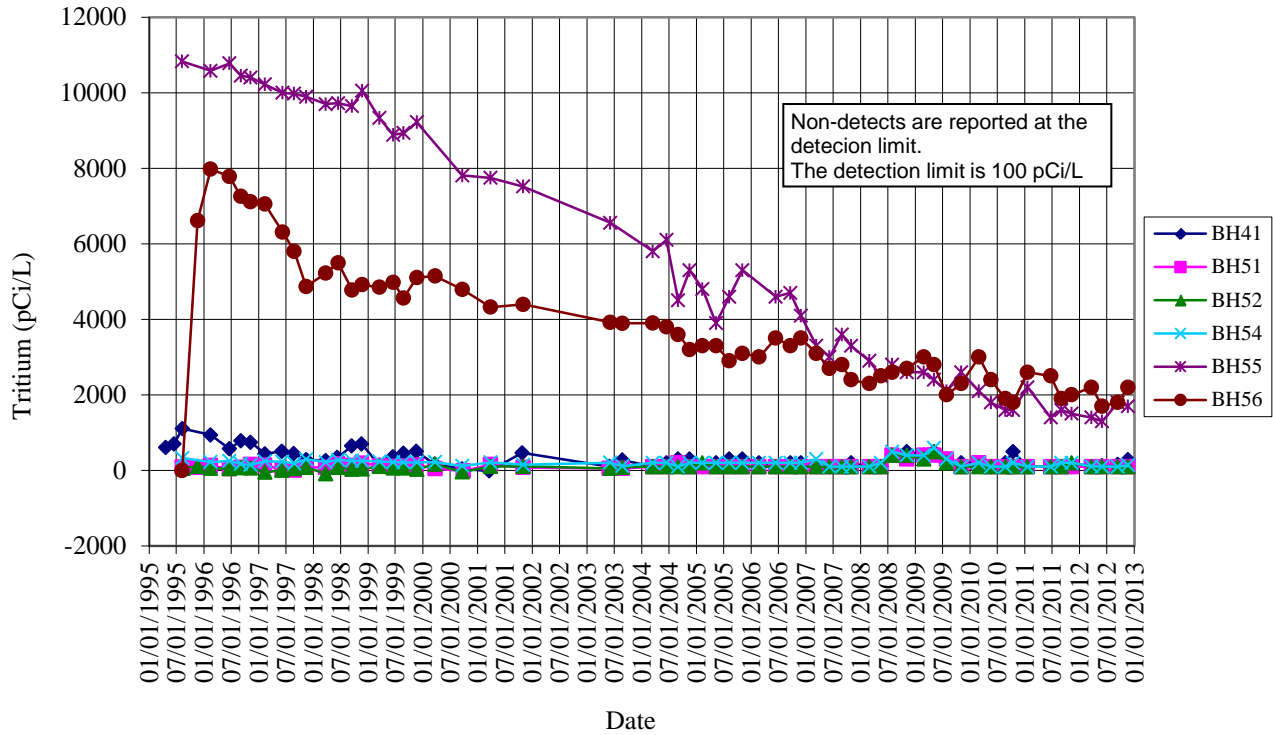
Figure 2. Tritium Activities in Groundwater in the Glacial Drift at Site A, Cook County, Illinois

In 2012, tritium was detected in the groundwater at Site A in four of the six monitoring well locations completed in the glacial drift. Tritium was not detected in monitoring wells B51 or B52. No measured activities exceeded the standard of 20,000 pCi/L. Activities ranged from non-detect (less than 100 pCi/L) to 2,200 pCi/L (Figure 2).

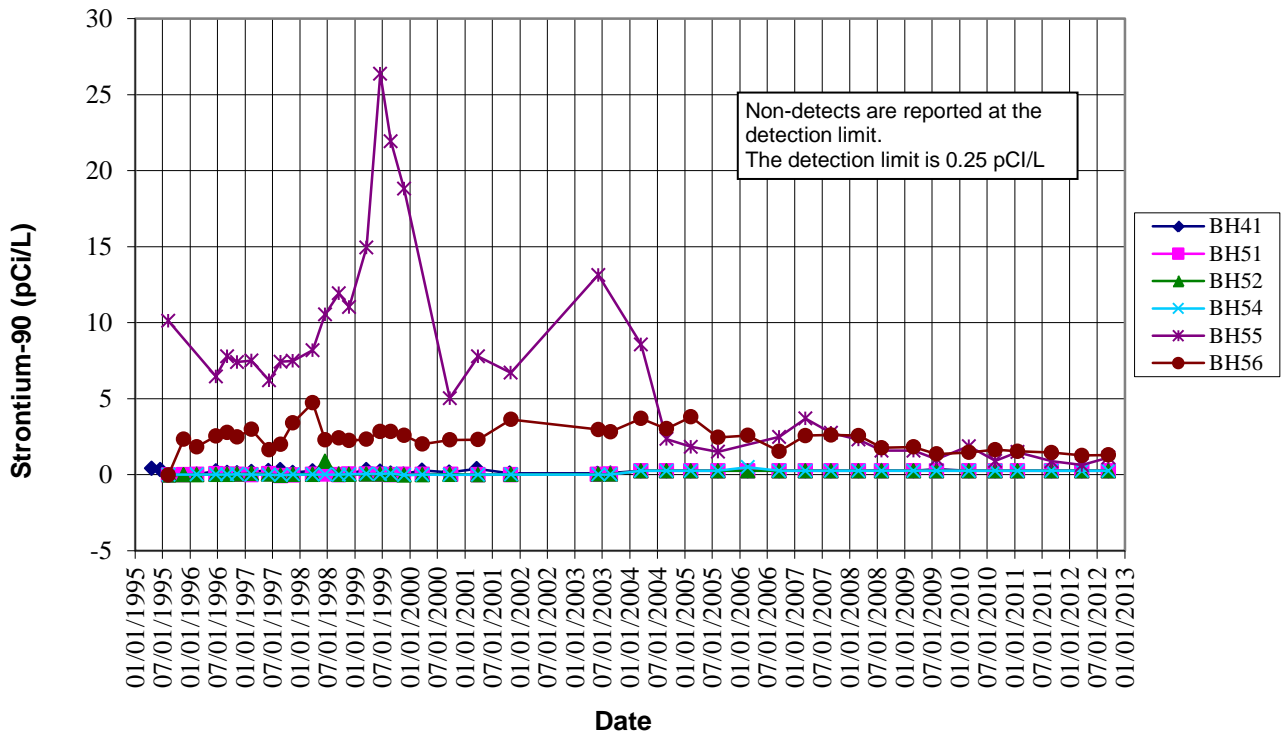
Figure 3. Strontium-90 Activities in Groundwater in the Glacial Drift at Site A, Cook County, Illinois

In 2012, strontium-90 was detected in the groundwater at Site A in two of the six monitoring well locations completed in the glacial drift. Activities ranged from non-detect (less than 0.25 pCi/L) to 1.30 pCi/L, but none exceeded the State of Illinois standard of 8 pCi/L (Figure 3).

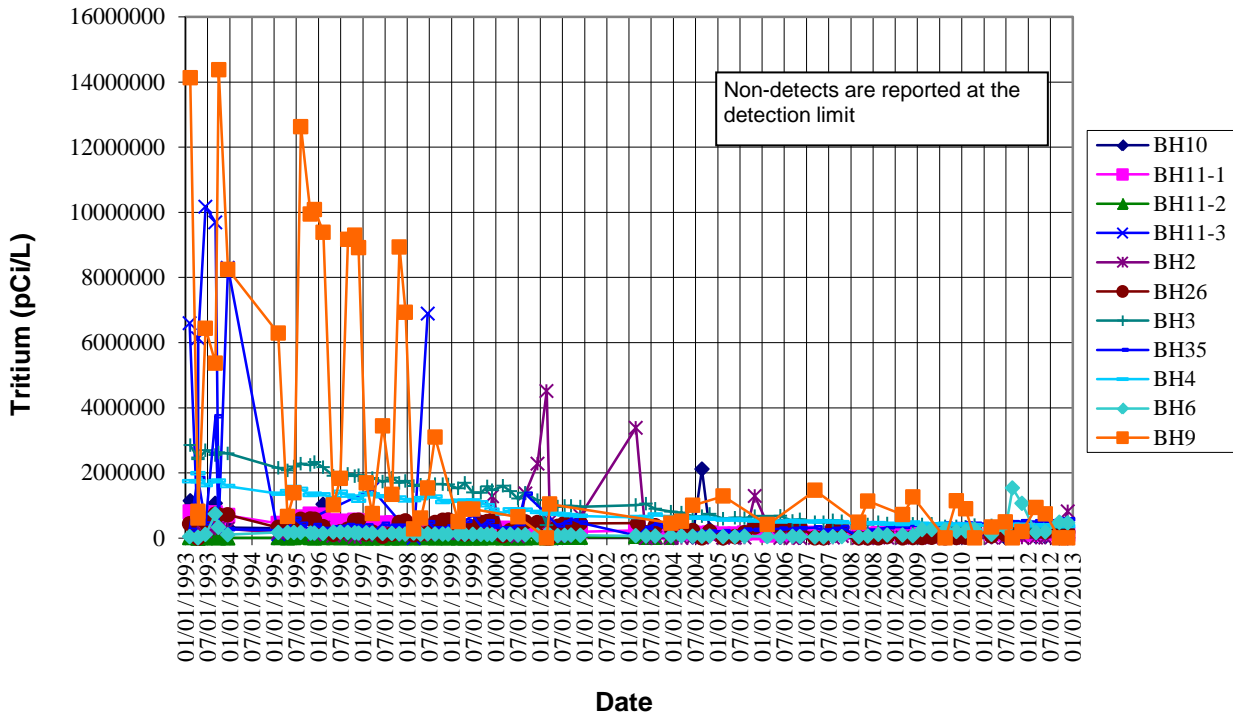
Figure 4. Tritium Activities in Groundwater in the Glacial Drift at Plot M, Cook County, Illinois

In 2012, tritium was detected in the groundwater beneath Plot M at all nine of the monitoring wells completed in the glacial drift. Tritium concentrations ranged from 9,100 pCi/L to 822,000 pCi/L (Figure 4). Locations BH9 and BH10 were both dry during third and fourth quarters of 2012.

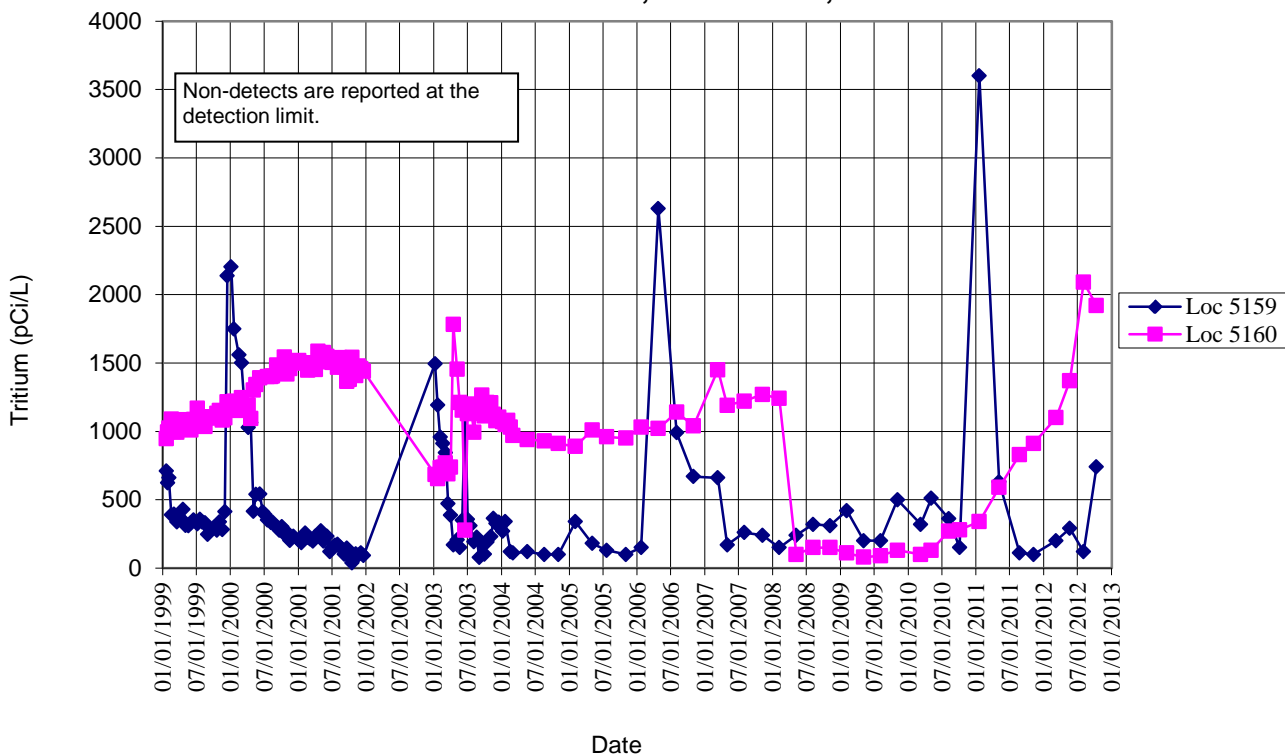
Figure 5. Tritium Activities in Groundwater in the Picnic Wells, Site A/Plot M, Cook County, Illinois

In 2012, tritium was detected in the groundwater at the picnic wells at the Red Gate Woods picnic area. As reported last year, in 2011 Picnic Well 5159 had its highest tritium activity ever (3,600 pCi/L). The activity at Picnic Well 5159 was much lower in 2012; the highest activity measured was 740 pCi/L (Figure 5). The tritium activity measured at Picnic Well 5160 increased in 2012 up to 2090 pCi/L. This is the highest activity measured at this well since 1999. Activities for the two picnic wells in 2012 ranged from 120 pCi/L to 2,090 pCi/L (Figure 5). No activities measured in 2012 exceeded the State of Illinois standard of 20,000 pCi/L.

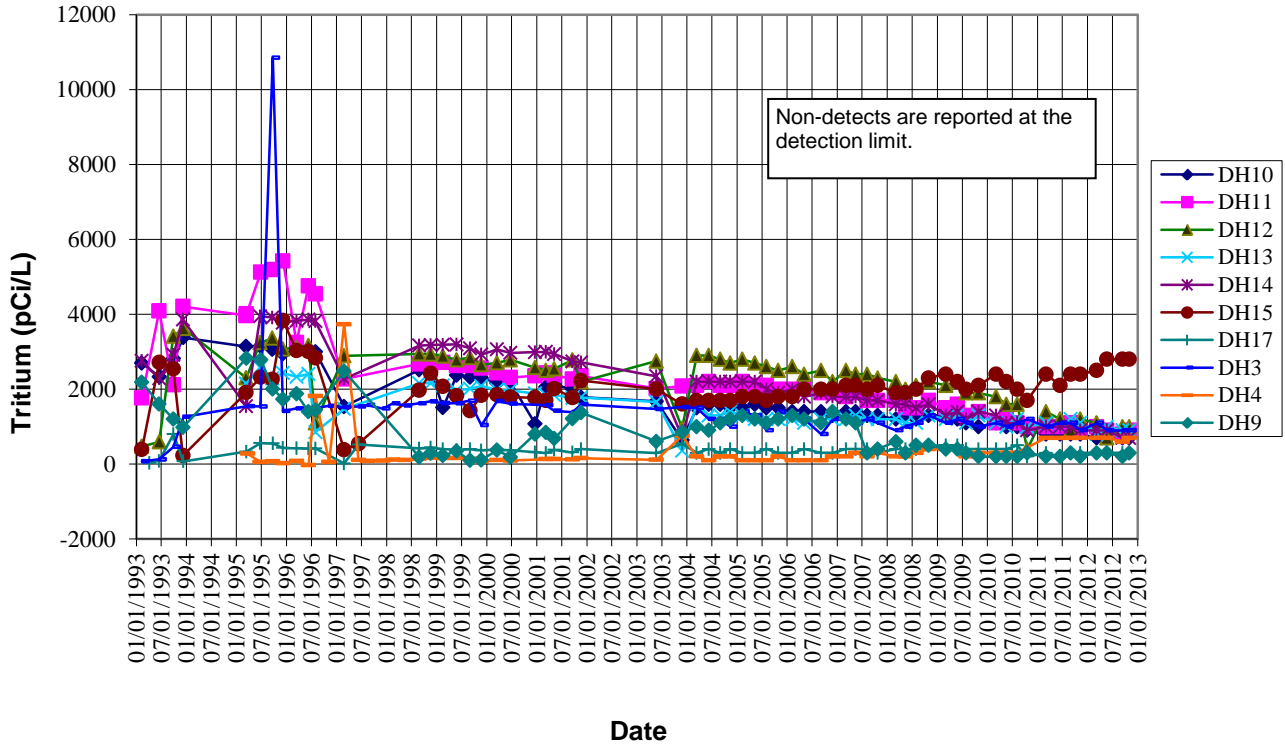
Figure 6. Tritium Activities in Groundwater in the Dolomite Bedrock, Site A/Plot M, Cook County, Illinois

In 2012, tritium was detected in the groundwater at all ten monitoring wells completed in the dolomite bedrock north of Plot M. Activities ranged from 200 pCi/L to 2,800 pCi/L (Figure 6). Tritium is no longer sampled for in the dolomite bedrock beneath Site A. Monitoring stopped in 2004 after approximately 30 years of sampling failed to detect tritium

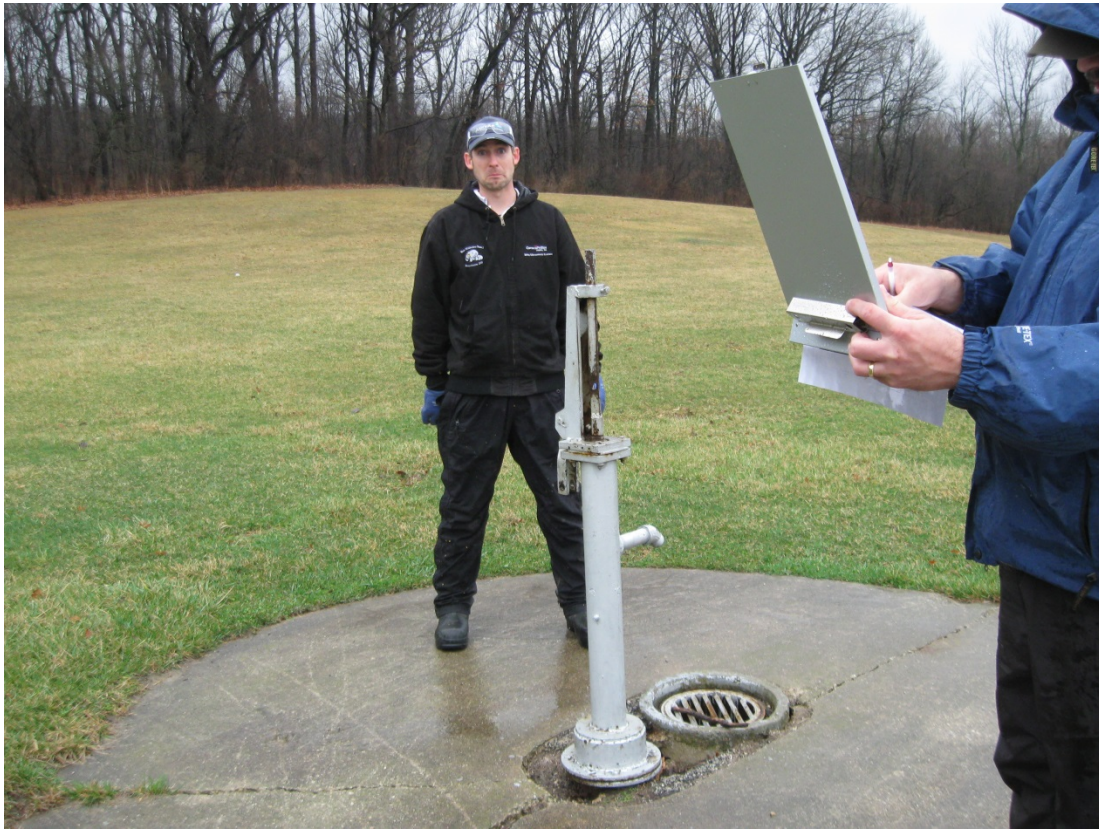
Inspectors met at the Red Gate Woods parking area and reviewed the Plan of the Day and the Job Safety Analysis. Inspectors noted that the pump handles remained off the picnic wells and that a portable restroom was no longer present in the area (PL-1). The handles were removed from the pumps years ago to prevent use of the well due to fecal coliform in the water. The fecal coliform originated from a nearby permanent restroom facility, which was removed.

SAM 4/2013. PL-1. Picnic well 5160.

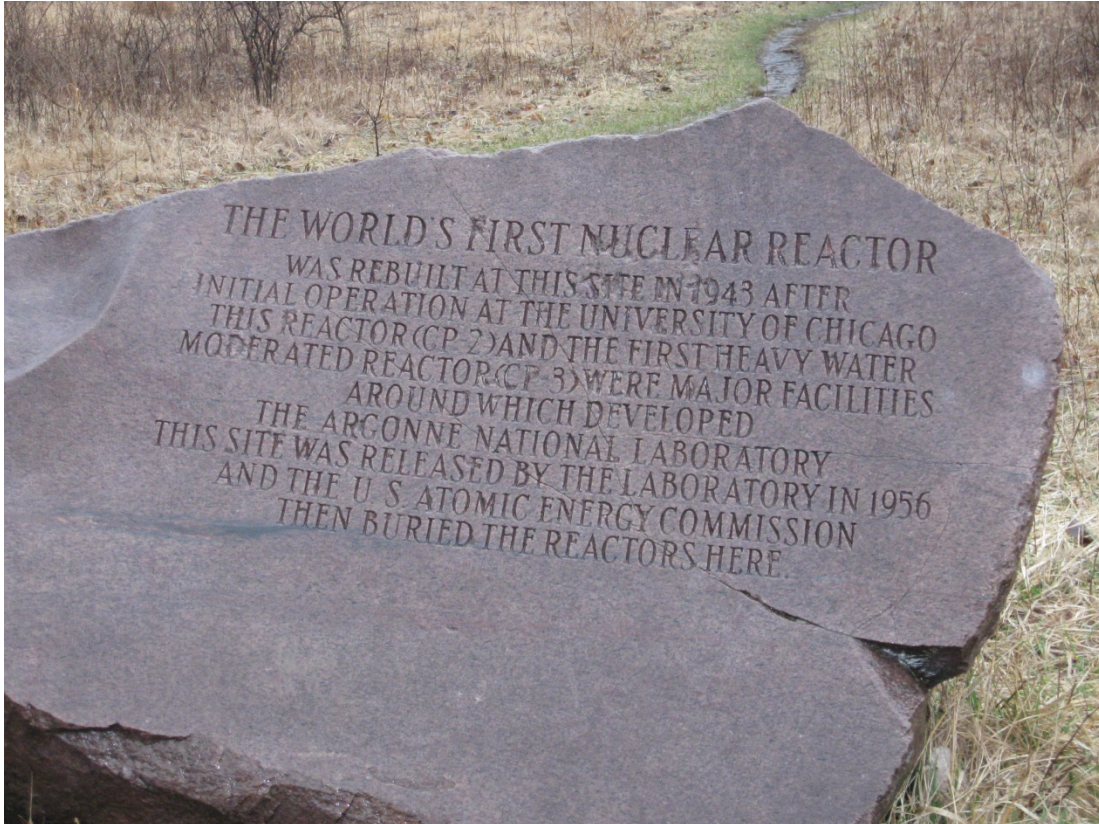
The tree which blocked inspectors from reaching Site A during the 2012 inspection has been removed from the access road, enabling inspectors to drive to Site A during this year's inspection. Site A and the Site A monument were in good condition (PL-2).

SAM 4/2013. PL-2. Site A Monument.

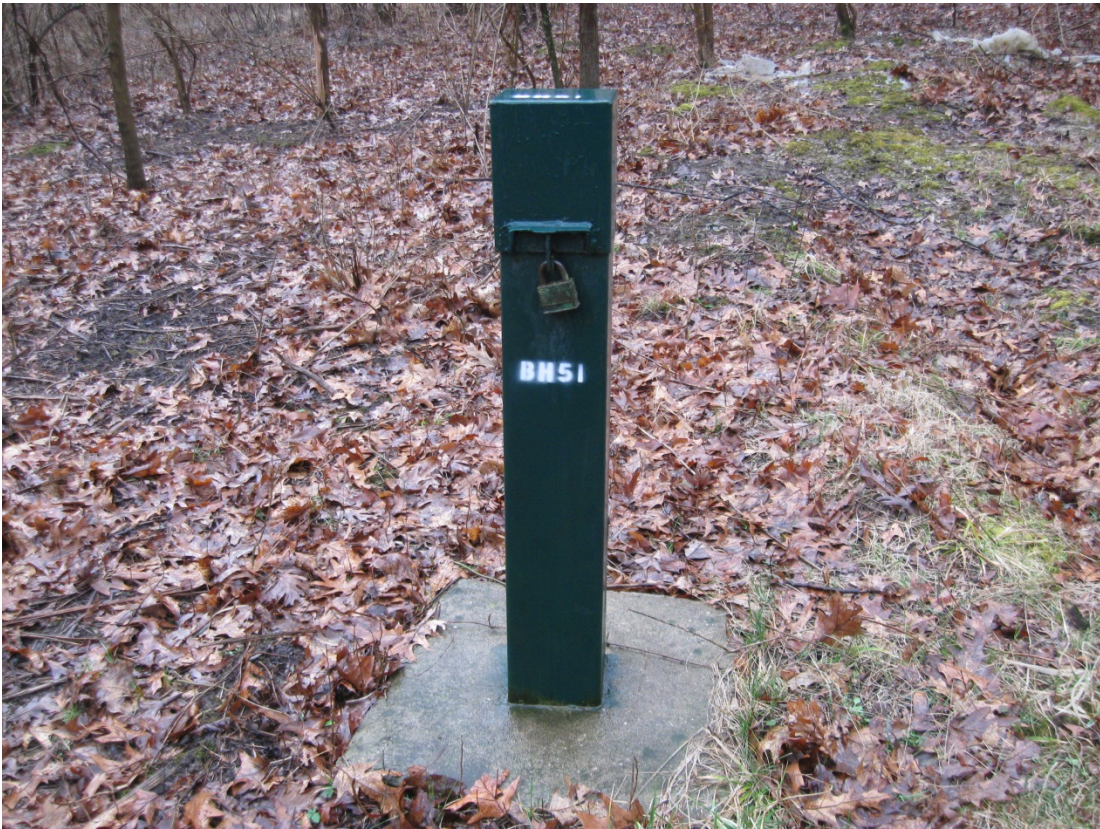
Monitoring wells at Site A were observed to be secured with locks and identified with a well number on the outer casing (PL-3). ANL personnel visit the wells quarterly for sampling, ensure well security, and perform required maintenance at that time.

SAM 4/2013. PL-3. Monitoring well BH-51.

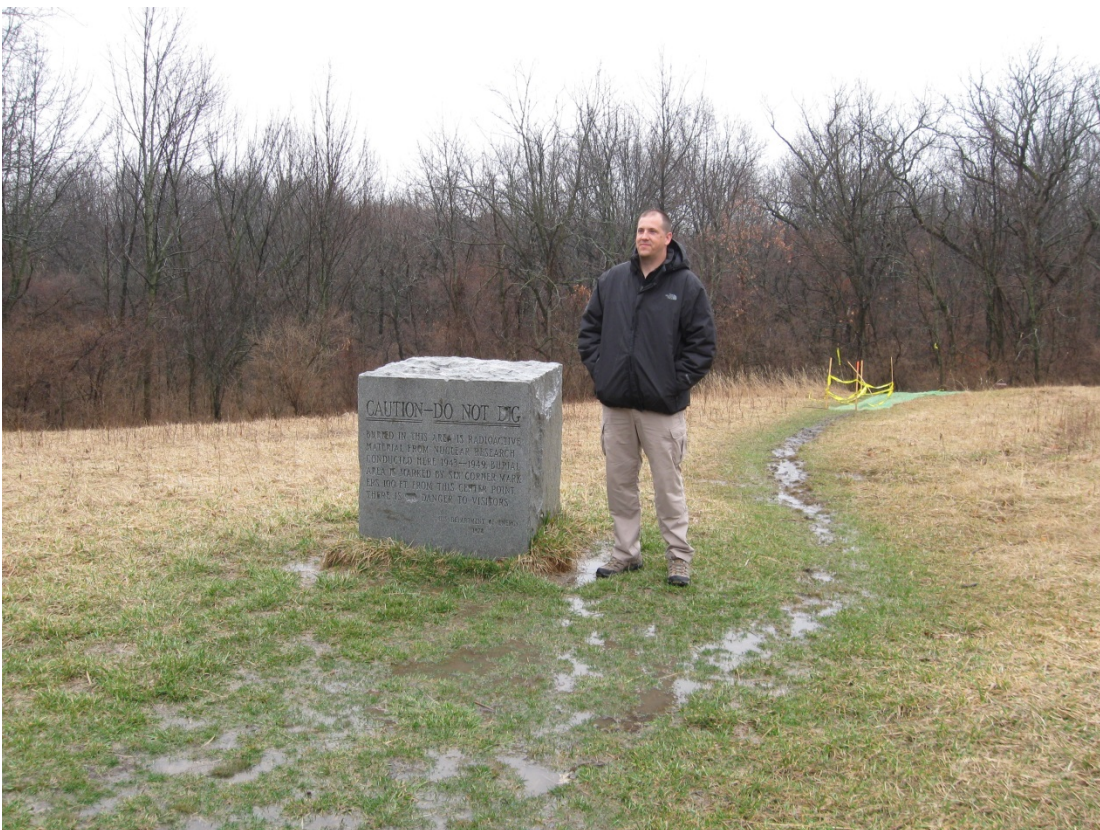
The Plot M site marker was observed to be unchanged from last year's inspection (PL-4). It was in good condition, with the exception of some minor vandalism that occurred several years ago.

Some words on the marker are chiseled off. All Plot M corner markers were located and observed to be in good condition (PL-5).

Erosion on top of the grass covered mound at Plot-M continues to be an issue. Repairs were made in 2010 by ANL. Two areas were fixed; one north of the site marker and one west of the site marker. The area north of the site marker was approximately 31 feet by 12 feet, by 2 feet deep. The erosion west of the site marker was approximately 13 feet by 3 feet by 1 foot deep, and was close to one of the Plot M corner markers. The erosion was caused by visitors riding their bicycles across the grass covered mound. Both areas were restored in 2010 to pre-erosion conditions using top soil. It was noted during the 2012 inspection that ruts were returning to the mound cover due to continued bicycle travel across the mound. It was recommended in 2012 that ANL conduct an annual maintenance review of the area and periodically add top soil to erosion ruts as needed to keep them from expanding. Erosion north of the site monument required corrective action by ANL in 2012. Three-inch ruts across the top of the mound were filled in with clean fill and reseeded (PL-6 and PL-7). Ruts are also forming south of the site monument due to continued bicycle use (PL-8 and PL-9). It is recommended if Plot M cannot be off limits to bikes that action should be taken to make a more sustainable pathway for bikes to help mitigate the ongoing cause of the erosion.

SAM 4/2013. PL-4. Plot M monument, and ruts next to monument.

Recommendation: It is recommended that if Plot M cannot be off limits to bikes, that action be taken to make a more sustainable pathway for the bikes to mitigate the ongoing erosion concerns.

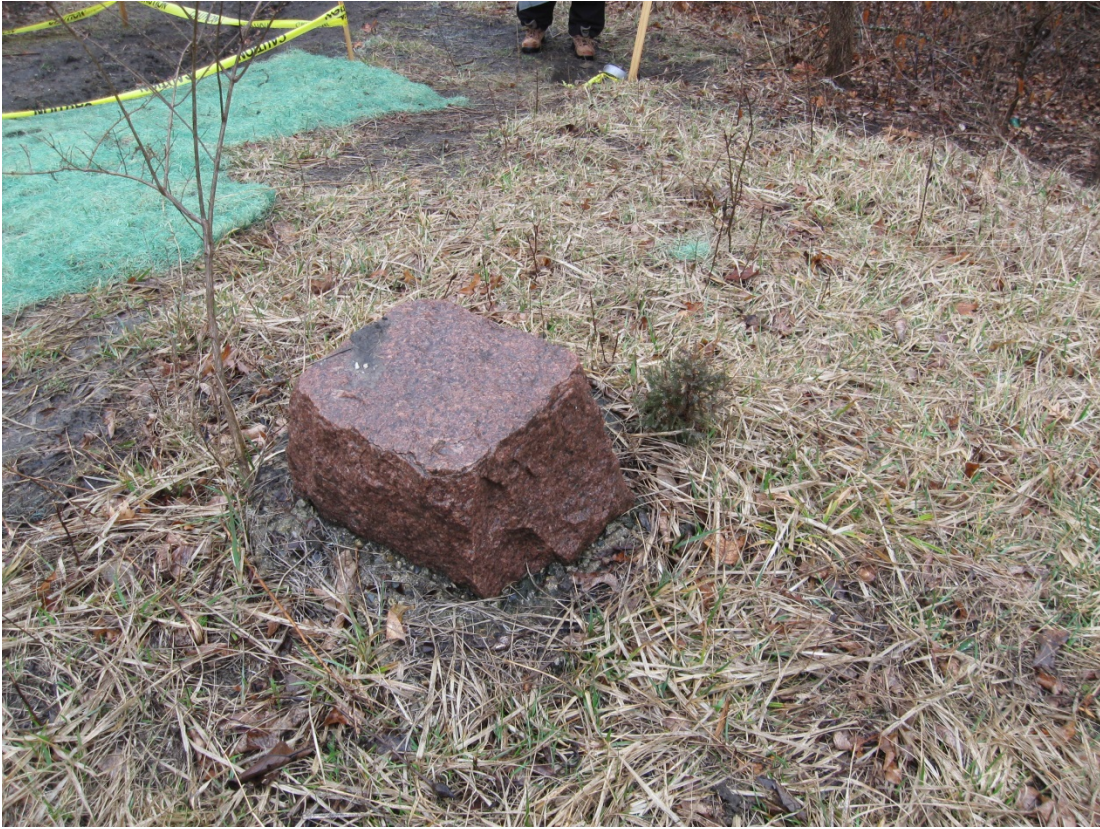
SAM 4/2013. PL-5. Plot M corner marker next to recent rut repair.

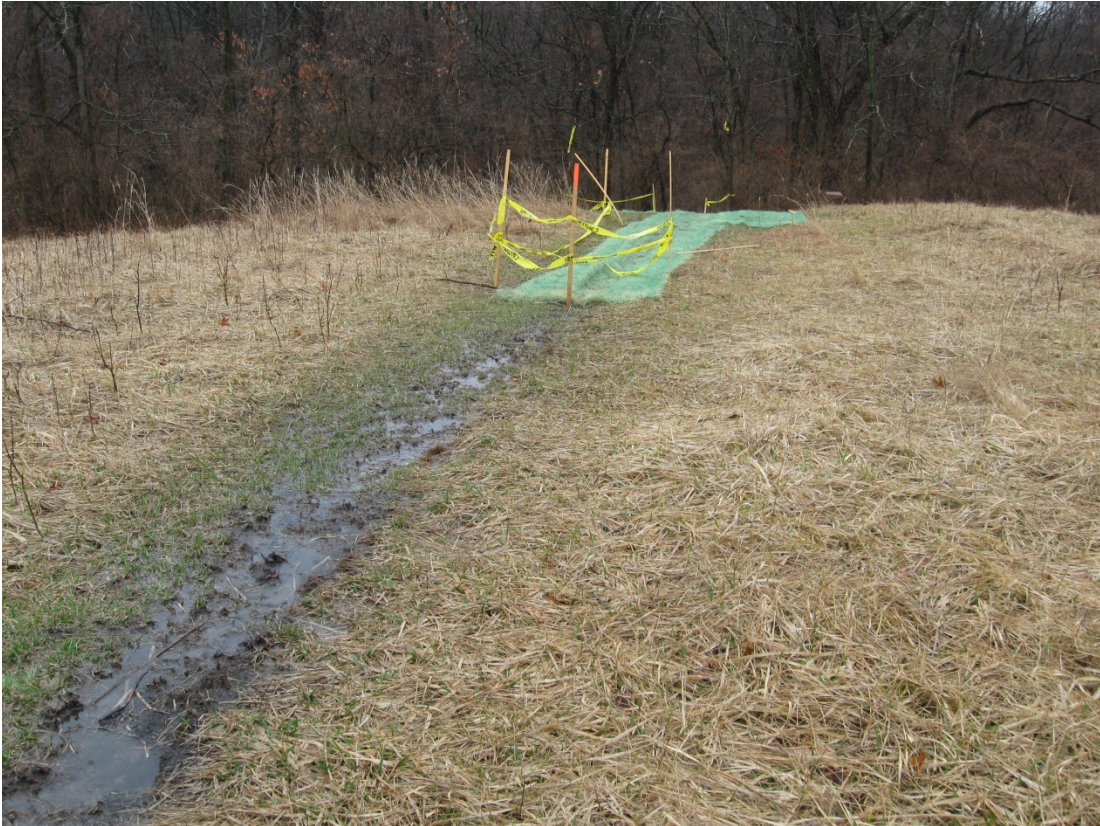
3. Additional erosion repair work was conducted by ANL at Plot M in 2012. The area was one of the areas that had been repaired in 2010. Ruts will continue to develop as long as bike traffic moves across the top of the mound (page 4).

SAM 4/2013. PL-6. Recent rut repair work on top of Plot M.

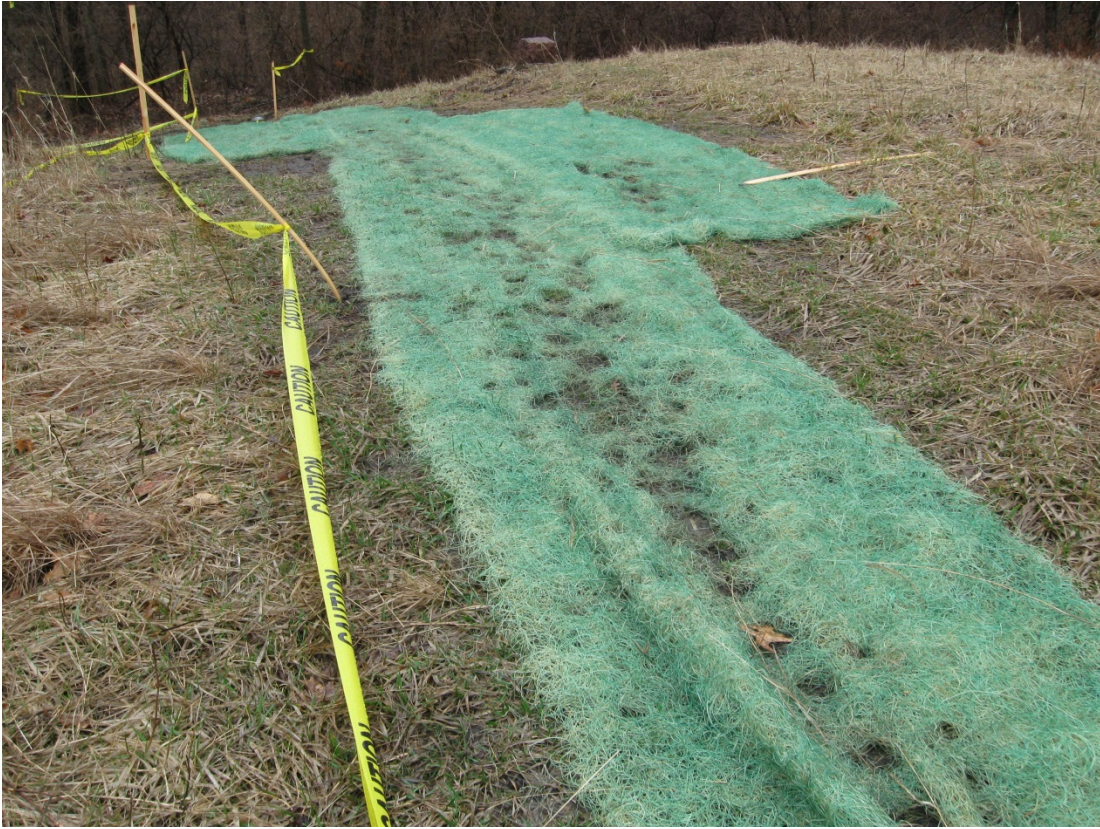
SAM 4/2013. PL-7. Recent rut repair work on top of Plot M.

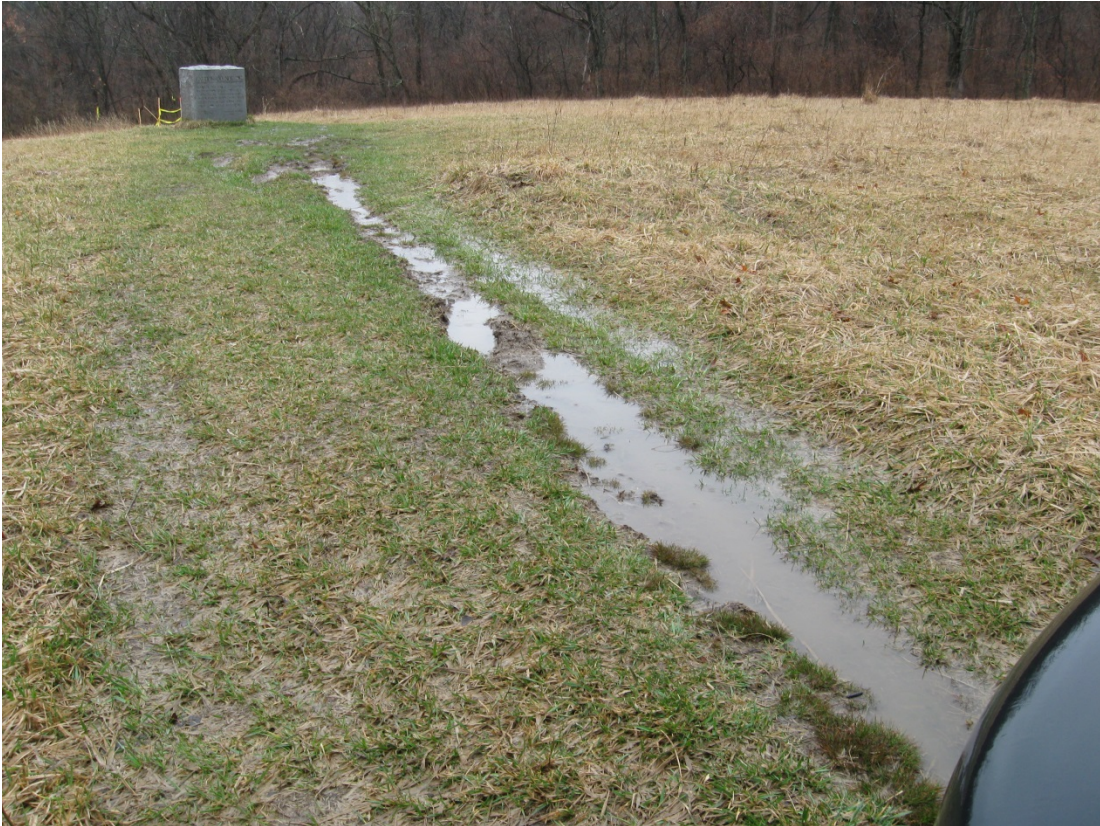
SAM 4/2013. PL-8. Ruts on top of Plot M.

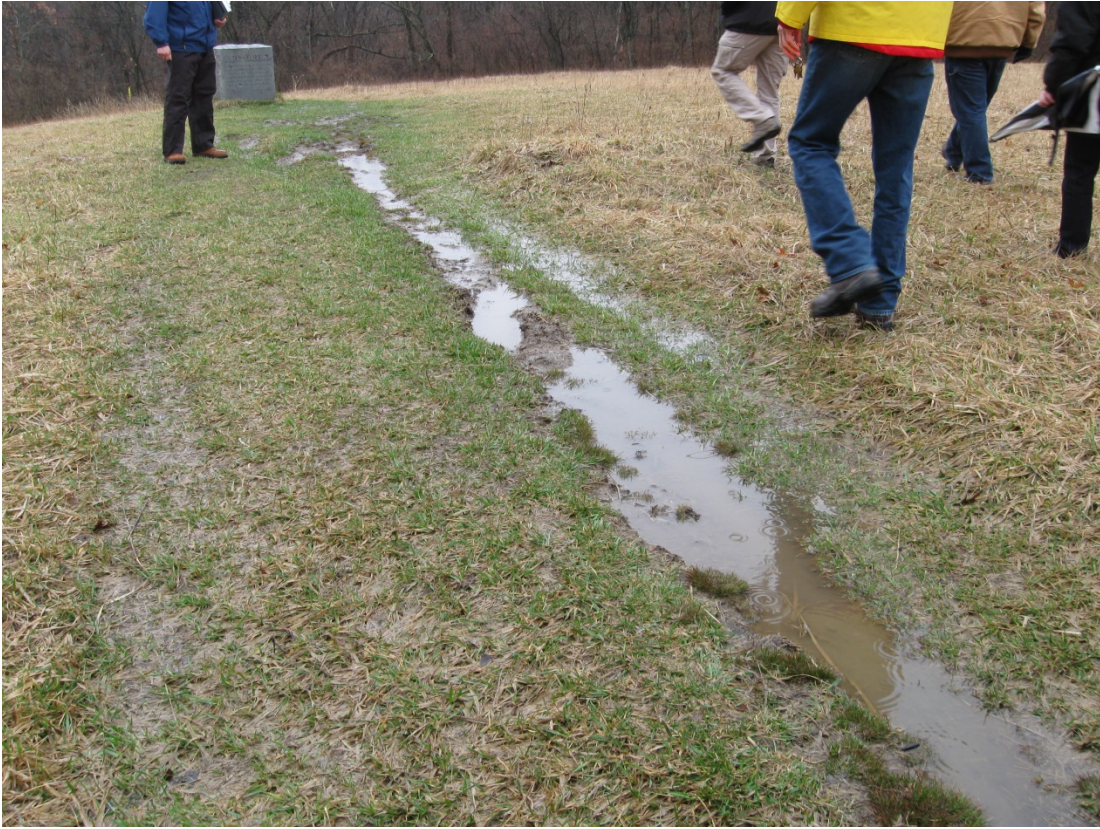
SAM 4/2013. PL-9. Ruts on top of Plot M.

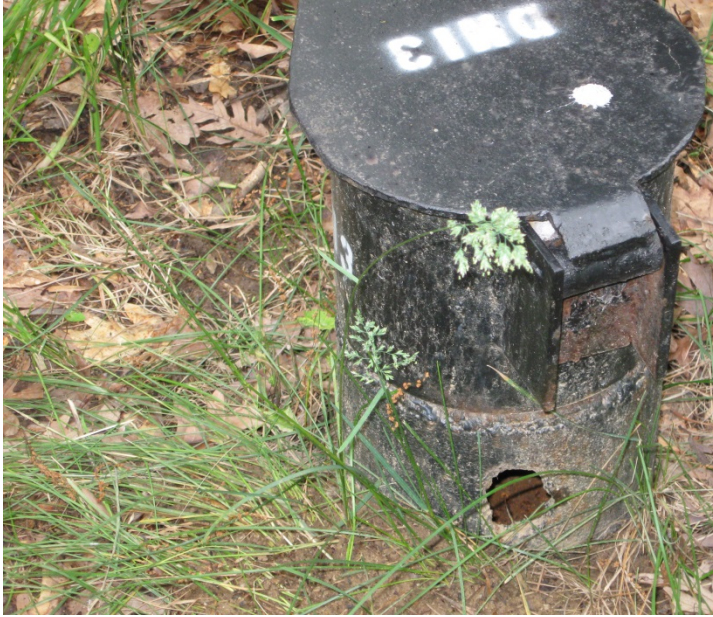
During the 2012 site inspection it was noted that holes were present in the protective casings of monitoring wells DH-13 and DH-15 that needed to be patched. ANL personnel did a great job patching the holes. Before and after photos for monitoring well DH-13 are provided in PL-10 and PL-11. Before and after photos for monitoring well DH-15 are provided in PL-12 and PL-13.

SAM 4/2013. PL-10. 2012 photo of monitoring well BH-13.

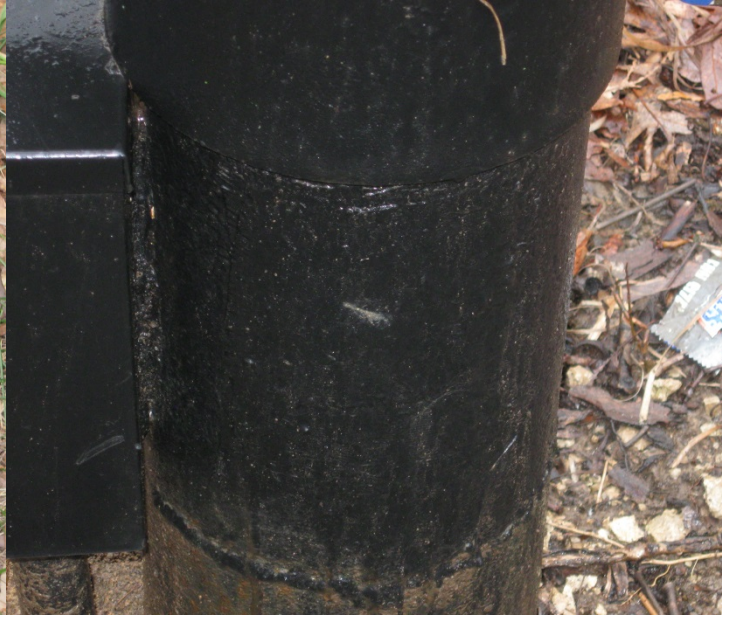
SAM 4/2013. PL-11. Repair on monitoring well BH-13.

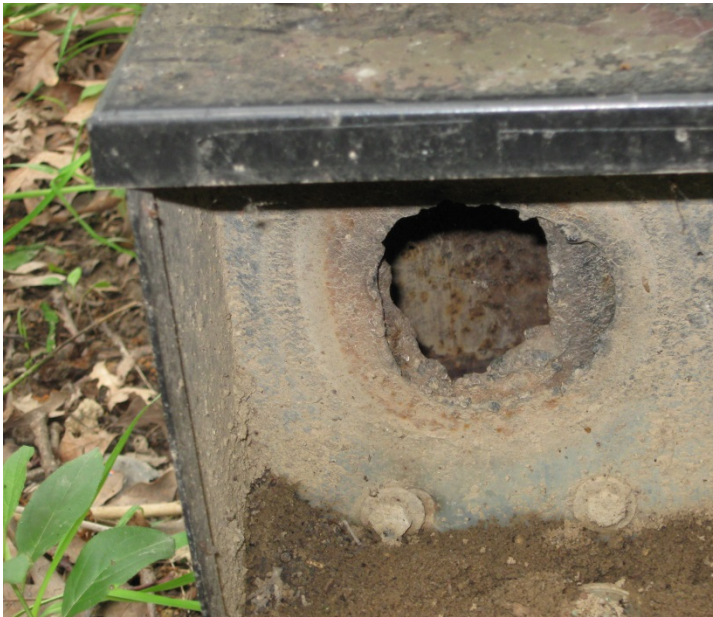
SAM 4/2013. PL-12. 2012 photo of monitoring well BH-15.

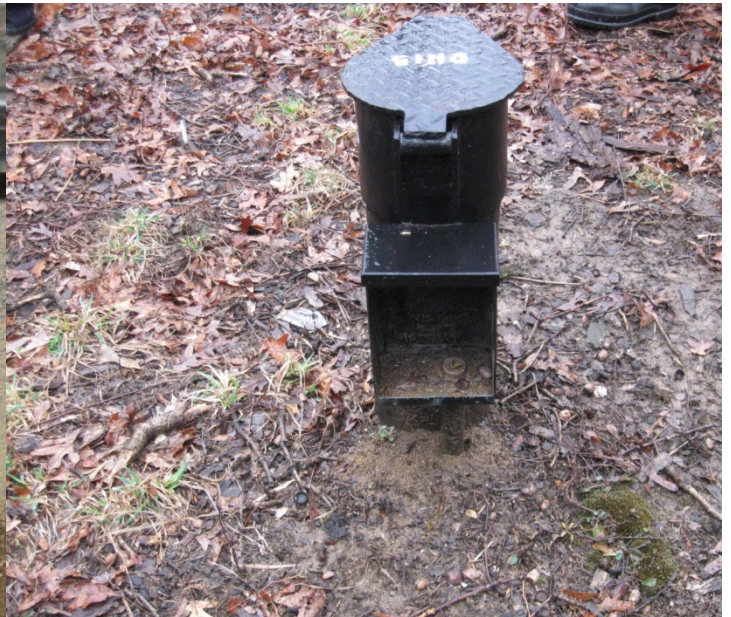
SAM 4/2013. PL-13. Repair on monitoring well BH-15.
