**2018 Inspection and Annual
Site Status Report for the
Site A/Plot M, Illinois,
Decommissioned Reactor Site**

August 2018

U.S. DEPARTMENT OF
ENERGY

Legacy
Management

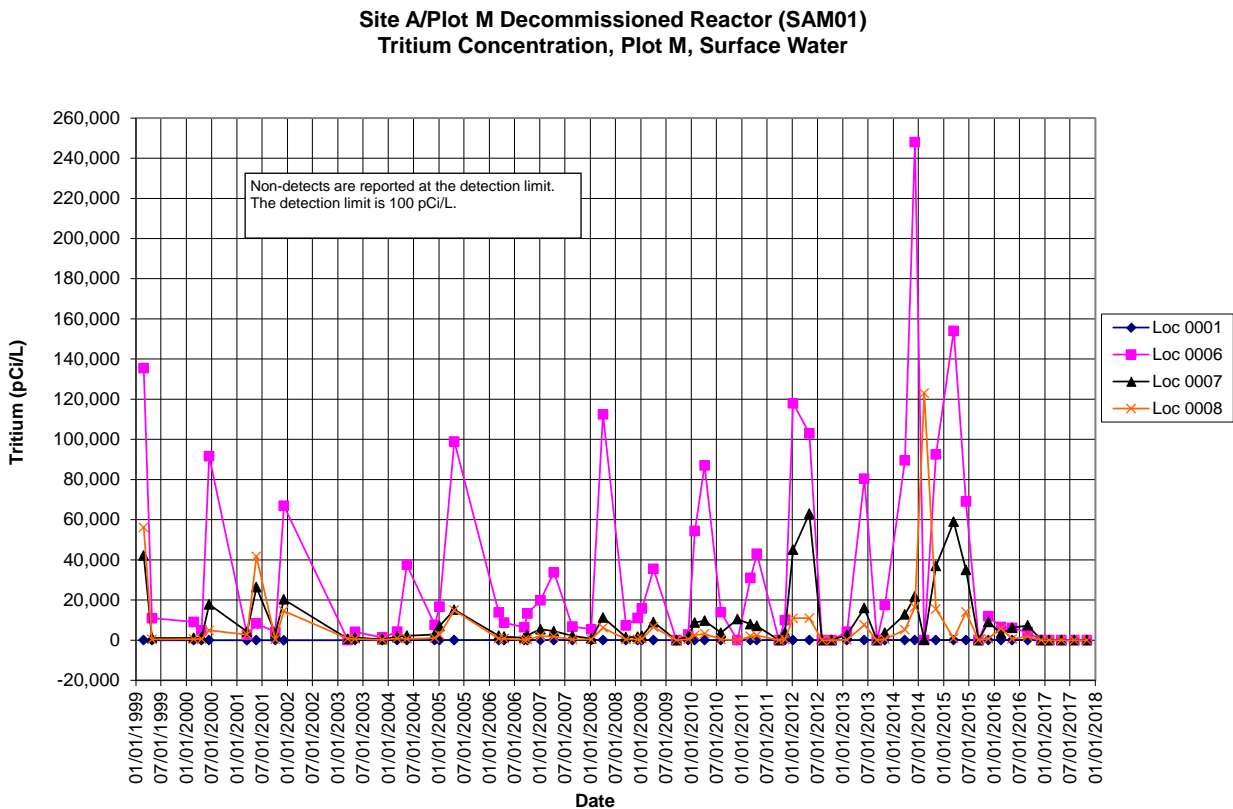
Figure 1. Tritium Activities in Surface Water at Plot M, Cook County, Illinois

For the intermittent stream that runs along the east side of Plot M, sample location 0001 is upgradient of Plot M, and sample locations 0006 and 0007 are downgradient of Plot M. In 2017, ³H activities did not exceed the State of Illinois drinking water standard of 20,000 picocuries per liter (pCi/L) at any sampled location in this intermittent stream (Figure 1). The highest ³H activity measured in 2017 in this intermittent stream was 5500 pCi/L at location 0007.

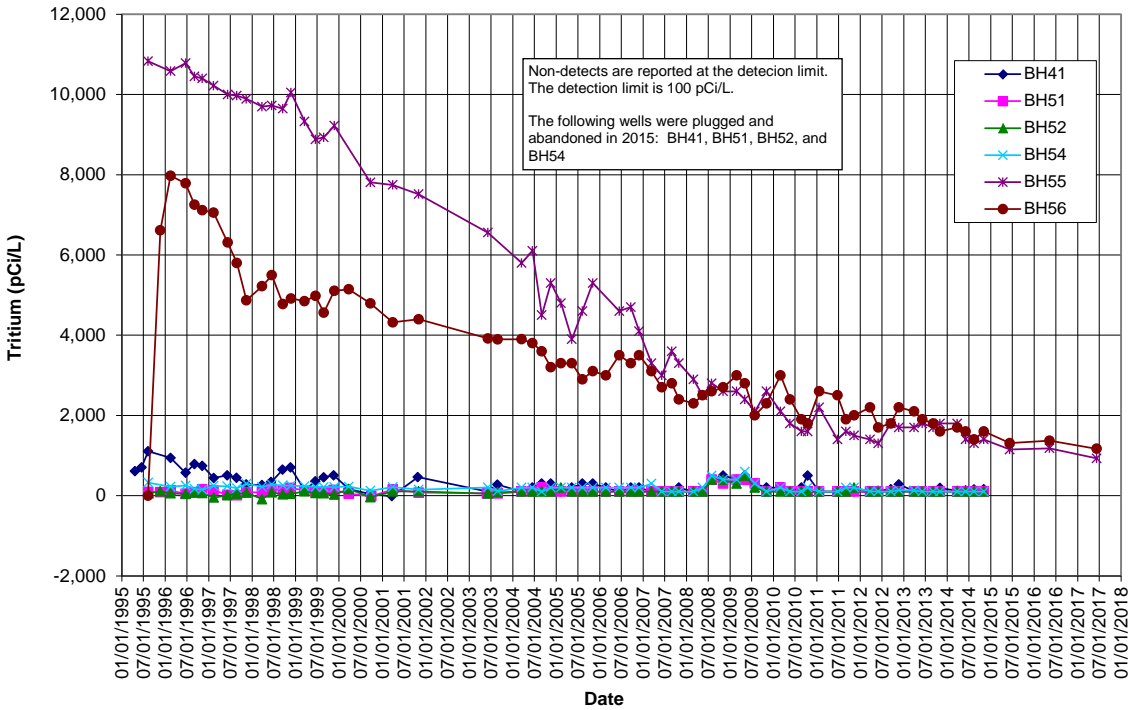
Figure 2. Tritium Activities in Groundwater in the Glacial Drift at Site A, Cook County, Illinois

In 2017, ^3H was detected in the groundwater at Site A at both monitoring well locations that are completed in the glacial drift. No measured activities exceeded the standard of 20,000 pCi/L. Activities ranged from 930 to 1170 pCi/L (Figure 2).

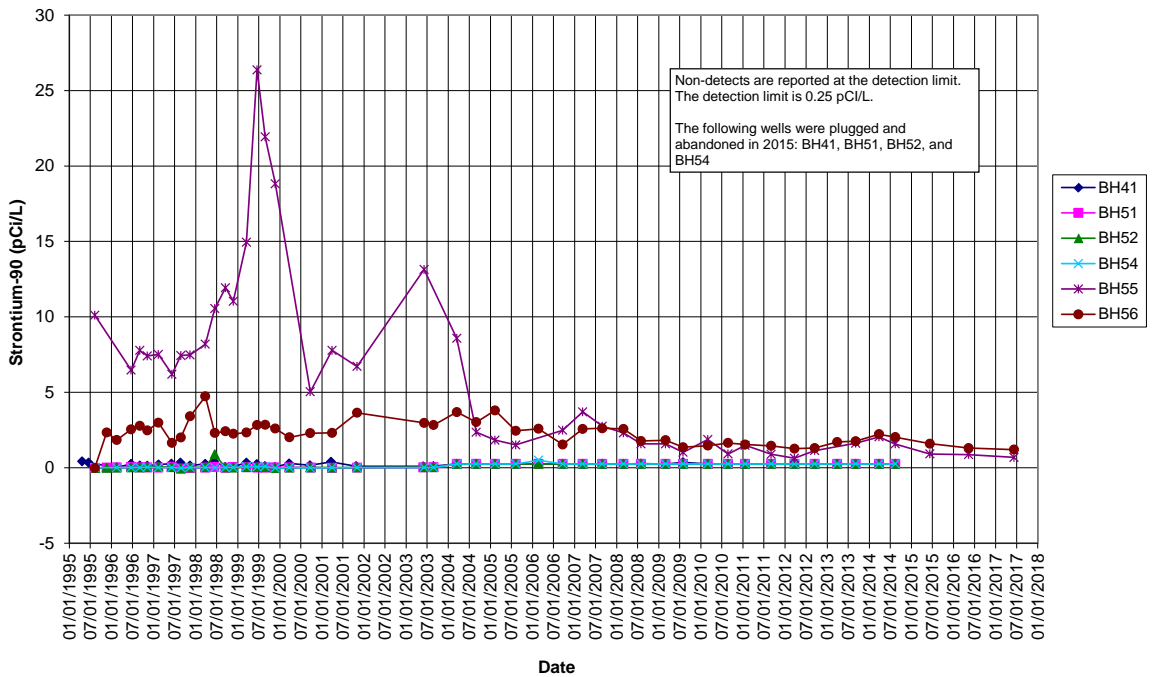
Figure 3. Strontium-90 Activities in Groundwater in the Glacial Drift at Site A, Cook County, Illinois

In 2017, ^{90}Sr was detected in the groundwater at Site A at both monitoring well locations completed in the glacial drift. Activities ranged from 0.68 to 1.2 pCi/L, but none exceeded the State of Illinois standard of 8 pCi/L (Figure 3).

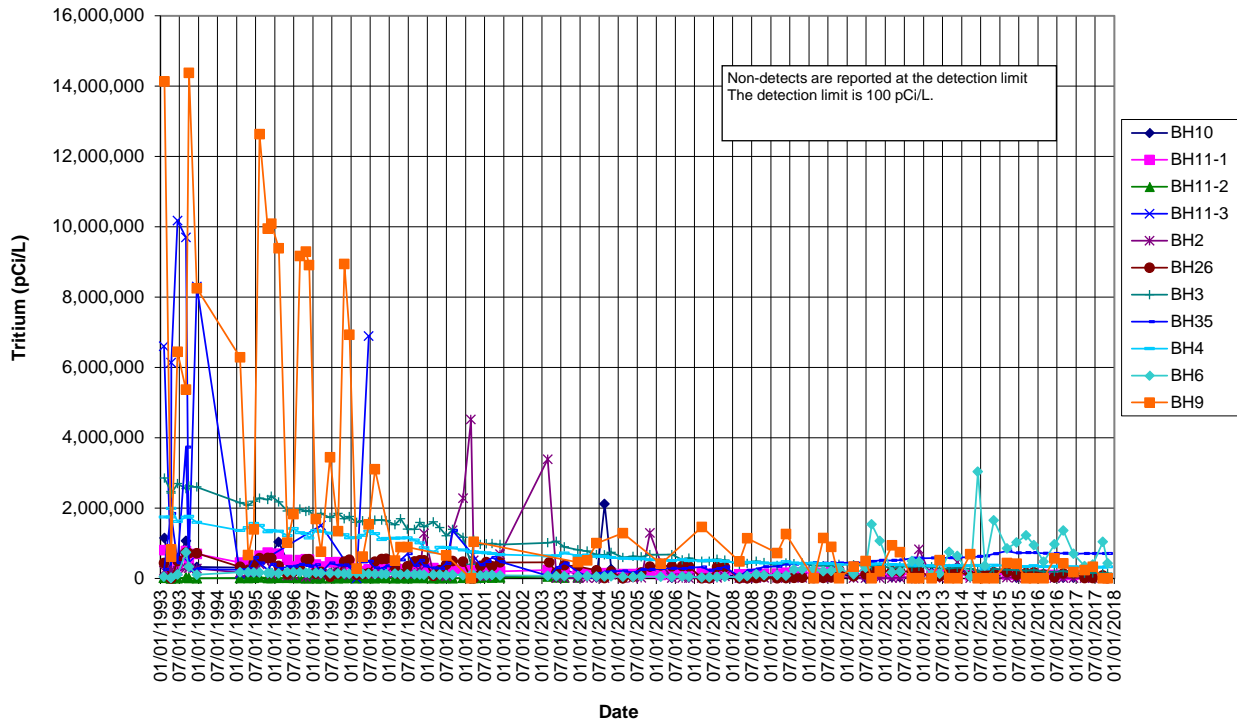
Figure 4. Tritium Activities in Groundwater in the Glacial Drift at Plot M, Cook County, Illinois

In 2017, ^3H was detected in the groundwater beneath Plot M in eight of the nine monitoring wells completed in the glacial drift. Monitoring Well BH9 was dry in 2017. Tritium activities ranged from 700 to 1,040,000 pCi/L (Figure 4).

As reported in the draft version of the *Surveillance of Site A and Plot M, Report for 2017*, the highest ^3H activity reported for monitoring well BH35 in 2017 was 707,000 pCi/L. This activity is within the historical range for the well. The historical maximum tritium activity (1,360,000 pCi/L) was measured in 2000; activities decreased to a low of approximately 61,250 pCi/L in 2003. Since 2003, activities have been increasing again and are now approximately one-half of their historical range. During the 2016 inspection, ANL personnel reported that the 2-inch diameter casing in monitoring well BH35 was cracked near the surface of the well. DOE requested that ANL plan to install a replacement well for BH35 in the next year or so to see if the damaged casing might be the cause for the increasing concentrations. Further analysis of the situation resulted in a decision not to replace this well.

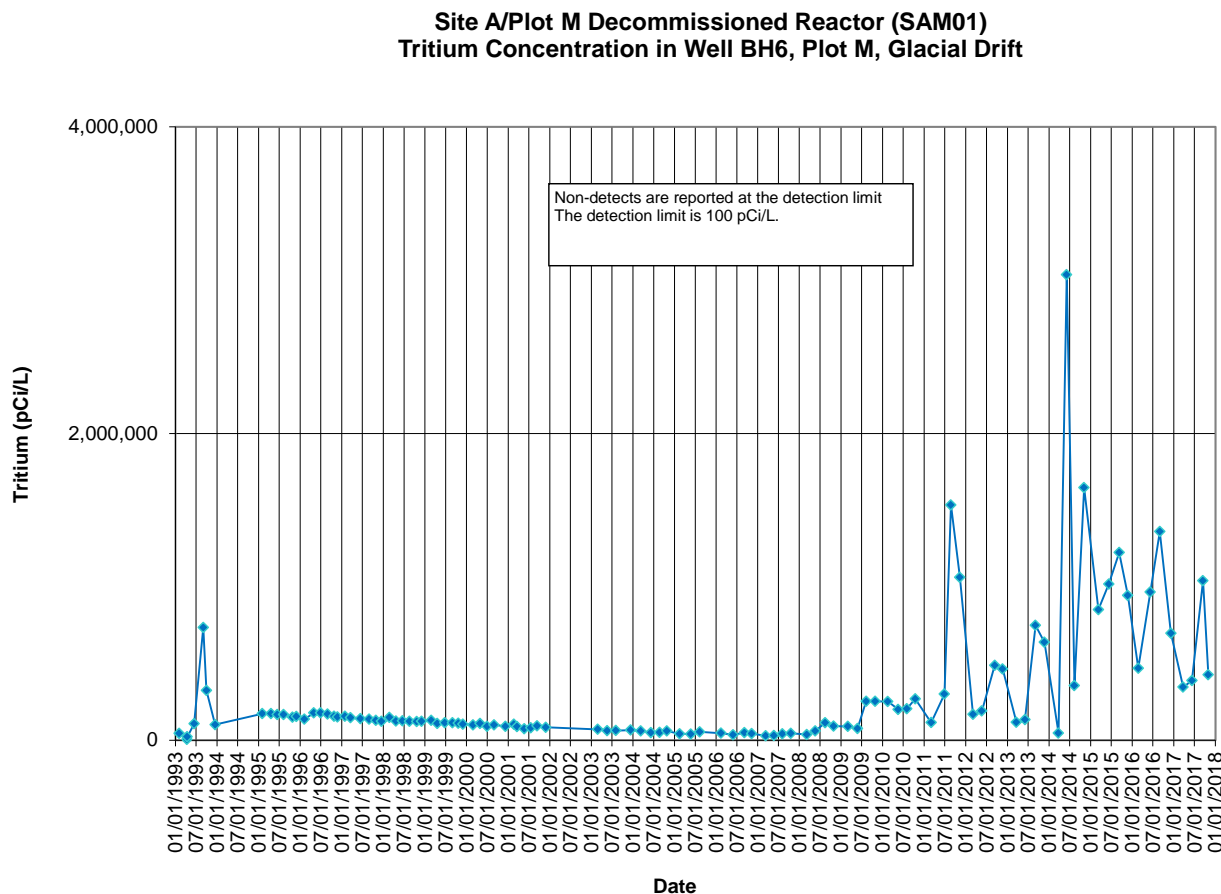
Figure 5. Tritium Activities in Groundwater in Well BH6 in the Glacial Drift at Plot M, Cook County, Illinois

As reported in the draft version of the *Surveillance of Site A and Plot M, Report for 2017*, ^3H activities and water levels in monitoring well BH6 began to increase and fluctuate erratically in 2009 (Figure 5). The increase and erratic fluctuation of ^3H activities after 2009 are being attributed to changing groundwater elevations. The situation will continue to be monitored. If ^3H concentrations continue to increase, DOE has requested that ANL investigate further.

3. Tritium activities and water levels in monitoring well BH6 have been fluctuating erratically since 2009.

Action: ANL will continue to monitor well BH6.

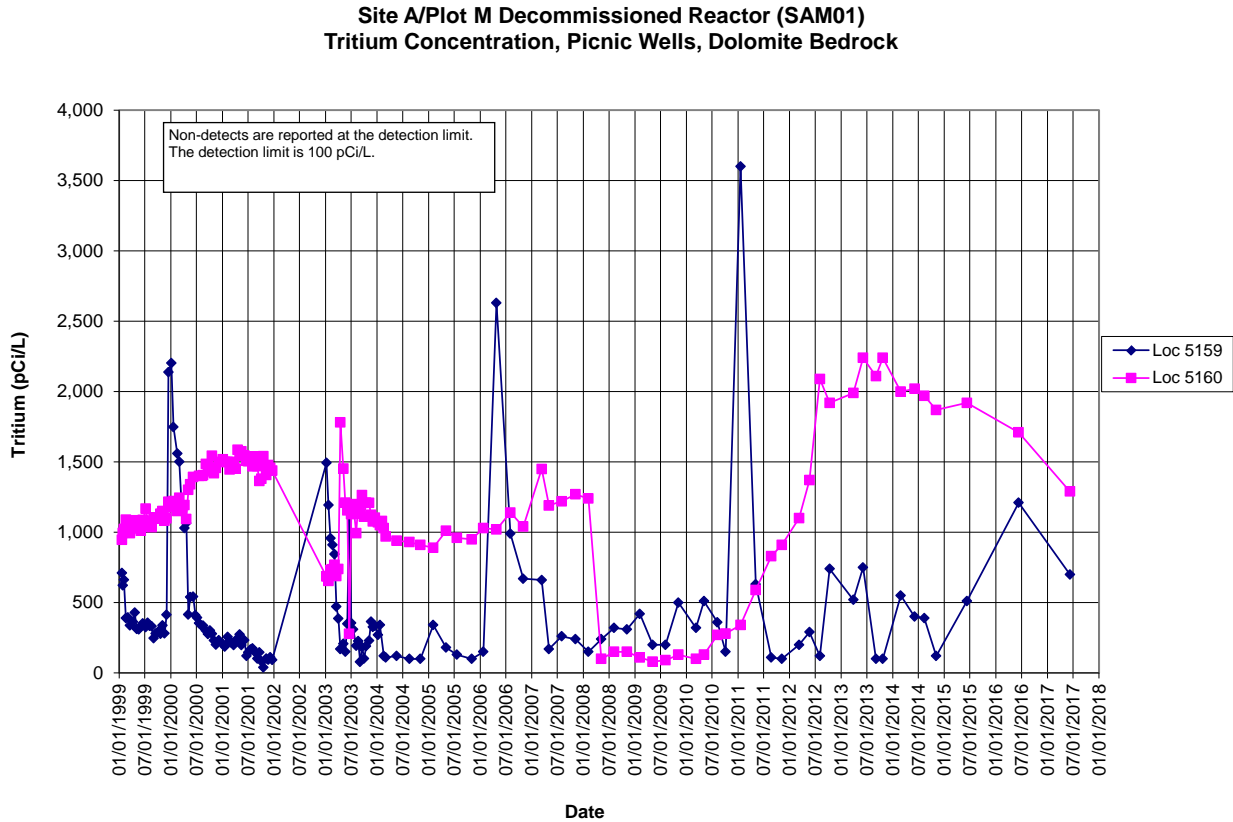
Figure 6. Tritium Activities in Groundwater in the Picnic Area Wells, Site A/Plot M, Cook County, Illinois

In 2017, ^3H was detected in the groundwater at the Red Gate Woods picnic area wells. Tritium activities for the two picnic area wells in 2017 ranged from 700 to 1290 pCi/L (Figure 6). No activities measured in 2017 exceeded the State of Illinois standard of 20,000 pCi/L.

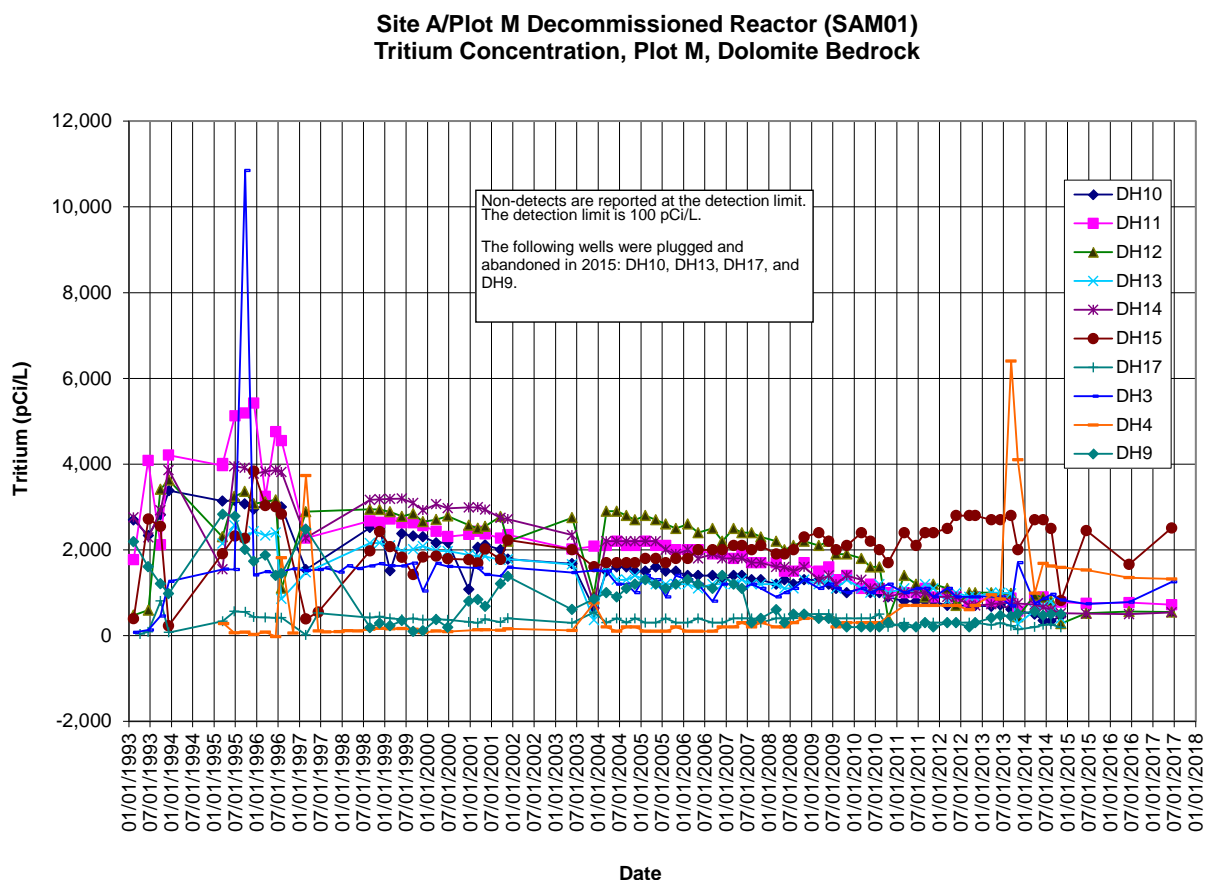
Figure 7. Tritium Activities in Groundwater in the Dolomite Bedrock, Site A/Plot M, Cook County, Illinois

In 2017, ^3H was detected in the groundwater at all six monitoring wells completed in the dolomite bedrock north of Plot M. Activities ranged from 540 to 2510 pCi/L (Figure 7). Tritium is no longer sampled for in the dolomite bedrock beneath Site A. Monitoring stopped in 2004 after approximately 30 years of sampling failed to detect this isotope.

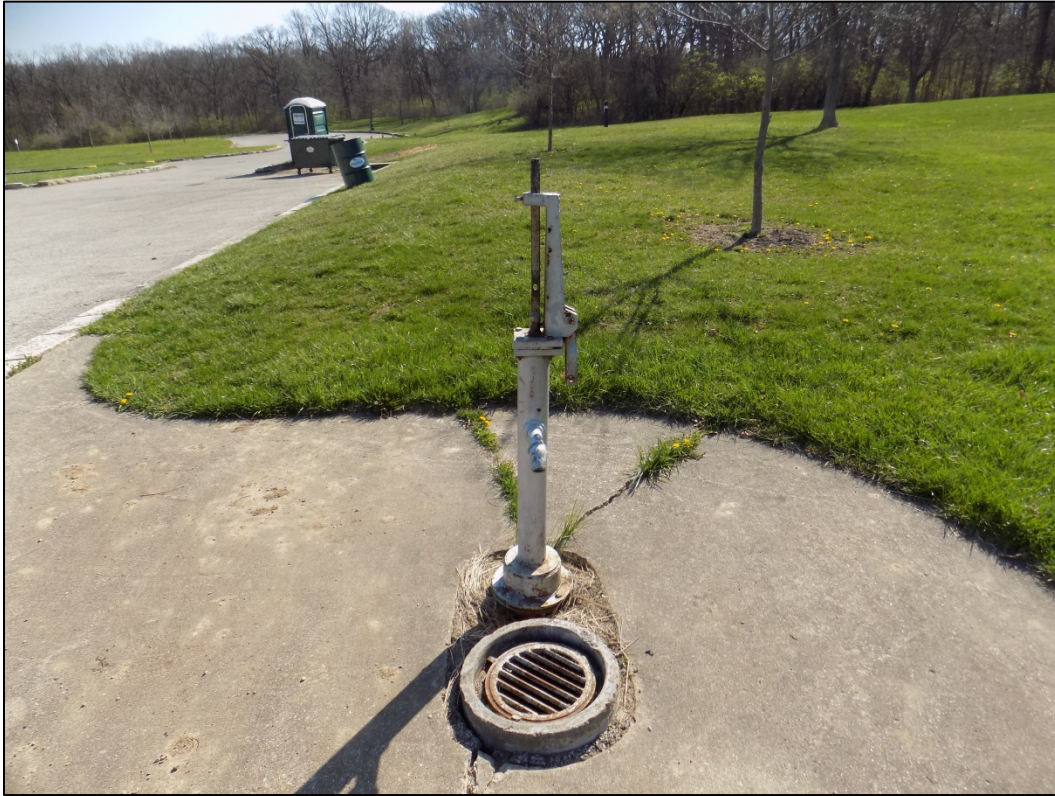
Inspectors met at the Red Gate Woods parking area and reviewed the Plan of the Day and Job Safety Analysis. Inspectors noted that the drinking water wells at the Red Gate Woods picnic area still have no pump handles (PL-1). The handles were removed from the pumps years ago to prevent the use of the wells because of fecal coliform in the water. The fecal coliform originated from a nearby permanent restroom facility, which was removed.

PL-1. Handle Removed from Picnic Area Well 5160 in Red Gate Woods Area

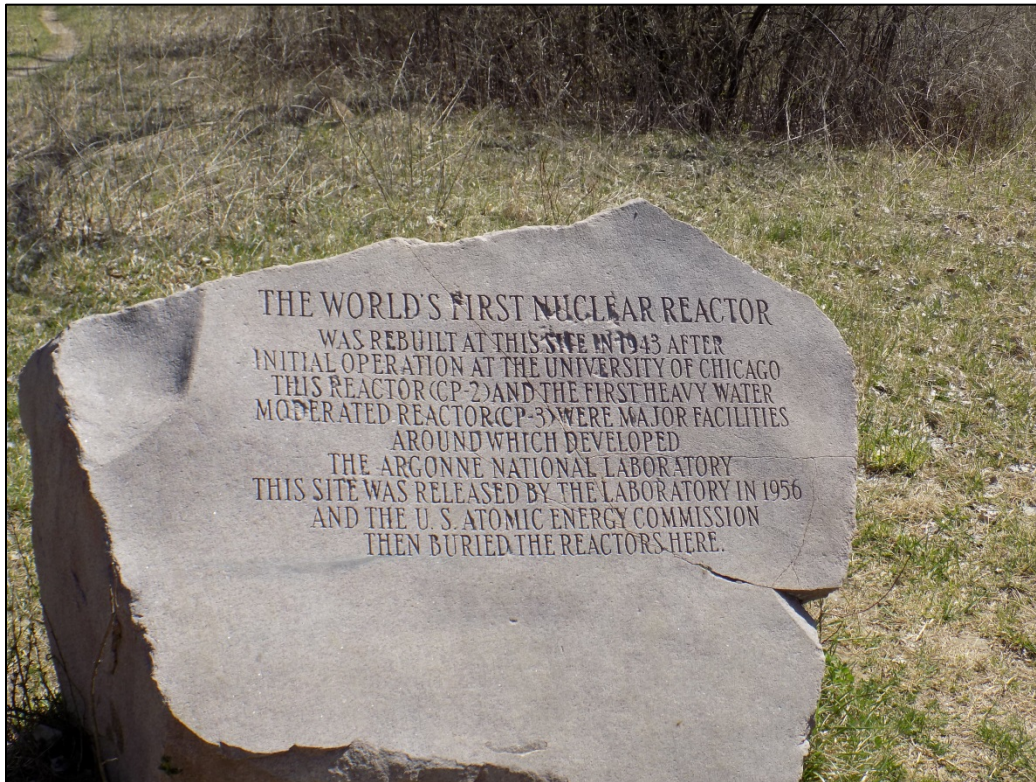
Inspectors were able to drive to Site A during this year's inspection. Site A was found to be in good condition. Stress cracks in the historic Site A monument appear to be getting larger over time (PL-2 and PL-3). It is anticipated that these cracks will continue to widen and eventually split and permanently damage the historic marker.

PL-2. Cracks on Front of Site A Marker

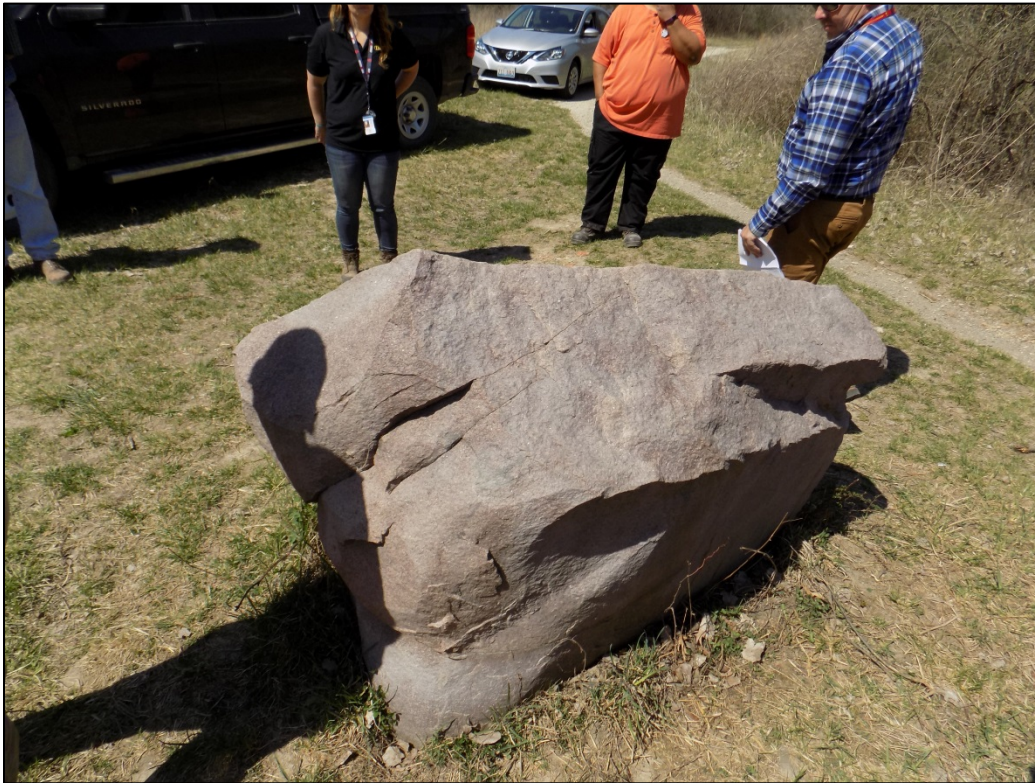
PL-3. Cracks on Back of Site A Marker

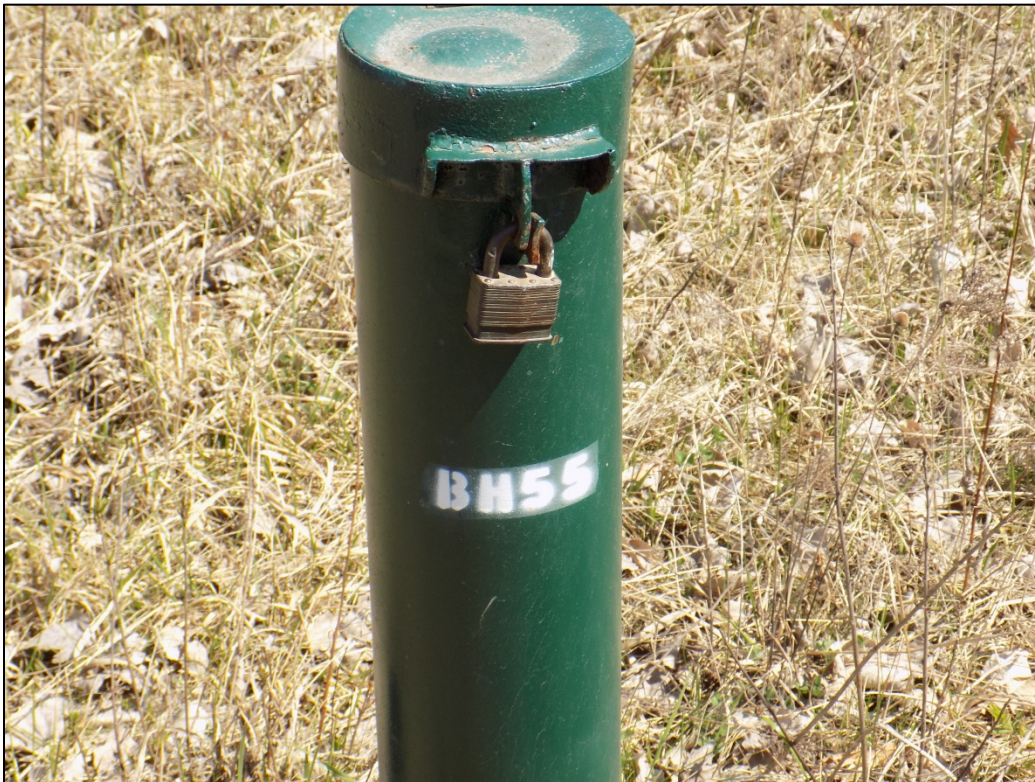
Two monitoring wells remain at Site A: BH55 (PL-4) and BH56 (PL-5). Both monitoring wells were secured with locks and identified with a well number on the outer casing. ANL personnel visited the wells once in 2017 for sampling to ensure well security and perform any required maintenance.

PL-4. Monitoring Well BH55 at Site A

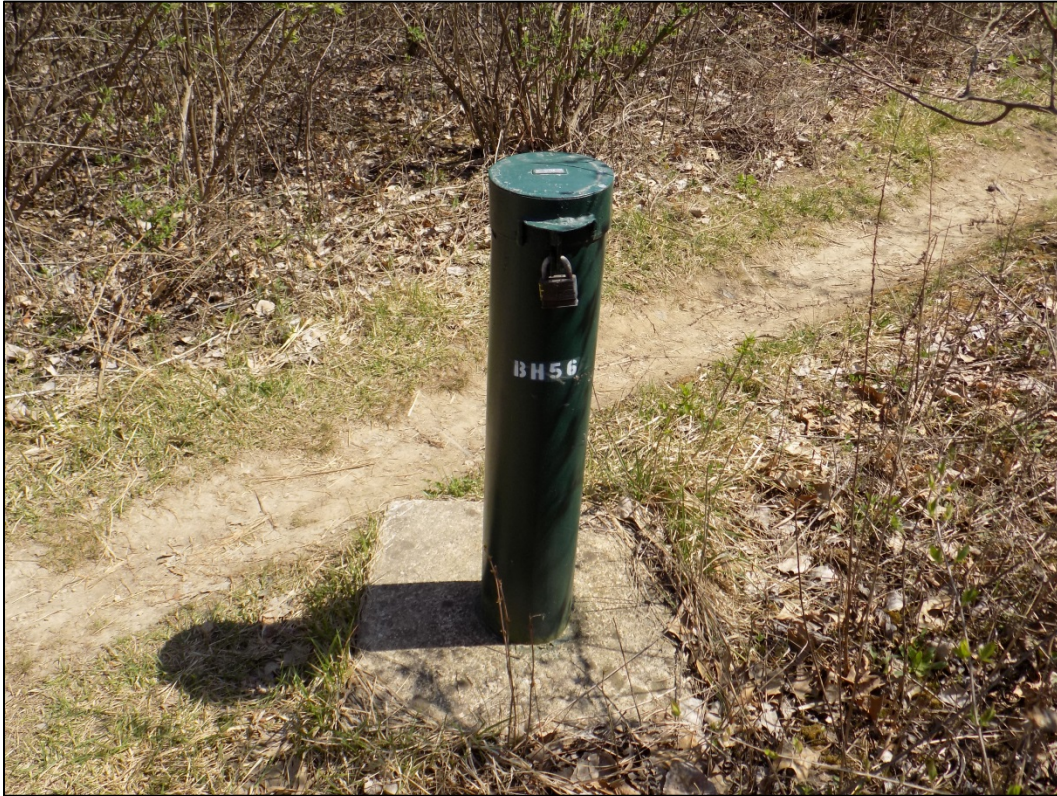
PL-5. Monitoring Well BH56 at Site A

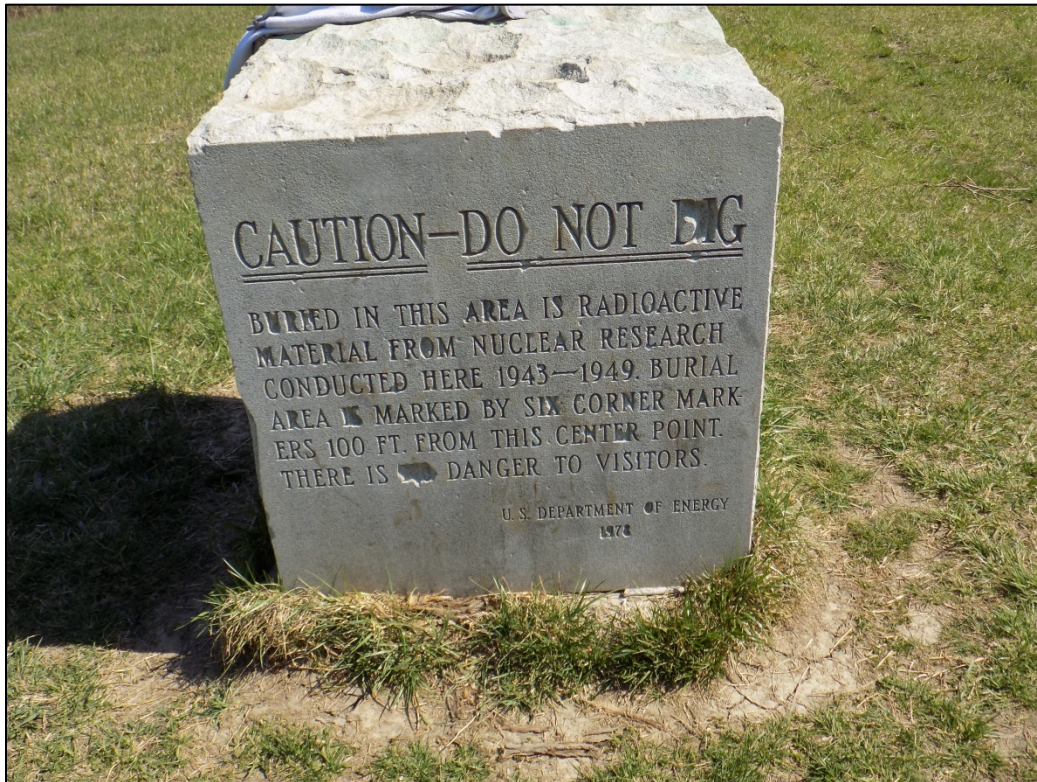
The Plot M historic site marker was unchanged from last year's inspection. It was in good condition, with the exception of some minor vandalism that occurred several years ago (i.e., some words on the marker are chiseled off) (PL-6). All Plot M corner markers were located and found to be in good condition.

PL-6. Looking North at the Plot M Site Marker

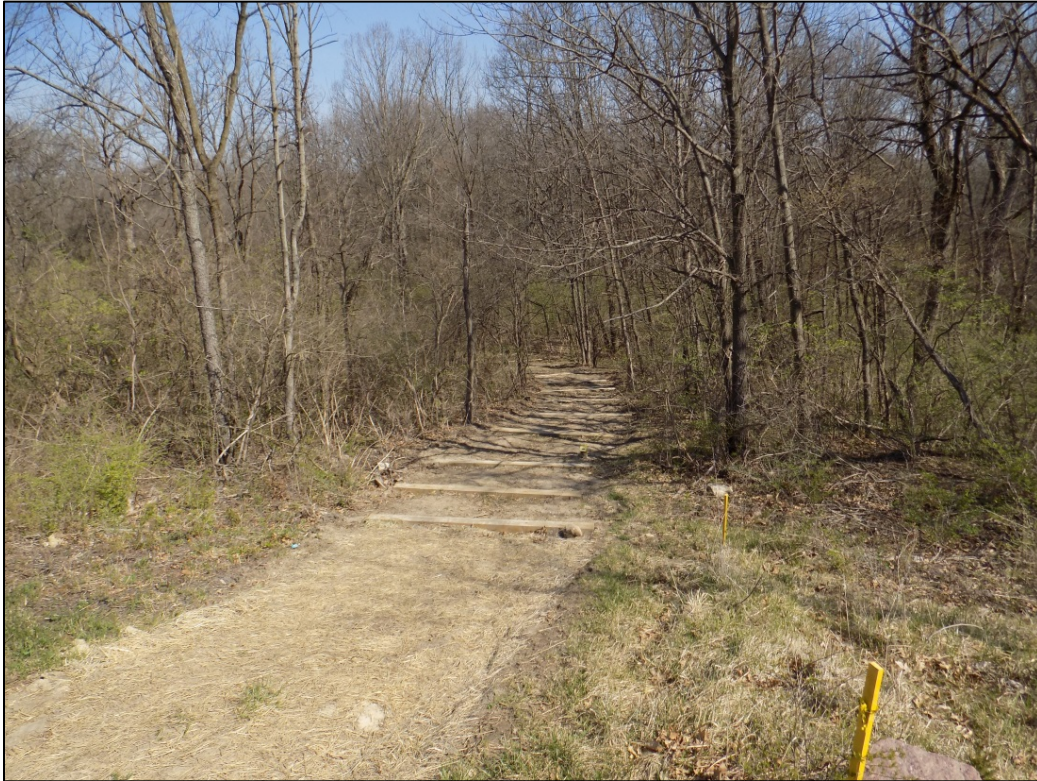
A new Cook County forest preserve campsite opened in 2015 at Bull Frog Lake, which is east of Plot M. Hiking and biking trails connect the Bull Frog Lake area with the Site A/Plot M area. Erosion on top of the grass-covered mound at Plot M continues to be a concern. The erosion is caused by pedestrian and bicycle traffic, but this traffic over Plot M appears to be less this year now that new trails are open around Plot M. ANL conducts annual maintenance reviews of the grass-covered mound and periodically adds topsoil to erosion ruts as needed to keep them from expanding. No additional repairs are needed at this time. A footpath on the north side of the mound was affected by water runoff and erosion. Landscaping timbers installed along the path appear to be effective in baffling surface water flow from precipitation down the path (PL-7 and PL-8).

2. Although improved this year, erosion on top of the grass-covered mound at Plot M continues to be a problem.

PL-7. Looking North down Path with New Timbers Installed to Reduce Erosion

Action: ANL will continue to routinely inspect the grass-covered mound and periodically repair ruts by filling them in with clean dirt and reseeding.

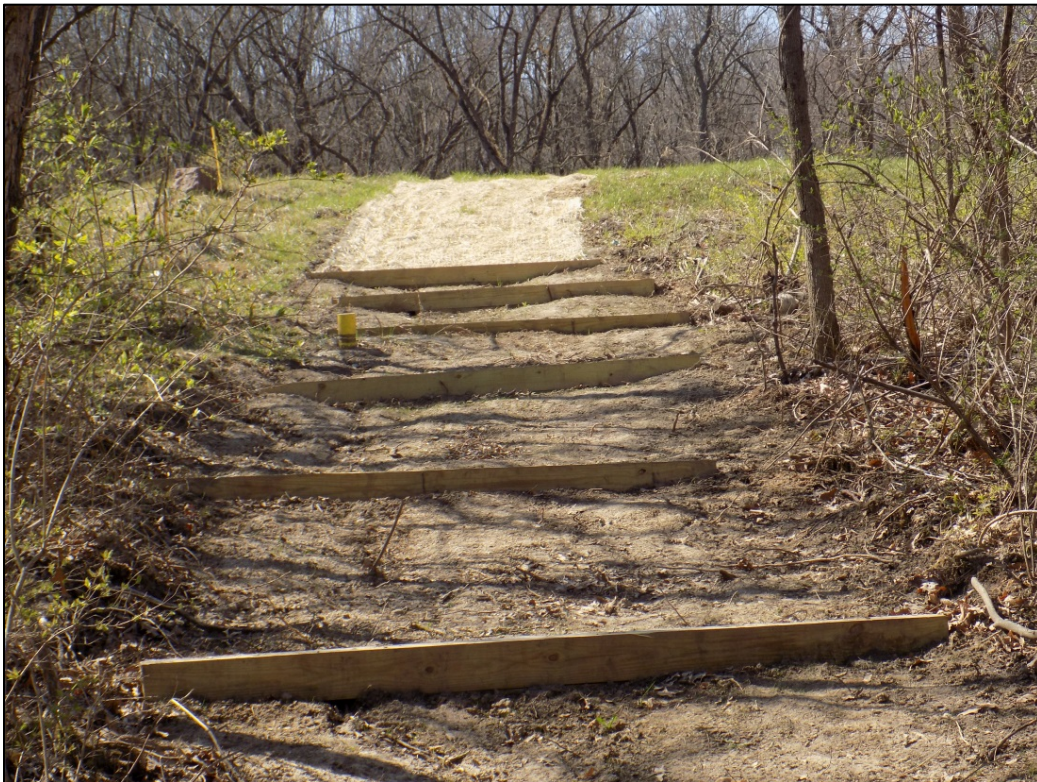
PL-8. Looking South at Erosion-Control Timbers Installed in Footpath Leading to Plot M
