# **Postclosure Inspection Report for the Tonopah Test Range and Nevada Test and Training Range, Nevada, Sites for Calendar Year 2024**

**March 2025**

**U.S. DEPARTMENT OF  
ENERGY**

**Legacy  
Management**

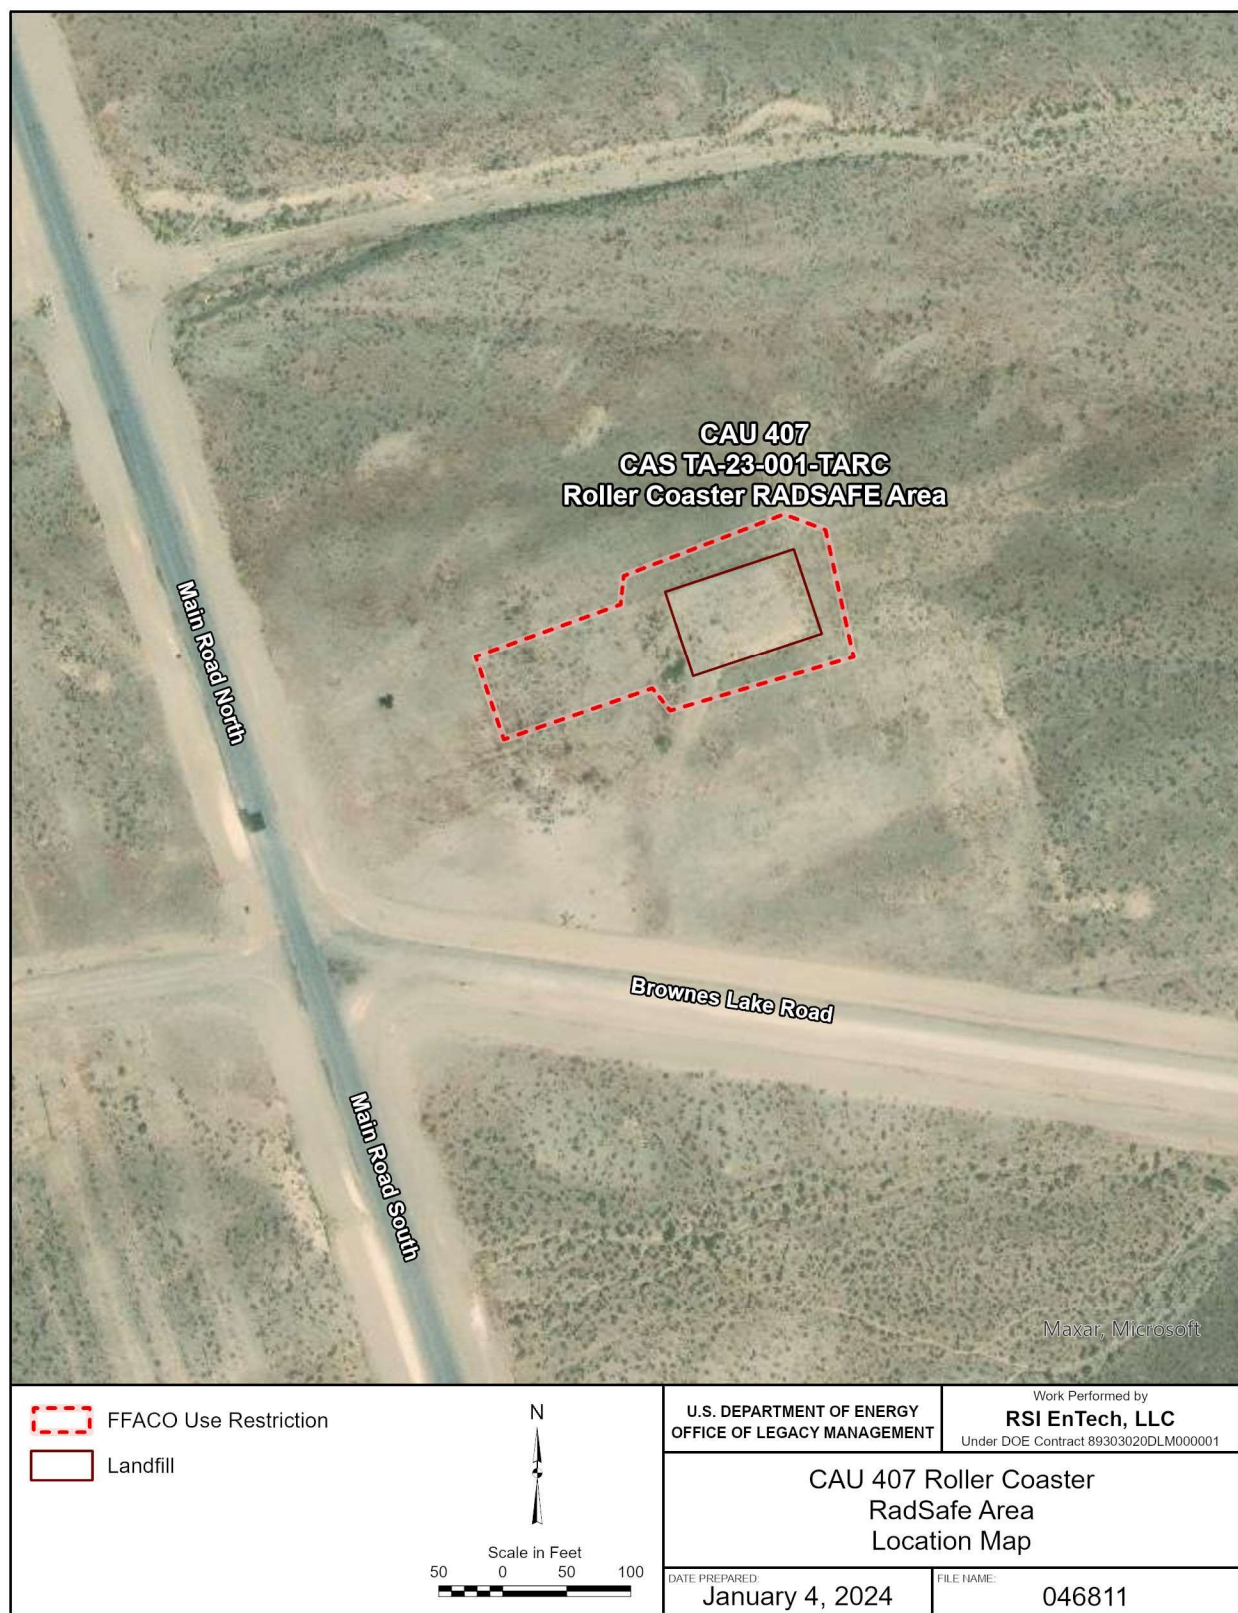
Figure 2. CAU 407, Roller Coaster RadSafe Area

Visual inspections were conducted according to the postclosure requirements for CAU 407, Roller Coaster RadSafe Area (TTR), CAS TA-23-001-TARC, Roller Coaster RadSafe Area, as described in the CAU 407 UR (DOE/EMNV 2019a). The site is shown in Figure 2 in Appendix A. The visual inspection was conducted on April 23, 2024. All signs were legible. Two signs were loose and reattached to the fence. Three sections of fence along the south, east, and north sides were repaired. Several small animal burrows were observed on the cell, but the burrows did not pose an imminent hazard to the integrity of the cell cover at the time of the inspection. No other repair or maintenance needs were observed.

The fence surrounding the CAU is starting to degrade. Numerous posts were loose, and the fence strands are losing integrity. The fence may need to be replaced in the future.

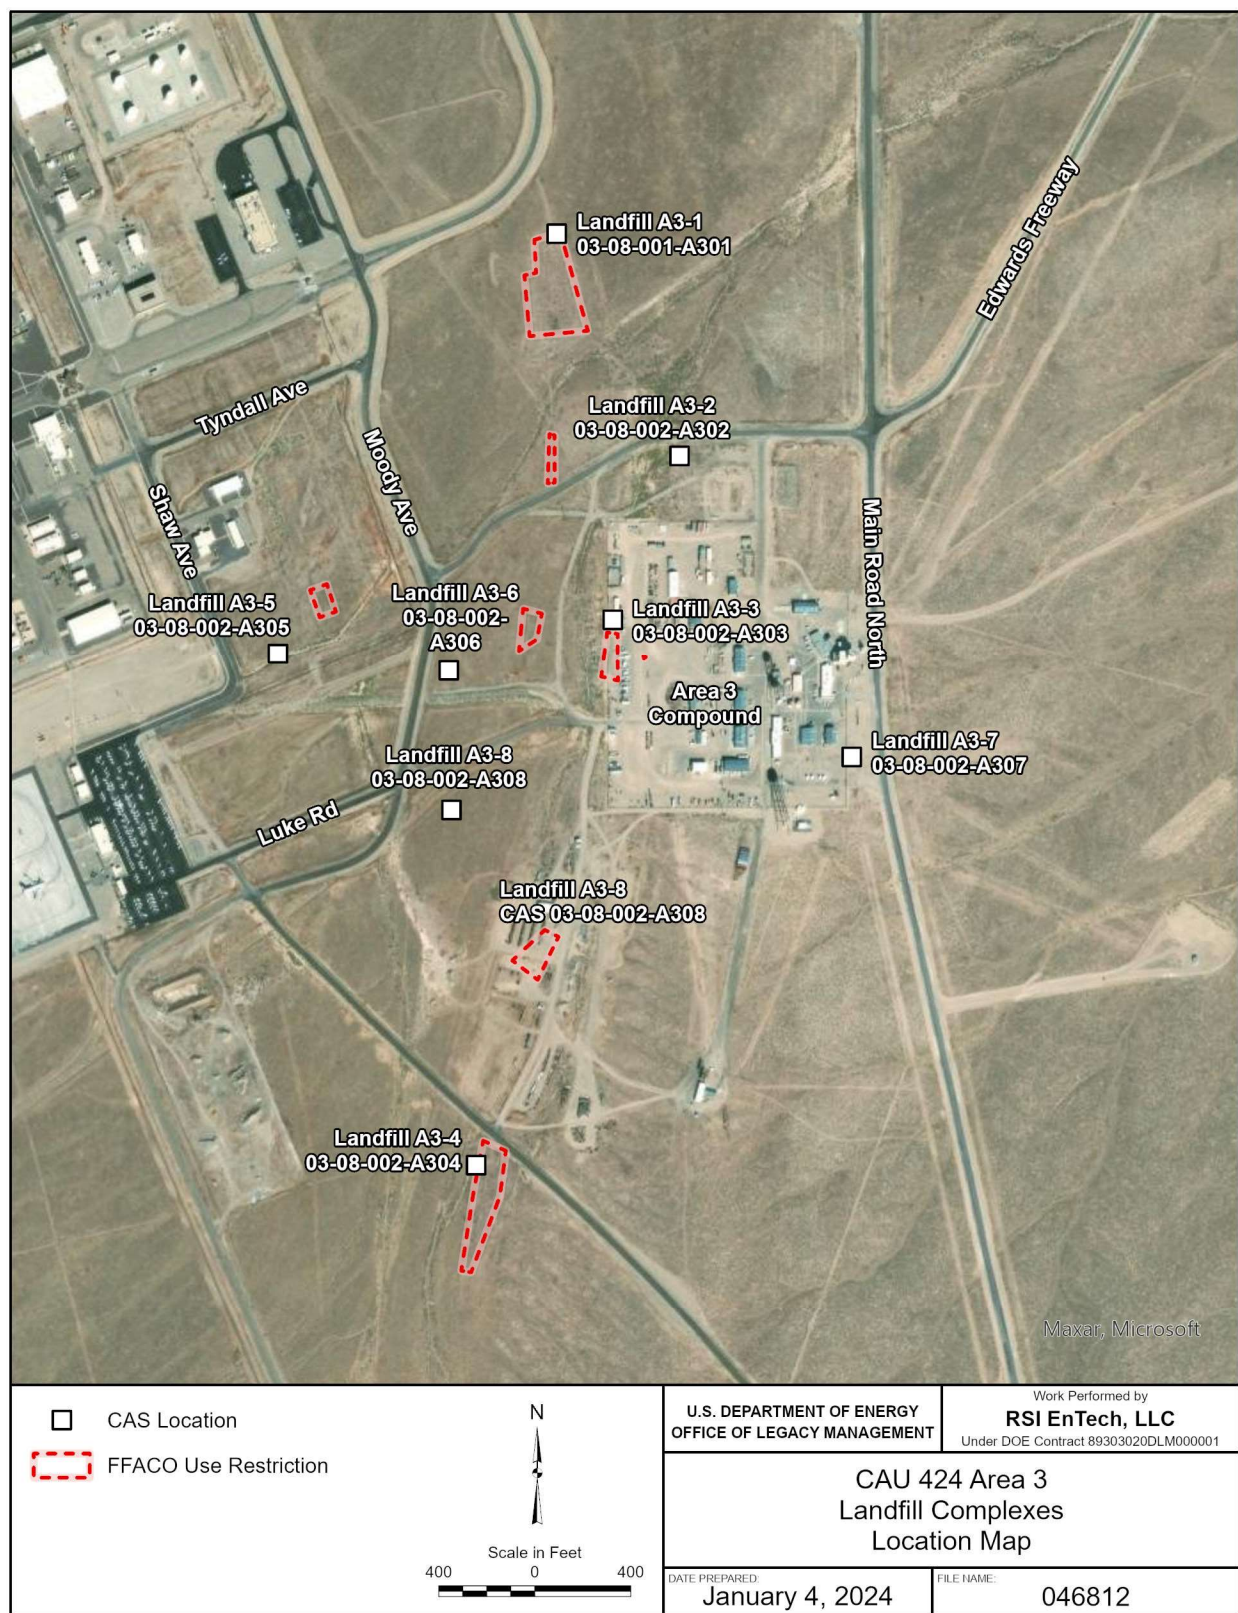
Figure 3. CAU 424, CAS Locations

Visual inspections were conducted according to the postclosure requirements for CAU 424, Area 3 Landfill Complexes (TTR), CAS 03-08-001-A301, Landfill Cell A3-1; CAS 03-08-002-A302, Landfill Cell A3-2; CAS 03-08-002-A303, Landfill Cell A3-3; CAS 03-08-002-A304, Landfill Cell A3-4; CAS 03-08-002-A305, Landfill Cell A3-5; CAS 03-08-002-A306, Landfill Cell A3-6; and CAS 03-08-002-A308, Landfill Cell A3-8, as described in the CAU 424 UR (DOE/EMNV 2019b). The landfill locations are shown in Figure 3 of Appendix A. The inspection was conducted on April 23, 2024.

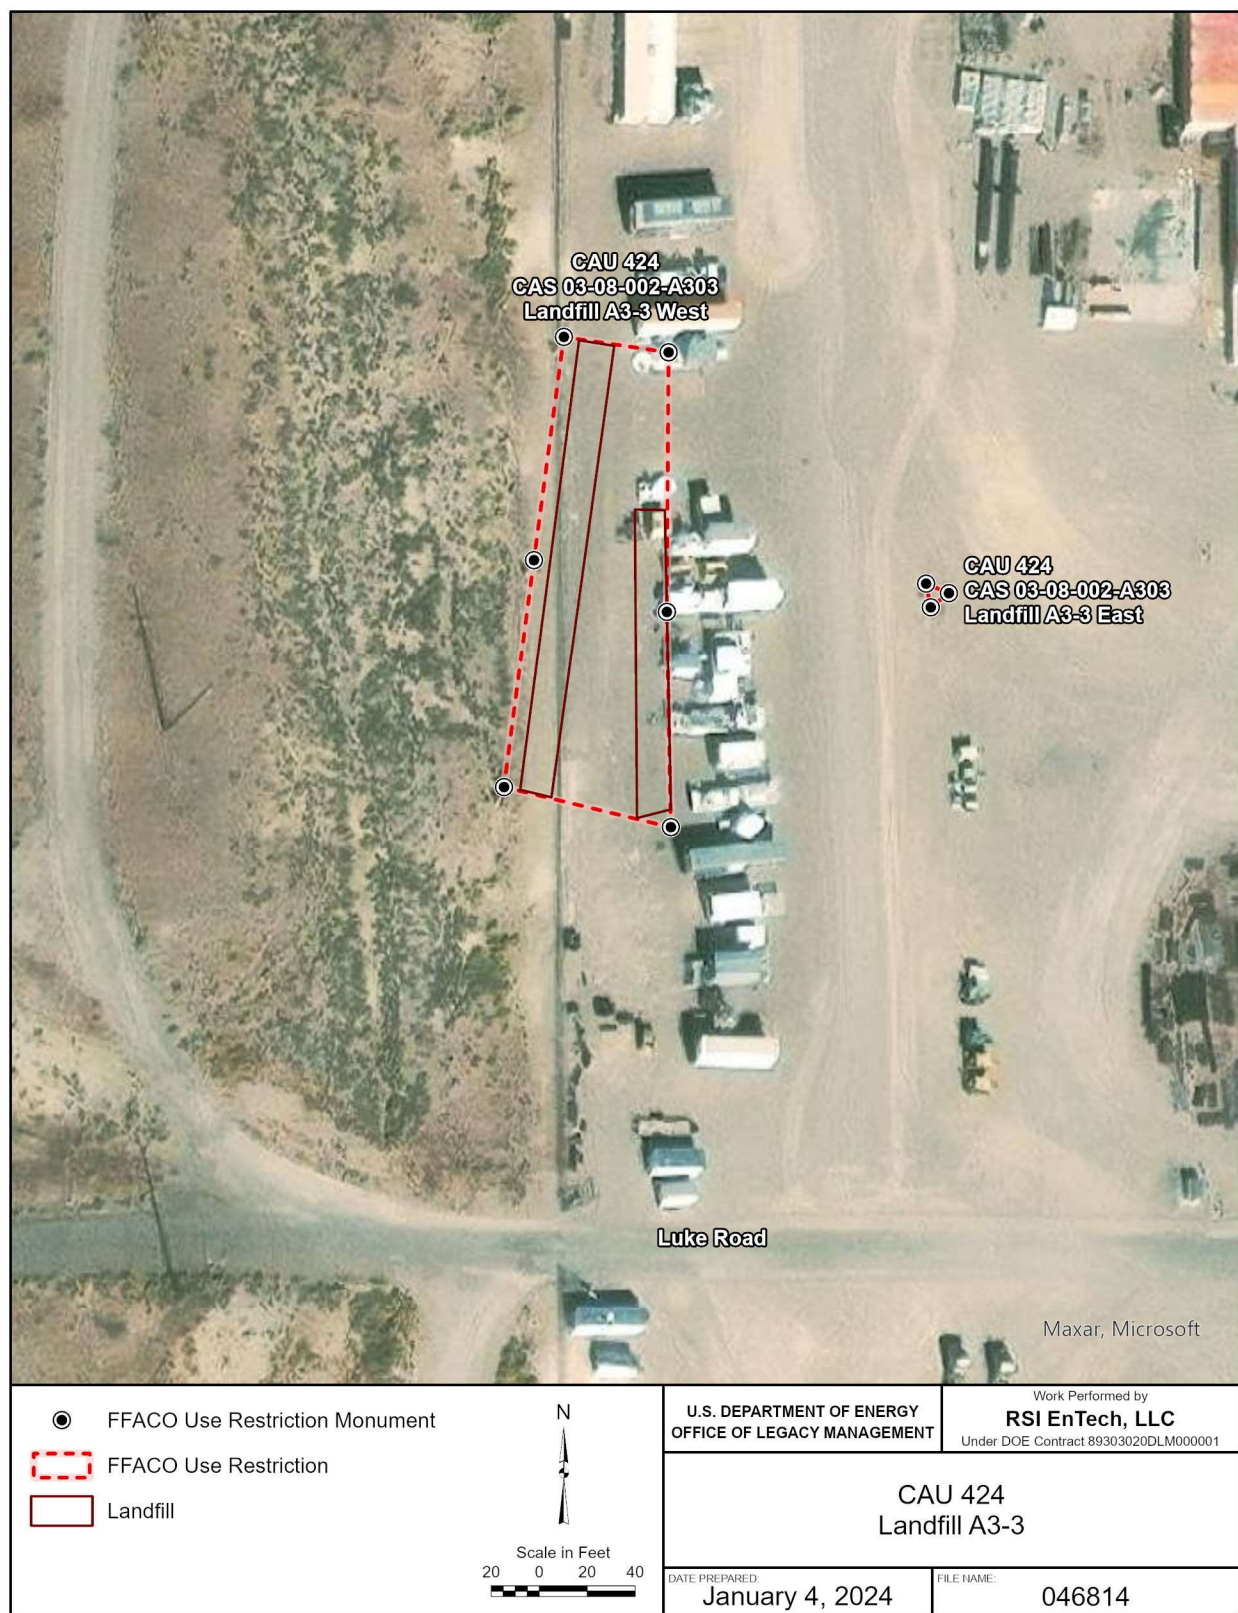
Figure 5. CAU 424, Landfill A3-3

**Landfill Cell A3-3 (CAS 03-08-002-A303):** All signs, monuments, survey markers (on the monuments), and ground survey markers were in good condition. All monuments had warning signs. The survey marker on the northeast corner of A303 (west) is obstructed by a vehicle tire. The vehicle is parked on top of the survey marker making identification difficult. No repair or maintenance needs were observed. The site is shown in Figure 5 of Appendix A.

**Landfill Cell A3-3 (CAS 03-08-002-A303):** Installation of monuments or concrete boundary markers on A303 (east) could help to protect cell integrity and field identification. The survey marker on the northeast corner of A303 (west) is obstructed by a vehicle tire. The vehicle is parked on top of the survey marker making identification difficult. Field identification would be easier and more efficient if the parked vehicle was moved off the marker. No other recommendations are proposed at CAS 03-08-002-A303.

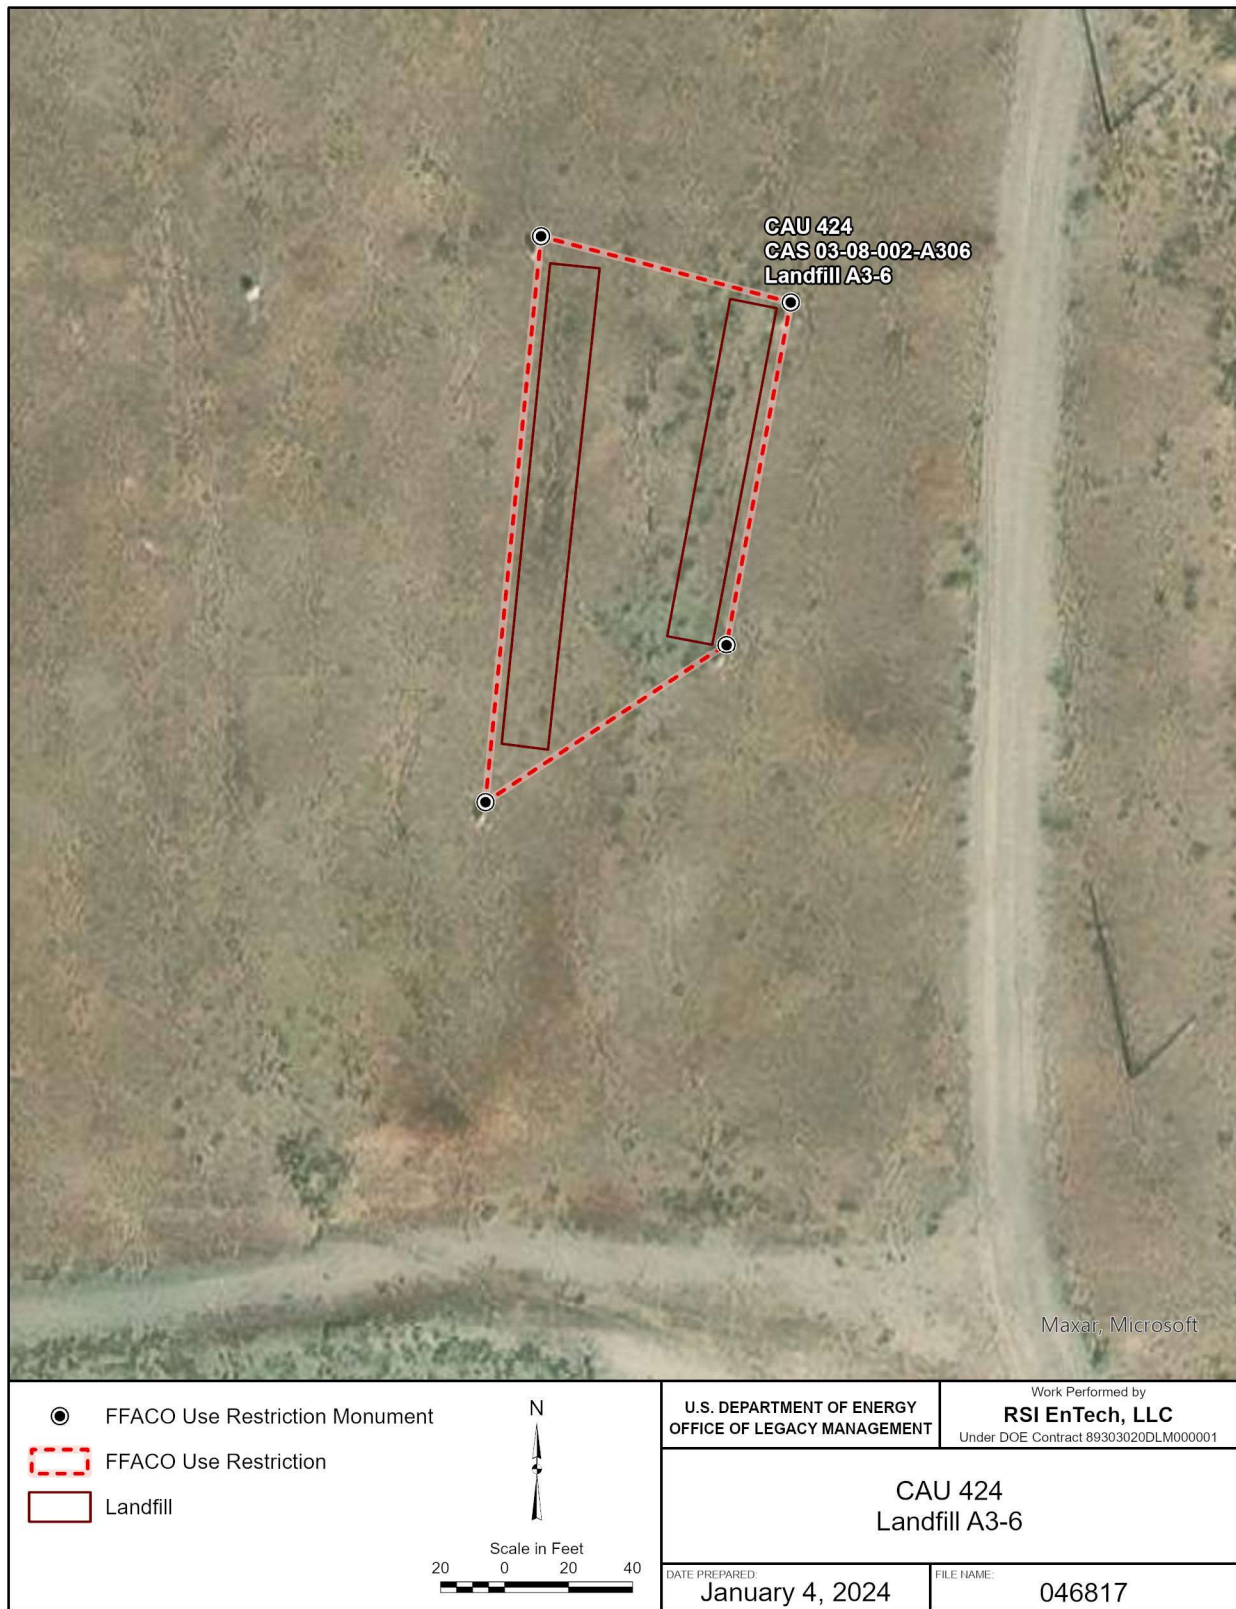
Figure 8. CAU 424, Landfill A3-6

**Landfill Cell A3-6 (CAS 03-08-002-A306):** All signs, monuments, and survey markers were in good condition. All monuments had warning signs. Several small animal burrows were observed on the cell. Some of these burrows were clustered around the southwest CAU Monument. While not an imminent hazard, these burrows could potentially cause instability to the Monument. The other burrows did not pose an imminent hazard to the integrity of the cell cover at the time of the inspection. Metal debris was observed on the surface, along with a small sign denoting its presence on cell. No repair or maintenance needs were observed. The site is shown in Figure 8 of Appendix A.

The southwest monument had several animal burrows surrounding the base. While not an imminent hazard, these burrows could potentially cause instability to the monument.

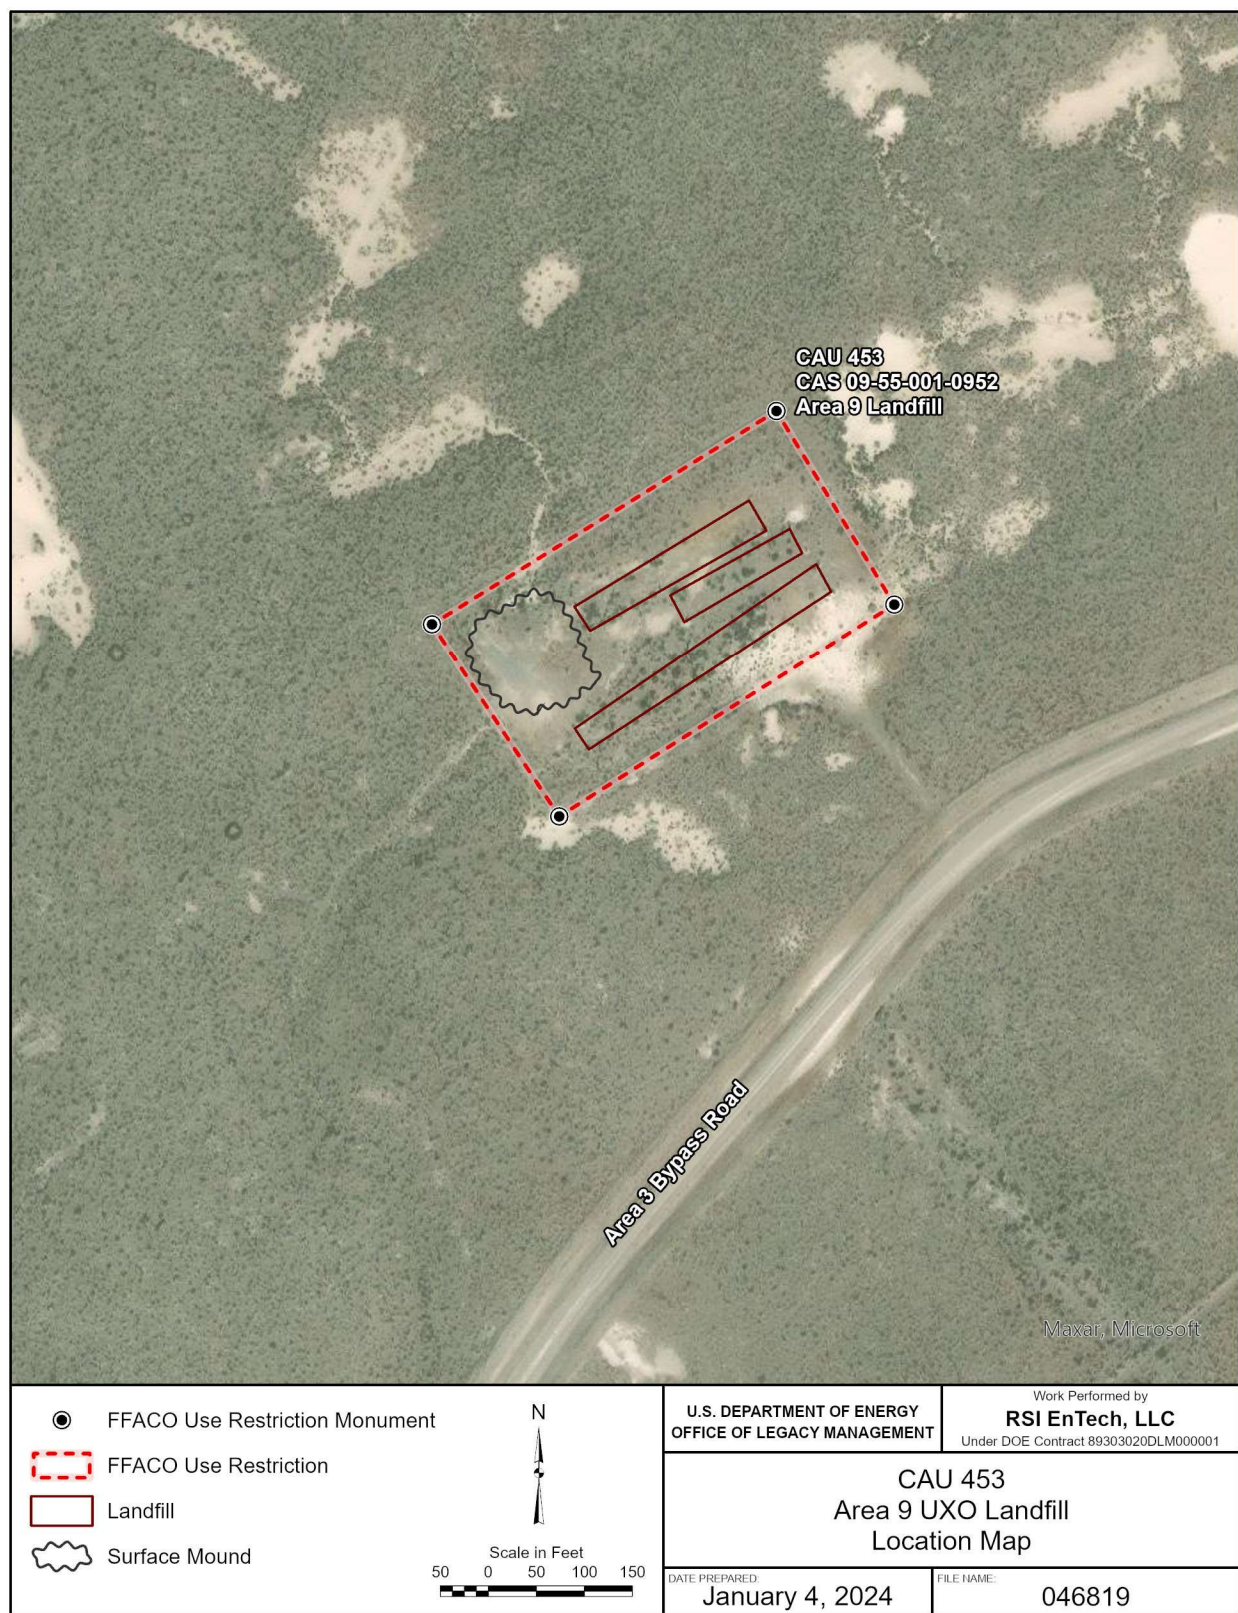
Figure 10. CAU 453, Area 9 UXO Landfill

Visual inspections were conducted according to the postclosure requirements for CAU 453, Area 9 UXO Landfill (TTR), CAS 09-55-001-0952, Area 9 Landfill, as described in the CAU 453 UR (DOE/EMNV 2019c). The site is shown in Figure 10 of Appendix A. The inspection was conducted on April 23, 2024. All signs and monuments were in good condition. The perimeter fence was in good condition. UR signs were attached to the fence and legible. Minor cracking was observed by the northern trench. Cracks were filled with dirt. Minor erosion was observed on the mound of soil on the northwestern side of the cell. During the time of inspection, the erosion did not present an imminent hazard to the cell cover. Several small animal burrows were observed on the cell, but the burrows did not pose an imminent hazard to the integrity of the cell cover at the time of the inspection. Metal debris was observed on the cover; it was partially buried in soil. The debris was left in place. No other repair or maintenance needs were observed.

The combination lock securing the gate to CAU 453 had to be cut to access the cell. The lock has been replaced with a keyed lock. Future site visits will need to be coordinated with Sandia Facility Security Officer to obtain access.

During the inspection a lock had to be cut to open the gate and access CAU 453. Due to employee turnover the combination to the lock was not communicated properly to the inspection team. Sandia National Laboratories (SNL) maintenance staff assisted the inspection team and cut the lock. The lock was replaced with a keyed lock. The keys are held by SNL staff and will be provided to the inspection team in future CAU inspection events. Future staff should keep in communication with SNL to access the gate to CAU 453. No other recommendations are proposed at CAS 09-55-001-0952, Area 9 Landfill.
