# **2024 Annual Inspection Report for the Parkersburg, West Virginia, Disposal Site**

**February 2025**

Legacy  
Management

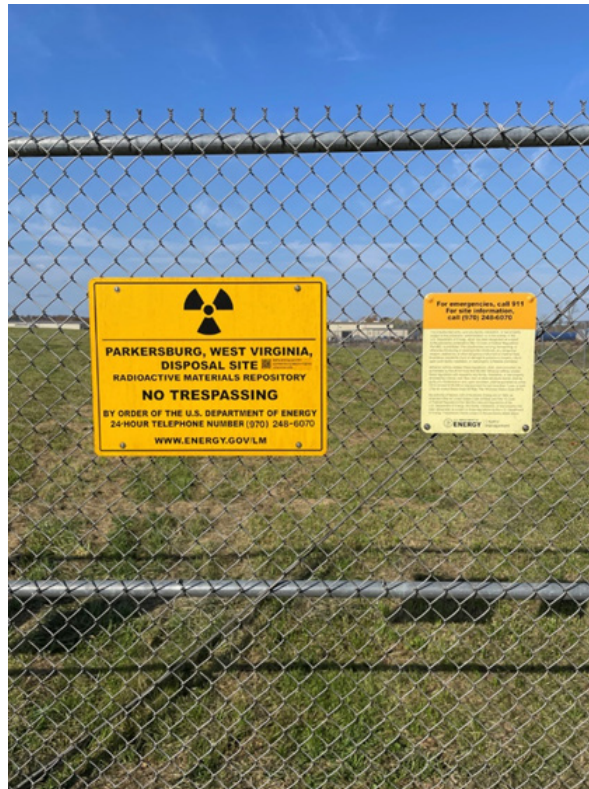
All entrance gates were properly secured, and signage posted on the gates was current with the exception of the phone number. The phone number was updated using a sticker (PL-1).

*PL-1. Updated Phone Number*

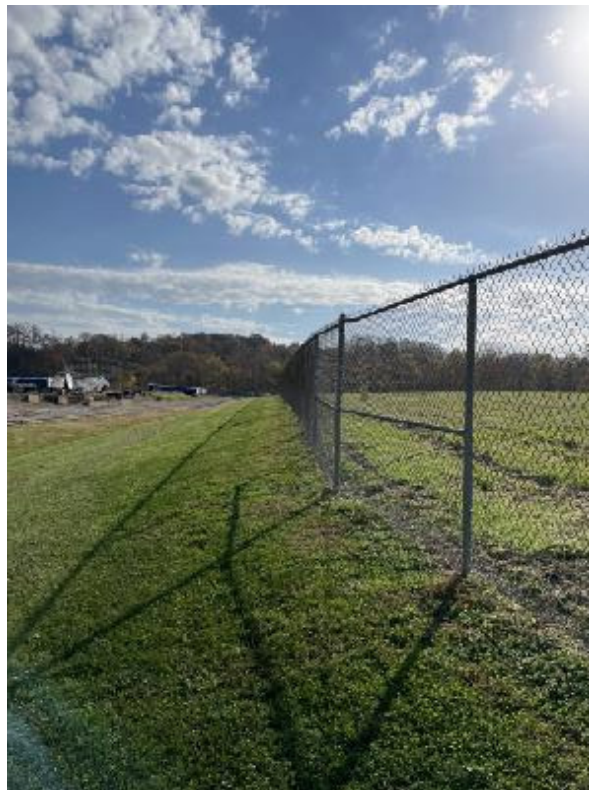
The perimeter fence was replaced in 2007. The site maintenance subcontractor maintains a vegetation-free zone along the base of the fence line and ensures that vegetation does not grow on the fence fabric. The vegetation-free zone along the fence line was being maintained (PL-2), and the fence fabric was free of vegetation.

*PL-2. Fence Line*

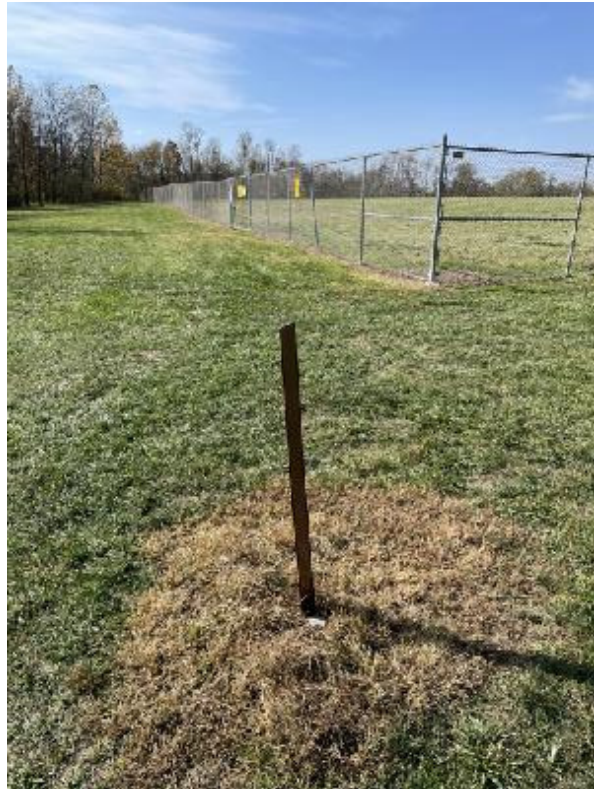
The Parkersburg site has six boundary monuments and one concrete survey monument. All six boundary monuments and the concrete survey monument were located during the inspection. A new trail marker was installed next to boundary monument 1 to make the monument visible to mowing crews (PL-3). The top of the concrete survey monument is missing, but its replacement is not necessary.

*PL-3. New Trail Marker Installed next to Boundary Monument BM-1*

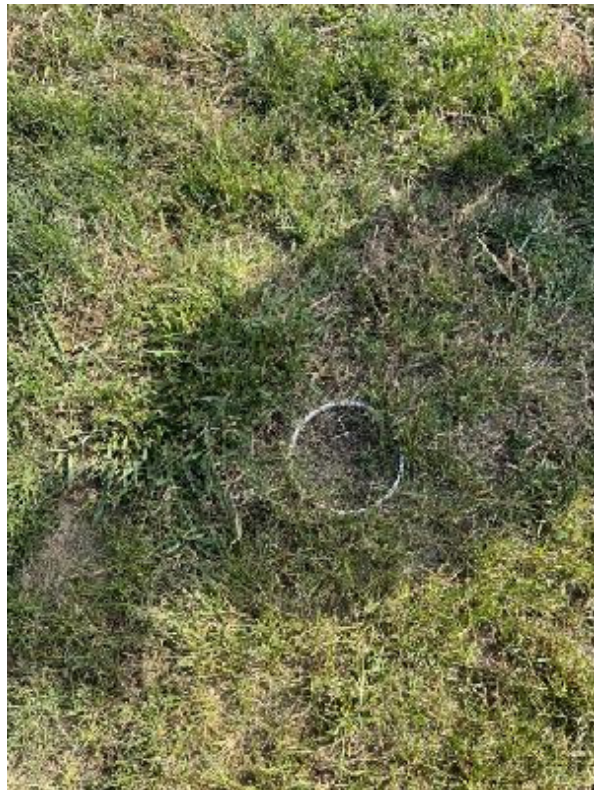
Boundary monument BM-3 is about 6 inches beneath ground surface. A 6-inch section of PVC pipe was installed around the monument and filled with pea gravel to make it flush with the ground surface (PL-4).

*PL-4. Location of Boundary Monument BM-3*

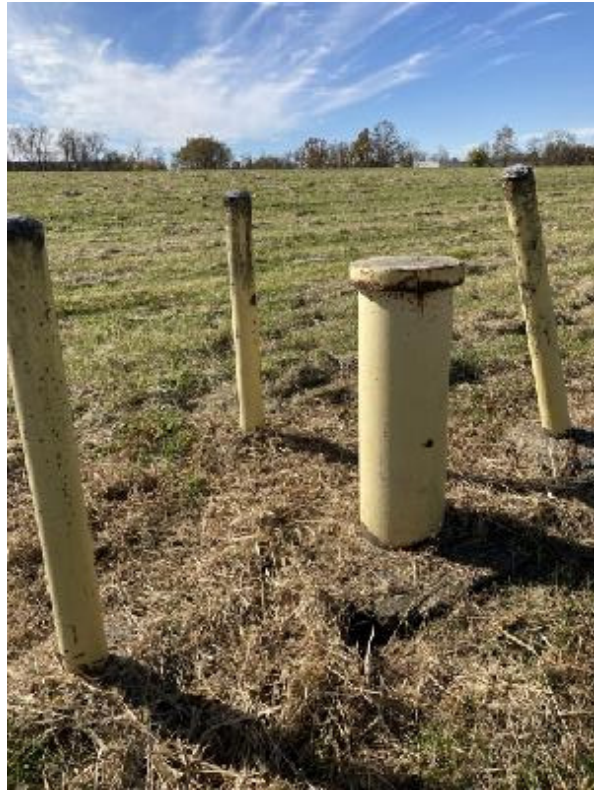
There are six groundwater monitoring wells at the Parkersburg site. All six wells are inside the security fence. The wells are numbered in the chronological order in which they were drilled and installed. All six wells were properly locked. The site maintenance subcontractor clears vegetation around the monitoring wells. Vegetation was being properly controlled around the monitoring wells (PL-5).

*PL-5. Monitoring Well MW-6*

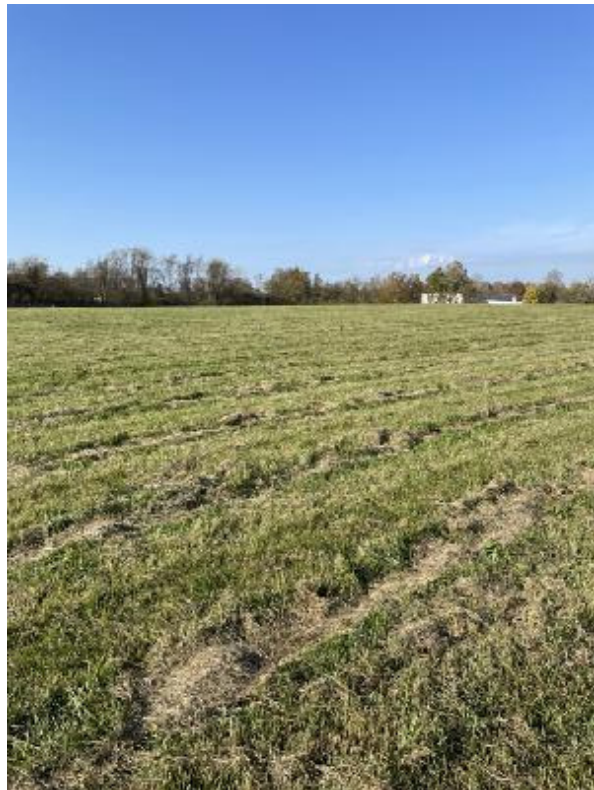
At the time of the inspection, vegetation on top of the disposal cell had been recently mowed. No evidence of erosion or slope instability on the disposal cell was noted during the inspection (PL-6).

*PL-6. Disposal Cell Surface*

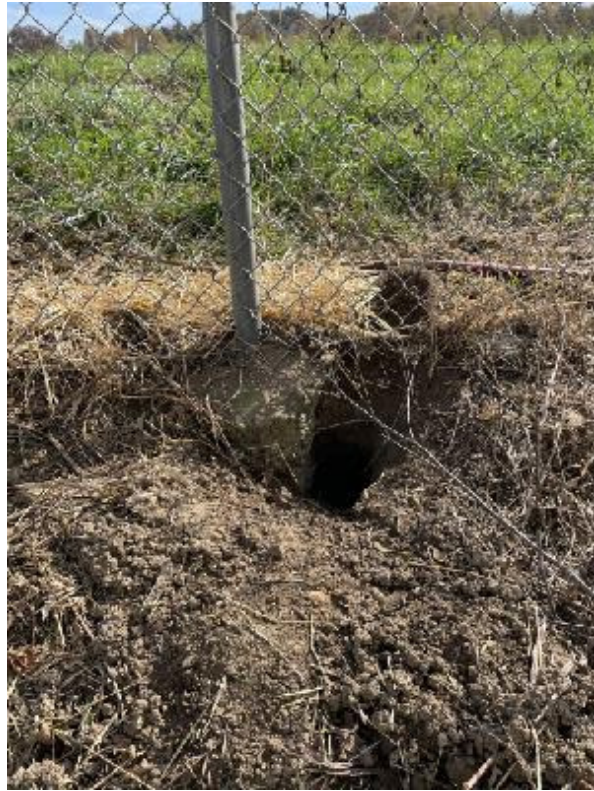
Animal burrowing activity at the site continues to be a challenge. In descending order, the cell cap consists of a 30-inch layer of topsoil, a 12-inch layer of impermeable clay, then a 6-inch layer of compacted clay. There is concern that if the burrowing is not controlled, the protective nature of the cell cap might be compromised. In 2021, 2 weeks of trap-and-release were conducted to remove two groundhogs from the site. Existing burrows were collapsed, filled with clean soil, and reseeded. Additional burrows were collapsed, filled with clean soil, and reseeded in 2022 and again in 2023. In 2022, a coyote den was found and collapsed. In 2024, several weeks of capture were conducted and several additional groundhogs were captured. During the site inspection, new additional animal burrows were discovered. Their locations are identified on the site map (Figure A-1). These new burrows will be collapsed, filled with clean soil, and reseeded as deemed appropriate. Inspectors also noted that some of the recently collapsed burrows showed signs of new animal activity. Additional trapping is planned for 2025 (PL-7).

*PL-7. Recent Activity at Animal Burrow*

LM needs to be vigilant about addressing animal burrows on the disposal cell. As burrows are located, they need to be collapsed, filled with clean soil, and reseeded. On going routine annual pest management is being conducted at the site.

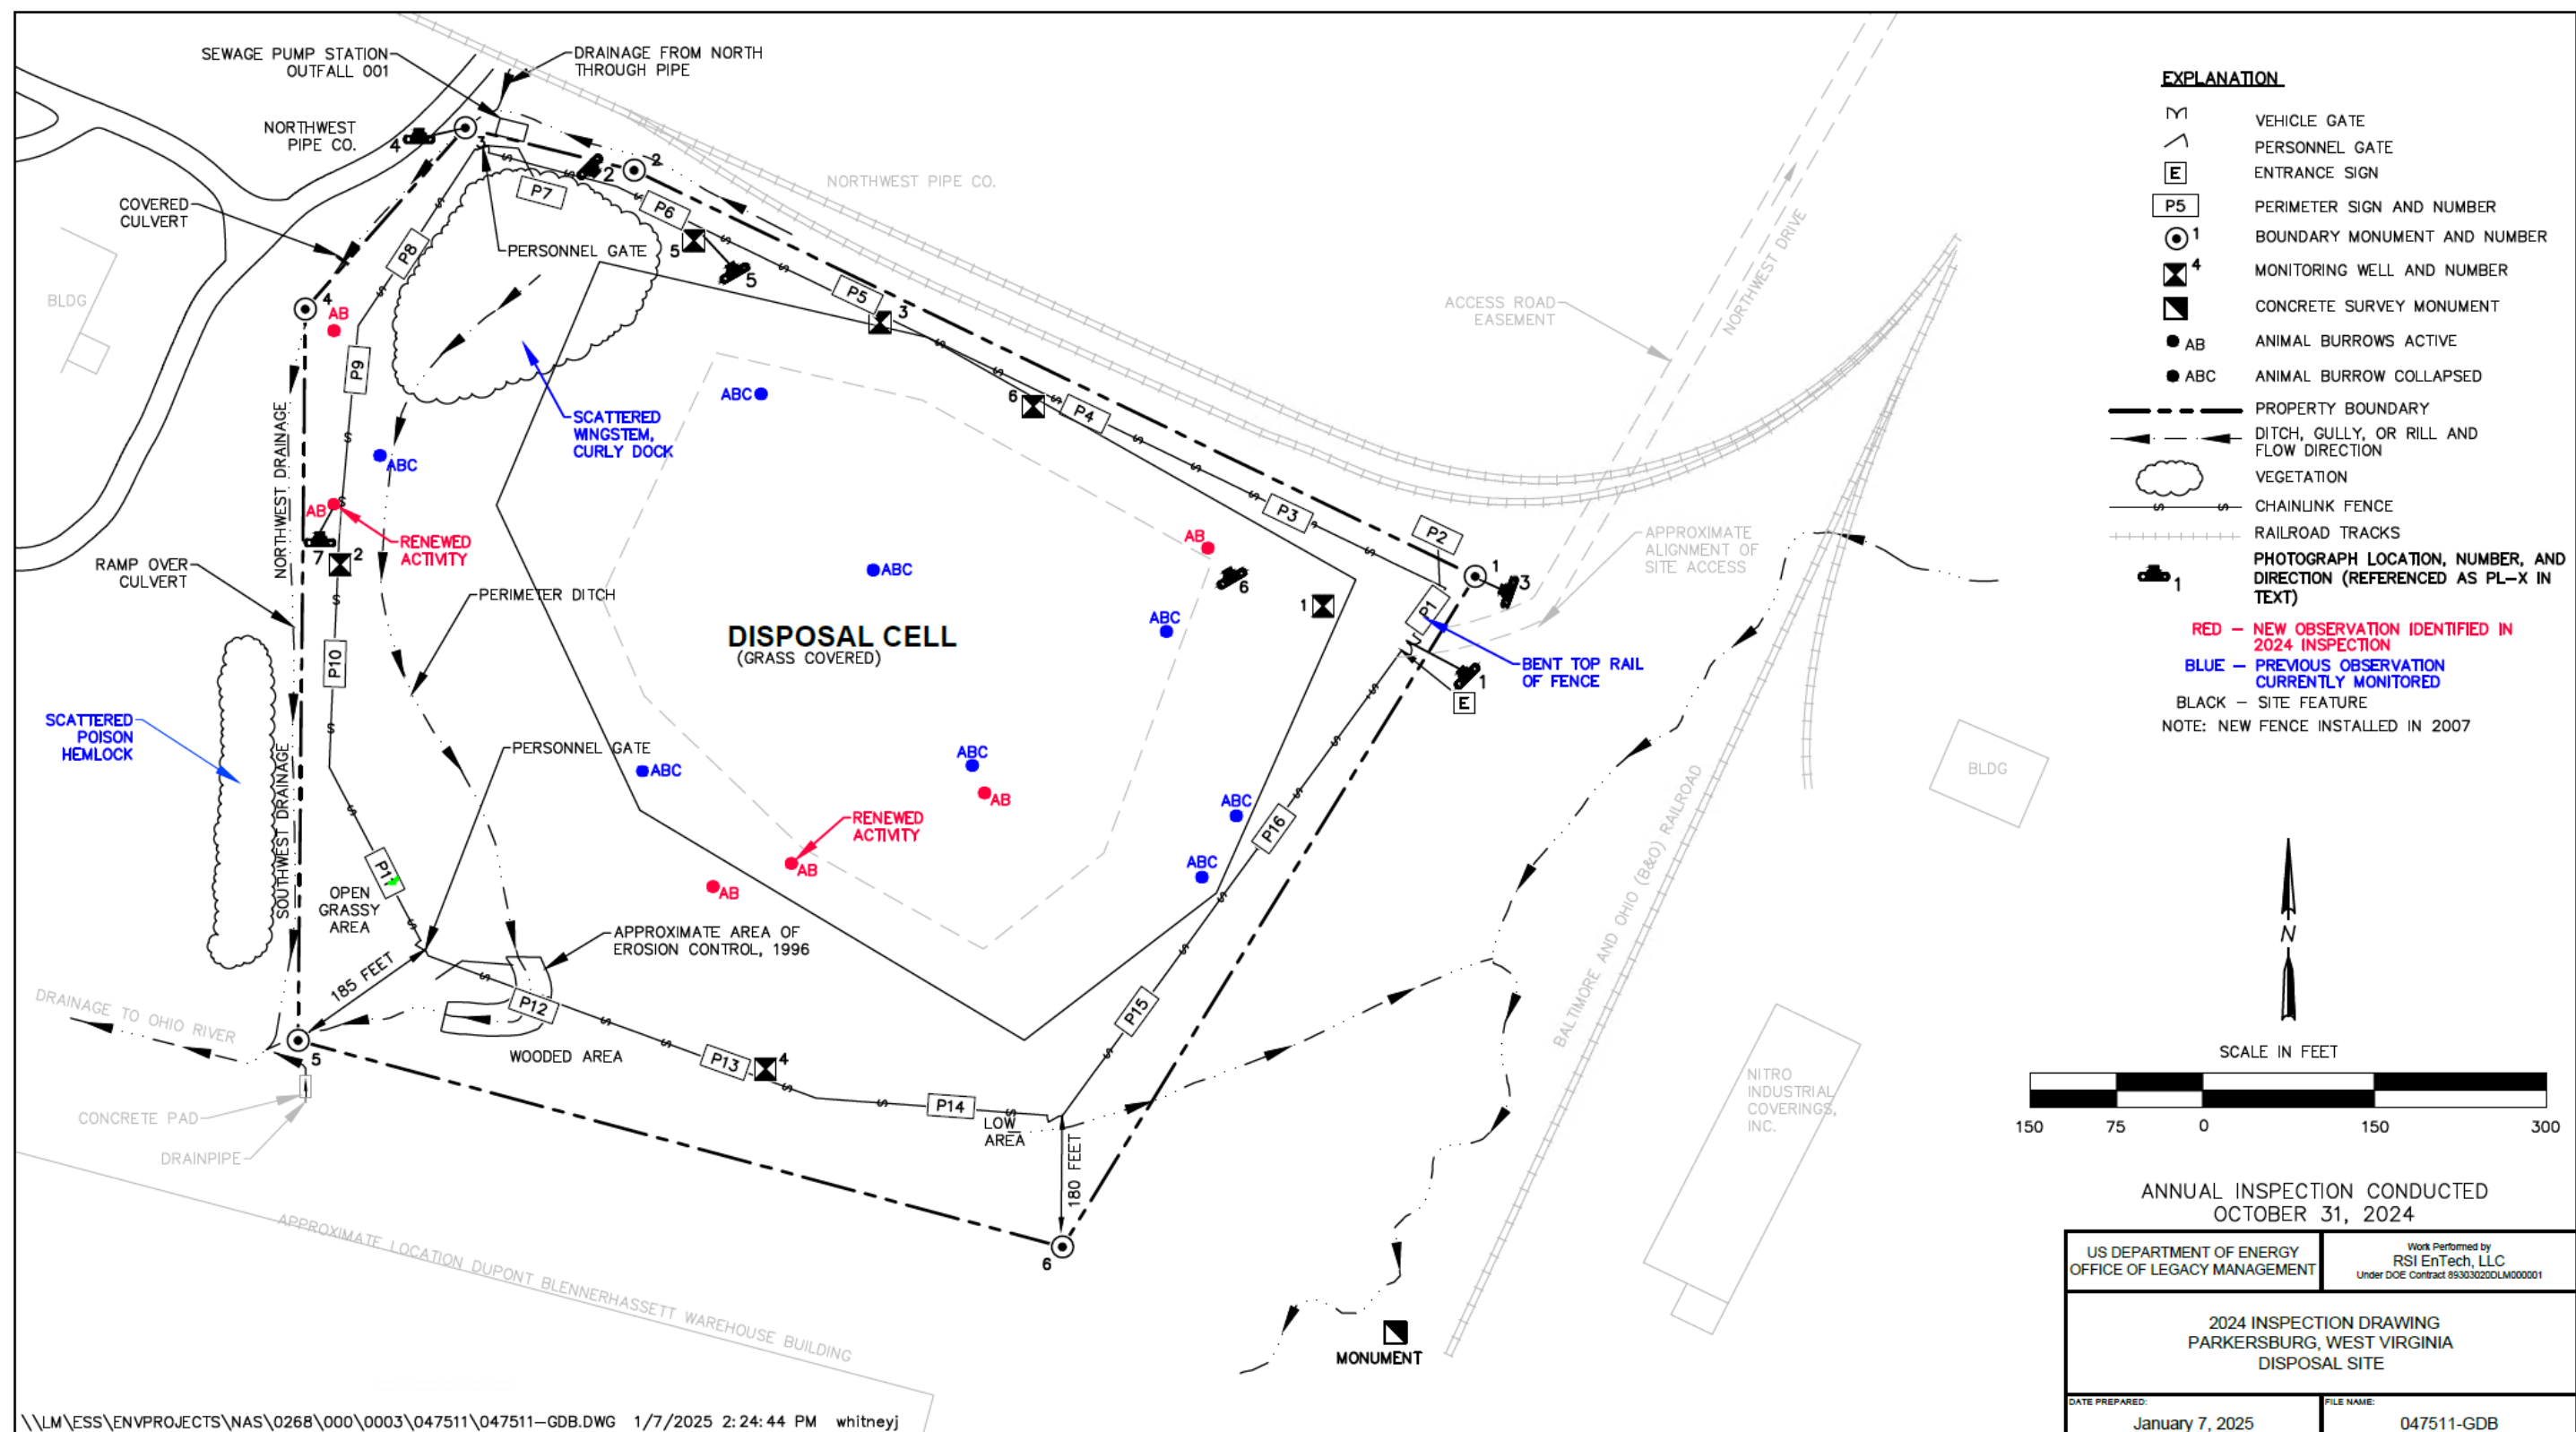
Figure A-1. 2024 Annual Inspection Drawing for the Parkersburg, West Virginia, Disposal Site

The locations of site surveillance features are shown in Figure A-1 (Appendix A). Inspection results and recommended maintenance activities associated with site surveillance features are described in the following subsections. Photographs to support specific observations are identified in the text and in Figure A-1 by photograph location (PL) number.

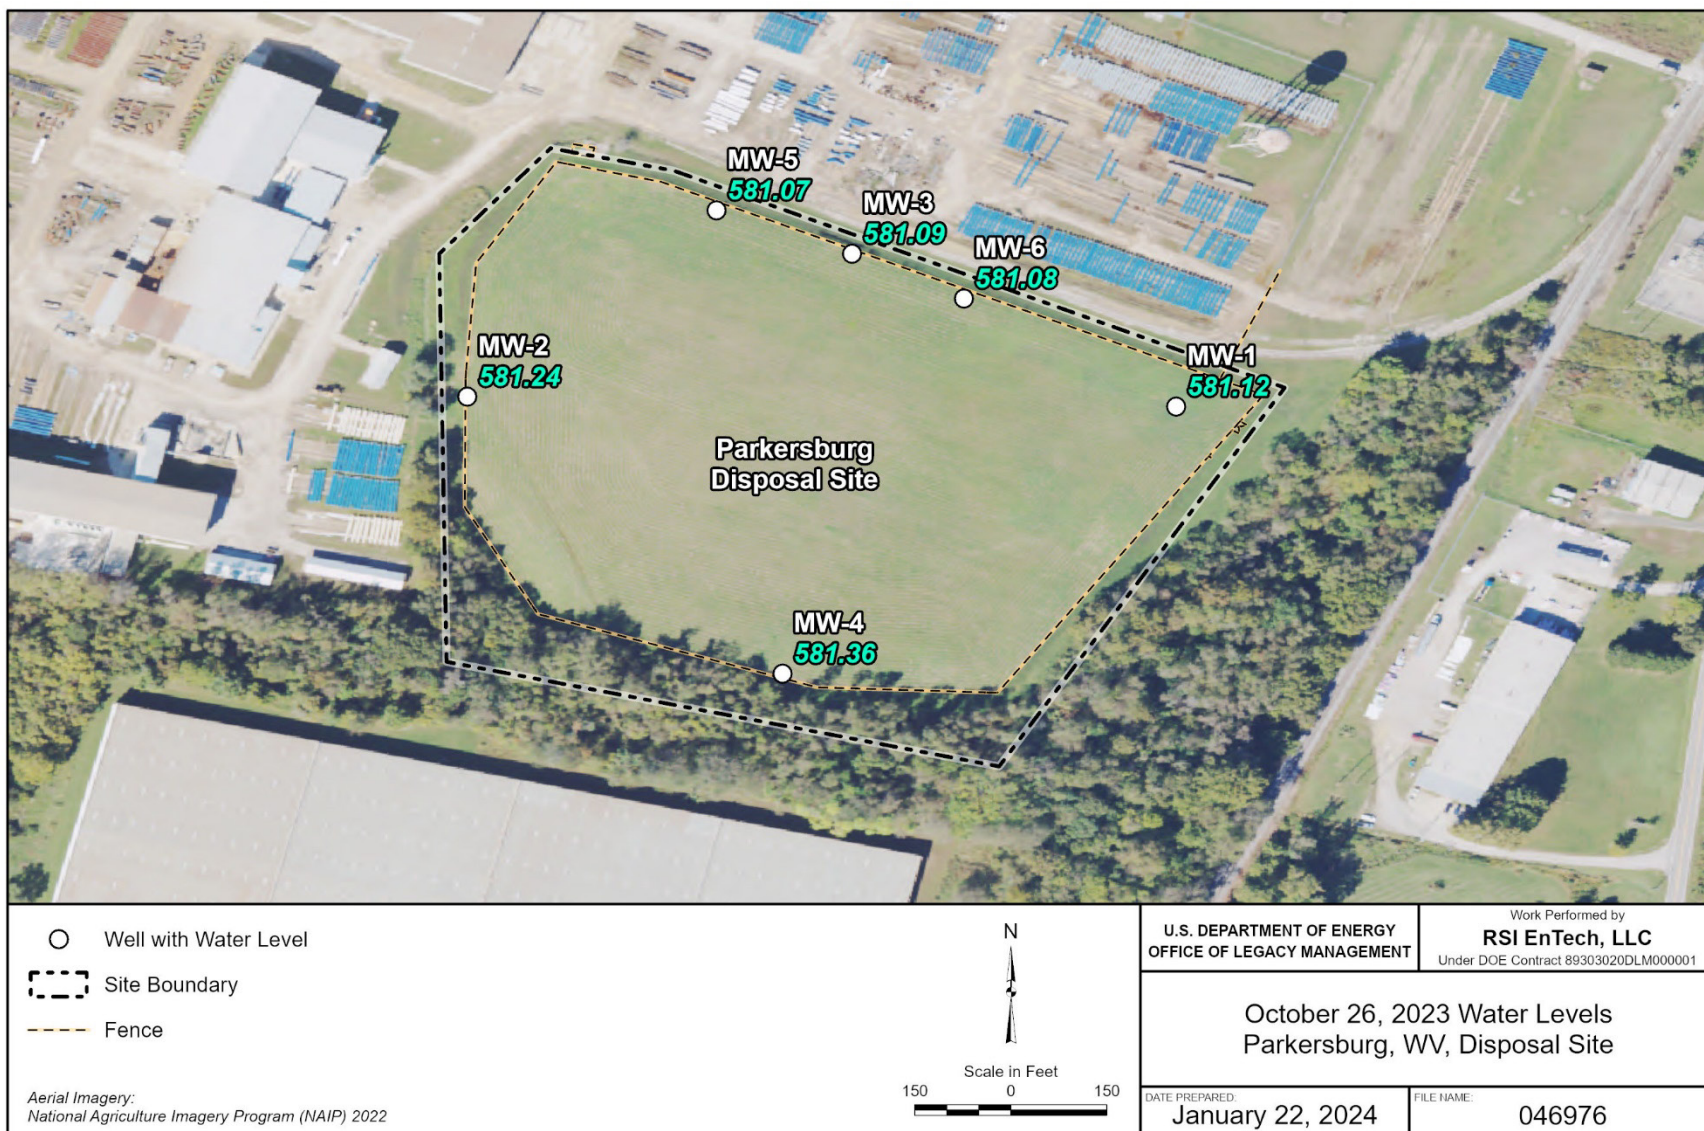
Figure A-2. 2023 Water Levels, Parkersburg, West Virginia, Disposal Site

Groundwater levels were measured at all six monitoring wells in 2023. As shown in Figure A-2, water-level elevations at the site ranged from 581.36 feet to 581.07 feet above mean sea level (amsl), a difference of 0.29 feet. Similar to previous years, the distribution of water-level elevations suggests groundwater flow away from the site is northerly (DOE 2014). Given the small measurement range, water elevation contours were not added to the figure.

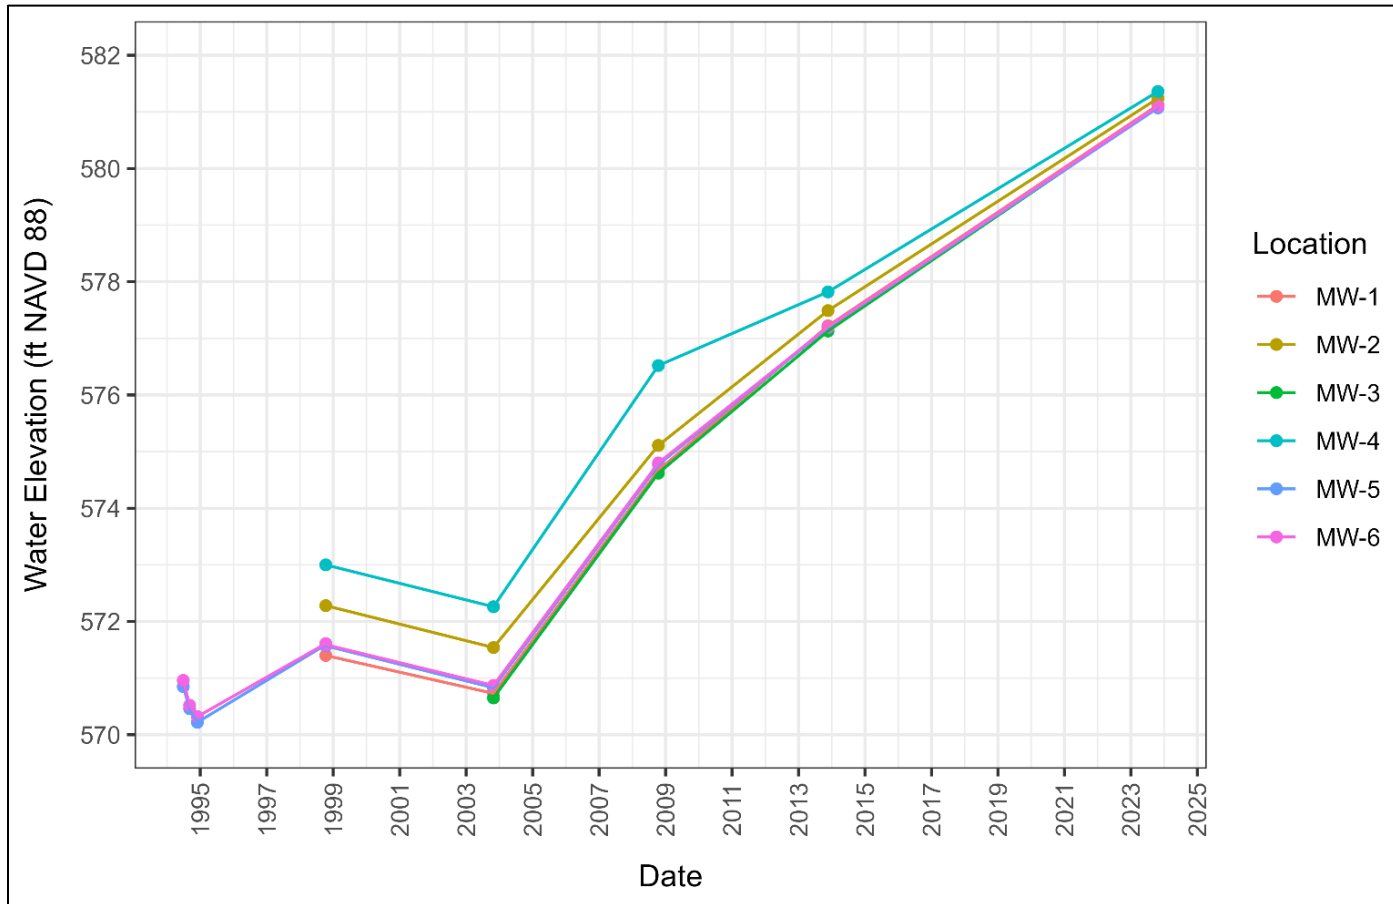
Figure A-3. Water Levels

Figure A-3 is a graph that shows water level measurements from 1994 to 2023. As shown in Figure A-3, the water levels have collectively risen from between 570 to 571 feet amsl in 1994 to slightly above approximately 581 feet amsl in 2023; a rise of approximately 11 feet in 29 years. As discussed below, LM plans to install water level transducers in all six monitoring wells to obtain more frequent water level measurements.
