2025 Annual Site Inspection Report for the Piqua, Ohio, Decommissioned Reactor Site

July 2025

U.S. DEPARTMENT OF
ENERGY

Legacy
Management

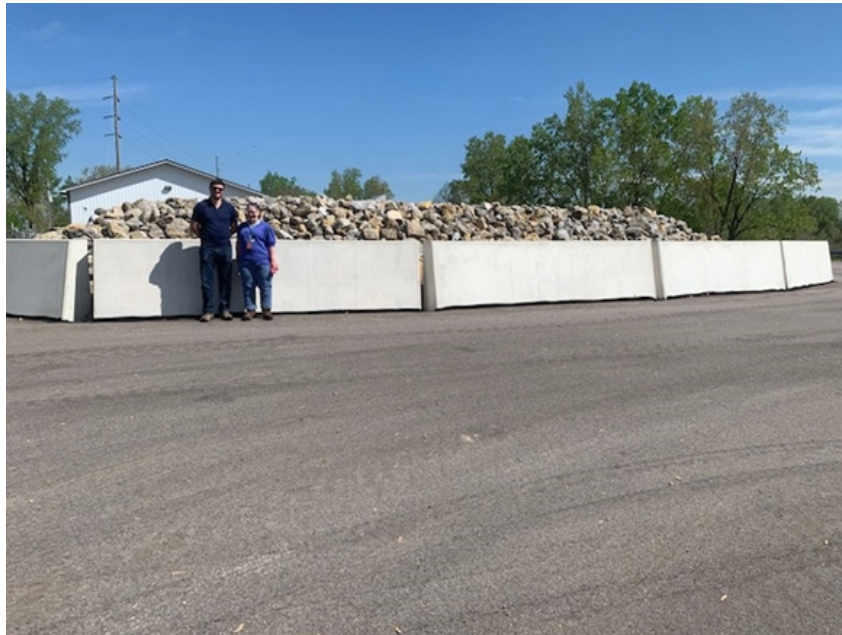
The onsite low-level radioactive waste entombment was found to be in excellent condition. No slumping was observed on the riprap cover (Figure 1). Vegetative sprouts were observed in a handful of areas across the riprap. This early growth appears to be surface in nature and was most likely blown in from the surrounding green space (Figure 2). Vegetation was found to be an aesthetic nuisance only and does not have the ability to negatively impact the protectiveness of the entombment to human health or the environment given the robust concrete and steel structure of the underlying entombment.

Figure 1. Entombment of Low-Level Radioactive Waste

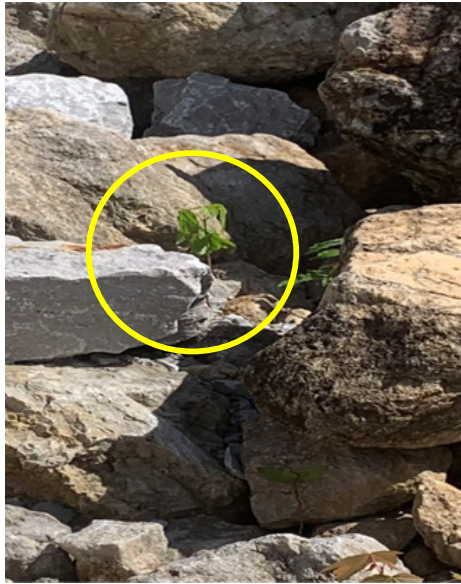
Figure 2. Observed Vegetation Growth Waste Entombment

Real-time photograph logging was utilized during the 2025 site inspection and is expected to continue in future inspections. No maintenance actions resulted from the site inspection. The new vegetation observed on the riprap will be reassessed in the next site inspection, which is currently planned for 2026. DOE may evaluate and implement future vegetation control if warranted.

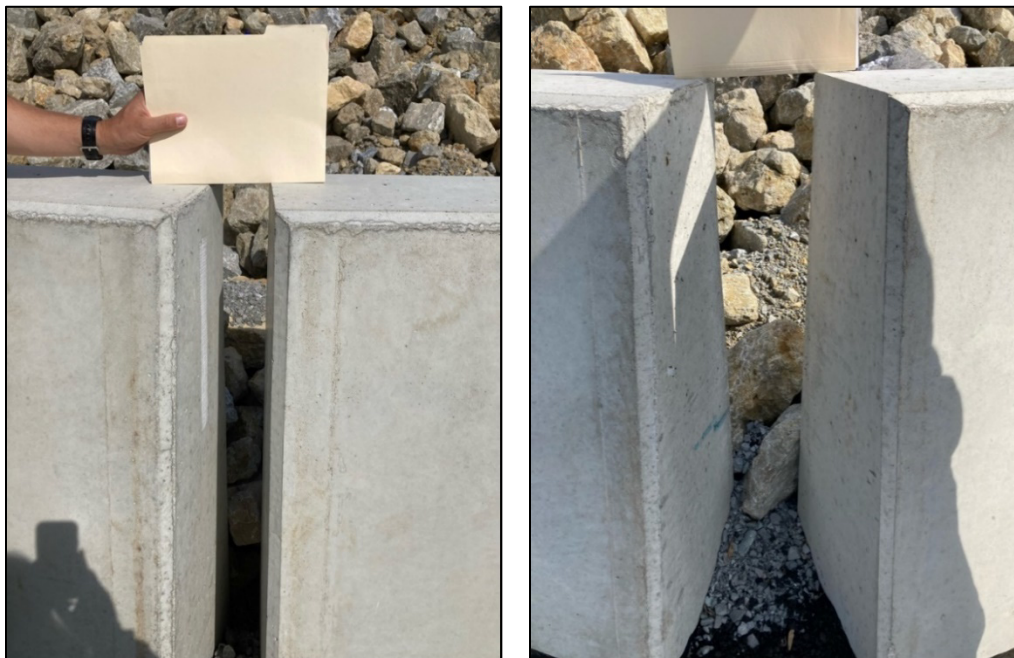
The protective jersey barriers are in place as designed surrounding the entombment. It was observed during the 2024 inspection that there are several instances where the jersey barriers do not contact each other, leaving gaps of up to 6 inches. Although this condition was observed, there is no adverse impact to the functionality or protectiveness of the barriers (Figure 3). The site marker remains in place at the center of the entombment and was found to be in excellent condition (Figure 4). Lastly, there was no evidence of trespassing or vandalism.

Figure 3. Examples of Spacing Between Protective Jersey Barriers Observed in 2024 and 2025

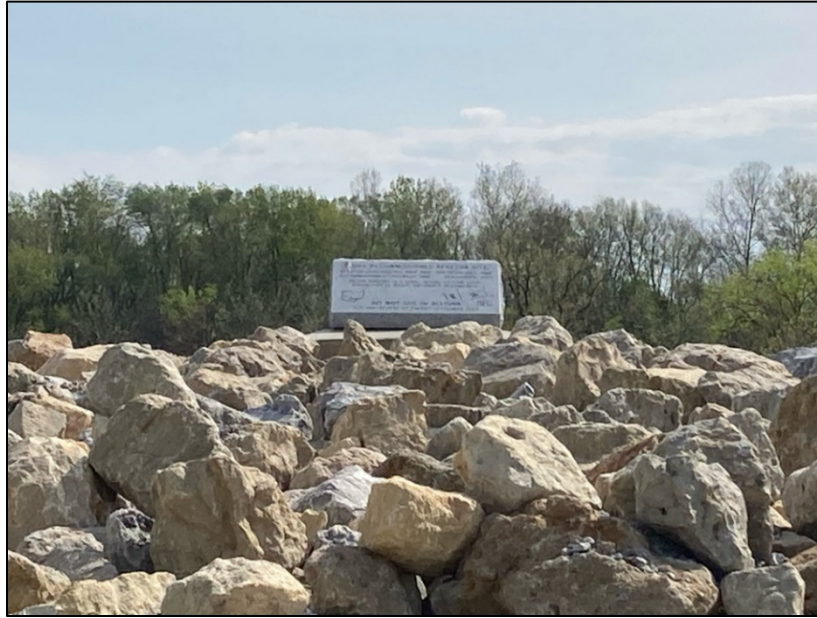
Figure 4. Piqua Site Marker Placed atop the Center of the Entombment

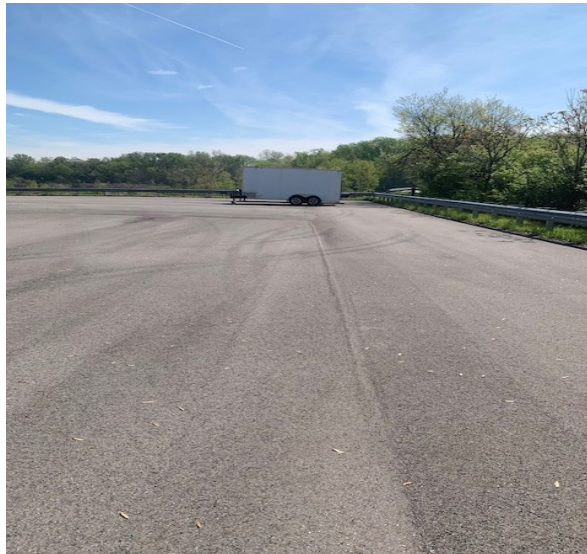
The area surrounding the entombment was visually observed. The four corner markers of the DOE-owned property were visually verified. In addition, the parking lot that was paved in 2023 and the 2-year-old vegetation on the eastern hillside were visually inspected. The parking lot was found to be in excellent condition. No subsidence was observed (Figure 5).

Figure 5. Paved Area Where Administration Building Stood Predemolition

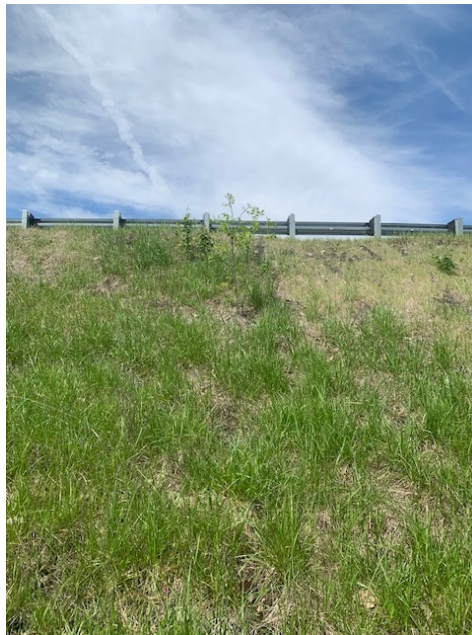
As for the eastern hillside, the vegetation was found to be in good health except for a few bare spots (Figure 6). No slumping or sliding was observed. The stability of the hillside remains sound, and the minor surface erosion observed during the 2024 inspection was unchanged and not impactful (Figure 7). The vegetation is considered fully established and will not be a primary focus area of future inspections unless an observation is made that could potentially impact protectiveness of the entombment. The City of Piqua remains responsible for maintenance of the nonnuclear areas of the site, including the hillside vegetation, in accordance with the lease amendment.

Figure 6. Vegetation on Eastern Hillside

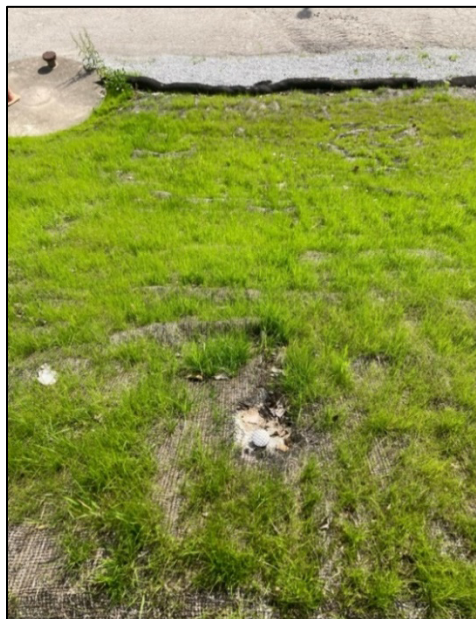
Figure 7. Small Erosion near Base of Hillside Observed During 2024 Site Inspection
