2025 Annual Inspection Report for the Parkersburg, West Virginia, Disposal Site

February 2026

Legacy
Management

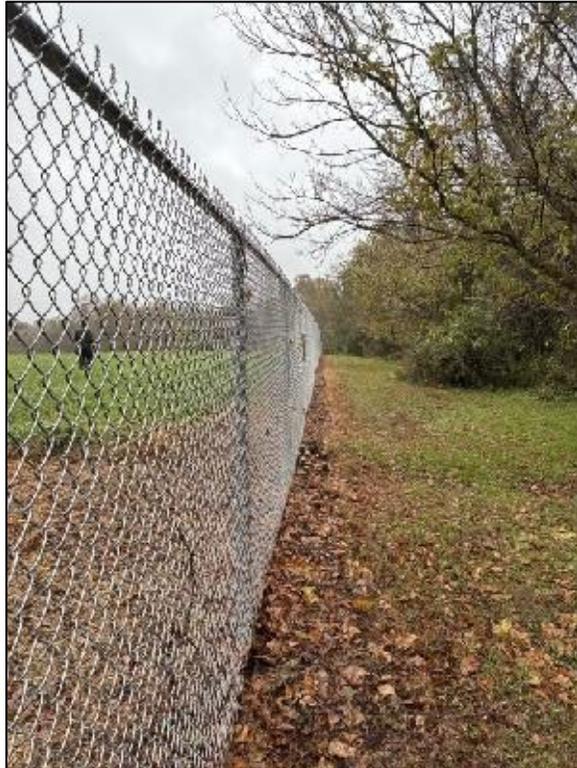
PL-1. Vegetation Free Fence Line

The perimeter fence was replaced in 2007. The site maintenance subcontractor maintains a vegetation-free zone along the base of the fence line and ensures that vegetation does not grow on the fence fabric. The vegetation-free zone along the fence line was being maintained (PL-1), and the fence fabric was free of vegetation.

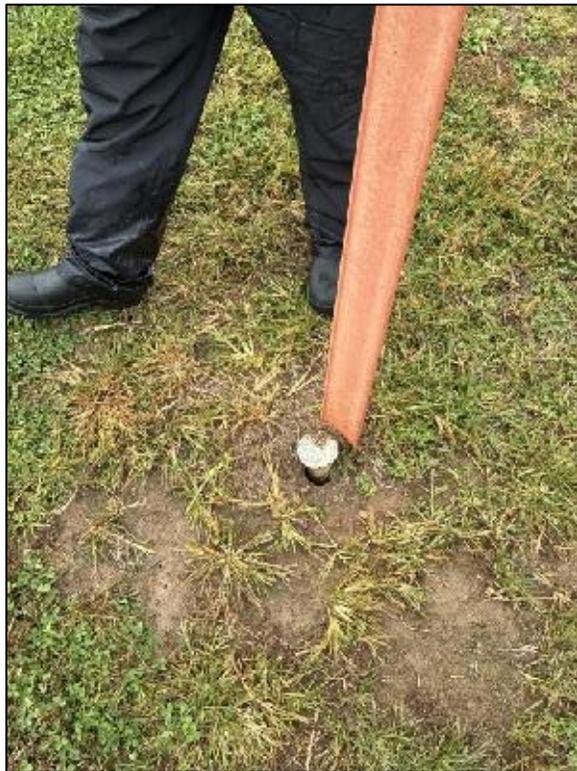
PL-2. Boundary Monument BM-2

The Parkersburg site has six boundary monuments and one concrete survey monument. All six boundary monuments were located during the inspection (PL-2). Due to rain, the concrete marker was not visited. The top of the concrete survey monument has been missing for years, but its replacement is not necessary.

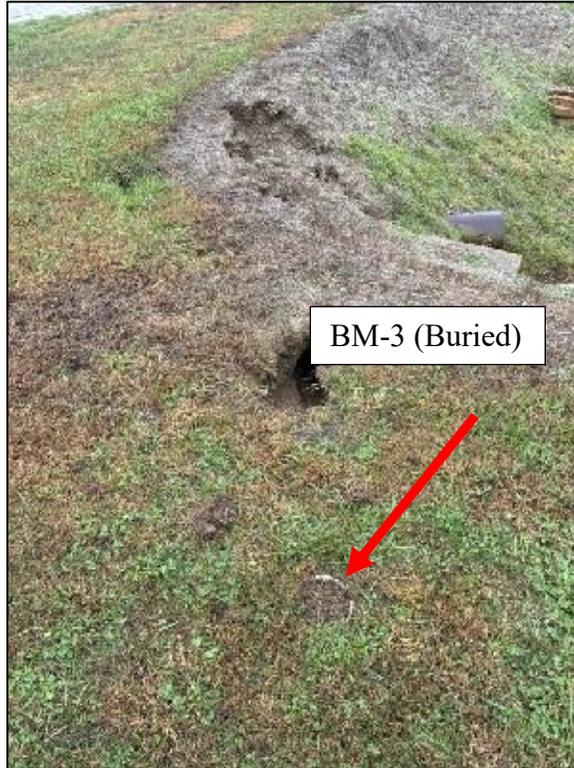
PL-3. Boundary Monument BM-3 (Buried)

Boundary monument BM-3 is about 6 inches beneath the ground surface. A 6-inch section of PVC pipe is installed around the monument and filled with pea gravel to make it flush with the ground surface (PL-3).

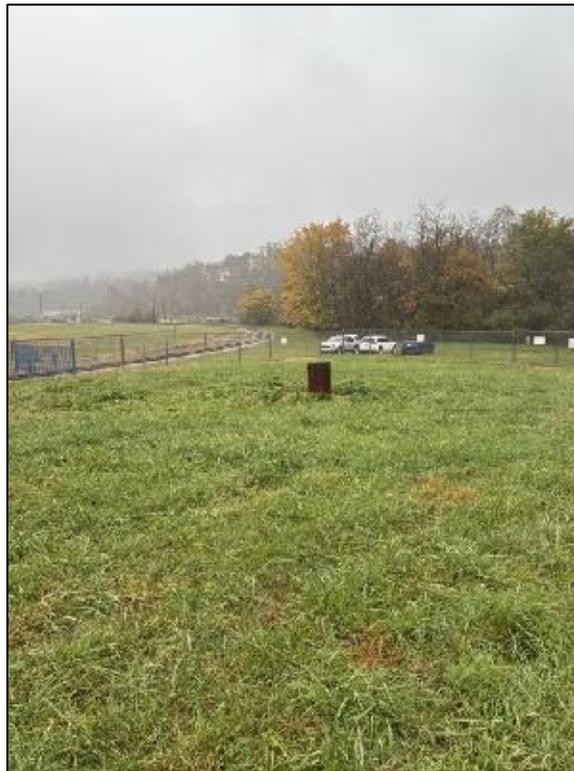
PL-4. Monitoring Well MW-1

There are six groundwater monitoring wells at the Parkersburg site. All six wells are inside the security fence. The wells are numbered in the chronological order in which they were drilled and installed. All six wells were properly locked. The site maintenance subcontractor clears vegetation around the monitoring wells. Vegetation was being properly controlled around the monitoring wells (PL-4).

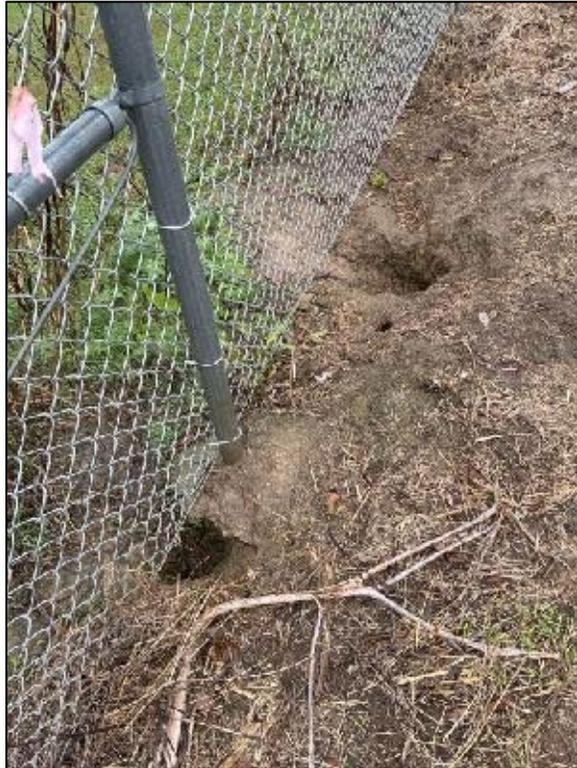
PL-5. Animal Burrows

Animal burrowing continues to be a challenge. In 2025, several groundhogs were trapped and removed from the property, and several animal burrows were collapsed, filled in with clean topsoil, and revegetated. A few of the collapsed burrows showed signs of new activity, but overall, conditions are improving.

Animal burrowing activity at the site continues to be a challenge. In descending order, the cell cap consists of a 30-inch layer of topsoil, a 12-inch layer of impermeable clay, then a 6-inch layer of compacted clay. There is concern that if the burrowing is not controlled, the protective nature of the cell cap might be compromised. In 2021, 2 weeks of trap-and-release were conducted to remove two groundhogs from the site. Existing burrows were collapsed, filled with clean soil, and reseeded. Additional burrows were collapsed, filled with clean soil, and reseeded in 2022 and again in 2023. In 2022, a coyote den was found and collapsed. In 2024, several weeks of capture were conducted, and several additional groundhogs were captured. During 2025, two separate weeks of trapping were conducted, and several groundhogs were trapped. During the site inspection, new additional animal burrows were discovered. Their locations are identified on the site map (Figure A-1). These new burrows will be collapsed, filled with clean soil, and reseeded as deemed appropriate. Routine trapping tasks will continue (PL-5).

LM needs to continue being vigilant about addressing animal burrows on the disposal cell. As burrows are located, they need to be collapsed, filled with clean soil, and reseeded as deemed appropriate. Ongoing routine annual pest management needs to continue.

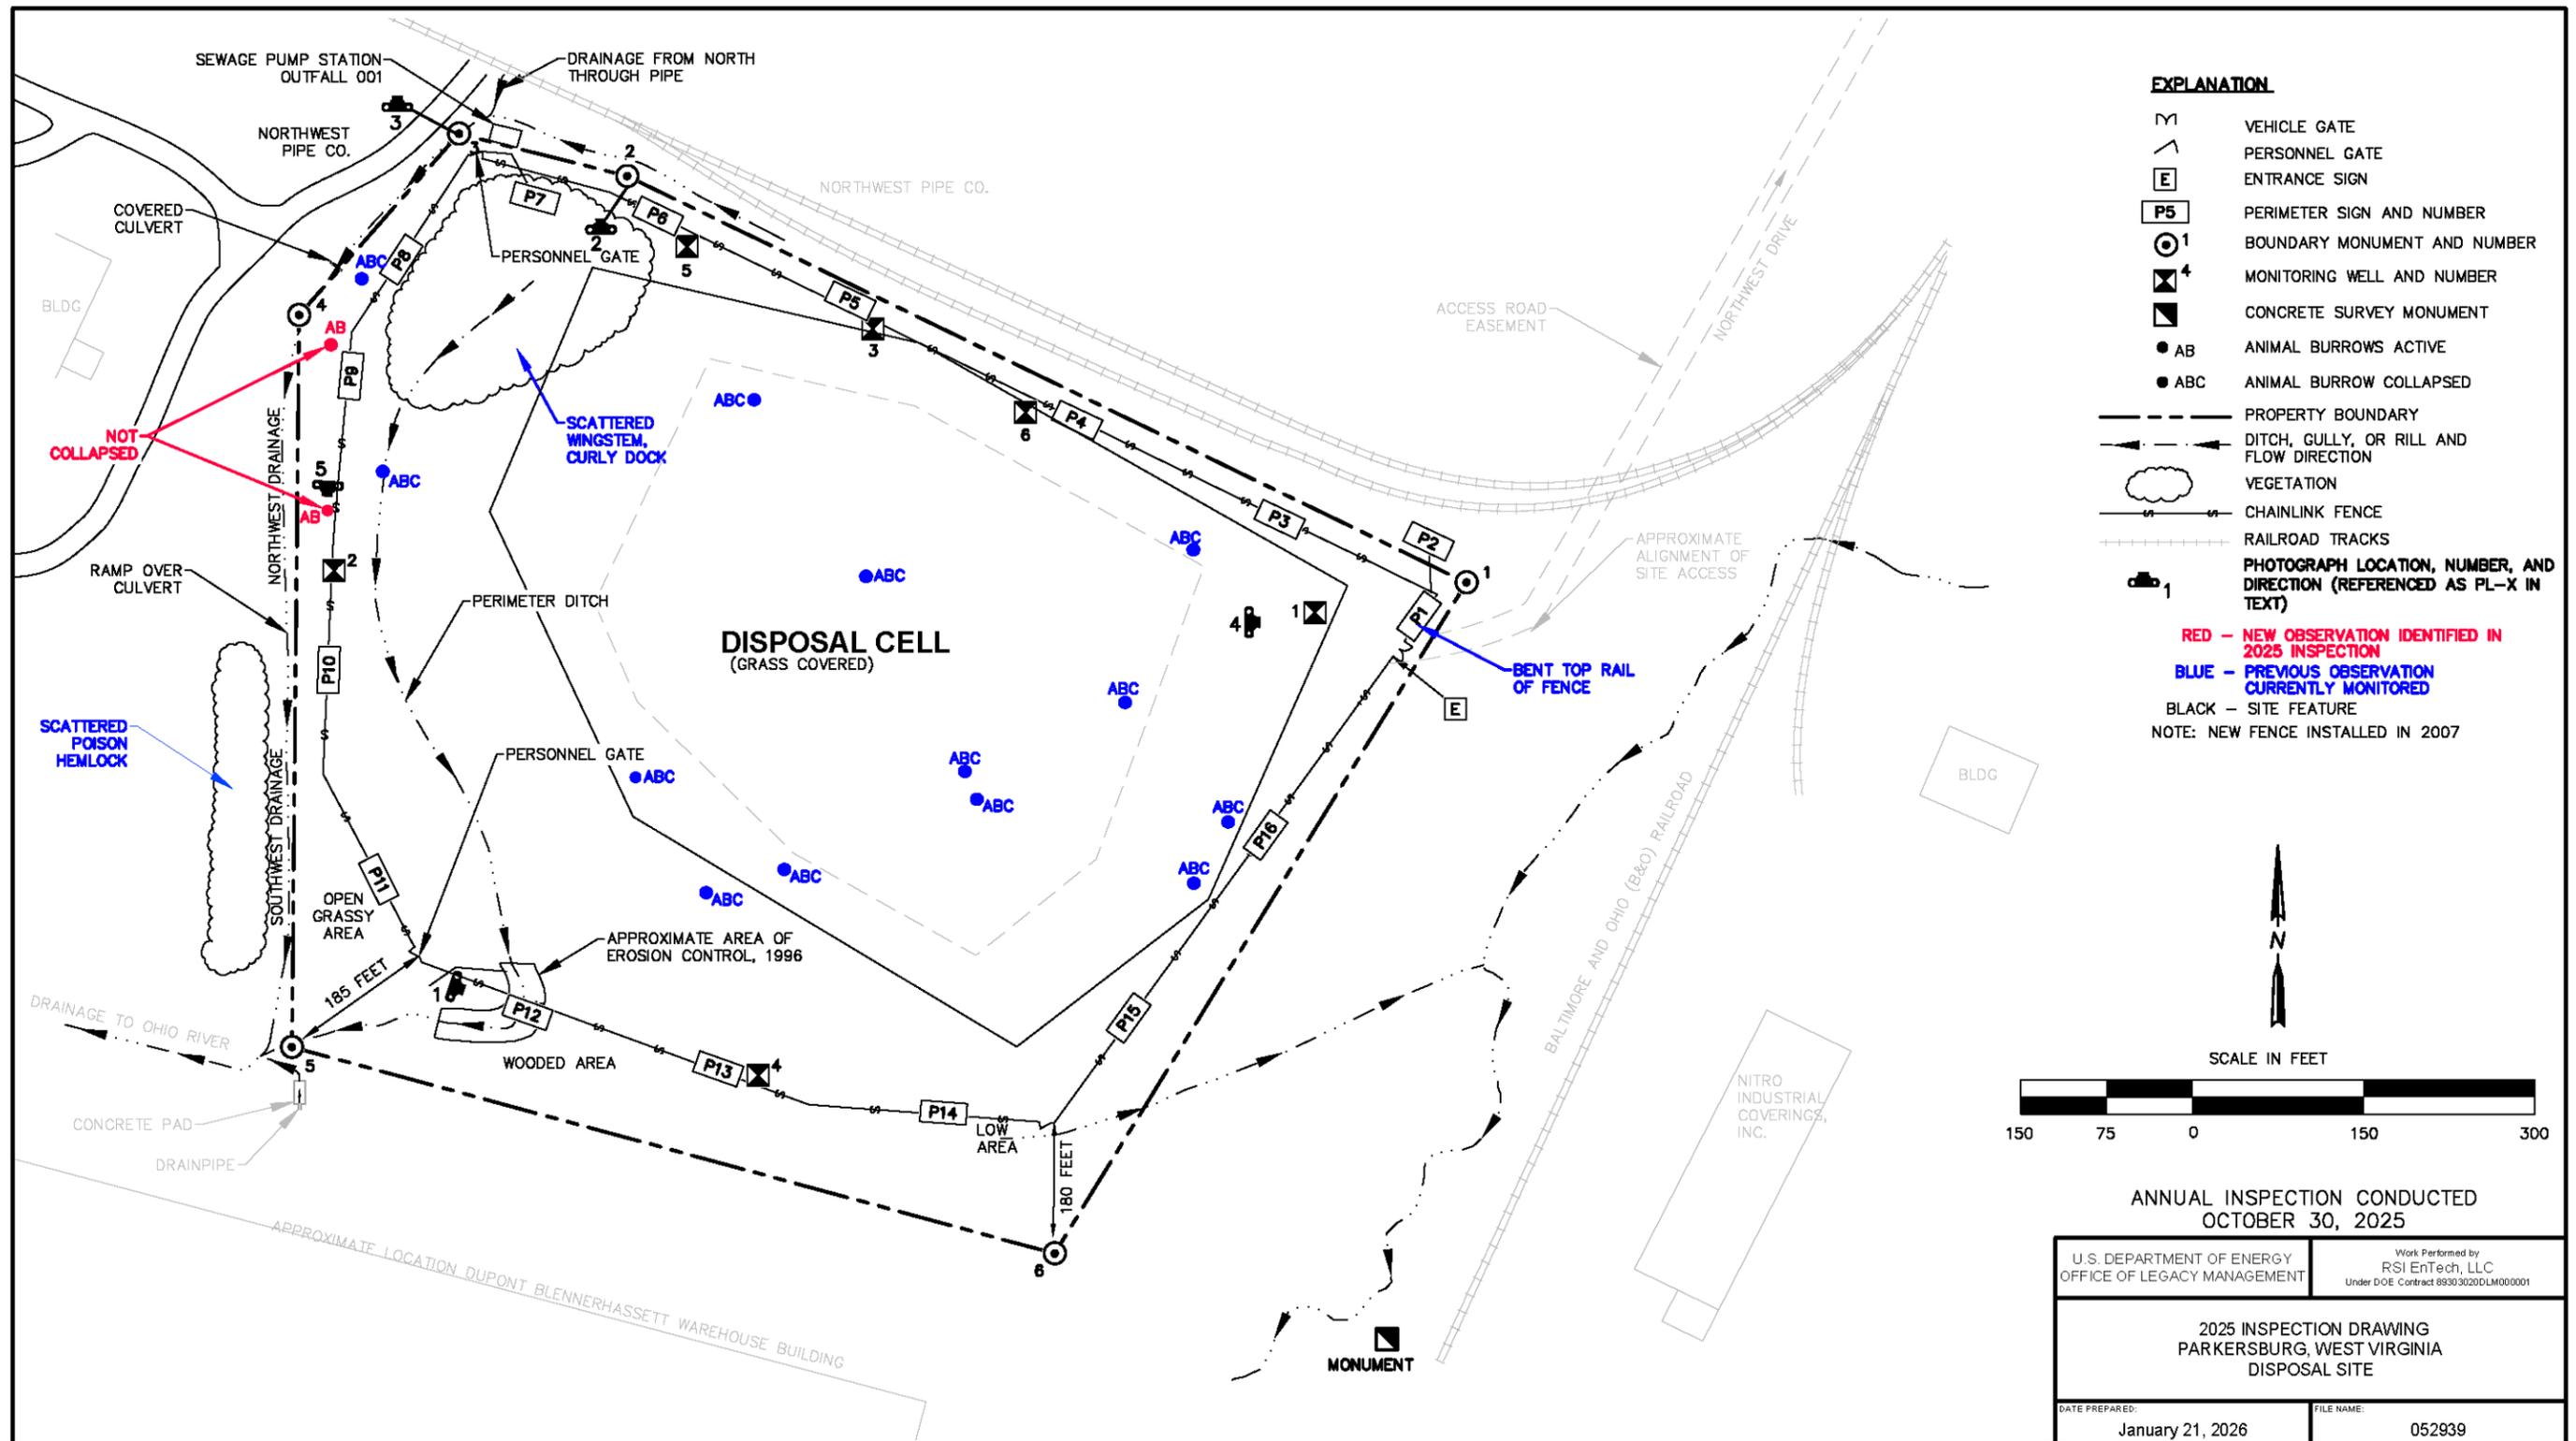
Figure A-1. 2025 Annual Inspection Drawing for the Parkersburg, West Virginia, Disposal Site

The locations of site surveillance features are shown in Figure A-1 (Appendix A). Inspection results and recommended maintenance activities associated with site surveillance features are described in the following subsections. Photographs to support specific observations are identified in the text and in Figure A-1 by photograph location (PL) numbers.

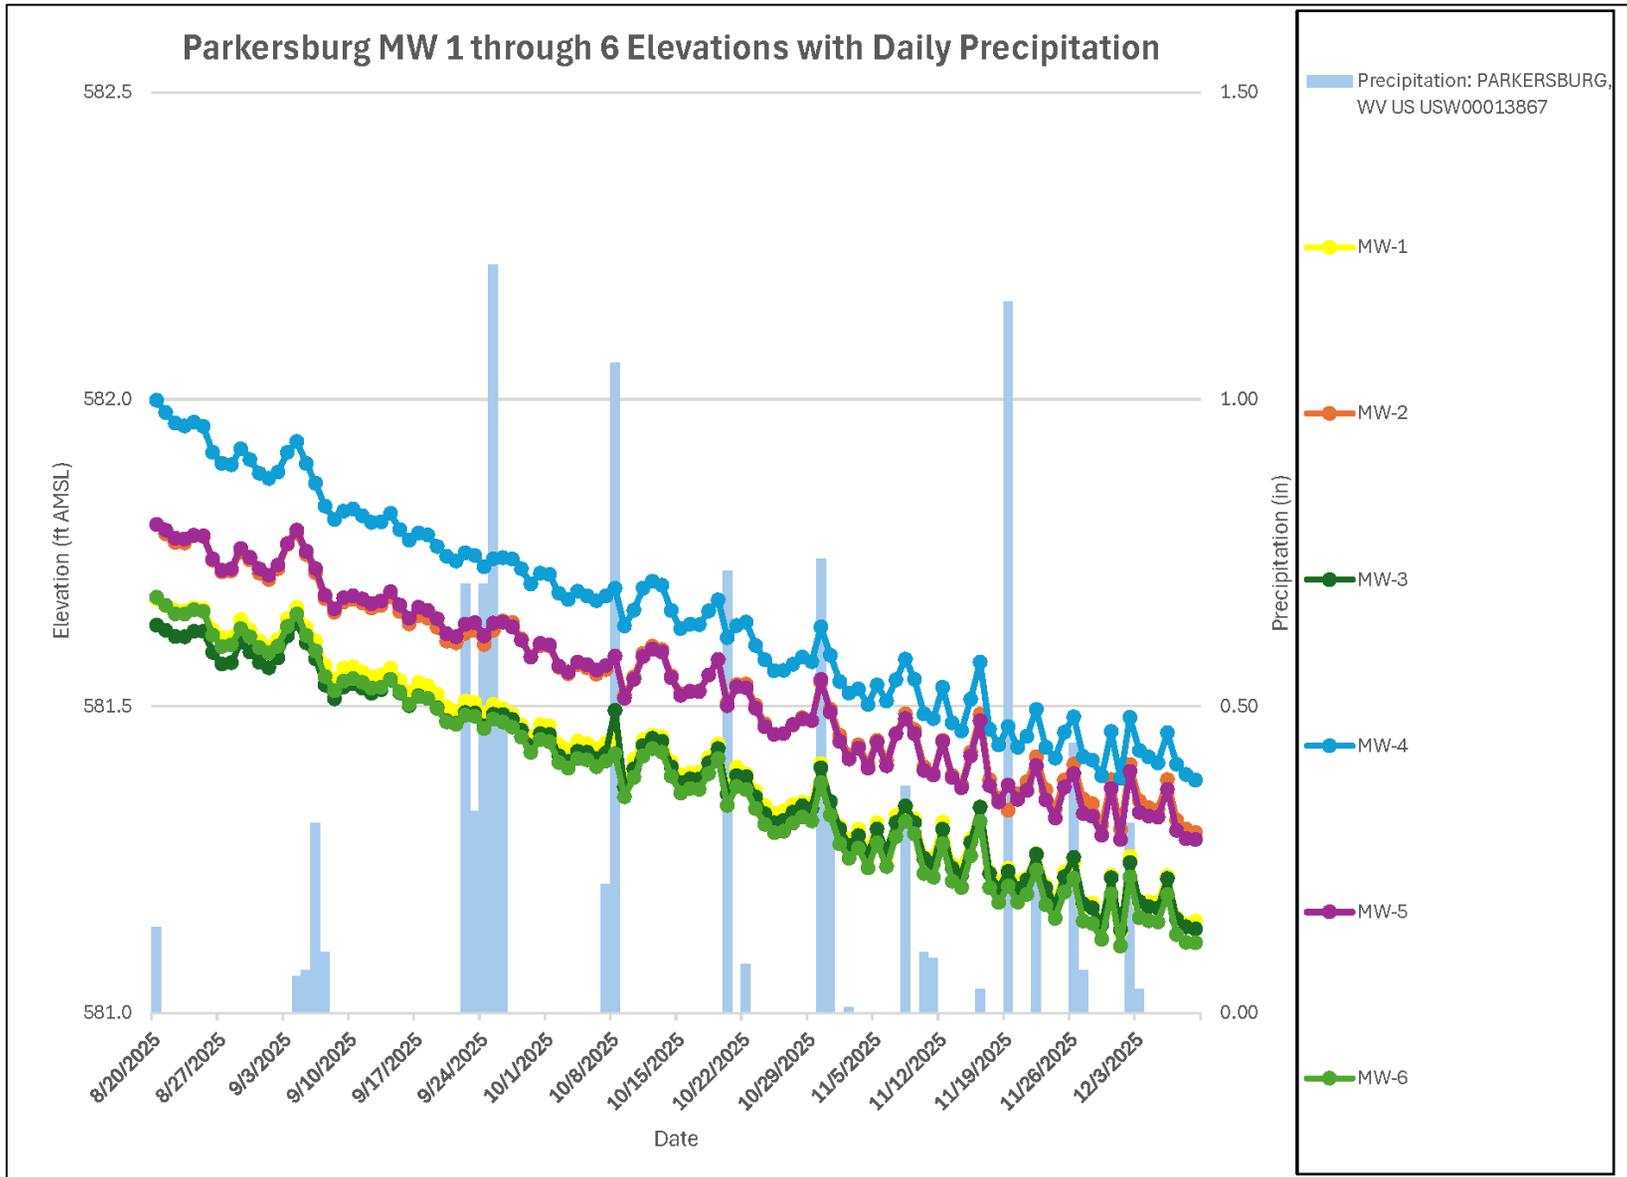
Figure A-2. Groundwater Elevations with Daily Precipitation, Parkersburg, West Virginia, Disposal Site

In August 2025, water level transducers were installed in monitoring wells MW-1 through MW-6 so that daily water level readings could be recorded. The data are used to evaluate both seasonal and long-term water elevation trends. On December 9, 2025, data were downloaded from the transducers.

The range of change in water levels was relatively consistent across the six wells, ranging from a maximum of 0.62 feet in monitoring well MW-4 to 0.50 feet in monitoring wells MW-2 and MW-3. Water levels during this time period were decreasing, and the decreasing pattern was consistent in all of the wells. Elevations show that groundwater flow was in the direction of monitoring well MW-6 for most of the time period. This interpretation is similar to past interpretations.

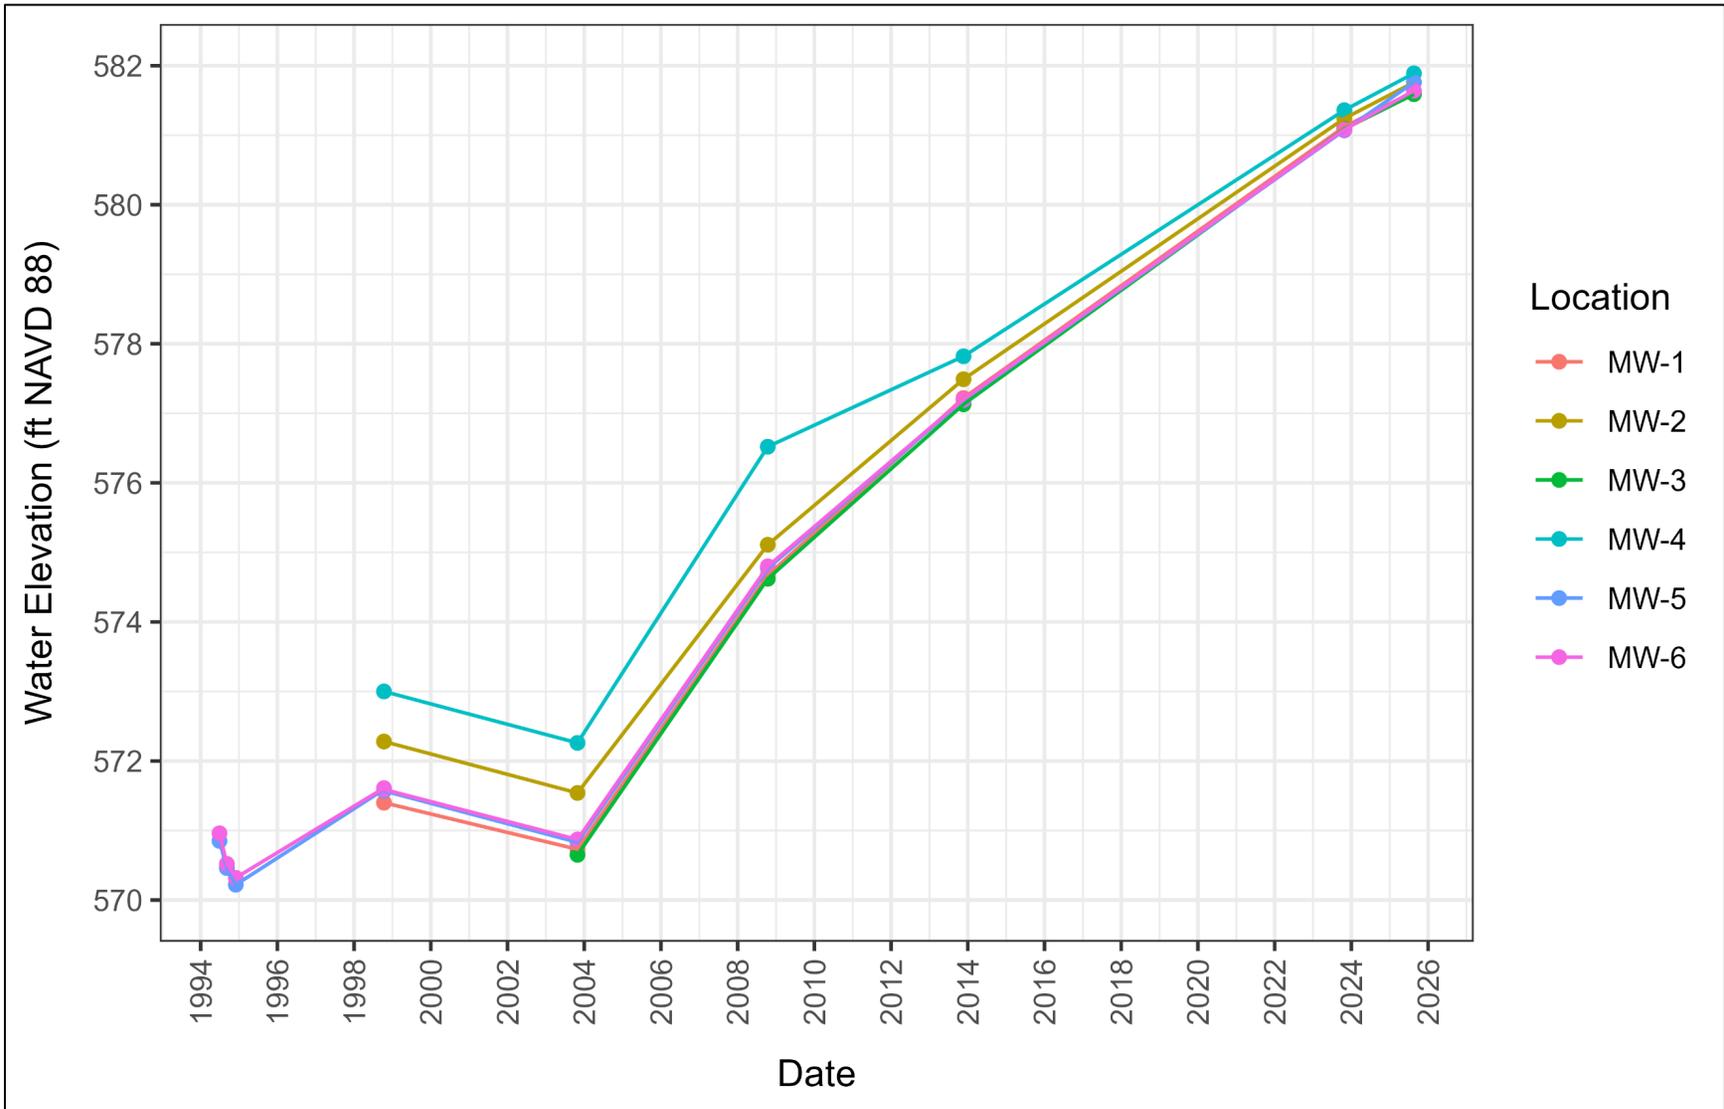
Figure A-3. Groundwater Water Elevations, Parkersburg, West Virginia Disposal Site

Figure A-3 is a graph that shows water-level elevations from 1994 to 2025. As shown in Figure A-3, the water levels have collectively risen from between 570 to 571 feet above mean sea level (amsl) in 1994 to slightly above approximately 581 feet amsl in 2025, a rise of approximately 11 feet in 31 years.
