6.0 Grand Junction, Colorado, Disposal Site

6.1 Compliance Summary

The Grand Junction, Colorado, Uranium Mill Tailings Radiation Control Act (UMTRCA) Title I Disposal Site was inspected on December 7, 2021. No changes were observed on the disposal cell or in the associated drainage features. Inspectors identified minor maintenance needs that will be handled during the next routine maintenance event, but no cause for a follow-up inspection was identified.

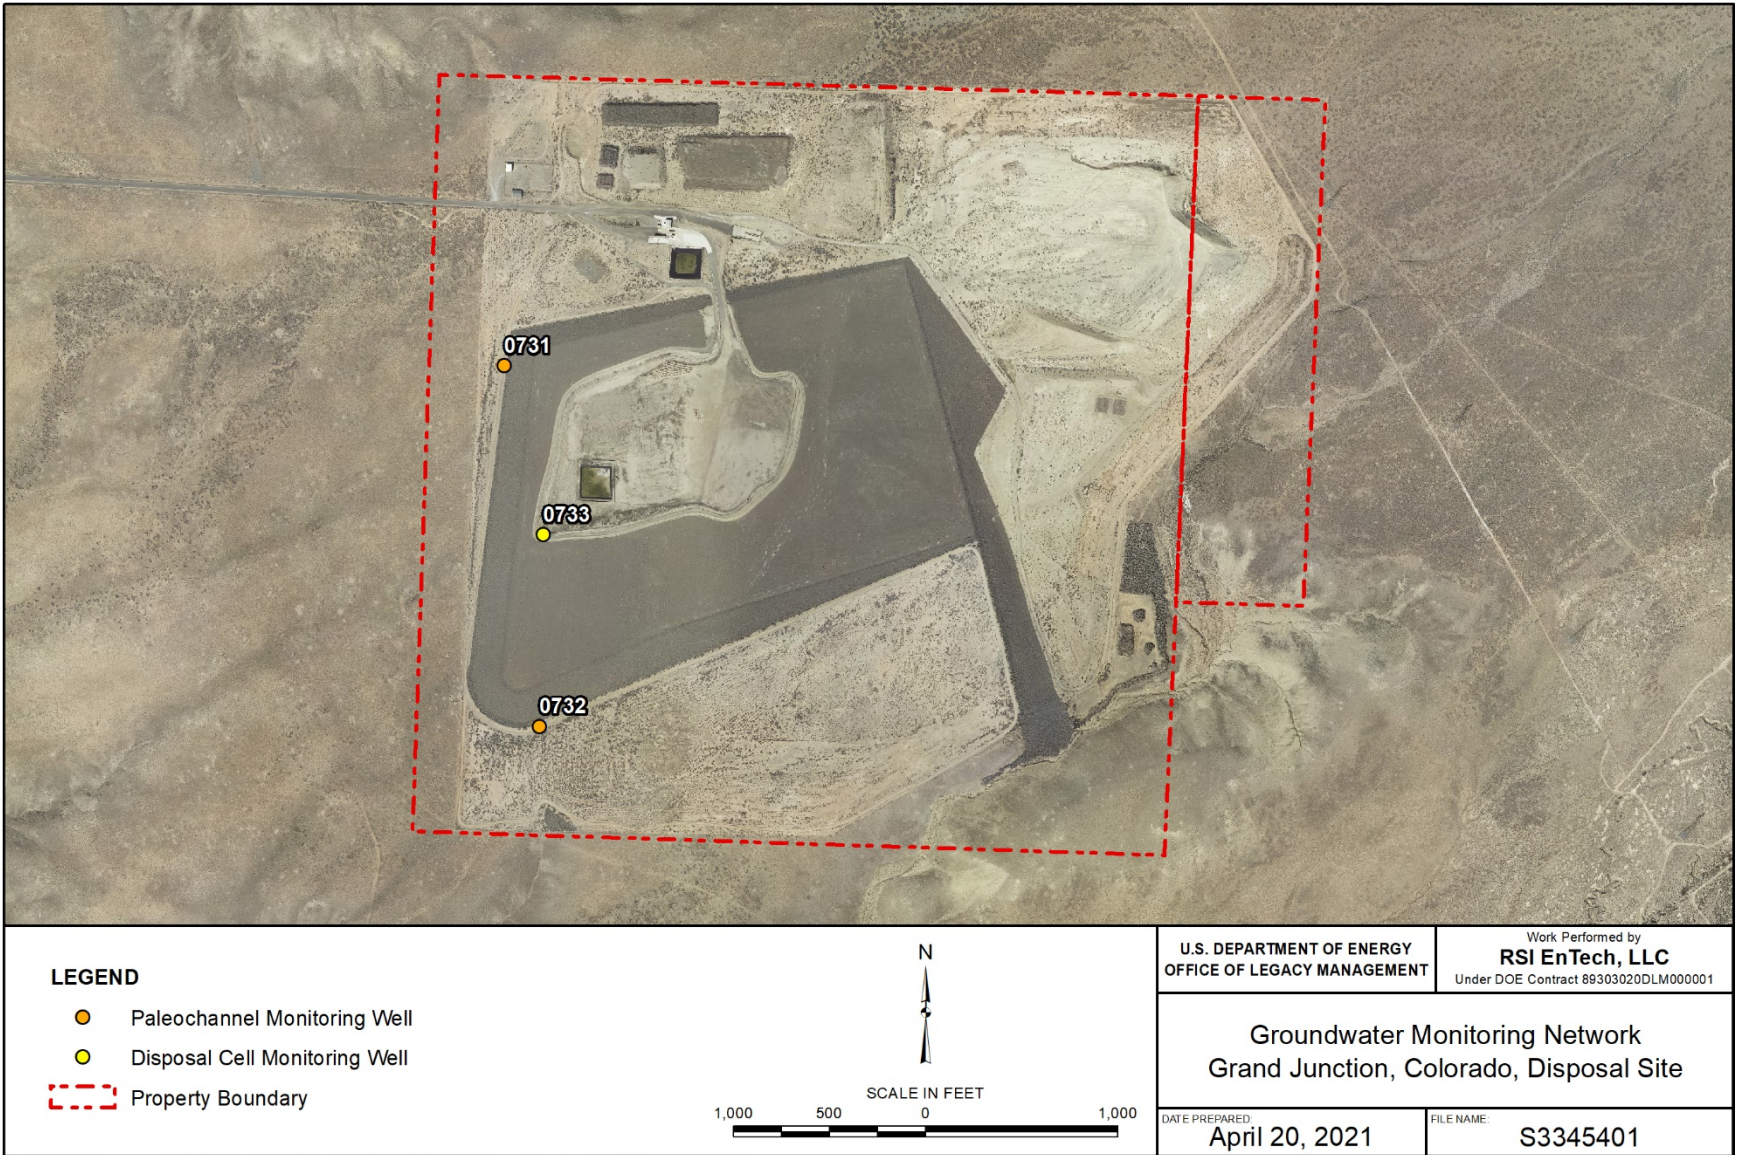
Figure 6-2. Groundwater Monitoring Network for the Grand Junction, Colorado, Disposal Site

Monitoring wells 0731 and 0732 are screened within the alluvial paleochannels adjacent to the disposal cell and extend 5 to 7.5 ft into weathered Mancos Shale. These wells are in two separate paleochannel systems downgradient from the disposal cell (DOE 1998). Monitoring well 0733 is screened below the paleochannel monitoring wells in the lower tailings in the disposal cell (Table 6-2 and Figure 6-2). Disposal cell construction was initiated by excavating Mancos Shale, which resulted in the base of the disposal cell being below the weathered Mancos Shale horizon. Monitoring well 0733 is primarily used to measure water levels within the disposal cell. All groundwater monitoring results for the site are reported and published on the LM Geospatial Environmental Mapping System (GEMS) website (<https://gems.lm.doe.gov/#site=GRJ>).

Monitoring Well	Hydrologic Relationship
0731	Paleochannel, downgradient, edge of disposal cell, north side
0732	Paleochannel, downgradient, edge of disposal cell, south side
0733	Disposal cell, deepest location, downgradient, center

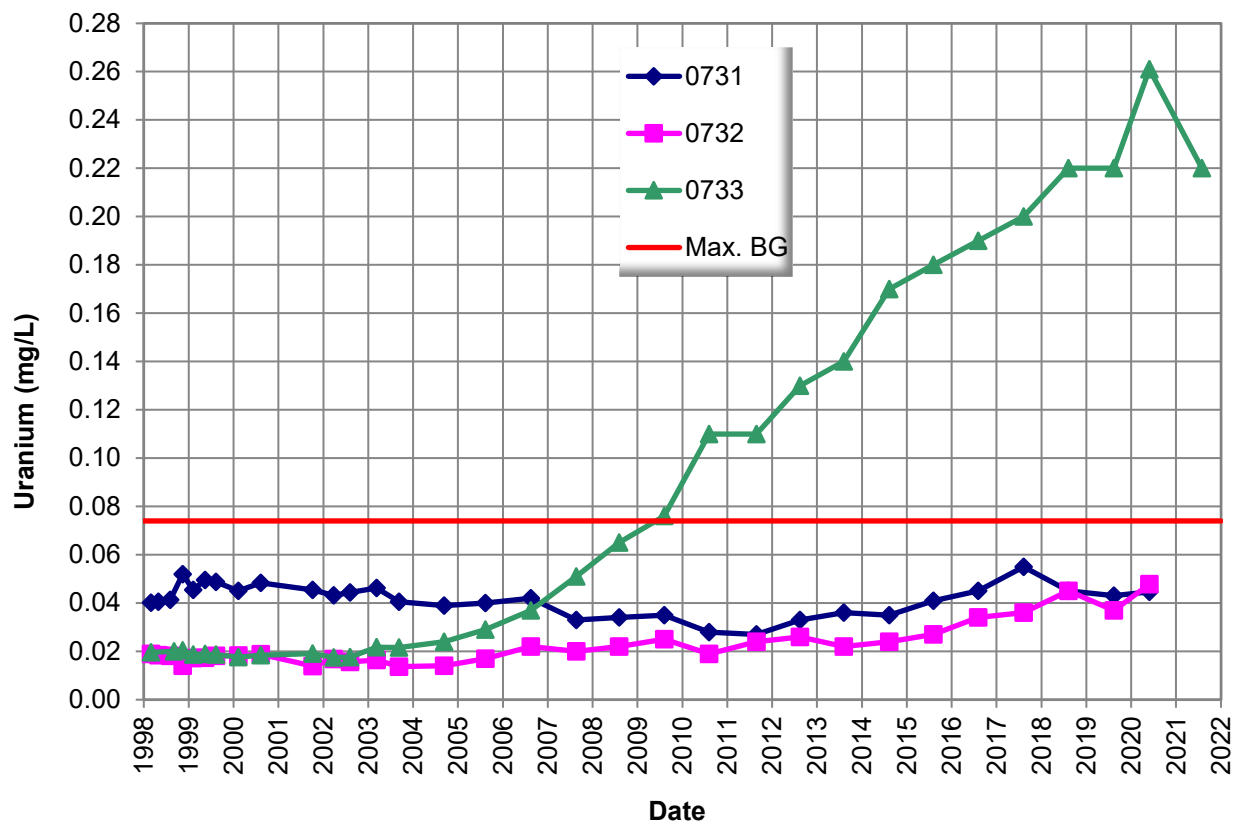
Figure 6-6. Uranium in Groundwater at the Grand Junction, Colorado, Disposal Site

Uranium concentrations in wells 0731 and 0732 have shown an apparent, gradually increasing trend since 2011 (Figure 6-6). Uranium concentrations in disposal cell monitoring well 0733 have increased from 0.02 mg/L in 2002 to 0.22 mg/L in 2021. Relatively high concentrations of uranium and other constituents are expected for a well screened in the disposal cell tailings. Constituents of concern and water levels in well 0733 are not subject to compliance goals and are monitored solely for information gathering purposes.

Note: Well 0733 is screened in the disposal cell tailings. “Max. BG” stands for maximum background concentration. Results include validated data only; results below the detection limit are presented at the laboratory reported value.

Wells 0731 and 0732 will not be sampled again until 2022 to ensure that any disturbances after root removal have passed. In 2022, the slightly increasing trends in uranium (albeit below maximum background concentrations) will be reevaluated. To assist in the determination of a Mancos Shale influence on nitrate and selenium in these two wells, duplicate samples will be collected 2 ft below the top of the water table in addition to the current sampling depth. Sampling just below the top of the water table will ensure that samples are from the alluvial groundwater only, resulting in less potential interference from reactions occurring within the top of the Mancos Shale that might release nitrate and selenium.

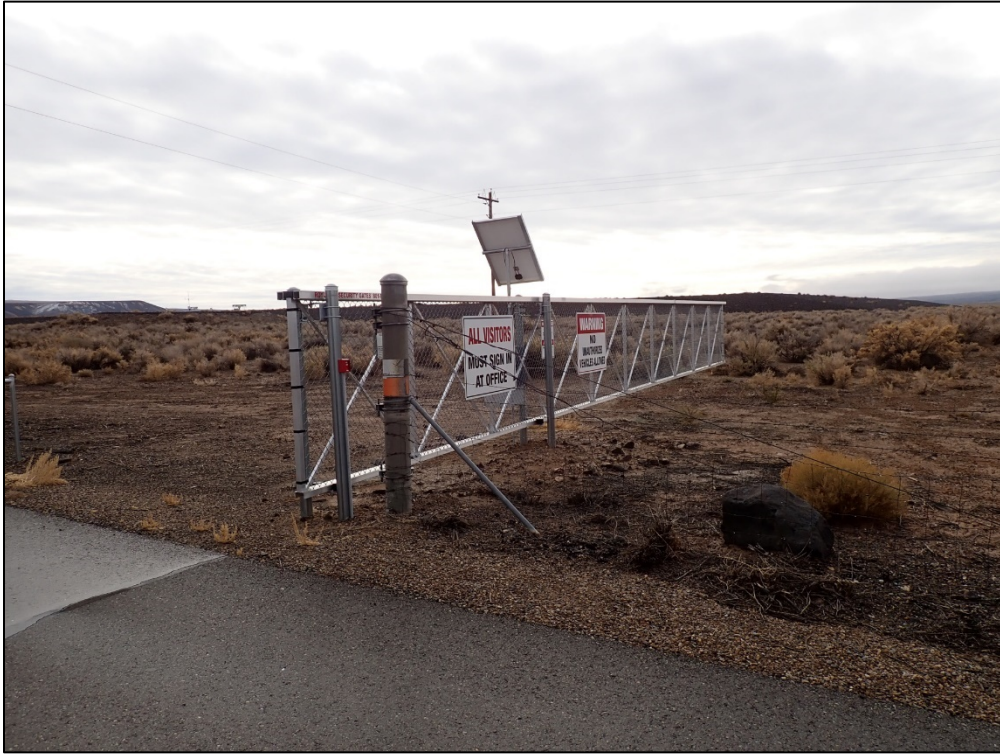
PL-1. Solar-Powered Site Entrance Gate

The site entrance gate was locked and functional, and site entrance signs on and next to the entrance gate were in good condition (PL-1). No maintenance needs were identified.

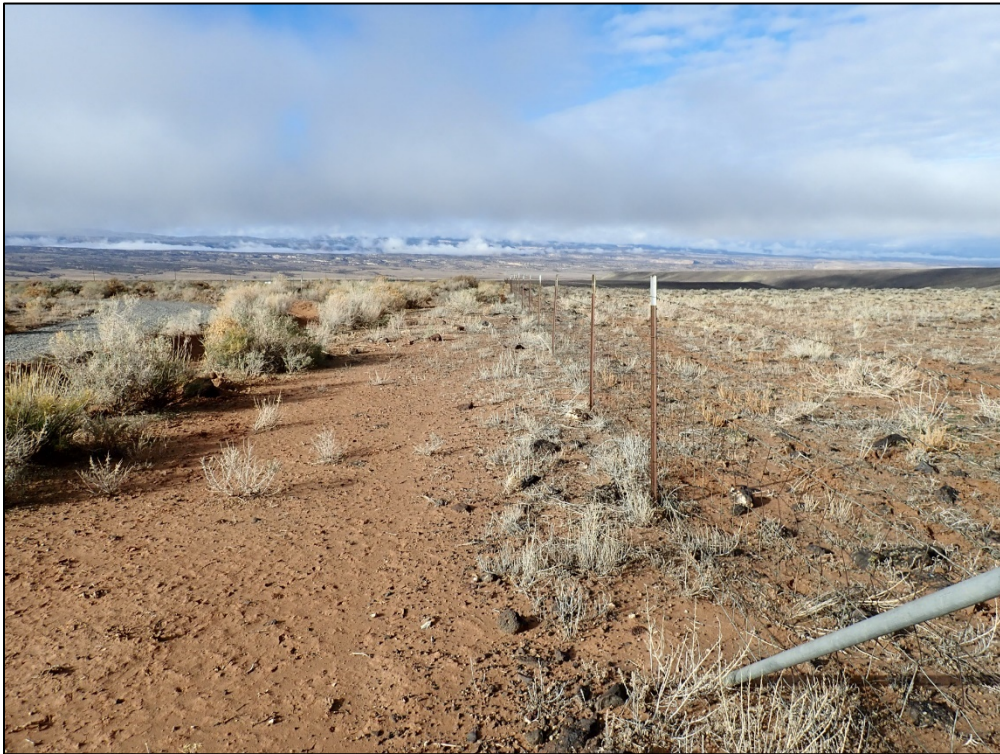
PL-2. North Perimeter Fence

A perimeter fence encloses the disposal cell features and operations areas (PL-2). It consists of a standard four-strand, barbed-wire fence in some areas and a woven wire fence topped with barbed wire in others. The perimeter fence does not match the property boundary in several areas. There are 29 perimeter signs attached to steel posts set in concrete positioned at regular intervals along the property boundary (PL-3). Several perimeter signs along the south property boundary are faded or peeling but remain legible. Perimeter signs P15 and P16 have bullet damage but remain legible. Perimeter sign P20, previously reported with bullet damage, was replaced. In addition to the perimeter signs, the perimeter fence also has warning signs (“No Trespassing” and “Controlled Area” signs). Several warning signs on the southeast perimeter fences reported in 2020 as damaged or detached will be repaired or replaced before the next inspection (PL-4). No other maintenance needs were identified.

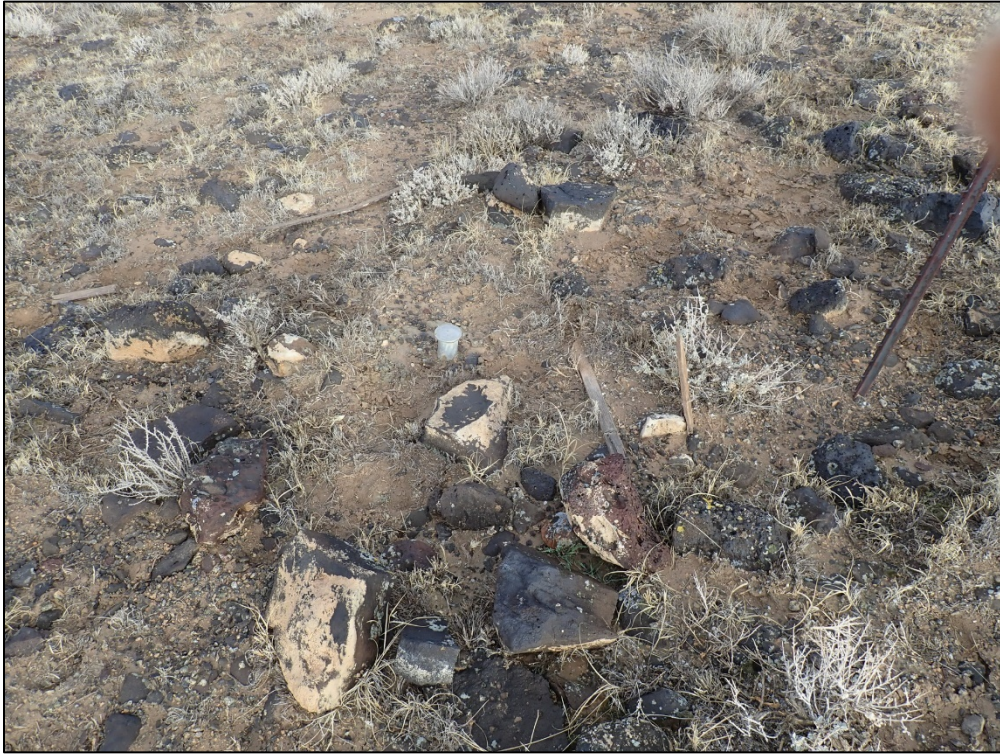
PL-5. Boundary Monument BM-1

Four boundary monuments delineate the corners of the property boundary (PL-5). All were present and in good condition during the inspection. No maintenance needs were identified.

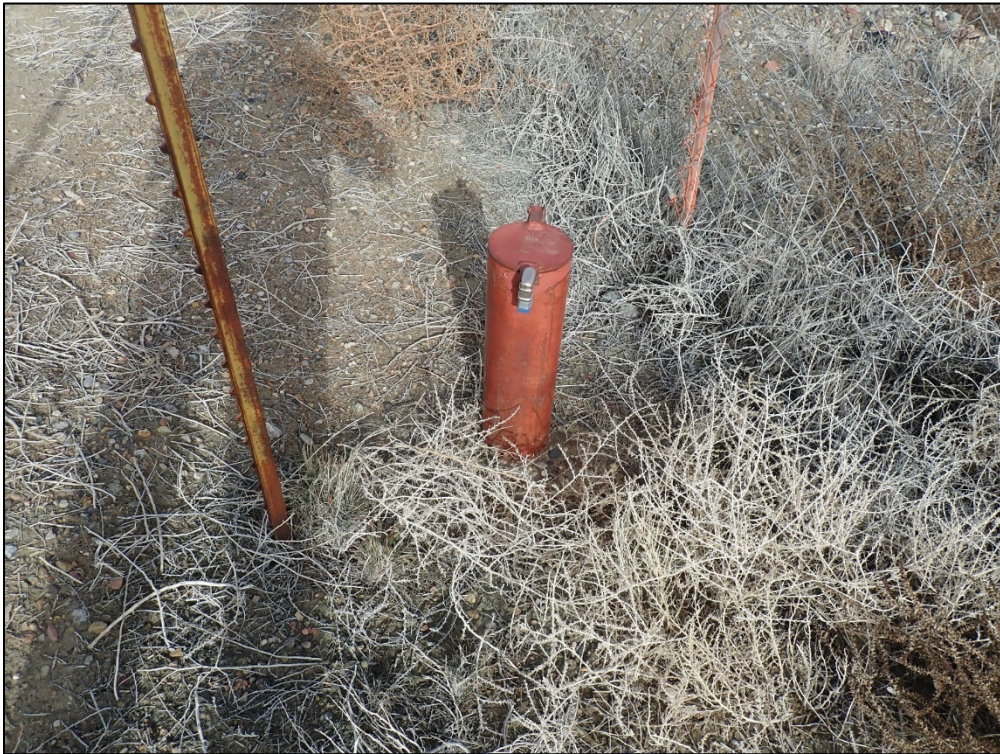
PL-6. Monitoring Well 0733

The groundwater monitoring network consists of three monitoring wells (0731, 0732, and 0733) (PL-6). Vegetation treatment was completed in a large radius around each wellhead. All wellhead protectors were locked and undamaged. Roots were found in monitoring wells 0731 and 0732; they will be removed and the wells redeveloped before the next inspection. No other maintenance needs were identified.

- Replacement or repair of warning signs on the southeast perimeter fences
- Maintenance to the site stormwater collection ditches
- Repairs to the two eroded areas on the site perimeter road adjacent to the east side of the disposal cell
- Root removal and well redevelopment for monitoring wells 0731 and 0732

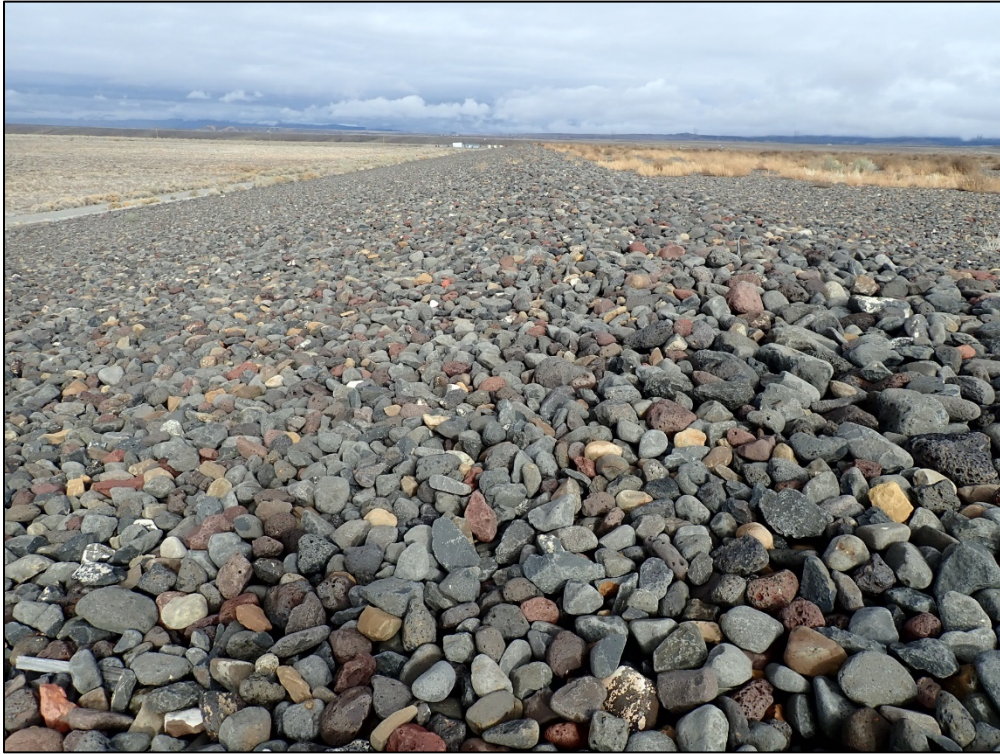
PL-7. West Side Slope Disposal Cell

The closed portion of the disposal cell is armored with basalt riprap to control erosion (PL-7). The rock showed no significant weathering. There was no evidence of erosion, settling, slumping, rock degradation, or other modifying processes that might affect the integrity of the disposal cell.

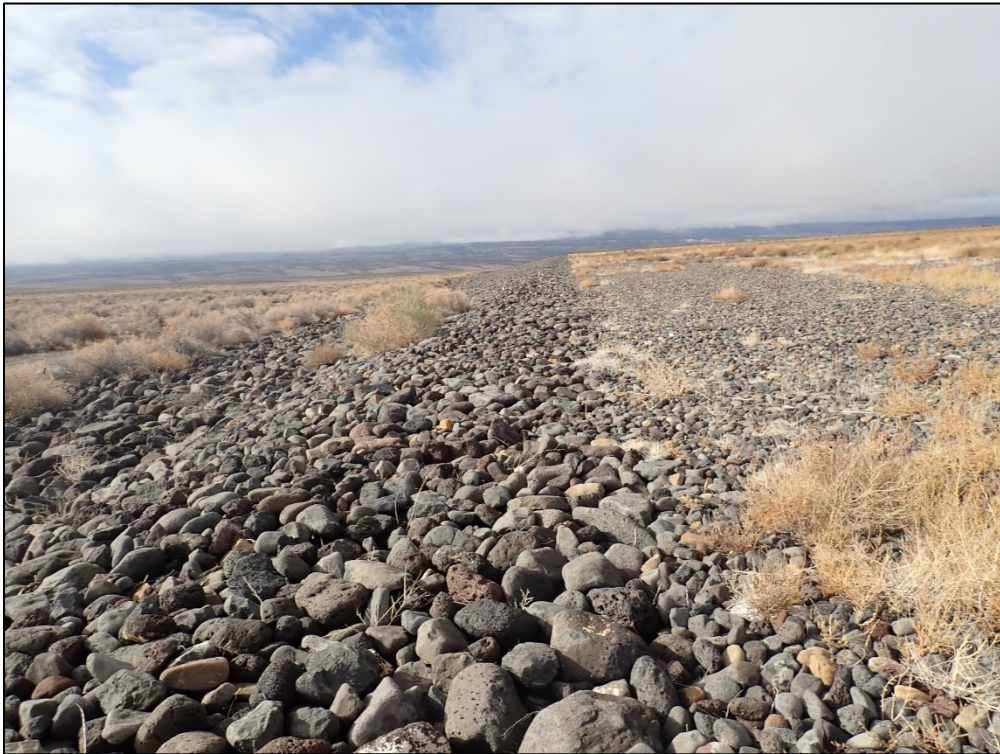
PL-8. Disposal Cell Top and Side Slope

Grasses and weeds were growing on most of the disposal cell cover (PL-8). Historically, deep-rooted shrubs on top of the disposal cell have been treated with herbicide. Although treatment is not required by the Interim LTSP, LM plans to continue controlling the deep-rooted shrubs as needed. No maintenance needs were identified.

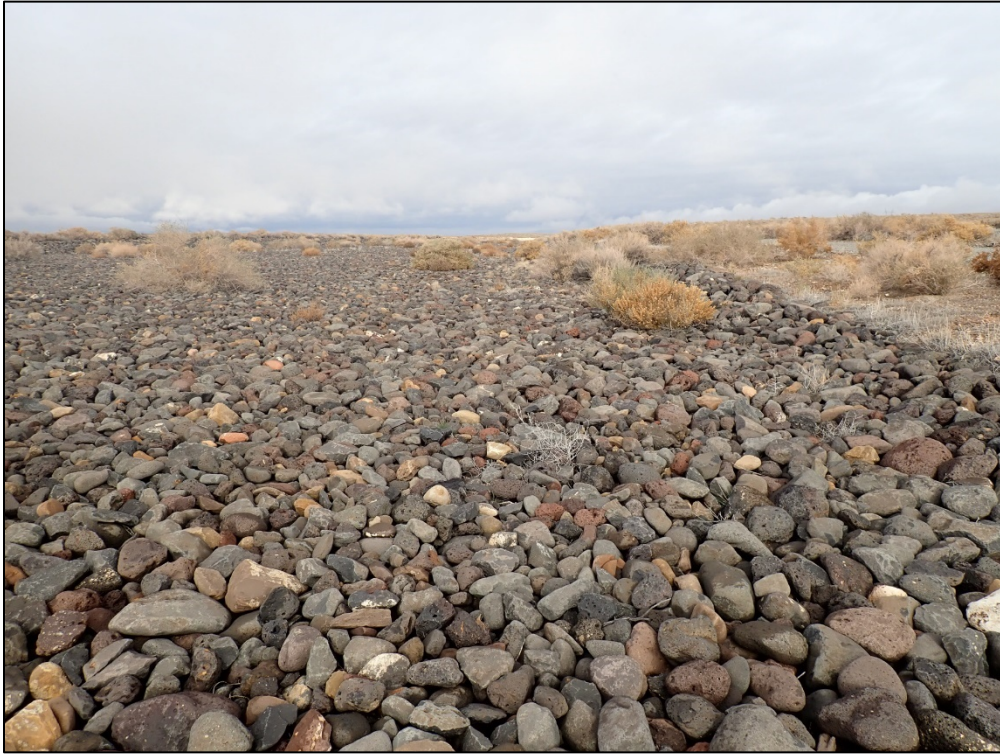
PL-9. South Diversion Channel

The south diversion channel is a large, riprap-armored structure that intercepts run-on water from offsite and onsite, as well as stormwater runoff from the disposal cell, and conveys the water into a natural drainage that flows away from the site to the southwest (PL-9). Grasses, weeds, and shrubs growing within the diversion channel is not expected to affect the channel's performance. The discharge area of the channel is armored with large-diameter basalt riprap.

Other drainage features at the site include north and south stormwater collection ditches, the north stormwater retention pond, and the east stormwater and sediment collection pond. These small drainage features control stormwater runoff primarily from the various stockpiles of disposal cell cover materials. The stormwater collection ditches also capture stormwater run-on from offsite locations. Maintenance (cleaning out) of several parts of the site stormwater collection ditches is ongoing and is expected to continue into 2022. The diversion channel, ditches, and ponds were functioning as designed. No other maintenance needs were identified.
