6.0 Grand Junction, Colorado, Disposal Site

6.1 Compliance Summary

The Grand Junction, Colorado, Uranium Mill Tailings Radiation Control Act (UMTRCA) Title I Disposal Site was inspected on November 12 and December 17, 2024. No major changes were observed on the disposal cell or in the associated drainage features. Inspectors identified minor maintenance needs that will be addressed before the next inspection, but no cause for a follow-up inspection was identified.

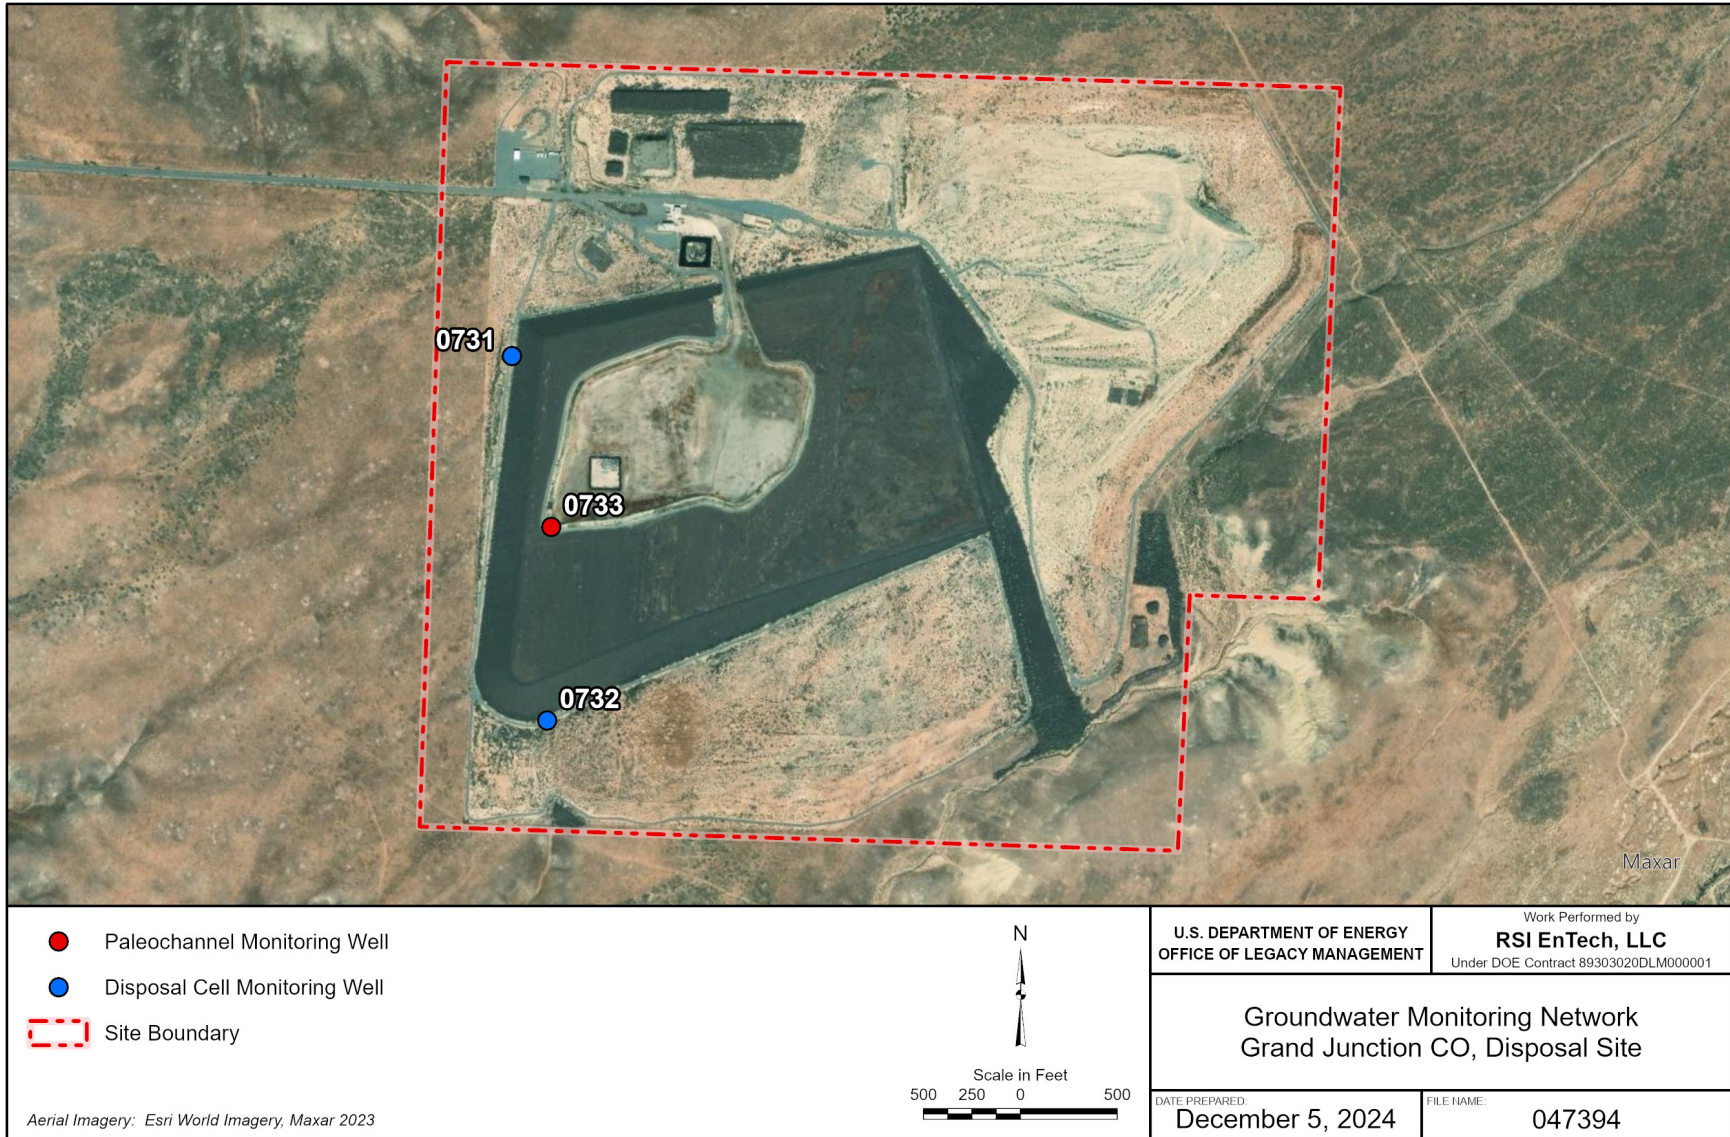
Figure 6-2. Groundwater Monitoring Network for the Grand Junction, Colorado, Disposal Site

The groundwater monitoring network consists of three monitoring wells: 0731, 0732 (PL-5), and 0733 (Figure 6-2). All wellhead protectors were locked and undamaged.

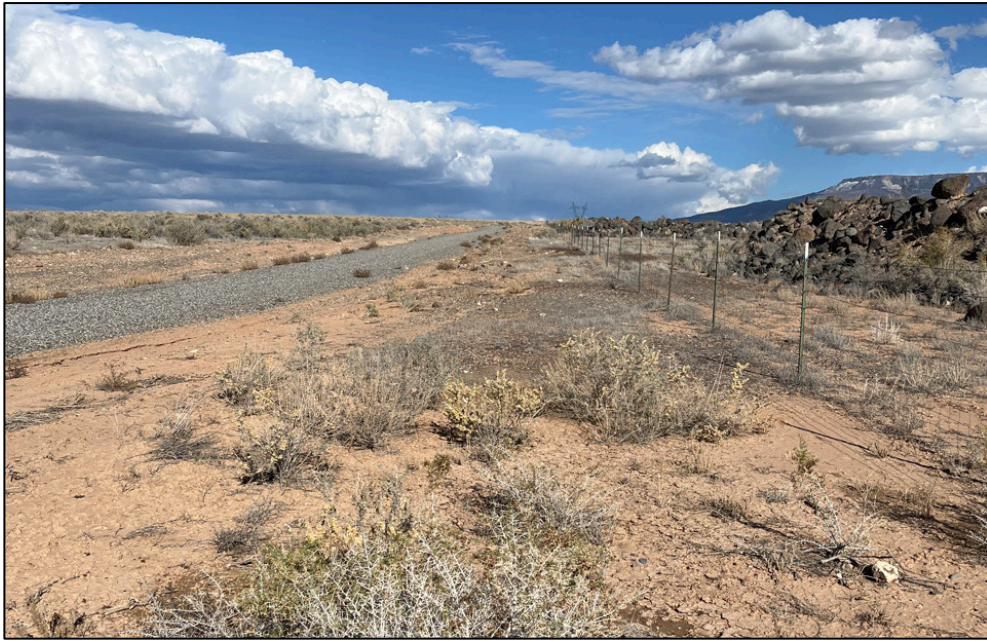
PL-1. Perimeter Fence

A perimeter fence encloses the disposal cell features and operations areas (PL-1). It consists of a standard four-strand barbed-wire fence in some areas and a woven wire fence topped with barbed wire in others. The perimeter fence does not match the property boundary in several areas. The perimeter fence includes warning signs (“No-Trespassing” and “Controlled Area” signs) positioned at regular intervals. Many of the no-trespassing signs around the perimeter are faded but remain legible (PL-2). A section of fence spanning a gully near perimeter sign P7 is bent but stable. No other maintenance needs were identified.

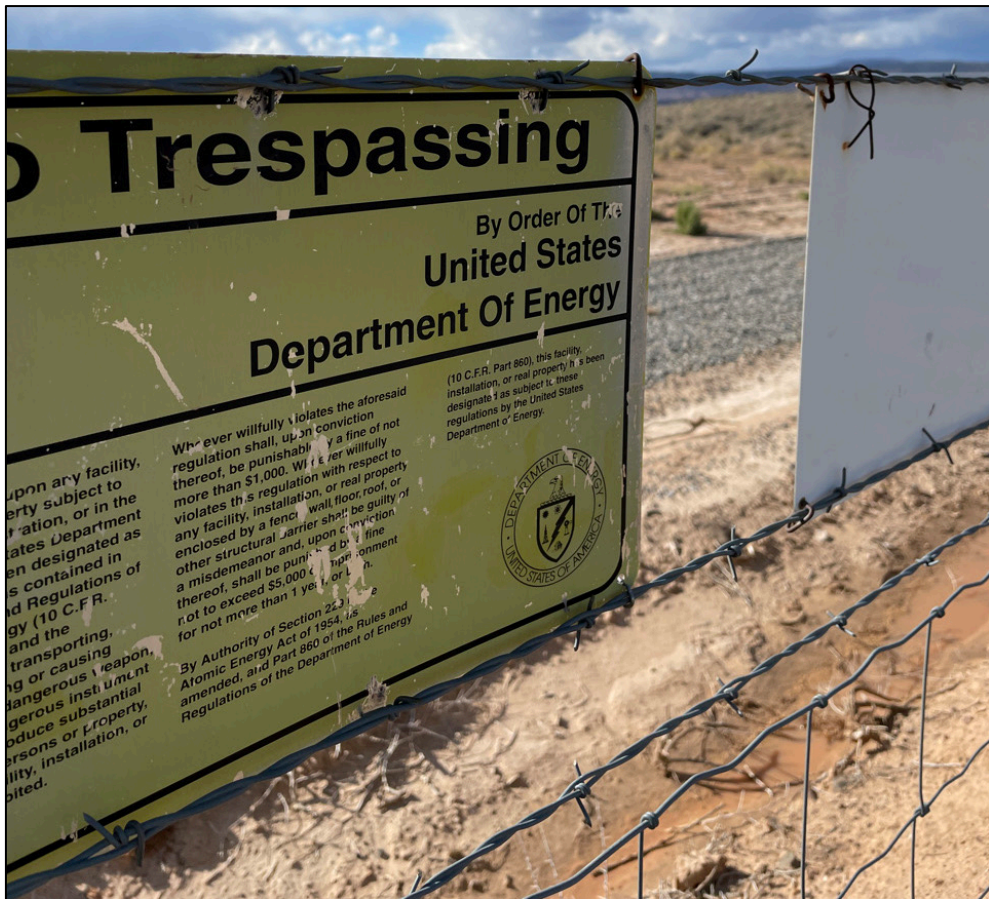
PL-2. No-Trespassing Sign (Faded but Legible)

There are 29 perimeter signs attached to steel posts set in concrete that are positioned at regular intervals along the property boundary (PL-3). Several perimeter signs along the south property boundary are faded or peeling but remain legible. Perimeter sign P20, replaced in 2021 because of bullet damage, has bullet damage again but remains legible. No other maintenance needs were identified.

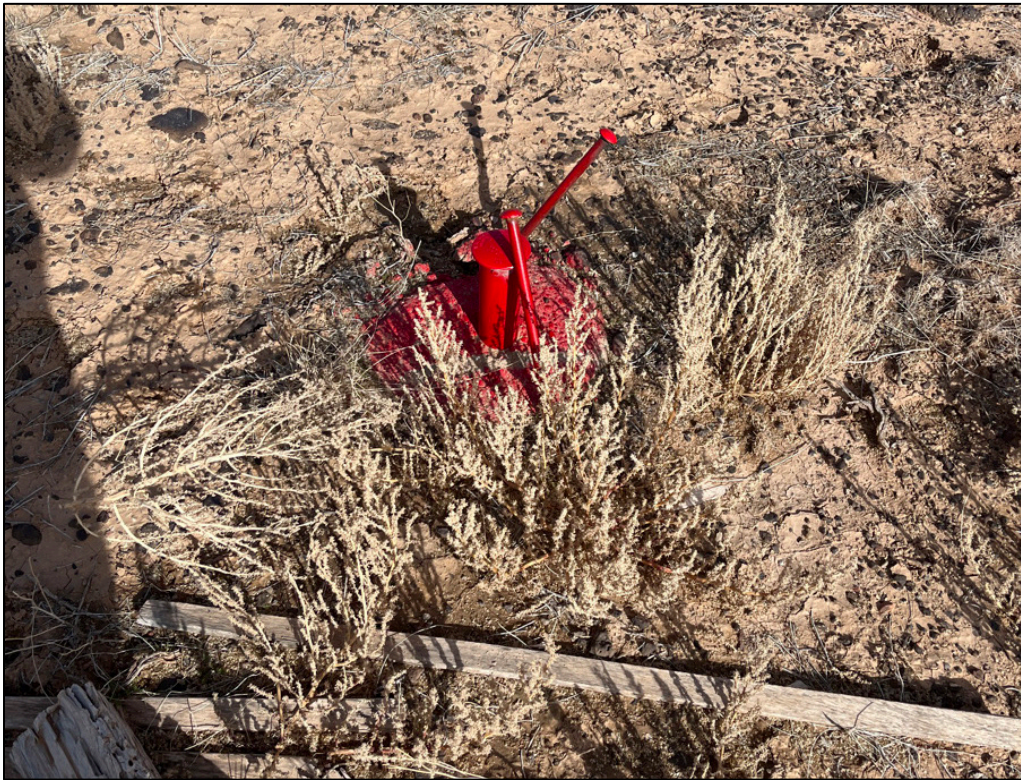
PL-4. Boundary Monument BM-4

Four boundary monuments delineate the corners of the property boundary (PL-4). All were present and in good condition. The location stakes at boundary monuments BM-3 and BM-4 were reset following the 2023 inspection. No other maintenance needs were identified.

- Resetting of the location stakes at boundary monuments BM-3 and BM-4.
- Maintenance of the previously observed localized erosion on the perimeter road (completed in June 2024). Maintenance was also completed for the stormwater retention ponds, sediment collection pond, and drainage channels to better control stormwater and spring runoff.

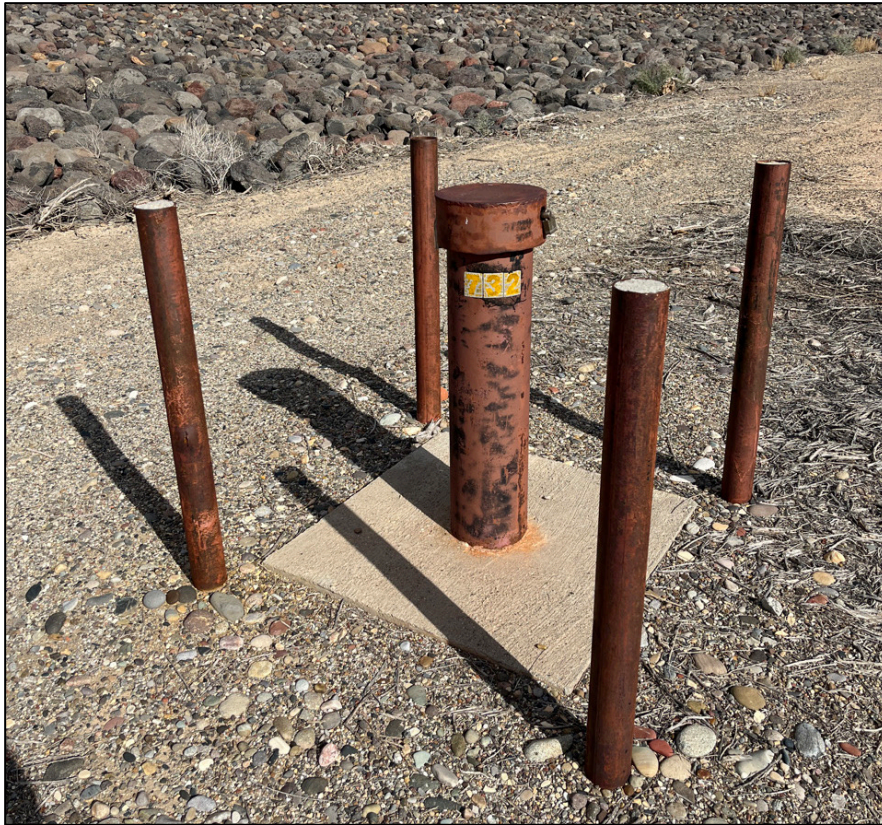
PL-5. Monitoring Well 0732

Root growth was observed in the well screens of monitoring wells 0731 and 0732 in 2021 (DOE 2022). The wells were redeveloped in 2022 (DOE 2023), and no root growth issues were observed during the 2024 sampling event. Weed spraying around each wellhead was completed in spring and fall 2024 to prevent the establishment of any deep-rooted plants. No other maintenance needs were identified.

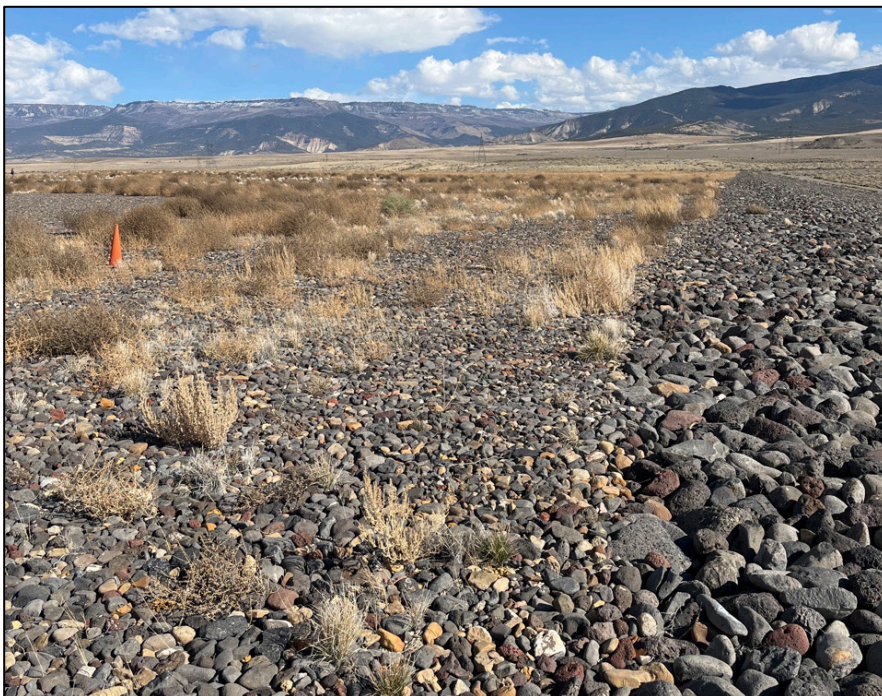
PL-6. Grasses Growing on Disposal Cell Cover

Grasses and weeds were growing on most of the disposal cell cover (PL-6). Historically, deep-rooted shrubs on top of the disposal cell have been treated with herbicide. Although treatment is not required by the Interim LTSP, LM plans to continue controlling the deep-rooted shrubs as needed. No maintenance needs were identified.
