**RADIOLOGICAL SCOPING SURVEY OF  
FORMER MONSANTO FACILITIES  
(Unit III and Warehouse)  
DAYTON, OHIO**

**Report Date: 4 September 1997**

**Survey Date: 27 August 1997**

**Prepared by: Mark L. Mays, Chief  
Radiation Safety Branch**

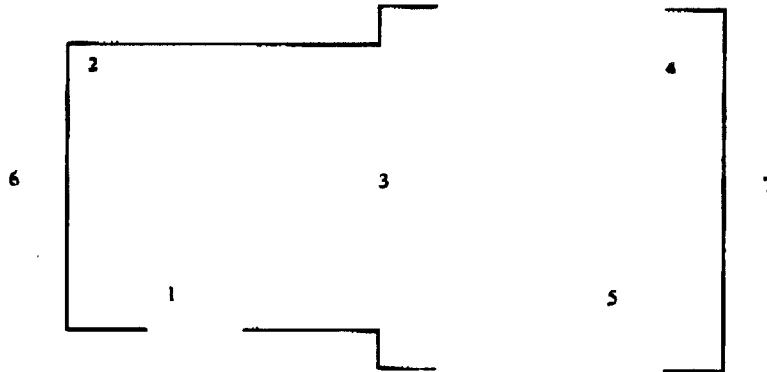
**Building 1  
(NOT TO SCALE)**

Location	1	2	3	4	5	6	7
alpha dpm/100 cm <sup>2</sup>	<4.14	<4.14	<4.14	<4.14	<4.14	<4.14	<4.14
Beta dpm/100 cm <sup>2</sup>	<6.91	<6.91	<6.91	<6.91	<6.91	<6.91	<6.91

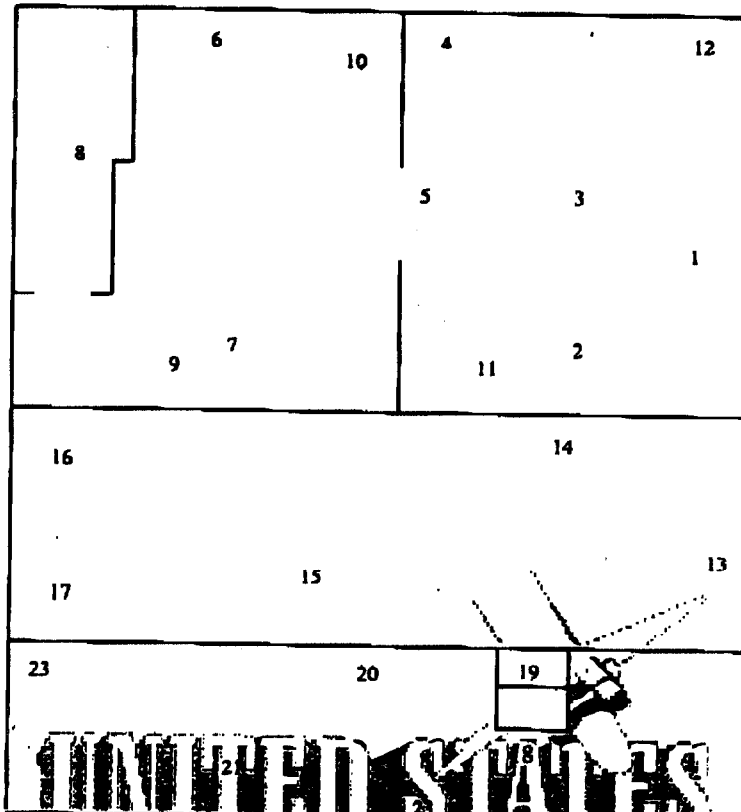
**Building 3  
(NOT TO SCALE)**

Location	1	2	3	4	5	6	7	8	9	10
alpha dpm/100 cm <sup>2</sup>	<4.14	<4.14	<4.14	<4.14	<4.14	<4.14	<4.14	<4.14	<4.14	<4.14
Beta dpm/100 cm <sup>2</sup>	<6.91	<6.91	<6.91	<6.91	<6.91	<6.91	<6.91	<6.91	<6.91	<6.91

Location	11	12	13	14	15	16	17	18	19	20
alpha dpm/100 cm <sup>2</sup>	<4.14	<4.14	<4.14	<4.14	<4.14	<4.14	<4.14	<4.14	<4.14	<4.14
Beta dpm/100 cm <sup>2</sup>	<6.91	<6.91	<6.91	<6.91	<6.91	<6.91	<6.91	<6.91	<6.91	<6.91

Location	21	22	23
alpha dpm/100 cm <sup>2</sup>	<4.14	<4.14	<4.14
Beta dpm/100 cm <sup>2</sup>	<6.91	<6.91	<6.91

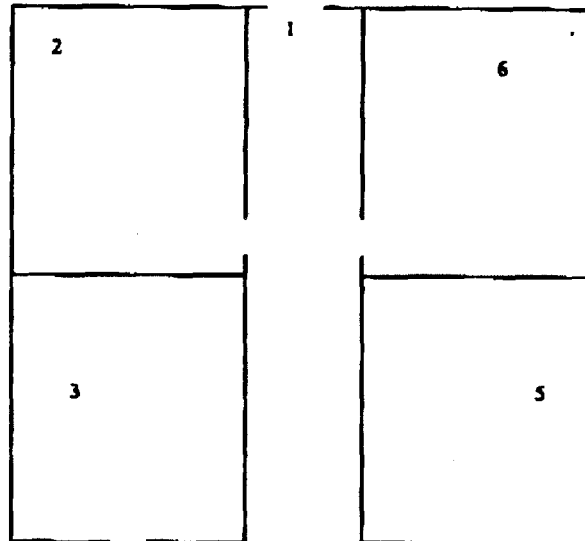
**Building 4  
(NOT TO SCALE)**

The background measurements of the exterior ranged from 10-12  $\mu\text{R/hr}$  at one meter. The highest contact reading obtained was 14  $\mu\text{R/hr}$  at two locations. One location was the west down spout of Building 4. Ohio Environmental Protection Agency will perform soil analysis at this point. The second location was approximately 5 feet north of the walk path that enters from Euclid Avenue and 5 feet west of the exterior fence.

Location	1	2	3	4	5	6
alpha dpm/100 cm <sup>2</sup>	<4.14	<4.14	<4.14	<4.14	<4.14	<4.14
beta dpm/100 cm <sup>2</sup>	<6.91	<6.91	<6.91	<6.91	<6.91	<6.91

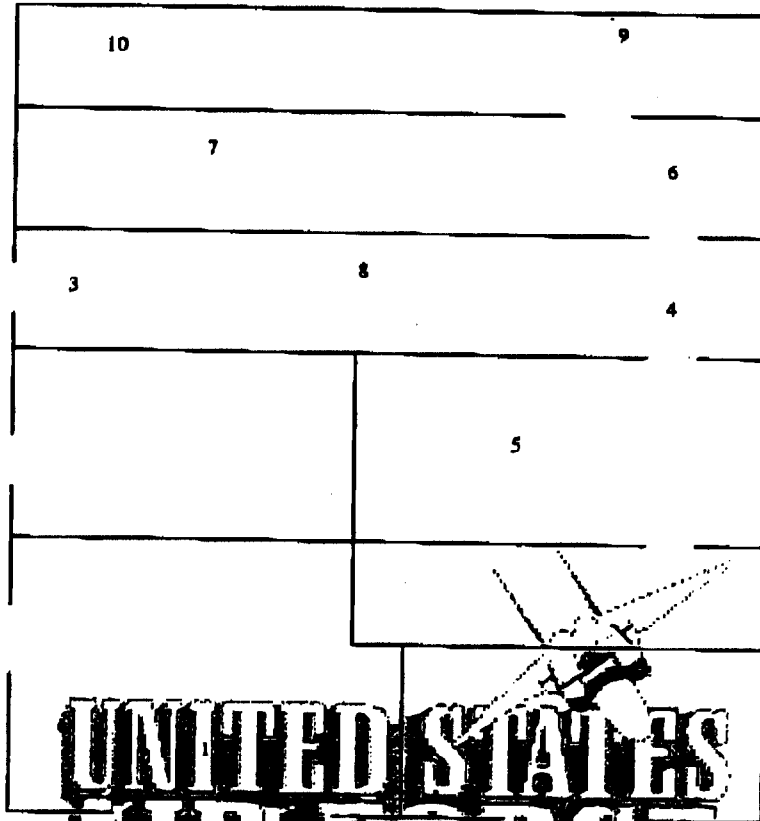
**Building 5  
(NOT TO SCALE)**

Location	1	2	3	4	5	6	7	8	9	10
alpha dpm/100 cm <sup>2</sup>	<4.14	<4.14	<4.14	<4.14	<4.14	<4.14	<4.14	<4.14	<4.14	<4.14
Beta dpm/100 cm <sup>2</sup>	<6.91	<6.91	<6.91	<6.91	<6.91	<6.91	<6.91	<6.91	<6.91	<6.91

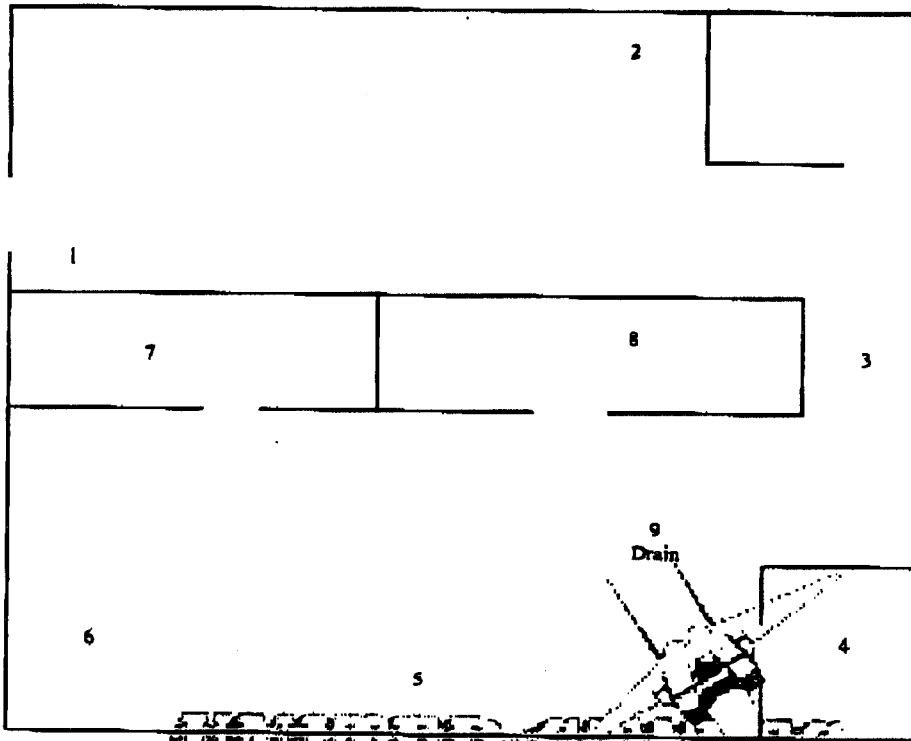
**Building 6  
(NOT TO SCALE)**

Location	1	2	3	4	5	6	7	8	9
alpha dpm/100 cm <sup>2</sup>	<4.14	<4.14	<4.14	<4.14	<4.14	<4.14	<4.14	<4.14	<4.14
Beta dpm/100 cm <sup>2</sup>	<6.91	<6.91	<6.91	<6.91	<6.91	<6.91	<6.91	<6.91	<6.91

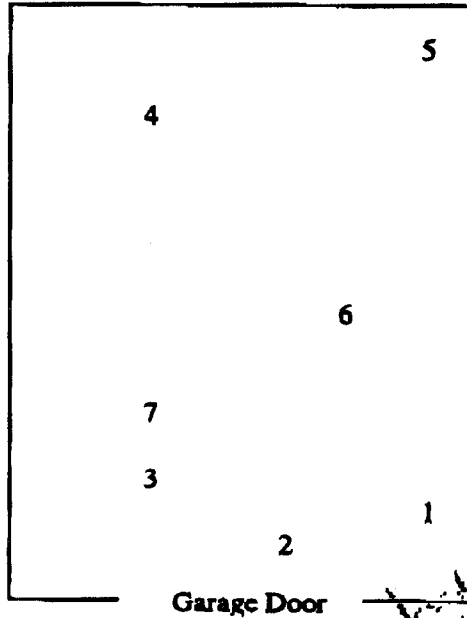
**Building 7  
(NOT TO SCALE)**

Location	1	2	3	4	5	6	7
alpha dpm/100 cm	<4.14	<4.14	<4.14	<4.14	<4.14	<4.14	<4.14
beta dpm/100 cm	<6.91	<6.91	<6.91	<6.91	<6.91	<6.91	<6.91
