STATEN ISLAND WAREHOUSE SITE
(The Former Archer-Daniels
Midland Company)
2393 Richmond Terrace
Port Richmond, New York

PRELIMINARY RADIOLOGICAL SURVEY REPORT OF THE
FORMER STATEN ISLAND WAREHOUSE SITE
(ARCHER-DANIELS MIDLAND COMPANY) AT
PORT RICHMOND, NEW YORK

October 1980

At the request of the Department of Energy (DOE), a preliminary radiological survey of this site was conducted on July 10, 1980, by members of the Health and Safety Research Division at Oak Ridge National Laboratory (ORNL). The site survey was intended to provide information on the present radiological condition and to determine the need for a more extensive radiological survey.

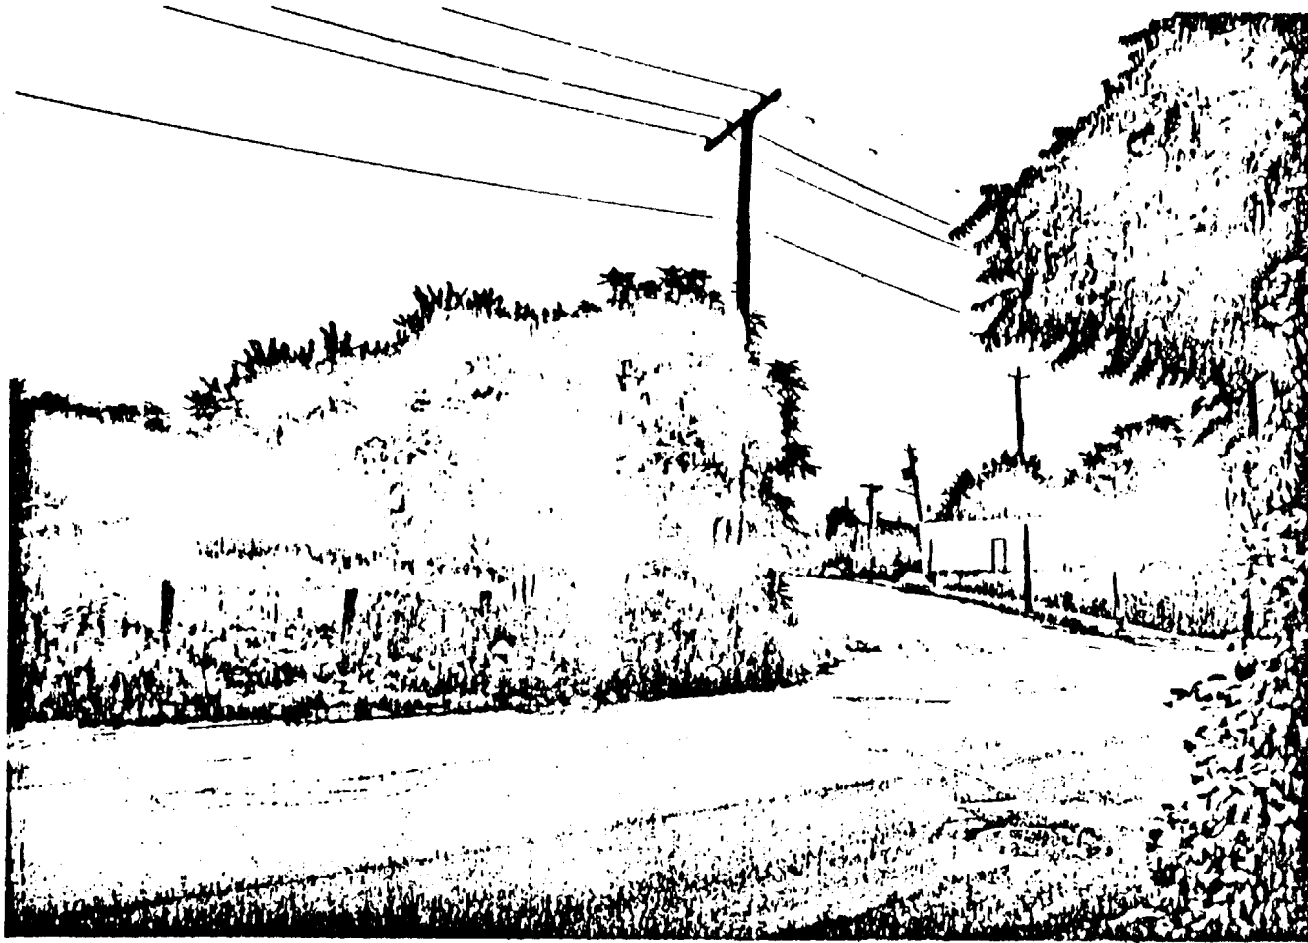
Currently, Parcel 1 is a vacant lot with no buildings present and ground cover of gravel and low weeds (Fig. 3). Parcel 2 is a vacant lot with no buildings present, but has remnants of a short retaining wall facing Richmond Terrace, a two-car garage foundation, and a ground cover of soil, rocks, high weeds, and small trees (Fig. 4). Parcel 3 is occupied by commercial and residential structures.

Figure 4. View of Parcel 2 (left side of John St.) and Parcel 3 (right side of John St.) of the former Staten Island Warehouse site looking south.

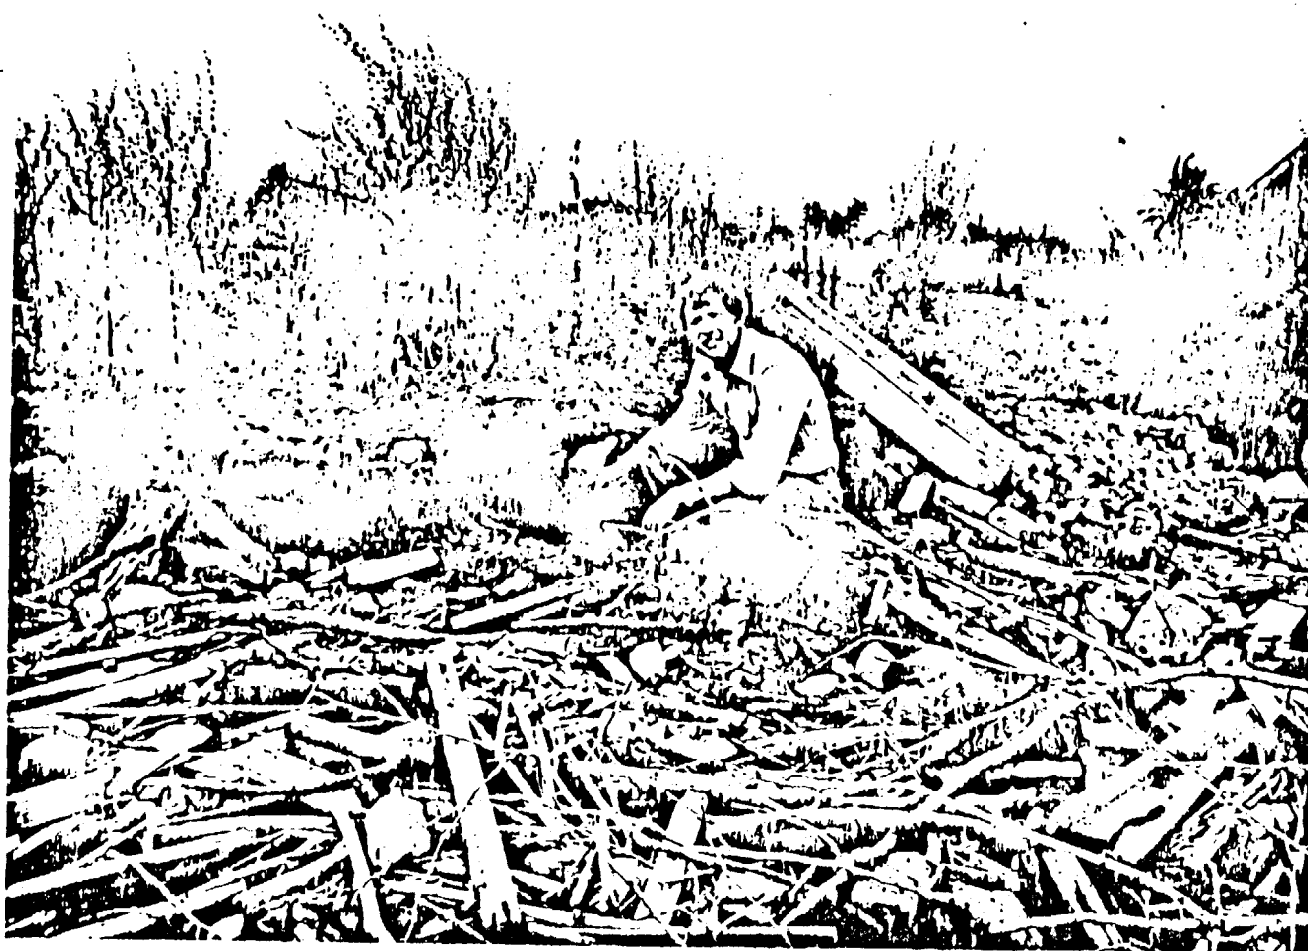
of contamination. Although the contamination was low-level throughout this area, there were localized spots with gamma exposure rates up to 0.2 mR/h (20 times background) on the ground surface (increasing to 0.4 mR/h at 15-cm depth). The contamination appeared to be in a 6-cm layer at a depth of approximately 35 to 40 cm (Fig. 6).

Figure 6. Location of soil sample ST 1 showing layer of contamination at 35 - 40 cm depth.

Based on the results of this preliminary survey at the former Staten Island Warehouse Site, it is recommended that a formal detailed radiological survey of Parcel 1 be conducted. There is evidence that a 20 m x 40 m area may have been contaminated with high-grade Belgian Congo uranium ore; preliminary results cannot rule out the existence of other such areas on this or other parcels.
