## 7.0 Green River, Utah, Disposal Site

### 7.1 Compliance Summary

The Green River, Utah, Uranium Mill Tailings Radiation Control Act (UMTRCA) Title I Disposal Site was inspected on March 18, 2021. No changes were observed on the disposal cell or in the associated drainage features. Inspectors identified several minor maintenance issues at the site but did not identify concerns that required a follow-up or contingency inspection.

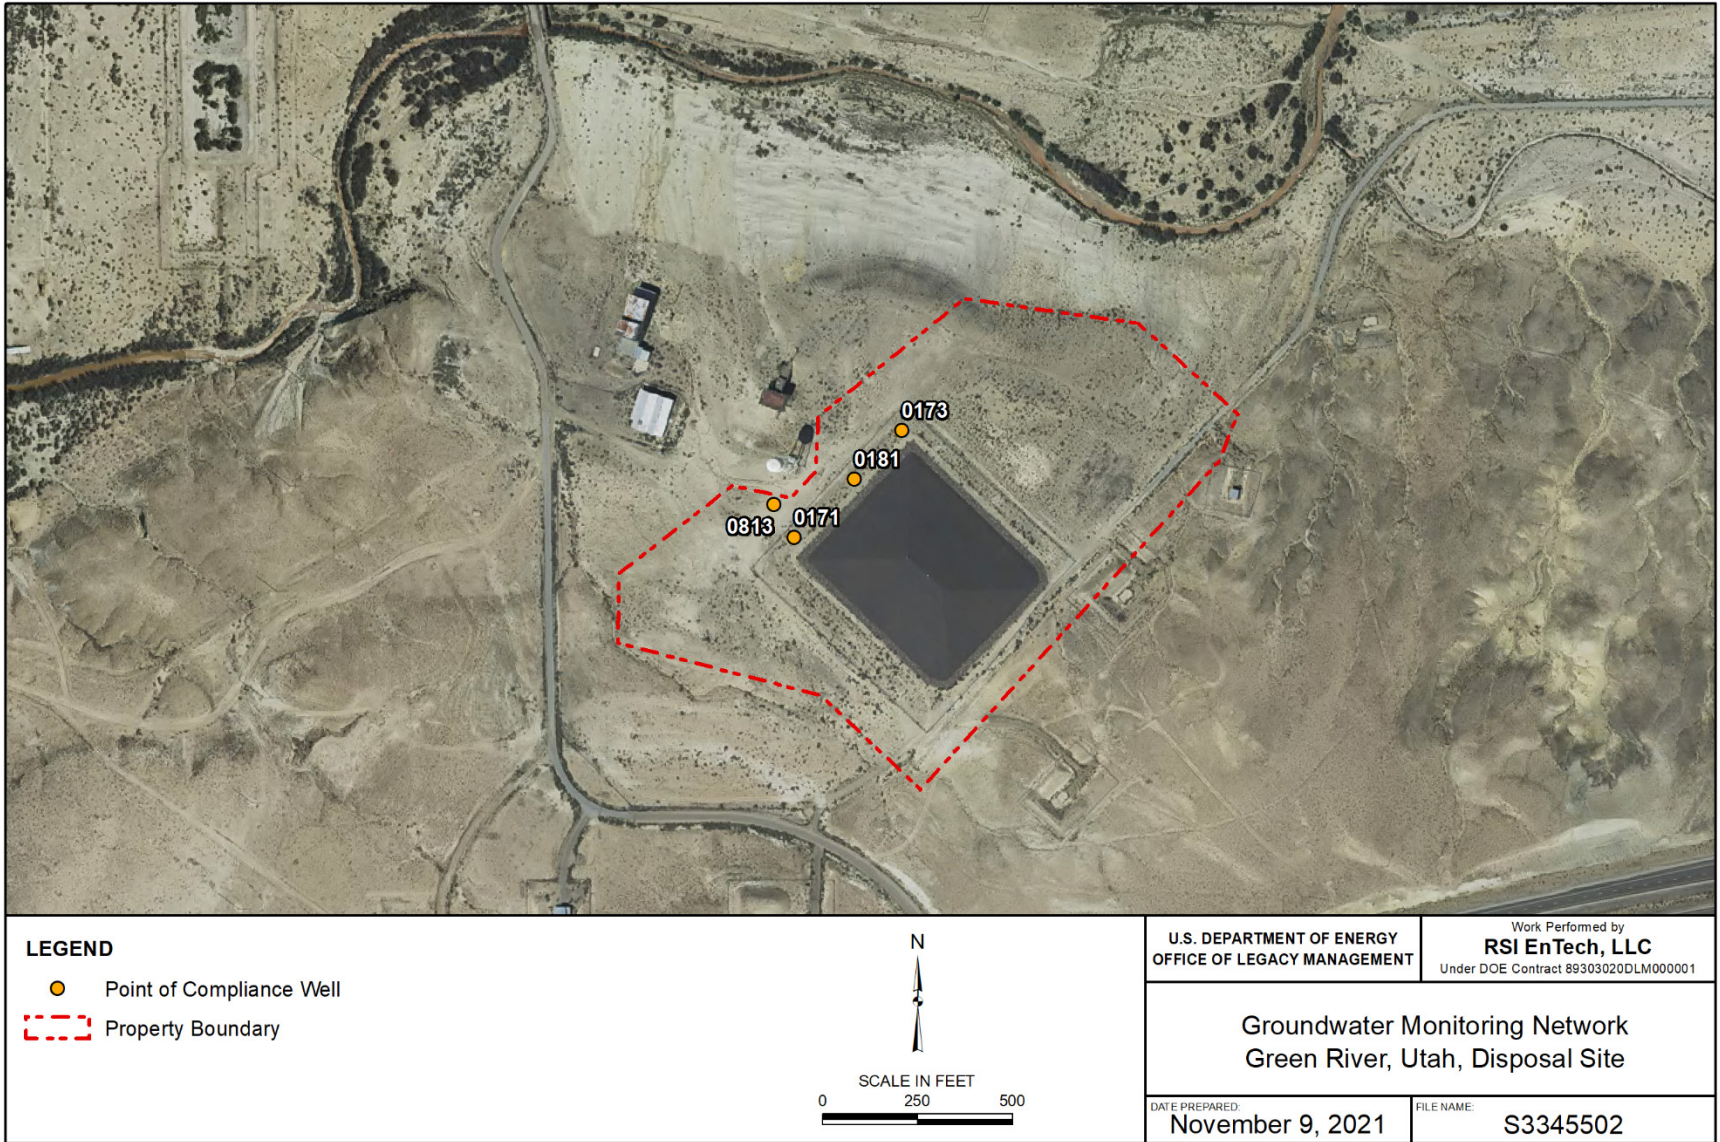
Figure 7-2. Groundwater Monitoring Network at the Green River, Utah, Disposal Site

The LTSP establishes four POC wells at the site for postclosure groundwater monitoring. The POC wells represent the intersection of a vertical plane with the uppermost aquifer (the middle sandstone unit of the Cedar Mountain Formation) underlying the site. The LTSP included monitoring well 0172, but its construction integrity was suspect, and the well was replaced with monitoring well 0181 in 2001 (PL-14). Well 0181 has been monitored as the replacement POC well since 2001. Table 7-2 and Figure 7-2 show the current groundwater monitoring network at the site.

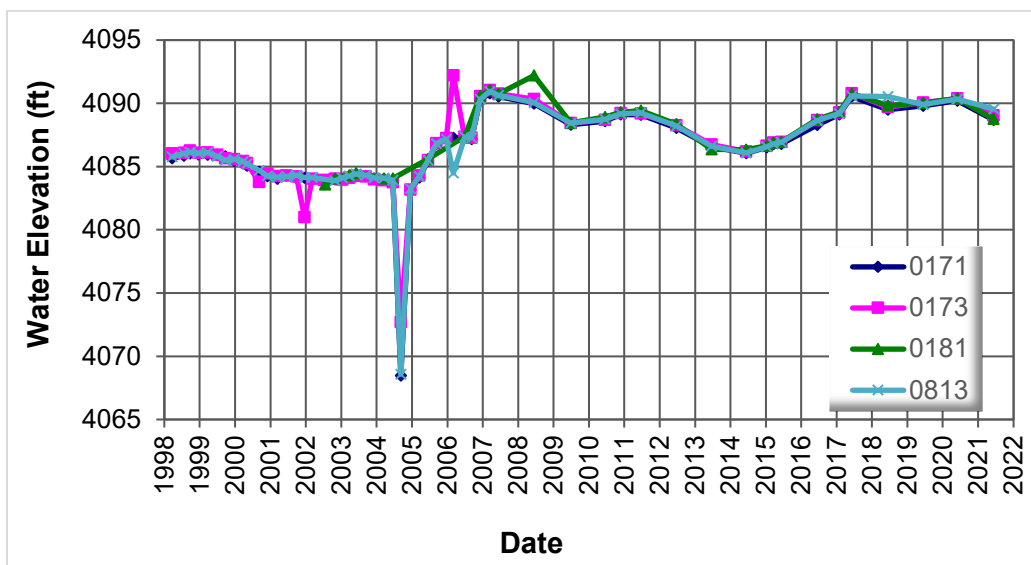
Figure 7-3. Groundwater Elevations at the Green River, Utah, Disposal Site

Water levels in the POC wells have been measured manually every year since 1991. The groundwater levels as measured from 1998 to present range from 4085 ft to 4090 ft, with two spikes of 4092.2 ft in 2006 and 2008. (Figure 7-3). The sharp drop in water levels shown in 2004 may have been due to instrument error or human error in recording the original field record. While it is likely this outlier is a result of an error, there is no definitive evidence of error and the data as shown are consistent with available documentation.

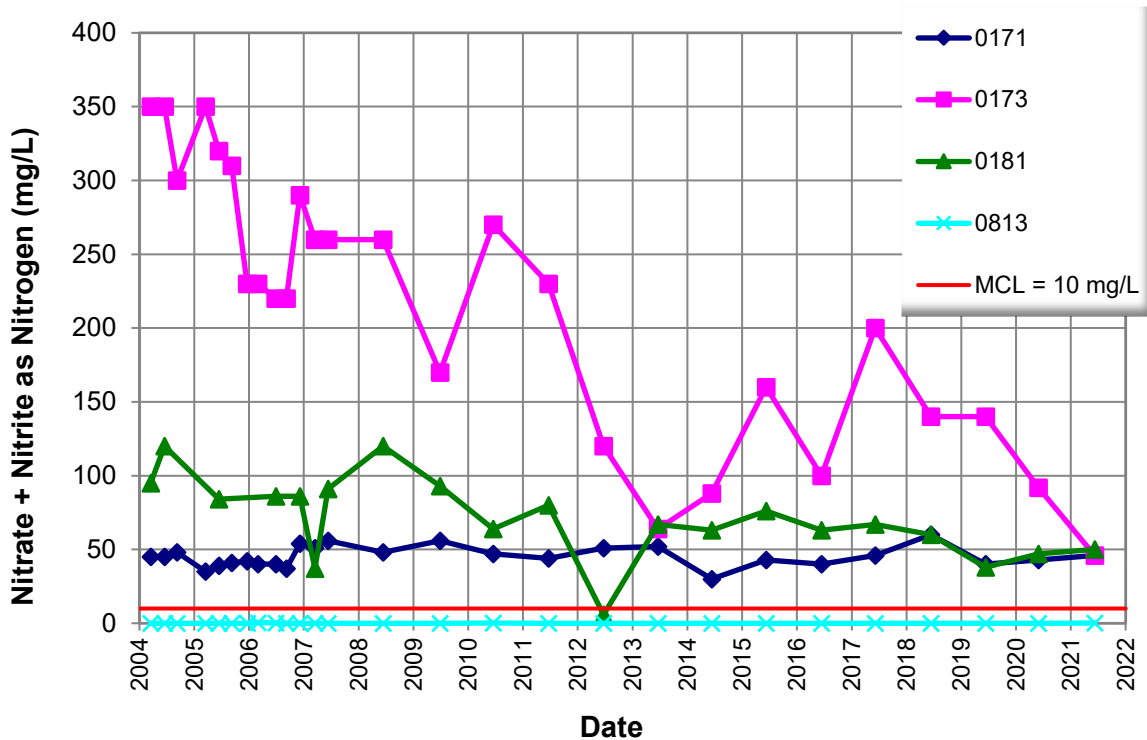
Figure 7-4. Nitrate Concentrations at POC Wells at the Green River, Utah, Disposal Site

Figure 7-4 through Figure 7-6 show the time-concentration plots for nitrate, sulfate, and uranium along with corresponding MCLs. Nitrate concentrations continue to exceed the MCL in POC wells 0171, 0173, and 0181. The 2021 nitrate concentrations were within the range of historical values for all POC wells (Figure 7-4).

**Notes:** Results include validated data only; results below the detection limit are presented at the laboratory reported value. Well 0813 is plotted at the detection limit of 0.056 mg/L.

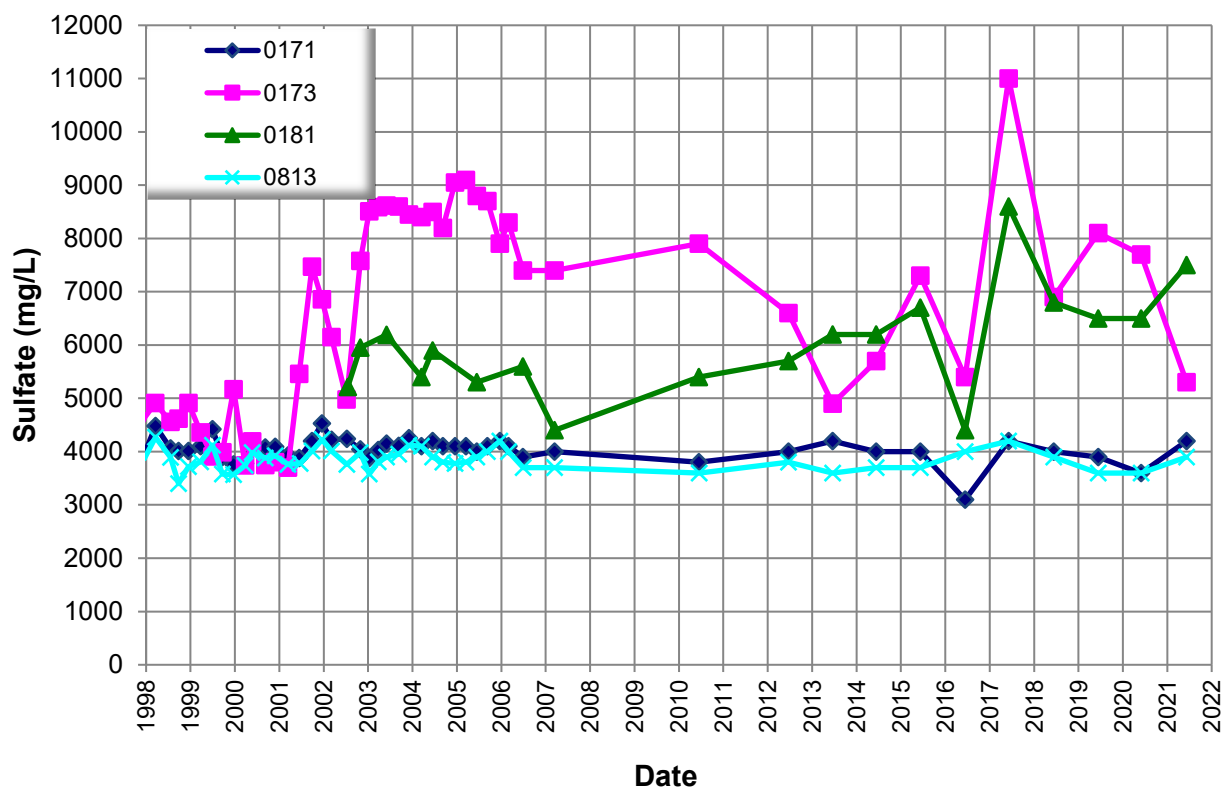
Figure 7-5. Sulfate Concentrations at POC Wells at the Green River, Utah, Disposal Site

Sulfate concentrations exceeded the LTSP background concentrations in all POC wells except POC well 0813. The 2021 sulfate concentrations were within the range of historical values for all POC wells (Figure 7-5).

**Note:** Results include validated data only; results below the detection limit are presented at the laboratory reported value.

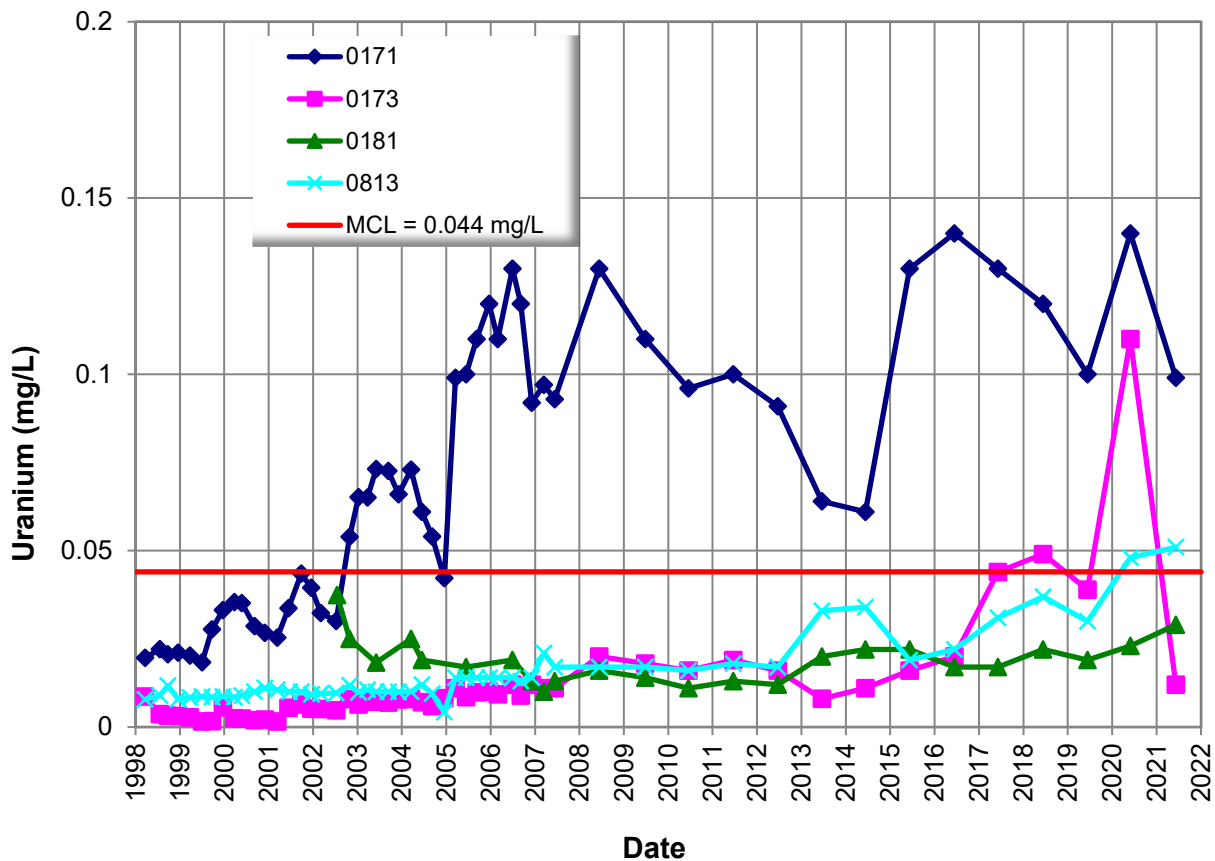
Figure 7-6. Uranium Concentrations at POC Wells at the Green River, Utah, Disposal Site

Uranium concentrations in POC well 0171 routinely exceed the UMTRCA and LTSP concentration limits, while the other POCs remain mostly below the MCL. Well 0173 exceeded the MCL of 0.044 mg/L in 2018 and 2020 (Figure 7-6). Well 0181 remains below the uranium concentration limit. The uranium concentration at well 0813 exceeded the standard for the first time in the 2020 and again in the 2021 event. Uranium concentrations in POC well 0171 have varied considerably, ranging from a low of 0.0184 mg/L in 1999 to a high of 0.14 mg/L in 2016. The 2021 uranium concentrations are within the range of historical values in POC wells 0171, 0173, and 0181 and exceed the highest historical values in POC well 0813.

**Note:** Results include validated data only; results below the detection limit are presented at the laboratory reported value.

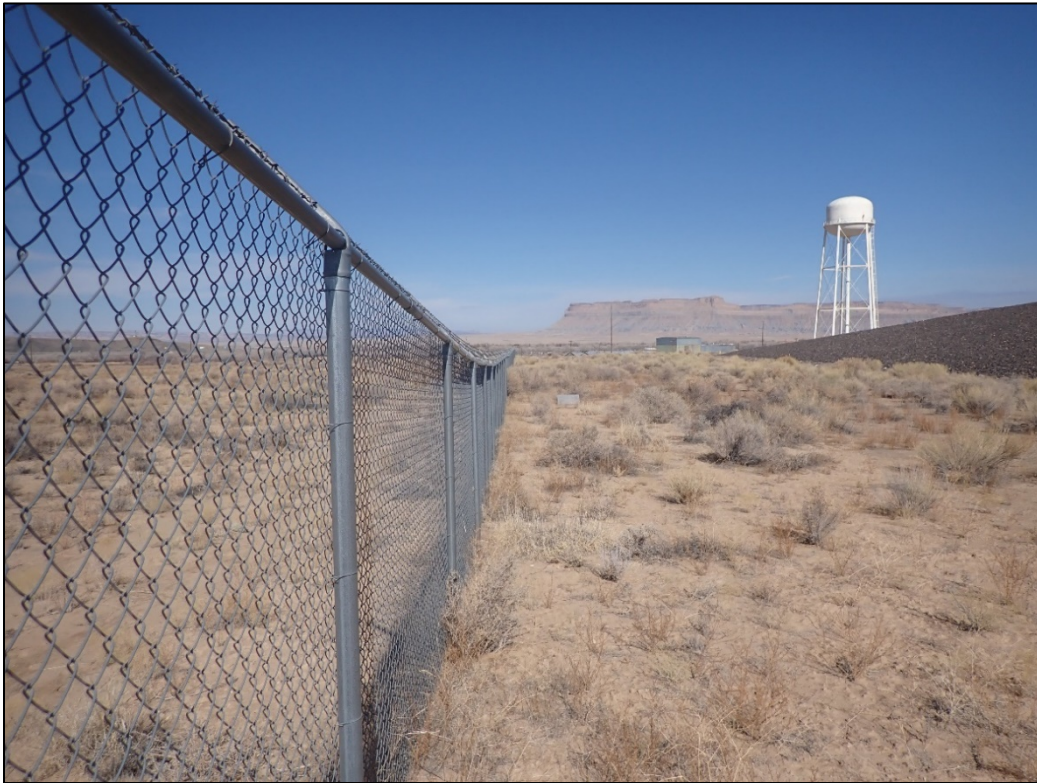
A chainlink security fence encloses the portion of the site that contains the disposal cell. Vehicle gates are at the south and east corners of the security fence, and a personnel gate is at the north corner of the security fence. The security fence (PL-1 and PL-2) was intact, and the gates were operable and locked at the time of the inspection.

*PL-1. Chainlink Security Fence and Site Marker SMK-1 in Background*

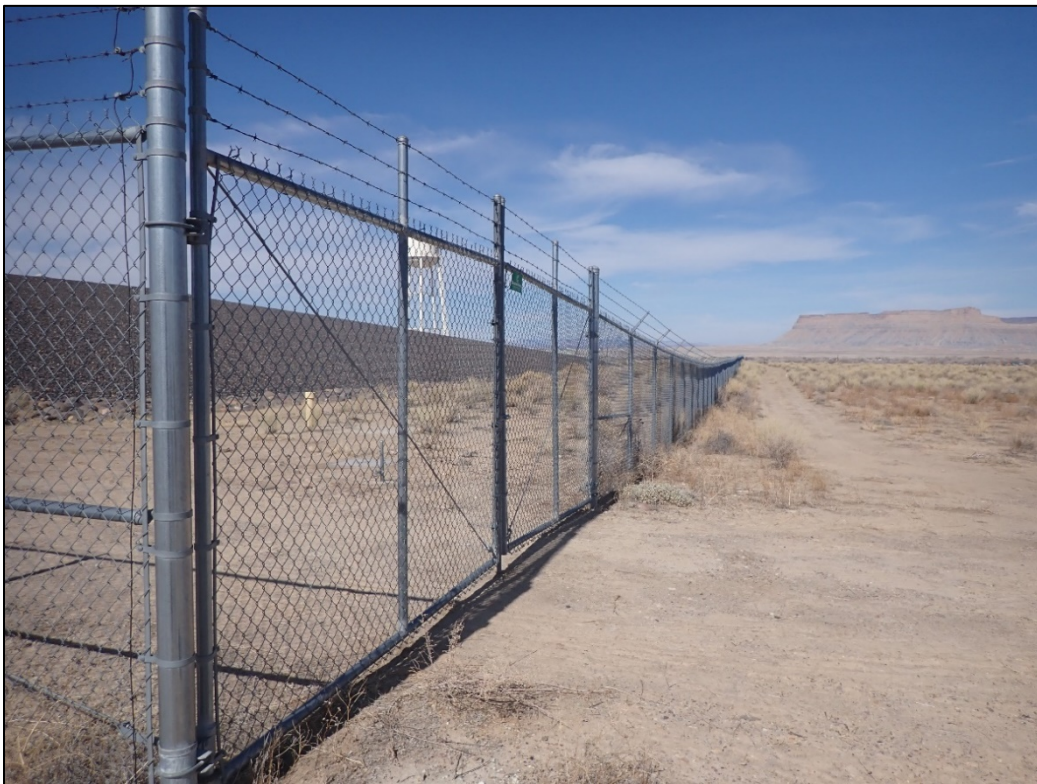
*PL-2. East Vehicle Gate and Fence*

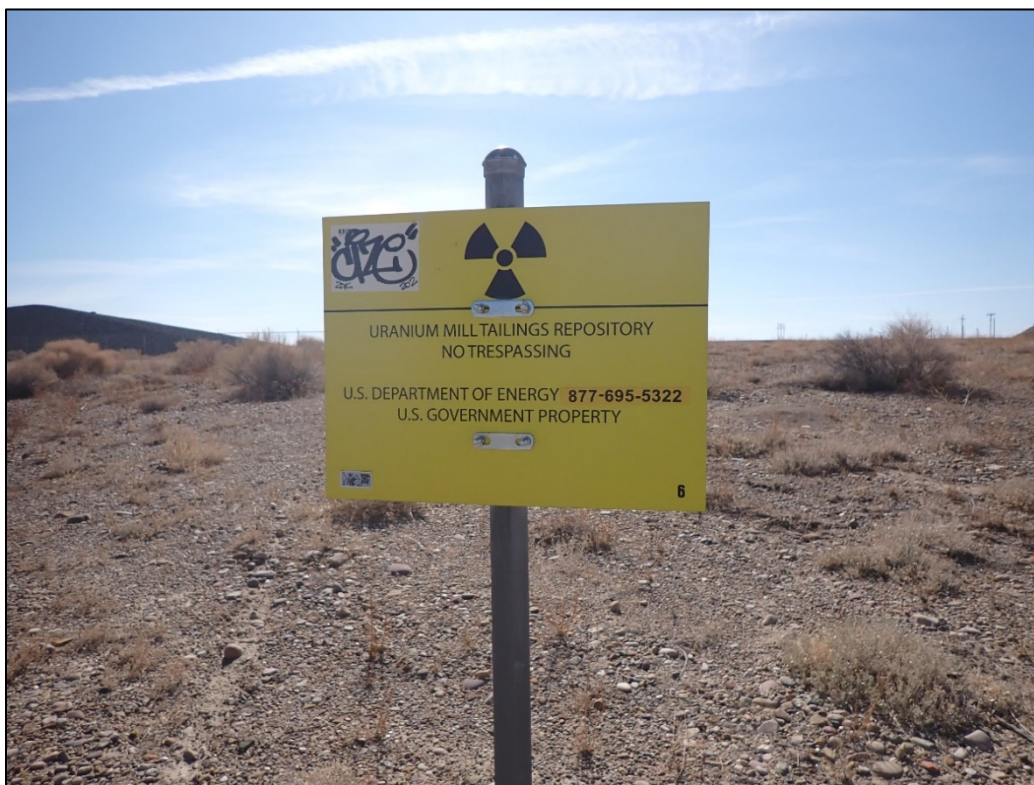
Seventeen perimeter signs, attached to steel posts set in concrete, are positioned along the unfenced property boundary. All perimeter signs were legible, although inspectors noted that perimeter sign P6 contained graffiti (PL-3). Because the sign is legible, it will not be replaced at this time.

*PL-3. Graffiti on Perimeter Sign P6*

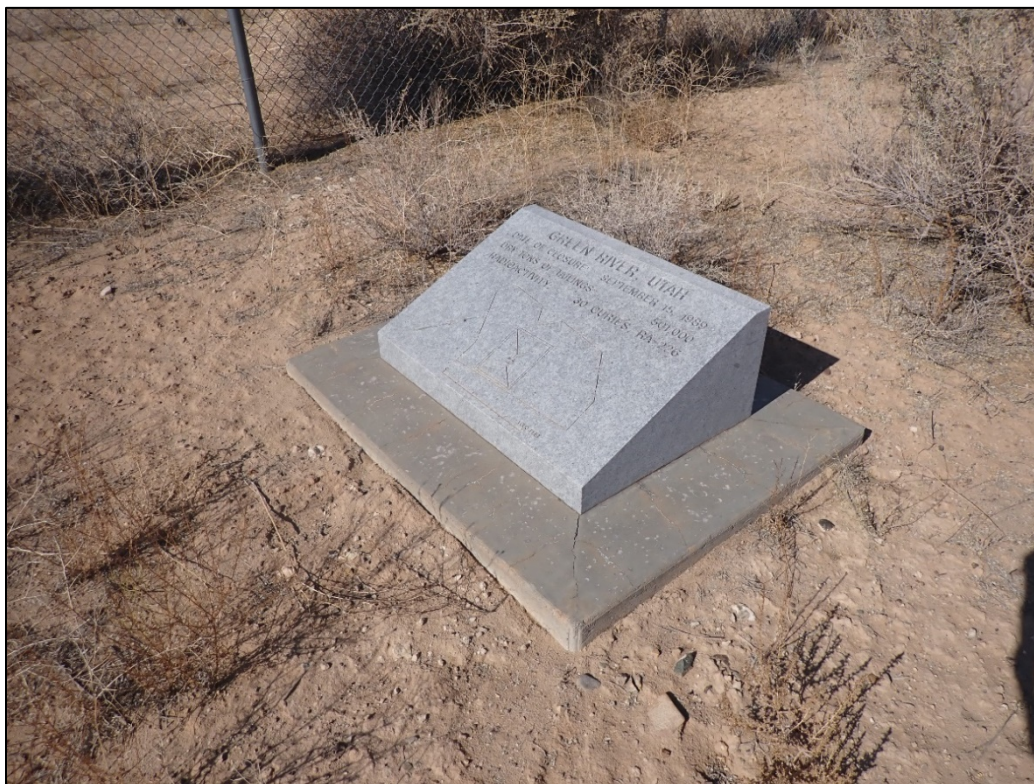
The site has two granite markers. Site marker SMK-1 is inside the security fence near the southwest corner of the site, and SMK-2 is on the crest of the disposal cell. The concrete base of SMK-1 has several minor cracks (PL-4), but they do not compromise the integrity of the base, and repairs are not necessary at this time.

*PL-4. Minor Cracks in the Base of Site Marker SMK-1*

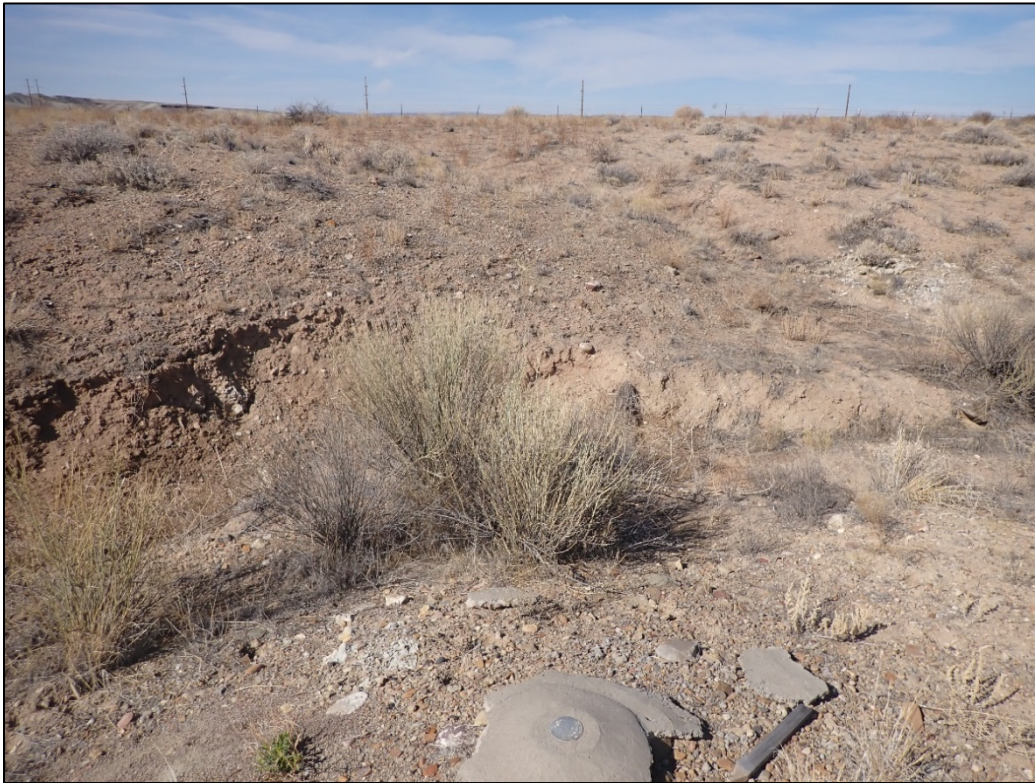
Eleven boundary monuments and three survey monuments delineate the property boundary. Boundary monument BM-5 is bent from being hit by a vehicle, and the concrete base around survey monument SM-2 is cracked and spalled on the ground (PL-5). Repairs of these monuments are not needed at this time.

*PL-5. Cracked and Spalled Concrete Around Survey Monument SM-2*

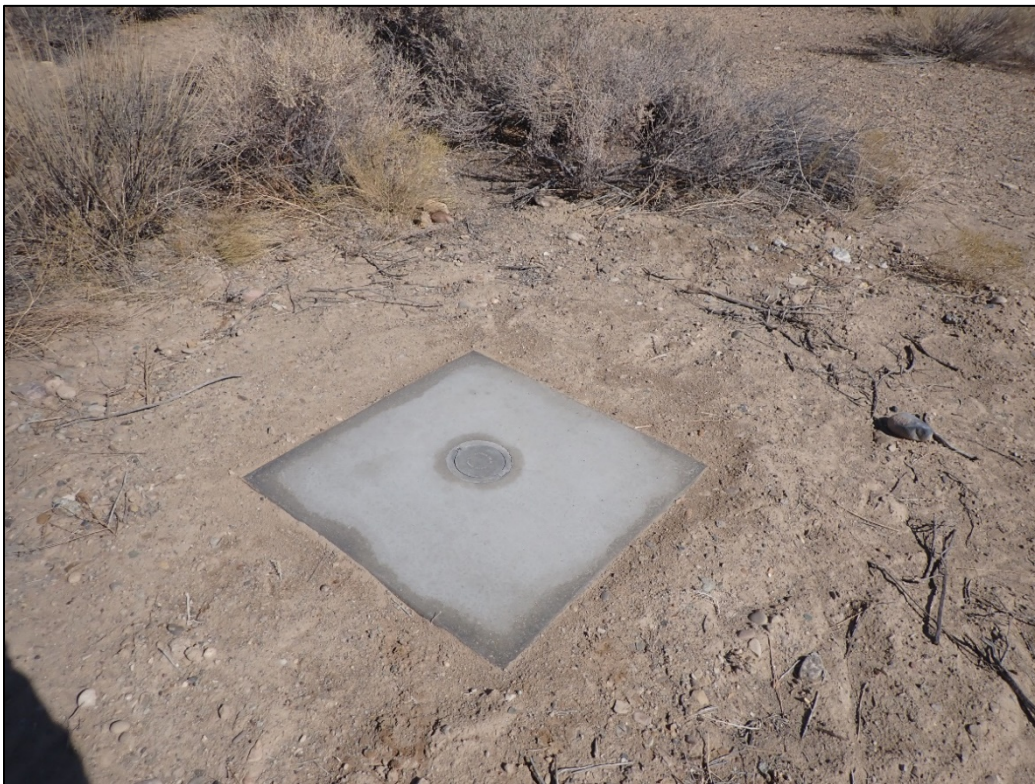
Four aerial survey quality control monuments were installed near the four corners of the disposal cell in October 2020 (PL-6). No maintenance needs were identified.

*PL-6. Aerial Survey Quality Control Monument*

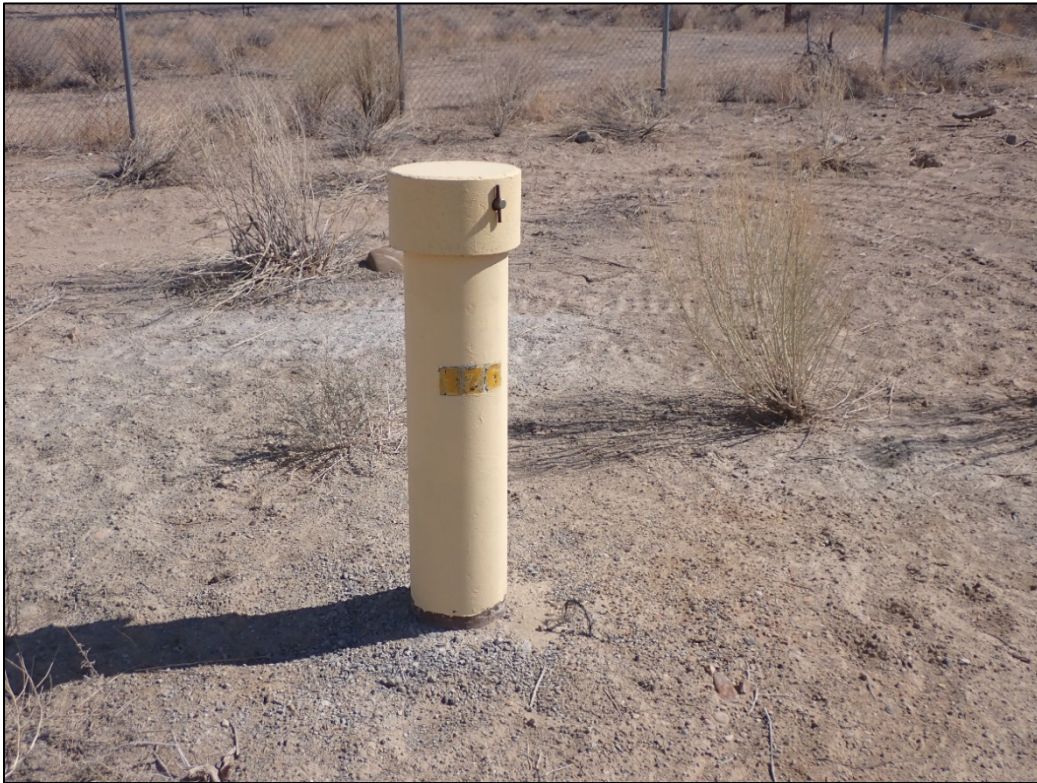
Twenty-two monitoring wells are on or near the site. The LTSP establishes four POC wells at the site for postclosure groundwater monitoring. All wellhead protectors observed during the inspection were undamaged and locked. Some of the concrete monitoring well collars were cracked, but the wellhead protectors were stable, and repairs are not necessary. Well identification numbers were faded or missing on several wells (PL-7). Well identification numbers will be reapplied before the next inspection.

*PL-7. Faded Identification Numbers on Monitoring Well 0176*

No maintenance needs were identified at the time of the inspection. Well ID numbers will be reapplied before the next inspection.

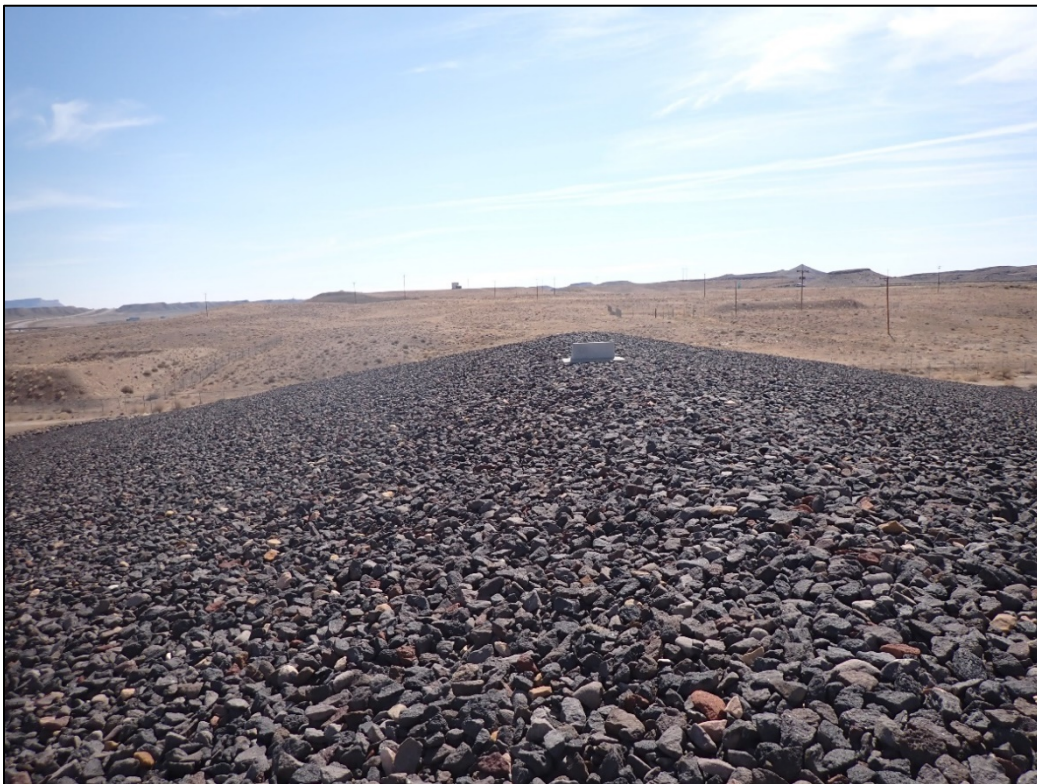
The disposal cell, completed in 1989, occupies 6 acres. The slopes of the disposal cell cover are armored with riprap, consisting primarily of competent basalt with a small fraction of sedimentary rocks, to control erosion. A small percentage of the rock, including basalt and sedimentary rock, has degraded, but the riprap cover is functioning as designed. Inspectors found no evidence of settling, slumping, erosion, or other modifying process that might affect the integrity of the disposal cell (PL-8, PL-9, and PL-10).

*PL-8. Site Marker SMK-2 on Disposal Cell Top Slope*

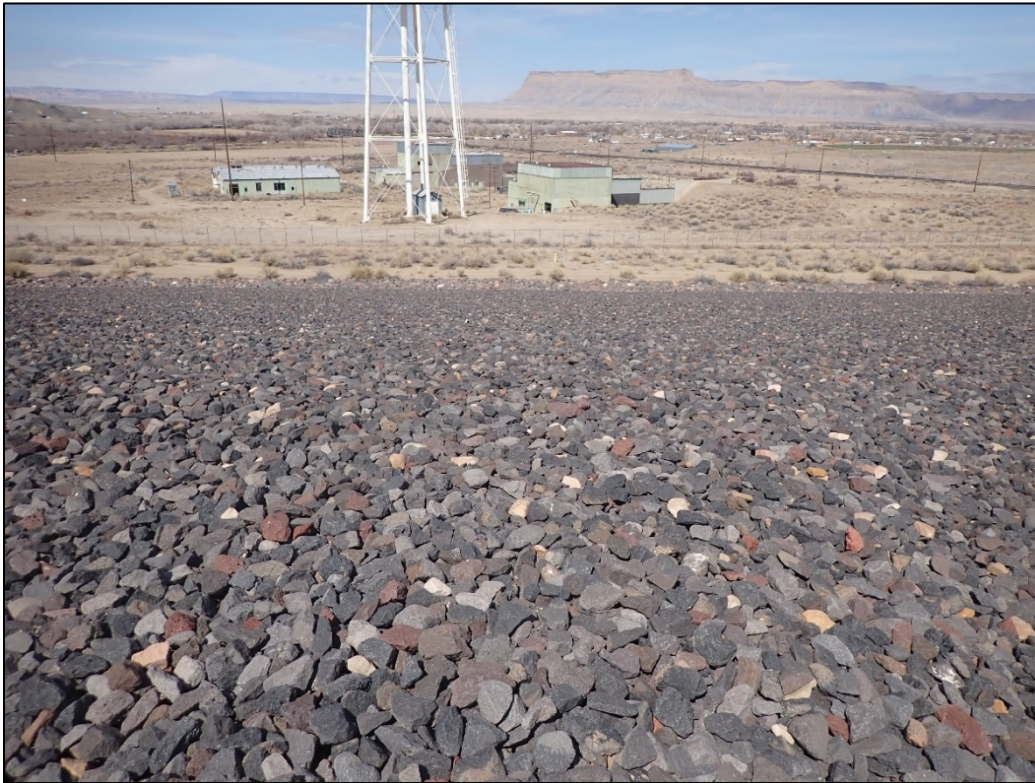
*PL-9. Disposal Cell Northwest Side Slope*

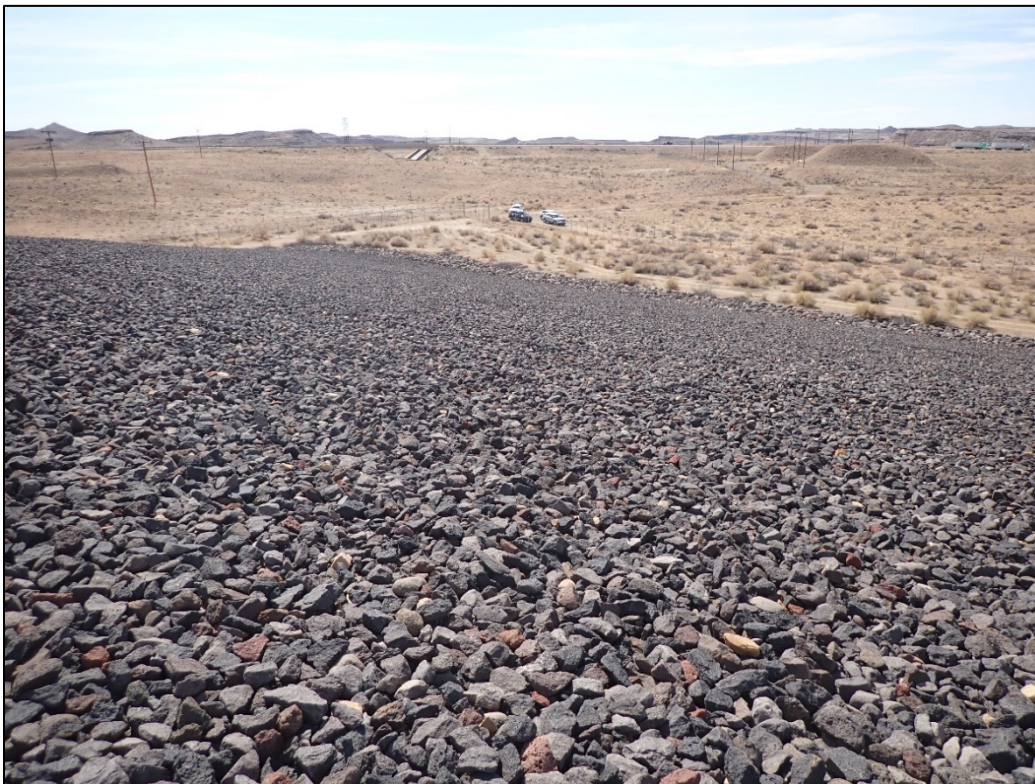
*PL-10. Disposal Cell Southwest Side Slope*

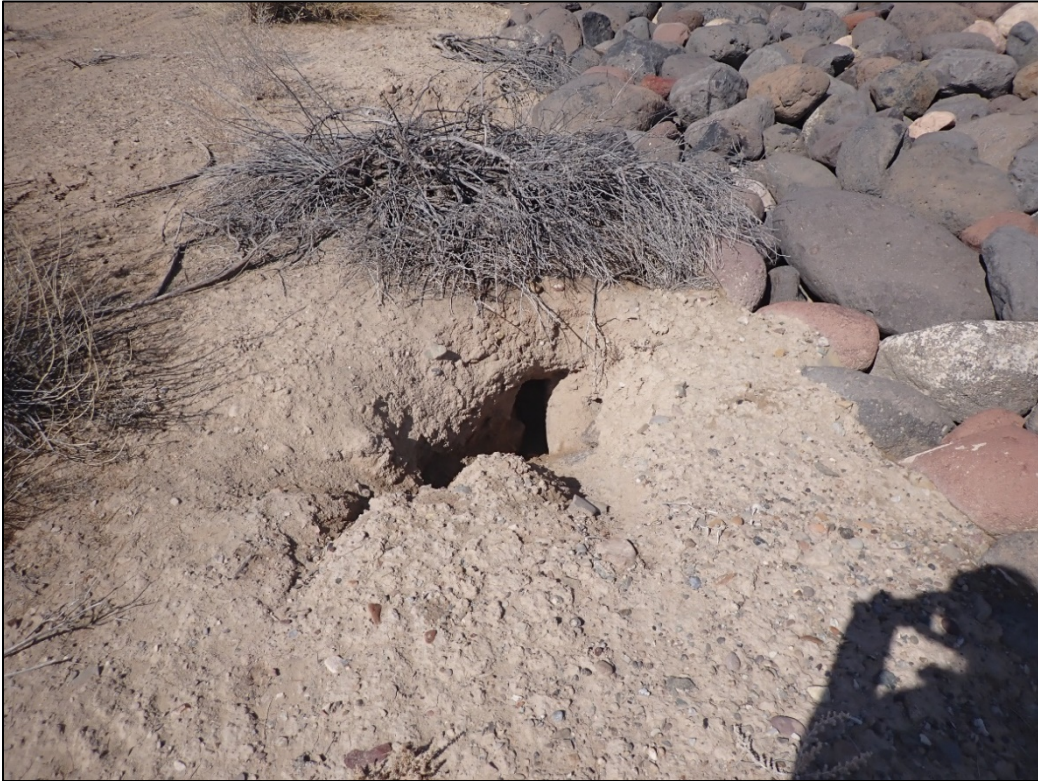
A boulder-filled trench, known as an apron, surrounds the disposal cell. The apron was intact and stable, with no observed erosion along the base of the side slopes. Small erosion rills and soil

pipng features (PL-11) were present along portions of the outside edge of the apron. The rills and piping features form as stormwater runoff along the perimeter road drains into the disposal cell apron. This occurrence is not a concern because the erosion is minor and sedimentation in the apron has not adversely affected the performance of the apron (the sediment has not filled the apron or become visible in the apron). Inspectors will continue to monitor the area.

*PL-11. Soil Piping on Edge of Rock Apron*

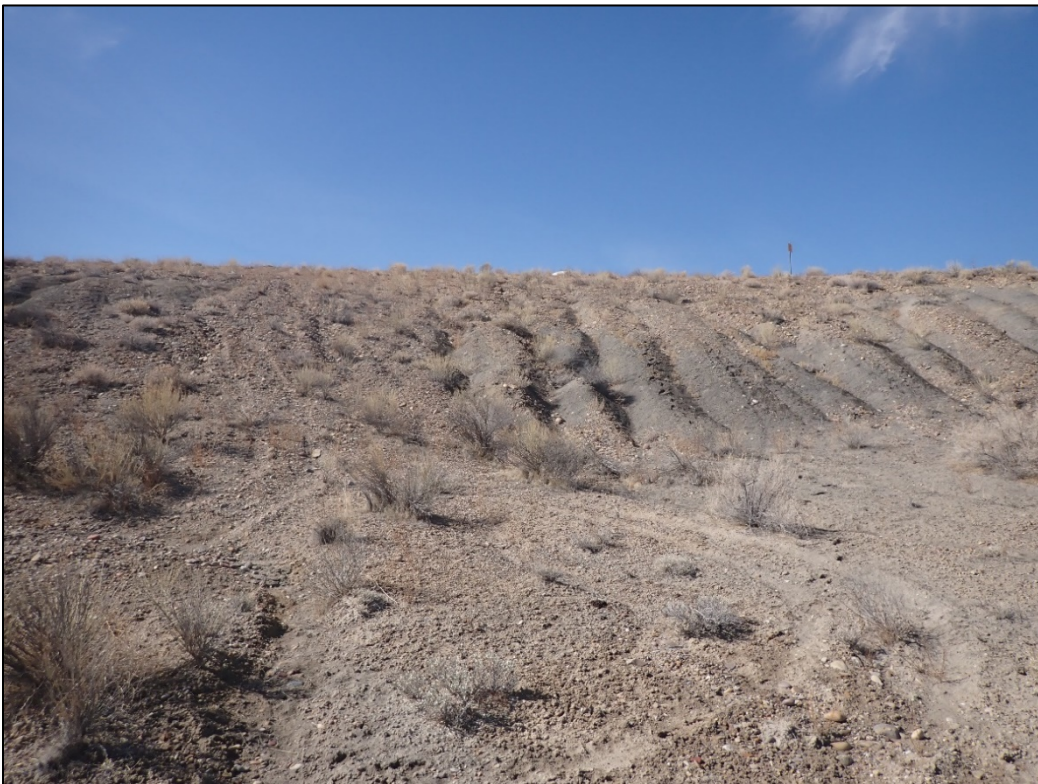
Signs of erosion appear in multiple areas in the site perimeter. Erosional rills are present on the west side of the site but are not affecting site surveillance features. Rills and gullies are also present along the escarpment northeast of the disposal cell between boundary monument BM-7 and survey monument SM-3 (approximately 400 feet [ft] from the base of the disposal cell) (PL-12 and PL-13). Maximum gully depth in this area is approximately 3 ft, but the erosion appears to be stabilizing. A portion of the stormwater diversion channel along the southeast side of the site continues to erode slowly. These erosional features could eventually damage site surveillance features (i.e., perimeter signs, boundary monuments, and the security fence). The closest erosional features are approximately 300 ft from the disposal cell and do not pose a risk to its integrity. Inspectors will continue to monitor these features. No immediate maintenance needs were identified.

*PL-12. Soil Erosion by Boundary Monument BM-7 (Offsite)*

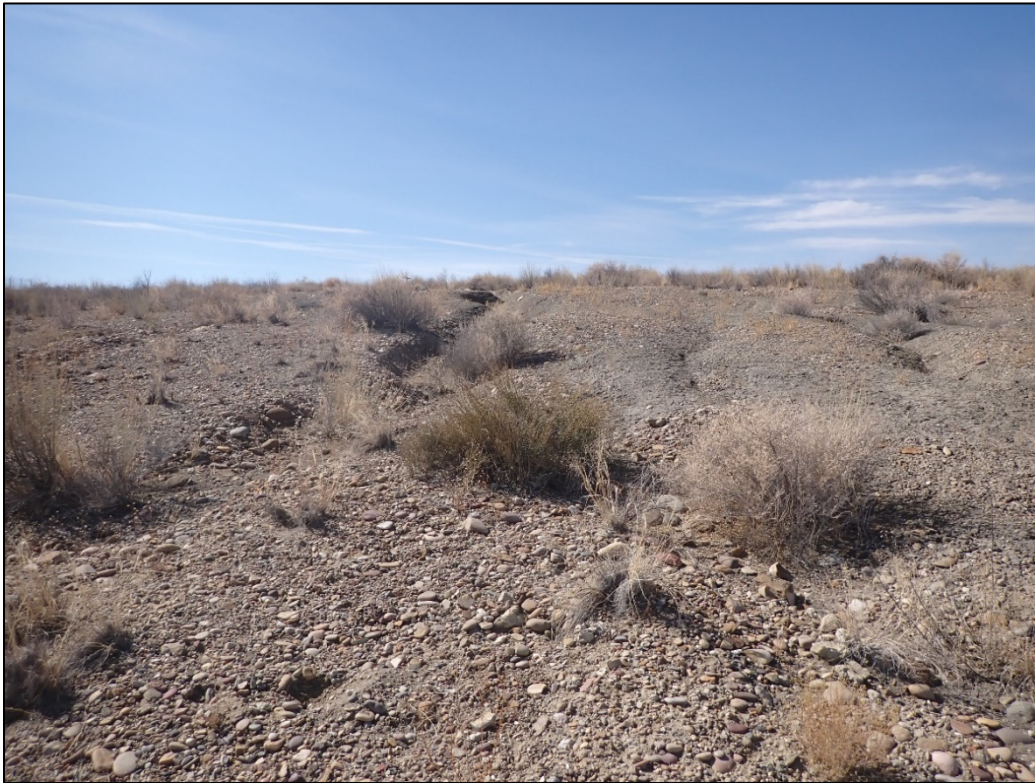
*PL-13. Soil Erosion by Boundary Monument BM-8 (Onsite)*

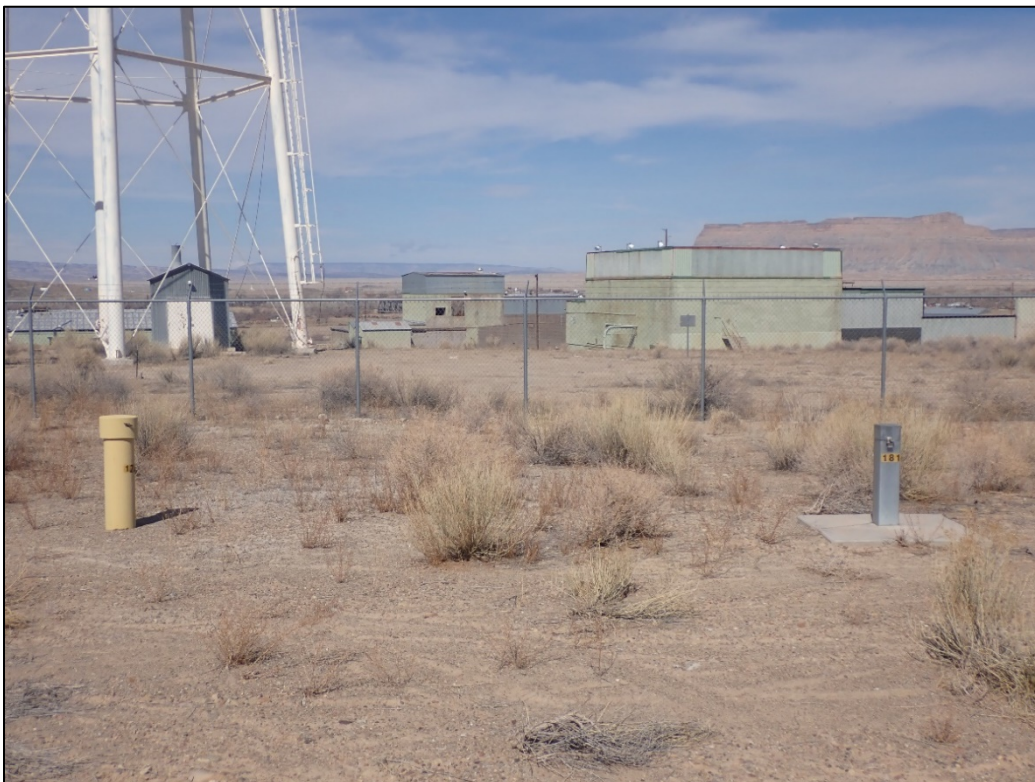
The area beyond the site boundary for a distance of 0.25 mile was visually observed for erosion, changes in land use, or other phenomena that might affect the long-term integrity of the site. No such impacts were observed. Abandoned buildings and a water tower associated with the former milling activities are northwest of the site (PL-14). The buildings are not maintained and are in disrepair, and debris tends to blow onto the site from surrounding buildings (e.g., shingles, siding, plastic). Accumulation of windblown debris is minor; it will continue to be monitored, and trash will be removed.

*PL-14. Monitoring Wells 0172 and 0181 (Onsite) and Abandoned Mill Buildings (Offsite)*

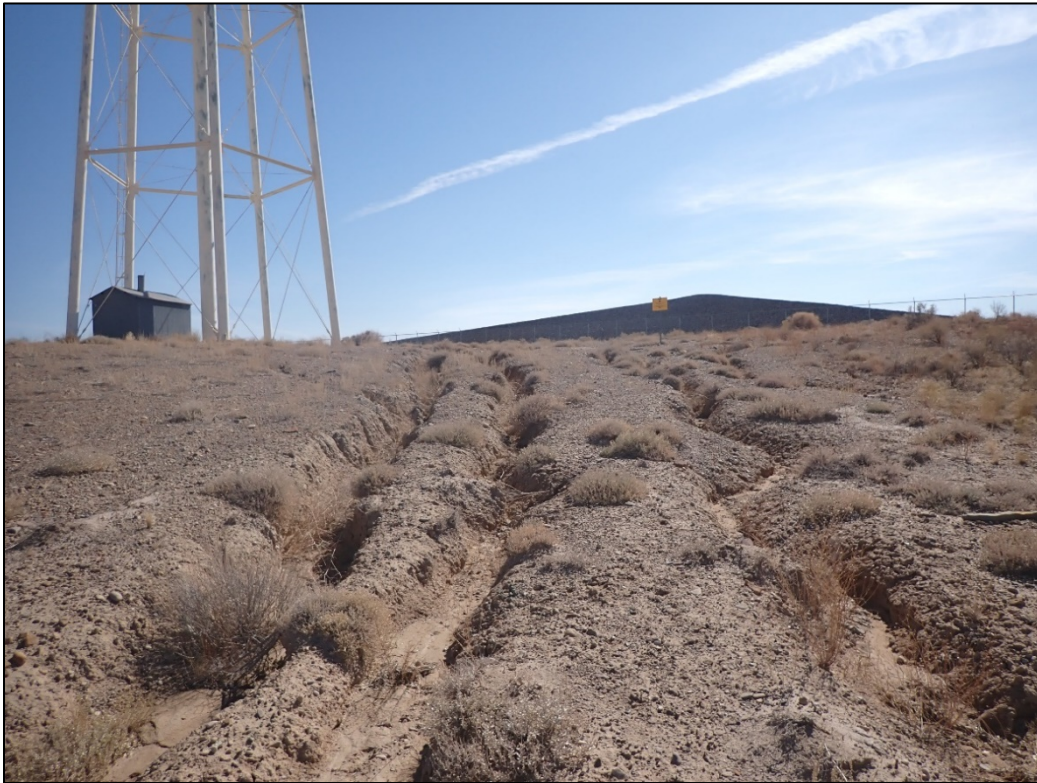
Areas of erosion noted during previous inspections include the natural drainage near the southwest side of the site and rills and gullies northwest of the water tower (PL-15). Evidence of continued erosion in these areas was apparent but does not threaten the integrity of the disposal

cell or site surveillance features. Inspectors will continue to monitor these erosional features. No maintenance needs were identified.

*PL-15. Soil Erosion (Offsite)*
