PRELIMINARY SURVEY OF
VITRO CORPORATION
(VITRO LABORATORIES)
WEST ORANGE, NEW JERSEY

Work performed
by the
Health and Safety Research Division
Oak Ridge National Laboratory
Oak Ridge, Tennessee 37830

March 1980

OAK RIDGE NATIONAL LABORATORY
operated by
UNION CARBIDE CORPORATION
for the
DEPARTMENT OF ENERGY
as part of the
Formerly Utilized Sites--
Remedial Action Program

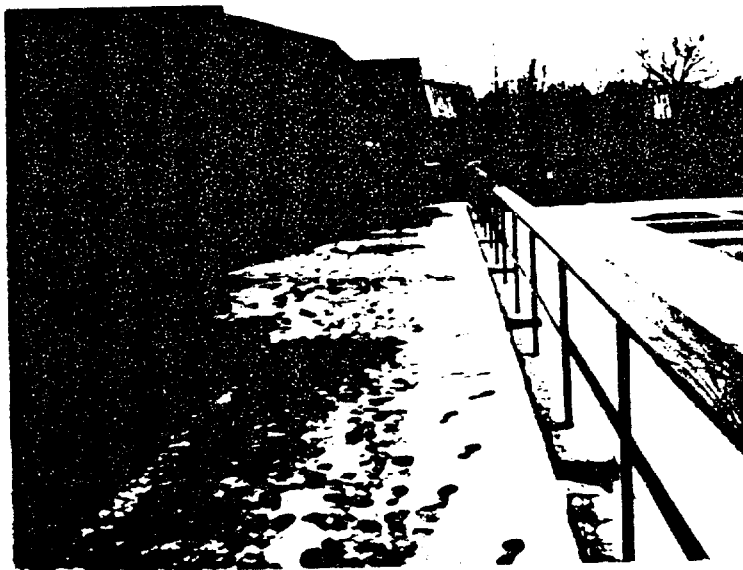
Fig. 2. Photographs showing present status of site.

Racquetball Clubhouse

Stream separates upper and lower tennis courts and clubhouses (water sample and soil sample taken on left bank)

The entire site, including the building where the contract work was conducted, has been purchased by the West Orange Tennis Club, Inc. The building has been completely demolished, and there is presently no trace of the original structures (see Figs. 2, 3, and 4). No information was available as to the disposition of building debris or equipment utilized in the process. There was also no information available as to the radiological status of the facility when the work was terminated; however, there was indication that some waste associated with Vitro operations may have been buried at sea.

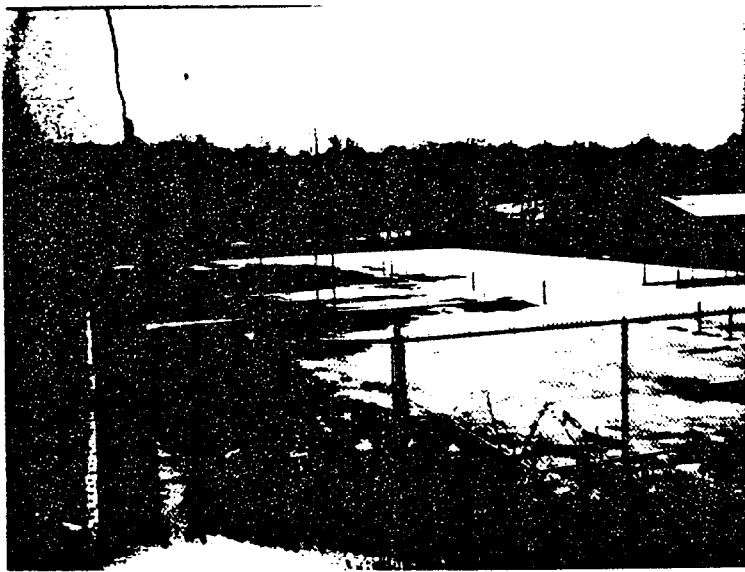
Fig. 4. Photographs showing present status of site.

View from Pleasant Valley Way showing upper tennis courts and clubhouse

View of lower tennis courts and clubhouse from access road
