**Status and Performance of the On-Site Disposal Facility
Fernald Preserve, Cincinnati, Ohio—11137**

Jane Powell*, Richard J. Abitz**, Kenneth A. Broberg***,
William A. Hertel***, and Frank Johnston***

ABSTRACT

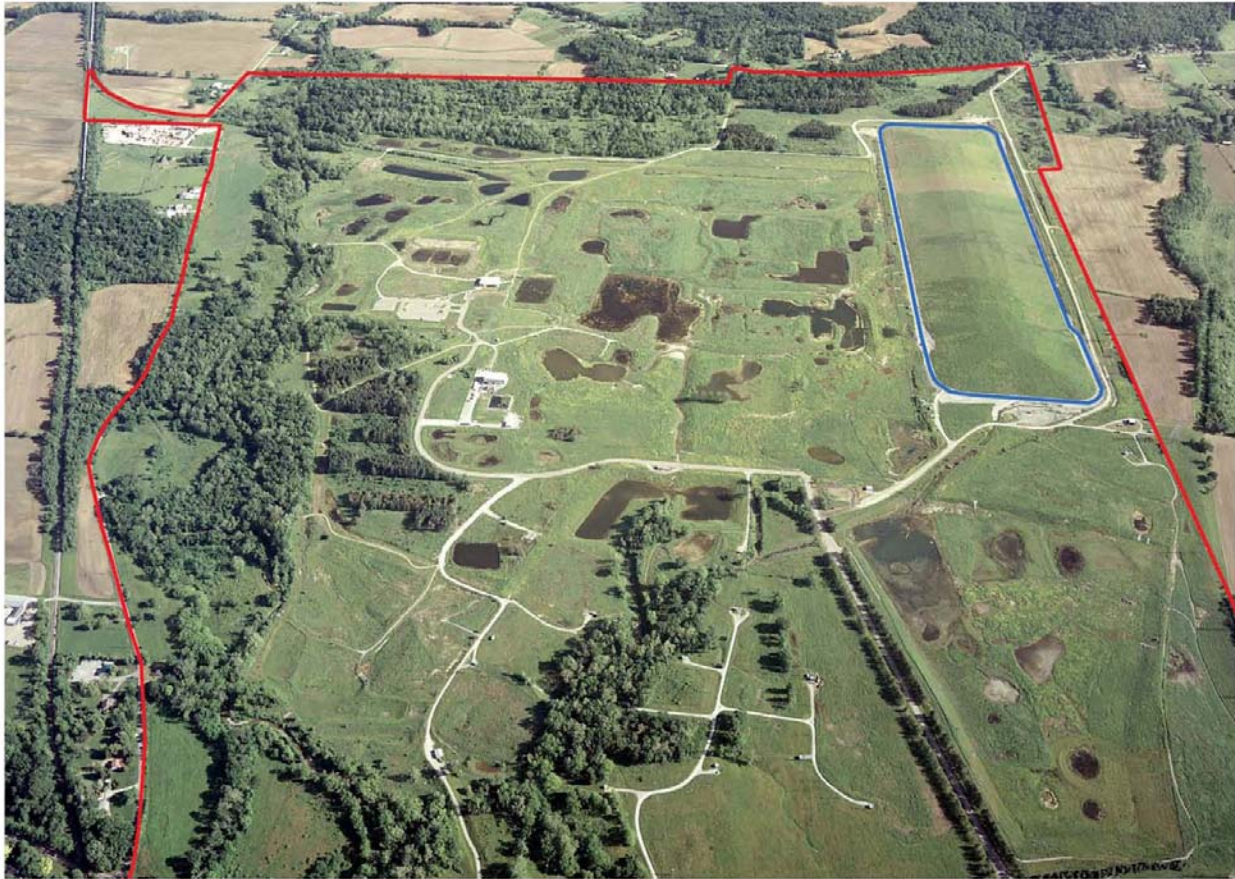
Fig. 1. Aerial View of the Fernald Site (outlined in red) June 2010 with OSDF Outlined in Blue.

The OSDF occupies approximately 36 ha in the northeast area of the Fernald Preserve (Fig. 1). It has a capacity of 2.26 million cubic meters and a maximum height of approximately 20 m. The facility consists of eight individual cells with a multilayer composite cover system nearly 3 m thick. Fig. 2 depicts the individual components of the cover. The purpose of the cover is to keep water, plant roots, and burrowing animals out of the facility.

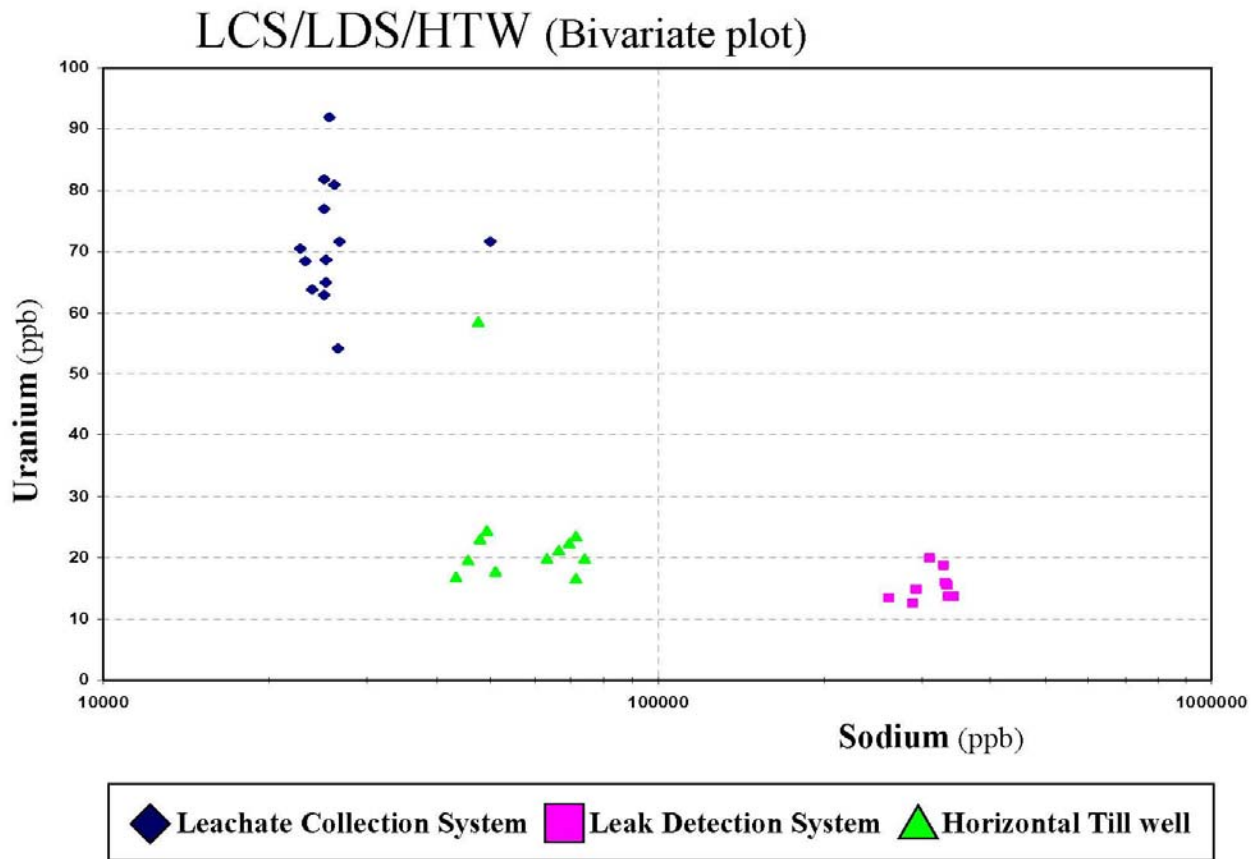
Fig. 4. Typical Uranium – Sodium Bivariate Plot.

Bivariate plots for each cell show that the chemical signatures of the uranium-sodium concentrations in the LCS, LDS, and HTW of each cell in the OSDF plot in distinct fields, indicating that mixing between the monitoring horizons is nonexistent or too insignificant to detect (Fig. 4). For example, if there was significant leakage from the LCS to the LDS, the LDS points would trend toward the LCS field. The same observation would hold for leakage from the LDS to the HTW. However, as noted above, there is no hydraulic drive to push fluid through the primary and secondary liners if there were a breach in the liners. Based on the LCS/LDS volumes and bivariate plots, the probability is very low to insignificant that leakage is occurring through the liners and the increasing concentration trends noted in the HTW are attributed to fluctuating residual contaminant concentrations beneath the facility.
