Post-Closure Inspection Report for the Tonopah Test Range and Nevada Test and Training Range, Nevada

For Calendar Year 2020

U.S. Department of Energy, Environmental Management Nevada Program
Las Vegas, Nevada

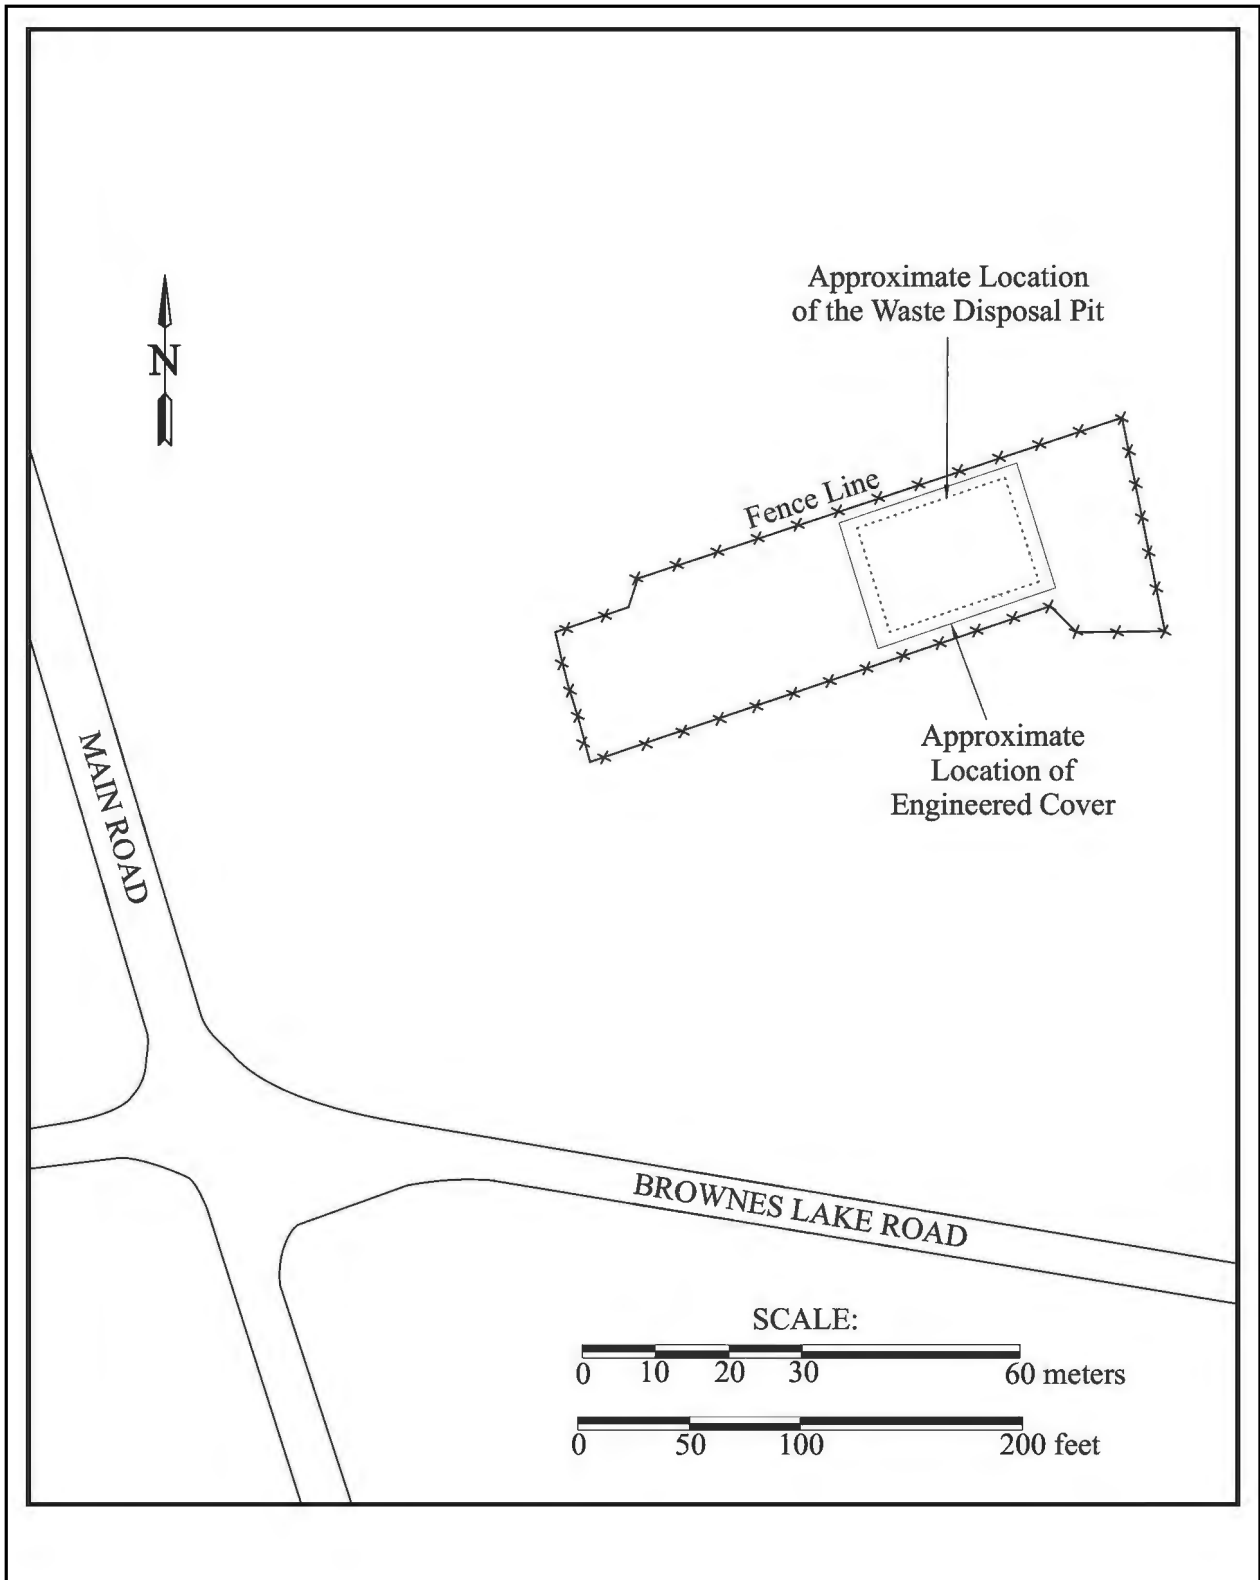
Figure A-2
CAU 407 Roller Coaster RadSafe Area Location Map

The visual inspection was conducted on May 20, 2020. All signs are legible. However, one sign was loose and was rehung during the inspection. No other issues or concerns were identified.

One sign was loose and was rehung during the inspection. No other issues or concerns were identified, and no additional recommendations are proposed at CAS TA-23-001-TARC, Roller Coaster RadSafe Area.

- **CAU 407**, CAS TA-23-001-TARC (Roller Coaster RadSafe Area): A UR sign was loose and was rehung during the inspection.
- **CAU 424**, CAS 03-08-002-A304 (Landfill Cell A3-4): The northeast monument needed a UR sign. The UR sign was attached to the monument on August 11, 2020.
- **CAU 424**, CAS 03-08-002-A308 (Landfill Cell A3-8): The southeast monument needed additional lava rock. The lava rock was added during the inspection.

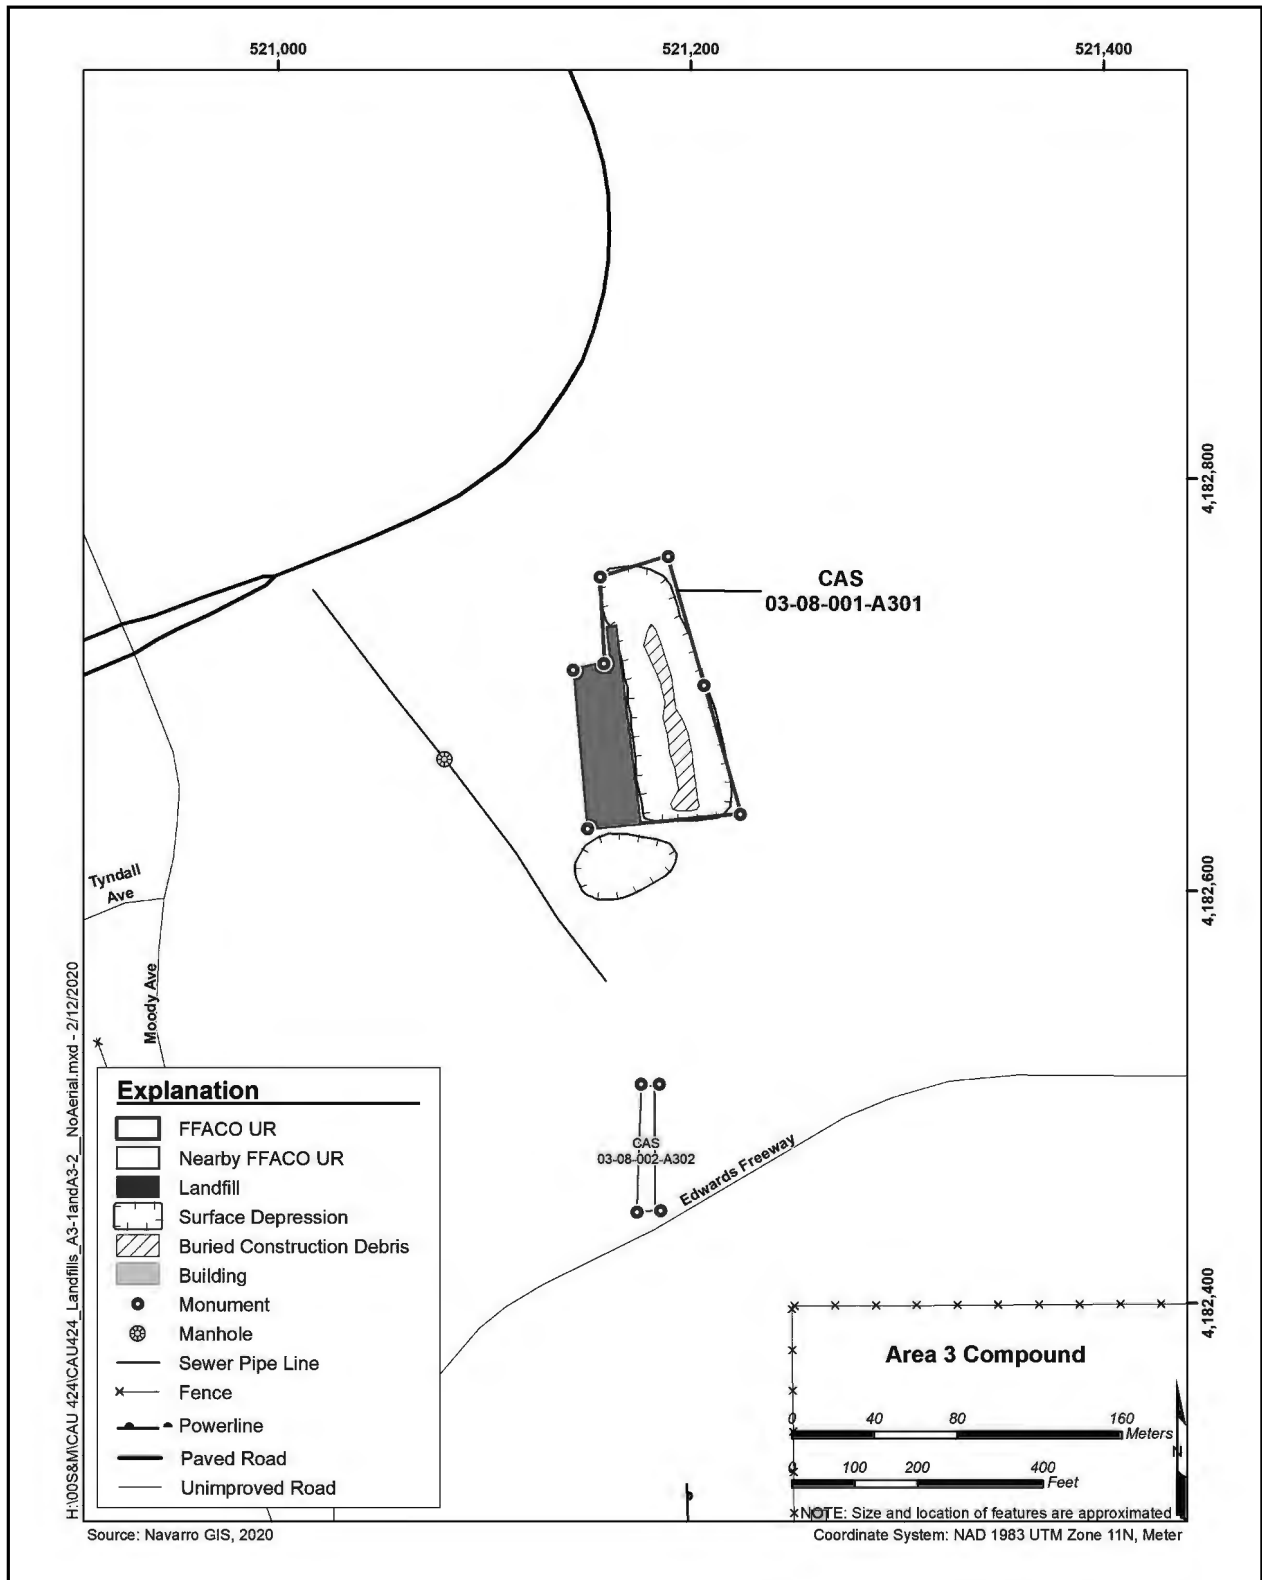
Figure A-4
CAU 424 Landfill Cells A3-1 and A3-2

Landfill Cell A3-1 (CAS 03-08-001-A301): All signs, monuments, survey markers are in good order. Markers denoted landfill identification, and Northings and Eastings. All corner monuments have warning signs. No issues were noted. The site is shown in [Figure A-4](#) of [Appendix A](#).

Landfill Cell A3-2 (CAS 03-08-002-A302): All signs, monuments, survey markers are in good order. Markers denoted landfill identification, and Northings and Eastings. All corner monuments have warning signs. No issues were noted. The site is shown in [Figure A-4](#) of [Appendix A](#).

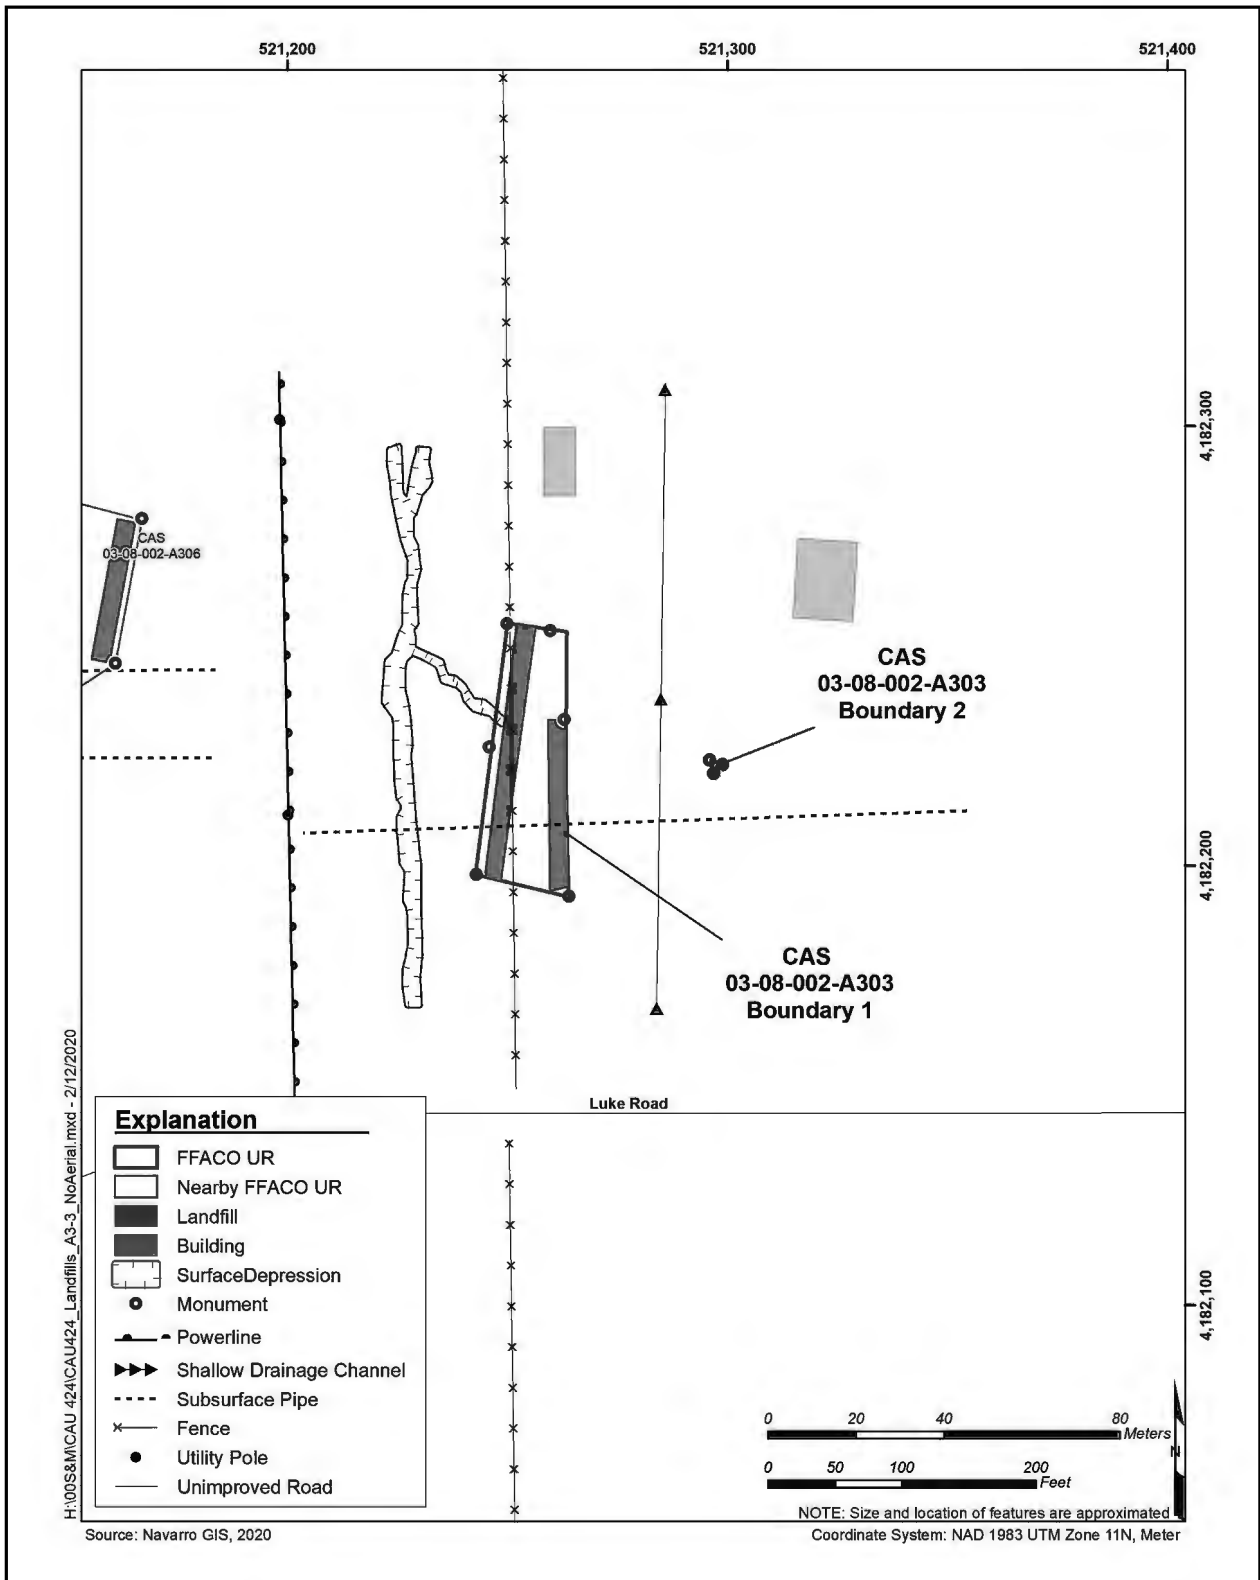
Figure A-5
CAU 424 Landfill Cell A3-3

Landfill Cell A3-3 (CAS 03-08-002-A303): All signs, monuments, survey markers (on the monuments), and ground survey markers are in good order. Markers embedded in aboveground monuments denoted landfill identification, and Northings and Eastings. All aboveground monuments have warning signs. All markers embedded in ground flush monuments denoted landfill identification, and Northings and Eastings. Two markers embedded in ground flush monuments (one per parcel) denoted warning. No issues were noted. The site is shown in [Figure A-5](#) of [Appendix A](#).

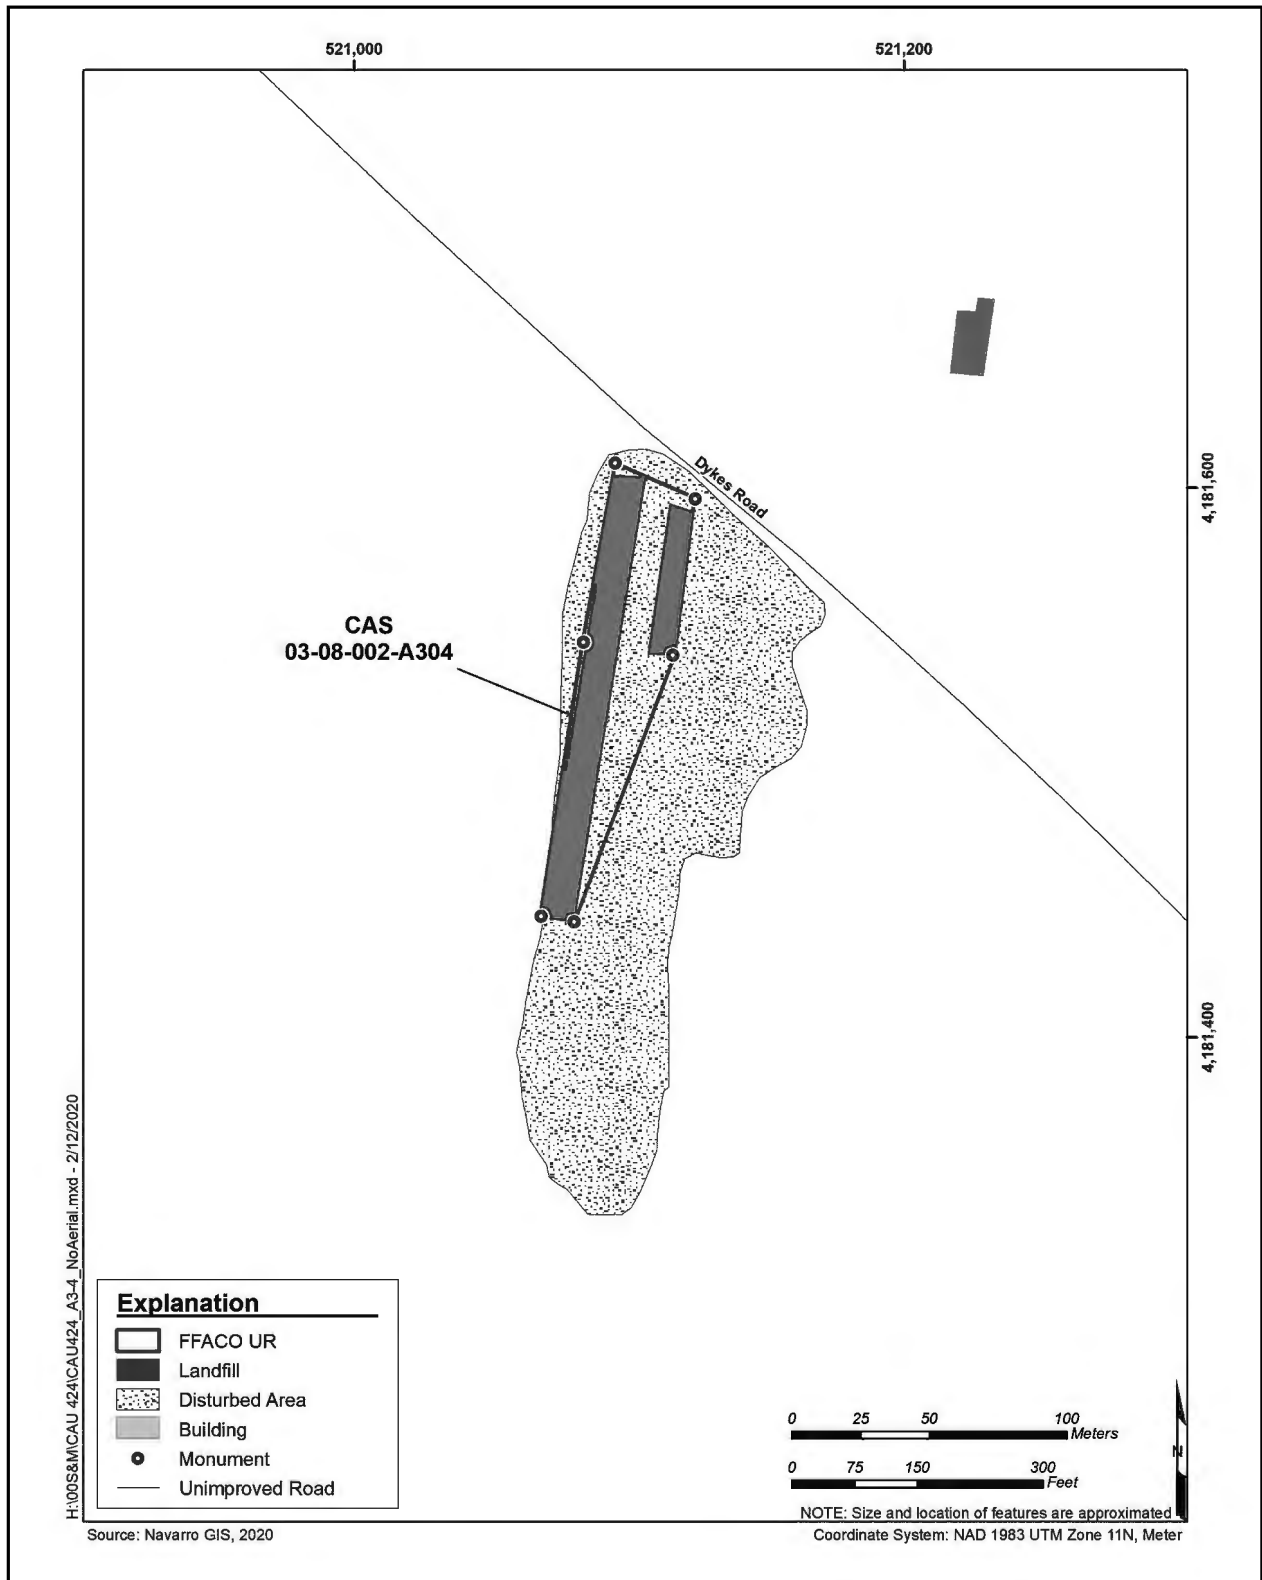
Figure A-6
CAU 424 Landfill Cell A3-4

Landfill Cell A3-4 (CAS 03-08-002-A304): A UR sign needed to be hung on the northeast monument. All other signs, monuments, and survey markers are in good order. Markers denoted landfill identification, and Northings and Eastings. All monuments (except the northeast) have warning signs. A warning sign was mounted on the northeast monument on August 11, 2020. No other issues were noted. The site is shown in [Figure A-6](#) of [Appendix A](#).

- **Landfill Cell A3-3 (CAS 03-08-002-A303).** No issues or concerns were identified, and no additional recommendations are proposed.
- **Landfill Cell A3-4 (CAS 03-08-002-A304).** All monuments (except the northeast) have warning signs. No other issues were noted. A warning sign was mounted on the northeast monument on August 11, 2020. No other issues or concerns were identified, and no additional recommendations are proposed.

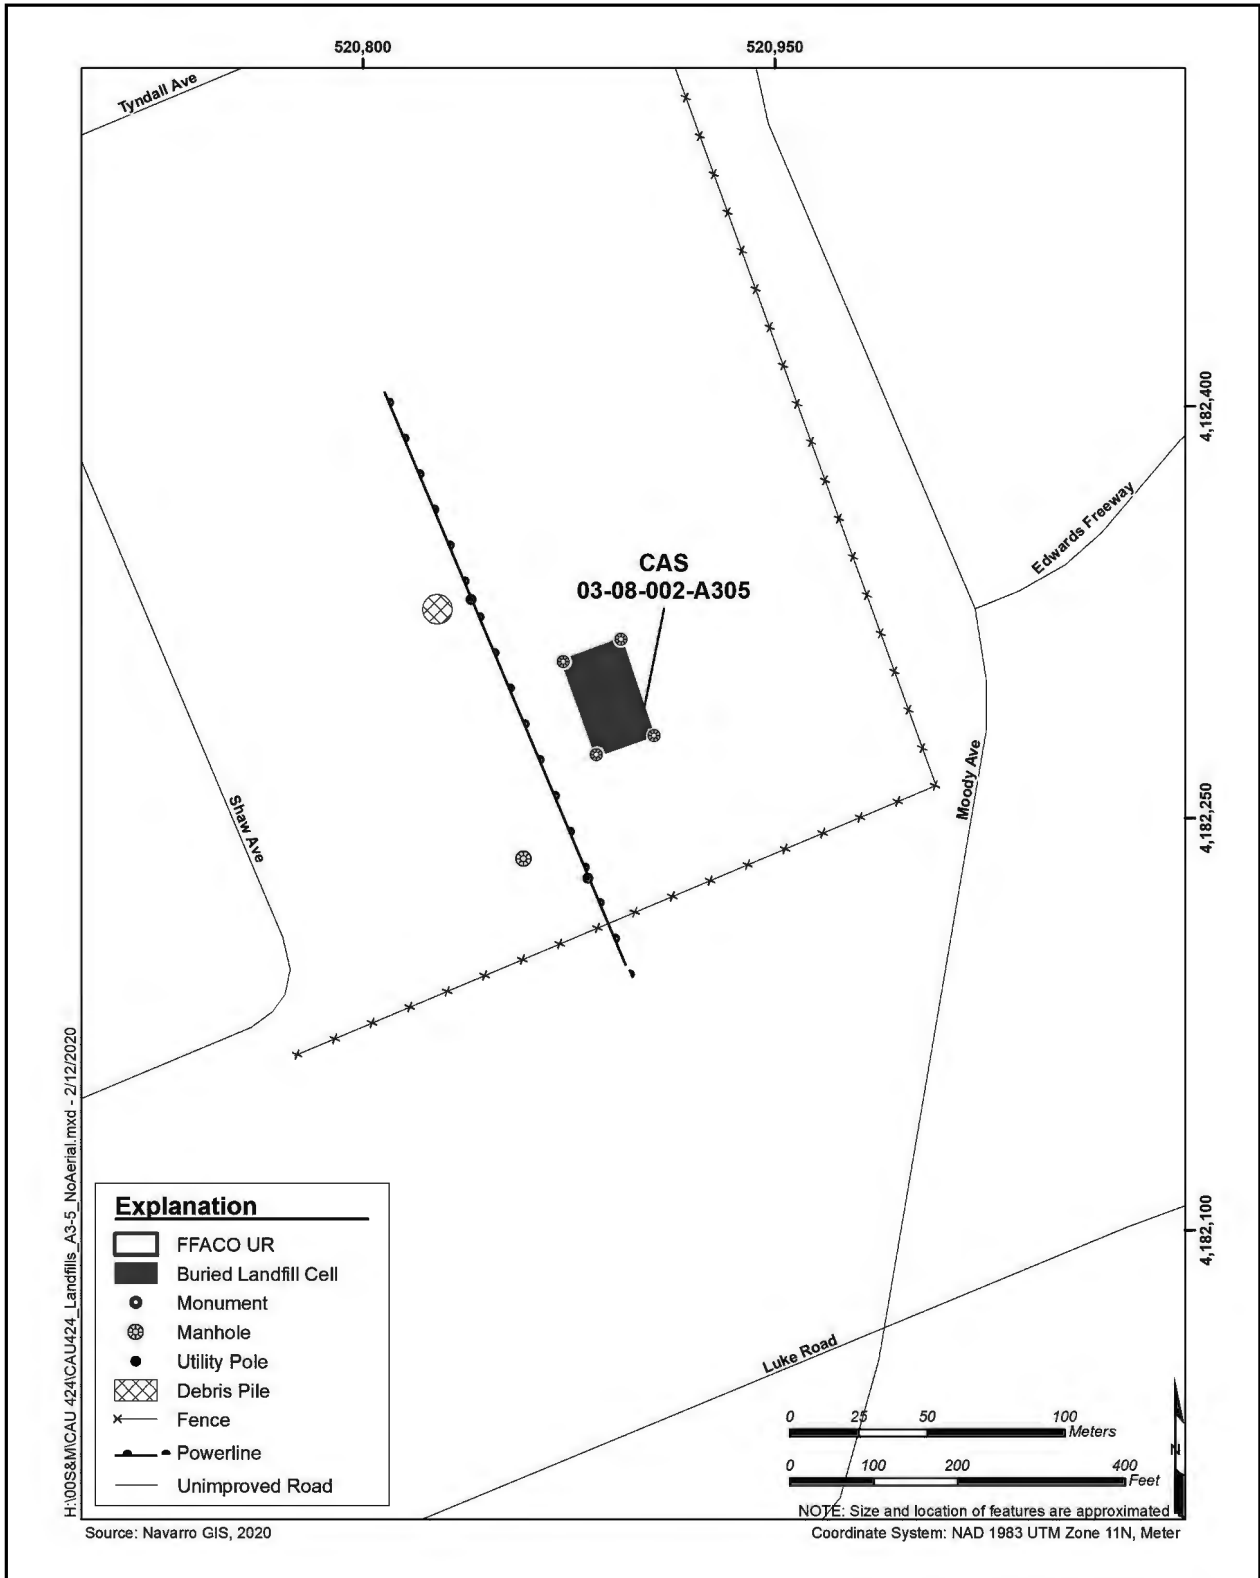
Figure A-7
CAU 424 Landfill Cell A3-5

Landfill Cell A3-5 (CAS 03-08-002-A305): All signs, monuments, and survey markers are in good order. Markers denoted landfill identification, and Northings and Eastings. All monuments have warning signs. No issues were noted. The site is shown in [Figure A-7](#) of [Appendix A](#).

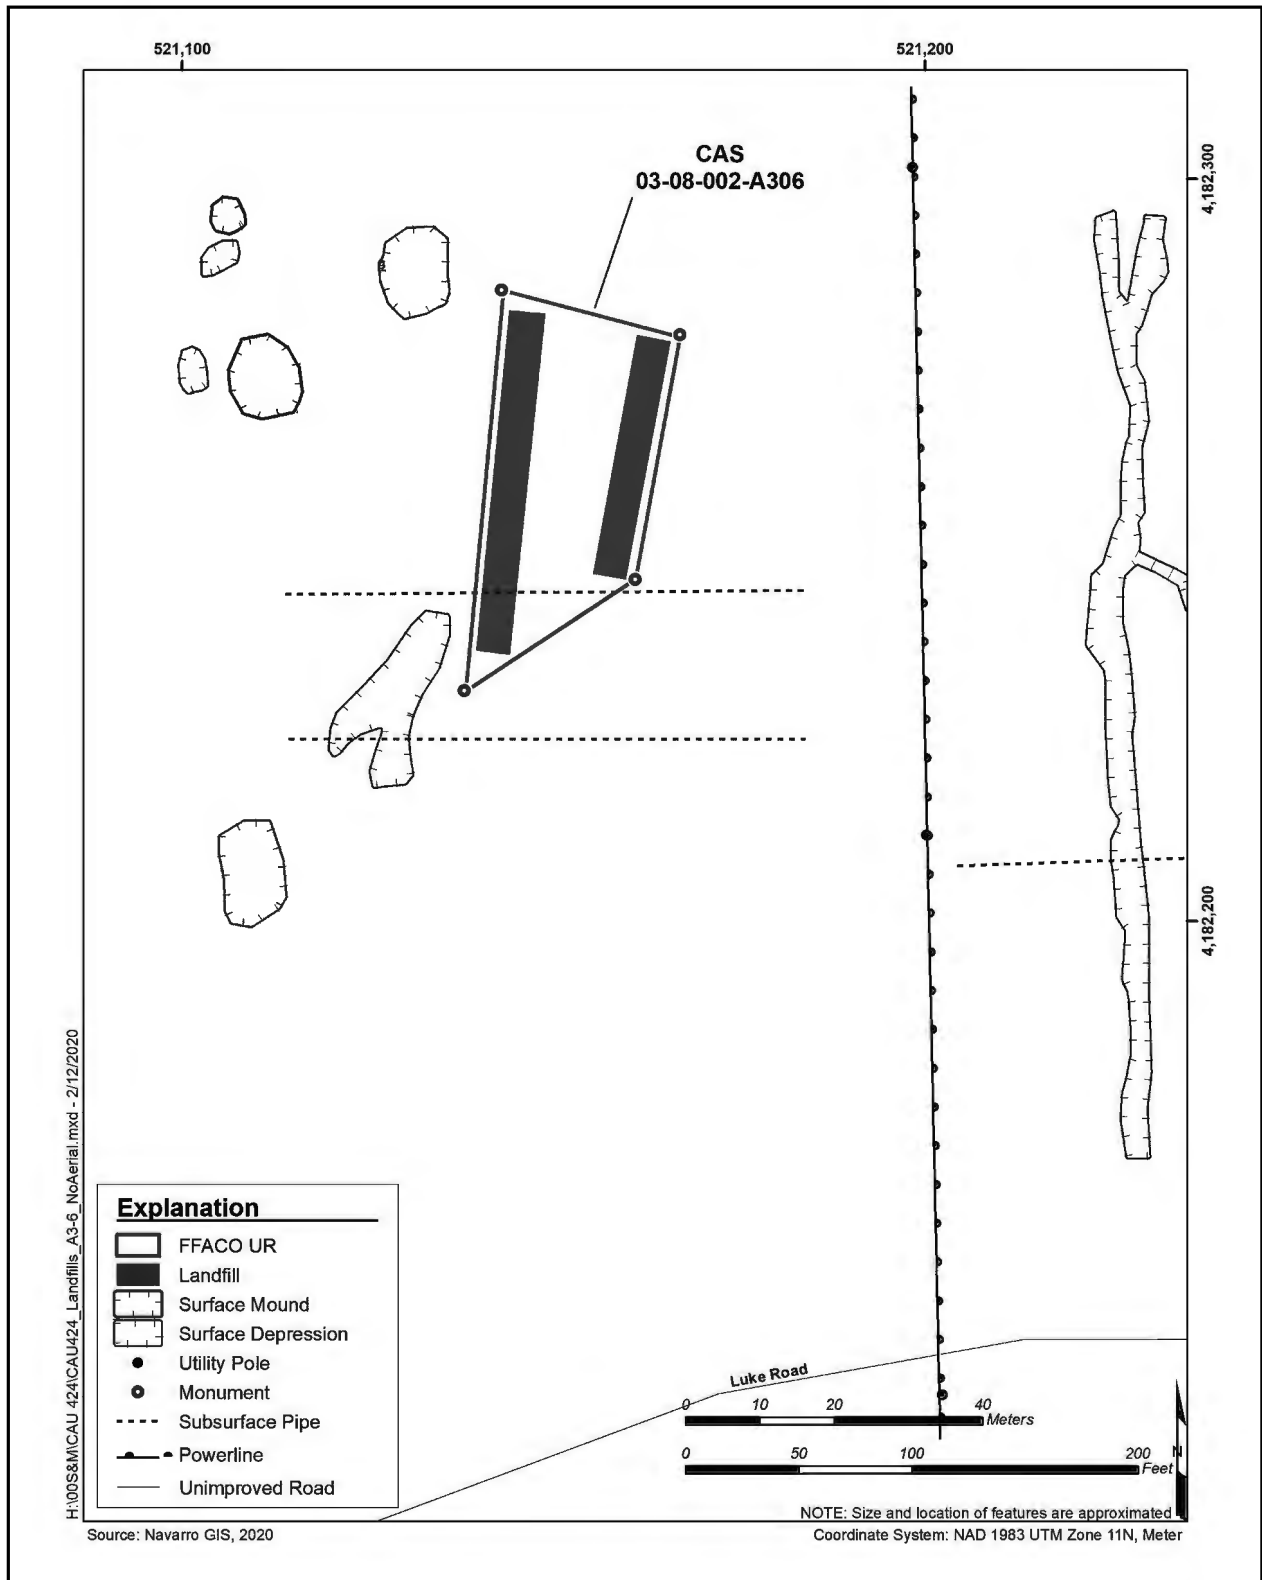
Figure A-8
CAU 424 Landfill Cell A3-6

Landfill Cell A3-6 (CAS 03-08-002-A306): The site is made up of two land parcels: a small triangle-shaped area to the east, and a rectangle-shaped area to the west. All signs, monuments, and survey markers are in good order. Markers denoted landfill identification, and Northings and Eastings. All monuments have warning signs. No issues were noted. The site is shown in [Figure A-8](#) of [Appendix A](#).

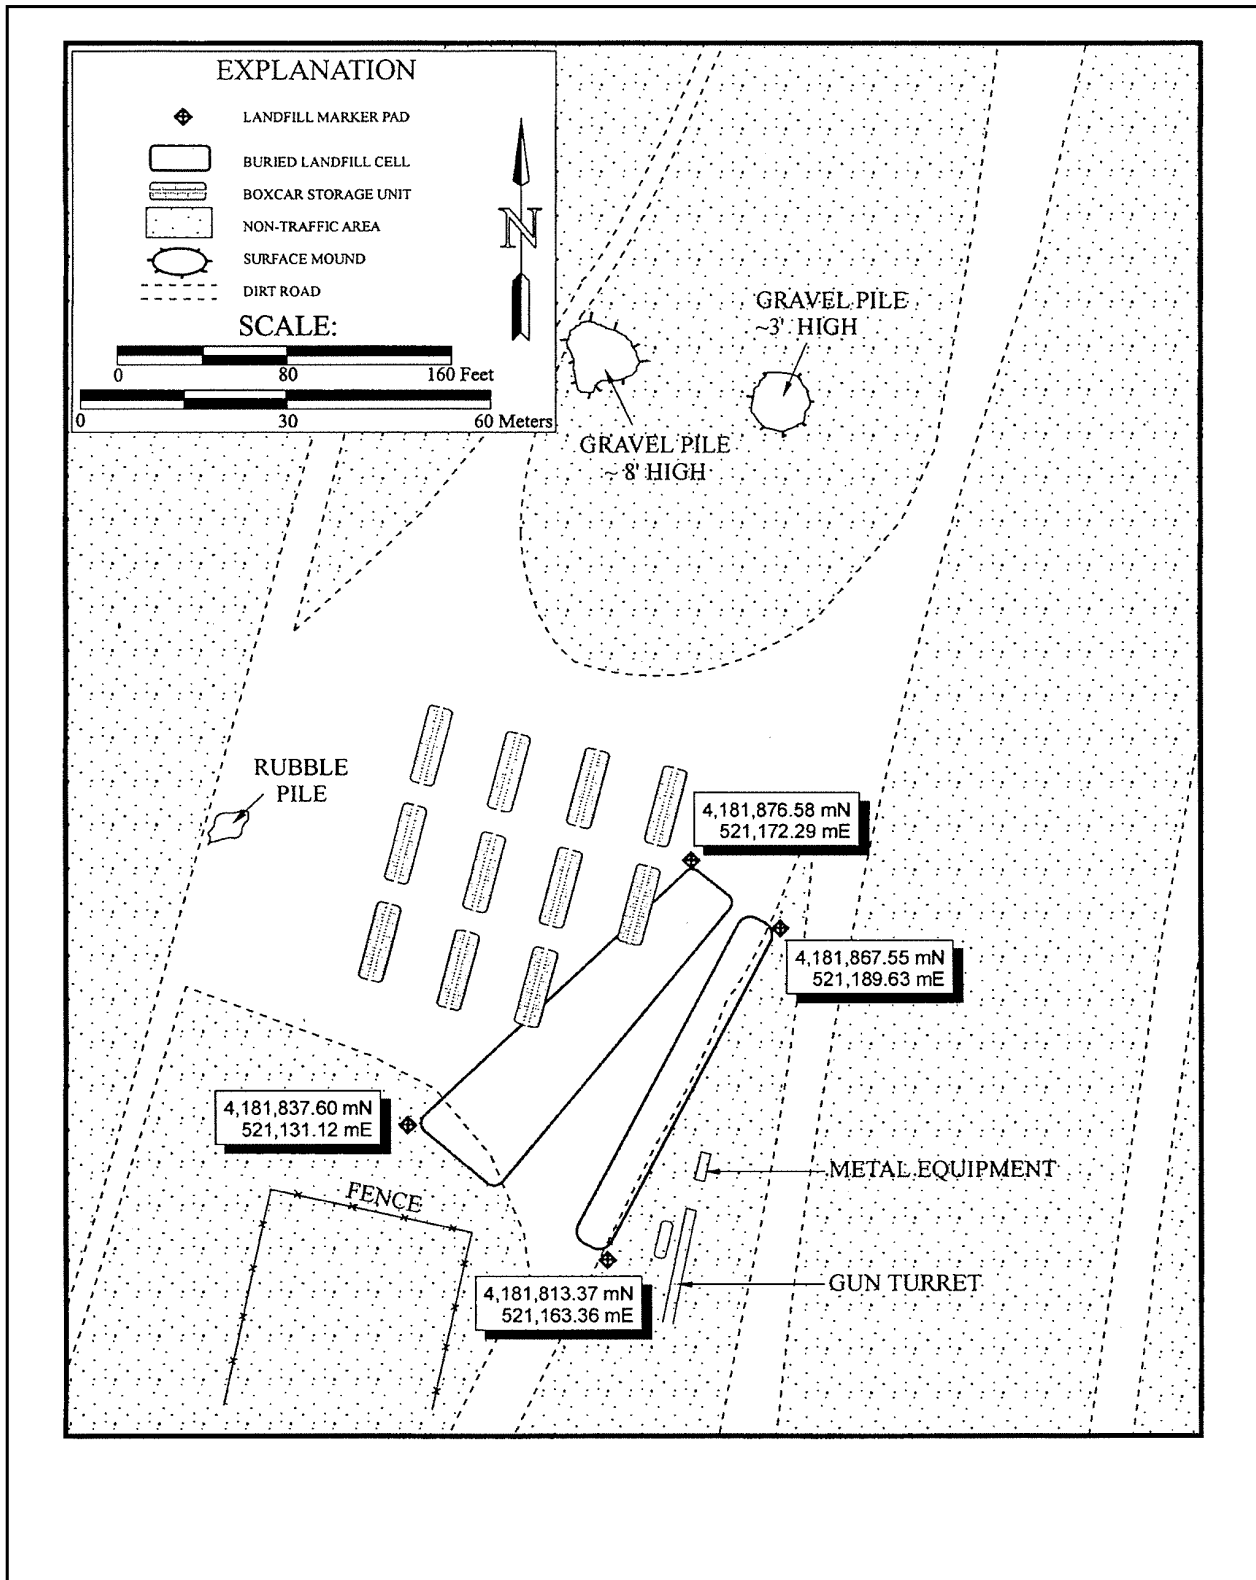
Figure A-9
CAU 424 Landfill Cell A3-8

ground survey marker during the inspection. No other issues were noted. The site is shown in [Figure A-9 of Appendix A](#).

- **Landfill Cell A3-8 (CAS 03-08-002-A308).** Although all ground survey monuments and markers are in good order, additional colored marking rock was added to the southeast ground survey marker during the inspection. No other issues or concerns were identified, and no additional recommendations are proposed.

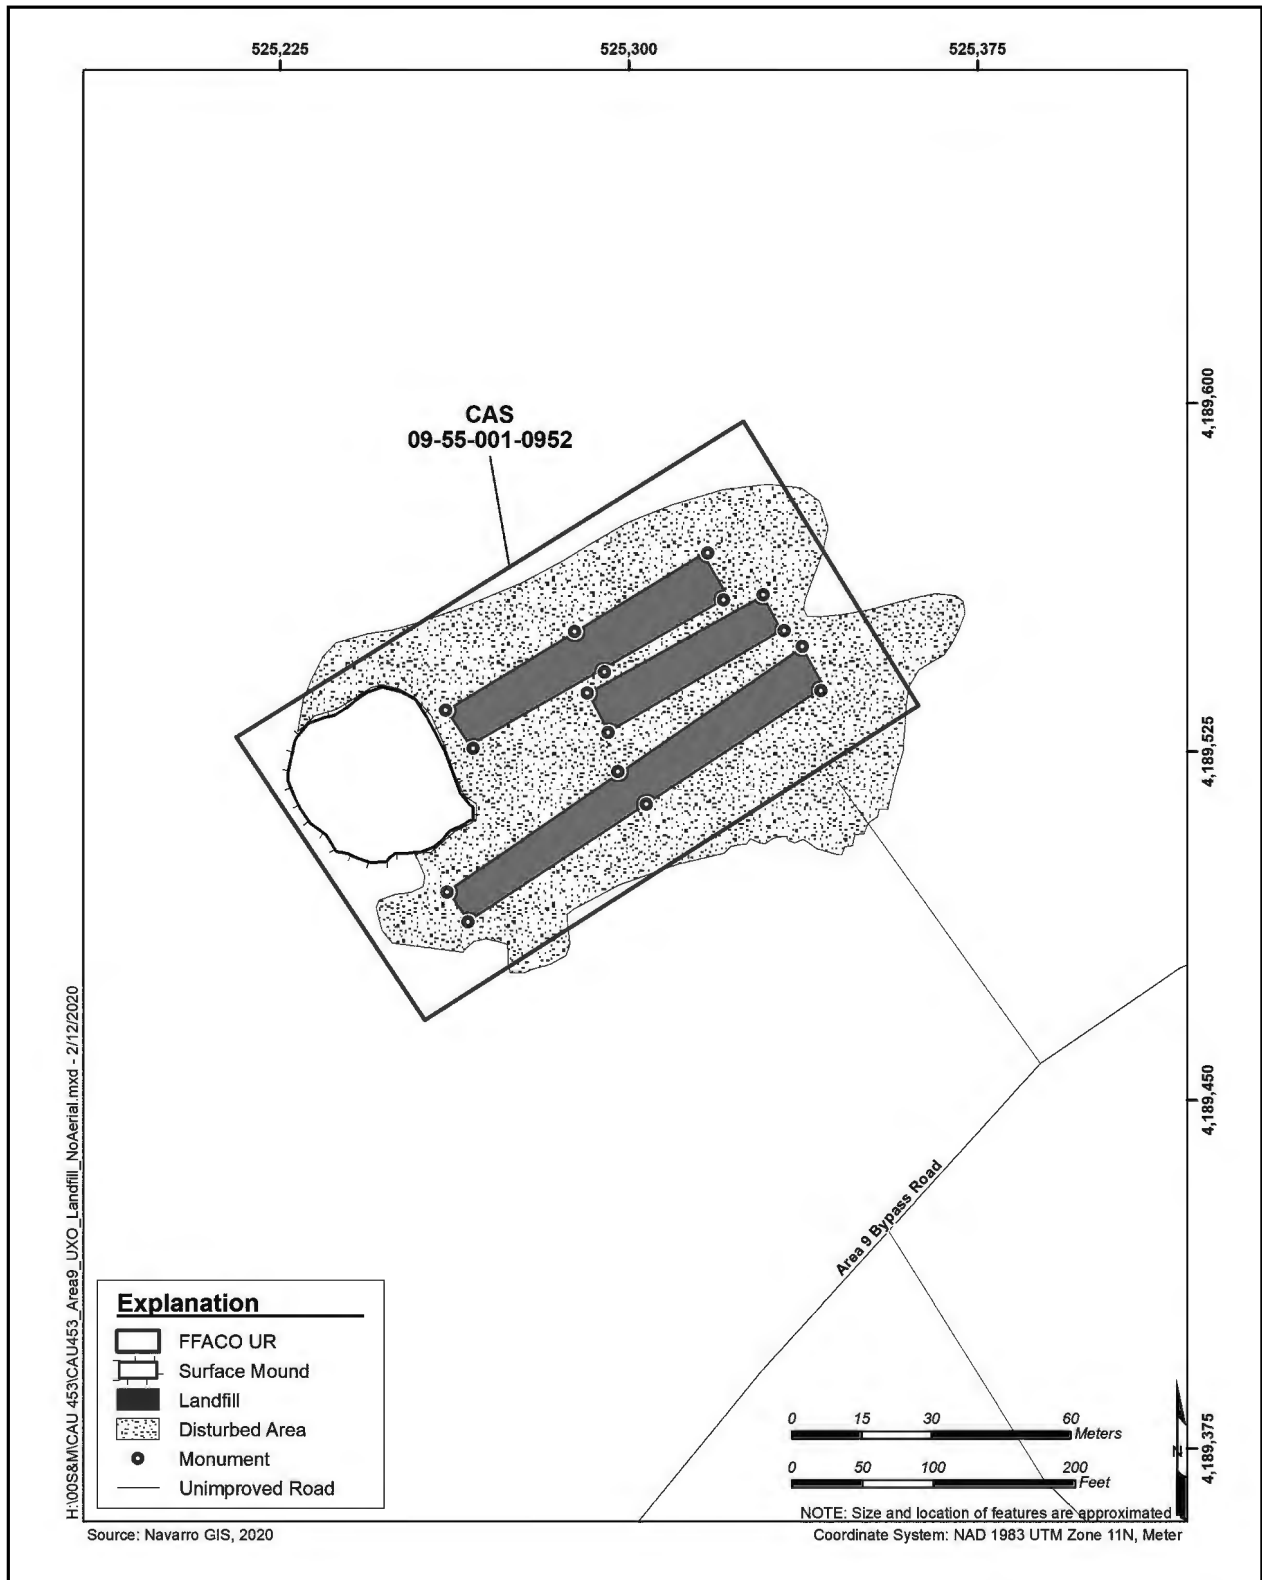
Figure A-10
CAU 453 Area 9 UXO Landfill Location Map

Two animal burrows were noted in the western portion of the northern and southern trenches (one burrow per trench). The animal burrows were repaired on August 11, 2020. No other issues or concerns were identified, and no additional recommendations are proposed at CAS 09-55-001-0952, Area 9 Landfill.

- **CAU 453**, *CAS 09-55-001-0952 (Area 9 Landfill)*: Two animal burrows were noted in the western portion of the northern and southern trenches (one burrow per trench). The animal burrows were repaired on August 11, 2020.

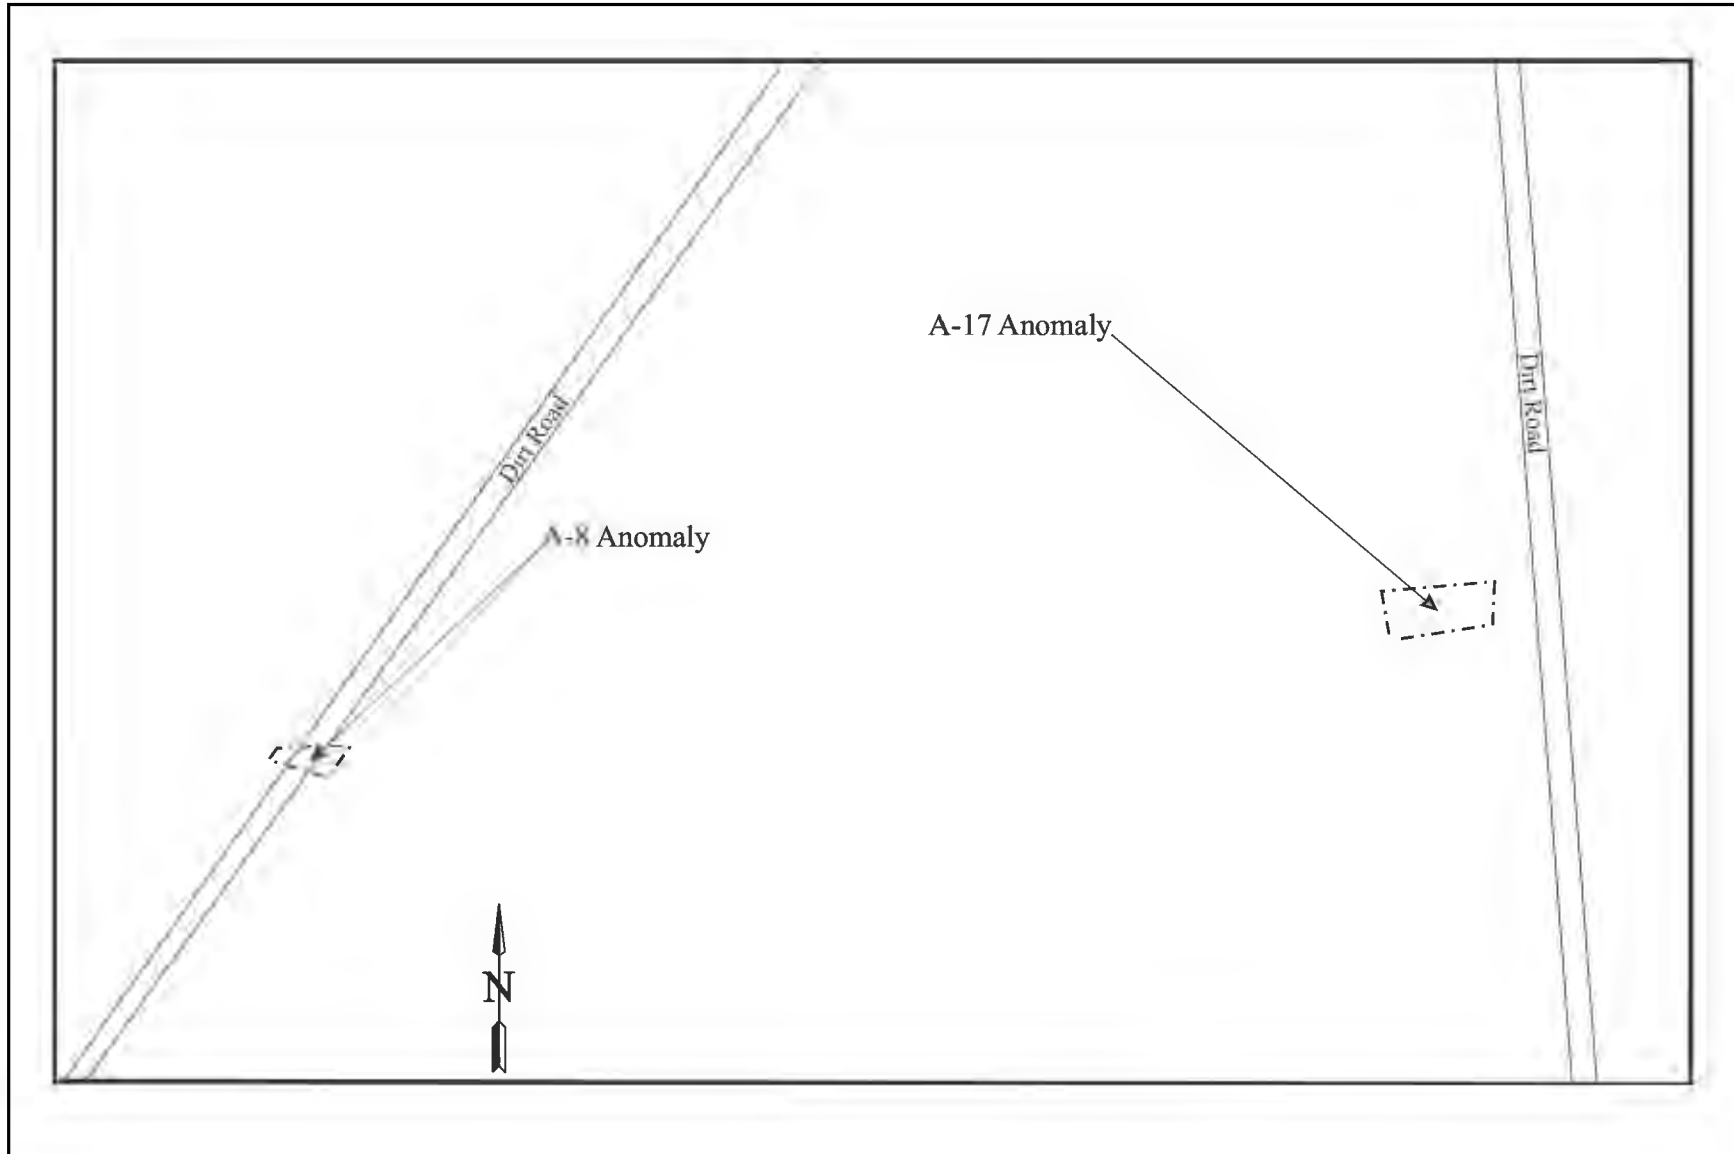
Figure A-11
CAU 487 Thunderwell Site Location Map

Visual inspections are conducted according to the post-closure requirements for CAU 487, Thunderwell Site (TTR), CAS RG-26-001-RGRV, Thunderwell Site, as described in the CAU 487 UR (DOE/EMNV, 2019d). The site is shown in [Figure A-11 of Appendix A](#). The annual inspection was conducted on May 20, 2020. The site is made up of two land parcels: the eastern area of A-17 Anomaly, and the western area of A-8 Anomaly. All signs, monuments, and survey markers are in good order. Markers denote Northings and Eastings. All monuments have warning signs. No issues were noted.

No issues or concerns were identified, and no additional recommendations are proposed at CAS RG-26-001-RGRV, Thunderwell Site.
