# Burris Park, California, Site Long-Term Surveillance and Maintenance Plan

September 2023

Legacy  
Management

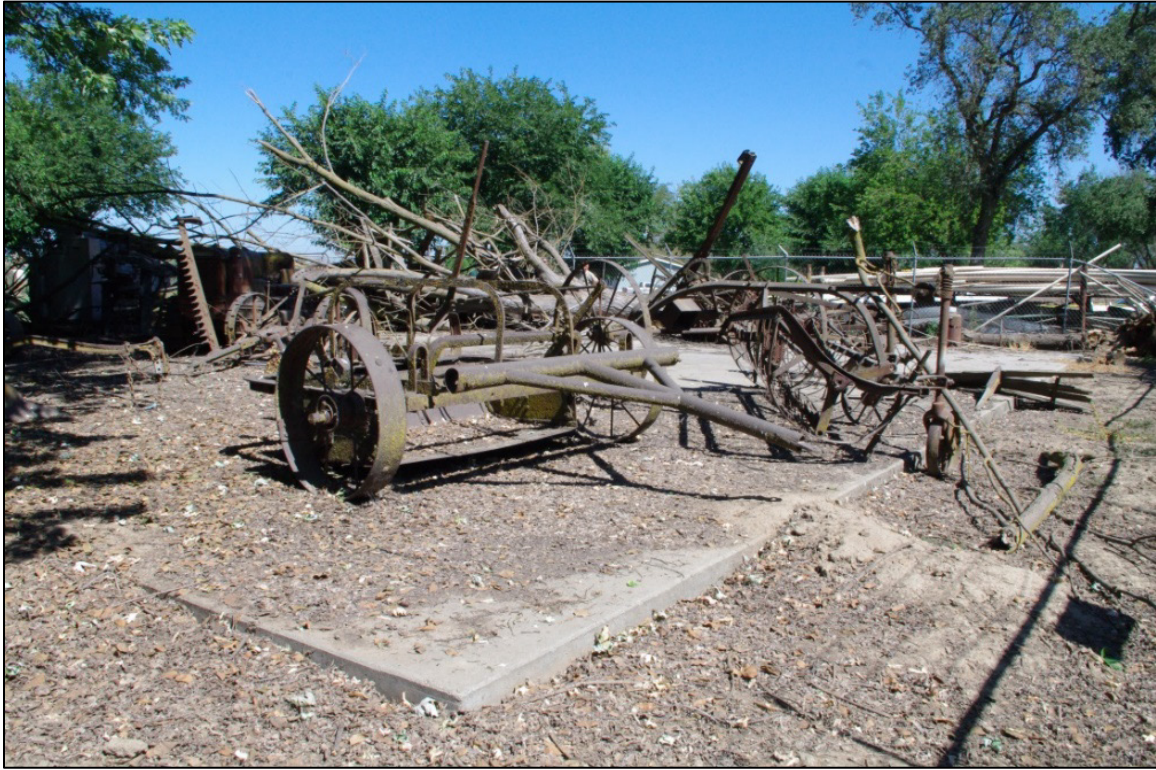
*Figure 2. Burris Park, California, Site (Interior Fence), July 2014*

In 2013, UC Berkeley staff contacted LM to discuss maintenance needs at the site. Representatives of LM visited the BPS on January 22, 2014, and observed that the fenced area was in disrepair. The protective concrete slab capping the  $^{90}\text{Sr}$  test plots was covered with broken tree limbs and debris. Some pieces of the farm exhibit and a section of the chainlink fence surrounding the protective slab were crushed from fallen dead trees within the fenced area.

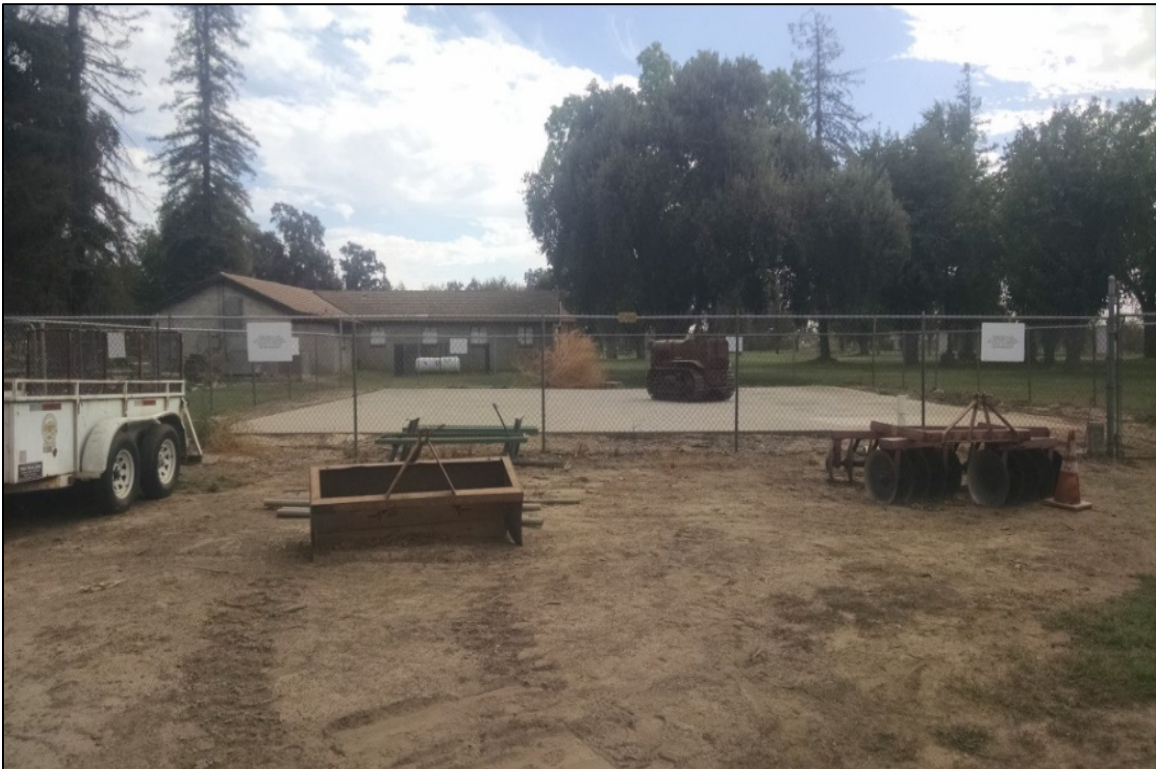
*Figure 3. Burris Park Site After Maintenance Activities, Looking West, September 2016*

LM repaired the crushed portions of the fence and entrance gate and removed the barbed wire that surrounded the site. LM also updated the signage with DOE's contact information and requested that Kings County remove the old farm equipment from the pad (Figure 2 and Figure 3). The site contained four large maple trees: Two were alive, and two were dead and had fallen over. UC Berkeley performed 10–15 borings per tree and collected more than 100 grams of sample material from each tree. Samples were collected using multiple cores from different portions of the tree at varying heights and perimeter locations to reduce errors associated with possible distributional heterogeneity of deposited <sup>90</sup>Sr. UC Berkeley analyzed composite core samples, as well as samples of branches and bark from the live and dead trees to determine whether they were contaminated as a result of fixed <sup>90</sup>Sr. UC Berkeley also selected a tree, distant from the research area and of an equivalent age and species, to collect background samples of core, bark, and branches using the same sampling and analytical methods. The sampling plans and analytical data resulted in a determination that at least two of the trees contained very low concentrations of <sup>90</sup>Sr from biouptake. Subsequently, LM cut, packaged, and removed the four trees in September 2015 and disposed of them at a facility licensed to receive <sup>90</sup>Sr.

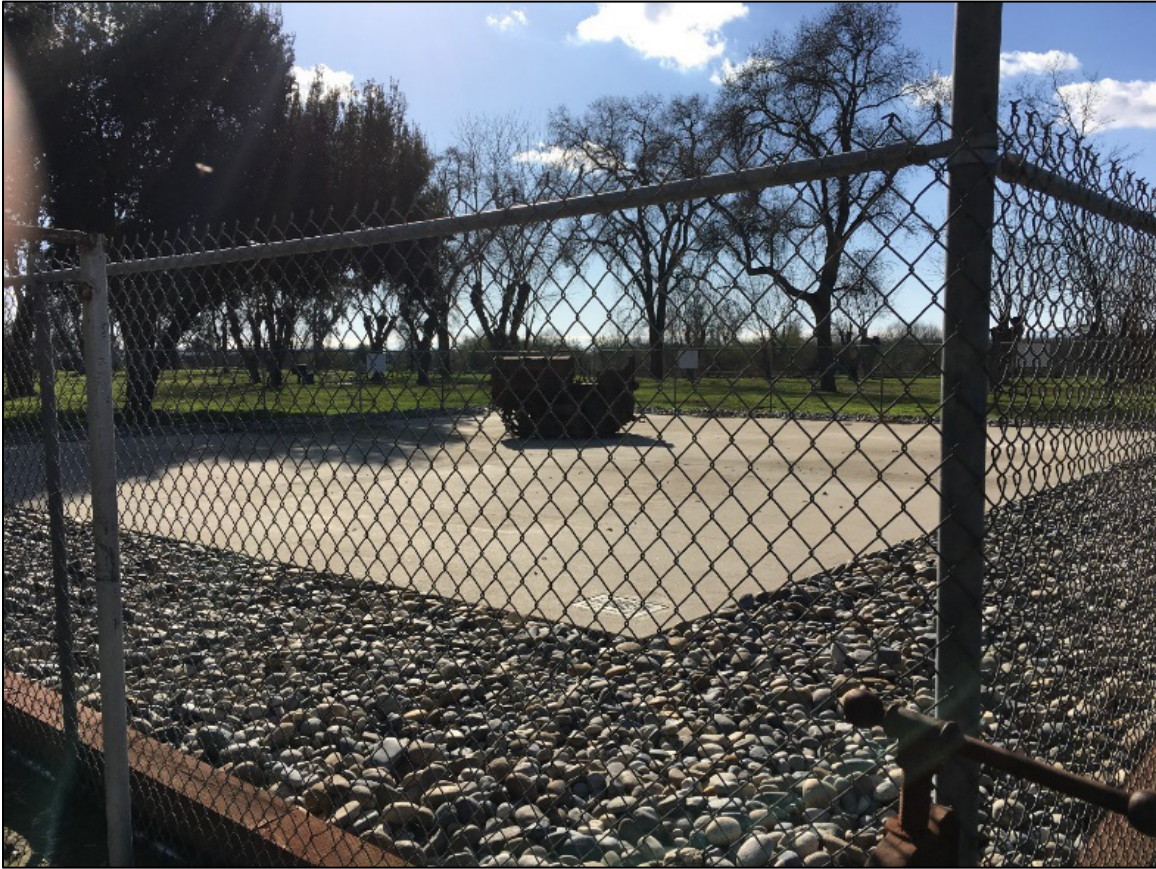
*Figure 4. Burris Park Site After 2018 Maintenance Activities, Looking West, February 2019*

In March 2018, vegetative management and minor site maintenance activities were conducted at the site before the 2018 season opening. Specific activities included landscape barrier and riprap placement around the protective pad within the fence to control dust and deter vegetative growth and animal burrowing. Also, fence improvements were made to the bottom rail to retain the newly placed riprap, and the vehicle gate was altered to swing outward (Figure 4). In February 2019, the annual inspection found the site in excellent condition with no follow-up action required.

1. In fall 2018, DOE conducted work at the site to add fabric and stone cover between the pad and the fence and reverse the gate so it opens outward for easier access.
