# Inspection Status Report of Site A/Plot M

*Report for 2022*

Environment, Health, and Safety Directorate

prepared by  
Gerald A. Baudino

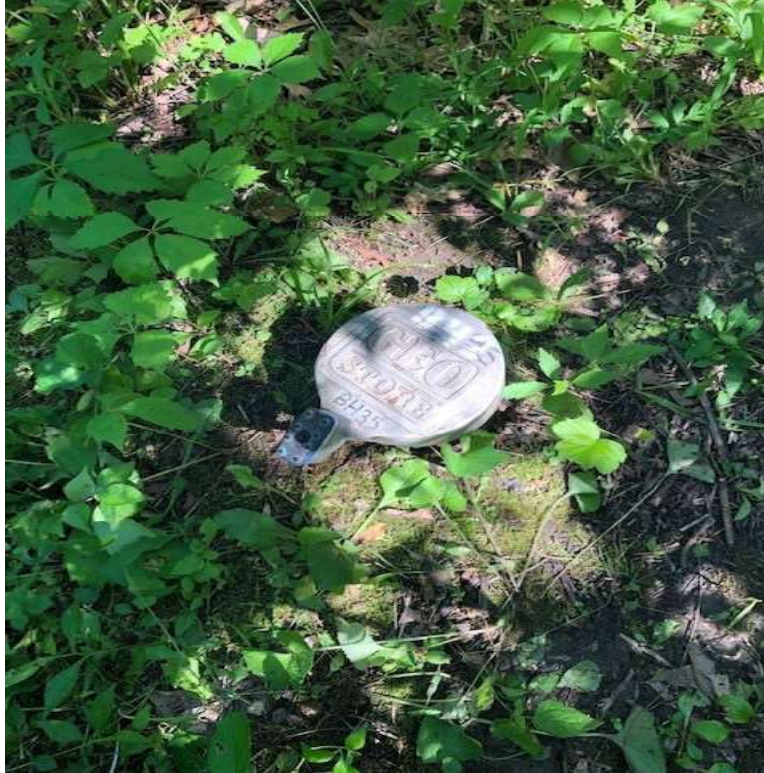
P05 - Monitoring Well BH35 (View #1) at Plot M

All groundwater wells at Plot M were locked and intact and found to be in good condition with all well numbers on the outer casing. During a previous groundwater sampling event, Argonne noted that the well cap to BH35 had been forcibly removed. Immediate action by Argonne involved borrowing the well cap from BH2 and placing it on BH35. A new well cap was subsequently placed on BH2. Cited as an improvement opportunity, and further discussed in Section 5.0 of this report, Argonne will re-paint the label to the BH35 well cap. Photographs P01 through P07 show the various monitoring wells at Plot M. Argonne personnel are keeping the Plot M monitoring wells secure and in good condition.

3. **Improvement Opportunity #3:** Repaint and/or affix a new label to well cap BH35. This well cap was borrowed from well BH2 when the well cap to BH35 was vandalized earlier this year.

*Corrective Action:* Argonne will order a new well cap and install for BH2 and repaint and/or affix a new label to well cap BH35.

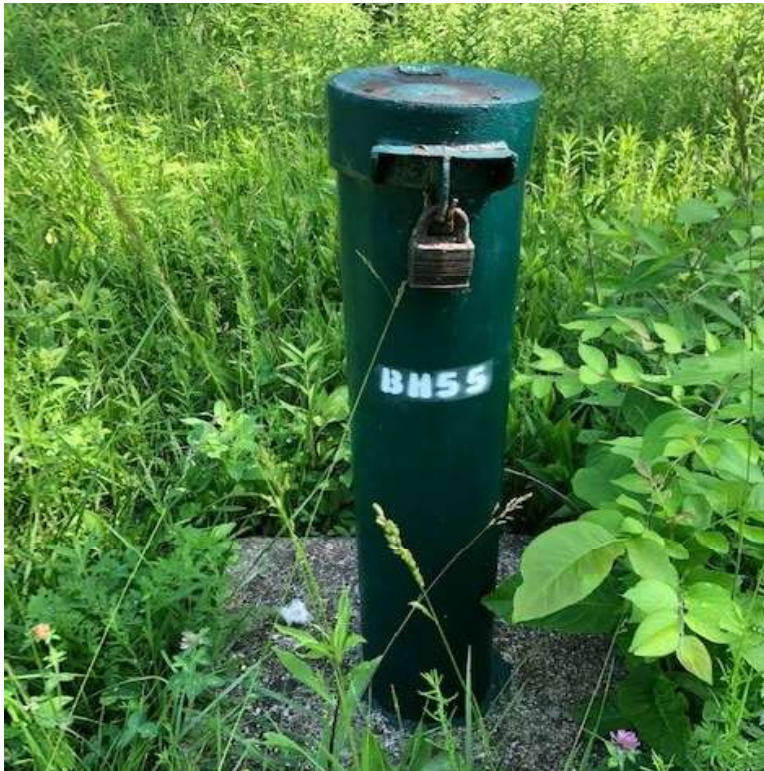
P08 - Monitoring Well BH55 at Site A

Photograph P22 shows the information marker at the entrance to Site A. The locations of the two groundwater wells at Site A are shown in Figure 4.4. Both wells, BH55 and BH56, were found to be locked and intact and in good condition, with the well numbers

visible on the outer casing. Photographs P08 to P10 show the two monitoring wells, BH55 and BH56, at Site A. Argonne personnel are keeping the two monitoring wells secure and in good condition at Site A. Upon removal of the well cap from BH56, the Argonne inspectors noted an ant infestation within this well. Noted as an improvement opportunity, Argonne will attempt to mitigate the ant population from within this well, further discussed within Section 5.0 of this report.

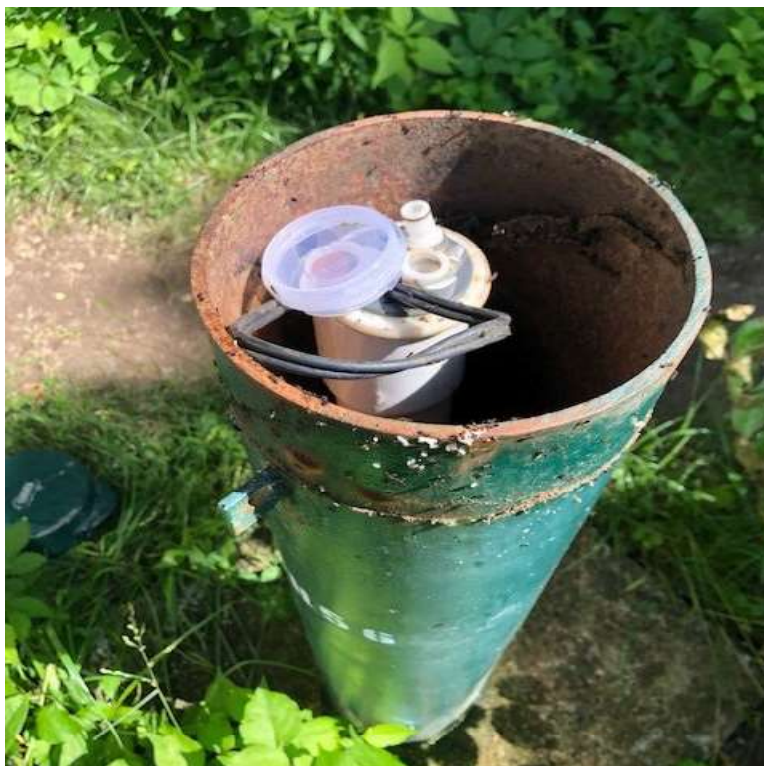
1. **Improvement Opportunity #1:** Monitoring Well BH56 was observed having an ant infestation. The presence of this colony of ants is a safety hazard while attempting to collect a groundwater sample from this well. The ant population needs to be safely eradicated by a means that will do no harm to the groundwater, as well as the surrounding flora and fauna.

P10 – Monitoring Well BH56 at Site A,  
Uncapped to Depict Ant Infestation with Ant Bait Trap Resting on Top

*Corrective Action:* Argonne will insert ant bait traps, e.g., Terra, into the top of the casing of this well to eliminate the ant colony.

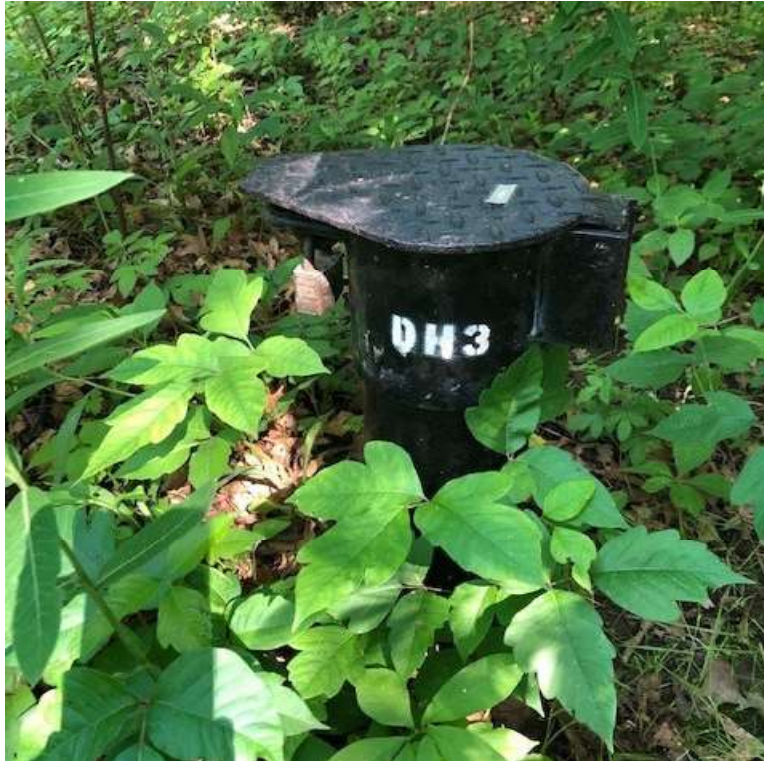
P11 – Monitoring Well DH3 at Red Gate Woods

Four dolomite wells, shown in Photographs P11-P14, in addition to dolomite wells DH04 and DH11, were all locked and intact and in good condition. The paint designation on dolomite well DH11 has become faded. Noted as an improvement opportunity, with further discussion found within Section 5.0 of this report, Argonne will re-paint and/or affix a new label to the well cap for DH11. Argonne personnel are keeping the Red Gate Woods monitoring wells secure and in good condition.

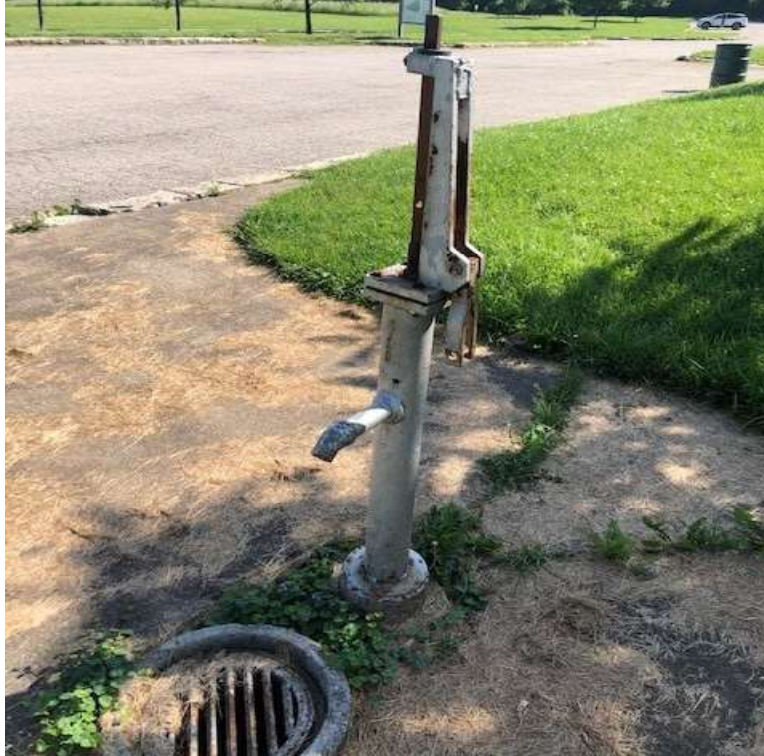
The former picnic well (#5160) does not have a pump handle, as shown in Photograph P15 (Section 6). Cook County Forest Preserve owns the well and removed the handle years ago because of fecal coliform found in the water. The fecal coliform originated from a nearby restroom facility, which has since been removed. Argonne uses a portable handle to collect the water sample. In 2020, it was found that the inner pump control rod was not functioning. At the request of Argonne, this handpump well was repaired in May 2021 by the Cook County Forest Preserve.

P15 – Handpump Well (#5160) at Red Gate Woods Parking Lot

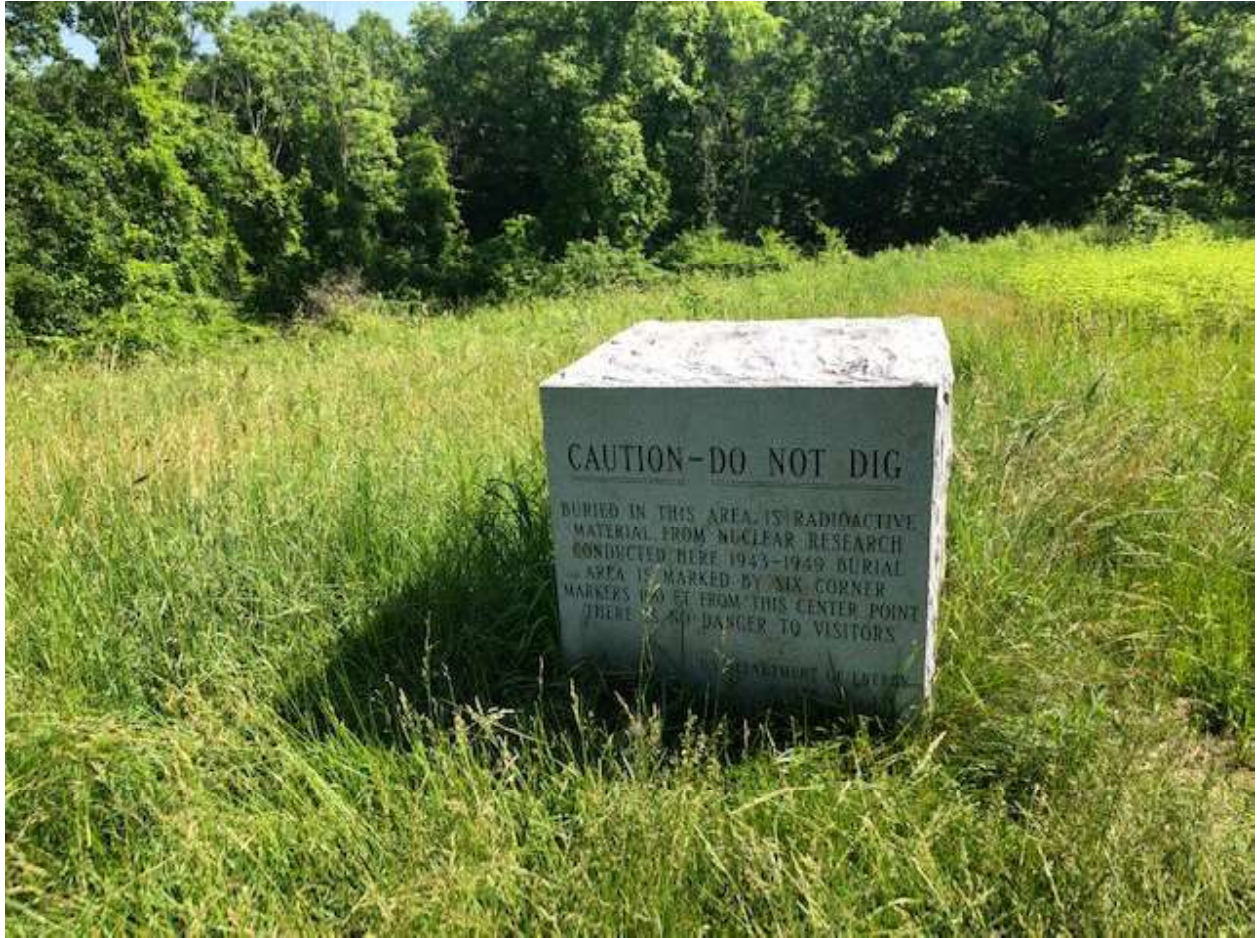
P17 – Plot M Monument, Front View

The Plot M monument was replaced in May 2021. Several letters had been chiseled off the old monument by vandals as reported years ago. Photographs P17 and P18 show the new monument at Plot M; it remains in excellent condition. All six corner markers of Plot M were located during the inspection and found to be in good condition. Photograph P16 shows one of the Plot M corner markers in the foreground, with a location marker for well BH06 in the background. Erosion controls have been reasonably effective with the addition of four additional landscape timbers installed in 2020 along the north trail. Argonne conducts quarterly maintenance reviews of the cap and north trail. Photograph P23 shows one of the Argonne inspectors, S. Miller, standing within the terraced timber steps along the eastern slope of Plot M.

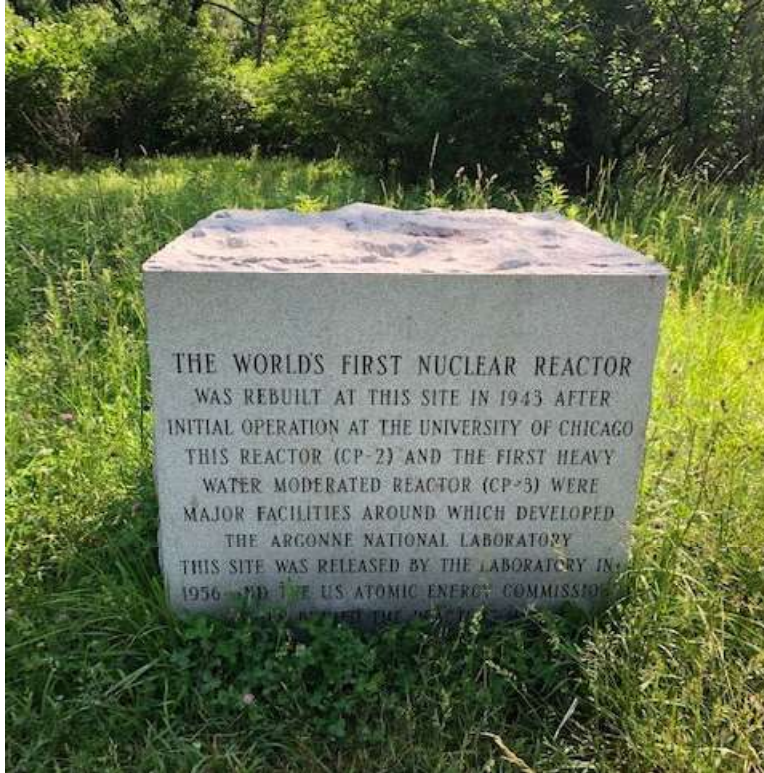
P19 - Site A Monument, Front View

The Site A monument was replaced in May 2021. Visible cracks were present in the old monument. Photographs P19 to P21 show the new monument at Site A, which remains in excellent condition.

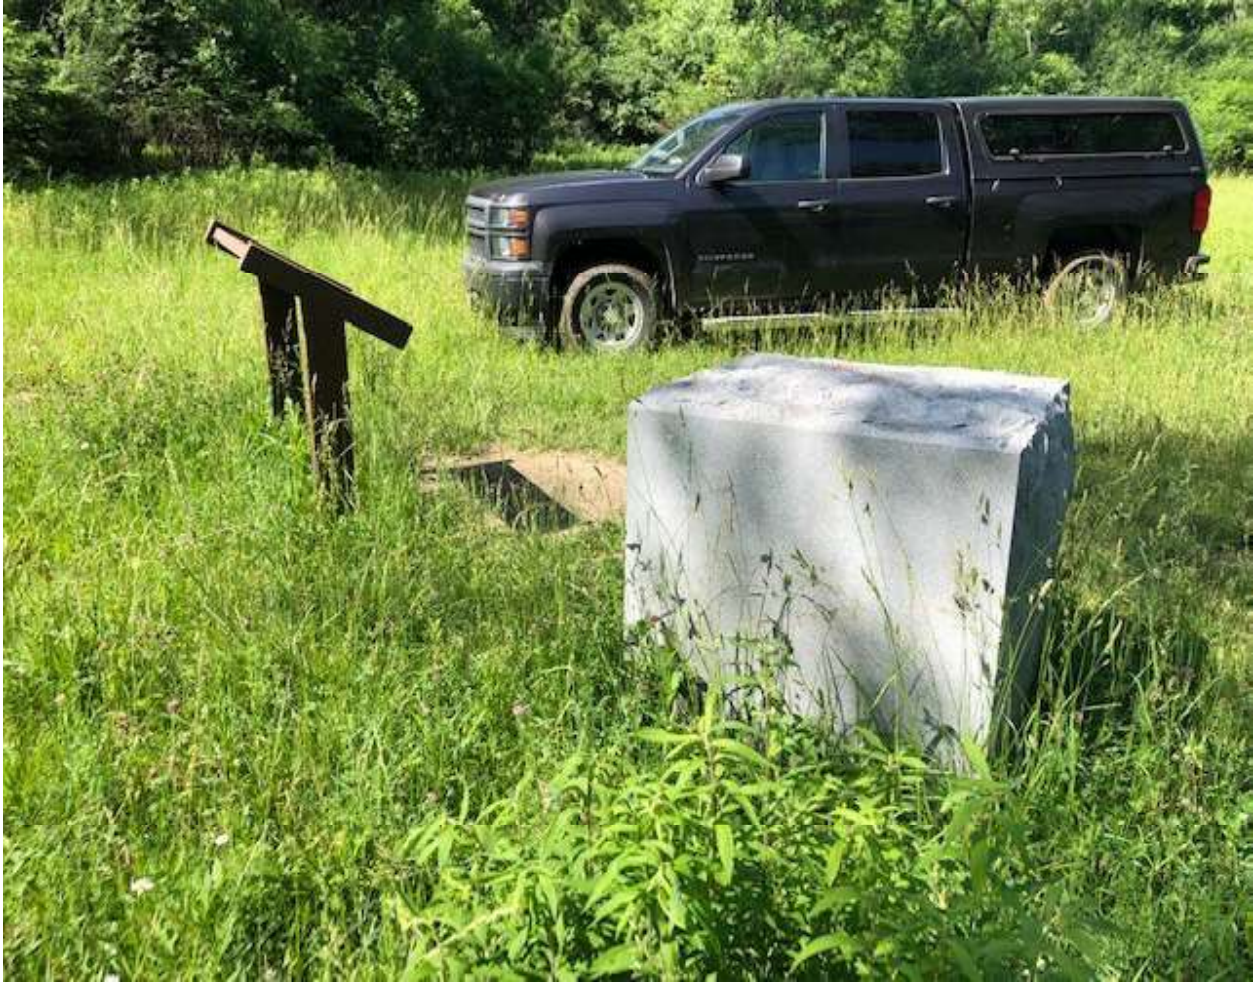
P20 - Site A Monument, Back View, with Information Signage to the Left

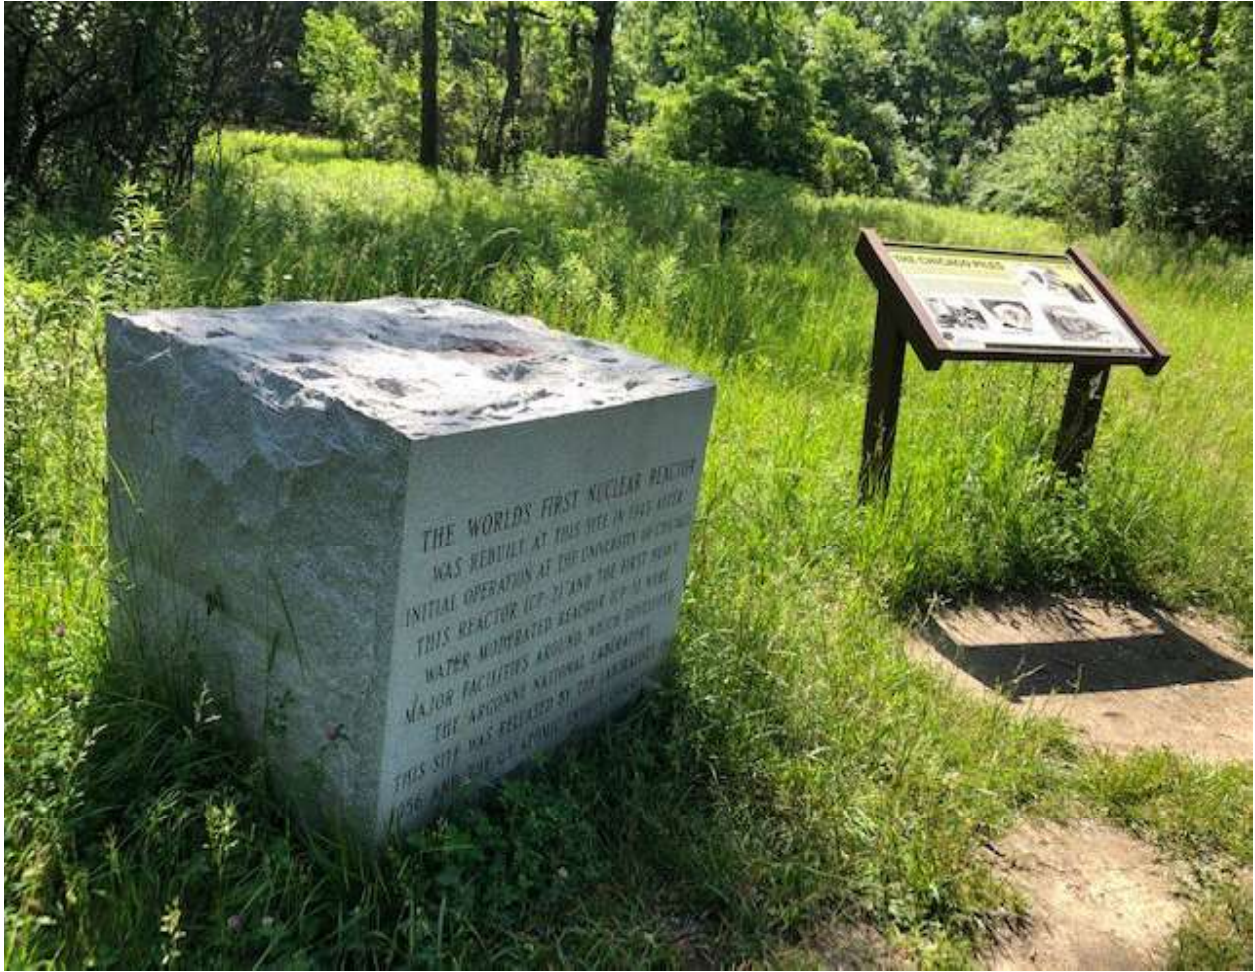
P21 - Site A Monument, Side View, with Information Signage to the Right

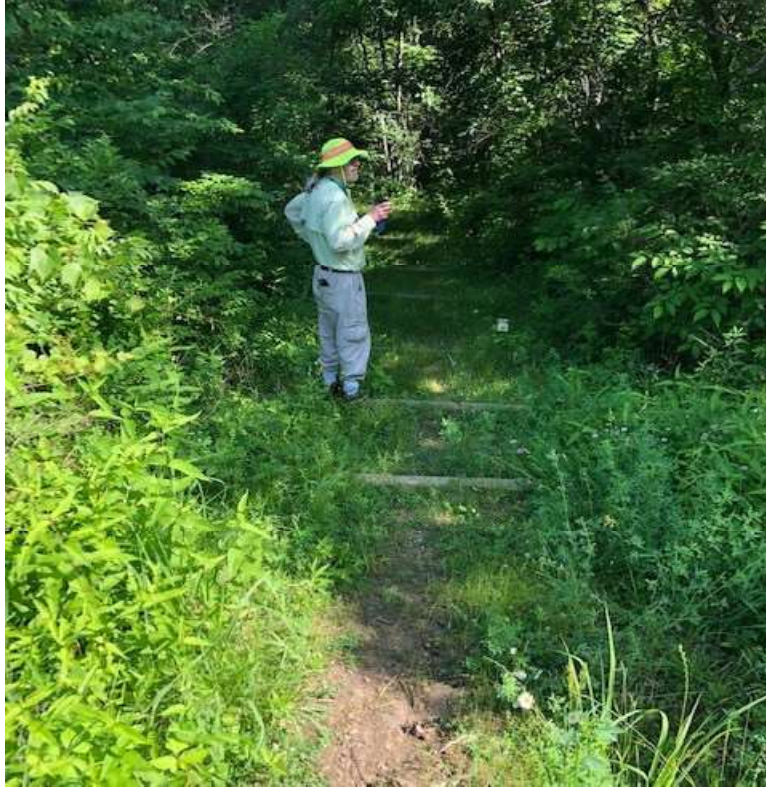
During the May 2018 Annual Inspection, increased erosion was noted along the path from the northeast corner of Plot M heading down towards the creek. Twelve timber steps were installed by Argonne during the Summer 2018 to reduce erosion along the northeast trail. In 2020, four additional timber steps were installed on the steep, top portion of the northeast trail. The installation of these timber steps has been effective in reducing erosion along this trail.

P23 - Terraced Timber Steps Along Eastern Slope of Plot M
