7.0 Green River, Utah, Disposal Site

7.1 Compliance Summary

Figure 7-1. 2020 Annual Inspection Drawing for the Green River, Utah, Disposal Site

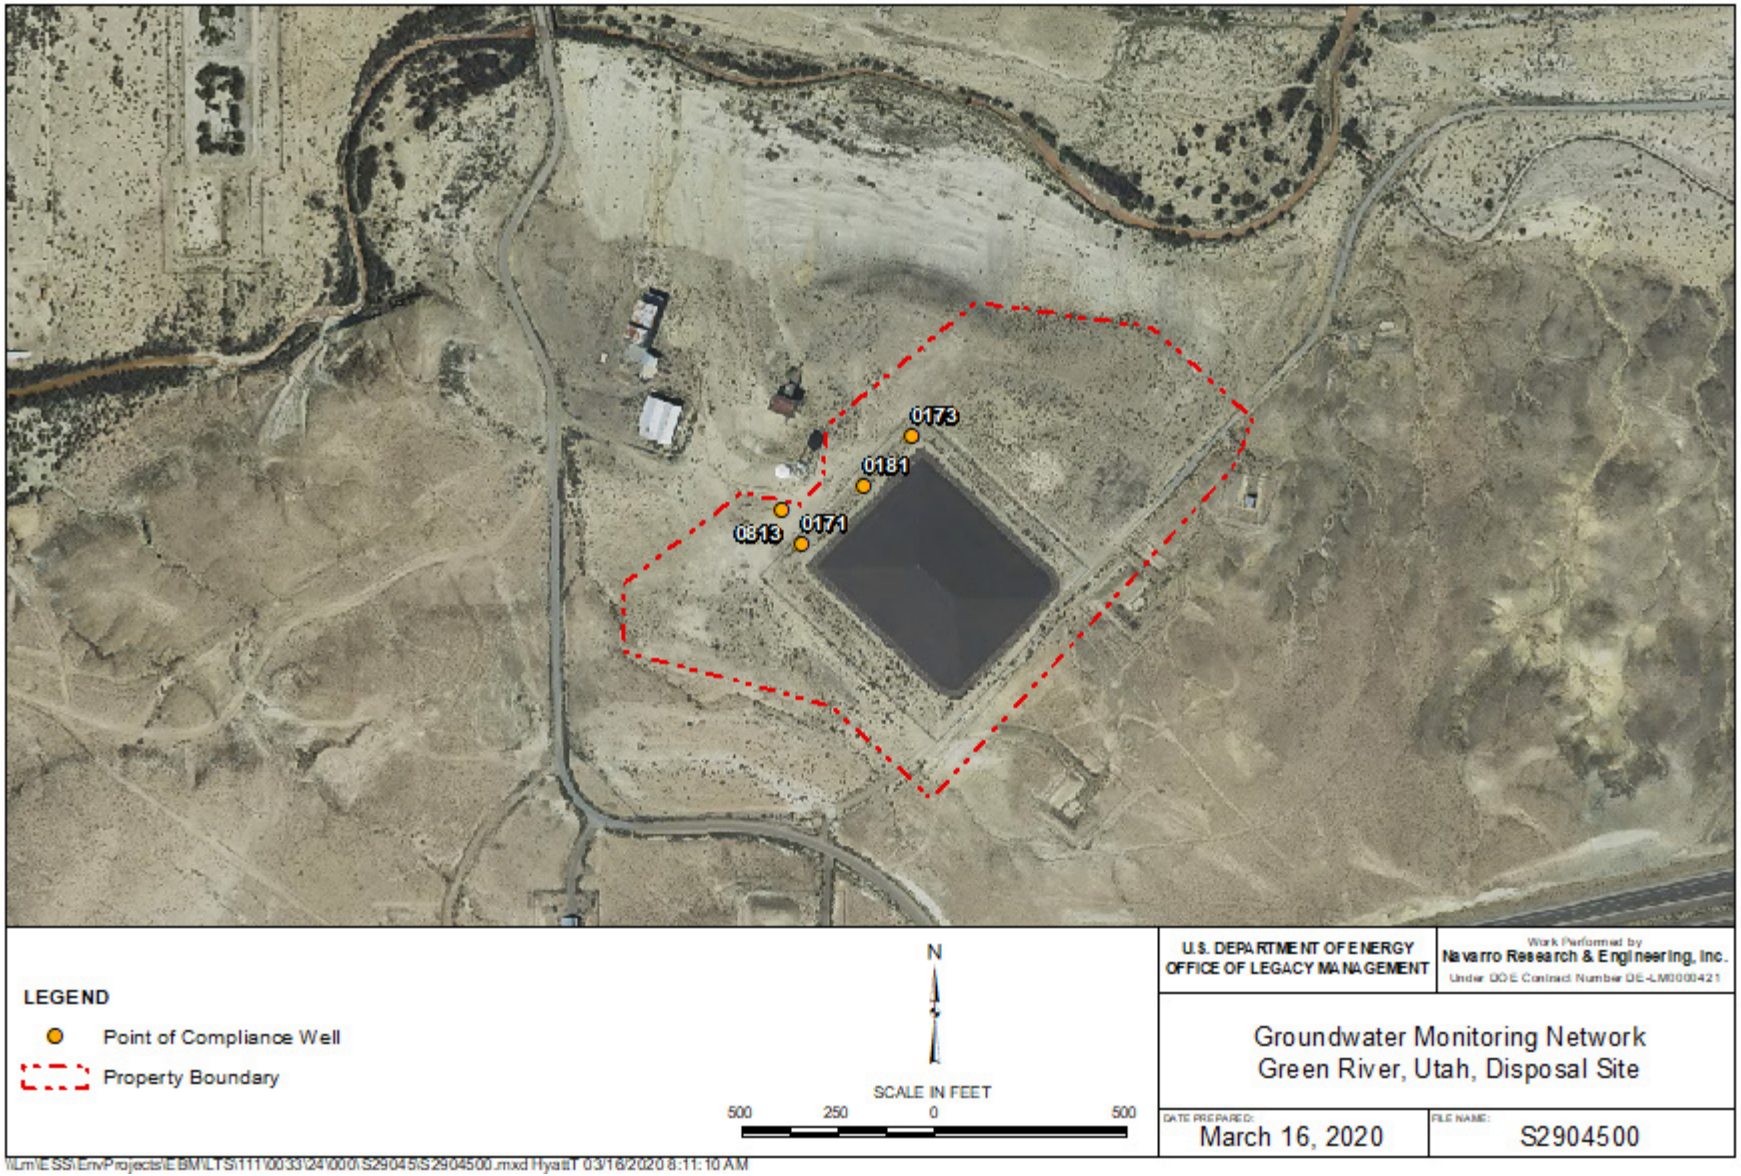
Figure 7-2. Groundwater Monitoring Network at the Green River, Utah, Disposal Site

The LTSP establishes four POC wells at the site for postclosure groundwater monitoring. The POC wells represent the intersection of a vertical plane with the uppermost aquifer (the middle sandstone unit of the Cedar Mountain Formation) underlying the site, which is at the hydrologic downgradient limit of the disposal cell. The LTSP included monitoring well 0172, but its construction integrity was suspect, and the well was replaced with monitoring well 0181 in 2001. It has been monitored as the replacement POC well since 2001. Table 7-2 and Figure 7-2 show the current groundwater monitoring network at the site.

POC wells are sampled for nitrate, sulfate, and uranium. Groundwater monitoring results are reported and published on the LM Geospatial Environmental Mapping System (GEMS) website (<https://gems.lm.doe.gov/#site=GRN>).

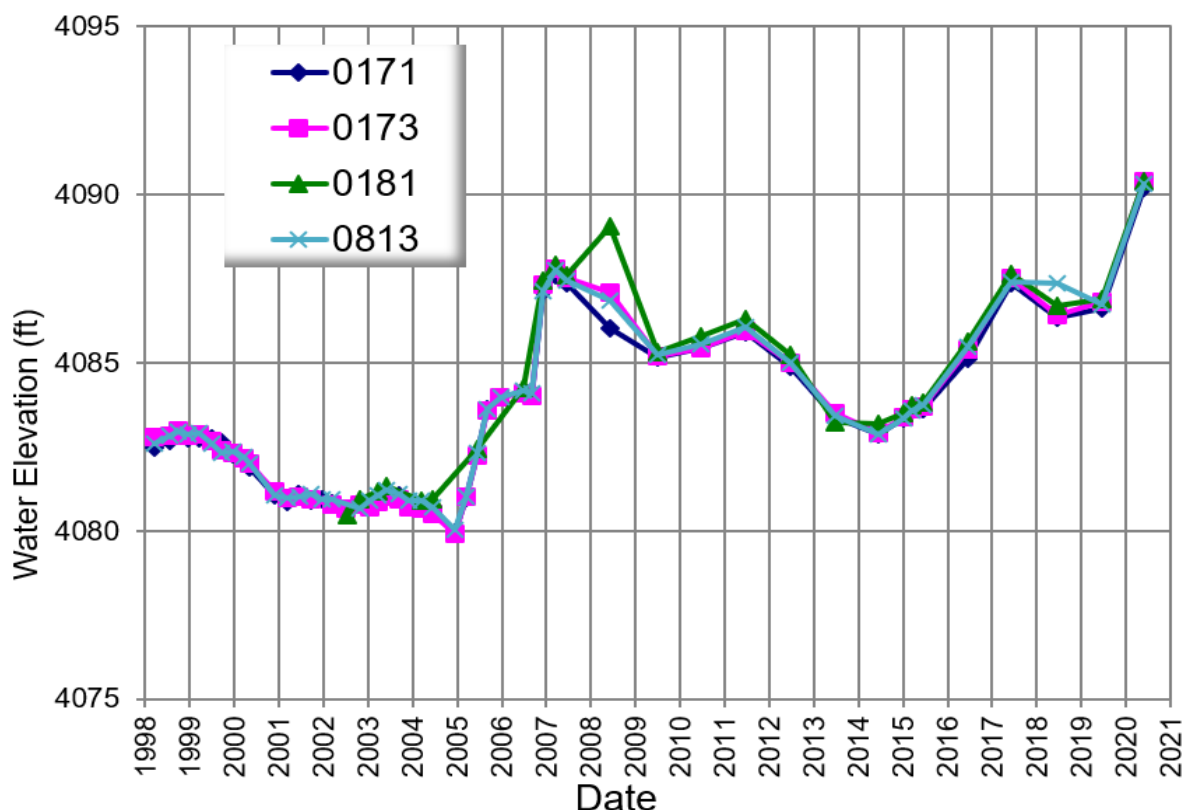
Figure 7-3. Groundwater Elevations at the Green River, Utah, Disposal Site

Water levels have been measured manually ever year in the POC wells since 1991. Water levels in the POC wells decreased slightly from 2017 to 2018 (Figure 7-3). Historically, the groundwater levels in these wells decreased approximately 3 ft overall from 1998 through 2004 and then increased approximately 8 ft between 2004 and 2007. Water level decreases ranged from 4 to 5 ft from 2007 through 2014. From 2014 to 2019, the water levels increased to elevations near the 2007 levels.

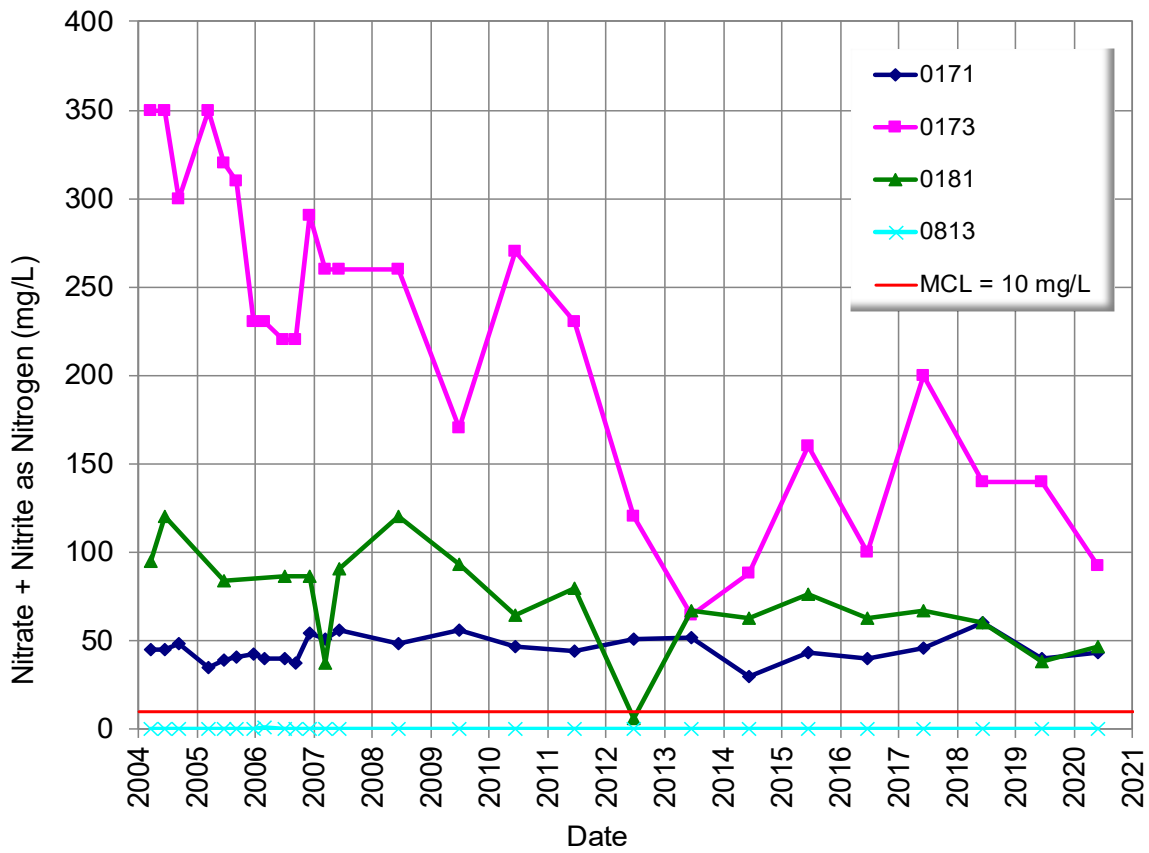
Figure 7-4. Nitrate at Point-of-Compliance Wells at the Green River, Utah, Disposal Site

Nitrate concentrations continue to exceed the MCL in POC wells 0171, 0173, and 0181. The 2020 nitrate concentrations were within the range of historical values for all POC wells (Figure 7-4).

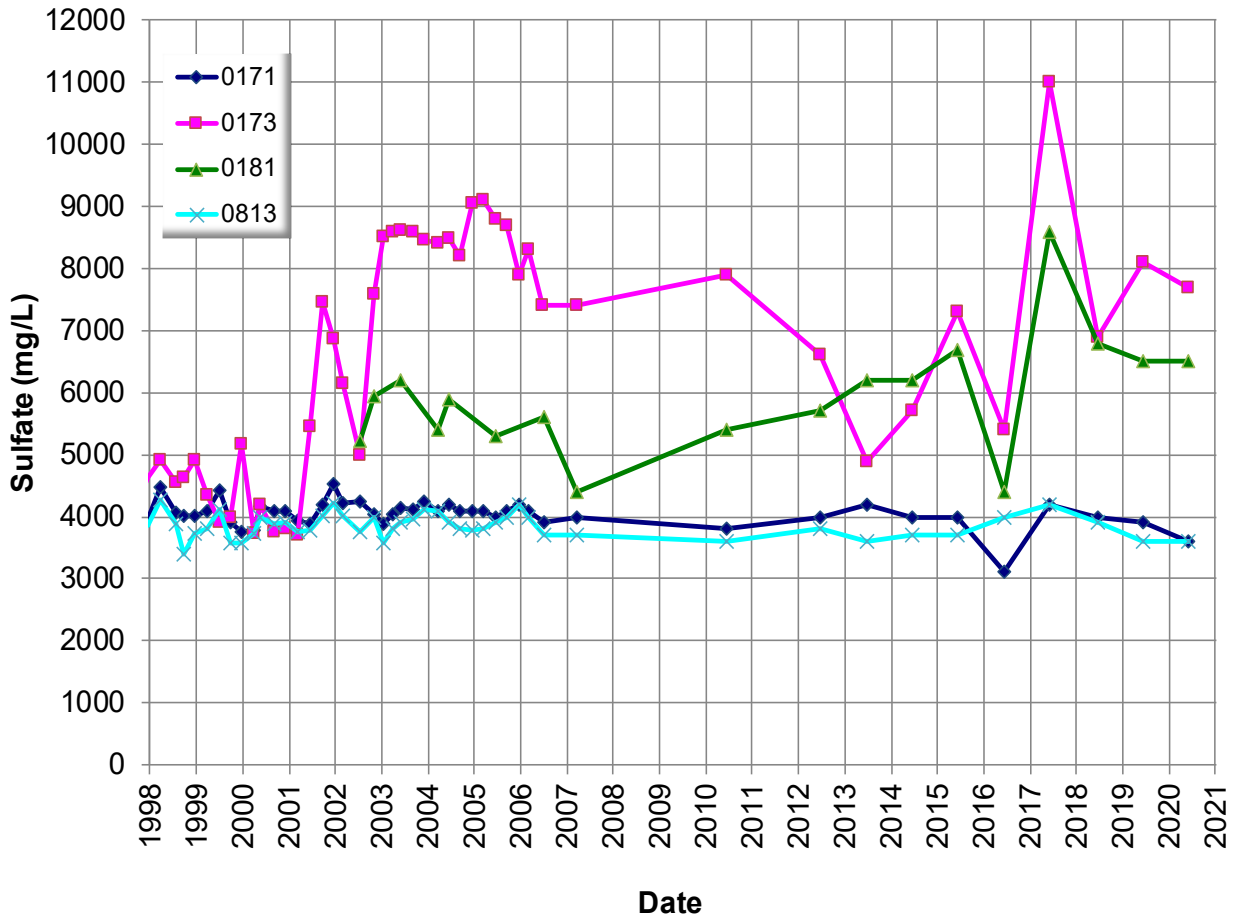
Figure 7-5. Sulfate at Point-of-Compliance Wells at the Green River, Utah, Disposal Site

Sulfate concentrations exceeded the LTSP background concentrations in all POC wells (Table 7-3) except POC well 0813. The 2020 sulfate concentrations were within the range of historical values for all POC wells (Figure 7-5).

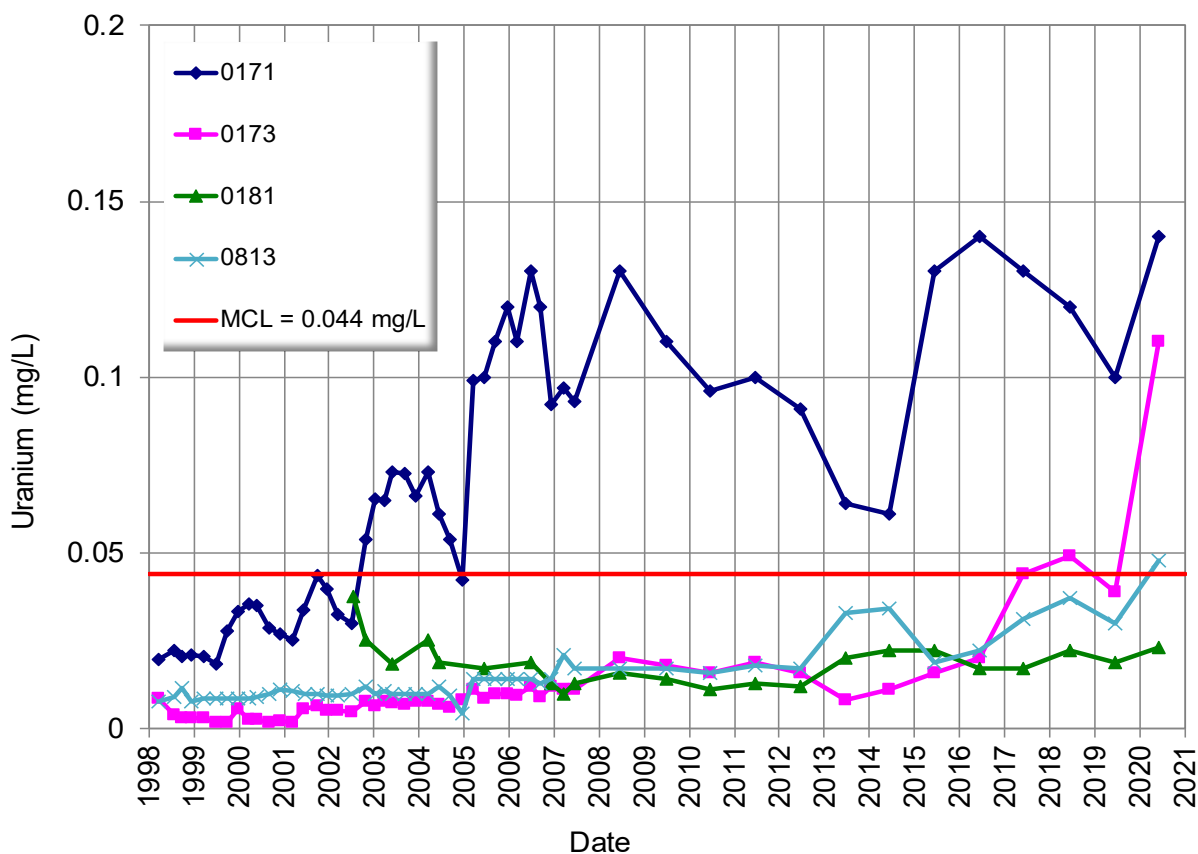
Figure 7-6. Uranium at Point-of-Compliance Wells at the Green River, Utah, Disposal Site

Uranium concentrations in POC well 0171 routinely exceed the UMTRCA and LTSP concentration limits, while the other POCs remain mostly below the MCL. Well 0173 exceeded 0.044 mg/L in 2018 and 2020 (Figure 7-6). Well 0181 remains below the uranium concentration limit. The uranium concentration at well 0813 exceeded the standard for the first time in the 2020 event. Uranium concentrations in POC well 0171 have varied considerably, ranging from a low of 0.0184 mg/L in 1999 to a high of 0.14 mg/L in 2016. The 2020 uranium concentrations are within the range of historical values in POC wells 0171 and 0181 and exceed the highest historical values in POC wells 0173 and 0813.

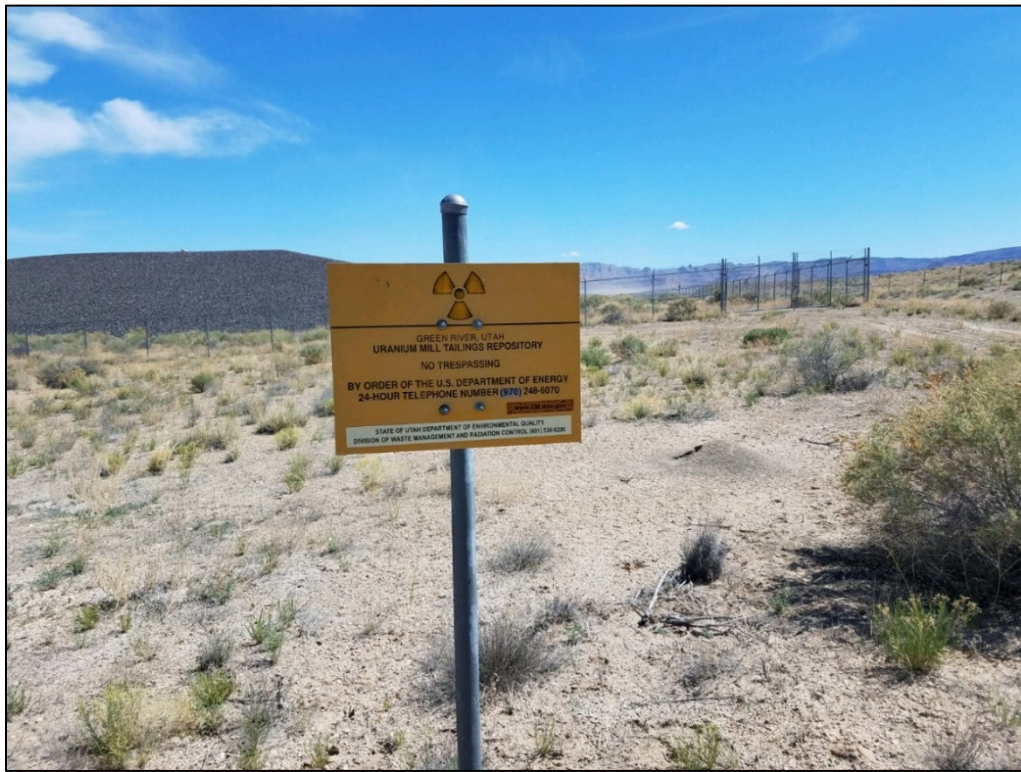
Access to the site is either from U.S. Highway 6 and 50 heading east from the town of Green River or from U.S. Interstate 70 via Street 1600 East. The paved access road crosses property owned by the State of Utah and the U.S. Army. Access has been granted to LM through right-of-way agreements with both entities. Entrance to the site is through a locked steel gate in the paved road right-of-way fence; LM does not own the gate or the right-of-way fence. Past this gate, a dirt road leads across State land to the site. The access road divides at the security fence, with one branch entering the security fence that encloses the disposal cell and the other providing access around the outside of the security fence. The entrance sign is next to the access road where it enters the site (PL-1). No maintenance needs were identified.

PL-1. Entrance Sign (Chainlink Access Gate and Disposal Cell in Background)

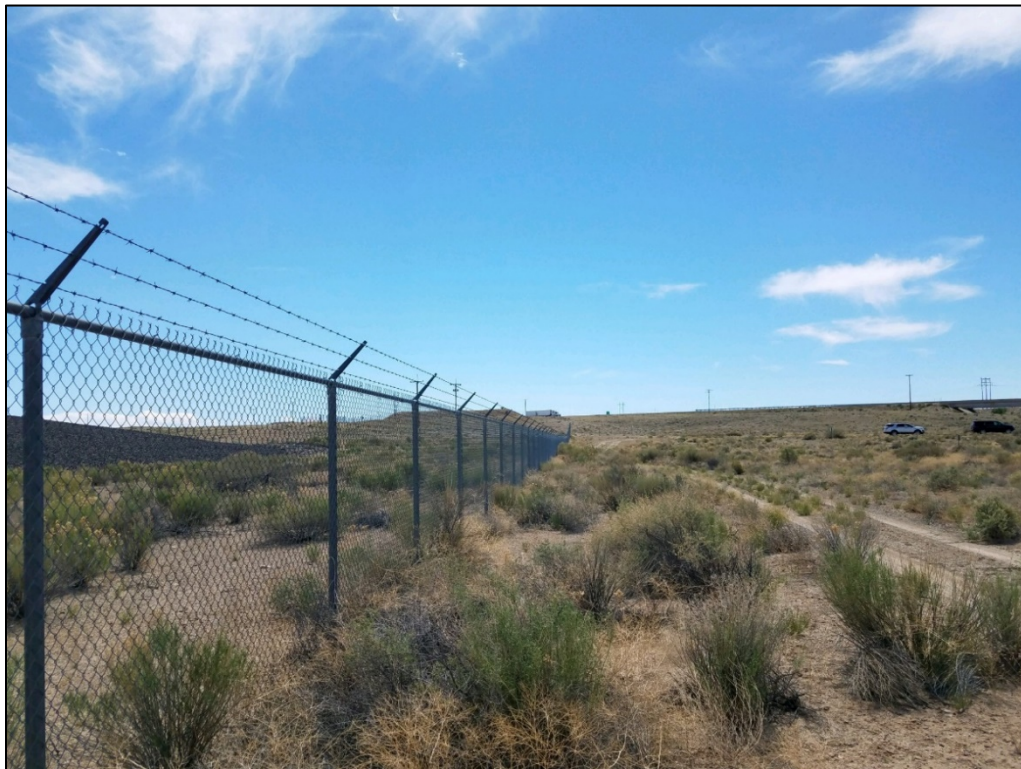
A chainlink security fence encloses the portion of the site that contains the disposal cell. Two vehicle gates are at the south and east corners of the security fence line, and a personnel gate is at the north corner of the security fence line. The security fence (PL-2) was intact, and the gates were locked. The minor erosion under the southeast fence line identified and repaired during the 2019 inspection remains stable.

PL-2. Chainlink Security Fence

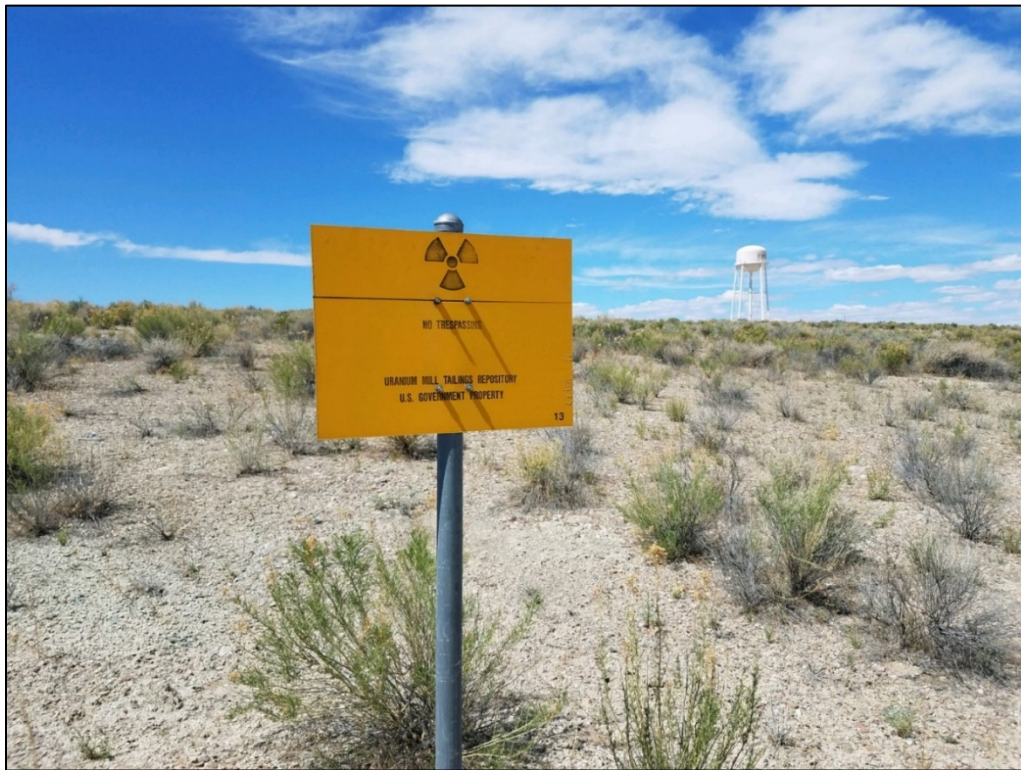
There are 17 perimeter signs (PL-3), attached to steel posts set in concrete, positioned along the unfenced property boundary. Two new unmanned aircraft system (UAS) warning signs will be installed before the next inspection. No maintenance needs were identified.

PL-3. Perimeter Sign P13

No maintenance needs were identified at the time of the inspection. Two new UAS warning signs will be installed before the next inspection.

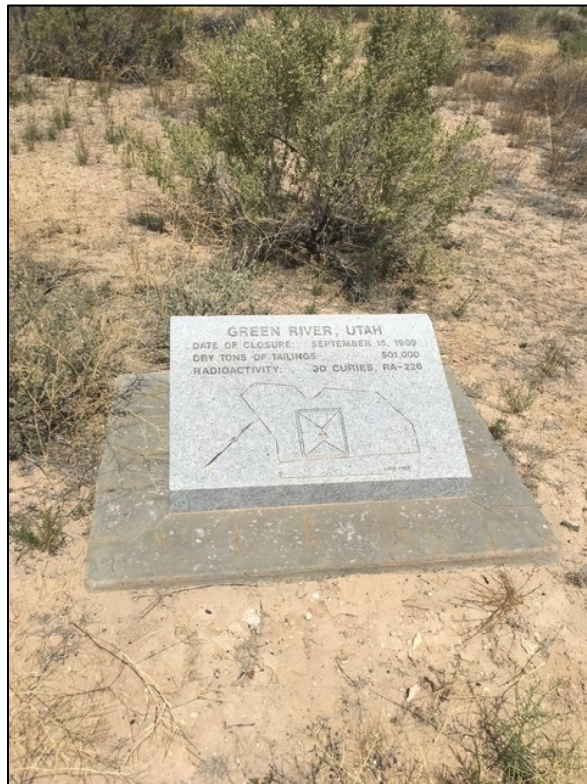
The site has two granite markers. Site marker SMK-1 is inside the security fence near the southwest corner of the site (PL-4), and SMK-2 is on the crest of the disposal cell. The concrete base of SMK-1 has several minor cracks, but they do not compromise the integrity of the base, and repairs are not necessary at this time. No maintenance needs were identified.

PL-4. Site Marker SMK-1

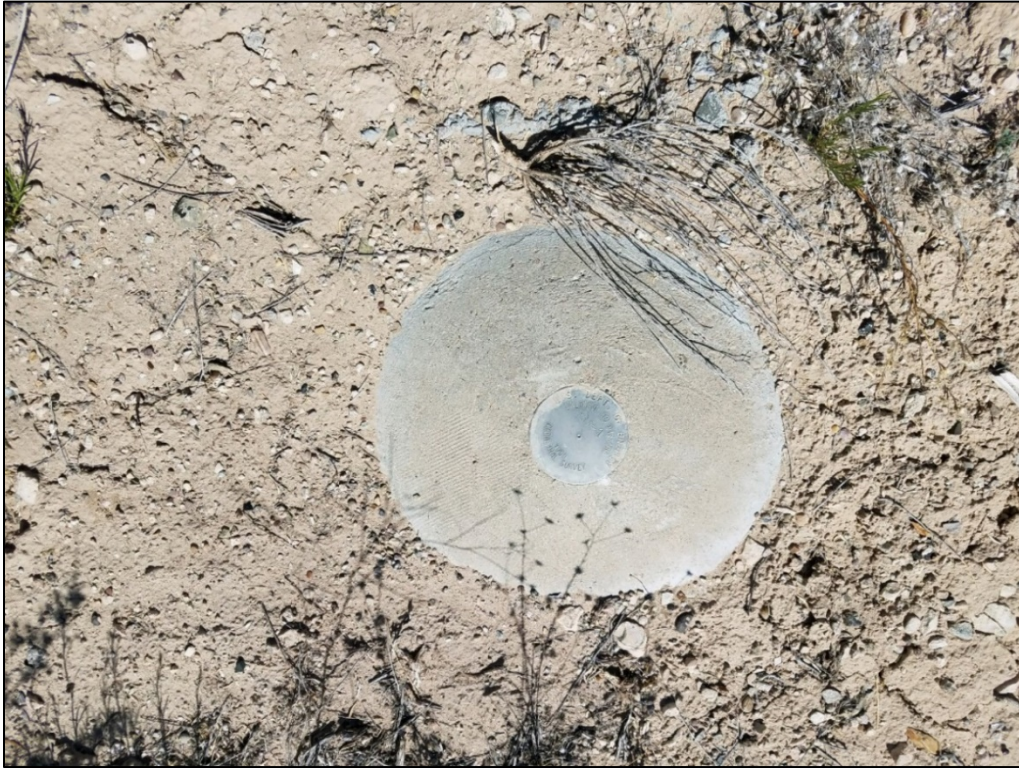
Eleven boundary monuments and three survey monuments (PL-5) delineate the property boundary. Boundary monument BM-5 is damaged (it is bent from being hit by a vehicle), but its condition does not require repair. No maintenance needs were identified.

PL-5. Survey Monument SM-1

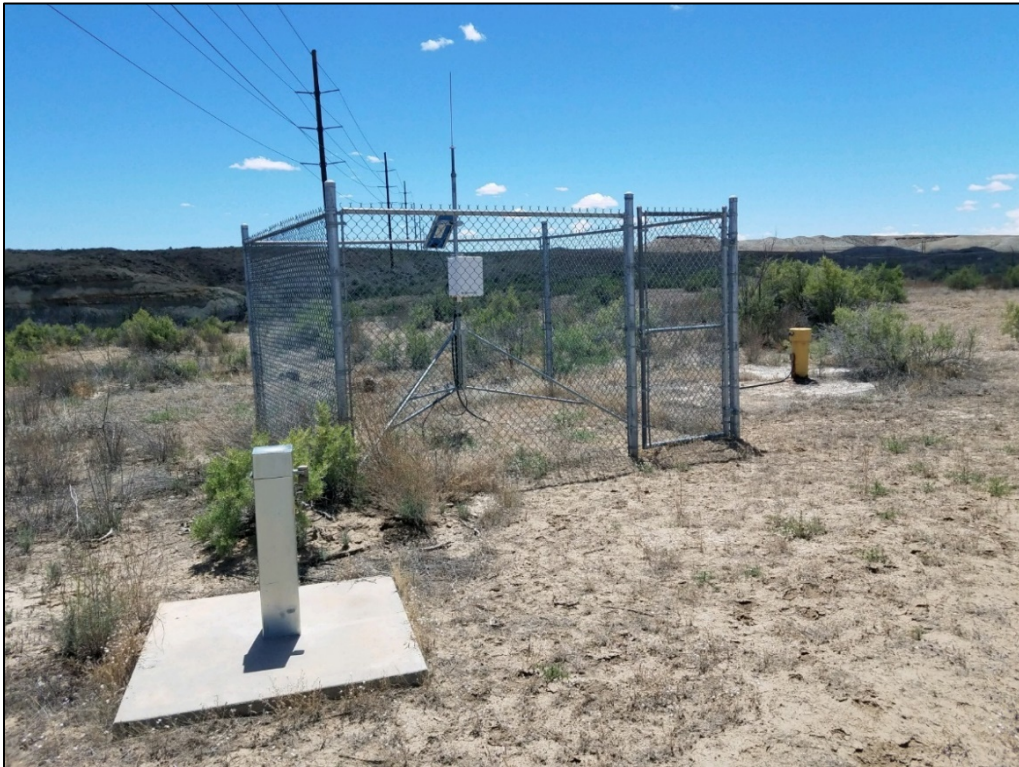
There are 22 monitoring wells on or near the site. Monitoring wells were inspected during the May 2020 sampling event. All wellhead protectors observed during the inspection were undamaged and locked (PL-6). Some of the concrete monitoring well collars are cracked, but the wellhead protectors are stable and repairs are not necessary. No maintenance needs were identified.

*PL-6. Monitoring Wells 0194 and 0582
(with the System Operation and Analysis at Remote Sites [SOARS] Station in Background)*

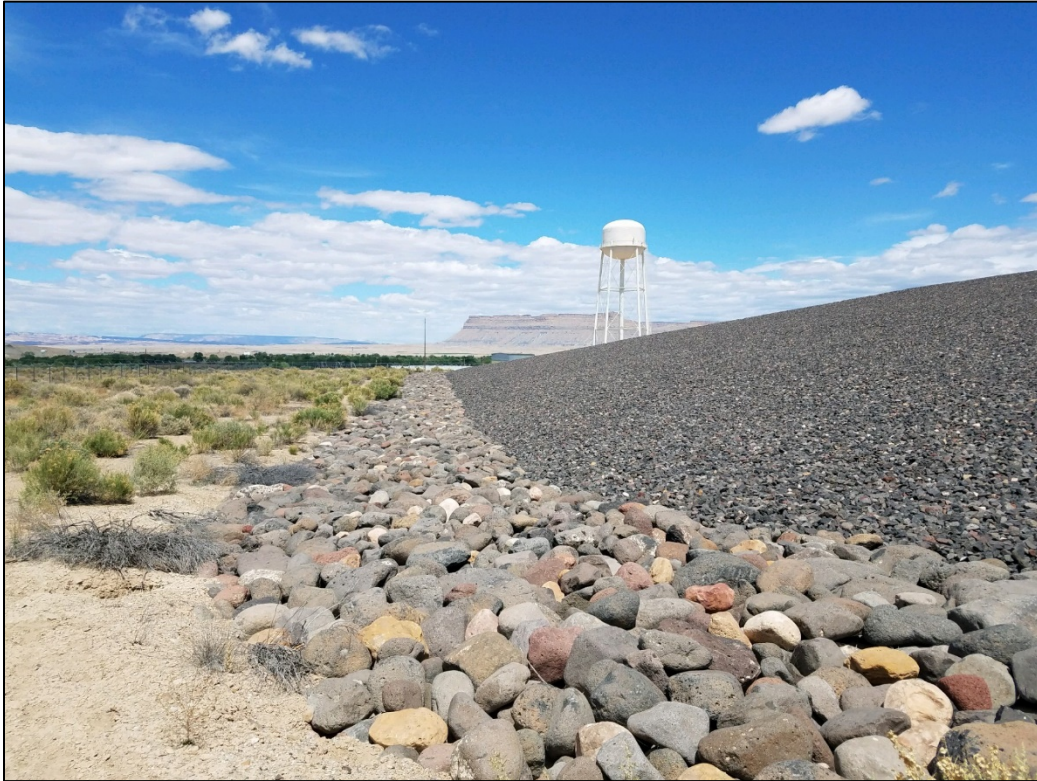
The disposal cell, completed in 1989, occupies 6 acres. The slopes of the disposal cell cover are armored with riprap, consisting primarily of competent basalt with a small fraction of sedimentary rocks, to control erosion (PL-7). A small percentage of the rock, including basalt and sedimentary rock, has degraded, but the riprap cover is functioning as designed. There was no evidence of settling, slumping, erosion, or any other modifying process that might affect the integrity of the disposal cell.

PL-7. Southwest Side Slope (and Apron) of Disposal Cell

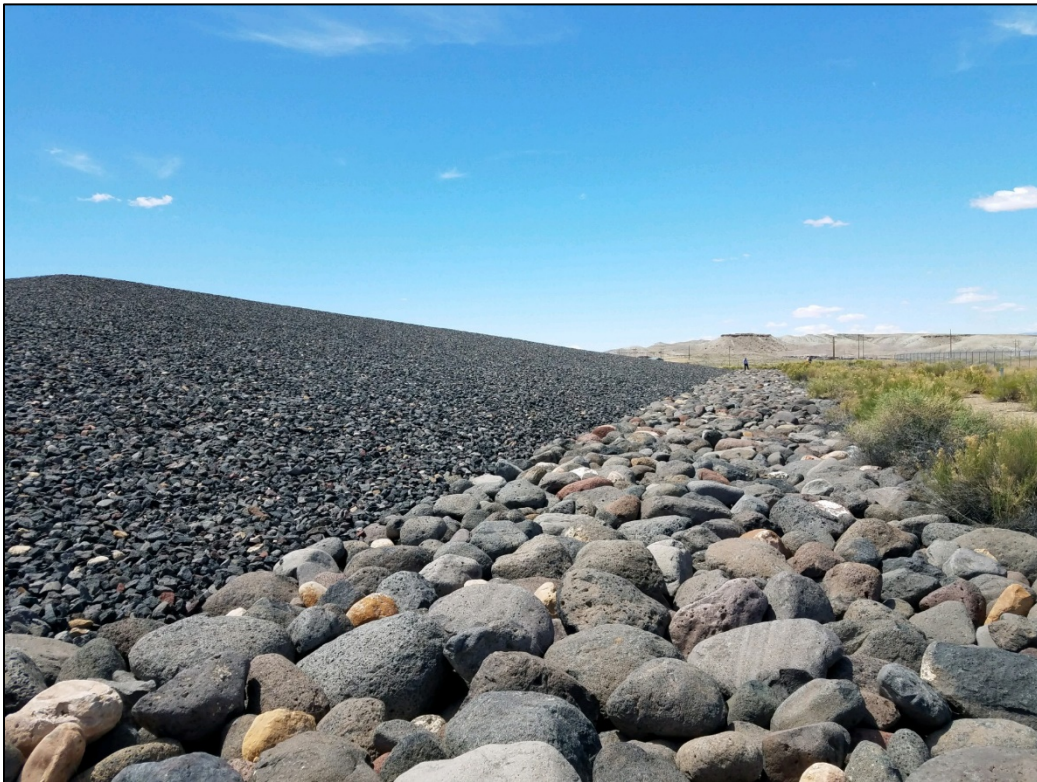
A boulder-filled trench, known as an apron, surrounds the disposal cell (PL-8). The apron was intact and stable, with no observed erosion along the base of the side slopes. Small erosion rills are present along portions of the outside edge of the apron. The rills form as stormwater runoff along the disposal cell perimeter road drains into the disposal cell apron. This occurrence is not a concern, because the erosion is minor and sedimentation in the apron has not adversely affected the performance of the apron (the sediment has not filled the apron or become visible in the apron). Inspectors will continue to monitor the area.

PL-8. Northwest Side Slope (and Apron) of Disposal Cell

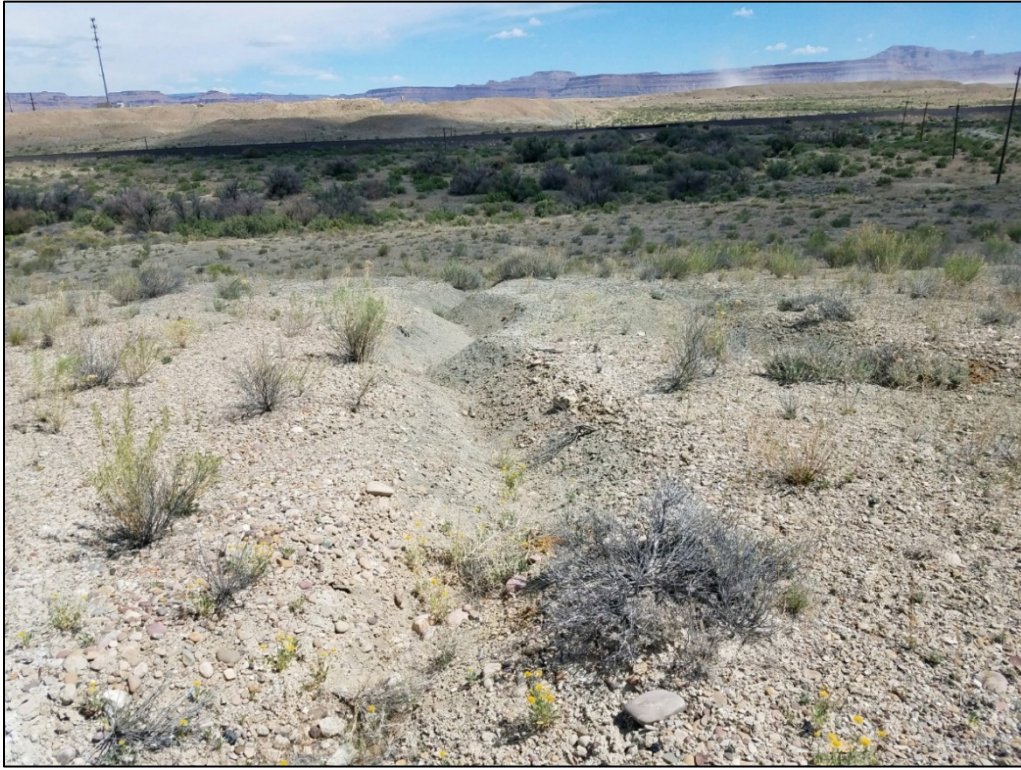
Signs of erosion appear in multiple areas in the site perimeter. Erosional rills are present on the west side of the site but are not affecting any site surveillance features. Rills and gullies are also present along the escarpment northeast of the disposal cell in the area between boundary monument BM-7 and survey monument SM-3 (approximately 400 feet [ft] from the base of the disposal cell) (PL-9). Maximum gully depth in this area is approximately 3 ft, but the erosion appears to be stabilizing. A portion of the stormwater diversion channel along the southeast side of the site continues to erode slowly. These erosional features could eventually damage site surveillance features (i.e., perimeter signs, boundary monuments, and the security fence). The closest erosional features are approximately 300 ft from the disposal cell and do not pose a risk to the integrity of the disposal cell. Inspectors will continue to monitor this area. No immediate maintenance needs were identified.

PL-9. Gullies Near Boundary Monument BM-8

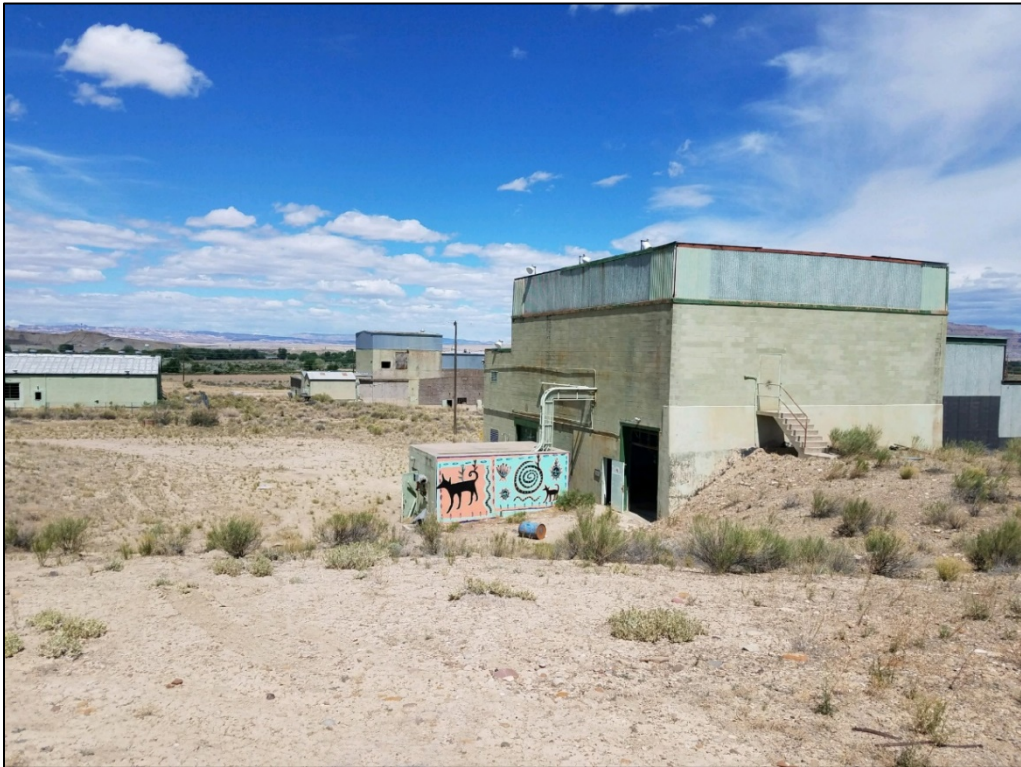
The area beyond the site boundary for a distance of 0.25 mile was visually observed for erosion, changes in land use, or other phenomena that might affect the long-term integrity of the site. No such impacts were observed. Abandoned buildings and a water tower associated with the former milling activities are northwest of the site (PL-10). The buildings are not maintained and are in disrepair, and debris tends to blow onto the site from surrounding buildings (e.g., shingles, siding, plastic). Accumulation of windblown debris is minor but will continue to be monitored and removed.

PL-10. Abandoned Mill Buildings

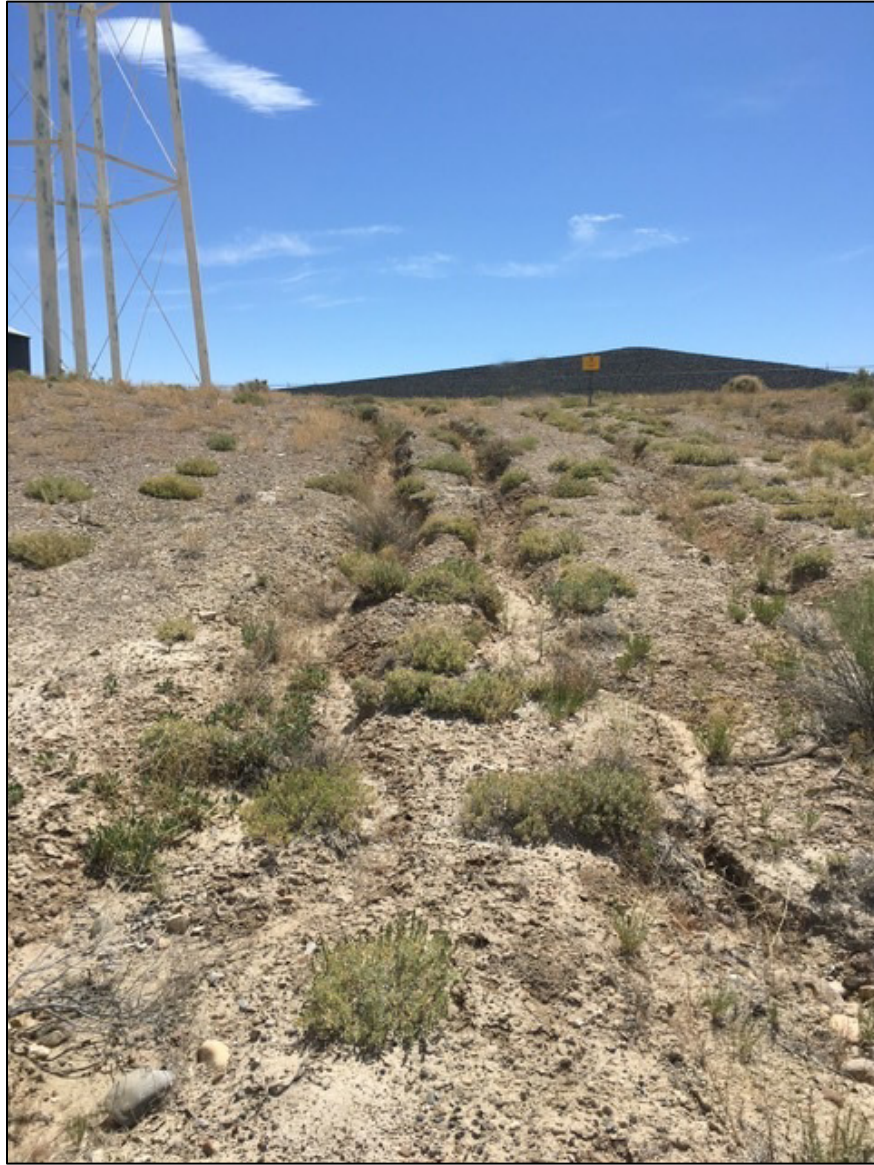
Areas of erosion noted during previous inspections include the natural drainage near the southwest side of the site and rills and gullies northwest of the water tower (PL-11). Evidence of continued erosion in these areas was apparent but does not threaten the integrity of the disposal cell or site surveillance features. Inspectors will continue to monitor these erosional features. No maintenance needs were identified.

PL-11. Gullies Downslope of Water Tower (Offsite)
