Annual Assessment of the Effectiveness of Institutional Controls at the Mound Site Miamisburg, Ohio

June 2013

U.S. DEPARTMENT OF
ENERGY

Legacy
Management

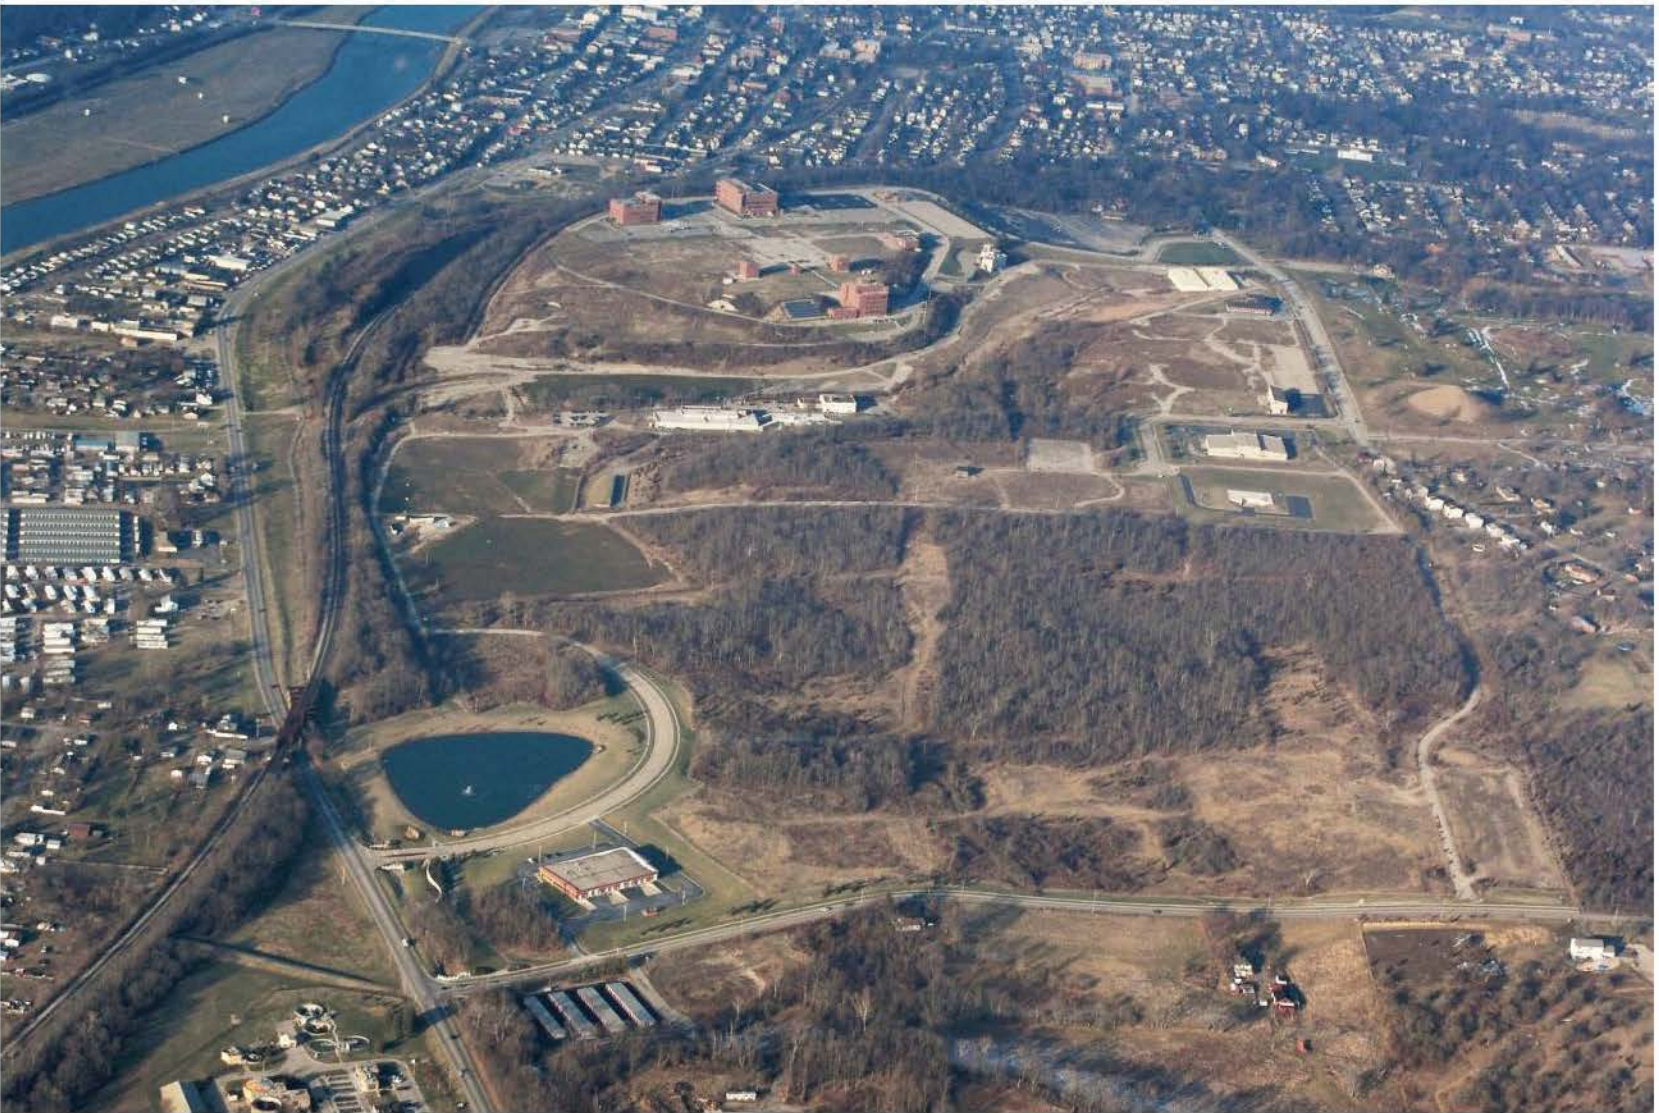
Figure 2. Mound Site Looking North (March 2011)

Figure 2 is an aerial photo, taken in March 2011, which shows the entire site looking north.

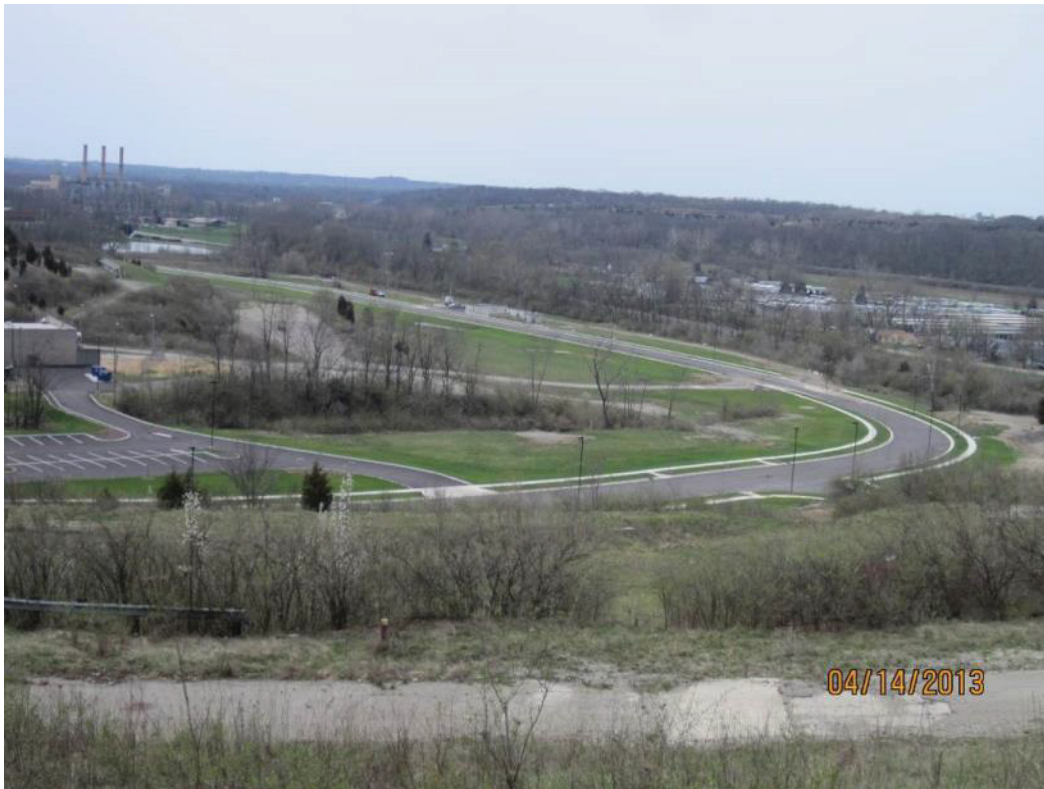
Construction of the Vanguard Boulevard (Blvd.) spine road continued during 2012. The roadway connecting the southwest and northeast site entrances was nearly completed at the time of the walkdown, and the final paving was scheduled for May 2013. The construction included the new roadway, a parking lot, storm and sanitary sewers, curbs and gutters, sidewalks, and street lights. Figure 5 through Figure 14 show the progress of the construction.

Figure 5. Vanguard Blvd. Looking South Toward OU-1 (Parcel 9) Area

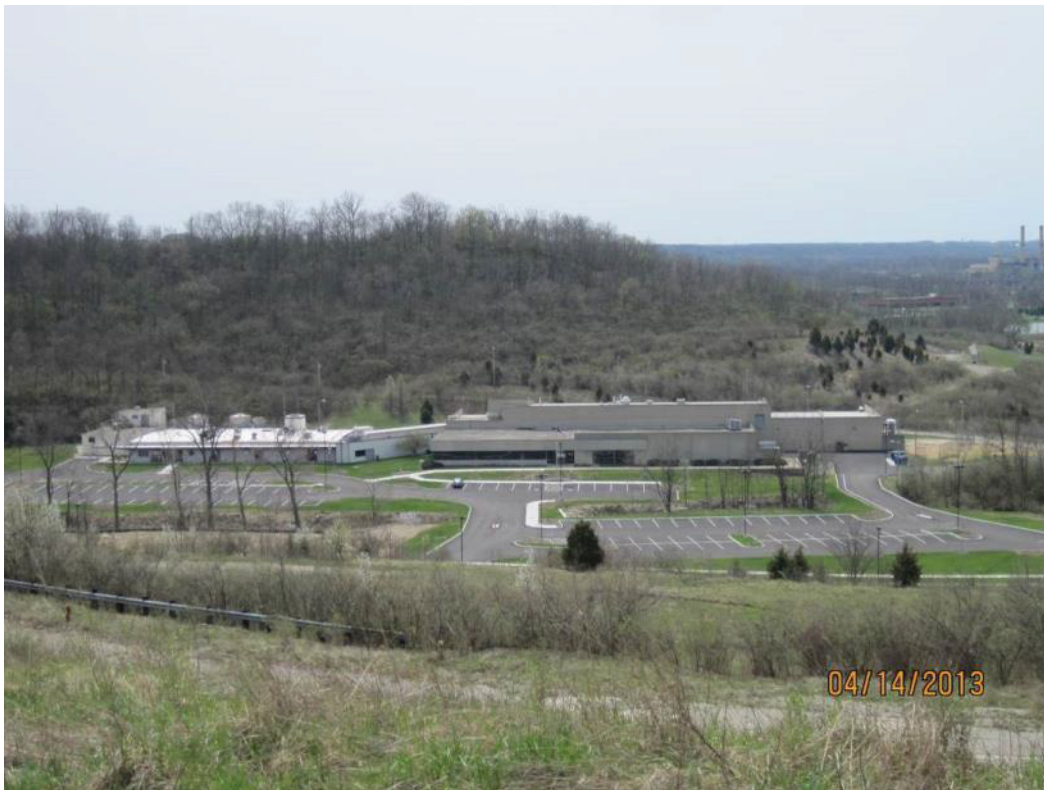
Figure 6. Vanguard Blvd. Looking South Toward Excelitas Building and New Parking Areas

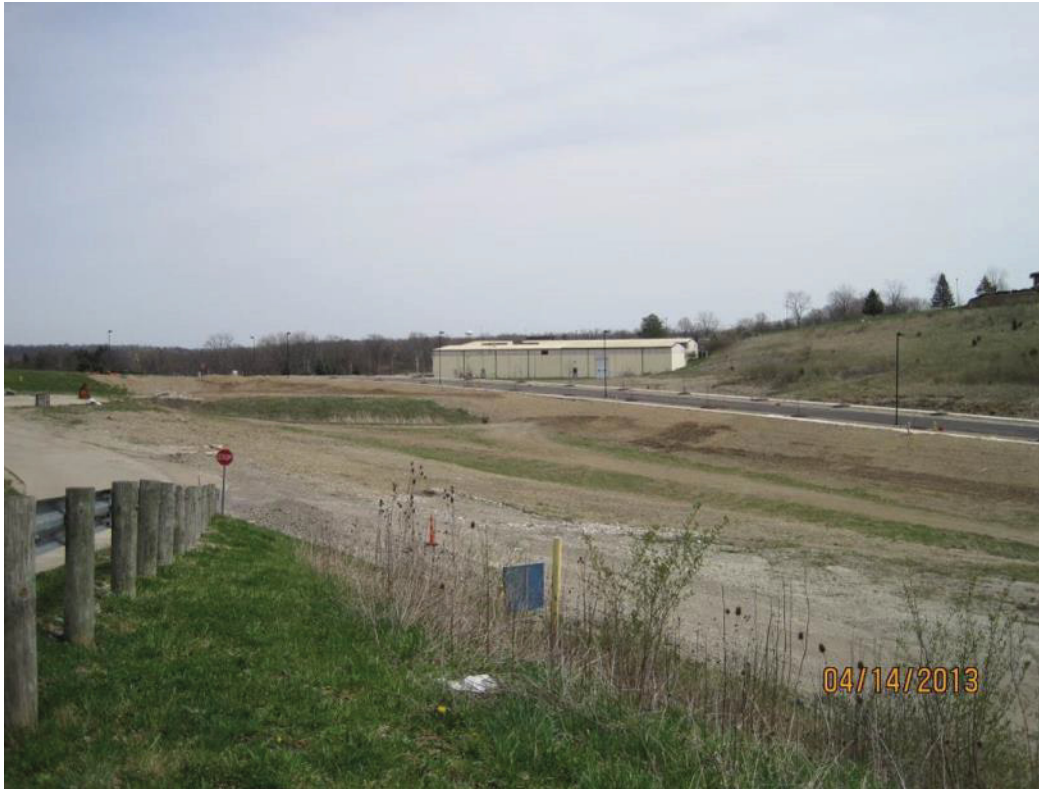
Figure 7. Vanguard Blvd. Looking Northeast Toward Building 61

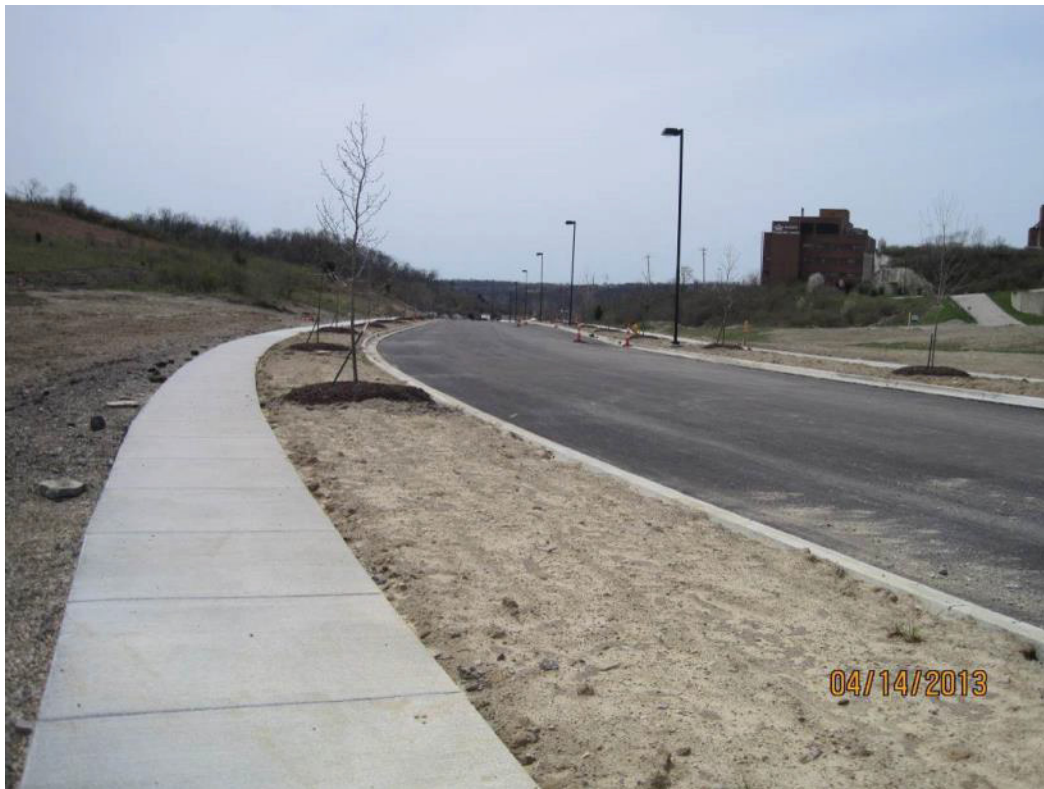
Figure 8. Vanguard Blvd. Looking Southwest Toward Central Office Space (COS) Building

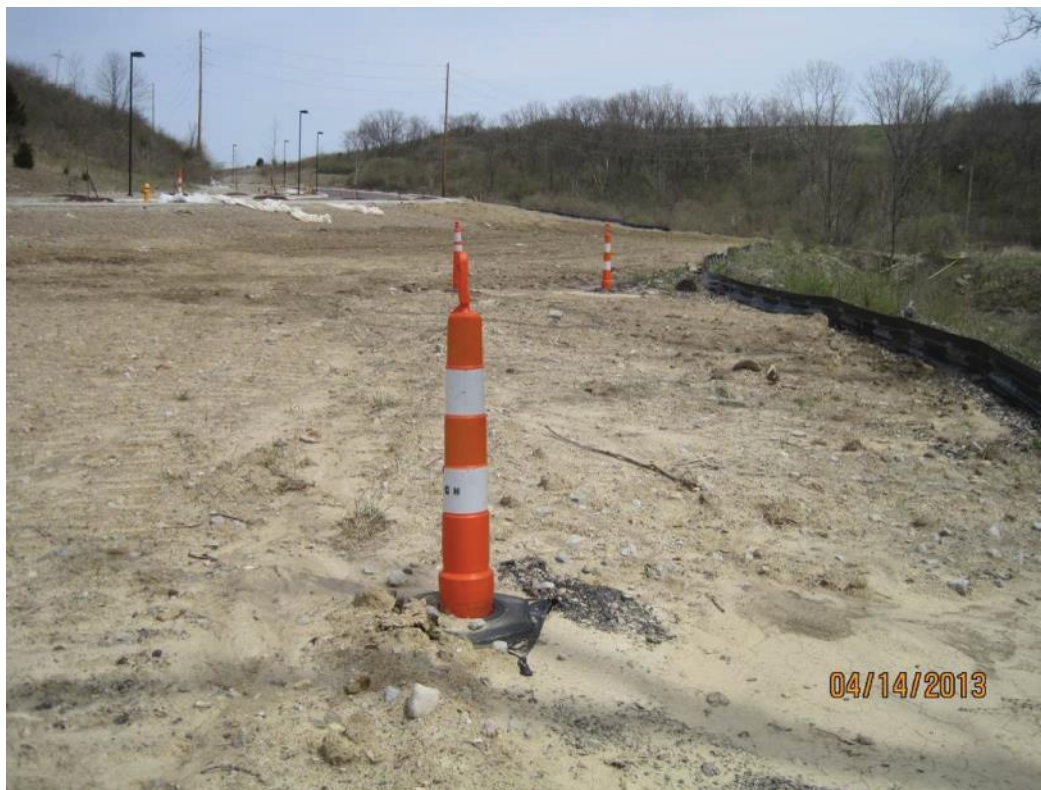
Figure 9. Erosion Problems South of Vanguard Blvd. near Well 0346

EMCBC instructed LM and Stoller to continue to monitor the construction through the DOE-owned parcels. The project followed the MDC soil management plan. No soil was removed from the site. The IC inspectors were told that EM had notified MDC of specific issues relating to soil erosion, drainage around wells, and well access. MDC advised that they were working with their contractor to resolve these issues. Figure 9 shows one of the problems observed.

Erosion problems were observed near the OU-1 area as shown in Figure 9 through Figure 14. Drainage issues can interfere with access to monitoring wells.

MDC and their contractor are correcting the sources of these drainage issues.

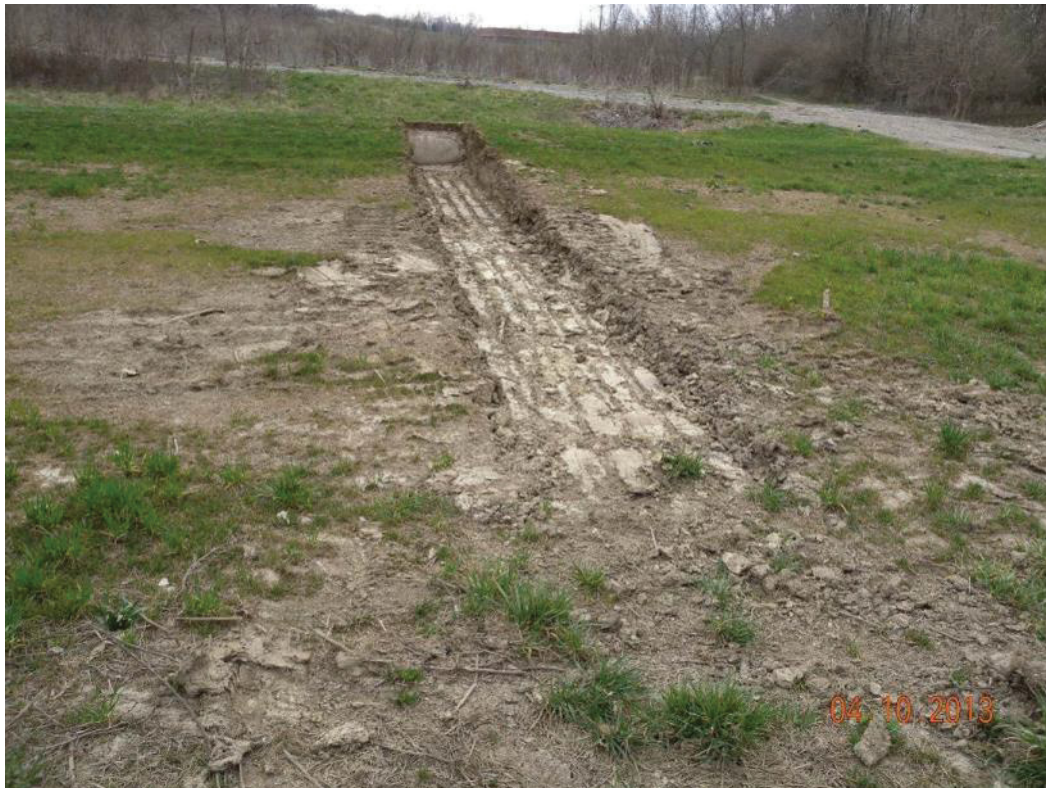
Figure 12. French Drain Installation Southward from Well P046 in OU-1 Area

In Figure 12, the drain connects to the storm-water pipe running west from Vanguard Boulevard.

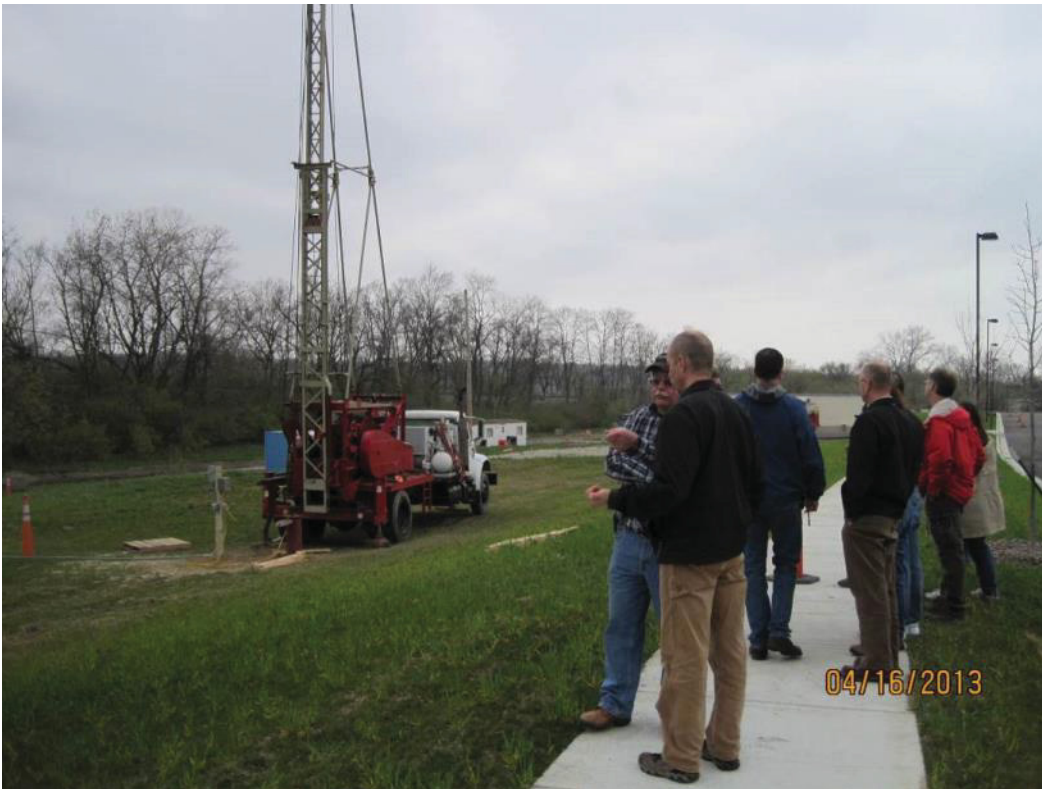
Figures 15 and 16 were taken during the walkdown of the OU-1 area. Participants observed the new wells and the drainage issues.

Figure 15. IC Walkdown Participants Observing the Area Around New Monitoring Wells in OU-1

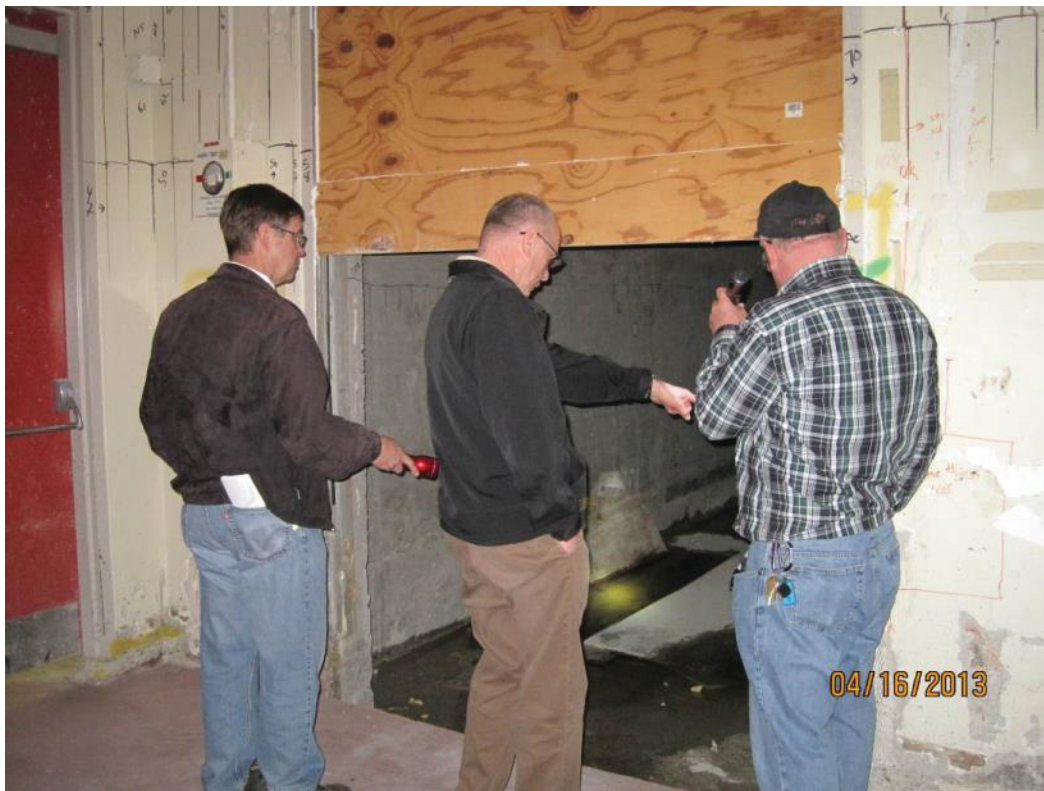
During the walkdown, standing water was observed in the special IC areas, rooms 57 and 58. The cause was identified as a rusted float valve on the sump pump for those rooms. Frank Bullock contacted his property maintenance contractor, who replaced the float, pumped out the water, and dried the area with fans.

Figure 17. Bob Ransbottom, Bill Hertel, and Gary Weidenbach (Stoller) Observing Water on the Floor of Room 57 in T Building During the IC Walkdown

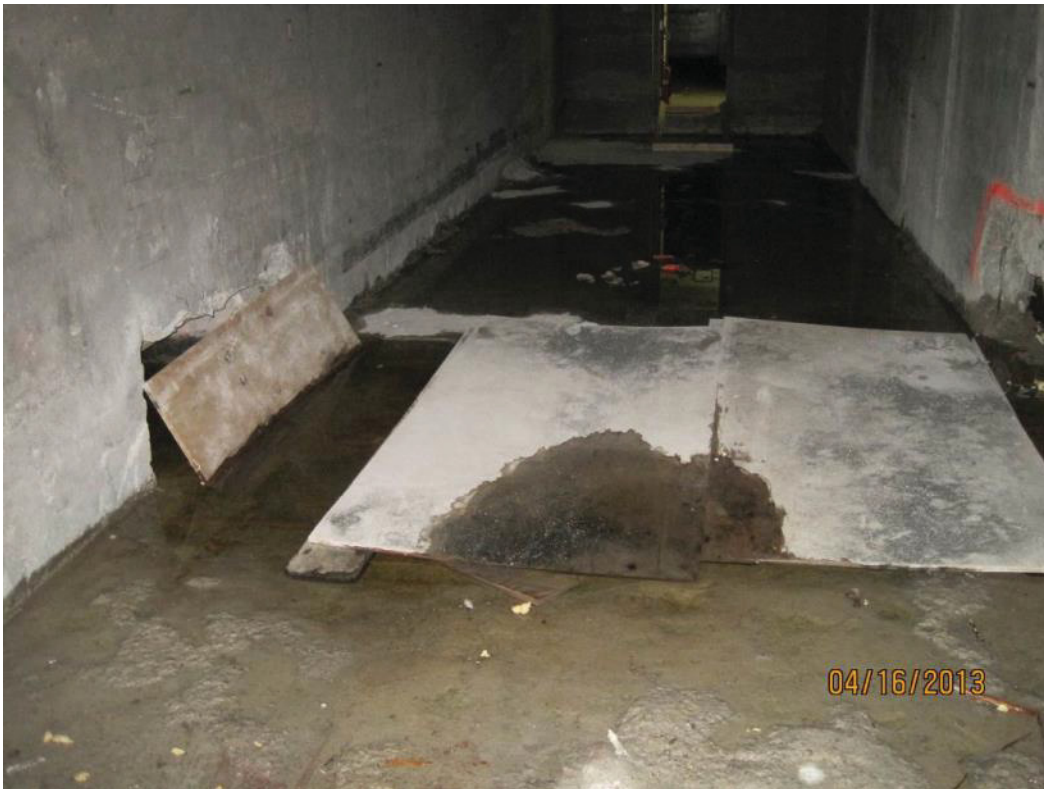
Figure 18. Standing Water Caused by Sump Pump Failure in T Building Room 57, Observed During the IC Walkdown

Standing water was observed during the walkdown in rooms T57 and T58. These are two of the rooms with special ICs. Stoller identified the source of the water, which was from the sump in room 99, whose float ball had rusted off.

After the walkdown, MDC instructed their property manager, Turner Property, to replace the ball float and to pump the excess water back to the drain. They also dried the area with fans. On April 18, 2013, Stoller verified with MDC that the correction had been made.

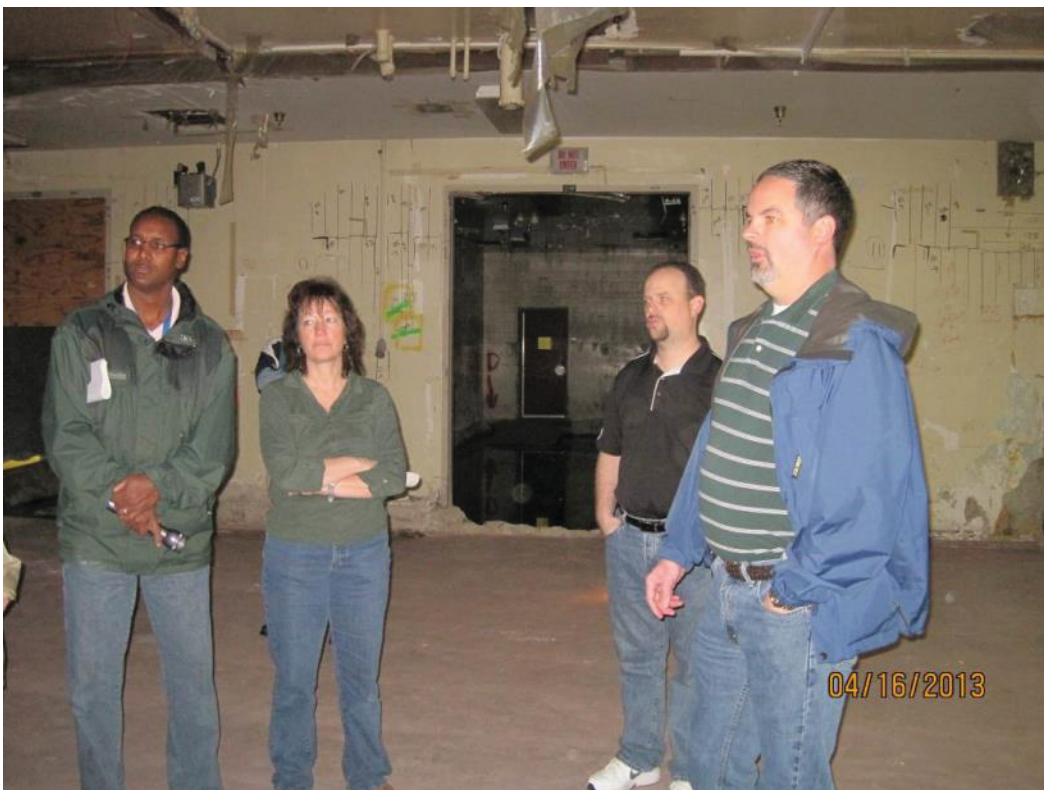
Figure 19. Anthony Campbell (Ohio EPA), Gwen Hooten (LM), Tim Fischer (EPA), and Greg Lupton (Stoller) Standing on Red Concrete in Front of Room 58 in the T Building During the IC Walkdown

The cracks in the red concrete covering Room 44 (survey unit 1C-10) were examined and discussed during the walkdown. A walkdown participant asked what size of crack would become a concern. LM will review the associated T Building documents and discuss the issue with the Core Team.

Number	Issue/Recommendation	Responsible
1	Review the records regarding the purpose of the red concrete. Discuss with Core Team.	LM/EM
2	Repeat the photographs of the cracks in the red concrete in 2014.	LM

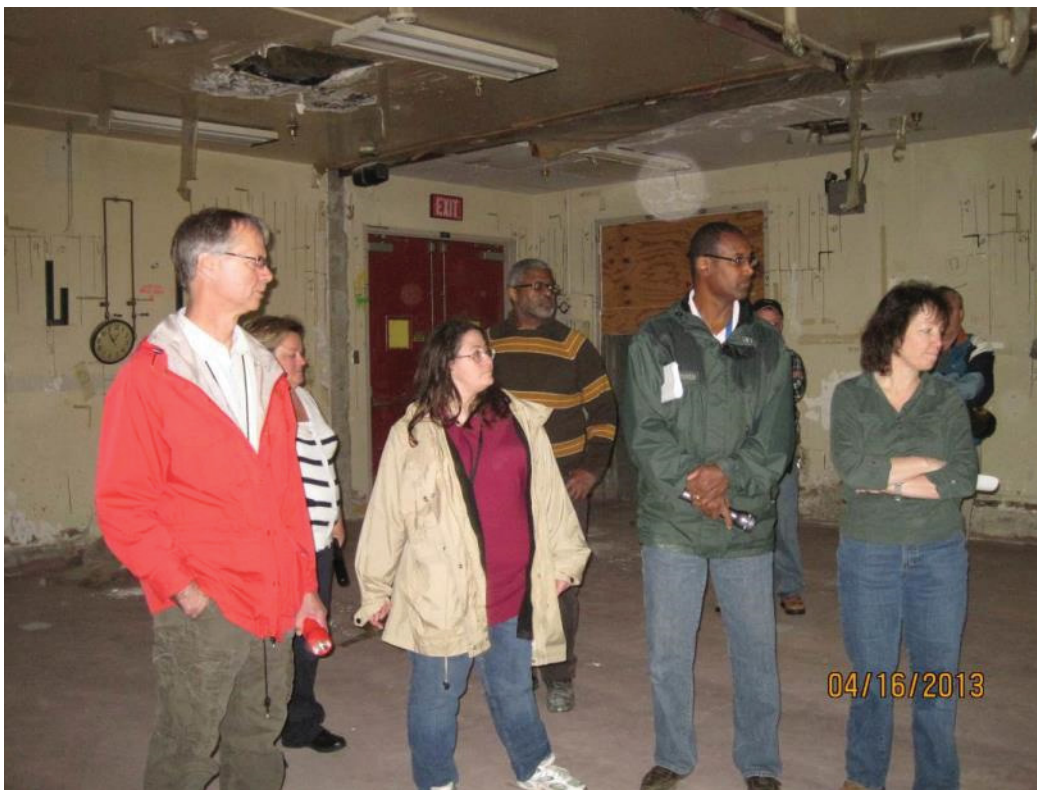
Figure 21. Brian Nickel (Ohio EPA), Ellen Stanifer (City of Miamisburg), Shannon Dettmer (ODH), Larry Kelly (EMCBC), Anthony Campbell (Ohio EPA), and Gwen Hooten (LM) Standing on Red Concrete in T Building Room 44 During the IC Walkdown

Cracks in the red concrete were again observed. Ohio EPA asked what crack width would trigger a repair action. LM advised they will review T Building documents to determine the intent of the red concrete and will discuss with the Core Team. LM photographed cracks to document any changes from the 2012 inspection. The photos did not show a significant change.

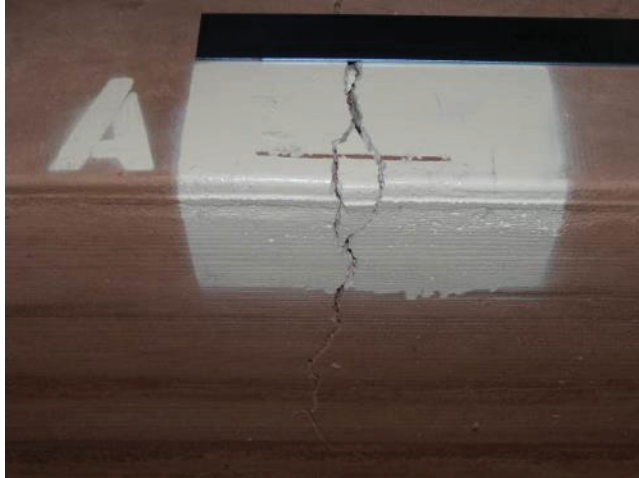
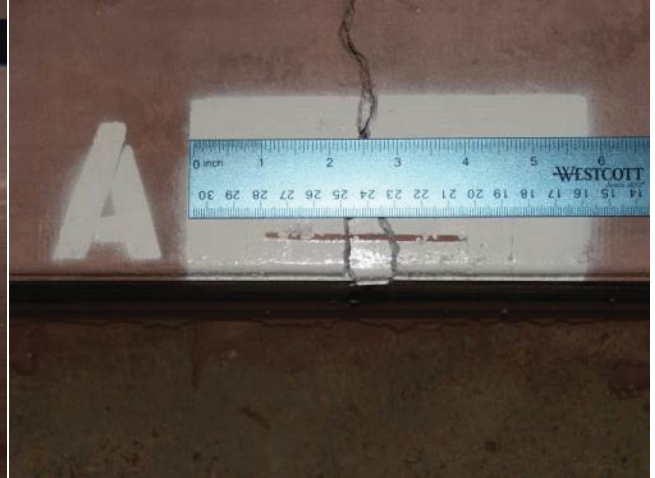
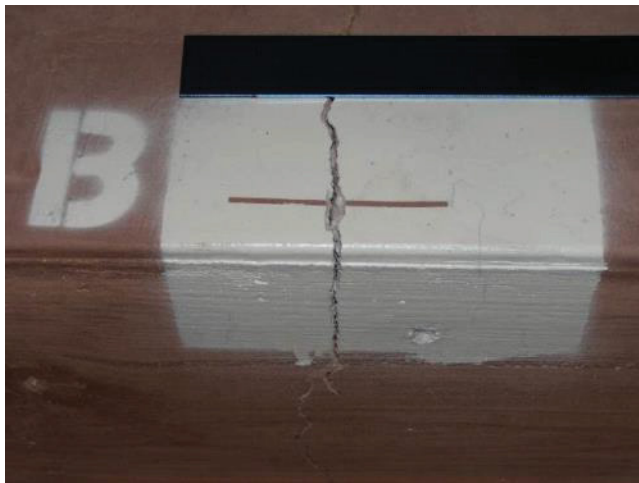
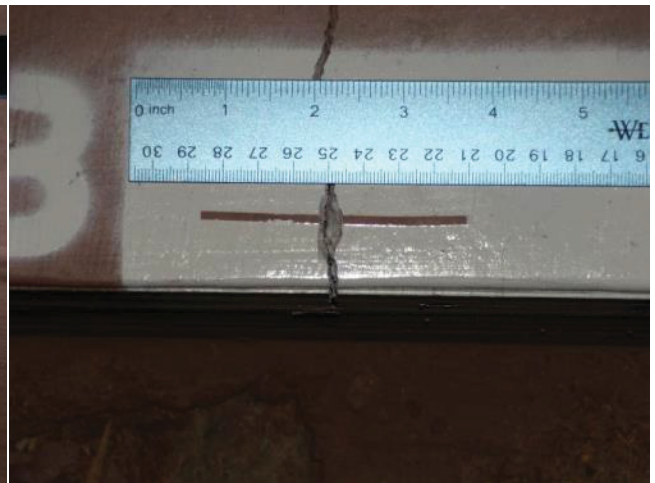
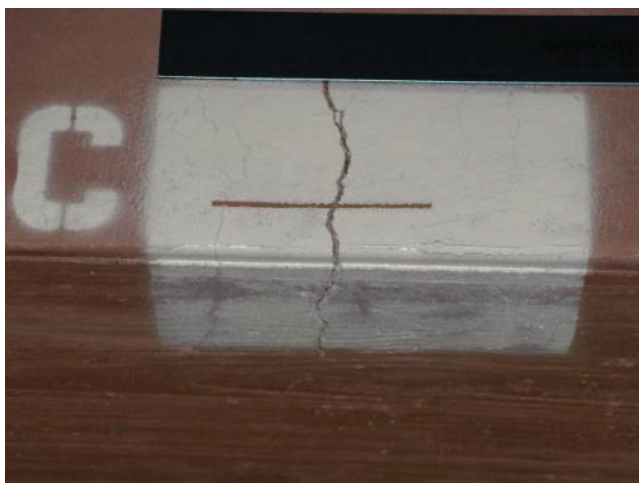
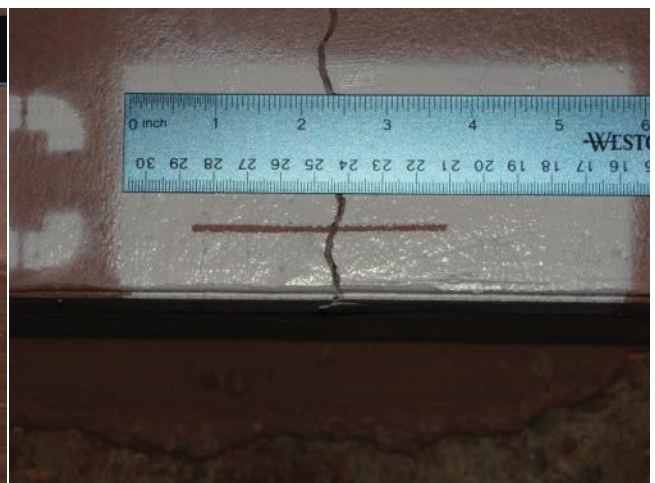
Appendix D contains the updated concrete crack photos taken on April 24, 2013. These photos document the crack locations and current condition. The cracks do not appear to have enlarged since 2012.

The following photographs were taken for the 2013 Mound Site Annual IC Assessment to document the current condition of the cracks in the red concrete in specified rooms in T Building. Figure D-1 room diagram shows the location of the crack monitoring points labeled A through I.
