**Monticello, Utah, National
Priorities List (NPL) Sites
Federal Facility Agreement
(FFA) Quarterly Report:
January 1–March 31, 2022**

May 2022

Legacy
Management

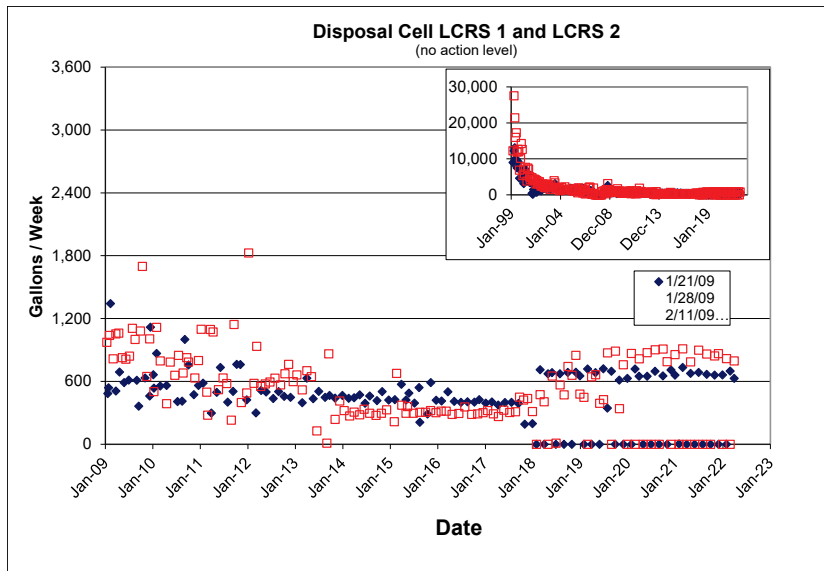
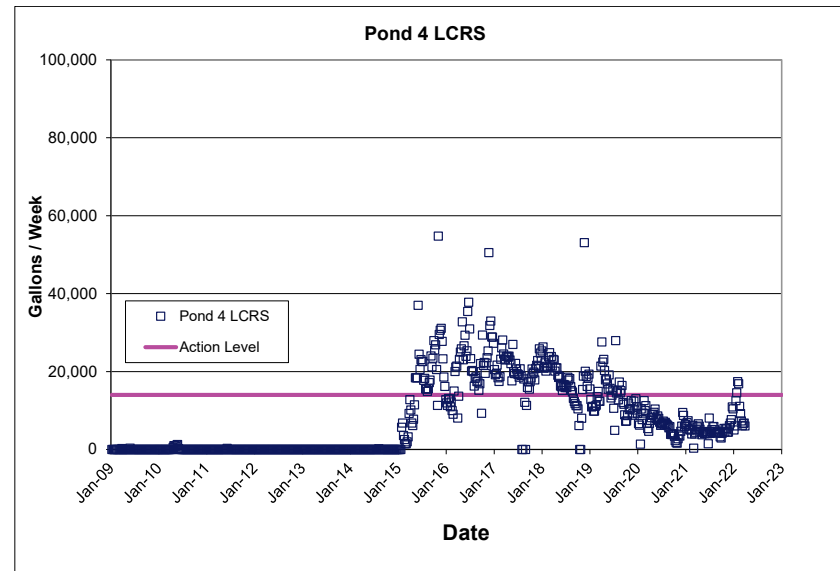
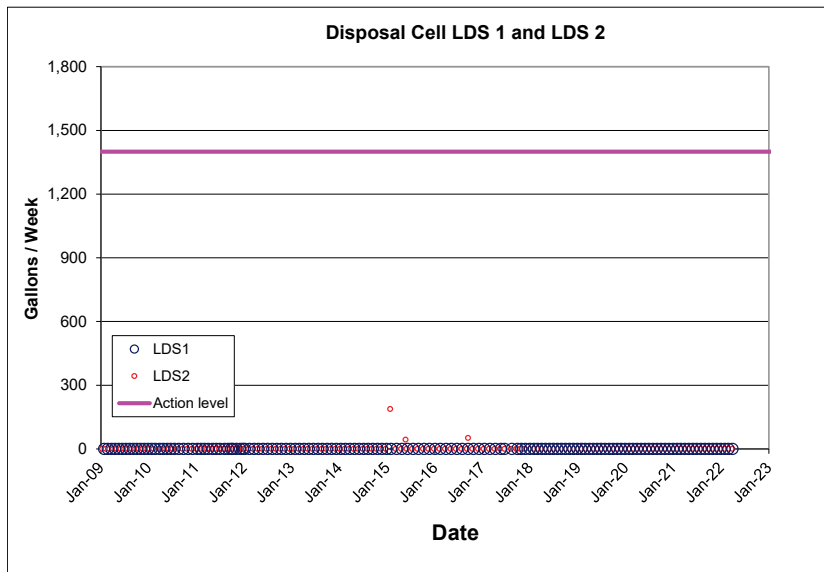
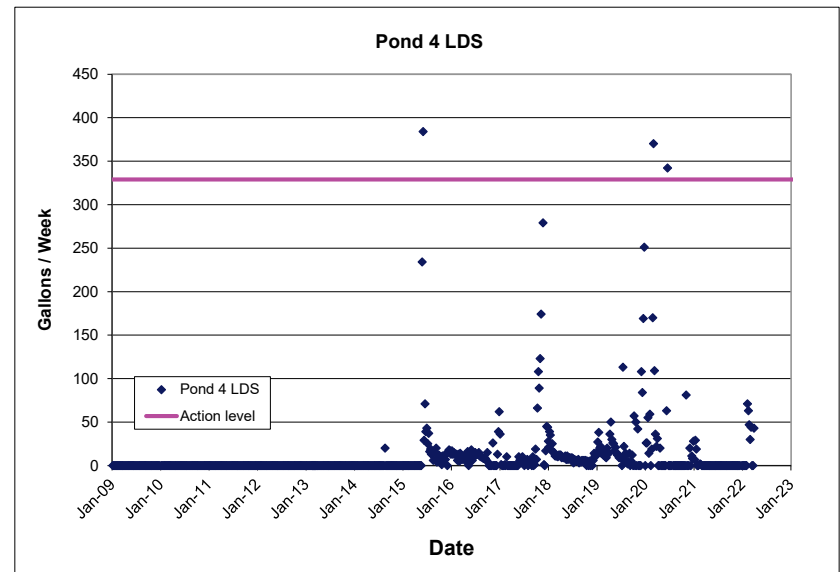
Graphs Showing Performance History for Disposal Cell and Pond 4 LCRS and LDS

- Leachate production from the disposal cell was approximately 990 gallons per week combined for sumps LCRS 1 and LCRS 2. There is no action level for the disposal cell LCRS. See Appendix B for a graphical depiction of leachate production history.

- The disposal cell LDS continues to receive no water; therefore, the disposal cell LDS action level was not exceeded. See Appendix B for a graphical depiction of leachate production history.

- Findings for the Pond 4 LCRS and LDS this period are as follows:
 - Water collection at the Pond 4 LCRS continued and exceeded the action level this quarter the weeks of January 24, January 31, and February 7, 2022 (see Appendix B). This action level has frequently been exceeded since the GRO system began operation in January 2015. DOE, EPA, and UDEQ were previously notified of this Pond 4 action level exceedance and concur with the plan of pumping contaminated water from the LCRS sump back into Pond 4 (DOE 2018a).
 - Water collection in the Pond 4 LDS remained below the action level (see Appendix B).
