Miamisburg Closure Project Building Data Package

Building 19

(Demolition)

Final
June 2003

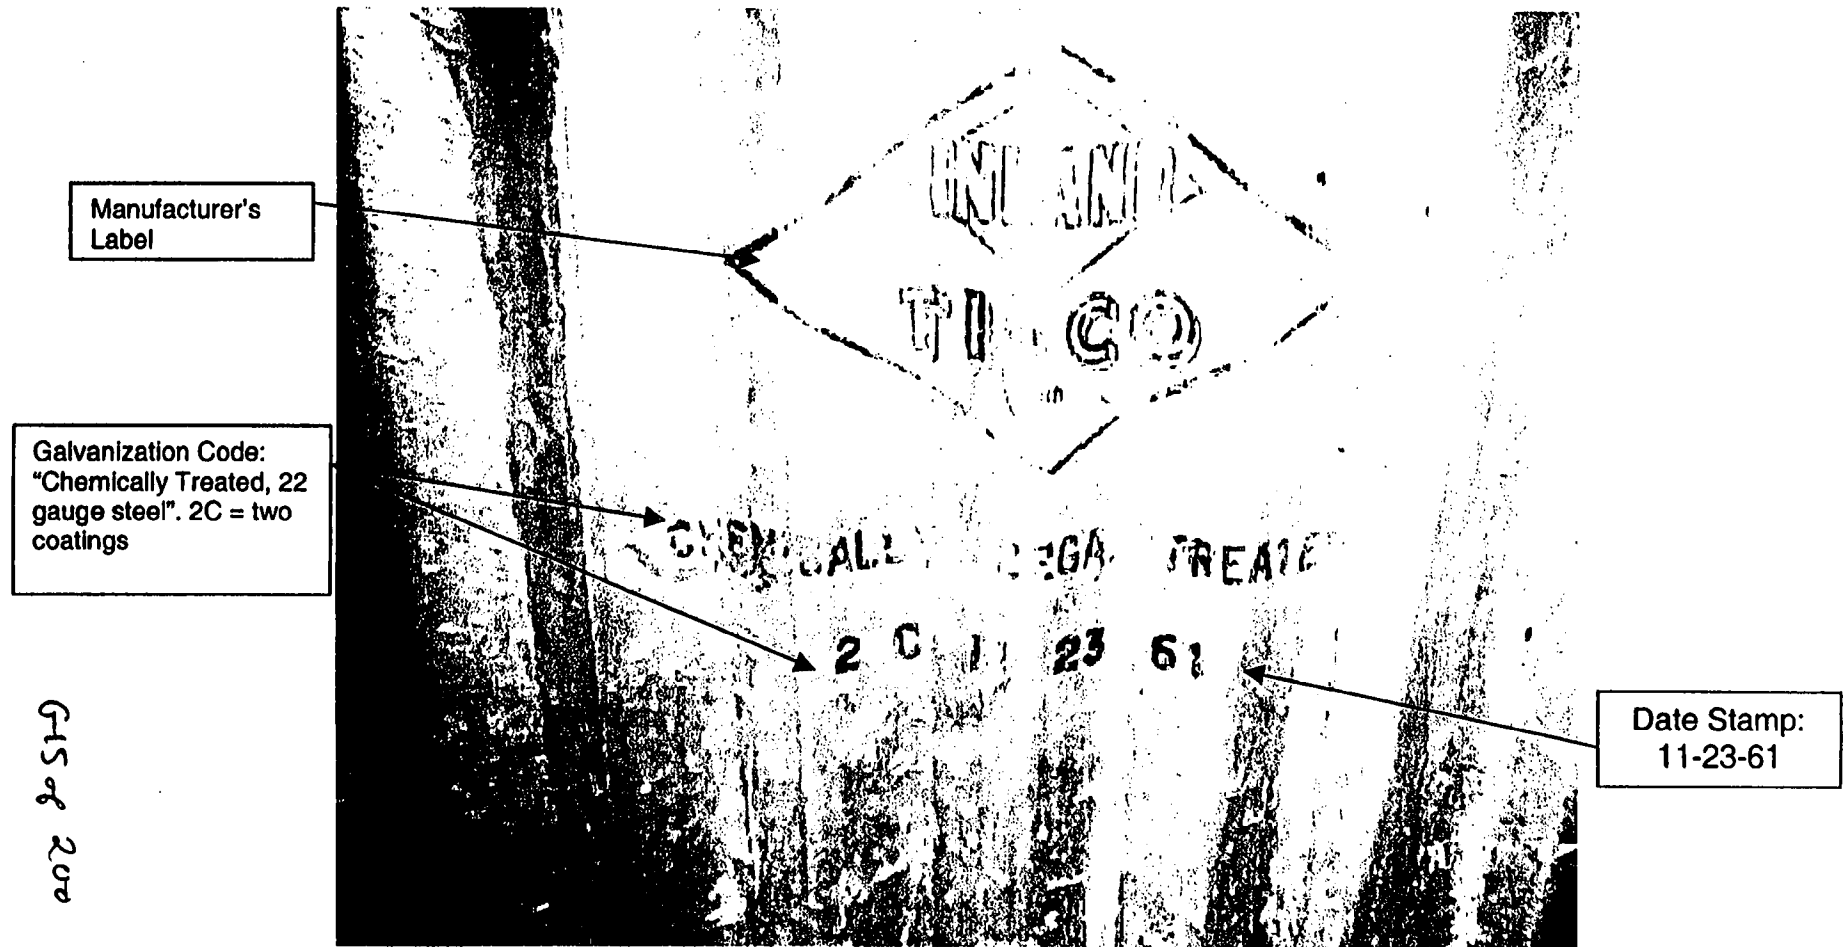
Building 19 Final Status Report
Attachment 1

Manufacturer's label, galvanization code, and date stamp on Building 19 corrugated siding as required by ASTM A653/653M.
