**From:** Tim Pac <Tim.Pac@erm.com>  
**Sent:** Wednesday, January 15, 2014 1:18 PM  
**To:** Charette, Carol A NAE  
**Subject:** [EXTERNAL] FW: Union Road Norton  
**Attachments:** photo 1.JPG; photo 2.JPG; photo 3.JPG; photo 4.JPG; photo 5.JPG; photo 6.JPG; photo 7.JPG; photo 9.JPG; photo 10.JPG; photo 11.JPG; photo 12.JPG; photo 13.JPG; photo 15.JPG; photo 16.JPG; photo 17.JPG; photo 18.JPG; photo 19.JPG; photo 20.JPG; photo 21.JPG; photo14.JPG; 8.JPG

From: Michael Yunits [mailto:MYunits@nortonmaus.com]  
Sent: Monday, January 13, 2014 10:13 AM  
To: Taylor.Melissag@epamail.epa.gov  
Cc: Michael P. Last (mlast@rackemann.com); John D'Agostino; scott.e.acone@usace.army.mil; Garry Waldeck (Garry.Waldeck@state.ma.us); Tim Pac; Mayor, [REDACTED]; Keith Silver; Selectman Bob Kimball; Mary Steele; [REDACTED]; Bob Salvo [REDACTED]; Timothy R. Giblin; Jennifer Carlino; Lisa.Nelson@mail.house.gov; dpwsupervisor@cityofattleboro.us; dpw2@cityofattleboro.us  
Subject: FW: Union Road Norton

January 13, 2014

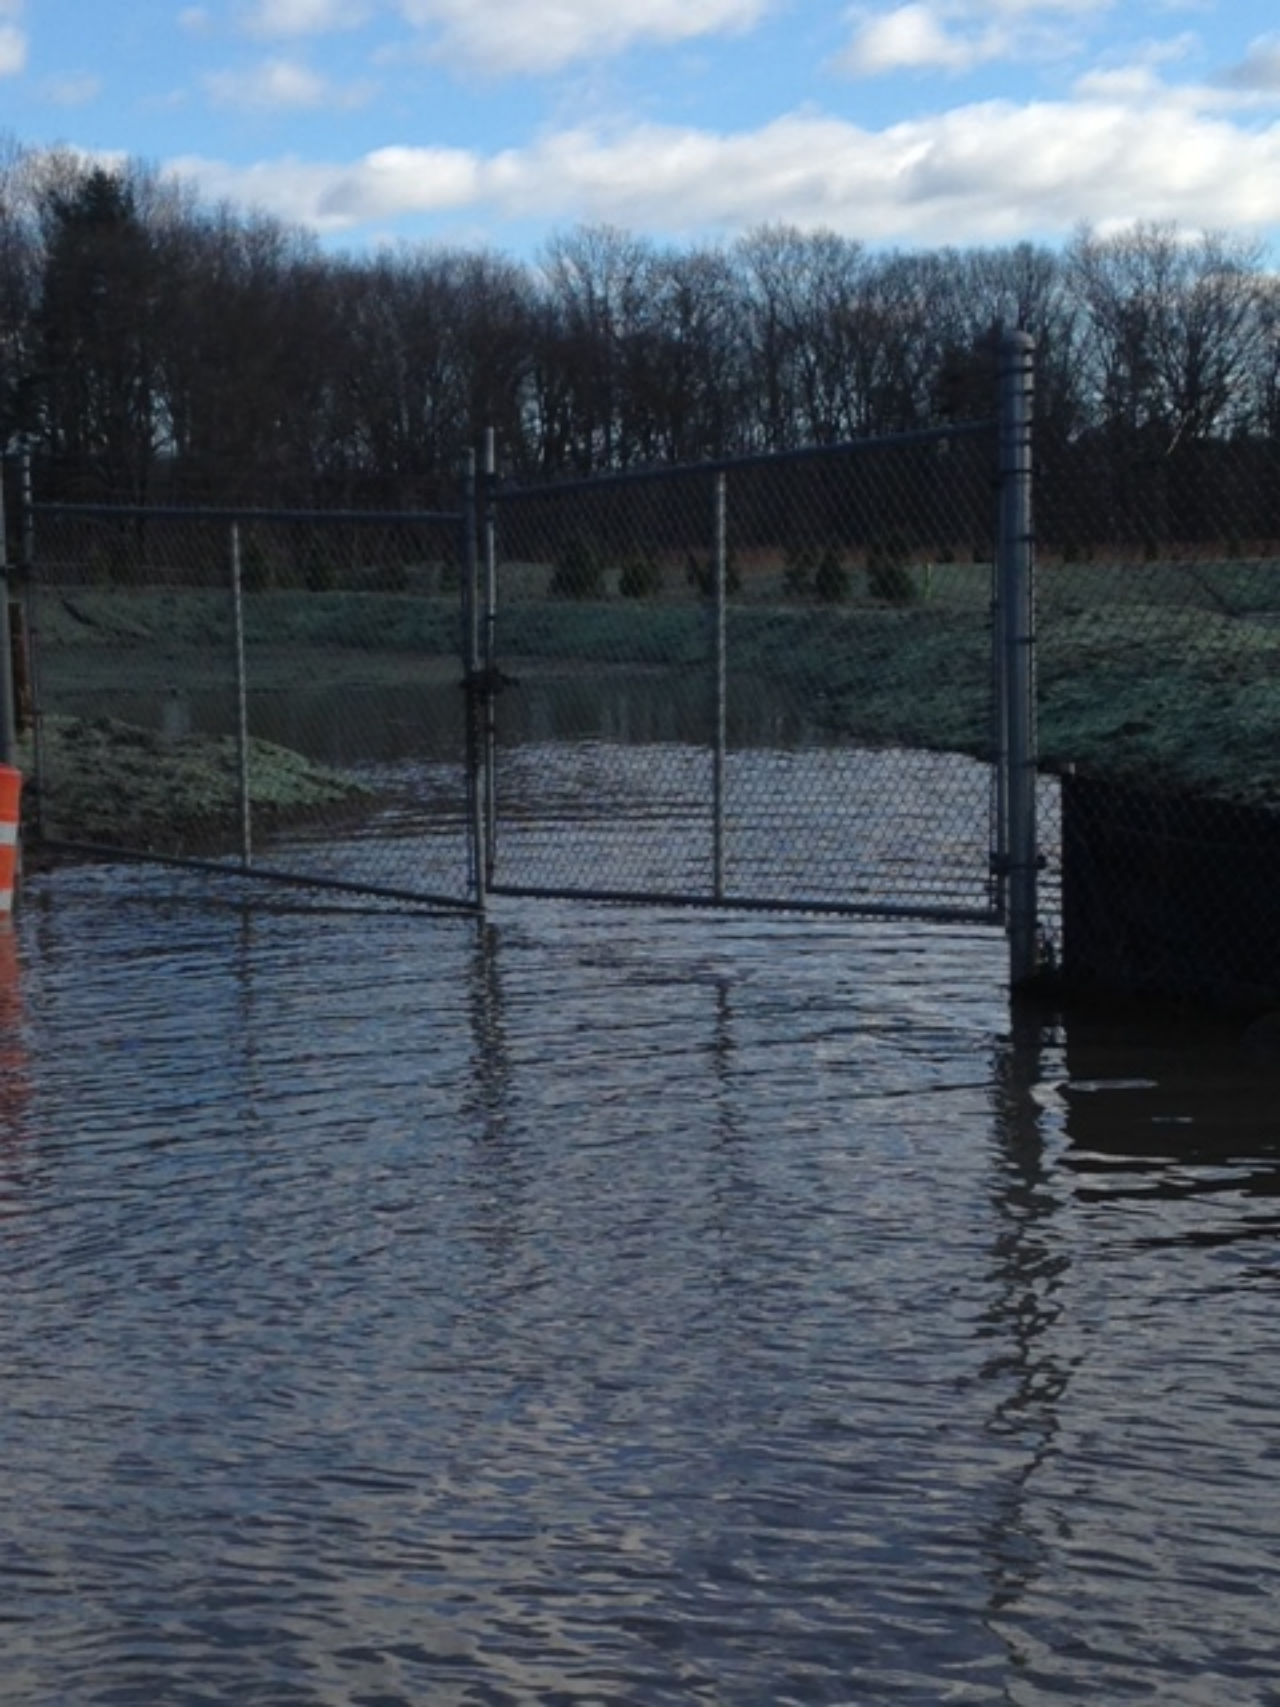
Photo 1 clearly shows that the upper basin is retaining water and then is draining onto the roadway. A solution to this design flaw is to install an outlet at a lower elevation allowing the water to drain into the lower basin and eventually onto the site.
