2006 Annual Inspection Report for the Weldon Spring, Missouri, Site

January 2007

U.S. Department
of Energy

Office of Legacy Management

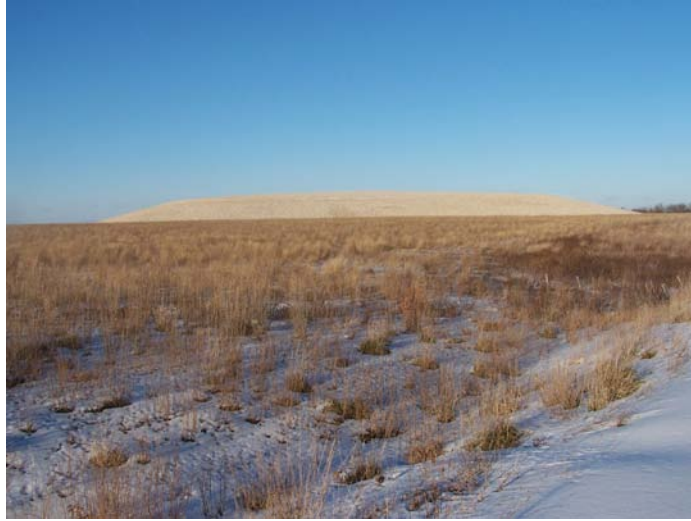
Inspection Results: This area was inspected (Photo 1) and no indications of excavations into soil or bedrock, groundwater withdrawal, or use were observed. MDC use and maintenance of the Hamburg Trail across DOE property is pending final agreement. Lindenwood University has been granted use of the Administration Building and its use is consistent with the agreement. Current land use remains consistent with the planned institutional controls.

Photo 1. The prairie and disposal cell viewed from the Hamburg Trail south of the cell.

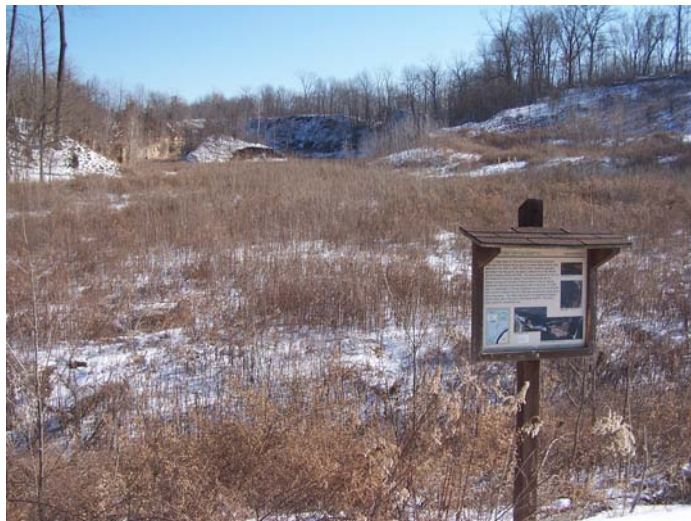
Inspection Results: The Quarry Property was inspected (Photo 3) and no indications of excavation into soil or bedrock or groundwater withdrawal or use were observed. Also, no party has been granted use of portions of the Quarry area. Quarry backfill continues to provide positive drainage from the Quarry to the Little Femme Osage Creek and vegetative cover remains well established. Current land use remains consistent with planned institutional controls.

Photo 3. Quarry and Historical Marker 9 along the Hamburg Trail.

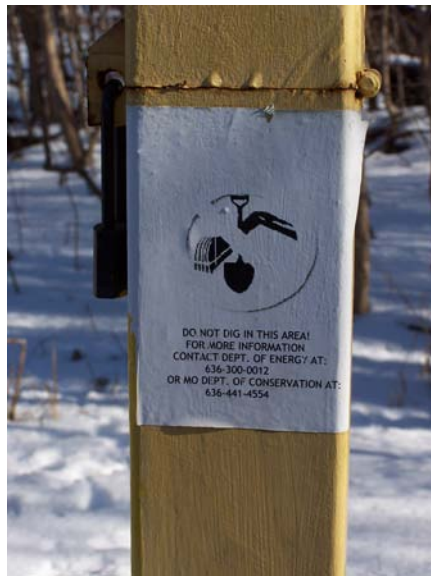
numbers for DOE and MDC. The red ink on the labels was observed to be badly faded (Photo 4) during the inspection and some recommendations to improve the labels were discussed. Land use remains consistent with planned institutional controls.

Photo 4. A faded “Do Not Dig” warning label on monitoring well MW-1051 in the Quarry reduction zone.

Note any observations: No indications of excavations into soils or bedrock. No land use changes. The "No digging" labels were faded and need to be replaced.

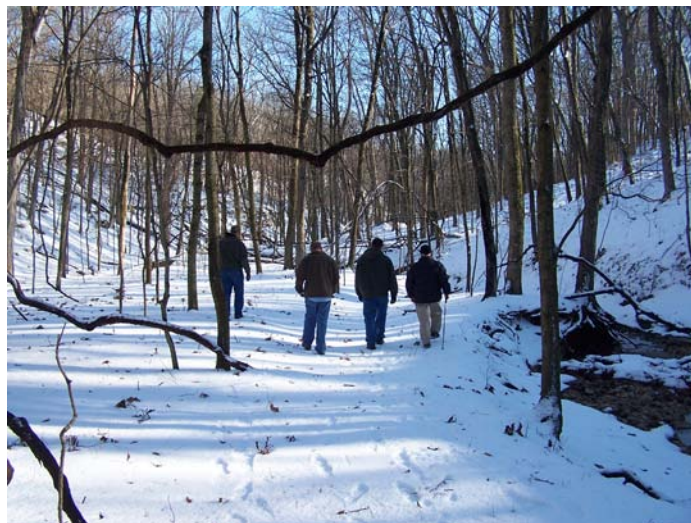
Inspection Results: The inspectors walked down the entire Southeast Drainage (Photo 5) and no indications of residential use, construction, or any other activity that would indicate non-recreational use of the area were observed. The springs also were inspected and no indications of residential, commercial, or agricultural use of the springs were observed (Photo 6). Current land use remains consistent with planned institutional controls.

Photo 5. Inspectors walking the Southeast Drainage.

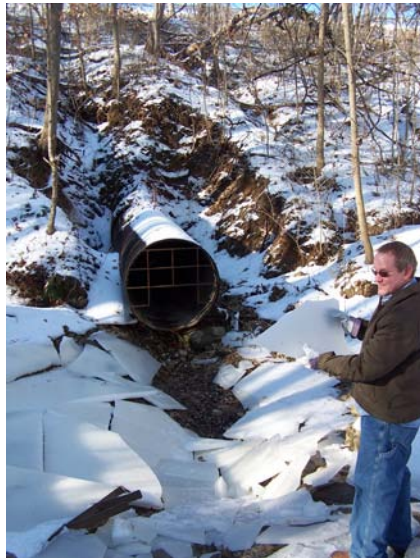
Inspection Results: The State Route 94 culvert was inspected (Photo 8) and it was noted that the condition had not changed from previous years' inspections.

Photo 8. Highway 94 culvert outlet in the Southeast Drainage.

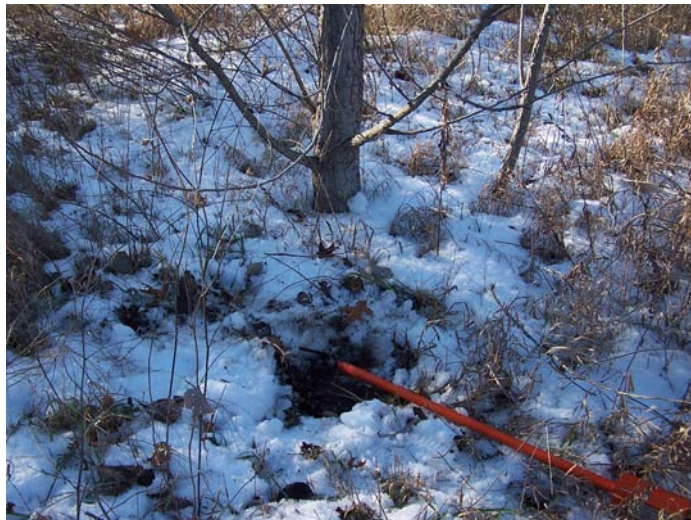
Inspection Results: The pipeline area was inspected. GPS surveying equipment was used to find the locations of the manholes and cleanouts. A map of the pipeline, indicating the manhole locations, is shown in Figure 6. It was noted that there were no on-site disturbances of the pipeline and there were no apparent disturbances in the area of the pipeline or manholes in the off-site areas. A tree was observed to be growing close to one of the manholes (Photo 9) and it is recommended to remove the tree.

Photo 9. Manhole No. 3 on the NPDES discharge pipe. Note tree next to the manhole.

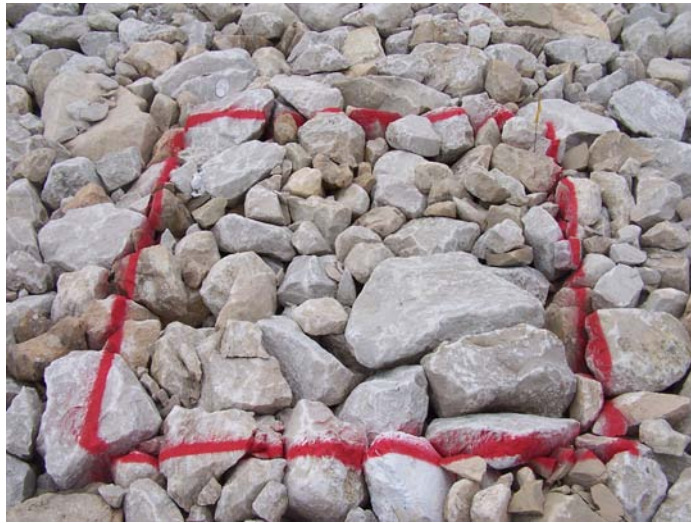
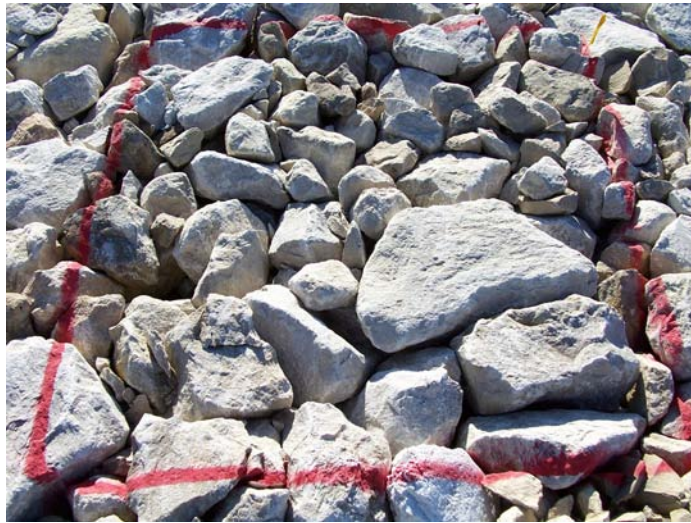
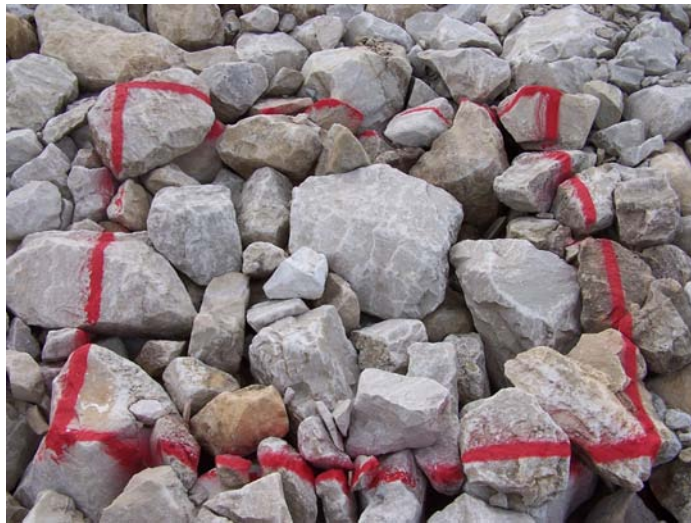
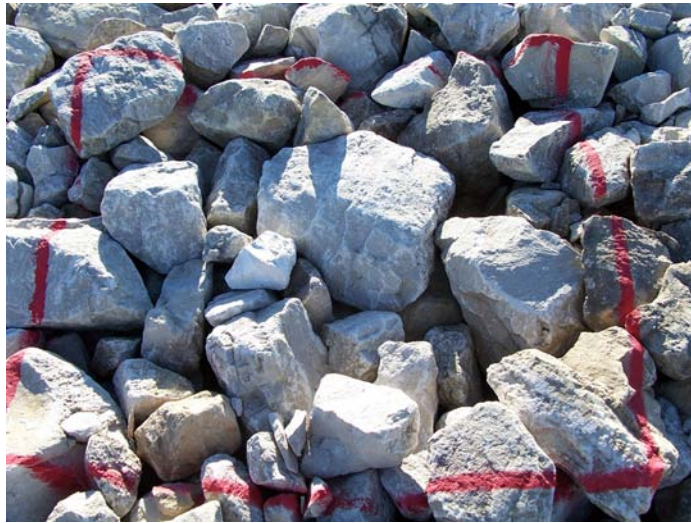
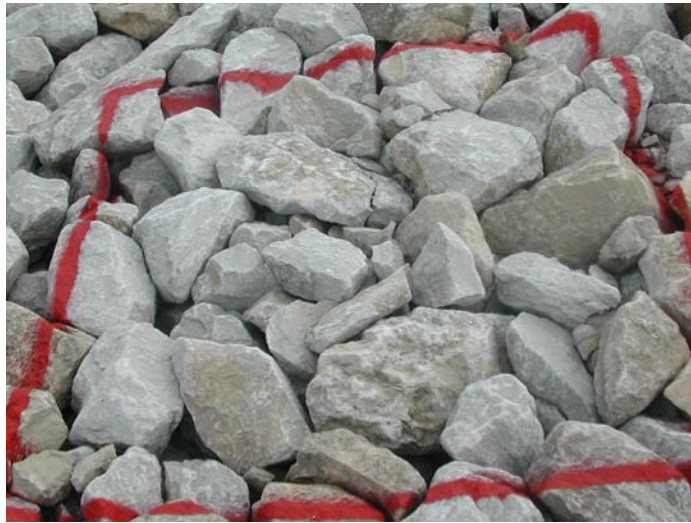
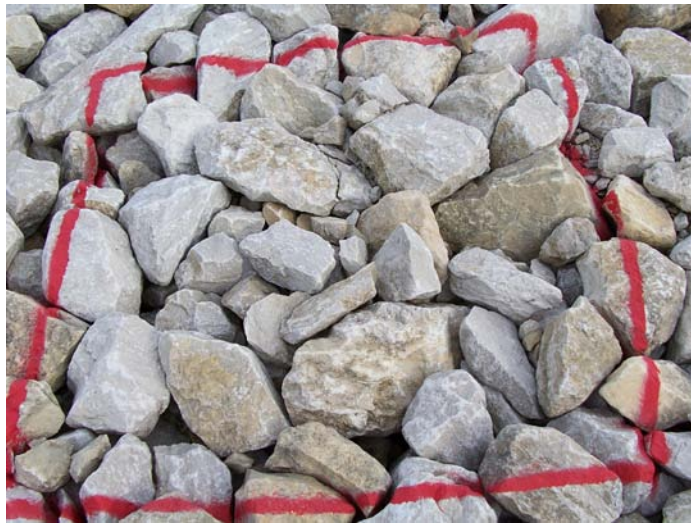
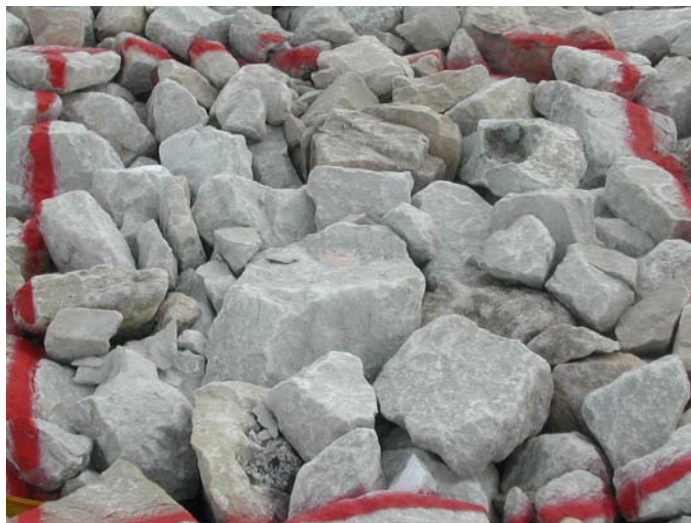
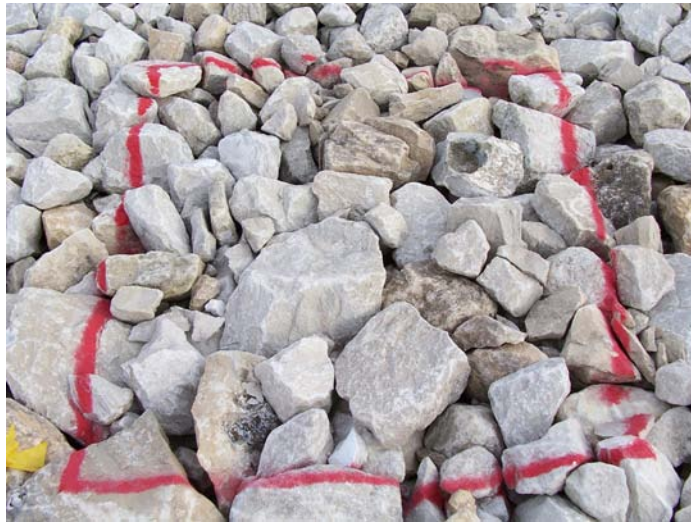
map five areas chosen for rock degradation review (Figure 7). The inspectors took photographs of these and compared them to photographs from the previous inspection of the same areas and observed no rock degradation. These areas are shown from last year and this year for comparison in Photos 10 through 19.

Photo 10. Cell cover rock test plot TP1; north edge of north facet (2005 Inspection).

Photo 11. Cell cover rock test plot TP1; north edge of north facet (2006 Inspection).

Photo 12. Cell side slope rock test plot TP2; bottom of north side slope (2005 Inspection).

Photo 13. Cell cover rock test plot TP2; bottom of north side slope (2006 Inspection).

Photo 14. Cell cover rock test plot TP3 northeast ridgeline (2005 Inspection).

Photo 15. Cell cover rock test plot TP3; northeast ridgeline (2006 Inspection).

Photo 16. Cell cover rock test plot TP4; located on lower west side (2005 Inspection).

Photo 17. Cell cover rock test plot TP4; located on upper west side (2006 Inspection).

Photo 18. Cell cover rock test plot TP5; located on upper west side (2005 Inspection).

Photo 19. Cell cover rock test plot TP5; located on lower west side (2006 Inspection).

Remarks The 5 Rock Test Plots are photographed and inspected/
observed annually. The rocks do not appear degraded.
Photos of 2005 and 2006 are included in report for
comparison.

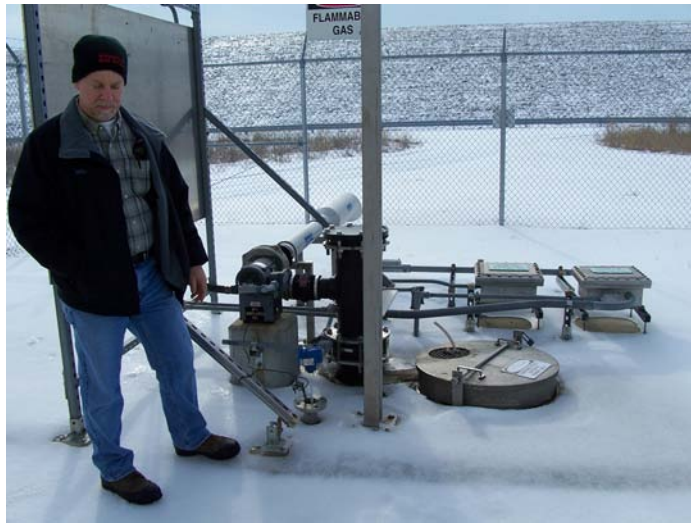
Operations of the LCRS were discussed with site personnel and the system was inspected (Photo 20). The fences and doors were locked and in good condition. The system was functioning as designed. The LCRS data and documentation were reviewed during the document review period of the inspection and the following information was checked and verified that it was available: sampling data, LCRS flow rates, action leakage rate information, “burrito” system flow rates, and leachate data. As required by the LTS&M Plan, the leachate production rates, analytical results, and disposal information are provided in Appendix D.

Photo 20. LCRS sump manhole.

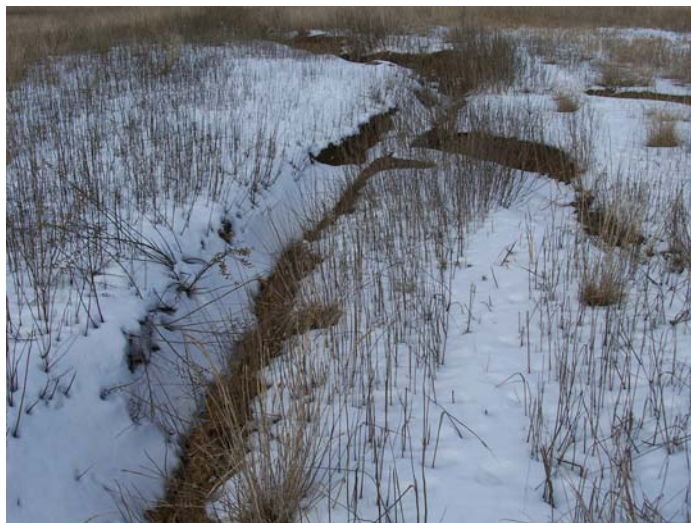
Areas of erosion in the prairie were identified in the following areas during the inspection: northeast and northwest of the cell close to the drainage areas, west of the cell (Photo 21) and along the Hamburg Trail area. The area northwest of the cell was the only area within the buffer zone and the area west of the cell had the deepest erosion gullies. The other areas were minor at this time. Due to the snowy conditions during the first part of the inspection and the muddy conditions during the December 15 portion of the inspection it is recommended that the prairie be inspected more thoroughly and the erosion areas be located and mapped by GPS and that erosion areas be repaired.

Photo 21. Erosion area in the prairie west of the cell.

Corrective Action: Identify and locate by GPS all areas of erosion in the prairie. Repair erosion areas.

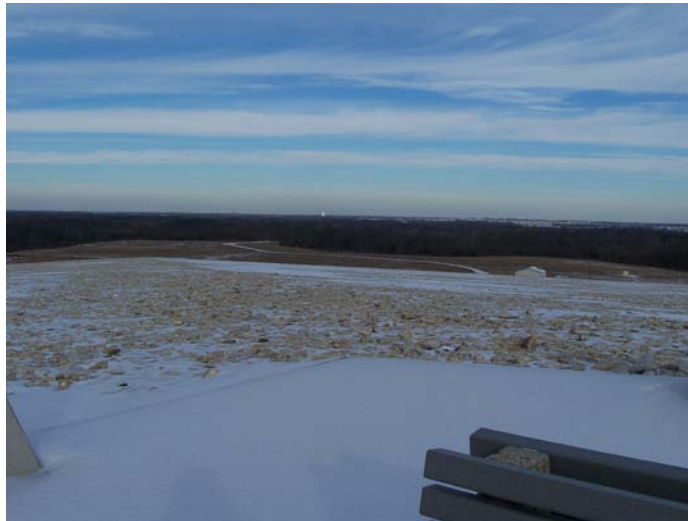
During the inspection it was observed that rocks on the cell are being moved around and this activity seems to be increasing (Photo 22). A historical marker (#10) also was shot up by small pellets. The sign is still readable. This sign was also vandalized in July 2005. The markers will continue to be routinely inspected.

Photo 22. View from top of cell facing northwest. Shows disturbance of rocks.

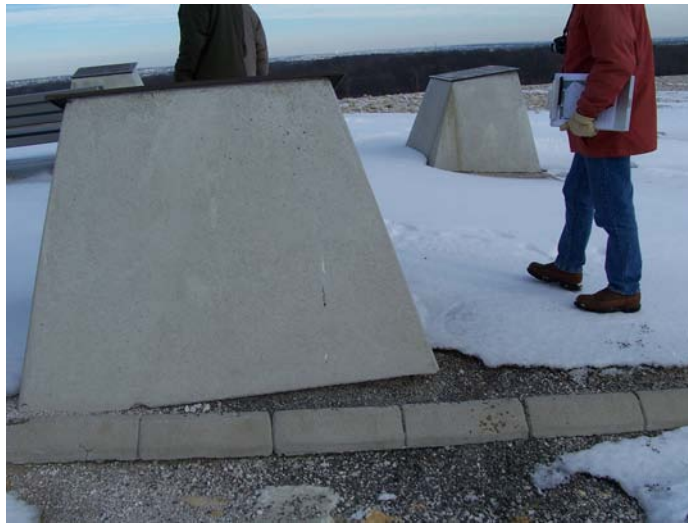
The four information plaques on top of the cell were generally in good condition. The pedestal on the south side of the viewing platform was eroded under the southeast corner (Photo 23) after it had been repaired from the previous inspection (See Appendix B). The historical markers were inspected during the inspection and found to be in good condition with the exception of Marker #10 which had been shot at with pellets. Photos were taken of each marker. Marker #10 is shown in Photo 24.

5. **Finding:** The pedestal on the south side of the viewing platform was eroded under the southeast corner after being repaired in 2006.

Photo 23. Corner of Pedestal on the SE Corner. Shows erosion under the bottom that had been repaired last year, but is reoccurring.

Corrective Action: Determine a more permanent repair and apply.

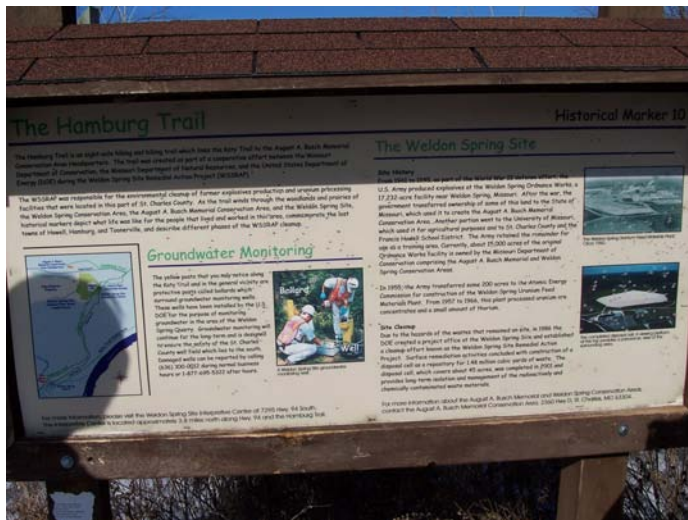
Photo 24. Historical Marker #10

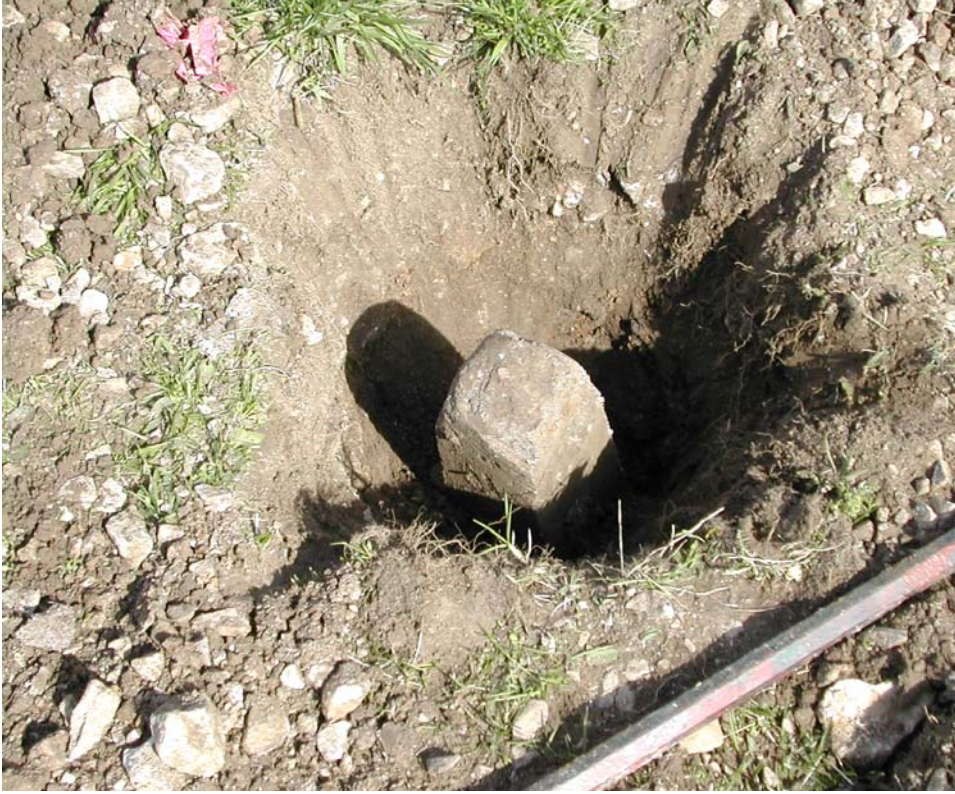
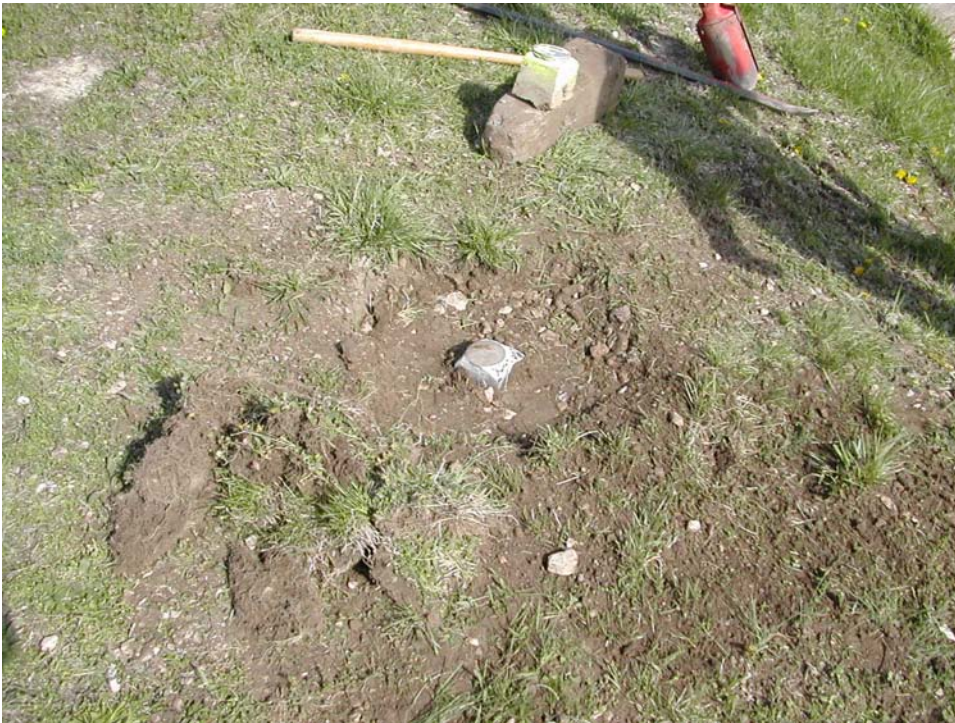
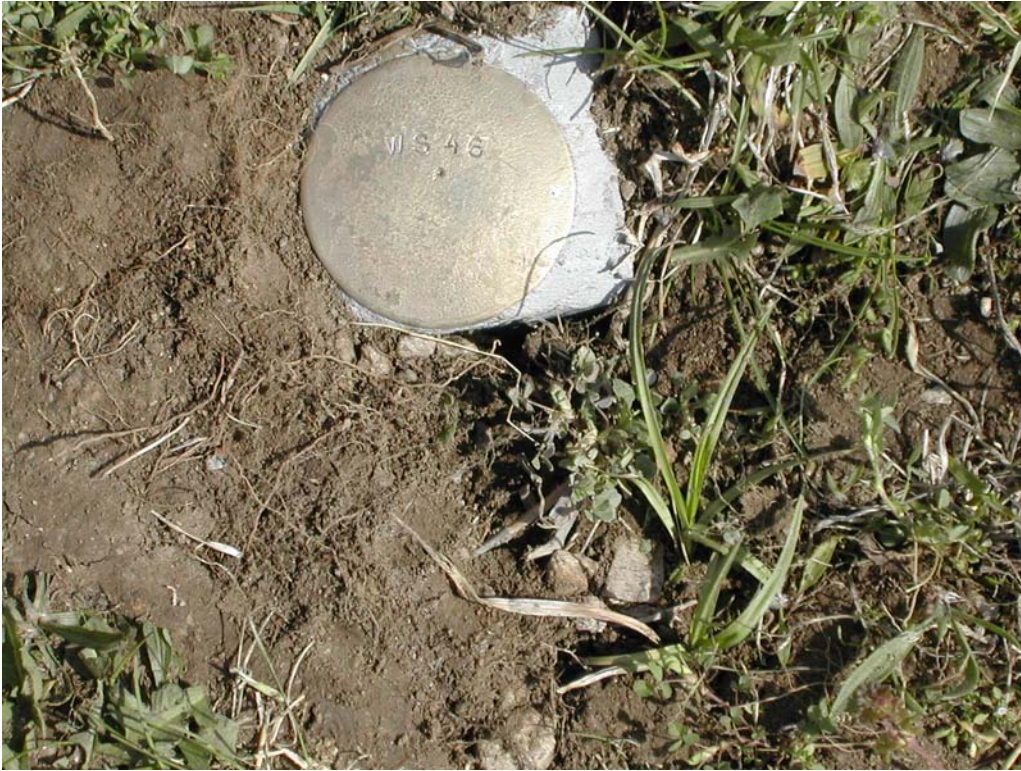
1. **Finding:** The boundary monument WS-46 was broken off.

Photo 1: Monument WS-46 Repair. Located on Army Property.

Photo 2: Monument WS-46 Repair. Located on Army Property.

Photo 3: Repaired WS-46 Monument. Located on Army Property.

Corrective Action: Coordinate repair of the monument.

Response: The monument was repaired. See Photos 1, 2 and 3.

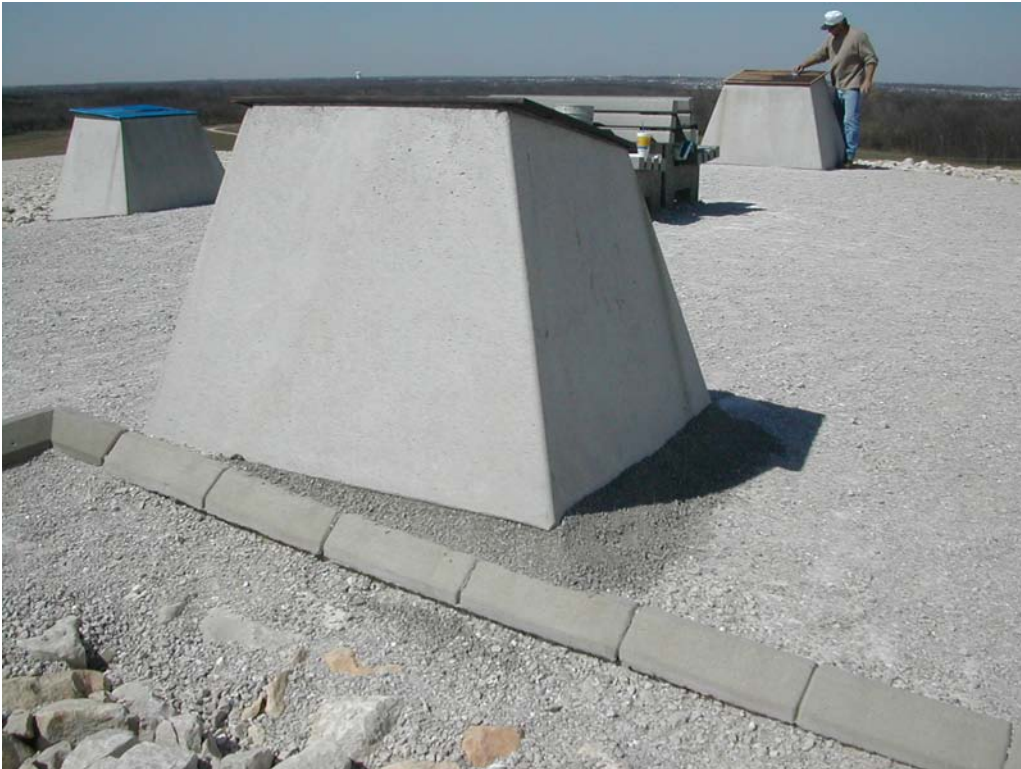
Photo 8: Repair of the erosion under the corner of the pedestal on top of the disposal cell.

Corrective Action: Repair the erosion.

Response: The erosion under the pedestal was repaired. See Photo 8.
