2007 Annual Inspection Report for the Weldon Spring, Missouri, Site

Office of Legacy Management

Summary

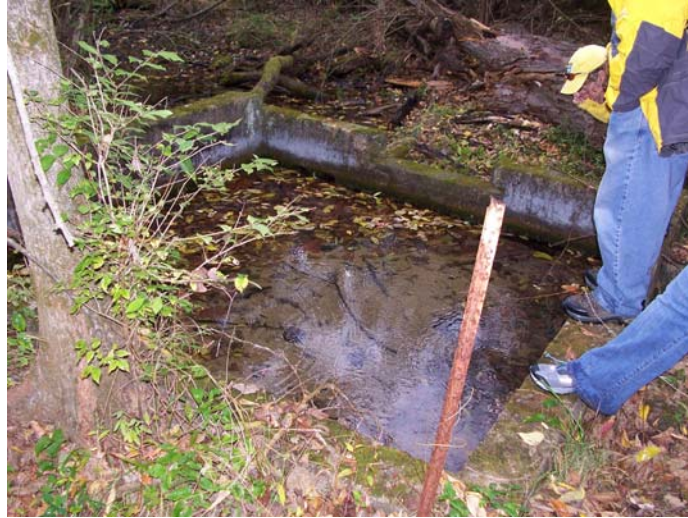
Photo 1. Burgermeister Spring

Inspection Results: The surrounding area where groundwater use will be restricted was inspected. This includes property owned by the Missouri Department of Conservation (MDC) and the Army. No evidence of groundwater use was observed and current land use remains consistent with planned institutional controls on both properties. Burgermeister Spring 6301 (Photo 1) and Spring 6303 on MDC property were inspected and there were no indications of spring water use. Spring 6303 was completely dry. On the Army property, survey monument WS46, noted as broken during the 2005 inspection and subsequently repaired was inspected. Also inspected was WS56P, a random survey pin chosen to locate during the inspection. The Chemical Plant groundwater restriction area boundary monuments are shown in Figure 4. The new well (MW-4042) (Photo 2) that was installed on the Army property in August was inspected. The well needs to be labeled with the well number. The well did have the metal plate with the identification number.

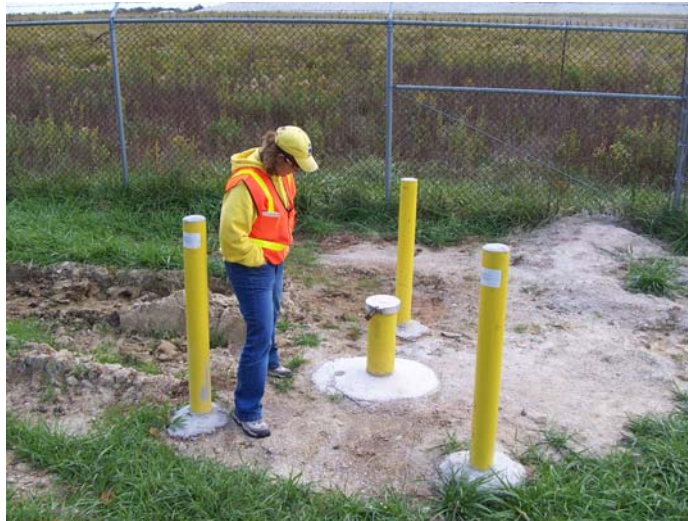
Photo 2. Recently installed monitoring well MW-4042 on the Army property.

2. **Chemical Plant Groundwater Monitor Well Network**
 Properly secured/locked Functioning Sampled in accordance with LTS&M Plan
 Good condition Evidence of surface water infiltration at casing Needs maintenance
 Acceptable quality of data Any issues with data trends (see Section II.2)
 List wells checked by number (> 10% of wells) MW-2006, 2012, 2017, 2013, 2023, 2024, 2033, 2034, 2036, 2045, 2053, 2054, 2074, 3025, 3028, 3029, 3031, 3039, 3040, 4001, 4006, 4007, 4022, 4026, 4027, 4028, 4029, 4030, 4032, 4034, 4039, 4040, 4041, 4042, 1004, 1005
 Remarks New well MW-4042 needs to be labelled 1006, 1101

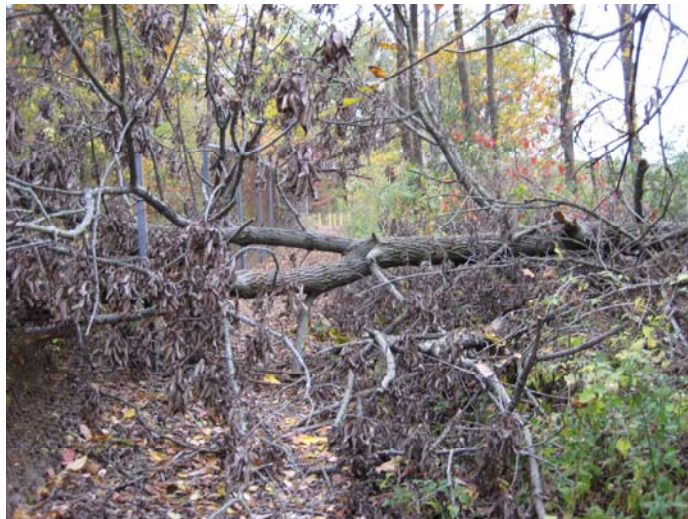
Inspection Results: The Quarry Property was inspected and no indications of excavation into soil or bedrock, or groundwater withdrawal or use were observed. Also, no party has been granted use of portions of the Quarry area. Quarry backfill continues to provide positive drainage from the Quarry to the Little Femme Osage Creek and vegetative cover remains well established. Current land use remains consistent with planned institutional controls. It was noted that there were some trees down at the rim of the quarry (Photo 3) that could become a safety hazard when accessing groundwater wells for sampling.

Photo 3. Quarry rim – fallen tree on Fence.

4. **Recommendation:** Cut trees at the quarry and remove enough so they are not a hazard during sampling.

Corrective Action: Cut trees at the quarry and remove enough so they are not a hazard during sampling.

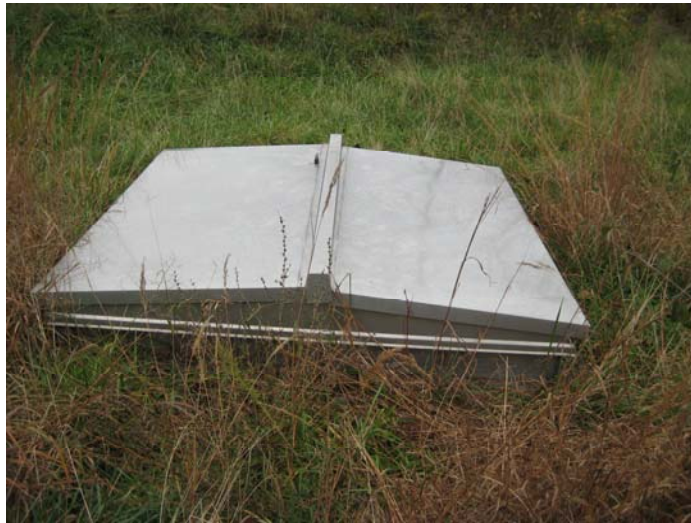
Inspection Results: The groundwater-restricted area was inspected and no evidence of groundwater withdrawal or use in the area was observed. The Quarry groundwater restriction area boundary survey monuments are shown in Figure 5. The following survey monuments were located during the inspection: WQ4A, WQ8, and WQ11. An abandoned water vault was discovered at the quarry (Photo 4) that was unlocked and could present a safety hazard. It was discussed and recommended that the party responsible for the vault be determined and that the vault be locked immediately to prevent an accident.

Photo 4. Water vault on MDOC property (unlocked).

5. **Recommendation:** An unlocked, abandoned water vault was found at the Quarry. Need to determine who is responsible for this vault and also lock it for safety reasons.

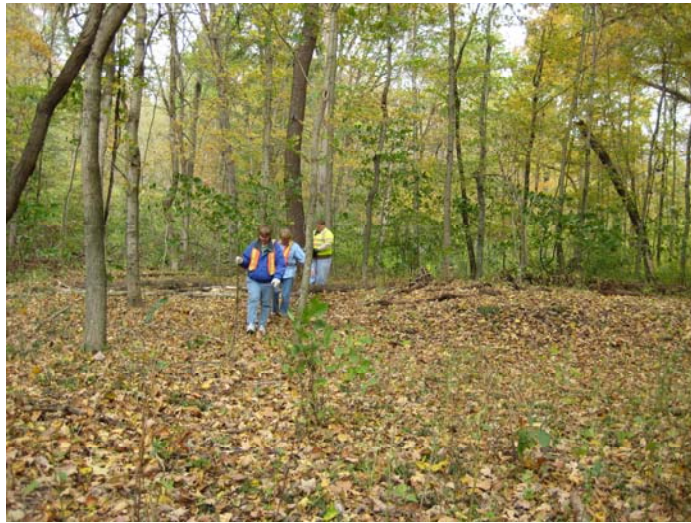
Inspection Results: The inspectors walked down the entire Southeast Drainage (Photo 5) and no indications of residential use, construction, or any other activity that would indicate non-recreational use of the area were observed. The springs also were inspected and no indications of residential, commercial, or agricultural use of the springs were observed. The springs were observed to be dry and not flowing. Current land use remains consistent with planned institutional controls.

Photo 5. Inspectors walking the Southeast Drainage.

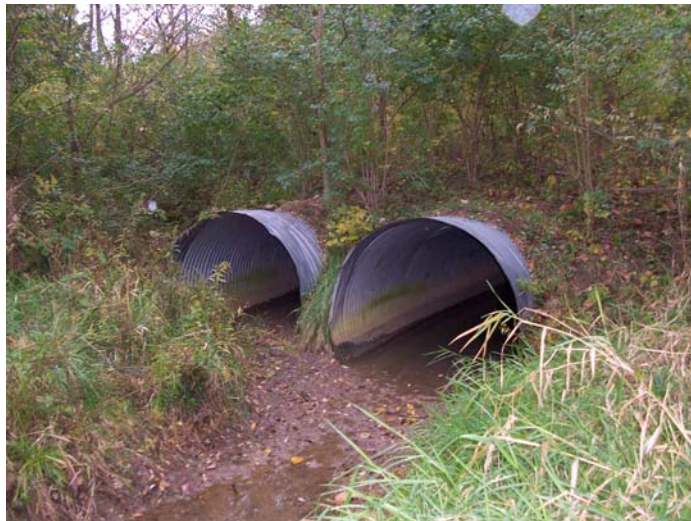
Inspection Results: The Highway D culverts were inspected (Photo 6). The gravel on top of the culverts that had been placed by MDOT last year to stabilize the erosion was still in place. It was discussed that some type of sign should be placed on or near the culverts to indicate the need for DOE to be contacted prior to any digging near the culvert or prior to replacement of the culvert.

Photo 6. Highway D culverts.

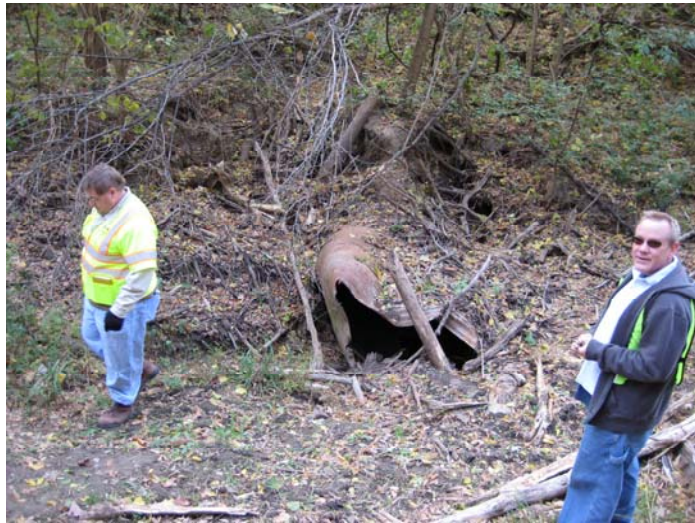
Inspection Results: The State Route 94 culvert was inspected (Photo 7) and it was noted that the condition had not changed from previous years' inspections. It was discussed that some type of sign should be placed on or near the culverts to indicate the need for DOE to be contacted prior to any digging near the culvert or prior to replacement of the culvert.

Photo 7. Highway 94 culvert inlet in the Southeast Drainage.

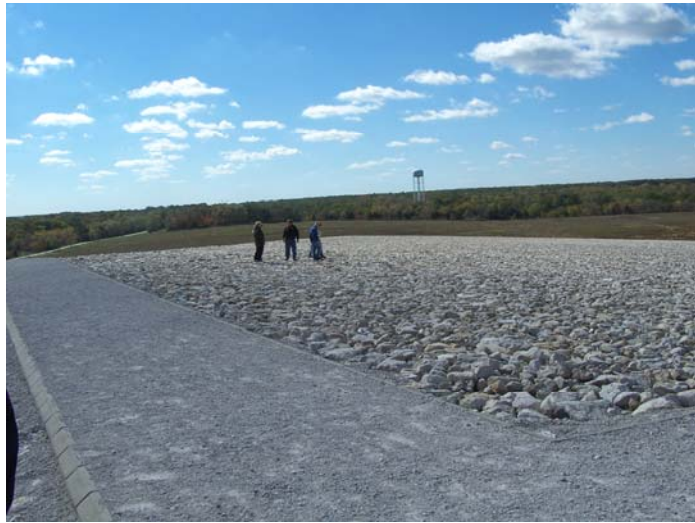
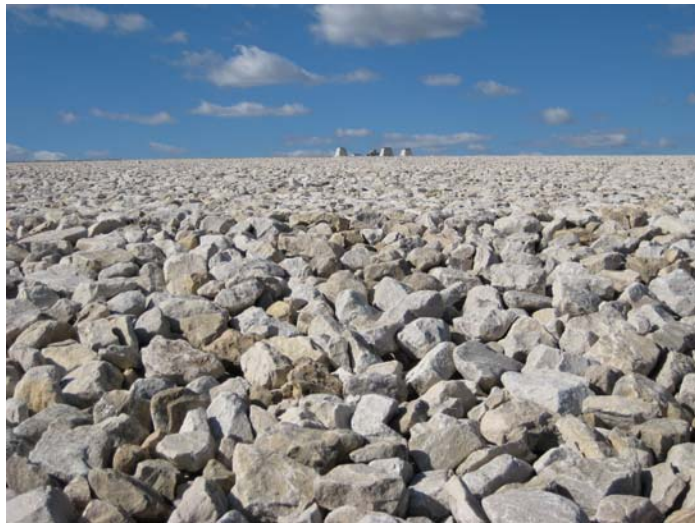
The disposal cell was inspected in accordance with the LTS&M Plan (Photos 8 and 9) and the annual inspection checklist. The cell was divided into ten transects (Figure 7). The inspectors separated into two groups and walked five transects each. The inspectors looked for depressions, shifts of cell plane vertices, and other indications of settlement. Other items for inspection were vegetation, wet areas, apron drains, guardrail, and the stairs. A GPS unit was used during the 2003 inspection to map five areas chosen for rock degradation review (Figure 7). The inspectors took photographs of these and compared them to photographs from the previous inspection of the same areas and observed no rock degradation.

A few small shallow depressions on the cell cover were noted during the inspection. It appeared that the depressions ranged up to approximately 2 or 3 inches deep. The majority of these areas had been identified during the previous inspection(s). These slight depressions are not unexpected for a disposal cell of this type and are not a cause for concern. They will continue to be monitored.

Photo 8. Inspectors from Group 2 on the disposal cell.

Photo 9. Disposal Cell inspection looking southwest.

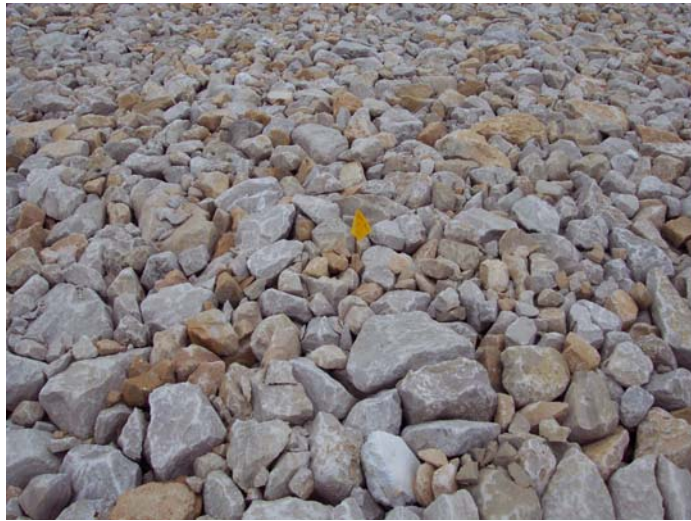
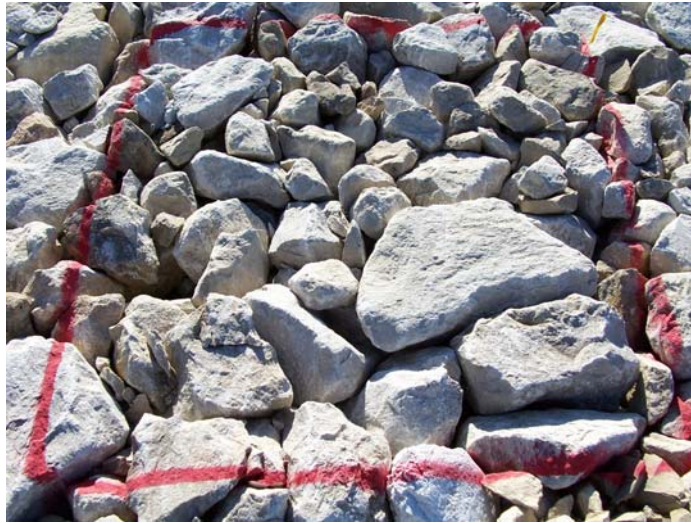
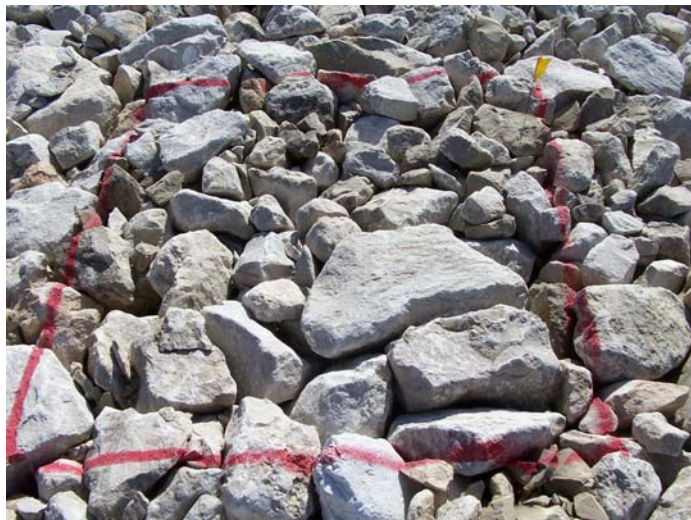
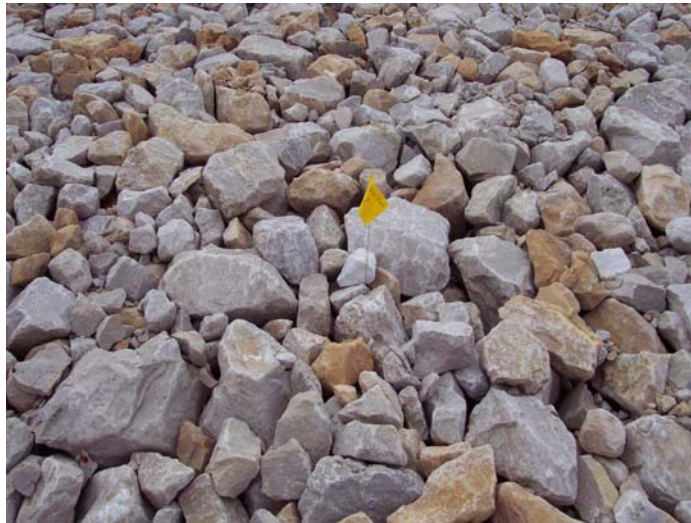
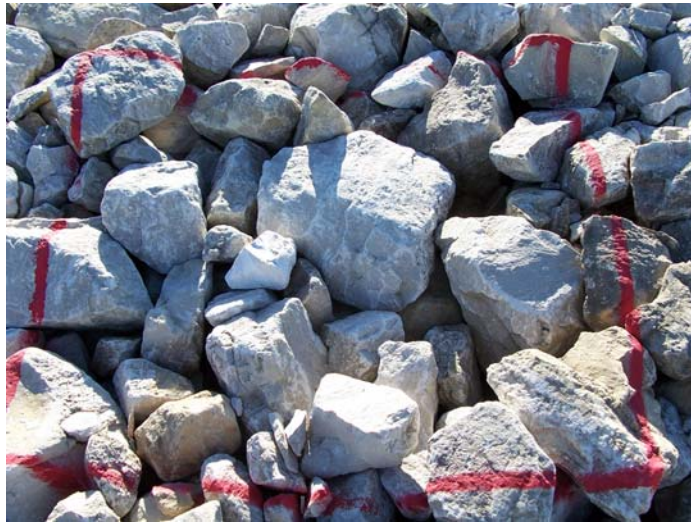
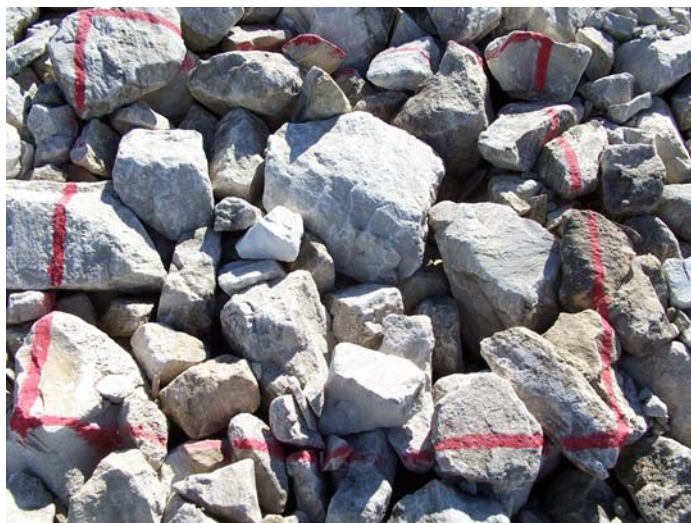
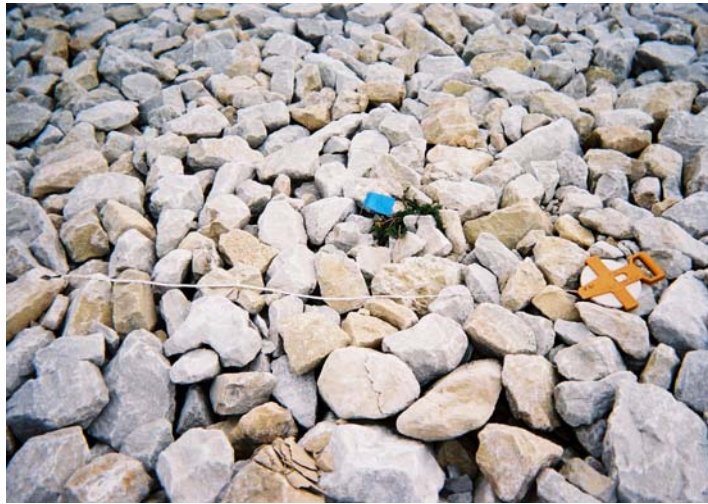
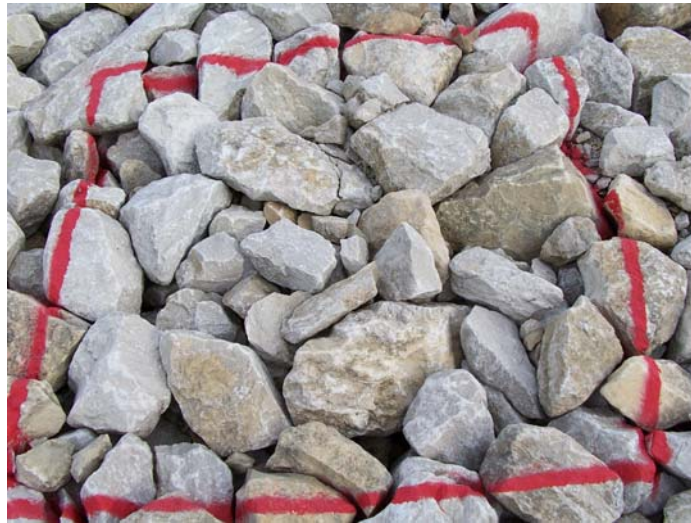
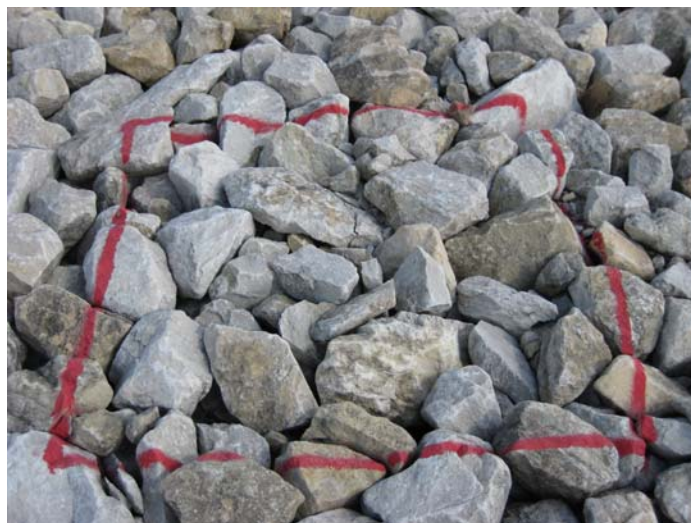
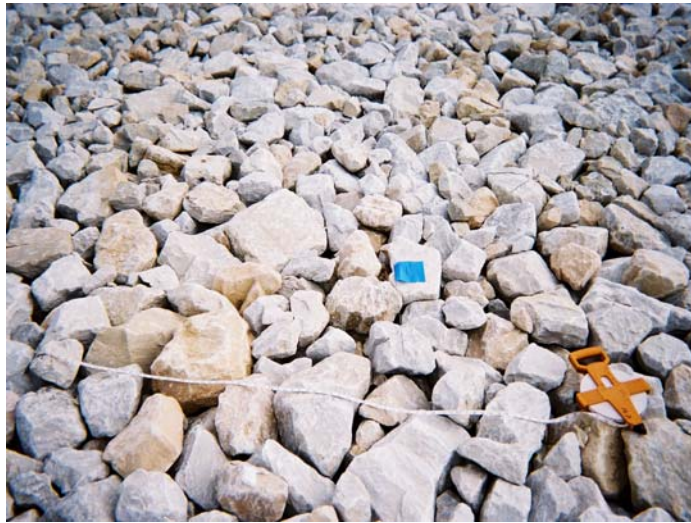
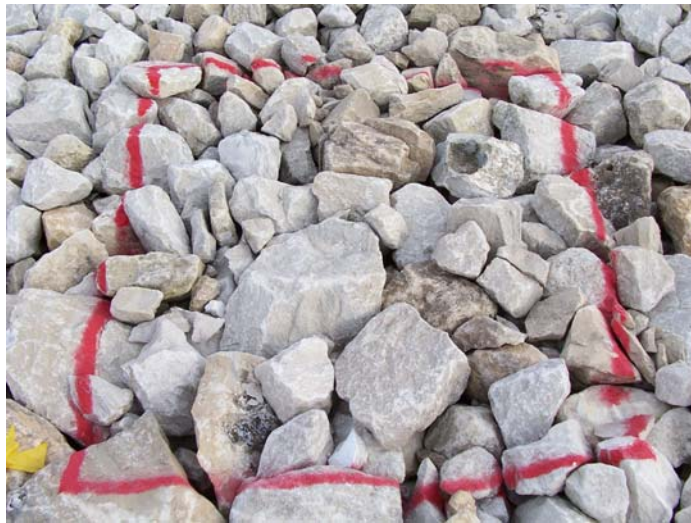
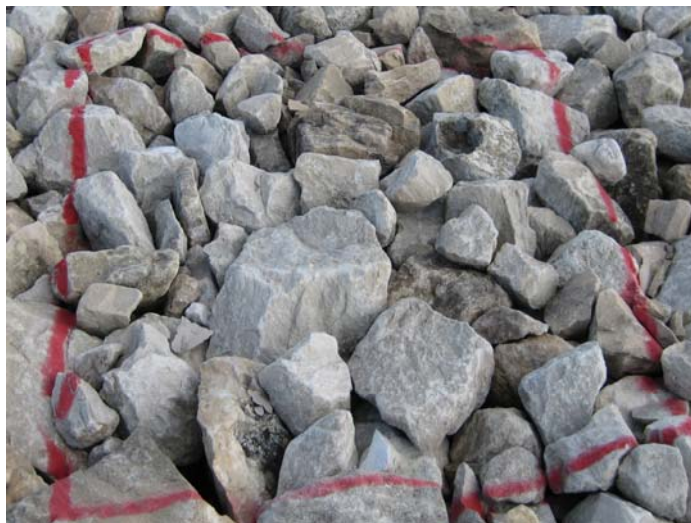
It was noted that the Test Plot 3 painted area is in the wrong location and this had been accounted for in previous years by using the photo for comparison, but it needs to be corrected and painted correctly. These areas are shown from the original inspection in 2003, last year and this year for comparison in Photos 10 through 24.

Photo 10. Cell cover rock test plot TP1; north edge north facet (2003 Inspection).

Photo 11. Cell cover rock test plot TP1; north edge of north facet (2006 Inspection).

Photo 12. Cell cover rock test plot TP1; north edge of north facet (2007 Inspection).

Photo 13. Cell cover rock test plot TP2; bottom of north side slope (2003 Inspection).

Photo 14. Cell cover rock test plot TP2; bottom of north side slope (2006 Inspection).

Photo 15. Cell cover rock test plot TP2; bottom of north side slope (2007 Inspection).

Photo 19. Cell cover rock test plot TP4; located on upper west side (2003 Inspection).

Photo 20. Cell cover rock test plot TP4; located on upper west side (2006 Inspection).

Photo 21. Cell cover rock test plot TP4; located on upper west side (2007 Inspection).

Photo 22. Cell cover rock test plot TP5; located on lower west side (2003 Inspection).

Photo 23. Cell cover rock test plot TP5; located on lower west side (2006 Inspection).

Photo 24. Cell cover rock test plot TP5; located on lower west side (2007 Inspection).

Remarks The 5 Rock Test Plots were photographed and inspected and compared w/ previous years photos. The rocks in the test plots had not degraded or changed from previous years.

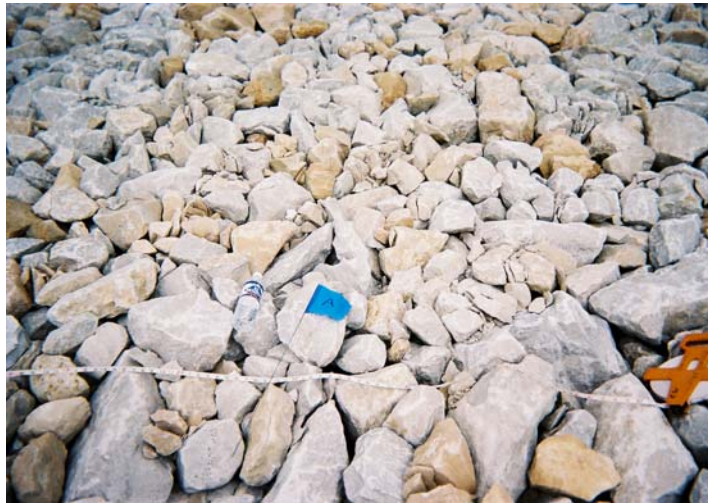
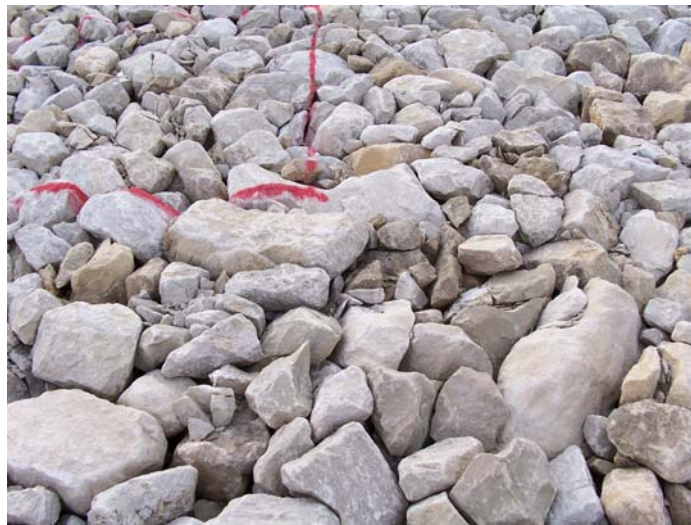
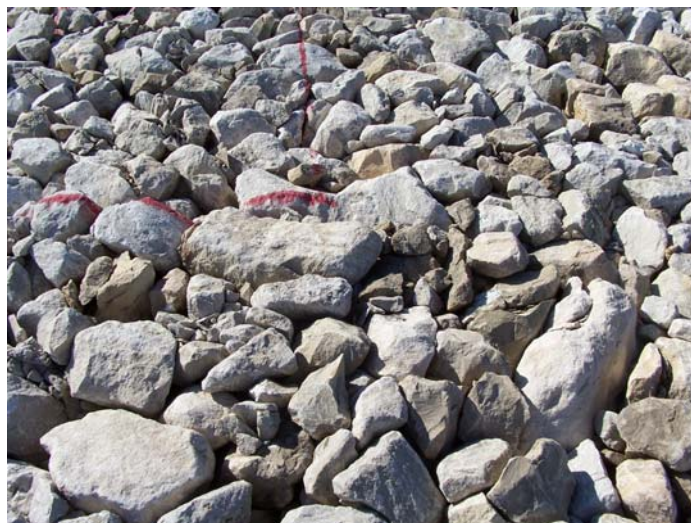
Photo 16. Cell cover rock test plot TP3; northeast ridgeline (2003 Inspection).

Photo 17. Cell cover rock test plot TP3; northeast ridgeline (2006 Inspection).

Photo 18. Cell cover rock test plot TP3; northeast ridgeline (2007 Inspection).

6. **Recommendation:** Rock degradation plot 3 needs to be painted in the correct location.

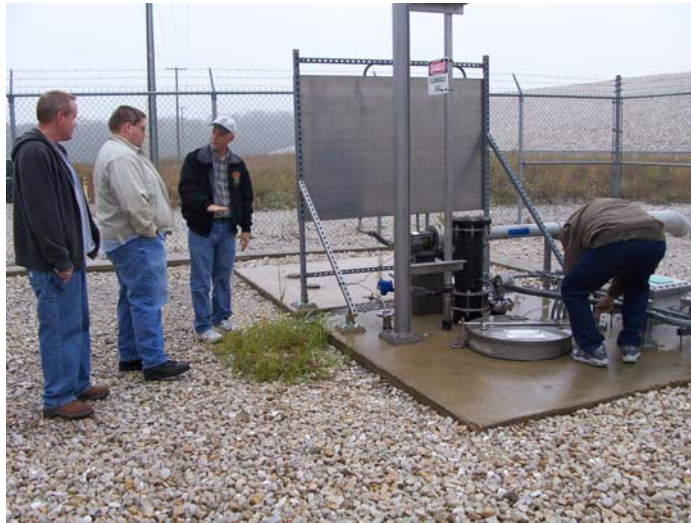
Operations of the LCRS were discussed with site personnel and the system was inspected (Photo 25). The fences and doors were locked and in good condition. The system was functioning as designed. The LCRS data and documentation were reviewed during the document review period of the inspection and the following information was checked and verified that it was available: sampling data, LCRS flow rates, action leakage rate information, “burrito” system flow rates, and leachate data. As required by the LTS&M Plan, the leachate production rates, analytical results, and disposal information are provided in Appendix D.

Photo 25. LCRS sump area.

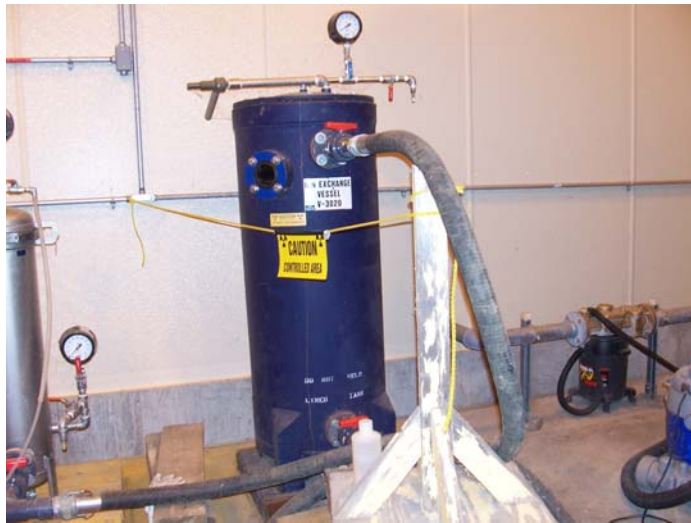
Photo 26. Ion Exchange vessel.

The ion exchange vessel has been labeled as “Potential Internal Contamination” (Photo 26) based on the potential for uranium to accumulate in the resin.

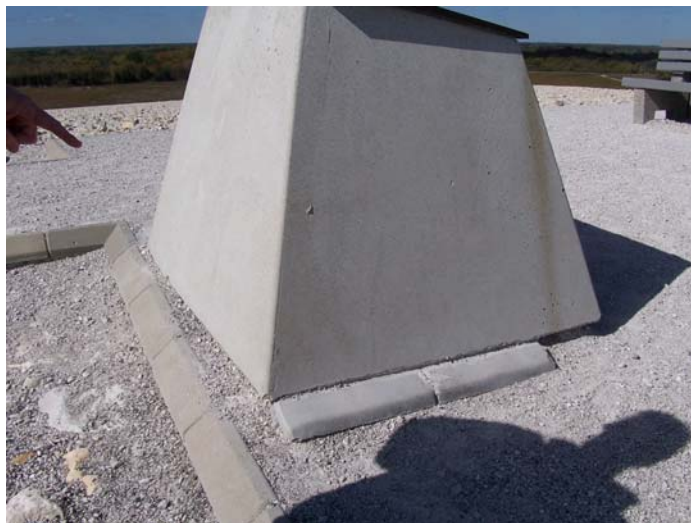
The four information plaques on top of the cell were generally in good condition. The pedestal on the south side of the viewing platform, under the southeast corner, was observed as eroded during the 2006 inspection after it had been repaired. It was repaired during 2007 and the repair was still in good condition during the inspection (Photo 27). Also, one of the bronze plaques had

Photo 27. Repair of erosion under the monument on the disposal cell

5. **Finding:** The pedestal on the south side of the viewing platform was eroded under the southeast corner after being repaired in 2006.

Corrective Action: Determine a more permanent repair and apply.

Response: The area was repaired in April 2007 by placing a concrete curb beneath the corner.

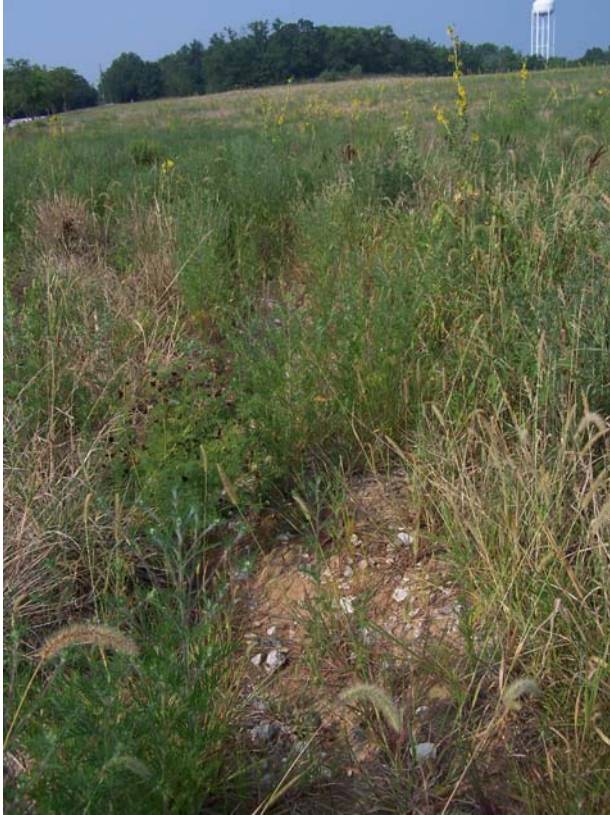
Photo 1: View upslope of stabilizing gully in Area #1 (note robust vegetation in gully)

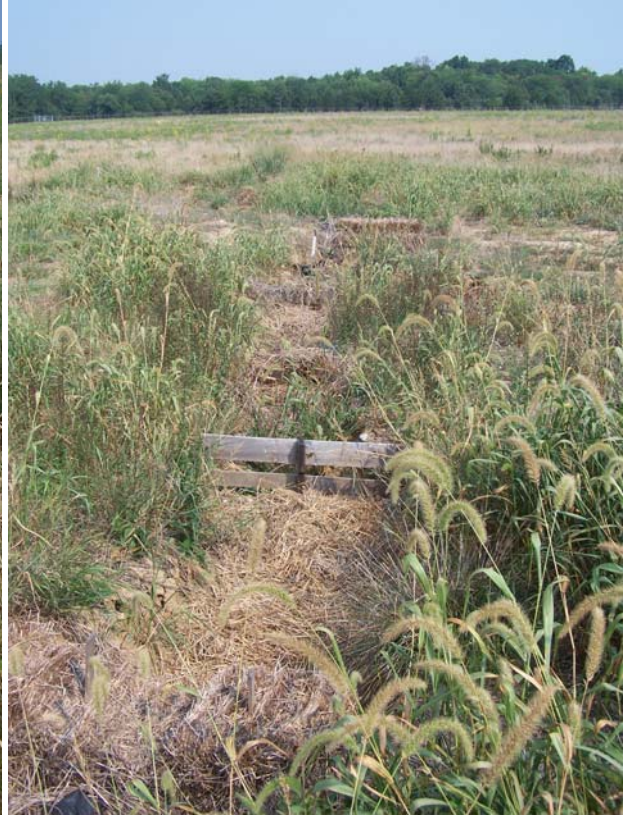
Photo 2: View downslope of stabilizing gully in Area #2. Some runoff waters are going around the straw bales, but the gully is becoming overgrown with vegetation, indicating a stabilizing trend.

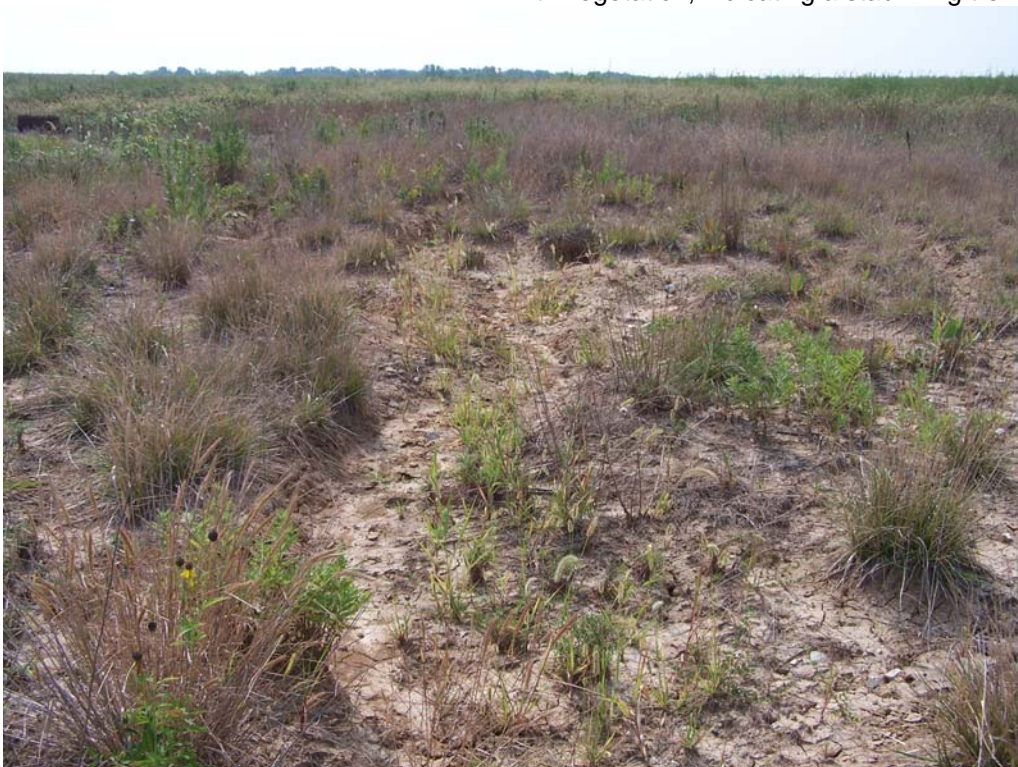
Photo 3: View upslope of active rills in basin area of Area #2. These rills do not continue to the lowest elevation of the landscape.

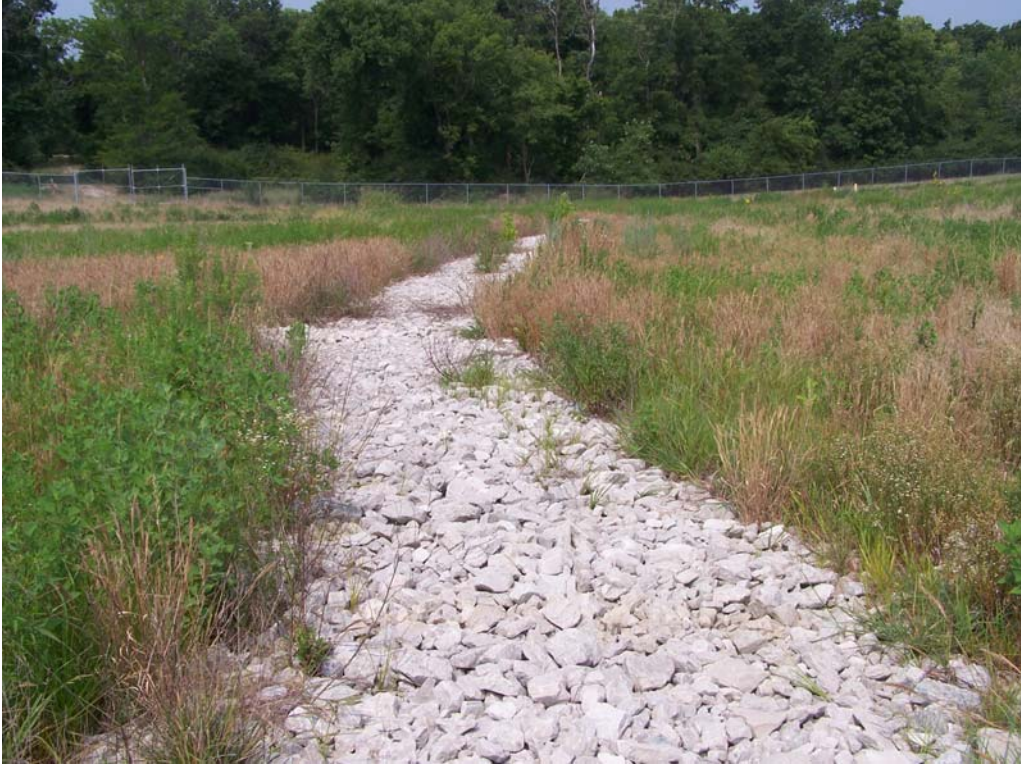
Photo 4: View downslope of repaired gully near Area #3; note vegetation encroaching on edges of repair. This repair is effectively controlling erosion.

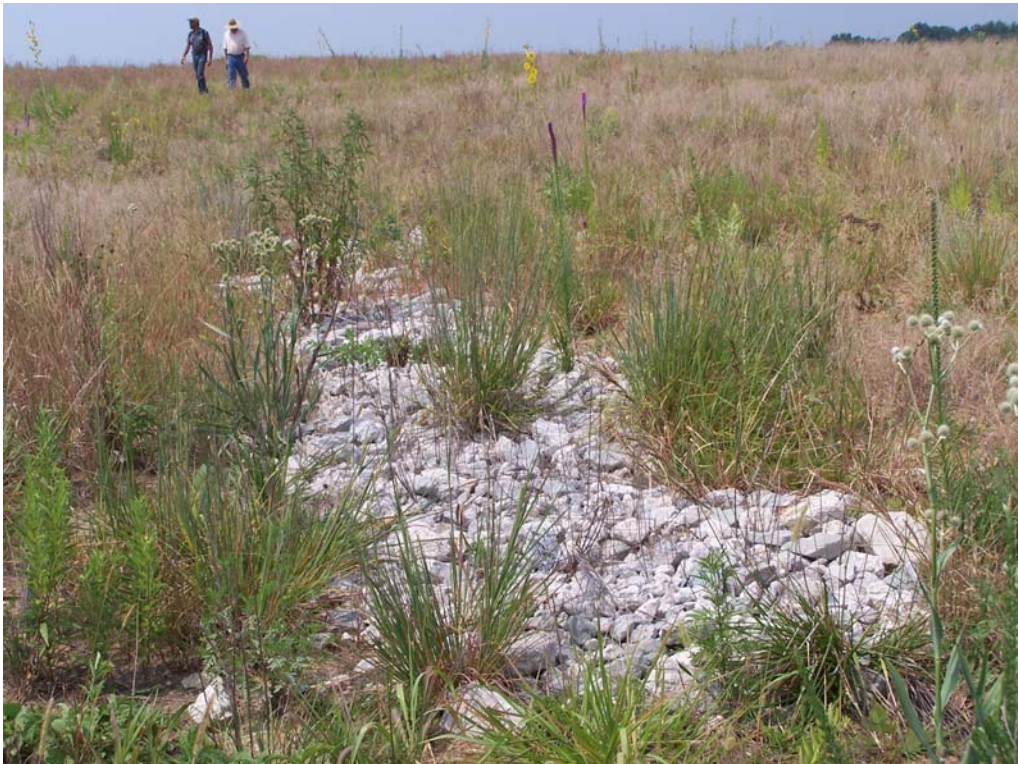
Photo 5: View upslope of repaired gully in Area #5; this repair is effectively controlling erosion.

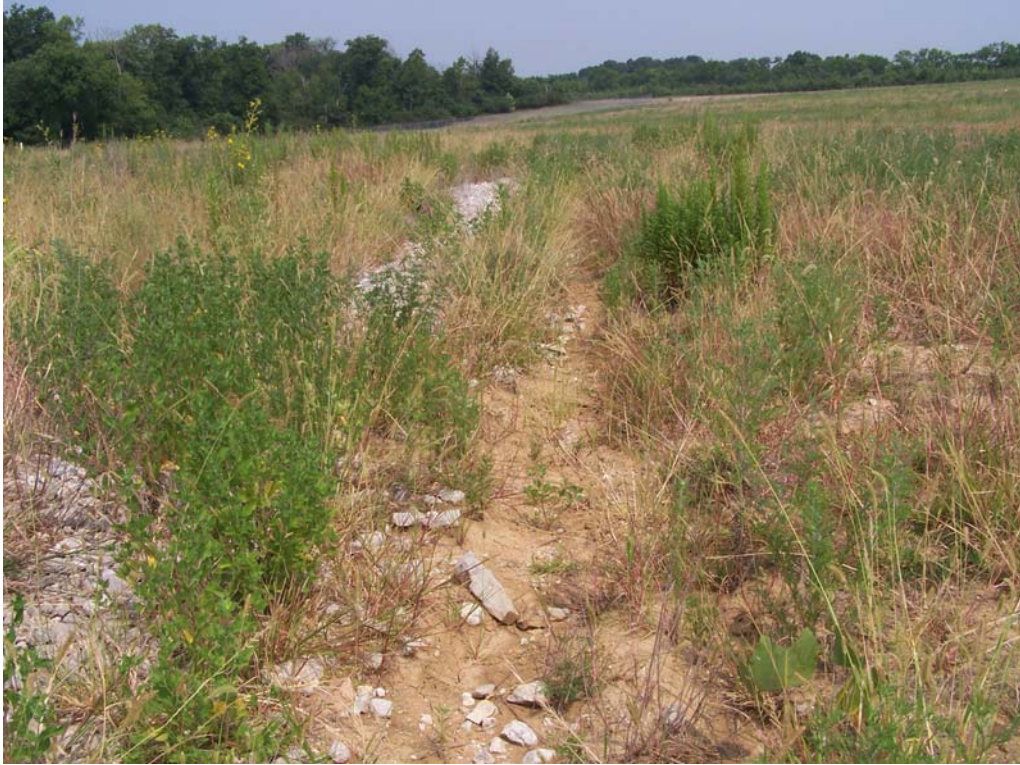
Photo 6: View downslope of repaired gully near Area #3 and newer rill forming to the right of the repair; note vegetation in bottom of rill.

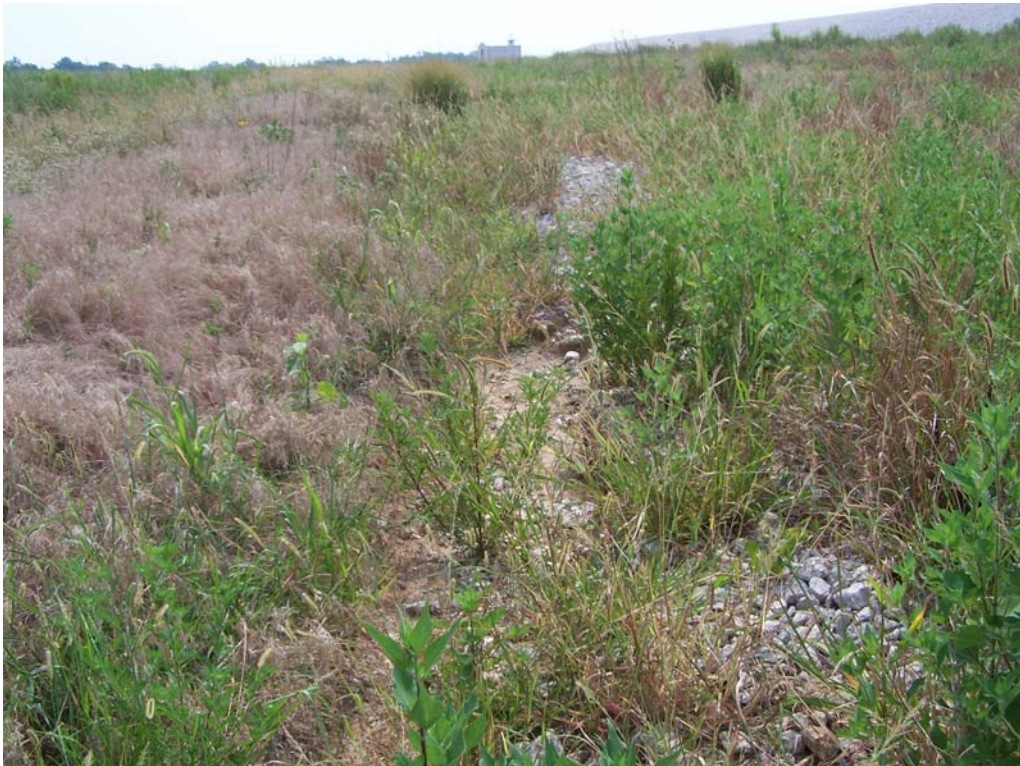
Photo 7: View upslope of repaired gully near Area #3 and newer rill forming to the left of the repair; note stabilizing vegetation in newer rill.

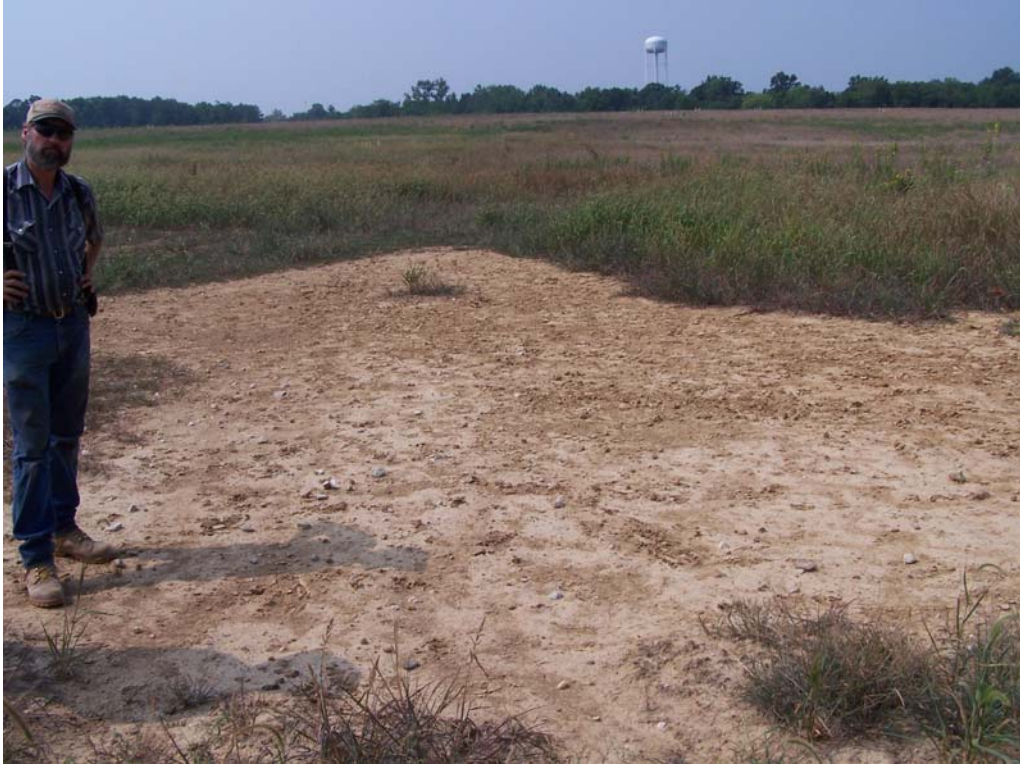
Photo 8: View SSE of barren area in NE portion of Area #2.
