# 2009 Annual Inspection Report for the Weldon Spring, Missouri, Site

January 2010

## Summary

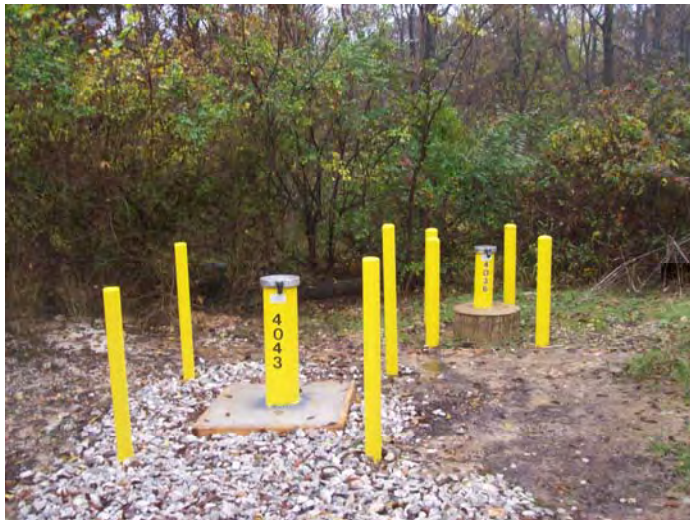
**Inspection Results:** The surrounding area where groundwater use will be restricted was inspected. This includes property owned by the Missouri Department of Conservation (MDC) and the Army. It was raining during the entire time of the inspection on this property. No evidence of groundwater use was observed, and current land use remains consistent with planned institutional controls on both properties. Burgermeister Spring 6301 (Photo 1) and Spring 6303 on MDC property were inspected, and there were no indications of spring water use. Spring 6303 was flowing. On the Army property, survey monument WS46 was inspected. Figure 4 shows the Chemical Plant groundwater restriction area boundary monuments. The new well (MW-4043) that was installed on the Army property earlier in October 2009 was inspected (Photo 2). All of the monitoring wells inspected were labeled appropriately and were locked.

*Photo 2. Monitoring well MW-4043 on the Army Property.*

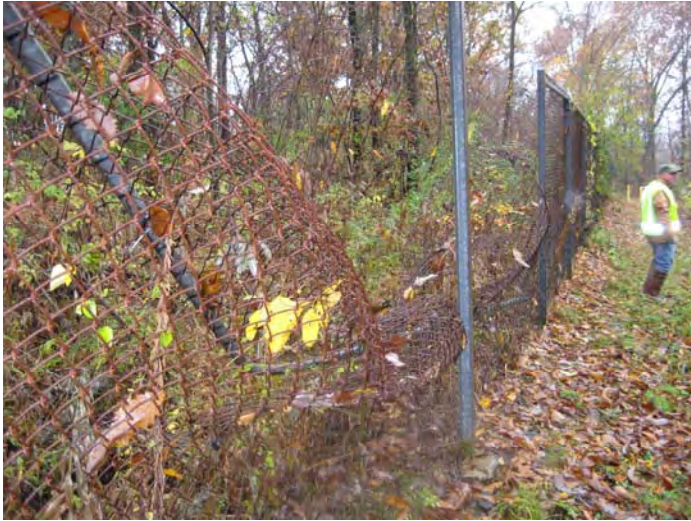
*Photo 4. Damaged fence at the quarry.*

1. **Recommendation:** Repair the fence at the Quarry

**Corrective Action:** The fence at the Quarry will be repaired.

**Response:** A subcontract for the work has been awarded and the fence is scheduled to be repaired the week of November 2, 2009.

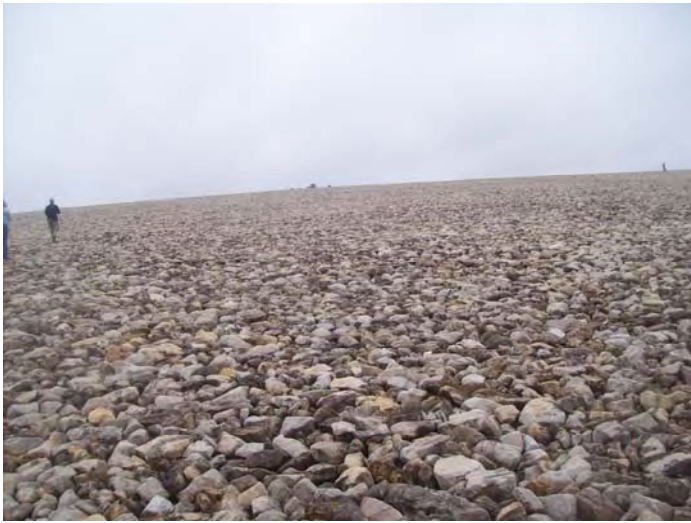
The disposal cell was inspected in accordance with the LTS&M Plan (Photos 5 and 6) and the annual inspection checklist. The cell was divided into 10 transects (Figure 7). The inspectors separated into two groups, and each group walked five transects. The inspectors looked for depressions, shifts of cell plane vertices, and other indications of settlement. Other items for inspection were vegetation, wet areas, apron drains, the guardrail, and the stairs. A GPS unit was used during the 2003 inspection to map five areas chosen for rock degradation review (Figure 7). The inspectors photographed these areas, compared them to photos from the previous inspection of the same areas, and observed no rock degradation. Photos 7 through 21 show these areas (during the original inspection in 2003, during last year's inspection, and during this year's inspection, for comparison).

*Photo 5. Disposal cell inspection looking south towards monuments.*

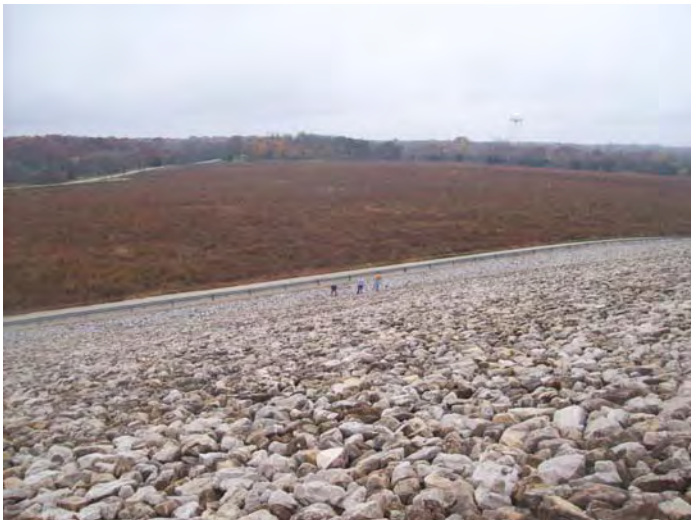
*Photo 6. Disposal cell inspection looking south.*

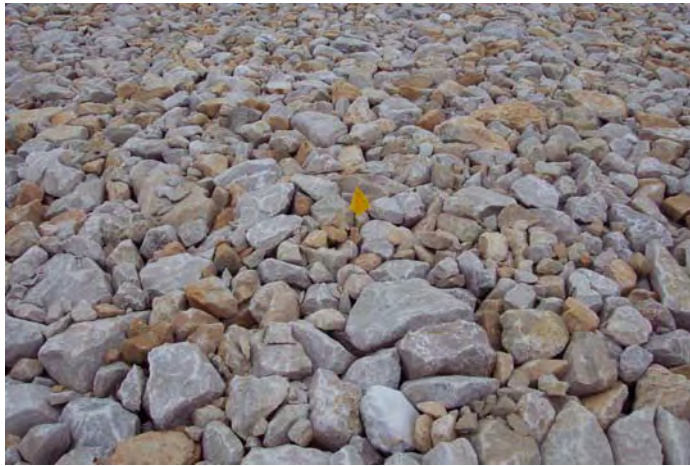
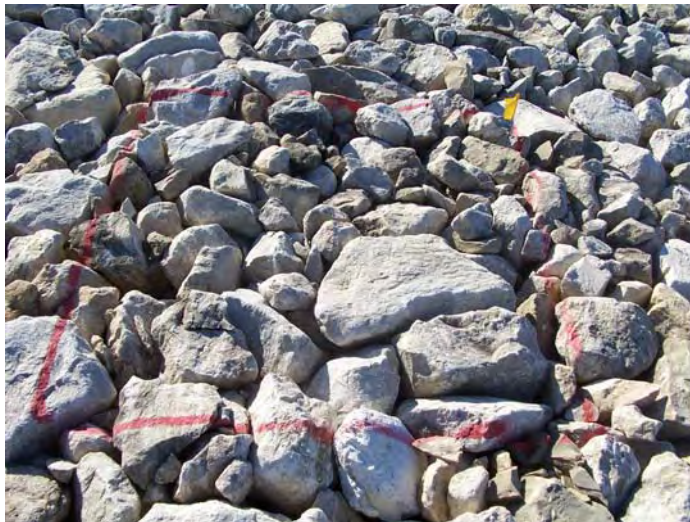
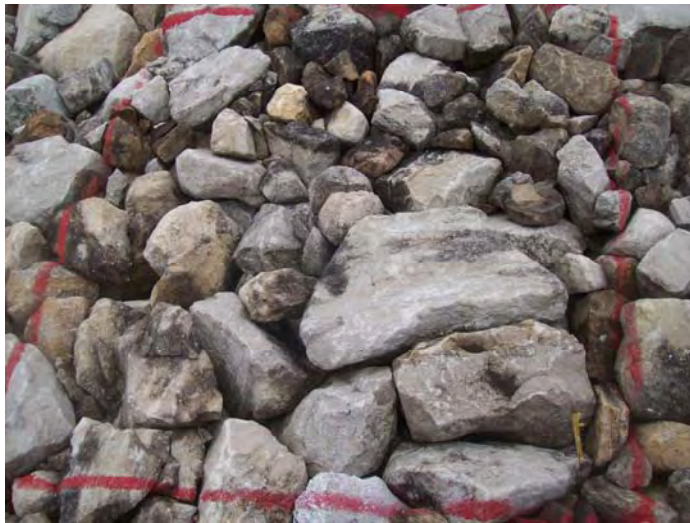
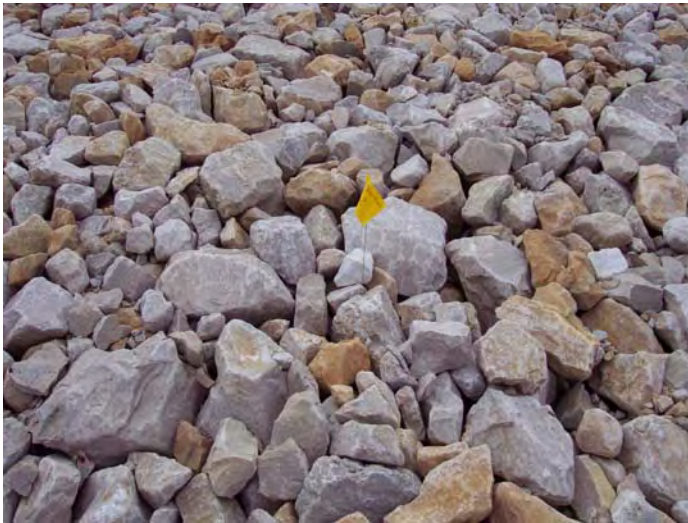
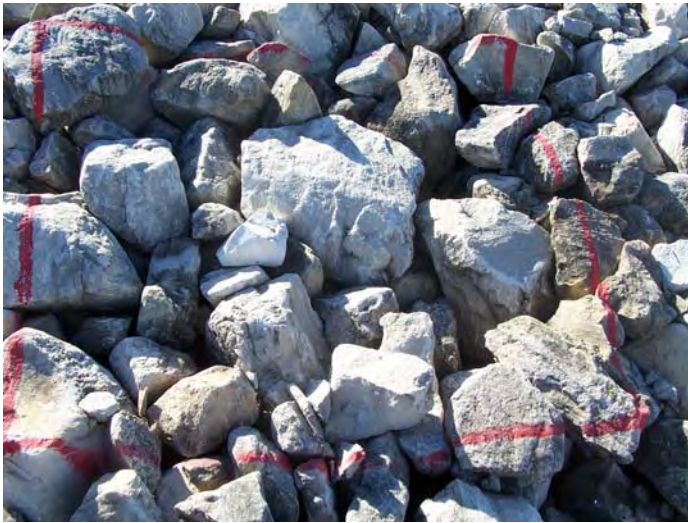
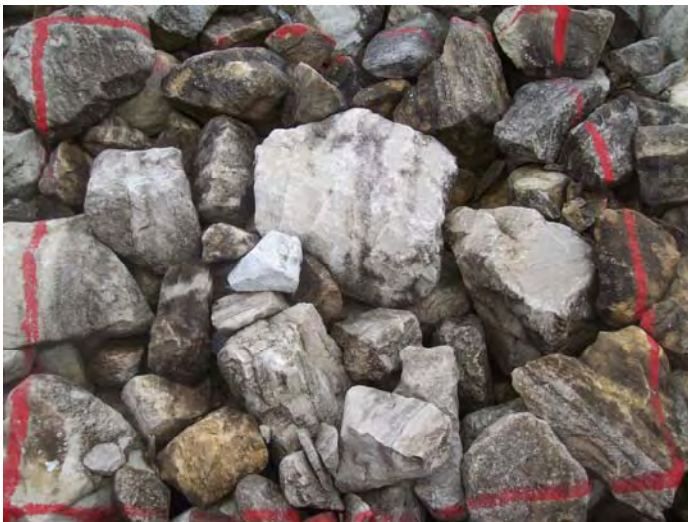
*Photo 7. Cell cover rock test plot TP1; north edge north facet (2003 Inspection).*

*Photo 8. Cell cover rock test plot TP1; north edge of north facet (2008 Inspection).*

*Photo 9. Cell cover rock test plot TP1; north edge of north facet (2009 Inspection).*

*Photo 10. Cell cover rock test plot TP2; north edge north facet (2003 Inspection).*

*Photo 11. Cell cover rock test plot TP2; north edge north facet (2008 Inspection).*

*Photo 12. Cell cover rock test plot TP2; north edge north facet (2009 Inspection).*

Remarks The 5 Rock Test Plots were compared to previous years photos (2003, 2006, 2008, 2007). The rocks in the test plots had not degraded or changed compared to the photos.

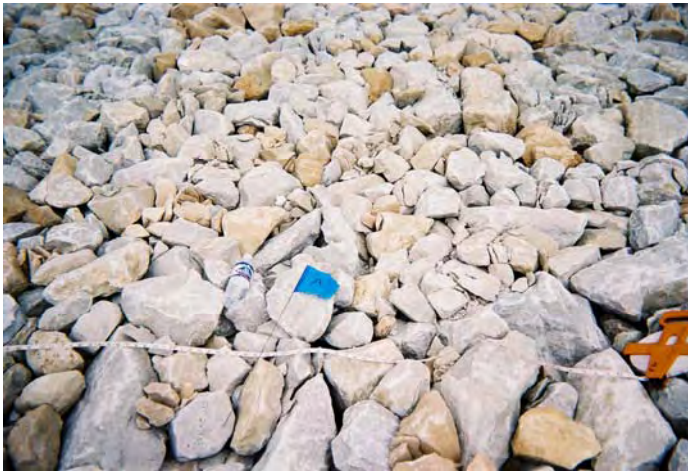
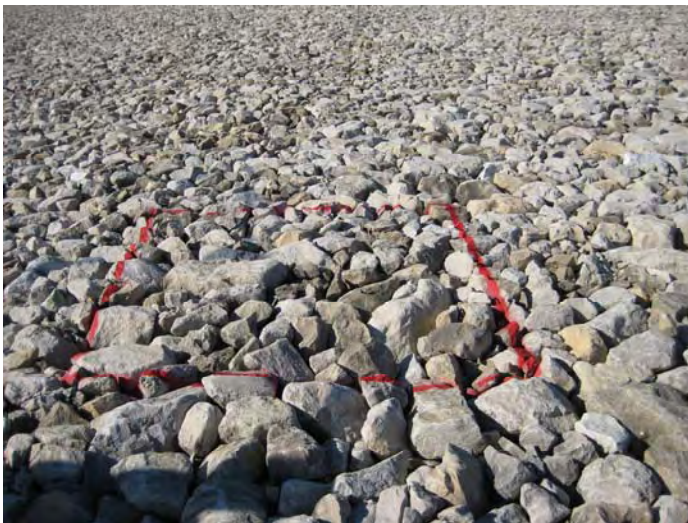
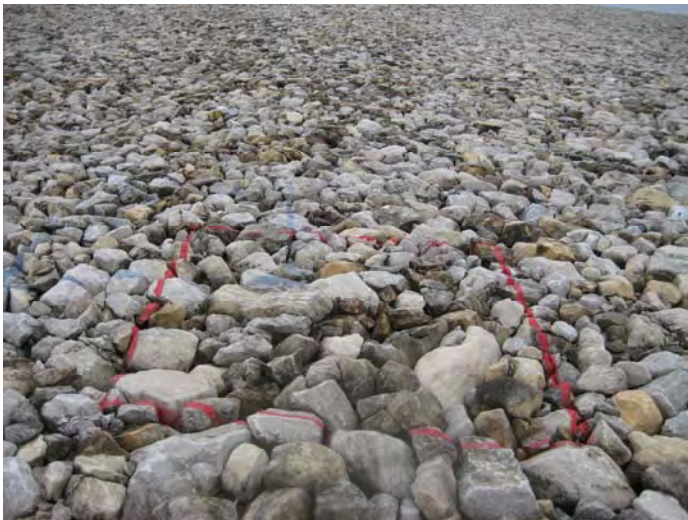
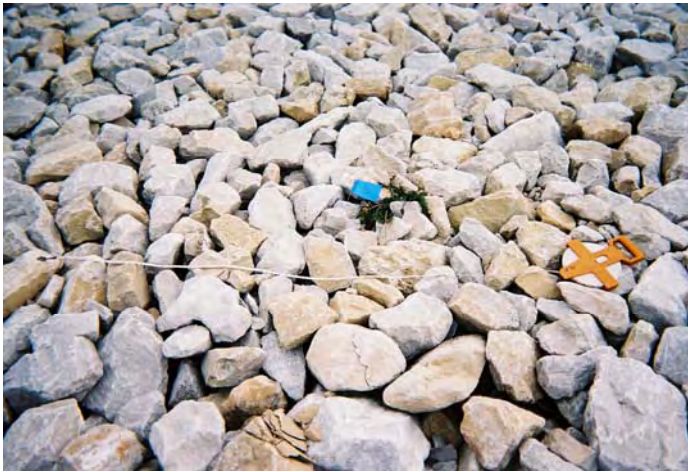
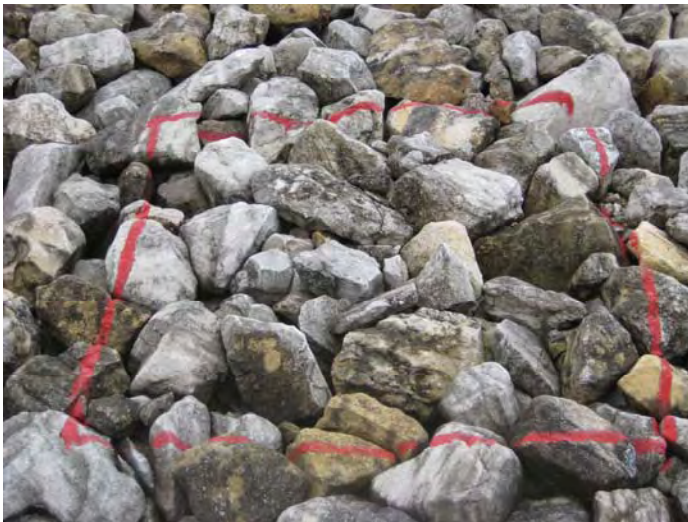
*Photo 13. Cell cover rock test plot TP3; northeast ridgeline (2003 Inspection).*

*Photo 14. Cell cover rock test plot TP3; northeast ridgeline (2008 Inspection).*

*Photo 15. Cell cover rock test plot TP3; northeast ridgeline (2009 Inspection).*

*Photo 16. Cell cover rock test plot TP4; located on upper west side (2003 Inspection).*

*Photo 17. Cell cover rock test plot TP4; located on upper west side (2008 Inspection).*

*Photo 18. Cell cover rock test plot TP4; located on upper west side (2009 Inspection).*

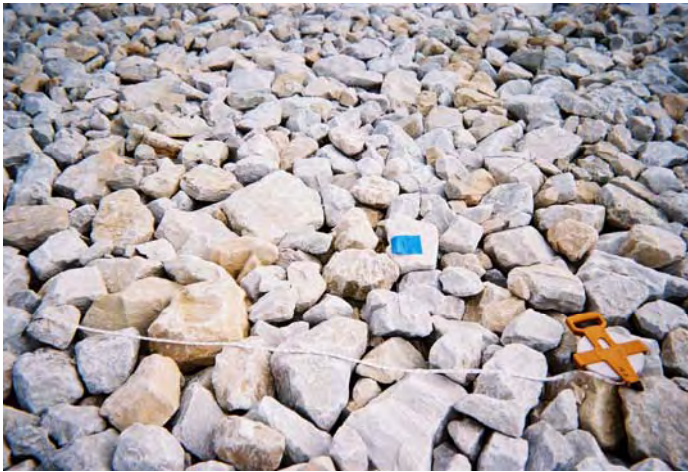
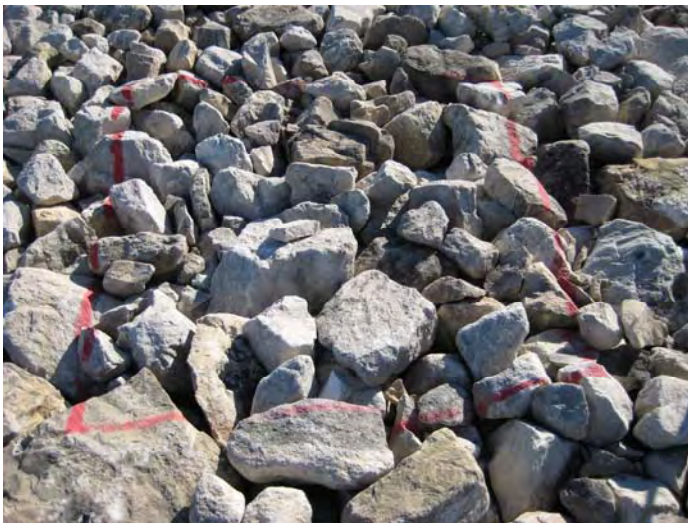
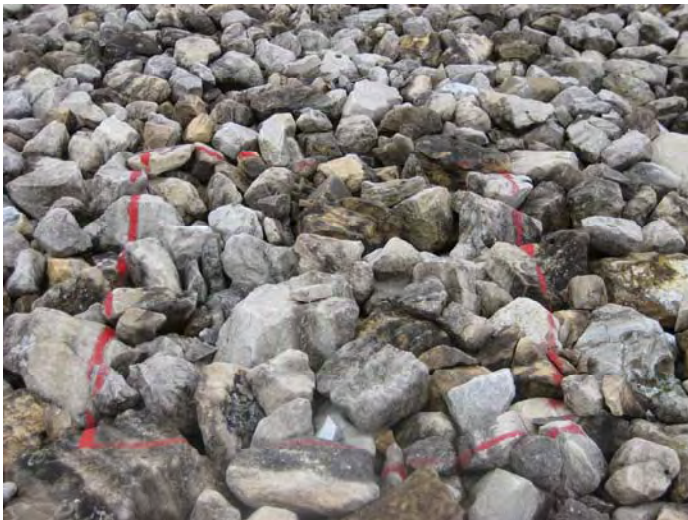
*Photo 19. Cell cover rock est plot TP5; located on lower west side (2003 Inspection).*

*Photo 20. Cell cover rock test plot TP5; located on lower west side (2008 Inspection).*

*Photo 21. Cell cover rock test plot TP5; located on lower west side (2009 Inspection).*

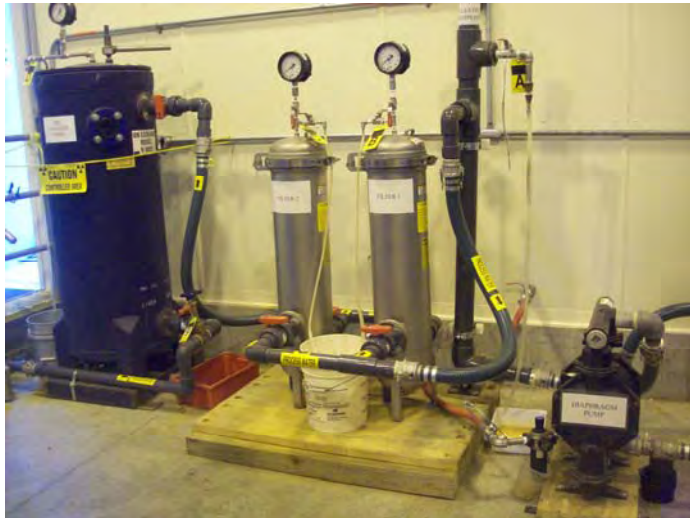
Operations of the LCRS were discussed with site personnel, and the system was inspected (Photo 22). The system had been reconfigured, and the building housekeeping had been improved during 2008. More labeling had been added during 2009. The fences and doors were locked and in good condition. The system was functioning as designed. The LCRS data and documentation were reviewed during the document review period of the inspection, and the following information was checked and verified to be available: sampling data, LCRS flow rates, action leakage rate information, “burrito” system flow rates, and leachate data. As required by the LTS&M Plan, the leachate production rates, analytical results, and disposal information are provided in Appendix D.

*Photo 22. Inside LCRS Building.*

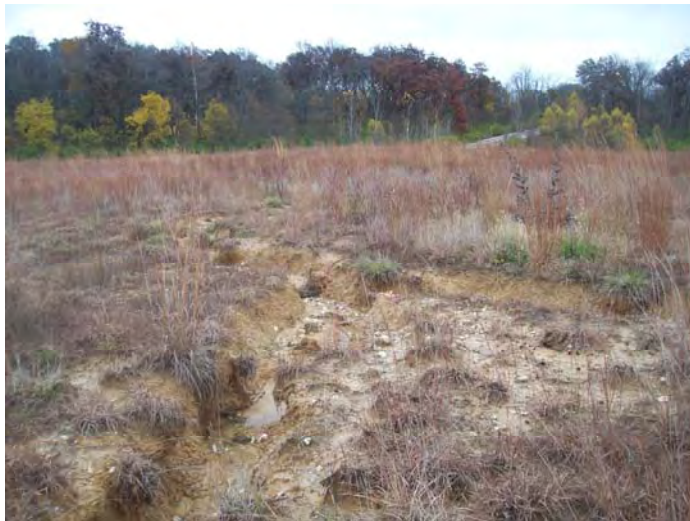
It was noted during the 2009 inspection that some areas of erosion had worsened (Photo 23) and that in other places vegetation had taken over the erosion areas considerably. Approximately 300 plugs of prairie cordgrass were planted within channels on the northeast side of the site as a test erosion control method. In September 2009, a group of Legacy Management Support subject matter experts met to discuss the current status of site erosion. They determined that existing erosion continued to be fairly typical for a reclaimed site and that no channels were currently a

*Photo 23. Erosion areas.*

- 2. Recommendation: Continue to monitor and evaluate erosion on the Chemical Plant Site.**

**Response:** The erosion channels within the entire prairie were mapped in June 2009 for the third year in a row. The resulting map indicated that erosion channels were repairing naturally in some locations and becoming deeper in others. Approximately 300 plugs of Prairie Cord Grass were planted within channels on the northeast side of the site as a test erosion control method. In September 2009, a group of Legacy Management Support subject matter expert personnel met to discuss the current status of site erosion. It was determined that existing erosion continued to be fairly typical for a reclaimed site and no channels were currently a threat to the integrity of the disposal cell. The group agreed that continued monitoring of erosion would be prudent.
