# **Five-Year Review Report (Second Five-Year Review Report)**

**Maxey Flats Disposal Site  
Fleming County, Kentucky**

**United States Environmental Protection Agency – Region 4**

**September 2007**

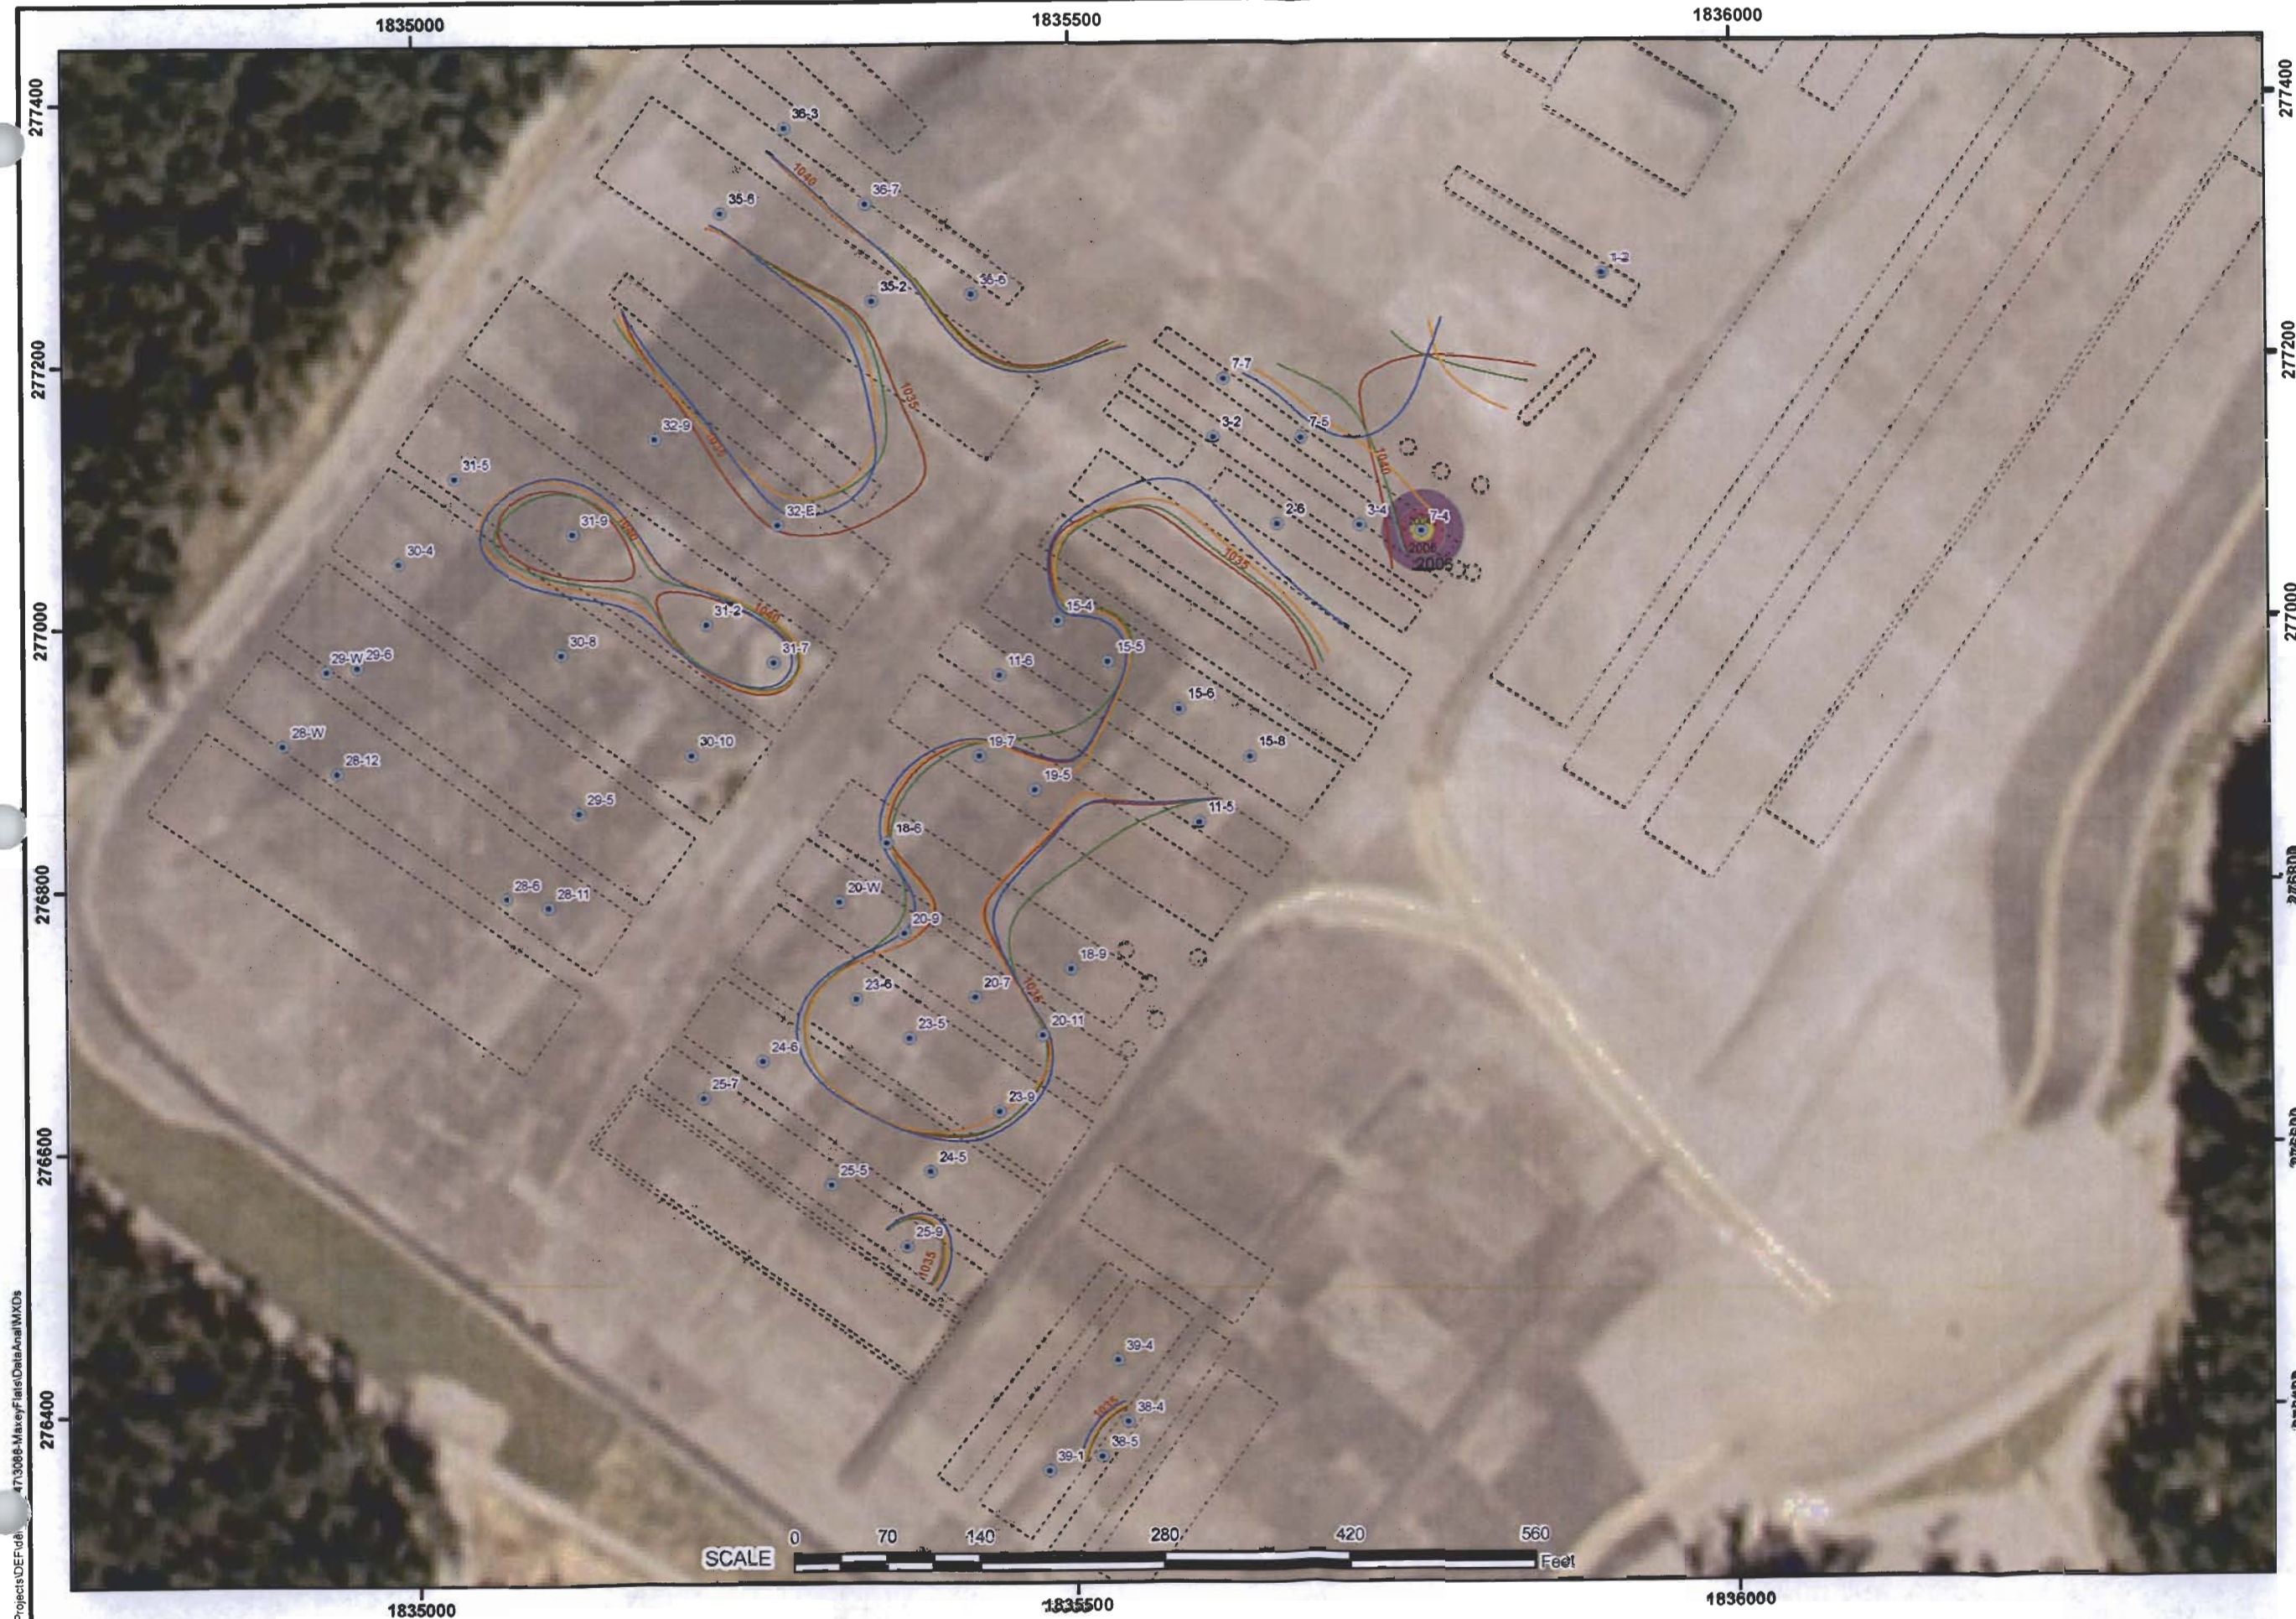
**Figure A.3.2.1**

**Potentiometric Map  
Lower Marker Bed Sump  
Comparisons 2003-2006**

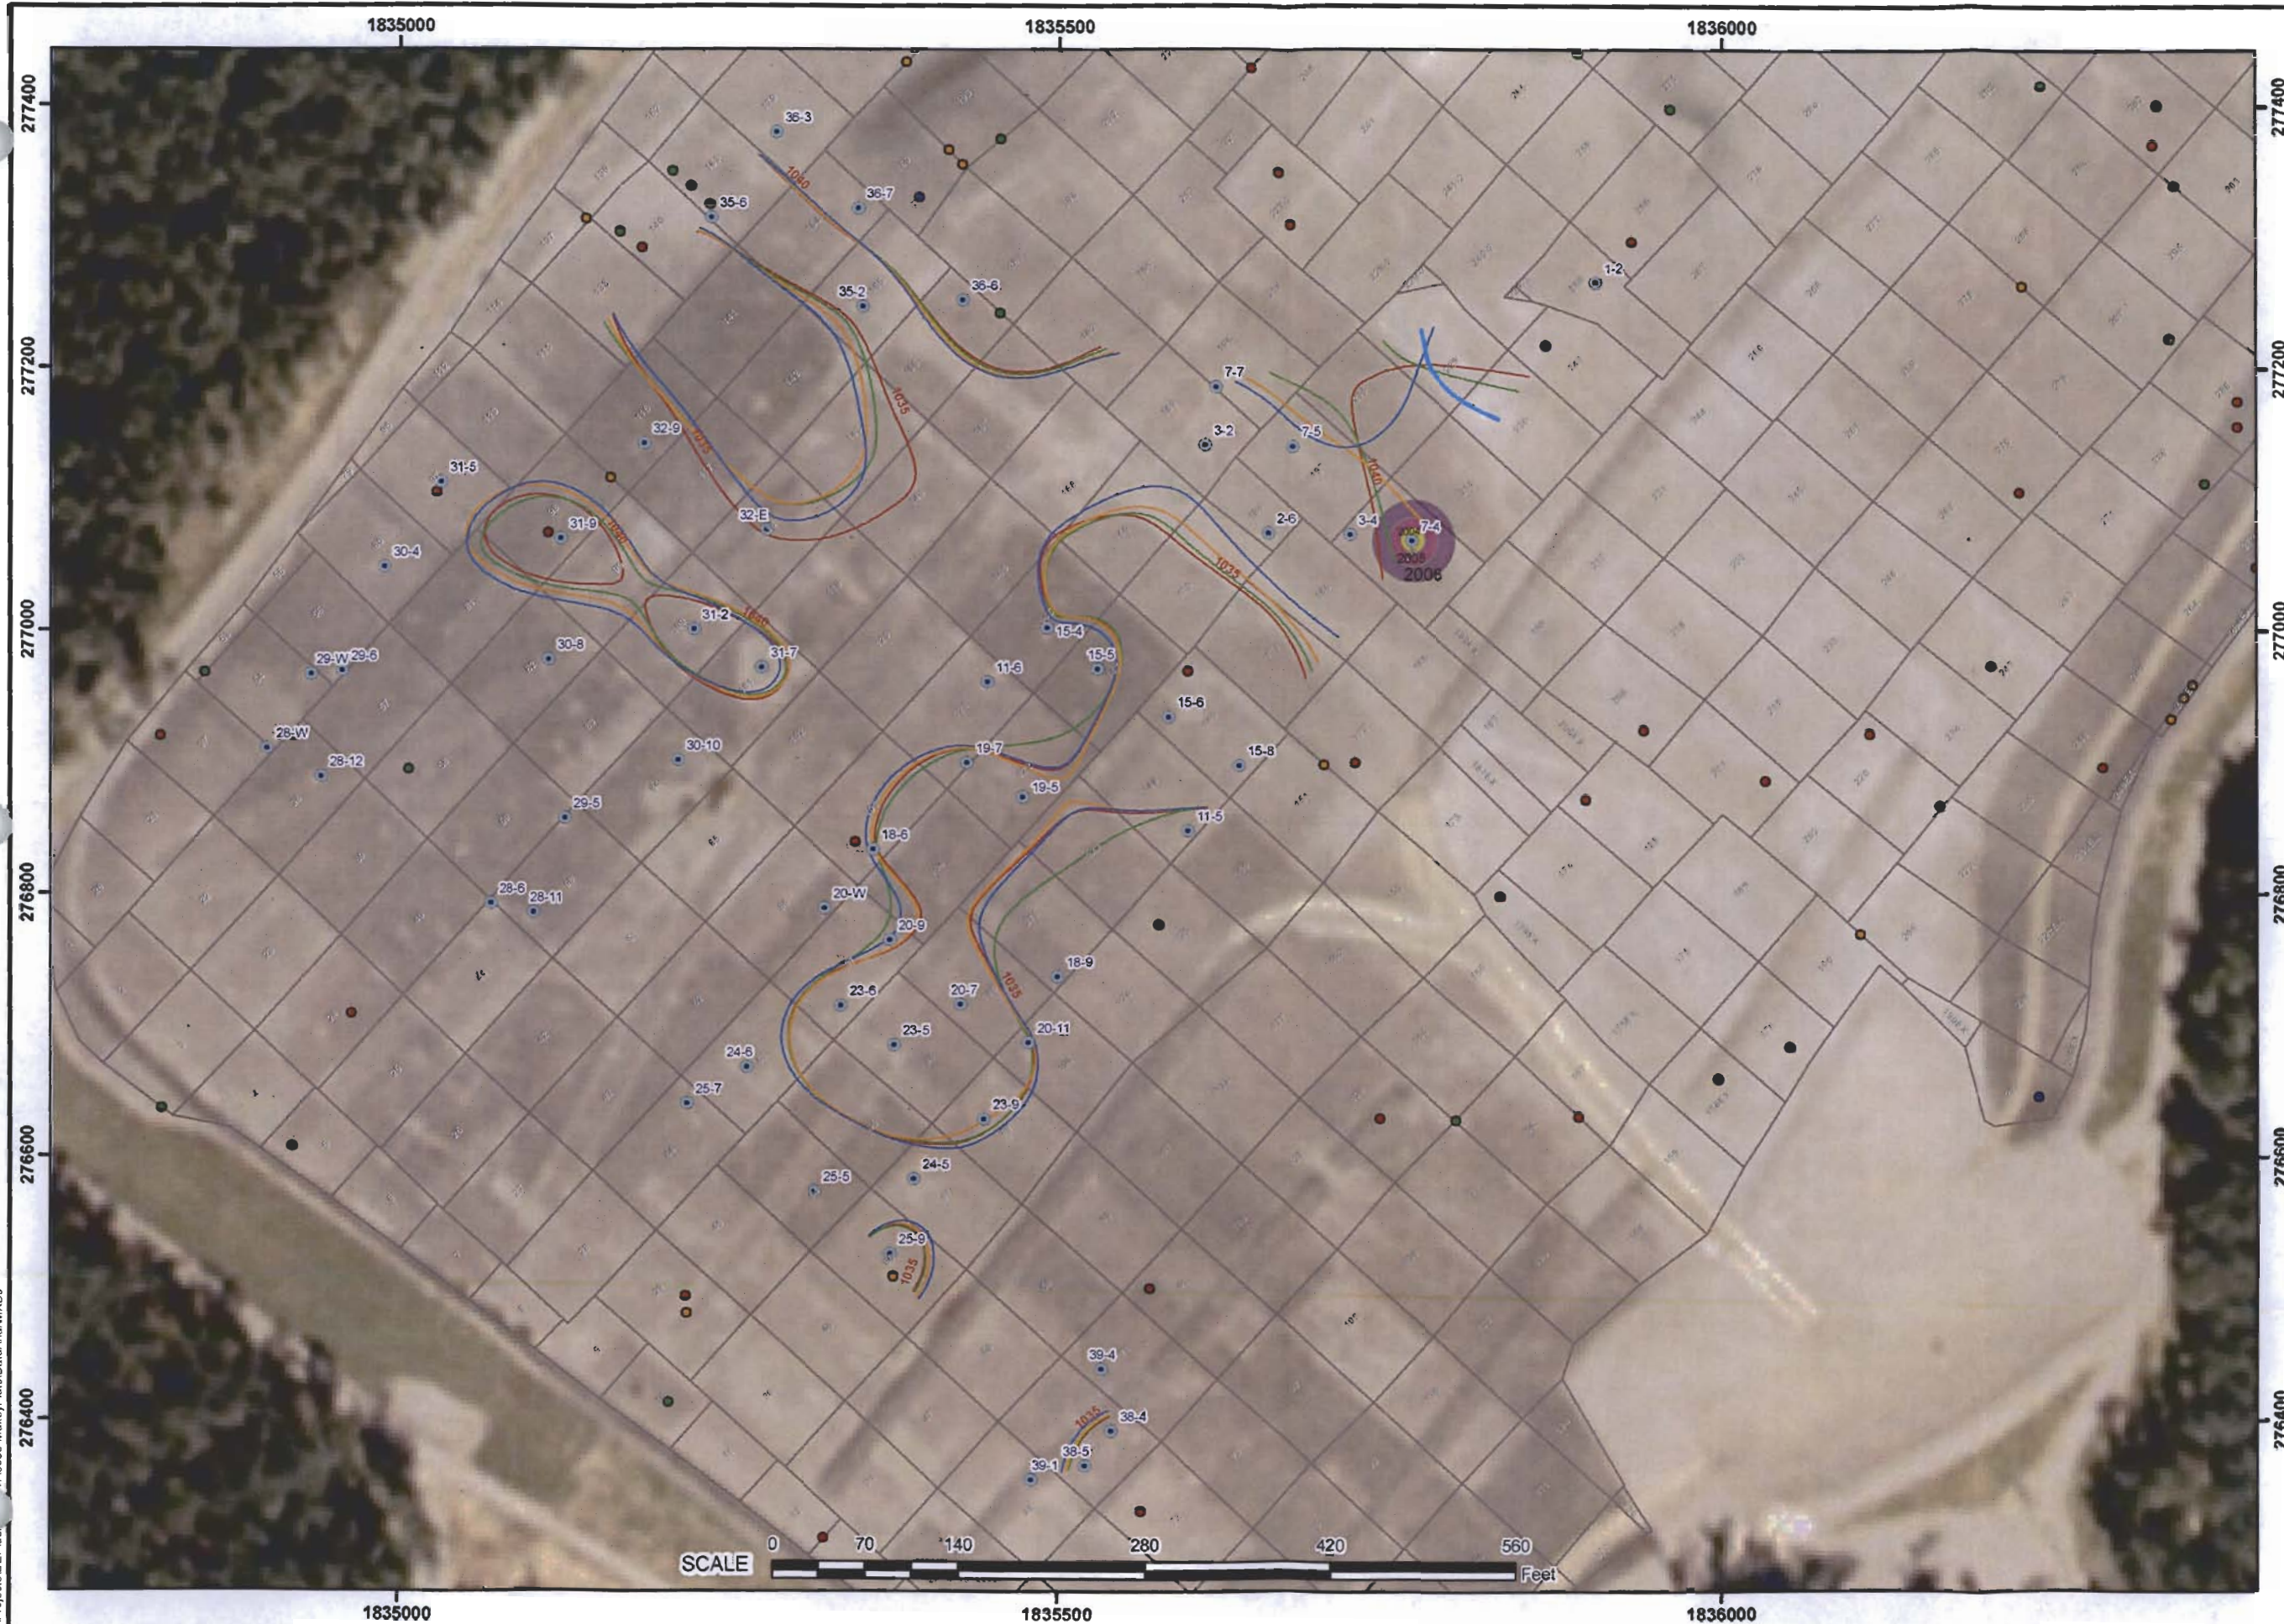
Figures A.3.2.3 and A.3.2.4 present the same potentiometric information as Figures A.3.2.1 and A.3.2.2 but overlaid on the IRP cap with geomembrane panel numbers and liner defects by year.

**Figure A.3.2.3**  
Potentiometric Map  
and Liner Maintenance  
Lower Marker Bed Sump  
Comparisons 2003-2006

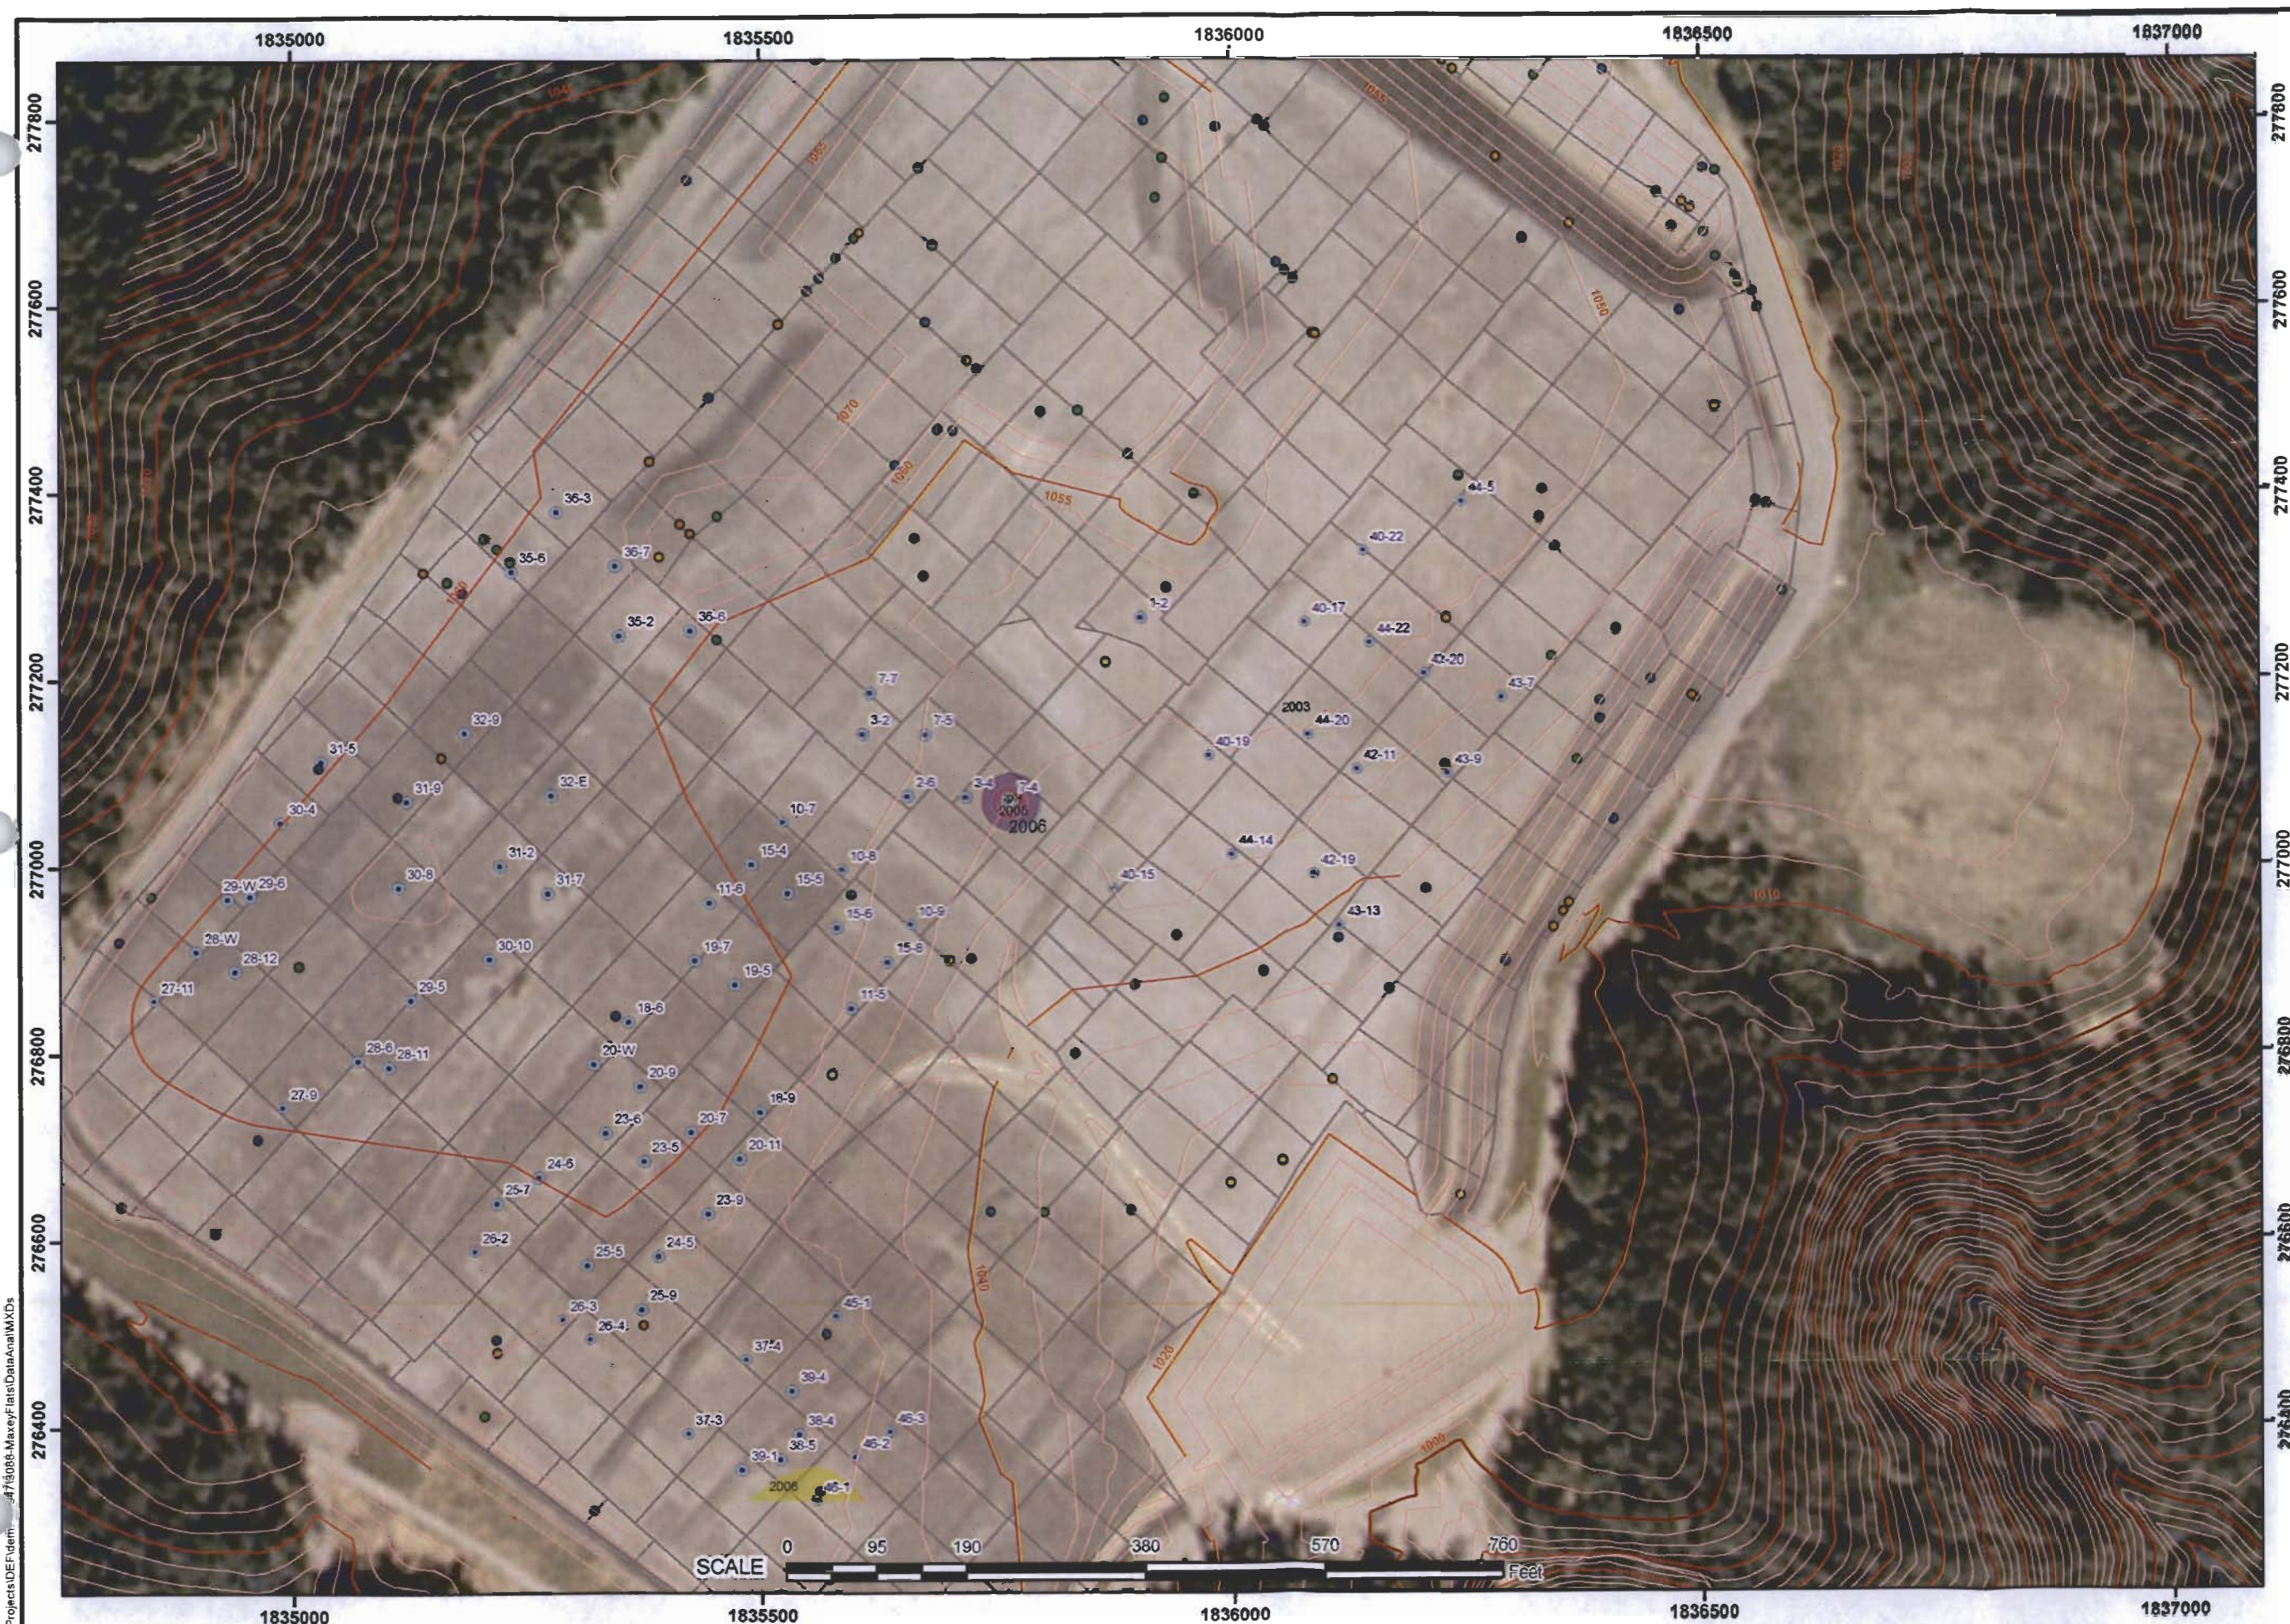
**Figure A.3.4**

Table A.3.1 compares baseline and annual measurements as well as the percent freeboard used in the sump. Freeboard is defined as the available column above the baseline water level to the top of sump. No leachate pumping has been required based on increasing water levels and loss of freeboard for the entire IMP to date. Only two out of eighty-three sumps have shown any significant increase in leachate levels or have a greater than 10% use of freeboard: sump 7-4 increased 5 feet and sump 46-1 increased approximately 3 feet. Figure 3.4 shows these sumps with the liner maintenance repairs and the site topography.

**Liner Maintenance  
and Sumps with Freeboard  
Loss 2003-2006**

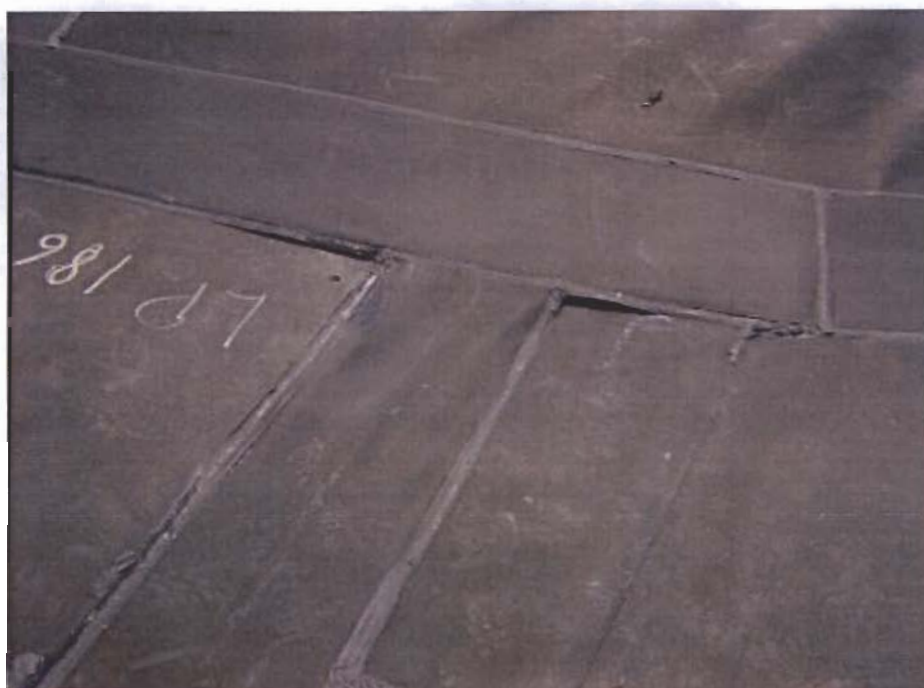
Photo 8: 2007 Seam Defect – Panel 186
