PRELIMINARY RADIOLOGICAL SURVEY REPORT OF THE
FORMER STATEN ISLAND WAREHOUSE SITE
(ARCHER-DANIELS MIDLAND COMPANY) AT
PORT RICHMOND, NEW YORK

Work performed
by the
Health and Safety Research Division
Oak Ridge National Laboratory
Oak Ridge, Tennessee 37830

October 1980

OAK RIDGE NATIONAL LABORATORY
operated by
UNION CARBIDE CORPORATION
for the
DEPARTMENT OF ENERGY
as part of the
Formerly Utilized Sites--
Remedial Action Program

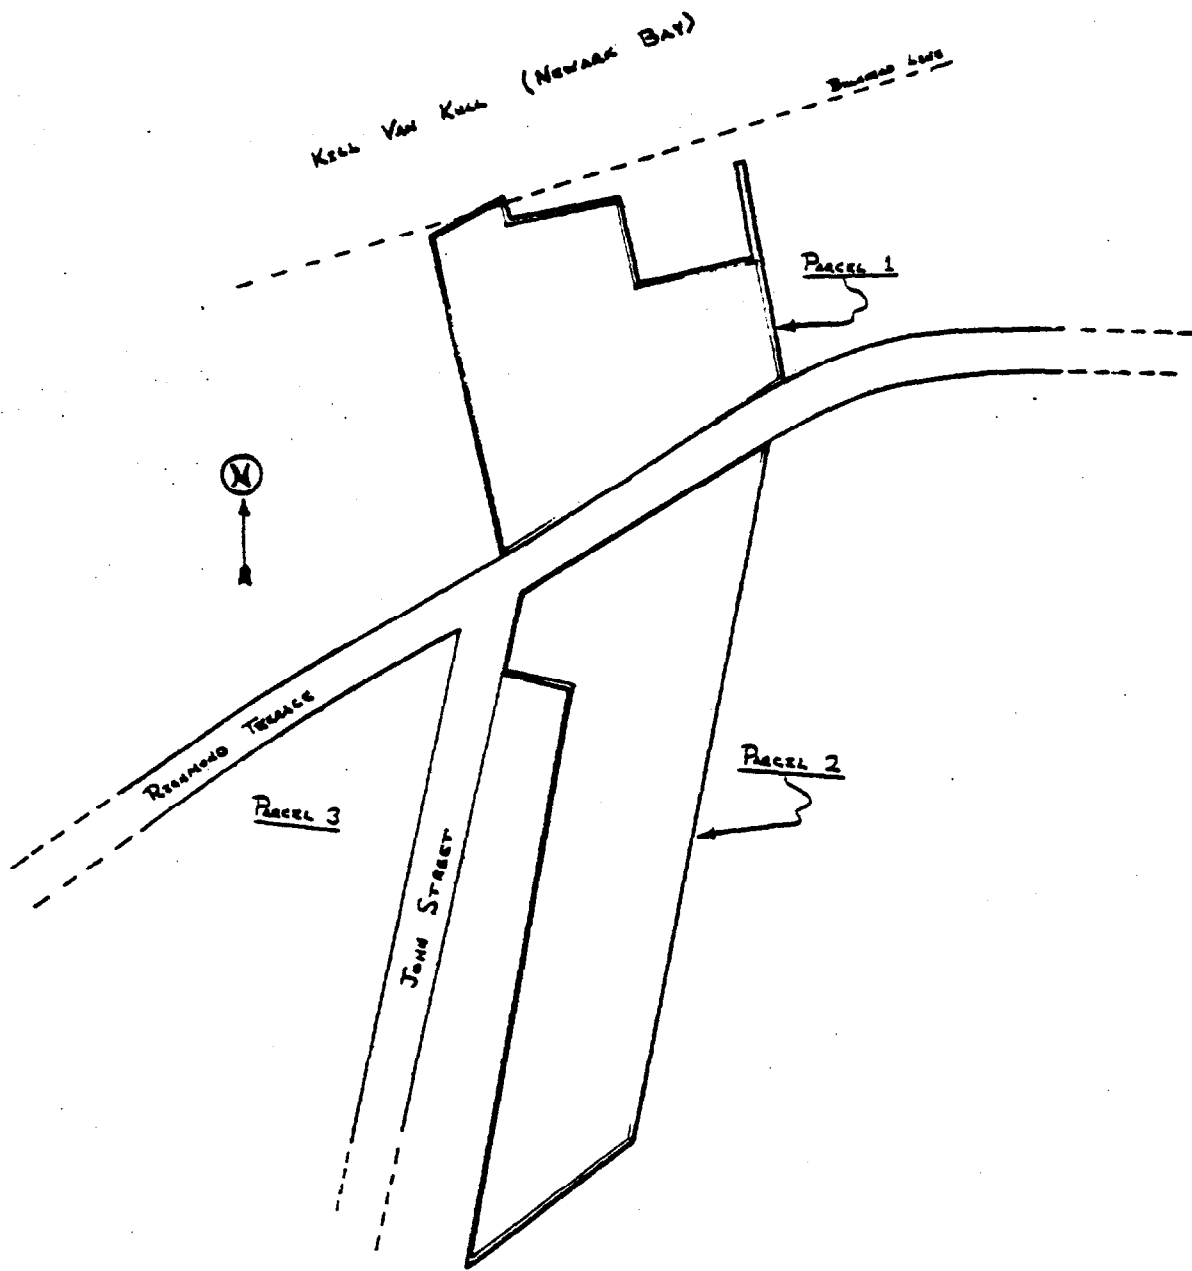
The site is located at the base of the Bayonne Bridge on Richmond Terrace Avenue in Staten Island, New York (Fig. 1). The original property owned by Archer-Daniels Midland Company was divided into three parcels (Fig. 2). Since 1942, these parcels have changed ownership numerous times. Parcels 1 and 2 are currently owned by R. H. S. Realty Corporation (New York, New York); the boundary dimensions have been accurately defined in present county property records. Ownership of Parcel 3 was separated from Parcels 1 and 2 in the 1950's, and the location of Parcel 3 is known, but not the boundary dimensions.

1. The warehouses were believed to be located on Parcel 1, exclusively;
2. Parcel 2 had always been a vacant lot; however, at one time there had been an aborted attempt at building a two-car garage on that lot;
3. Parcel 3 has had a number of buildings on it that have been located there for over 30 years.

Figure 2. Location of three property parcels formerly owned by Archer-Daniels Midland Company in Port Richmond, New York.

A detailed historical and property search is needed to determine whether the uranium ore was ever stored on Parcels 2 and 3. Aerial photographs taken during the early 1940's might provide information as to the specific location of the ore storage warehouses. If enough evidence cannot be gathered to adequately determine the locations of uranium ore storage, then it is also recommended that Parcels 2 and 3 of the former Staten Island Warehouse site receive a formal radiological survey.

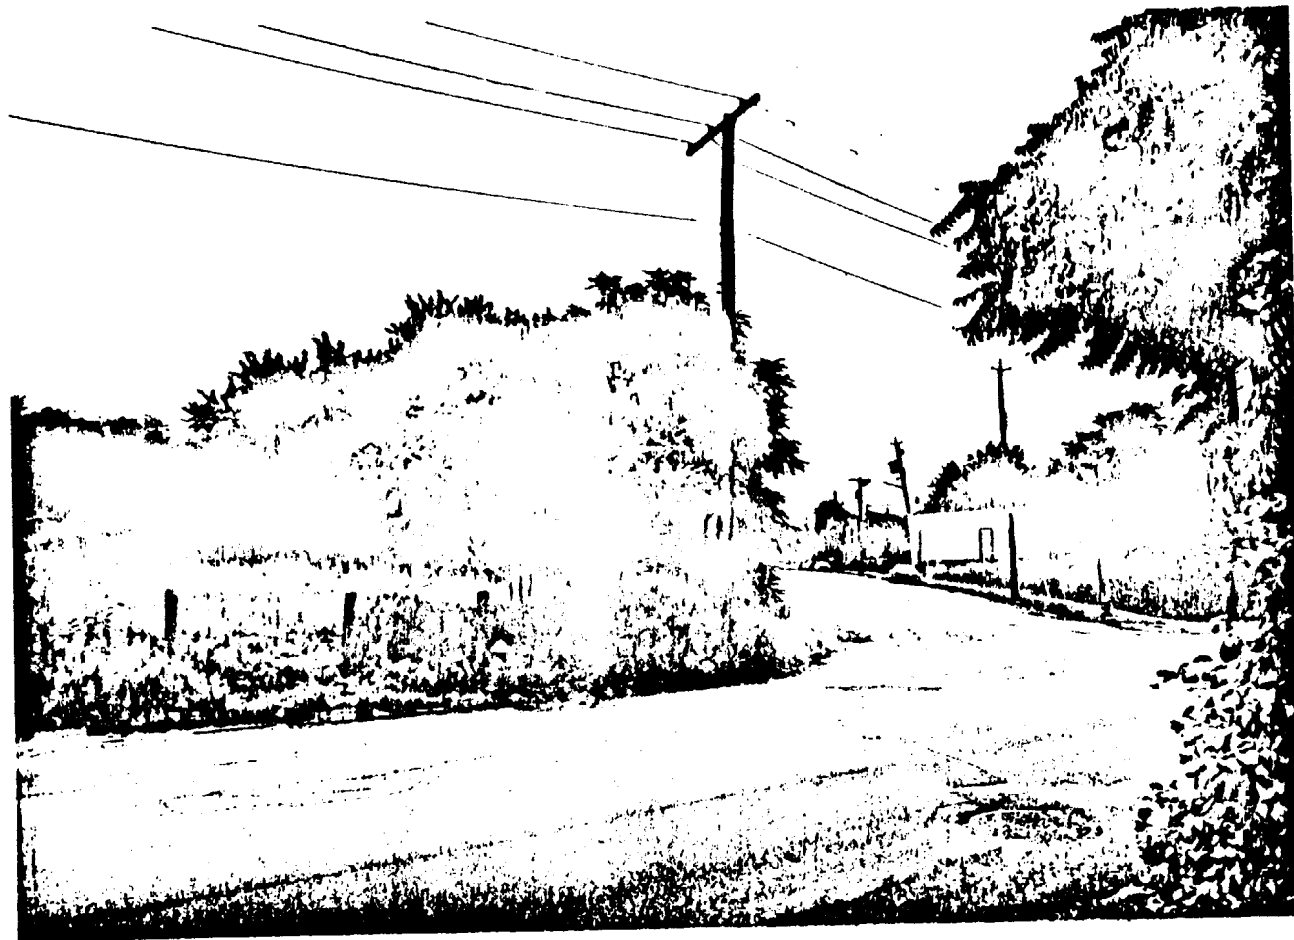
Currently, Parcel 1 is a vacant lot with no buildings present and ground cover of gravel and low weeds (Fig. 3). Parcel 2 is a vacant lot with no buildings present, but has remnants of a short retaining wall facing Richmond Terrace, a two-car garage foundation, and a ground cover of soil, rocks, high weeds, and small trees (Fig. 4). Parcel 3 is occupied by commercial and residential structures.

The gamma scan of the perimeter of these parcels indicated there were no radiation levels significantly above background. Higher than normal gamma radiation levels were observed from a short stone retaining wall facing Richmond Terrace on Parcel 2. This was not considered unusual since the type of stone encountered has typically higher concentrations of ²²⁶Ra than the surrounding soil. It should be noted that the gamma scan was very limited and yielded information only about a 2 to 3 m strip around the perimeter of these parcels.

Figure 4. View of Parcel 2 (left side of John St.) and Parcel 3 (right side of John St.) of the former Staten Island Warehouse site looking south.

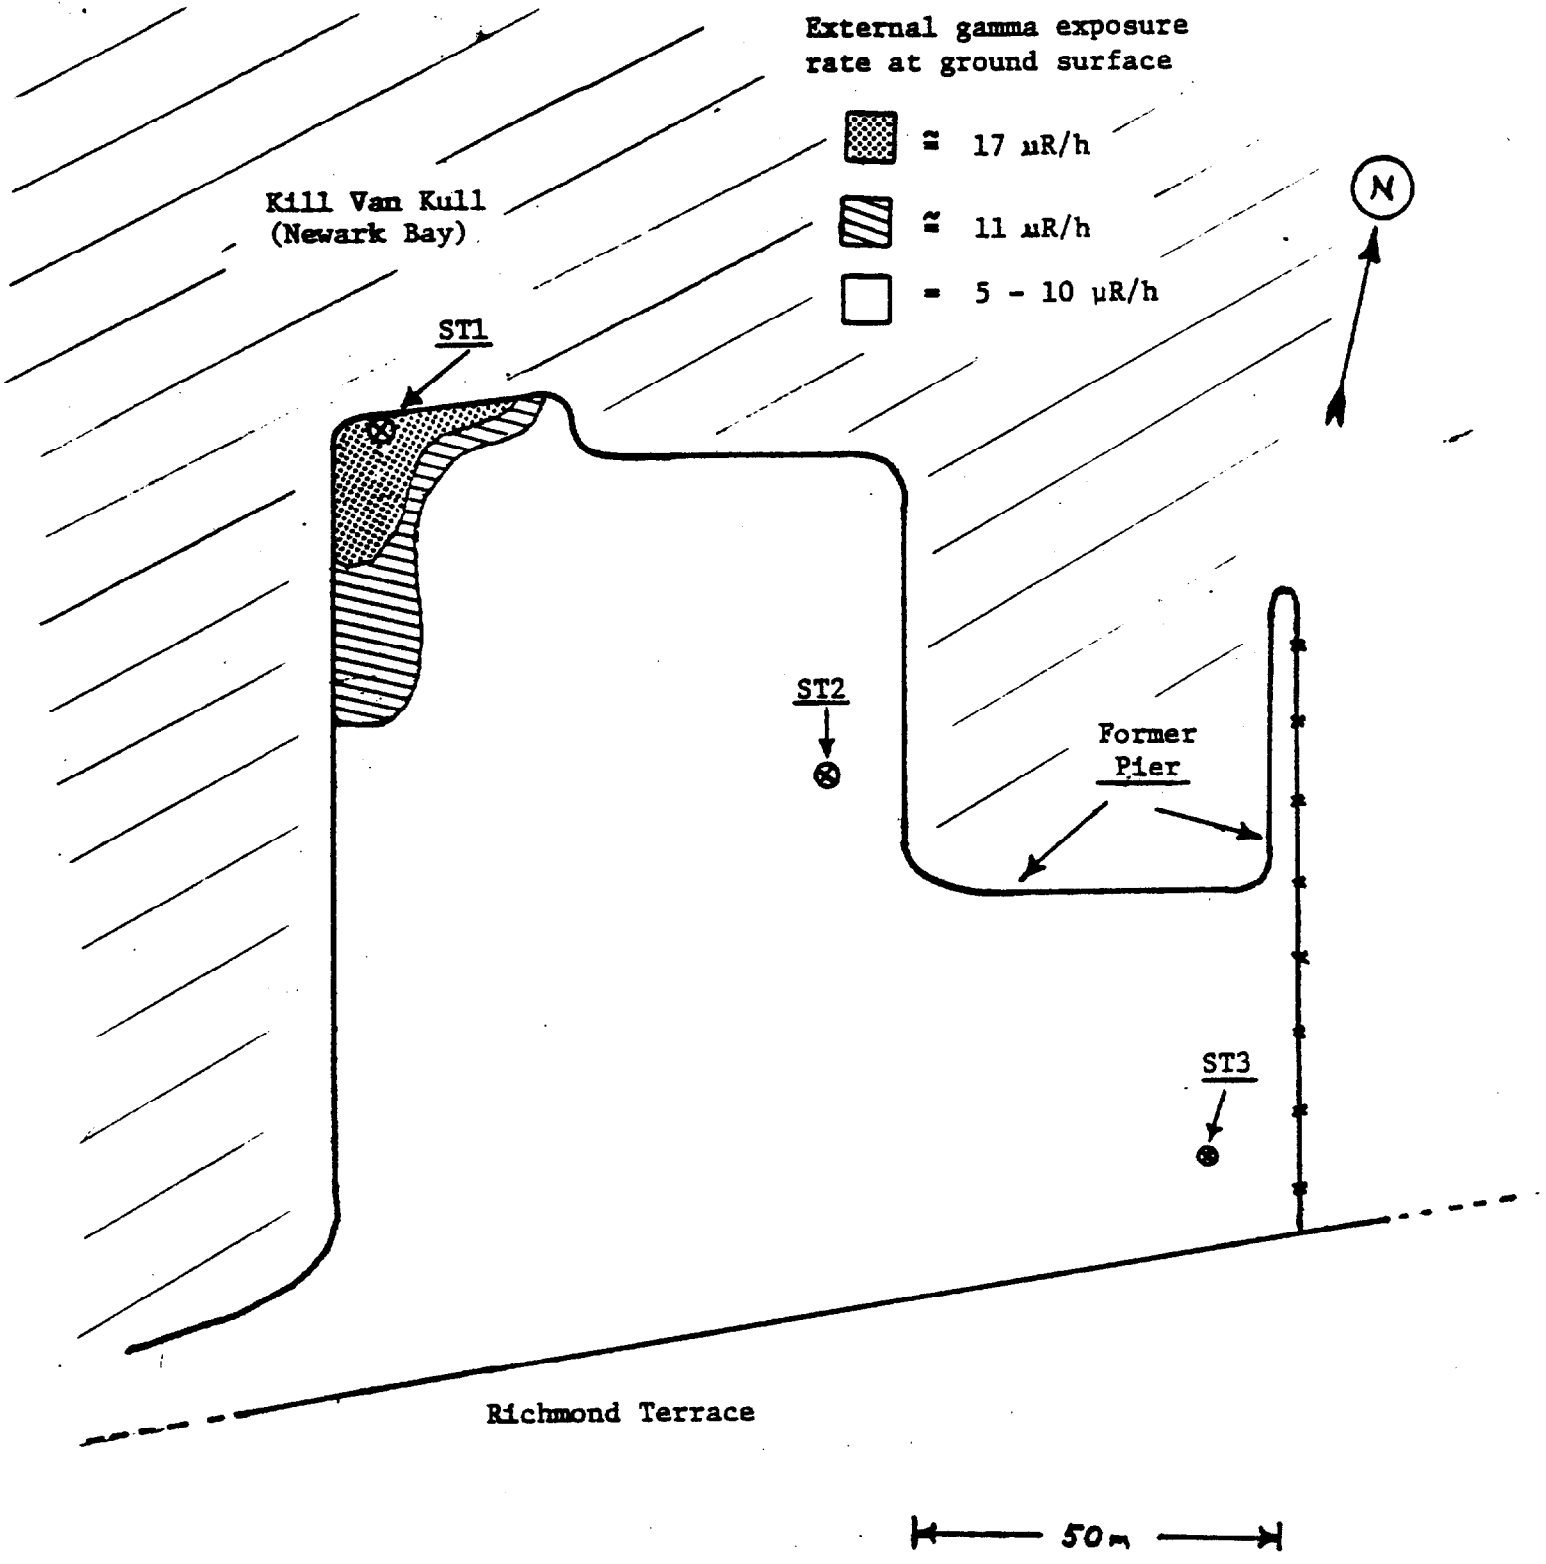
External gamma-ray exposure rate levels were generally 20 to 50% lower than most background values observed in New Jersey (Fig. 5). However, in the northwest corner of the parcel, gamma radiation levels were found to be significantly above background, indicating the presence

of contamination. Although the contamination was low-level throughout this area, there were localized spots with gamma exposure rates up to 0.2 mR/h (20 times background) on the ground surface (increasing to 0.4 mR/h at 15-cm depth). The contamination appeared to be in a 6-cm layer at a depth of approximately 35 to 40 cm (Fig. 6).

Three soil samples were taken for radionuclide analyses. The location of these samples are identified in Fig. 5 and the results of the analyses are listed below.

Figure 5. External gamma exposure rates observed at ground surface on Parcel 1 and location of three surface soil samples.

Based on the results of this preliminary survey at the former Staten Island Warehouse Site, it is recommended that a formal detailed radiological survey of Parcel 1 be conducted. There is evidence that a 20 m x 40 m area may have been contaminated with high-grade Belgian Congo uranium ore; preliminary results cannot rule out the existence of other such areas on this or other parcels.

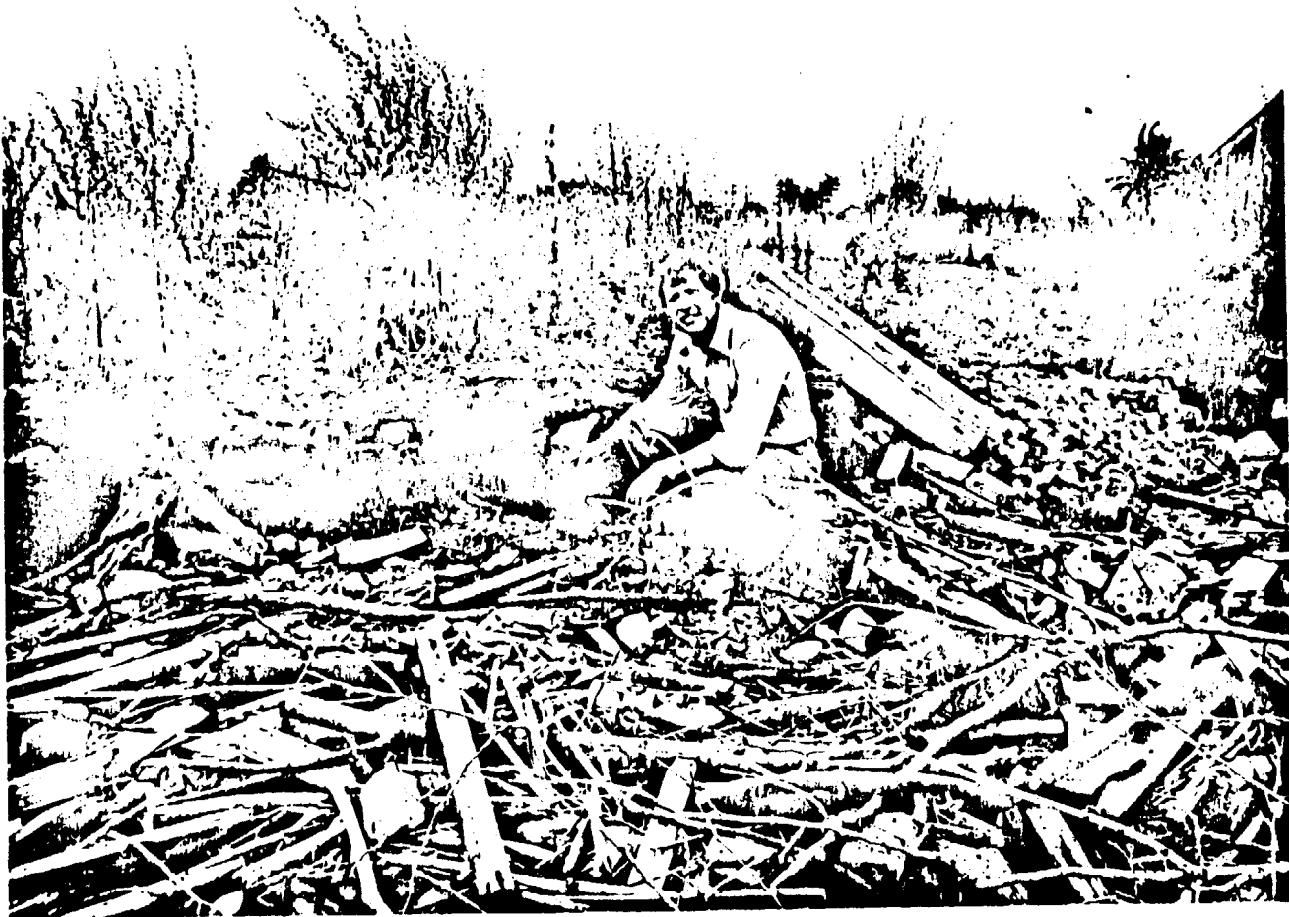
Sample	Depth From Ground Surface (cm)	Concentration of Radionuclides (pCi/g) ^a		
		²³⁸ U	²²⁶ Ra	²³² Th
ST 1	35 - 40	660 ± 3%	590 ± 0.2%	<i>b</i>
ST 2	0 - 10	1.1 ± 3%	1.2 ± 2%	1.4 ± 3%
ST 3	0 - 5	0.62 ± 3%	0.62 ± 3%	0.45 ± 2%

Figure 6. Location of soil sample ST 1 showing layer of contamination at 35 - 40 cm depth.
