ORNL/TM-11817

Radiological Characterization Survey of the Former Diamond Magnesium Company Site, 720 Fairport–Nursery Road, Painesville, Ohio (DMP001, DMP002)

Publication issued — December 1991

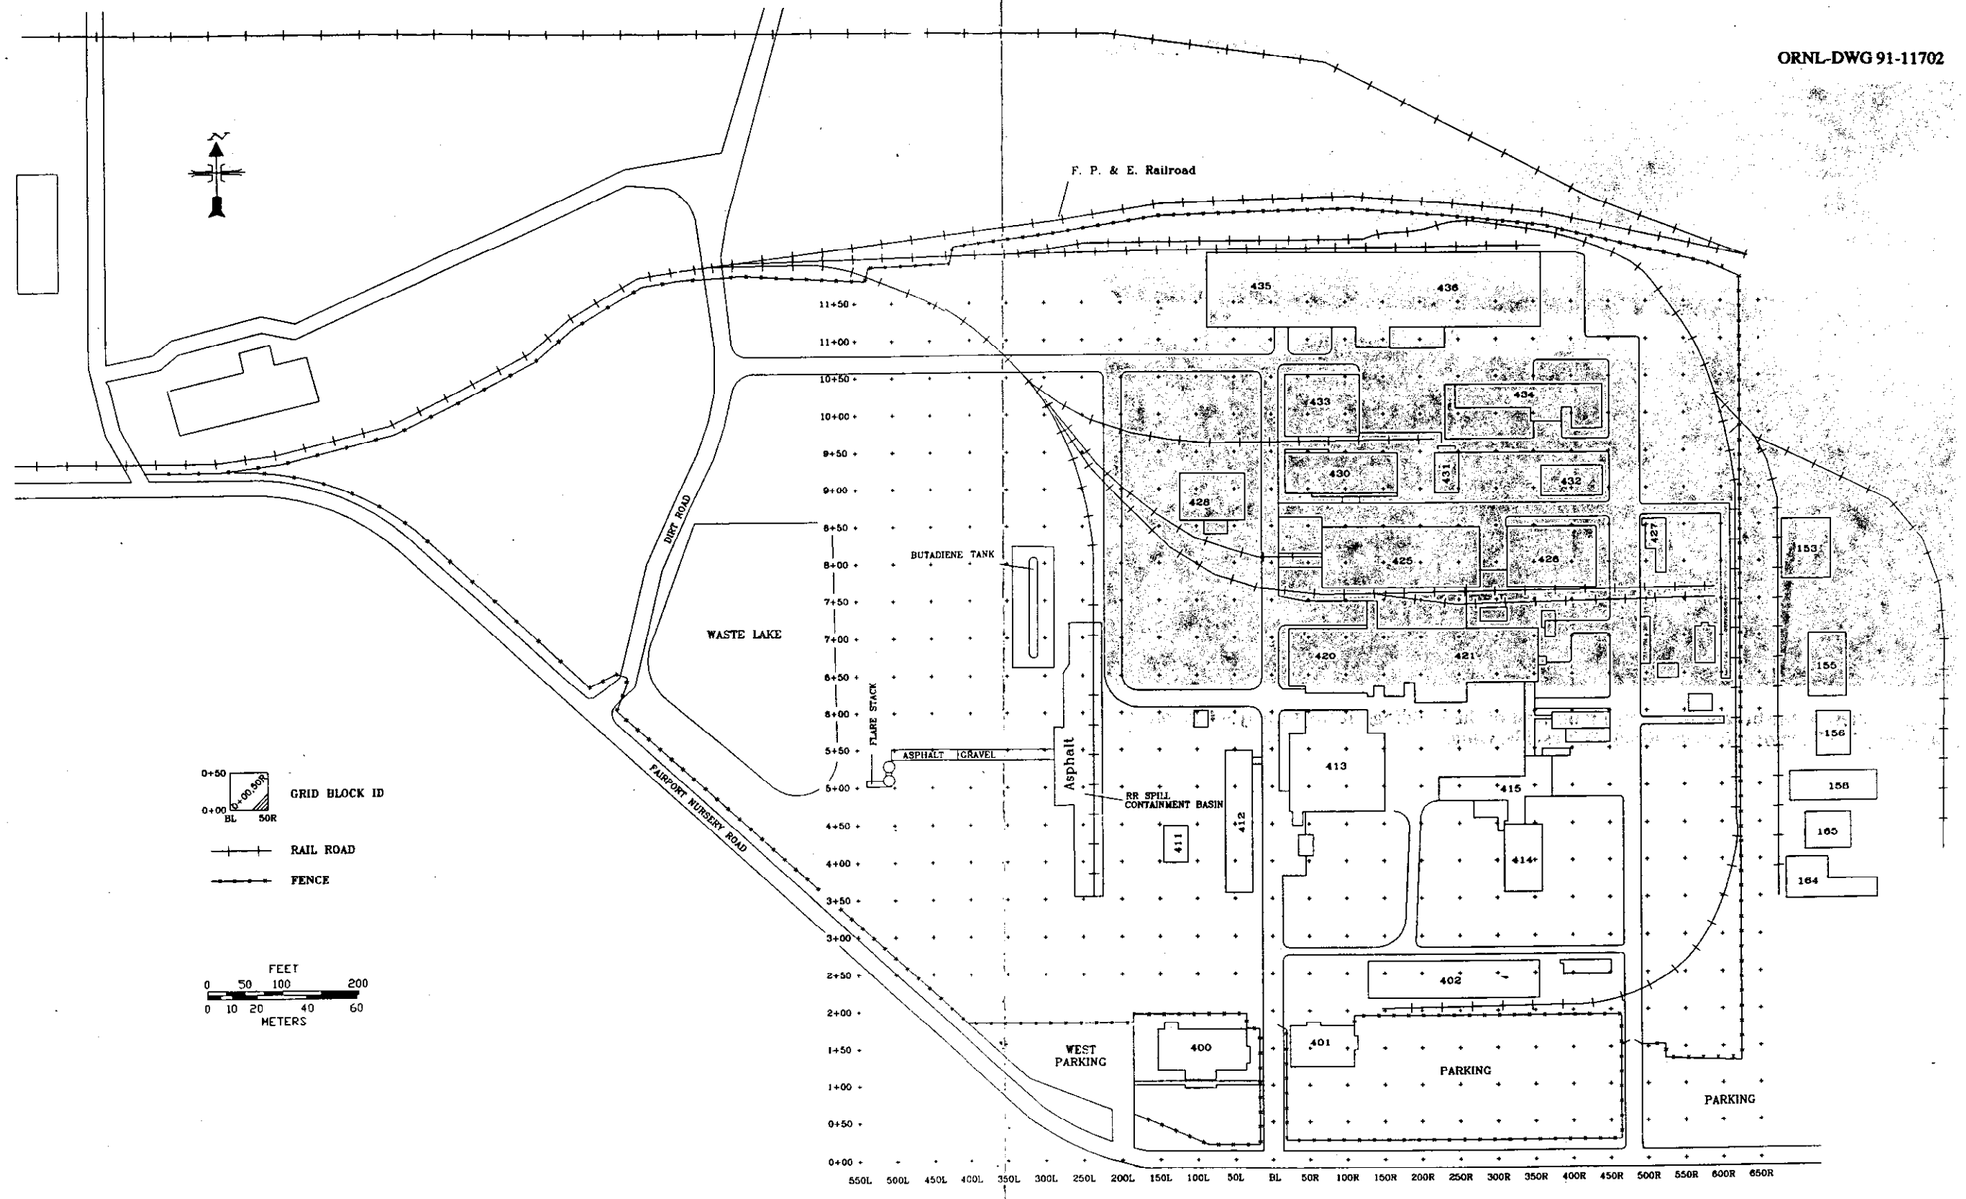
ORNL-DWG 91-11697

In reporting outdoor survey results for the Uniroyal property, locations of measurements and samples were identified by use of a grid system previously established by the company within its property boundaries (Fig. 5). Gamma exposure rates at the ground surface were recorded by range and average for each 100-ft grid block in all areas having gamma levels near background. Wherever elevated gamma levels were detected, the gamma measurements were recorded for individual 50-ft grid blocks. The ungridded remainder of the Uniroyal property was scanned at the ground surface. To determine whether or not the Lonza Chemical Company property is radiologically contaminated, a strip of land approximately 50-ft wide along the adjoining east property lines was scanned at the ground surface.

Fig. 5. Diagram showing the Uniroyal Chemical Company property, Painesville, Ohio, grid system used by ORNL to locate measurements and samples.

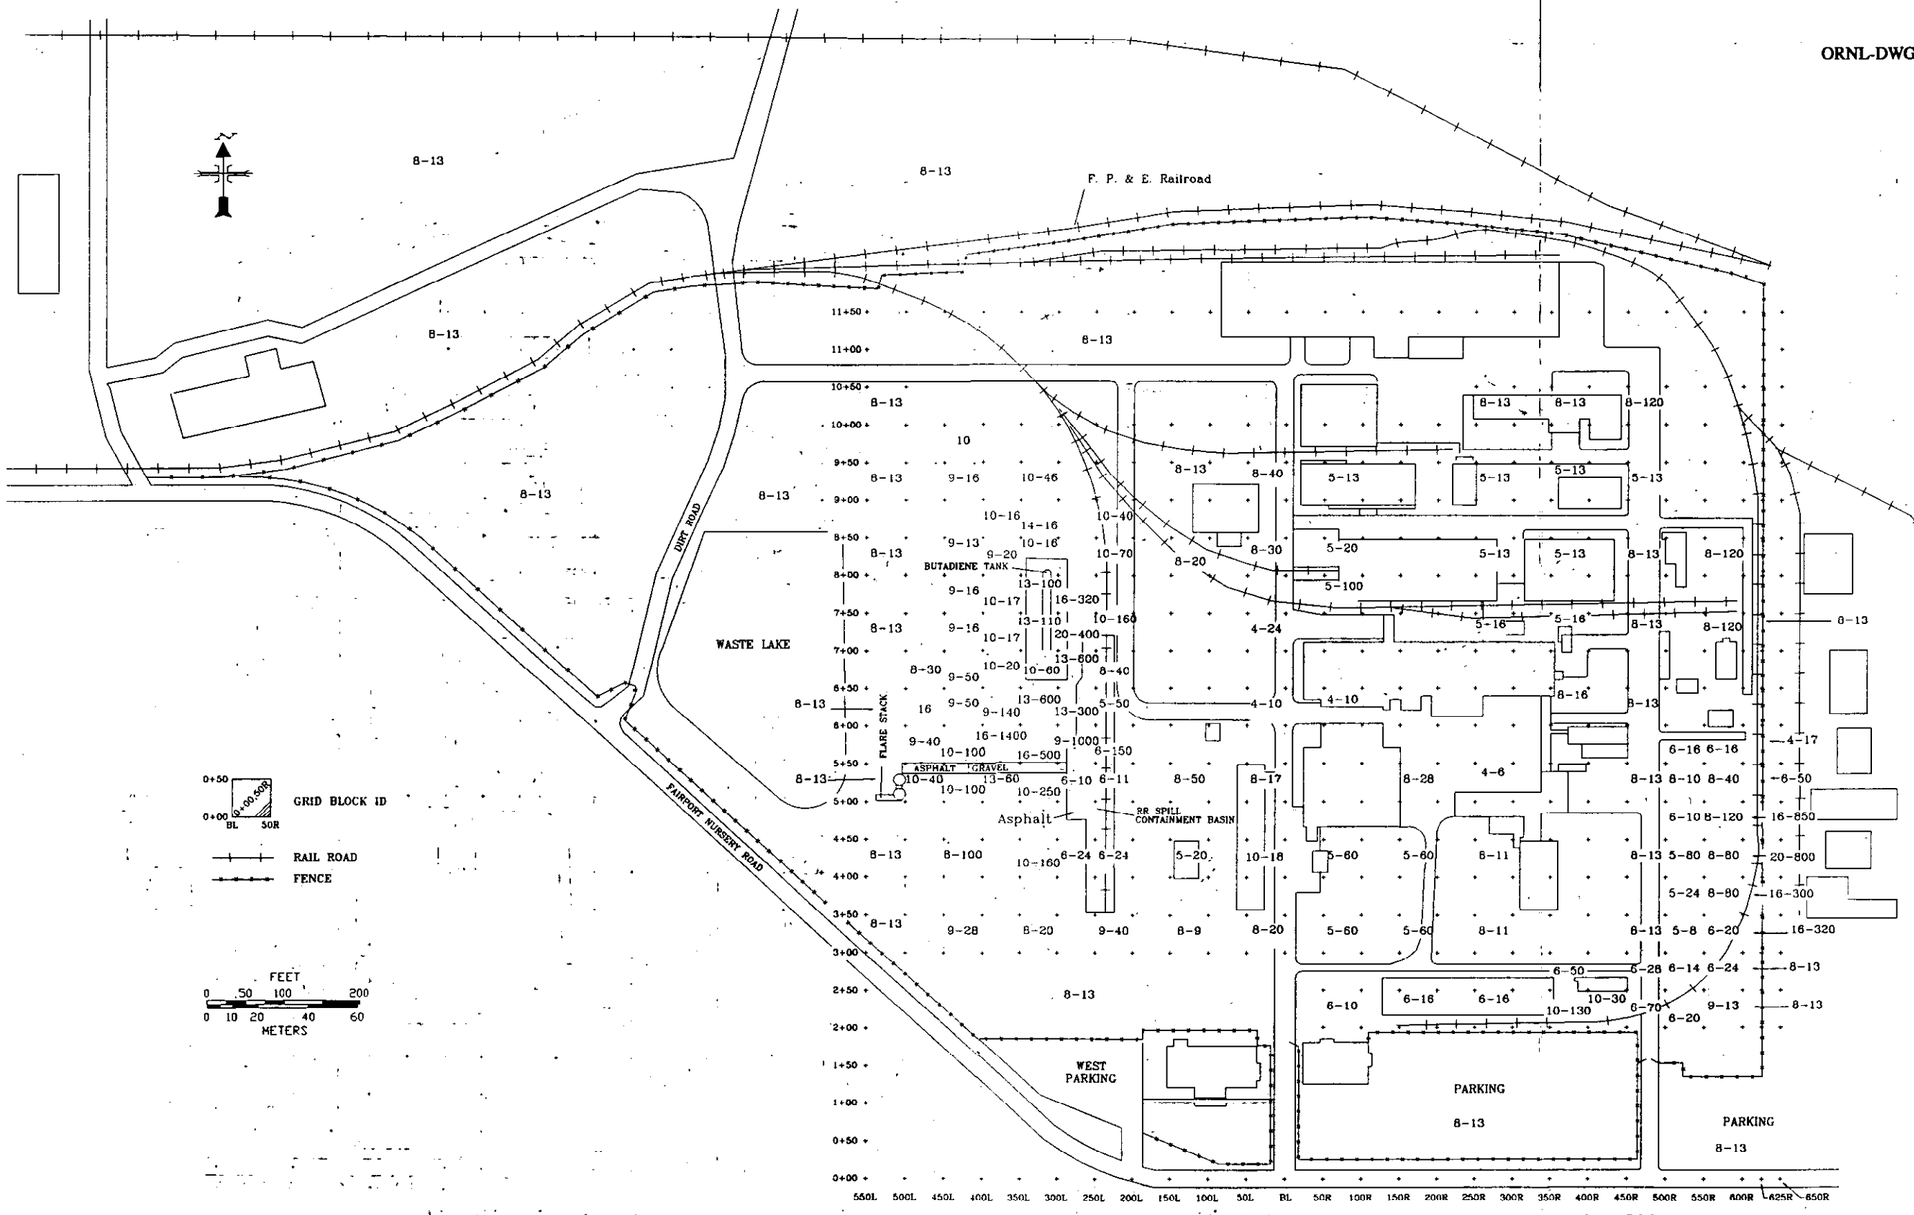
Results of gamma scanning over the ground surface of the site are shown on Fig. 6 and listed in Table 3. With the exception of two isolated hot spots scanning 90 and 200 μR/h between the dirt road and the railroad tracks west of the gridded area, exposure rates over the ground surface of the ungridded portion of the Uniroyal property were 8 to 13 μR/h. These values are comparable to the typical average background for the area (9 μR/h, Table 2). Surface scan measurements over the gridded portion of the Uniroyal property ranged from 4 to 1400 μR/h and averaged from 8 to 60 μR/h within individual grid blocks (Table 3). Grid point measurements were 5 to 180 μR/h at the ground surface and 4 to 96 μR/h at 1 m above the surface. Large areas

Gamma exposure rates were generally 4 to 16 μR/h over the ground surface of the surveyed 50–ft wide strip of the Lonza Property adjacent to Uniroyal (Fig. 6). These values are not significantly different from typical background (Table 1). Small, isolated spots of elevated exposure rates, 48 and 260 μR/h, were found at grid locations 4+25, 627R and 4+08, 626R, respectively.

Fig. 6. Ranges of gamma exposure rates (μR/h) measured over the surface at the Uniroyal and Lonza Chemical Company properties, Painesville, Ohio.

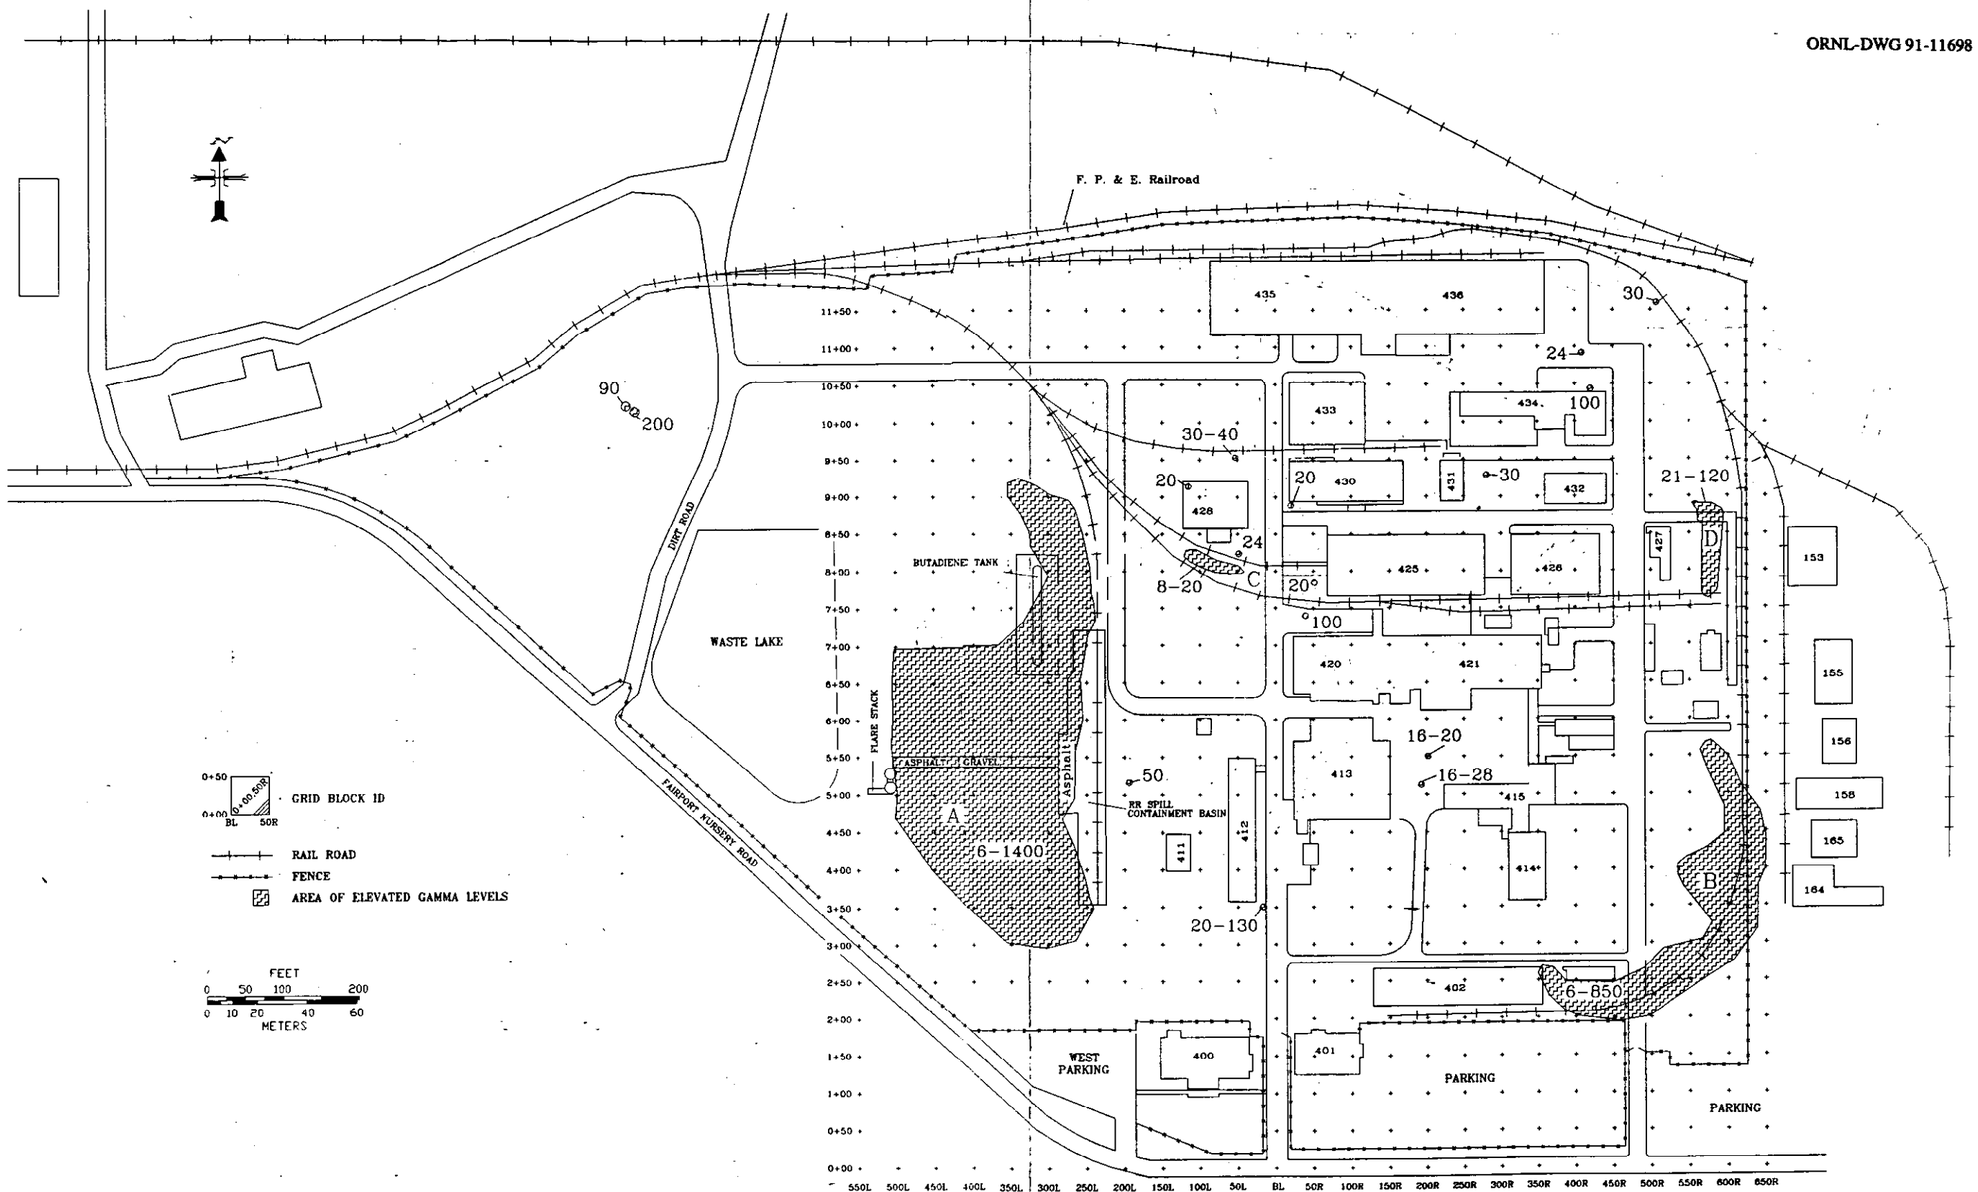
and numerous spots of elevated gamma radiation both isolated and clustered were measured throughout the gridded portion of the site. For the purposes of discussion, four of the regions have been designated A through D (Fig. 7). The two largest regions, A and B, roughly coincide with areas where the contaminated scrap metal was known to have been used and/or stored. Exposure rates were 6 to 1400 μR/h over area A measuring approximately 38,500 ft² (3600 m²) of ground surface under and around the butadiene tank (Figs. 8 and 9). Scan measurements were 6 to 850 μR/h over the surface of a ~22,000 ft² (2000 m²) area (B) extending along and beside the railroad tracks in the southeast corner of the property (Fig. 10). The northern end of that contaminated area is shown in the foreground of Fig. 11. Approximately 2500 ft² (230 m²) of ground surface between railroad tracks south of Building 428 had gamma exposure rates of 8 to 20 μR/h (Area C). A fourth contaminated region measuring ~5000 ft² (460 m²) in size (Area D) had gamma levels ranging from 21 to 120 μR/h. The southern end of that region lies in the foreground of Fig. 12. Exposure rates on contact with brick walls of buildings were generally 14 to 16 μR/h. These slightly elevated values are consistent with those frequently measured on contact with bricks and other structural materials containing technologically enhanced concentrations of naturally occurring radionuclides.

Fig. 7. Areas of elevated gamma radiation levels on the Uniroyal and Lonza Chemical Company properties, Painesville, Ohio.

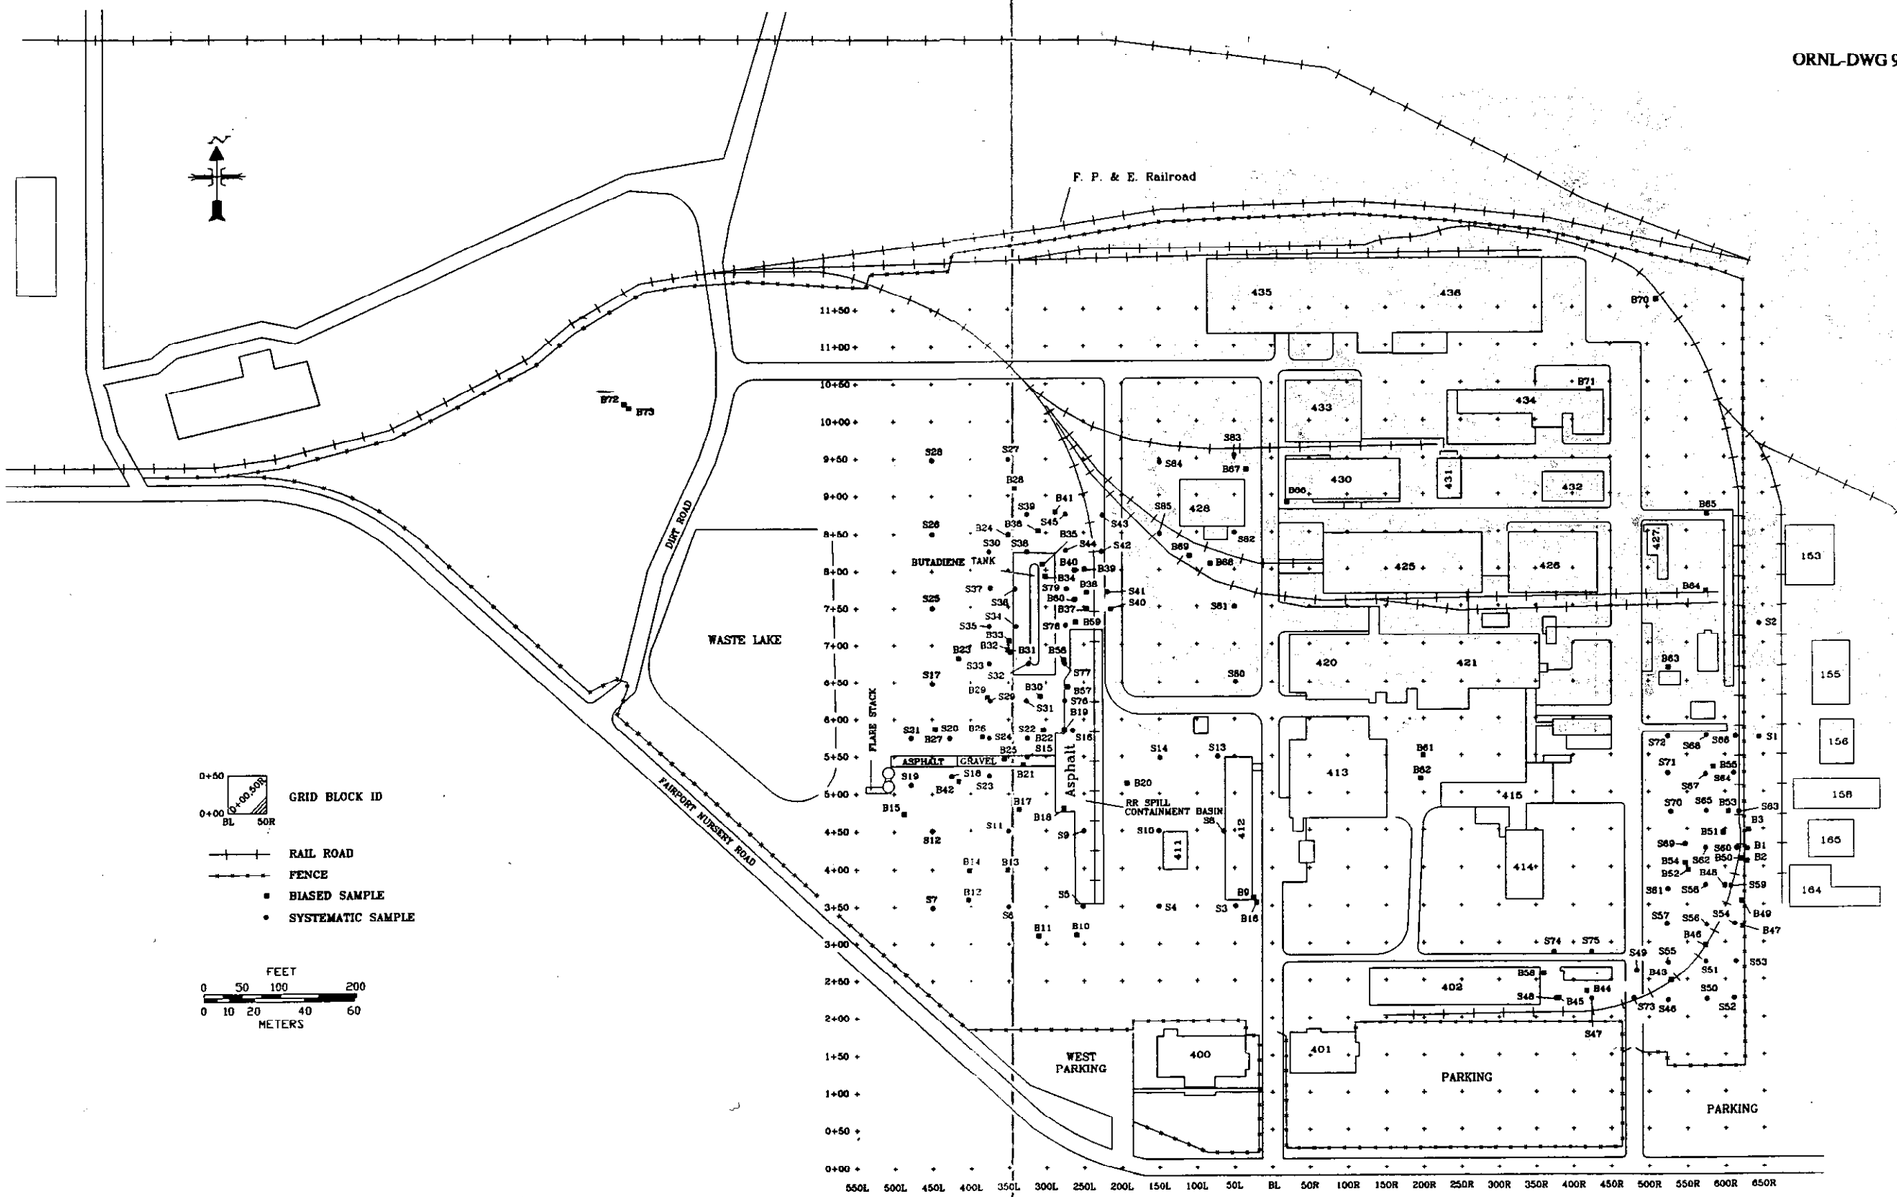
Locations of systematic soil samples are diagrammed in Fig. 13 and results of analyses are listed in Table 4. Maximum concentrations of ^{238}U, ^{232}Th, and ^{226}Ra in surface soil (0-15 cm) were 33, 1.3, and 180 pCi/g, respectively. In subsurface soil, maximum values were 130 pCi/g for ^{238}U, 1.5 pCi/g for ^{232}Th, and 190 pCi/g for ^{226}Ra. The analyses demonstrate concentrations of ^{226}Ra exceeding the guidelines. The surface soil guideline (Table 1) is exceeded in sample S22 by a factor of approximately 35, and the subsurface soil guideline by a factor of ~13 (S79B). Although no specific guideline for uranium concentrations has been derived for this site, concentrations of 35 to 40 pCi/g ^{238}U have been applied at FUSRAP sites elsewhere (Table 1). Uranium-238 concentrations in some systematic subsurface samples exceed those values. Typical Painesville area background concentrations average 1.2, 1.1, and 1.1 pCi/ g, for ^{238}U, ^{232}Th, and ^{226}Ra, respectively (Table 2).

Biased soil sample locations are shown on Fig. 13. Gamma exposure rates on contact with 13 biased samples were 110,000 to 630,000 counts per minute (cpm) using the NaI detector indicating radionuclide concentrations significantly in excess of guidelines. It was unnecessary, therefore, to analyze those samples for precise values. Rough estimates of concentrations of radionuclides in these samples were achieved by comparing gamma exposure rates on contact with the samples to exposure rates measured on contact with analyzed samples and extrapolating from analysis results. On this basis, estimated concentrations of ^{226}Ra in those samples range from 1500 to 9800 pCi/g. Sample B22A contained the maximum estimated value. Surface, subsurface, and hot spot DOE guidelines are exceeded (Table 1). Analysis of a highly radioactive

Six biased soil samples were collected from two different depths at each of three different locations near the fence separating the two properties (Fig. 13). The photograph reproduced in Fig. 15 shows the general area from which the biased samples were collected. Concentrations of ^{232}Th ranged from 0.32 to 0.83 pCi/g in the six samples (Table 6). Uranium-238 concentrations ranged from 5.5 to 310 pCi/g in surface samples and from 4.7 to 63 pCi/g in subsurface samples. Concentrations of ^{226}Ra ranged from 8 to 1000 pCi/g in surface soil samples and from 4.2 to 170 pCi/g in subsurface soil samples. Radium-226 concentrations exceed DOE hot spot guidelines for surface and subsurface soil (Table 1). Uranium results exceed site-specific guidelines used at other sites (Table 1) in samples B1A, B2A, and B2B. The gamma scanning results demonstrate that contamination on the Lonza property is probably confined to the general area of the sample locations.

Fig. 13. Locations of biased (B) and systematic (S) soil samples collected from the Uniroyal and Lonza Chemical Company properties.

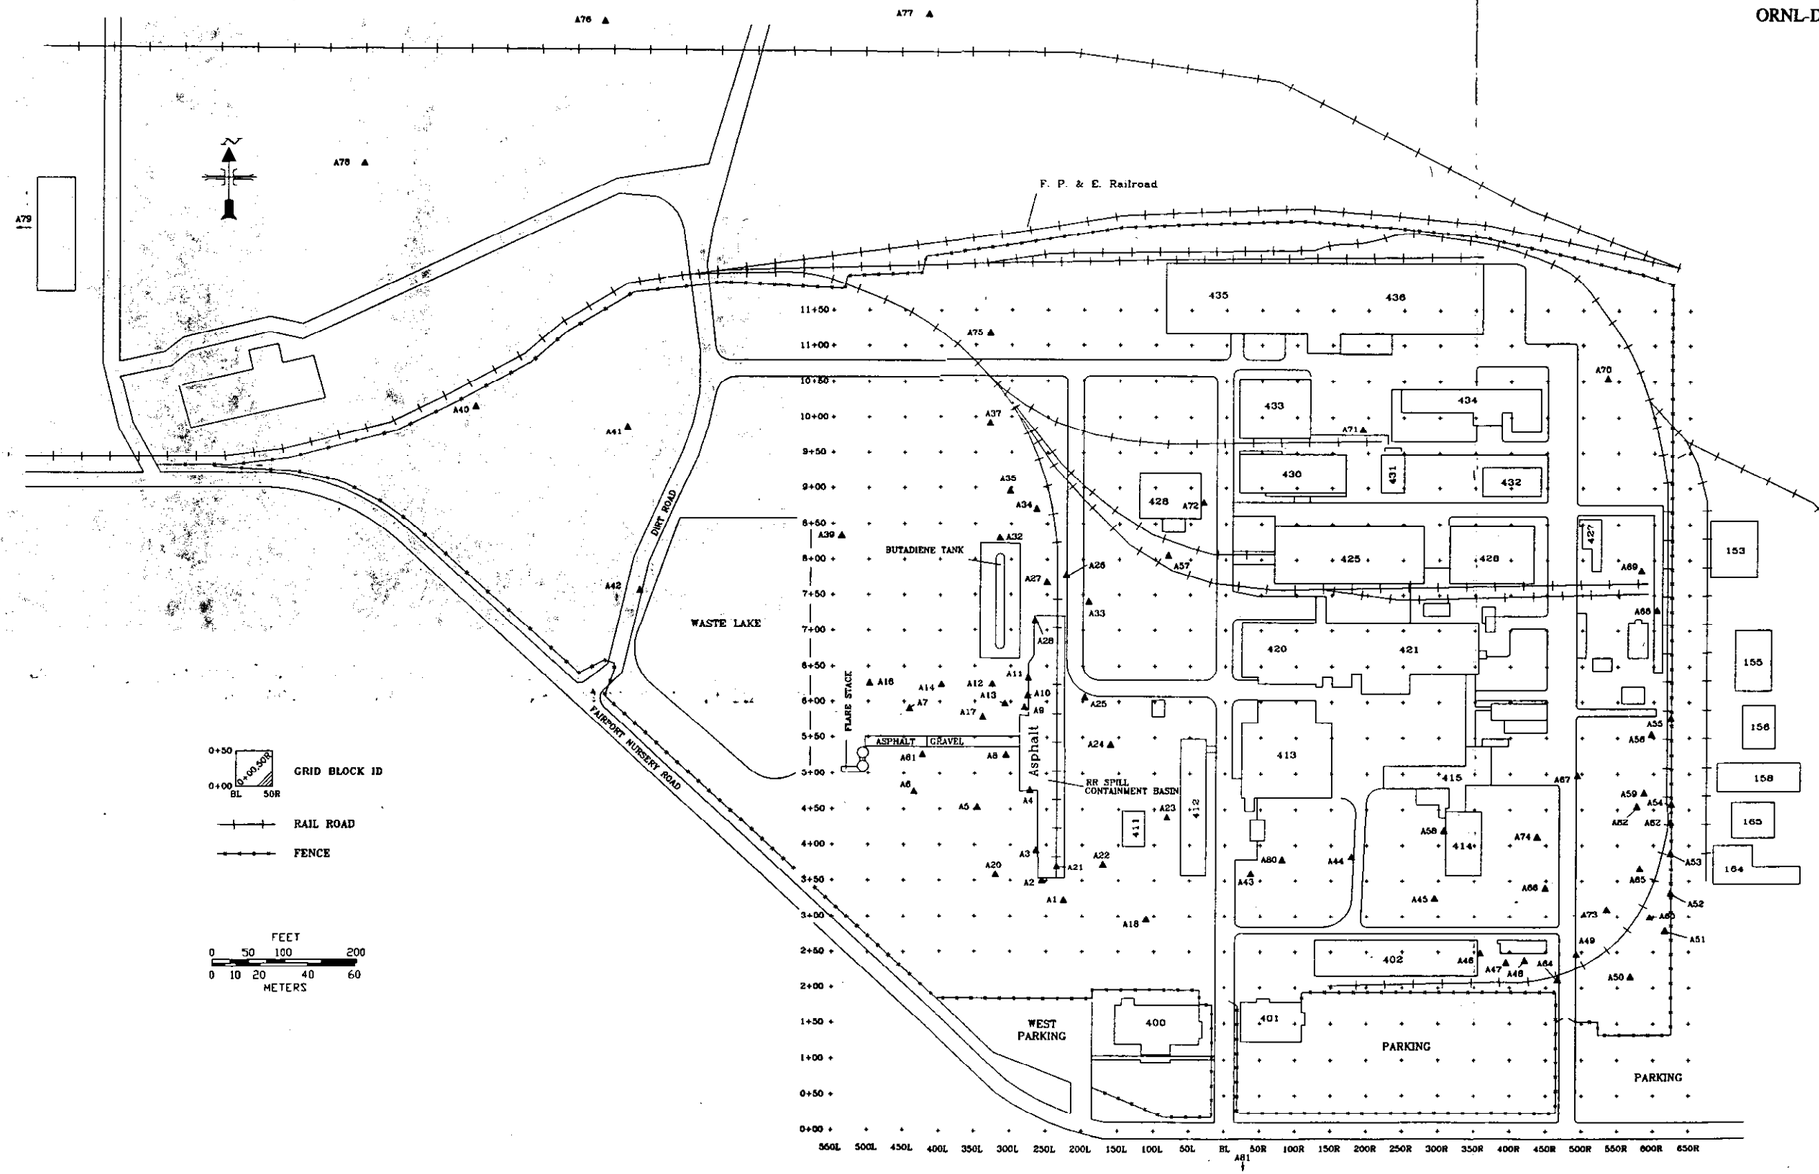
Auger hole locations are shown on Fig. 14 and radionuclide concentrations are given in Table 4. Analysis results reveal maximum concentrations of ^{238}U, ^{232}Th, and ^{226}Ra in samples from the top 15 cm of soil to be 41, 2.5 and 370 pCi/g, respectively. Maximum concentrations in samples collected from 15 cm and below were 63 (^{238}U), 1.5 (^{232}Th), and 230 (^{226}Ra) pCi/g. Concentrations of ^{226}Ra exceed guidelines in both surface and subsurface soil (Table 1). Furthermore, concentrations of ^{226}Ra in some auger hole samples are a factor of 30 higher than the authorized limit for non-homogeneous contamination (Table 1). FUSRAP guidelines state that "In addition," (to the 5 and 15-pCi/g guidelines) "every reasonable effort will be made to remove any source of radionuclide that exceeds 30 times the Authorized Limit irrespective of the average concentration in the soil." Uranium–238 concentrations in auger hole samples are elevated above background as well as above guideline concentrations used elsewhere (Table 1).

Fig. 14. Locations of auger holes (A) drilled on the Uniroyal Chemical Company property.

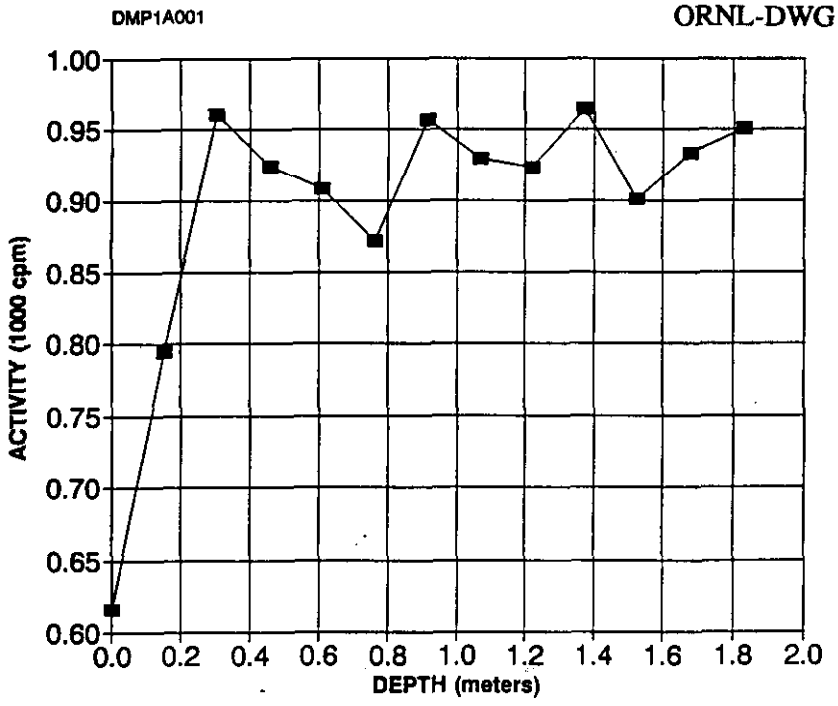
Fig. A.1. Gamma profile of auger hole A1.

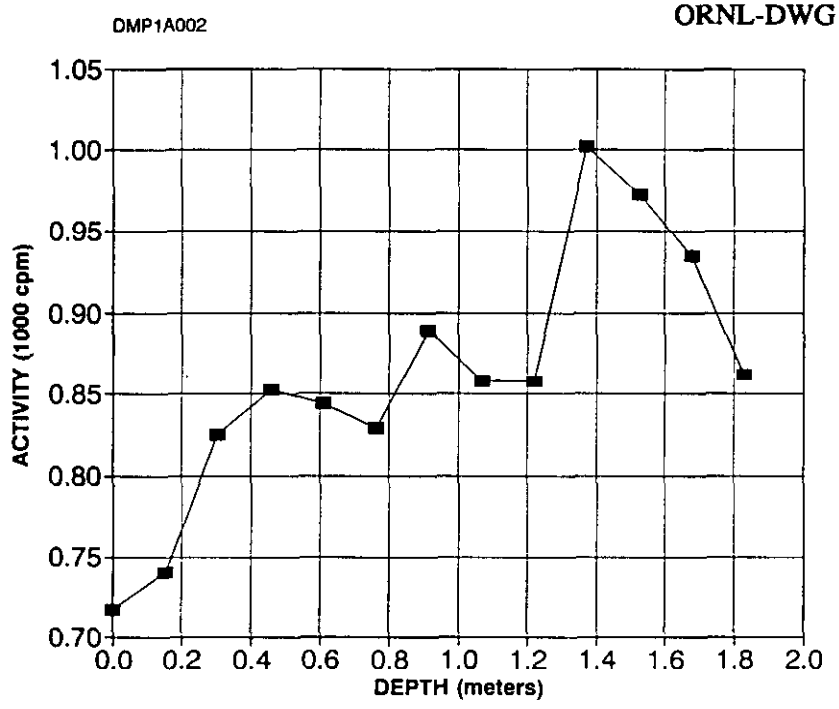
Fig. A.2. Gamma profile of auger hole A2.

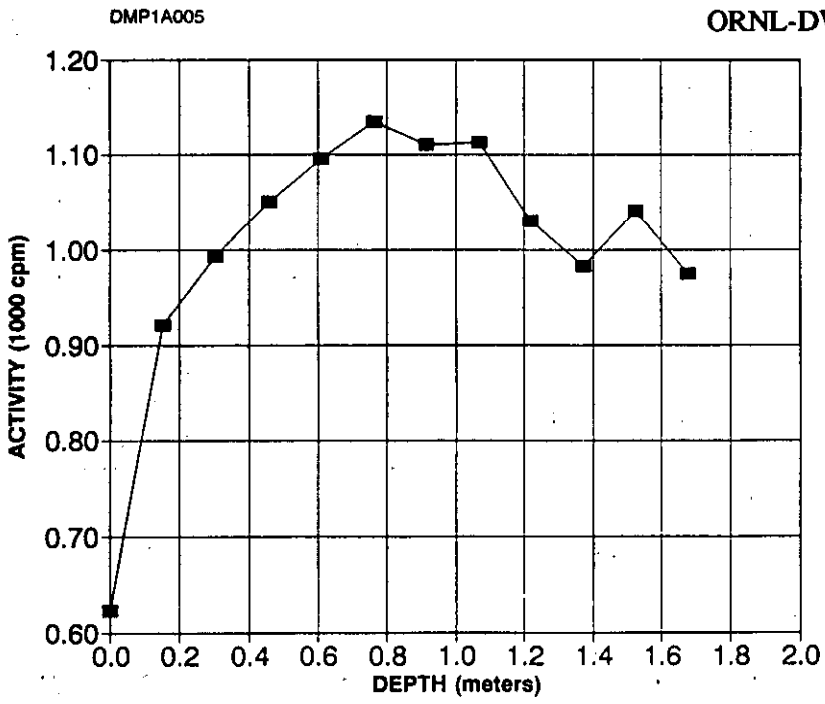
Fig. A.5. Gamma profile of auger hole A5.

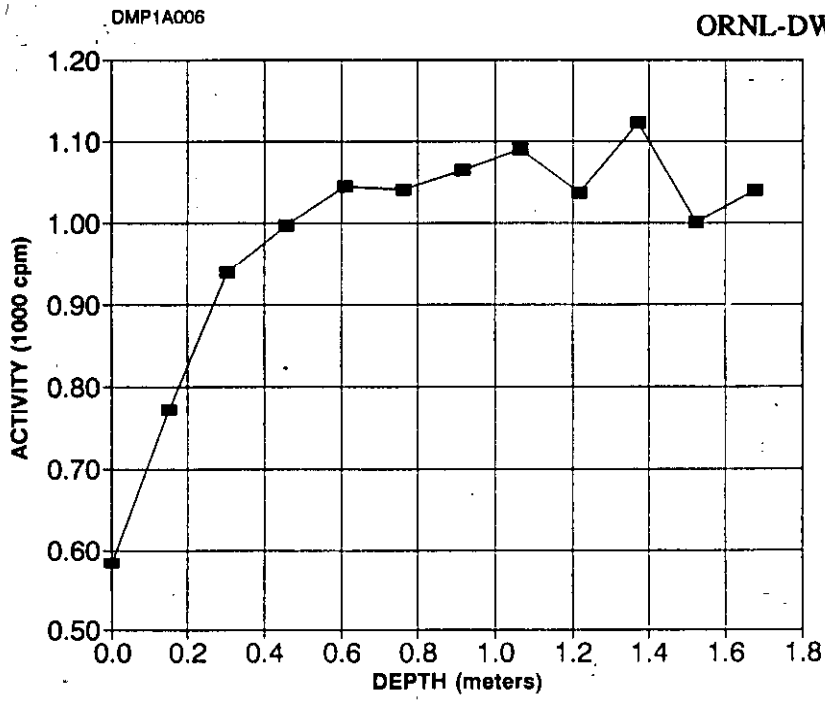
Fig. A.6. Gamma profile of auger hole A6.

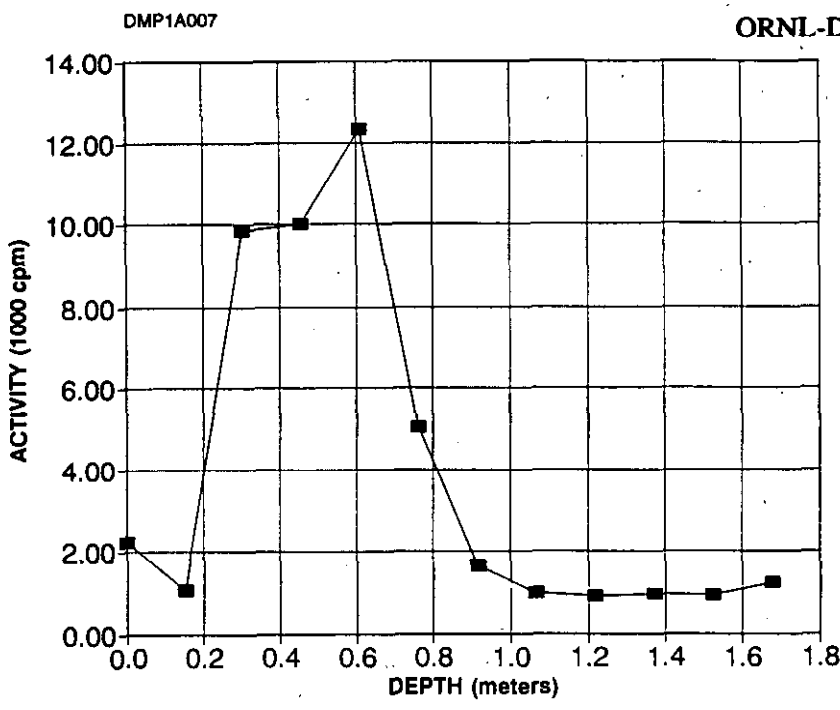
Fig. A.7. Gamma profile of auger hole A7.

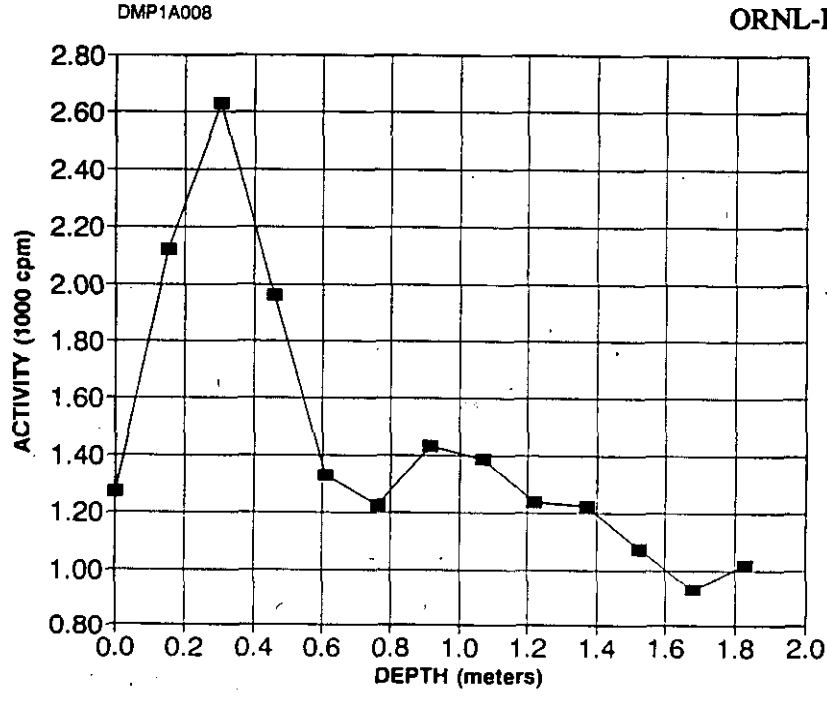
Fig. A.8. Gamma profile of auger hole A8.

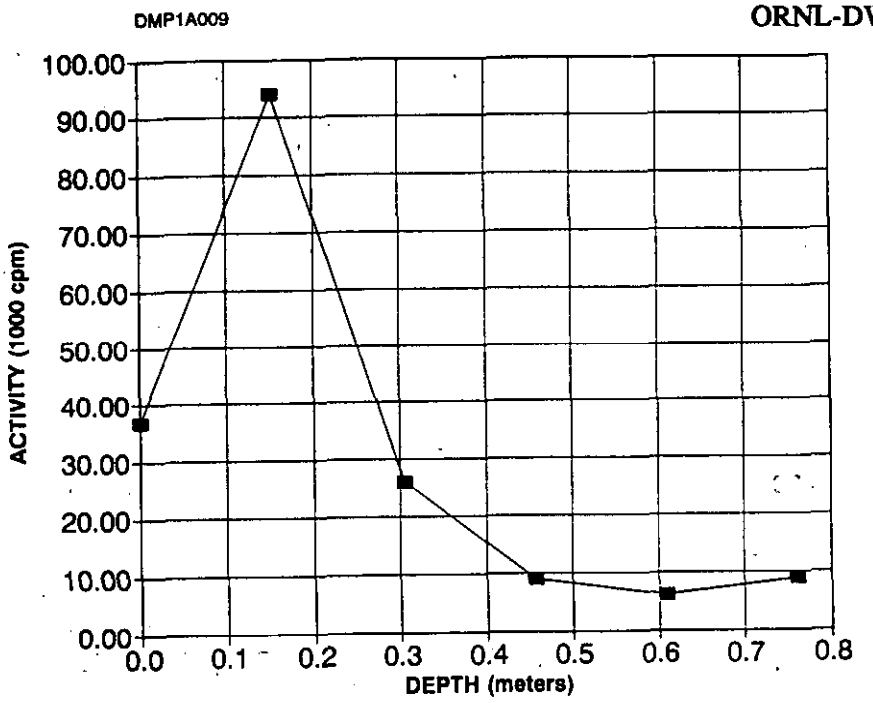
Fig. A.9. Gamma profile of auger hole A9.

Gamma readings for the logged holes ranged from 360 to 94,000 cpm. The maximum gamma level measured was ~94,000 cpm in hole A9 where soil sample B19B contained the maximum concentration of ^{226}Ra on the site as demonstrated by analysis (1500 pCi/g). Thirty-six holes had

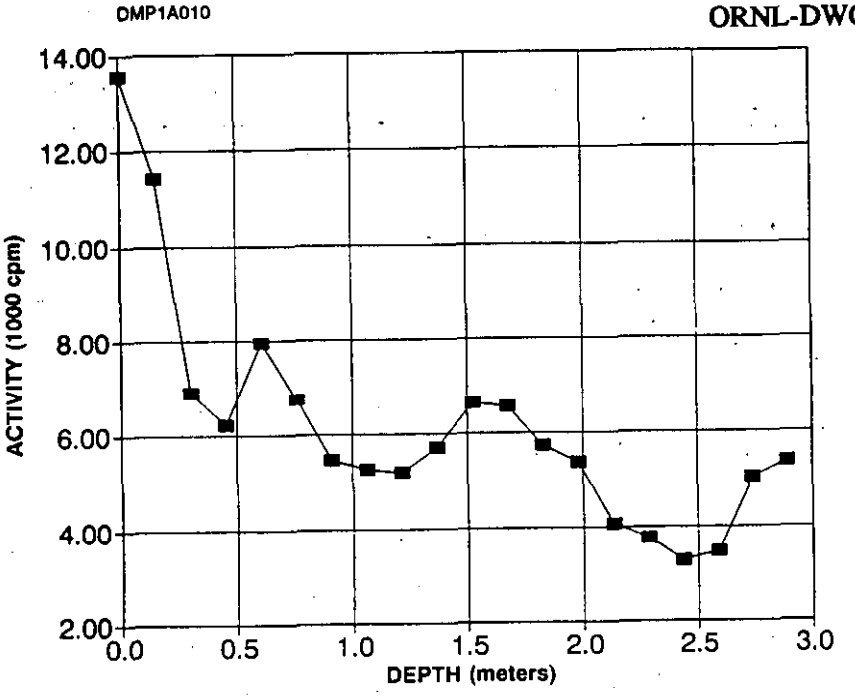
Fig. A.10. Gamma profile of auger hole A10.

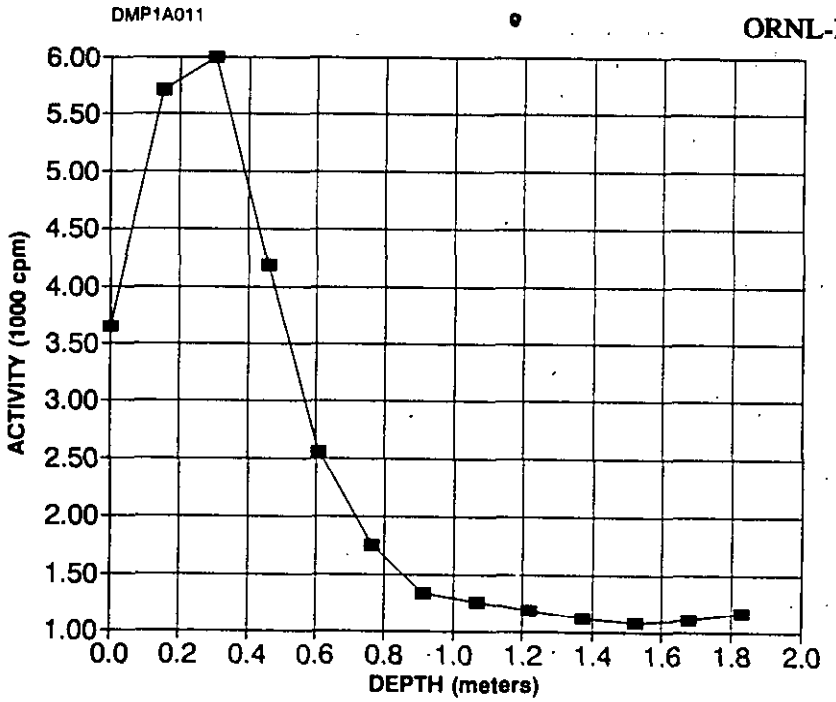
Fig. A.11. Gamma profile of auger hole A11.

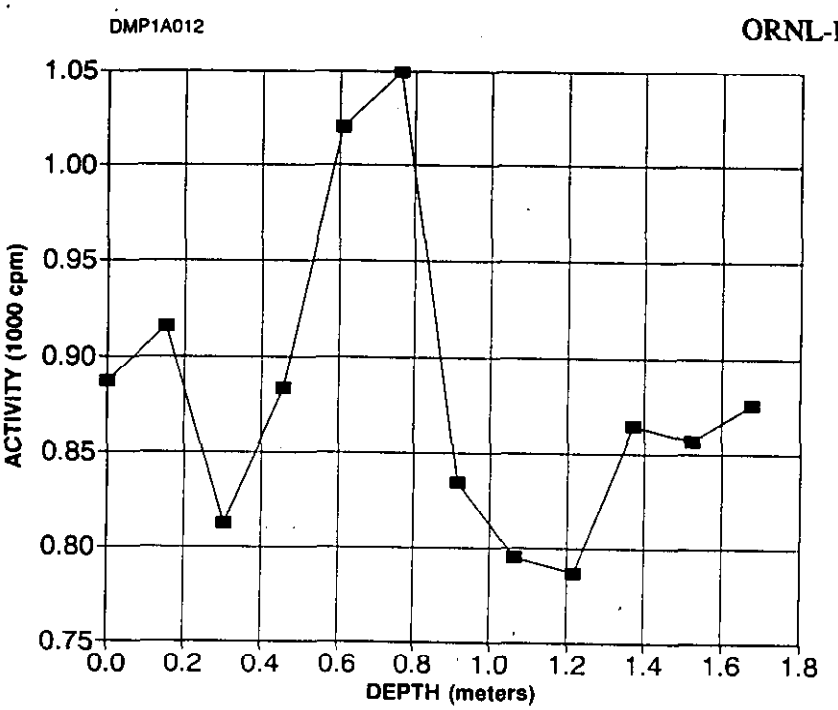
Fig. A.12. Gamma profile of auger hole A12.

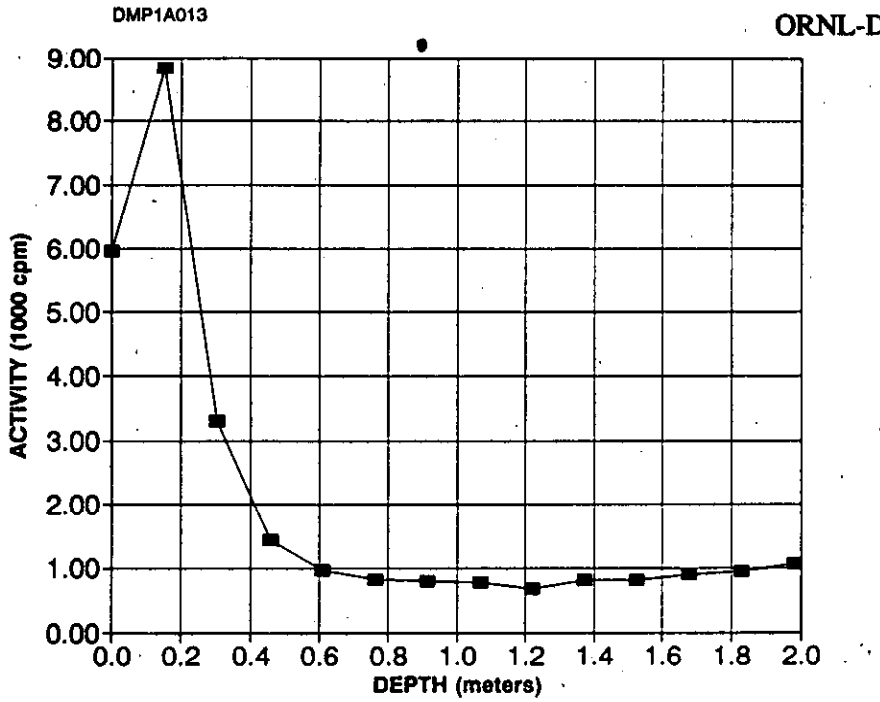
Fig. A.13. Gamma profile of auger hole A13.

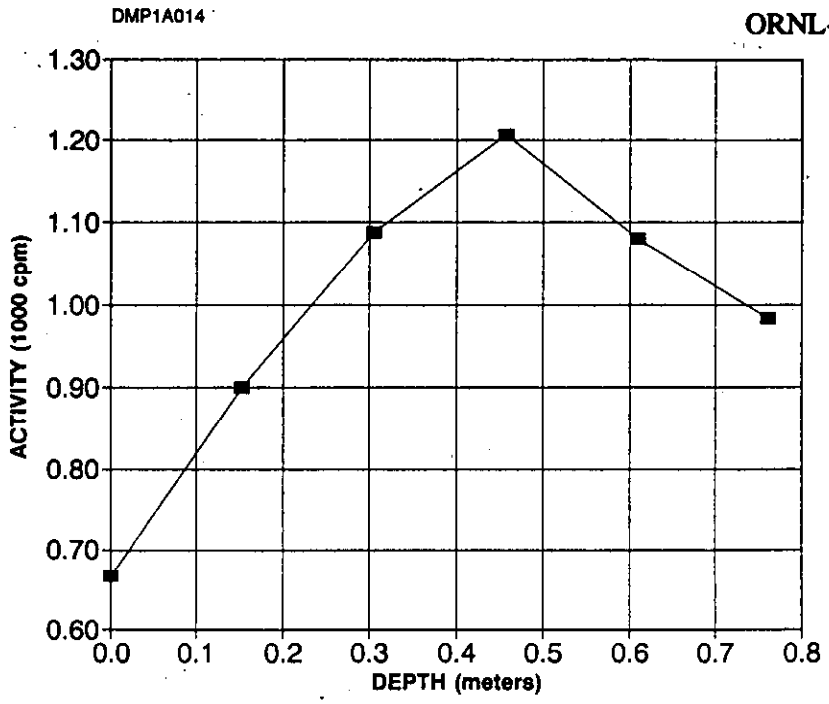
Fig. A.14. Gamma profile of auger hole A14.

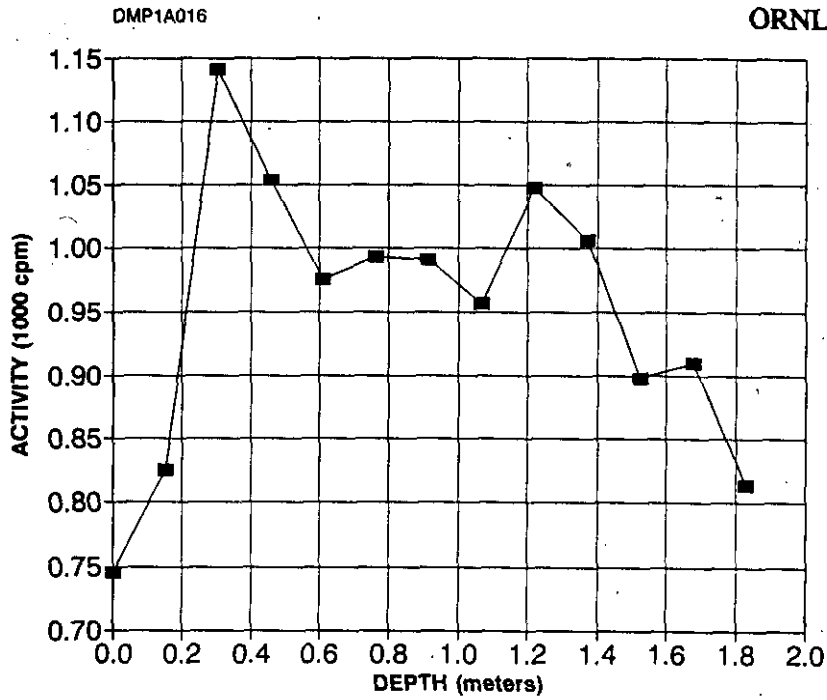
Fig. A.15. Gamma profile of auger hole A16.

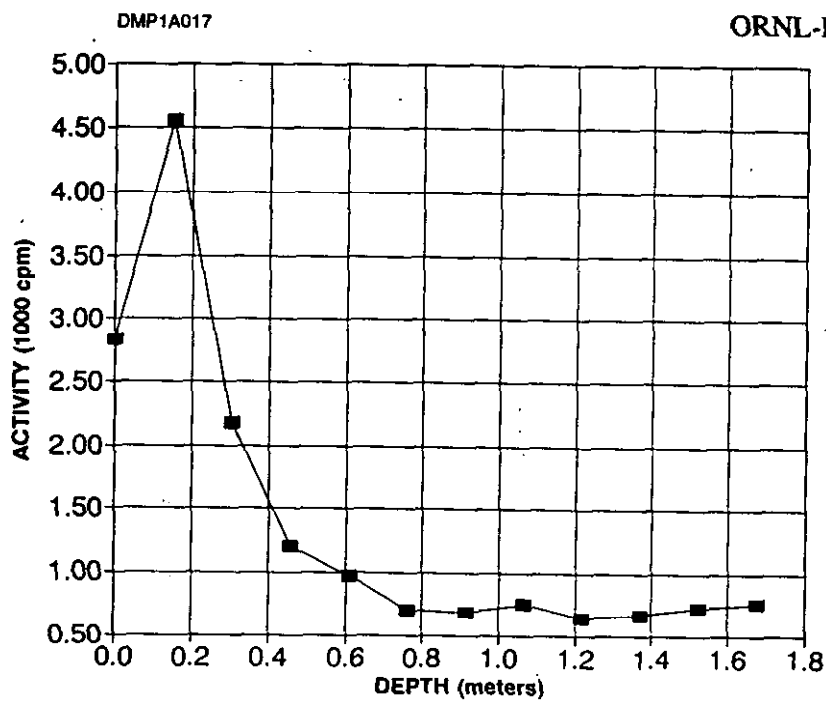
Fig. A.16. Gamma profile of auger hole A17.

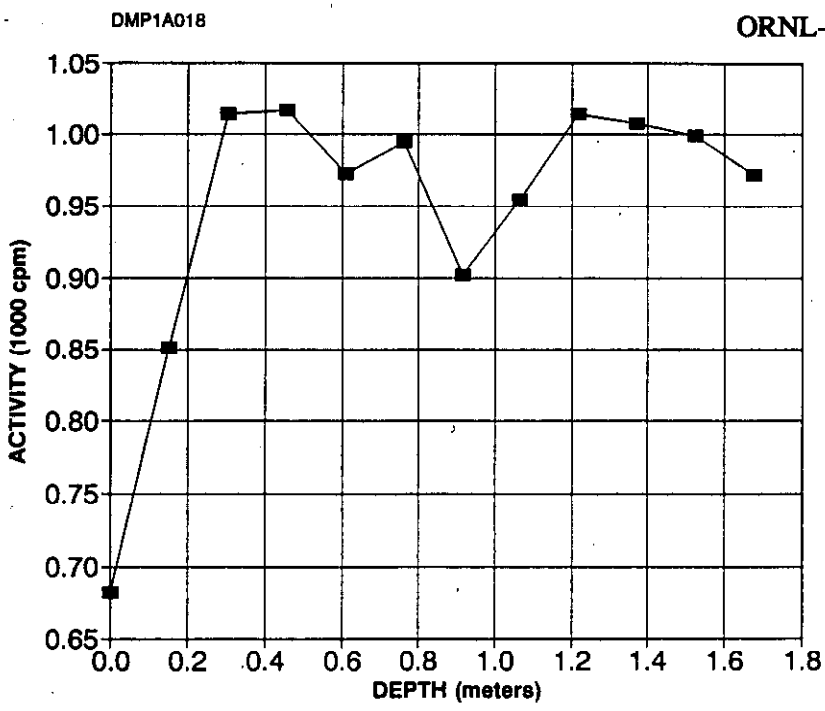
Fig. A.17. Gamma profile of auger hole A18.
