ORNL/TM-11817

Radiological Characterization Survey of the Former Diamond Magnesium Company Site, 720 Fairport–Nursery Road, Painesville, Ohio (DMP001, DMP002)

Publication issued — December 1991

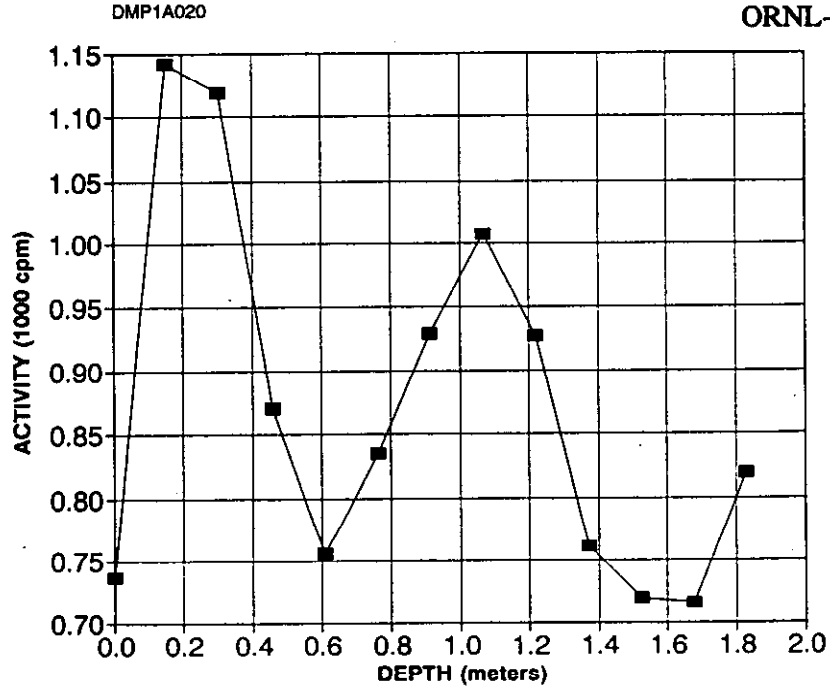
Fig. A.18. Gamma profile of auger hole A20.

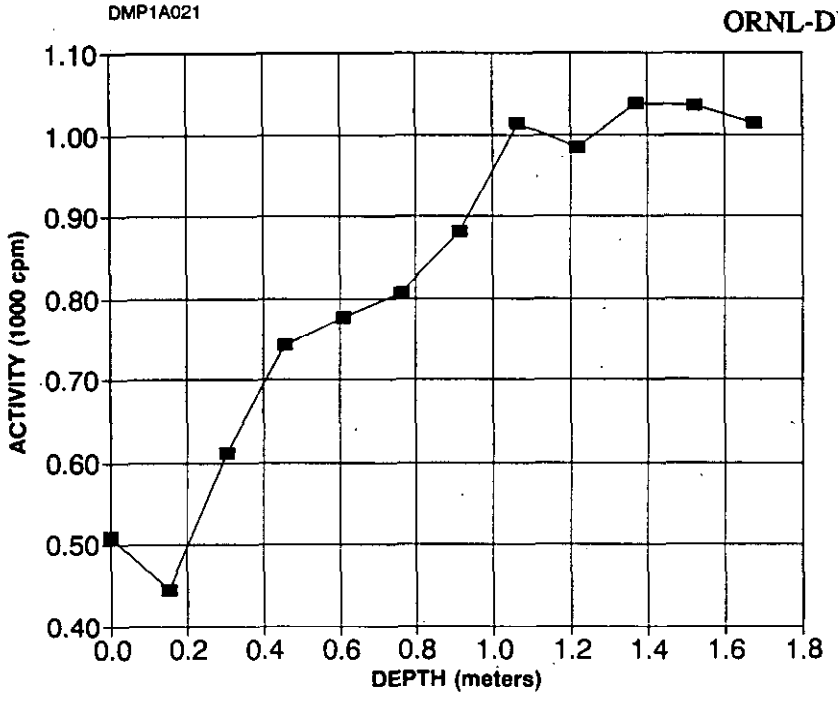
Fig. A.19. Gamma profile of auger hole A21.

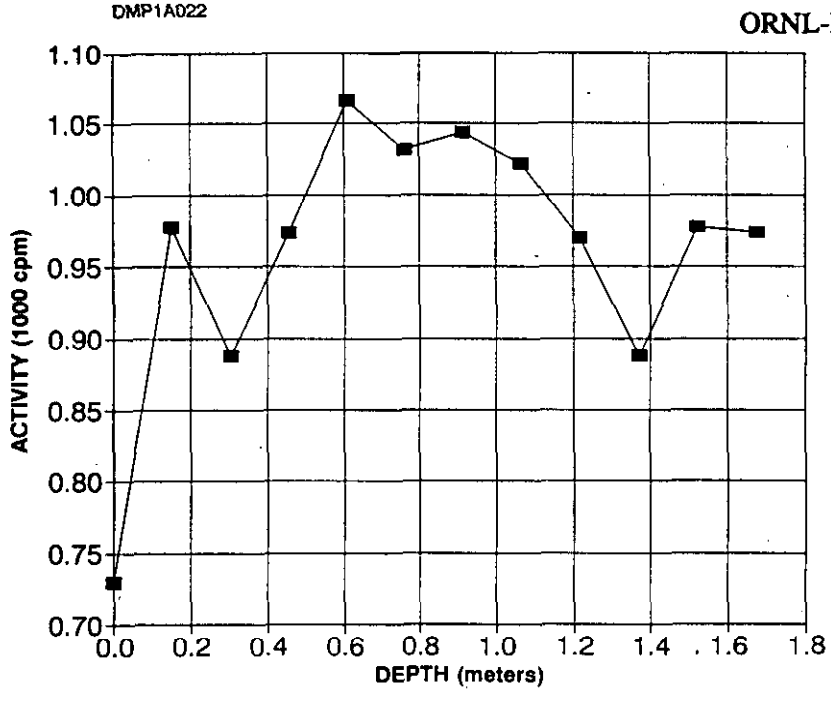
Fig. A.20. Gamma profile of auger hole A22.

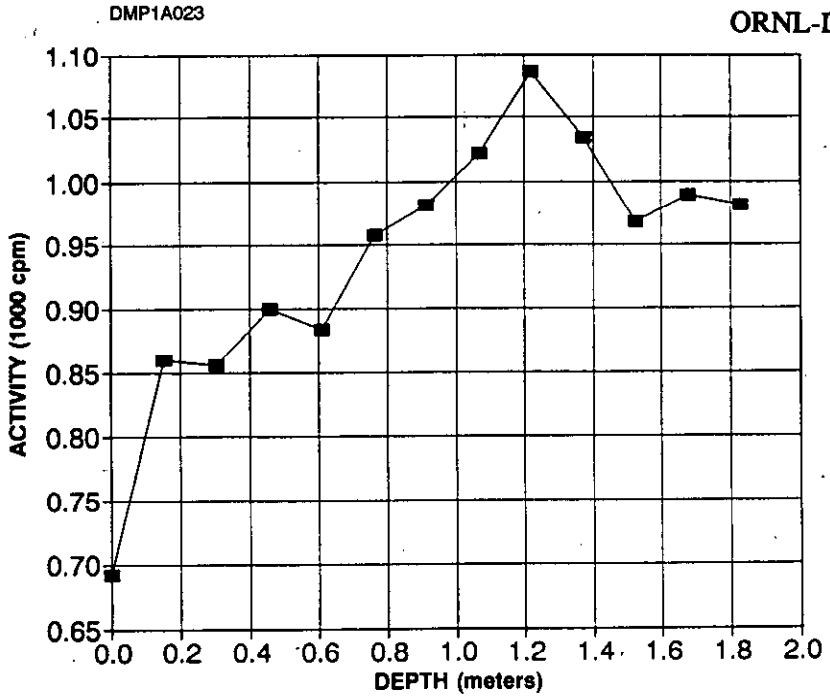
Fig. A.21. Gamma profile of auger hole A23.

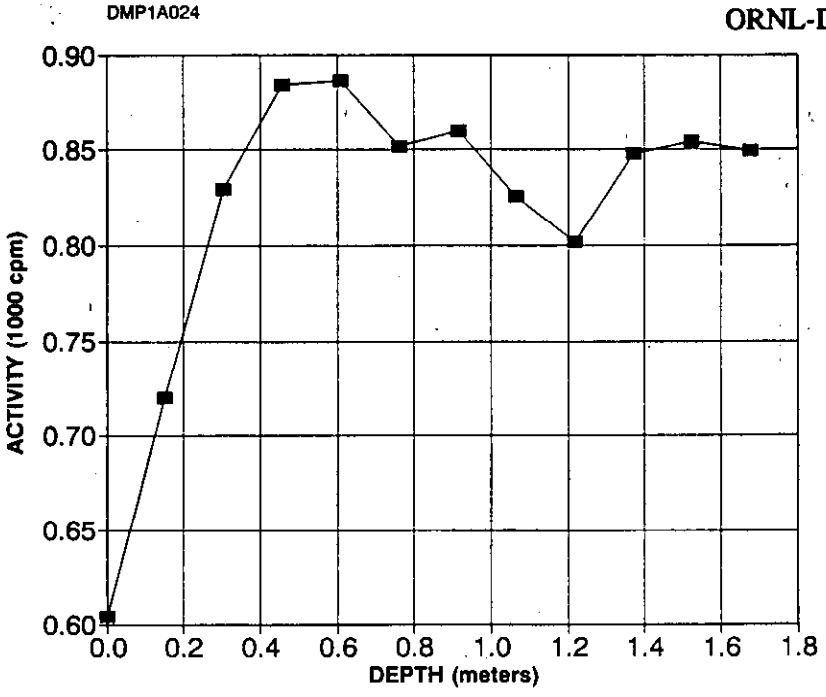
Fig. A.22. Gamma profile of auger hole A24.

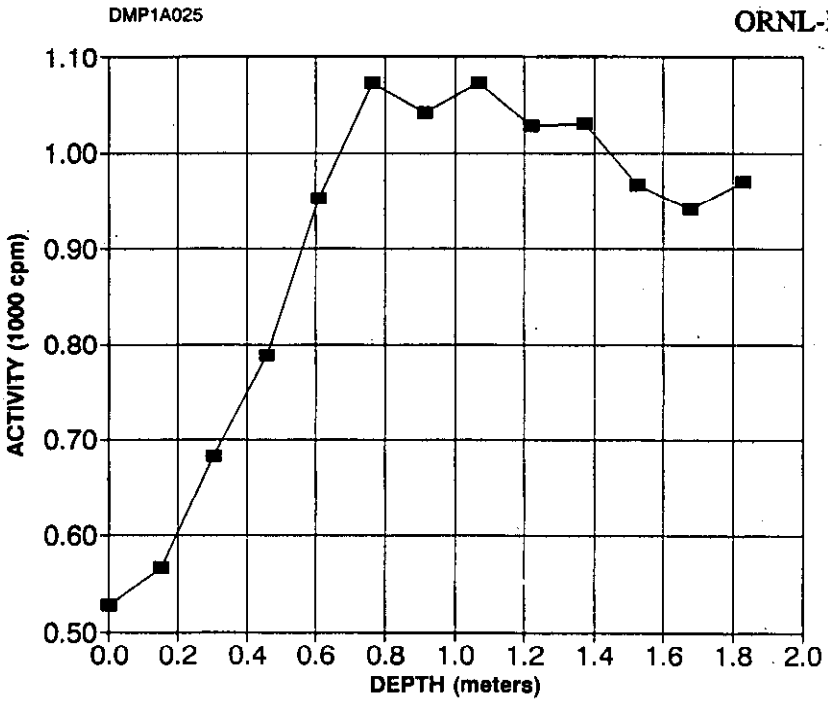
Fig. A.23. Gamma profile of auger hole A25.

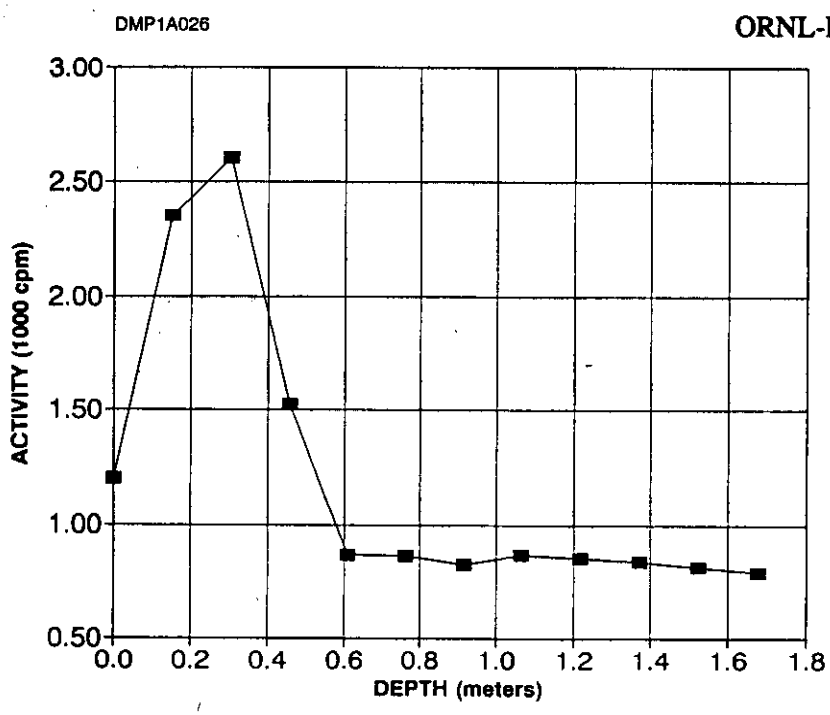
Fig. A.24. Gamma profile of auger hole A26.

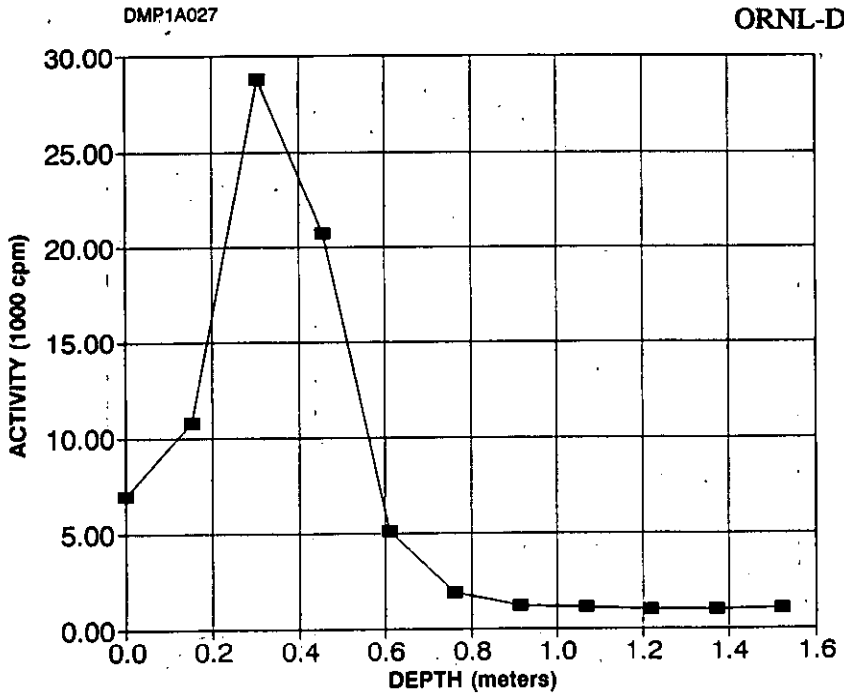
Fig. A.25. Gamma profile of auger hole A27.

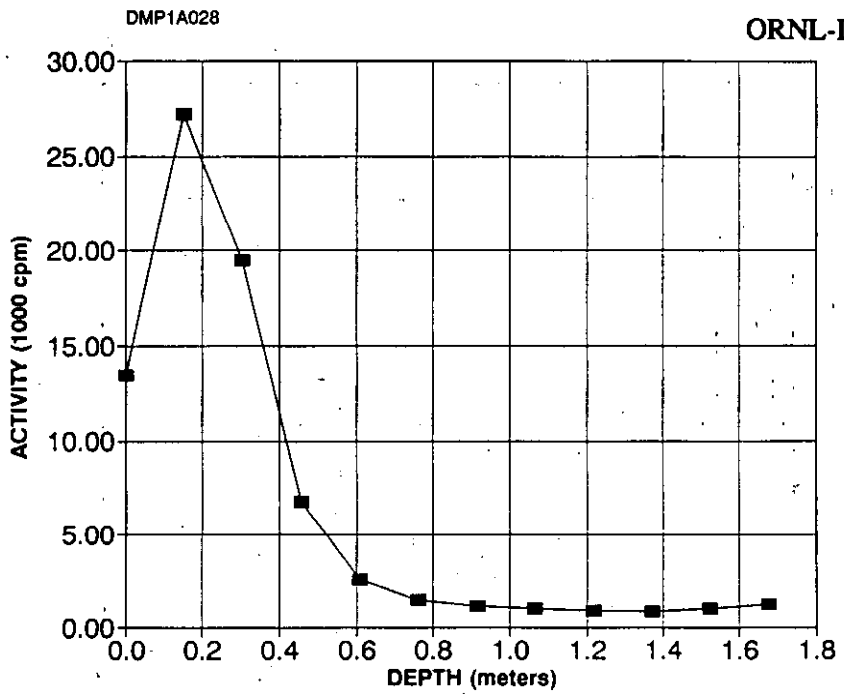
Fig. A.26. Gamma profile of auger hole A28.

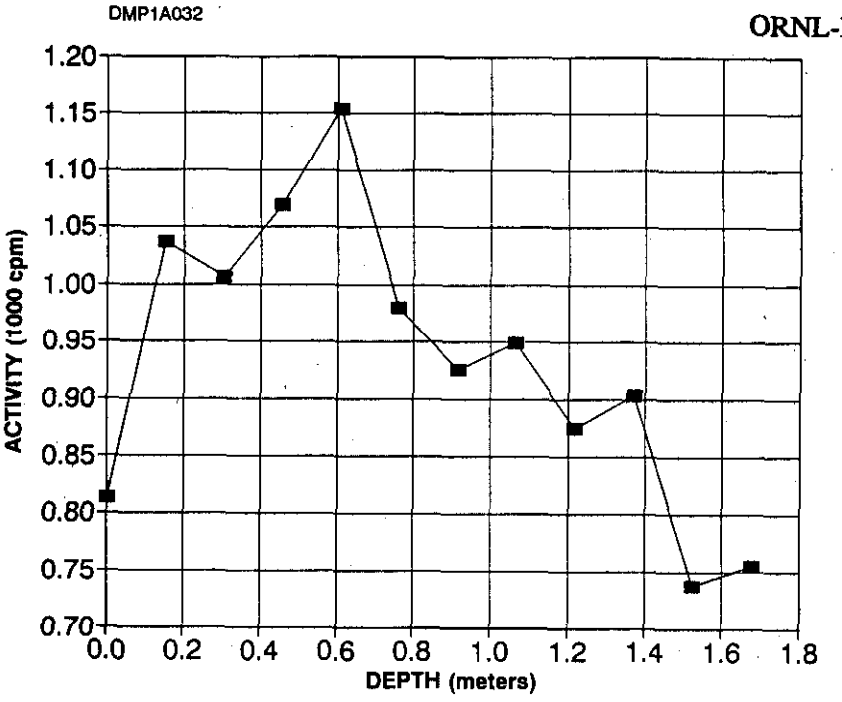
Fig. A.27. Gamma profile of auger hole A32.

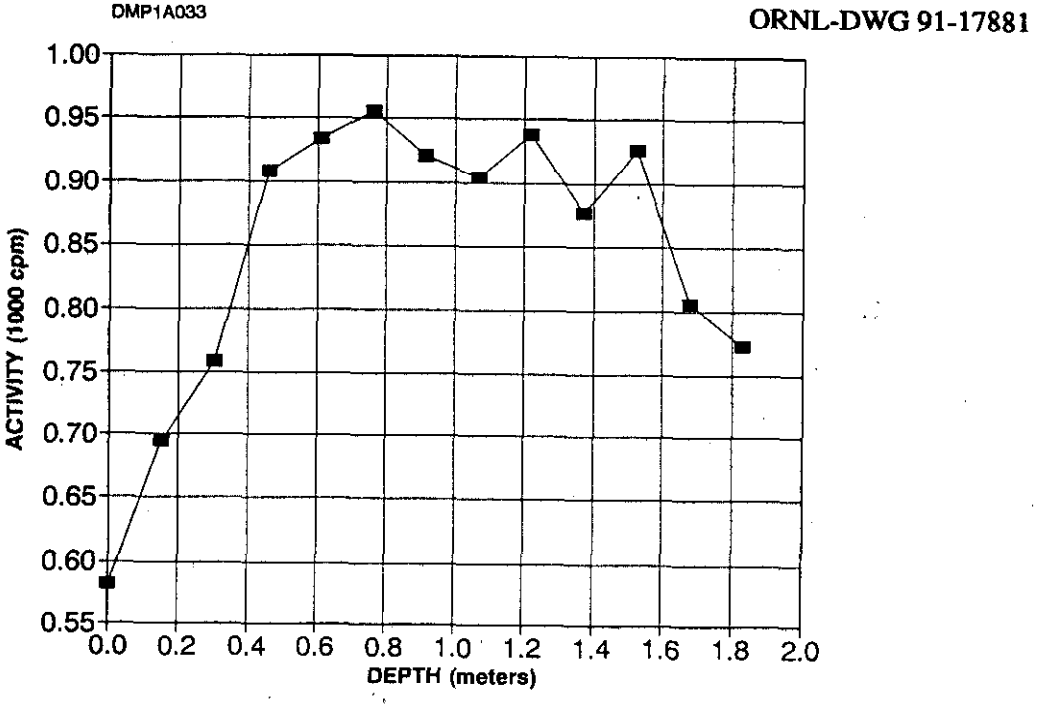
Fig. A.28. Gamma profile of auger hole A33.

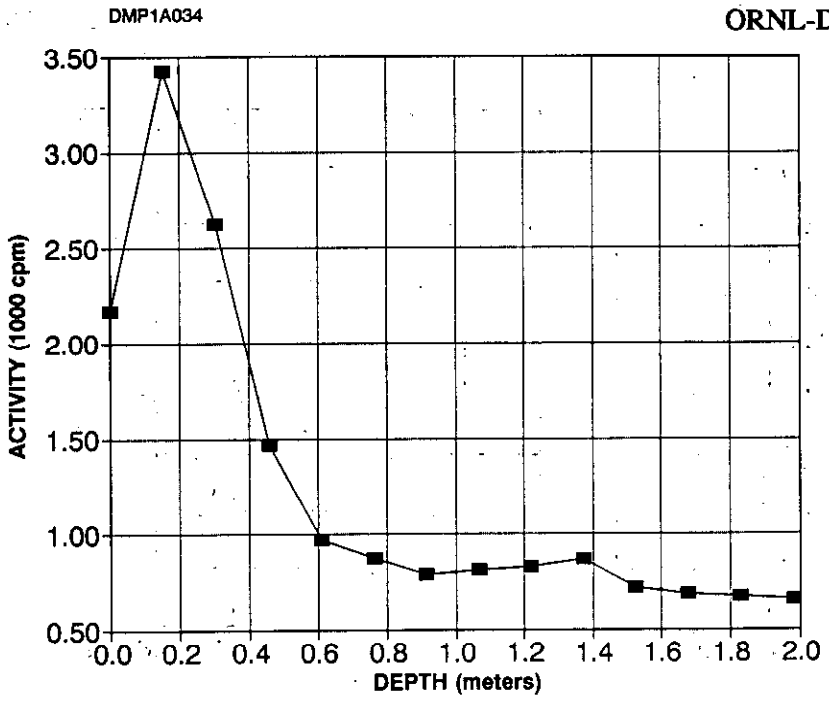
Fig. A.29. Gamma profile of auger hole A34.

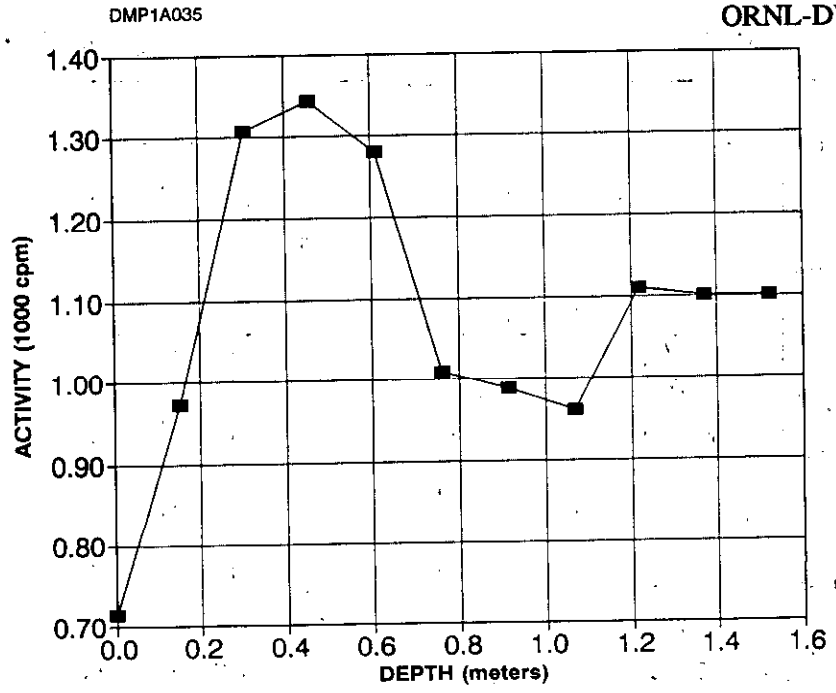
Fig. A.30. Gamma profile of auger hole A35.

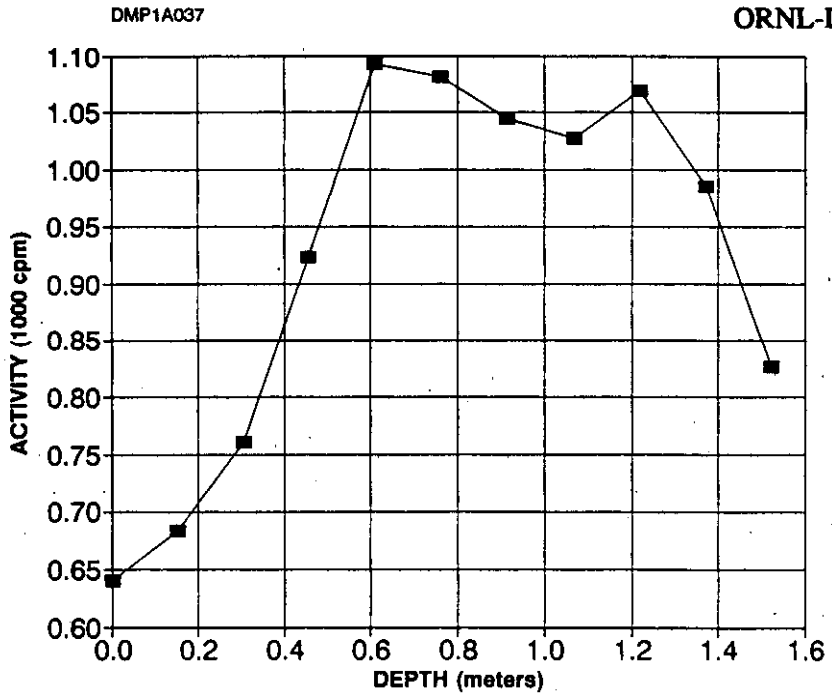
Fig. A.31. Gamma profile of auger hole A37.

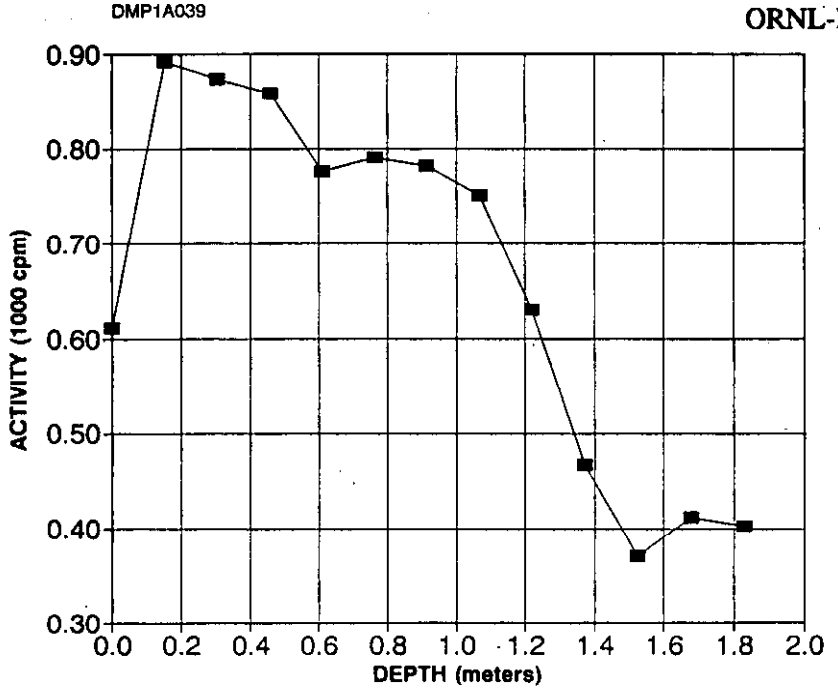
Fig. A.32. Gamma profile of auger hole A39.

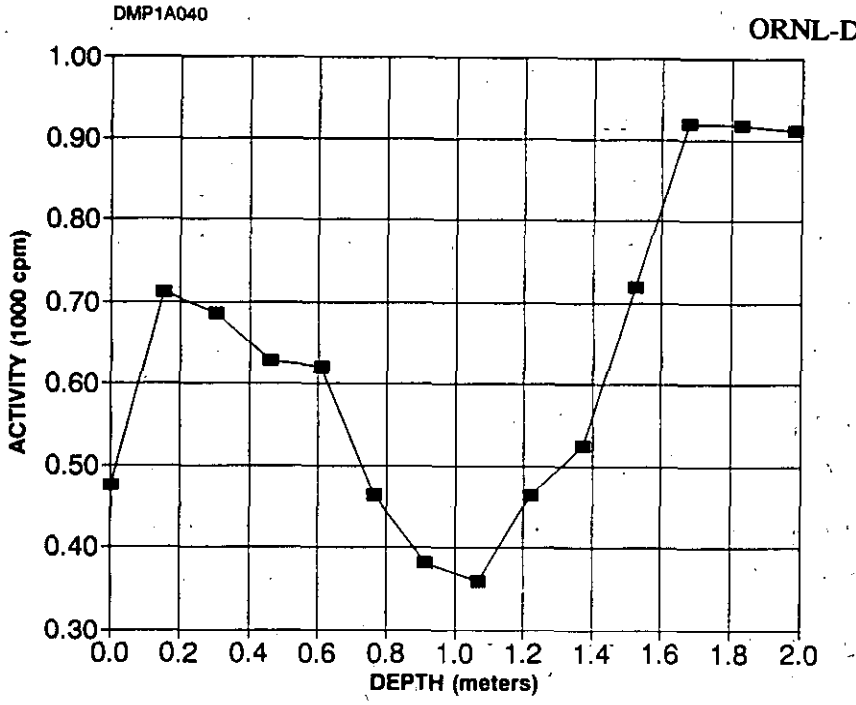
Fig. A.33. Gamma profile of auger hole A40.

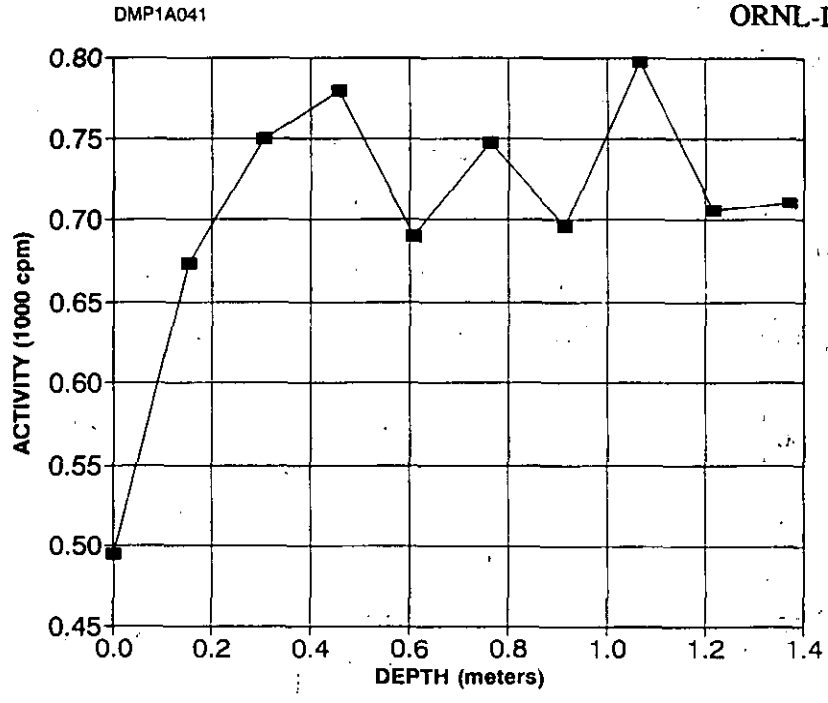
Fig. A.34. Gamma profile of auger hole A41.

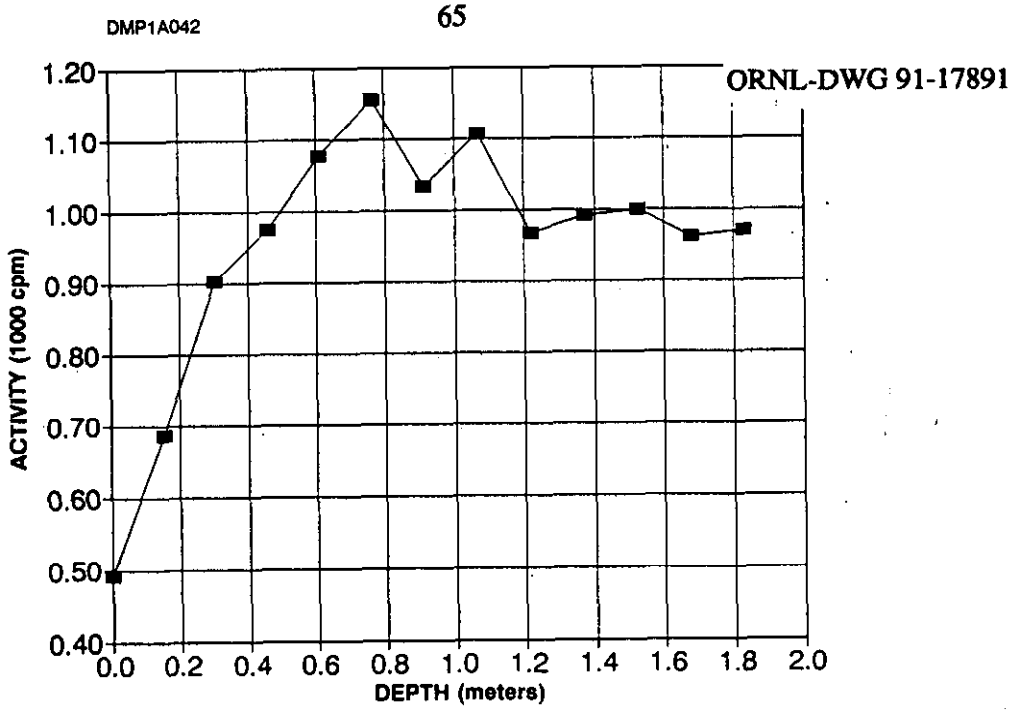
Fig. A.35. Gamma profile of auger hole A42.

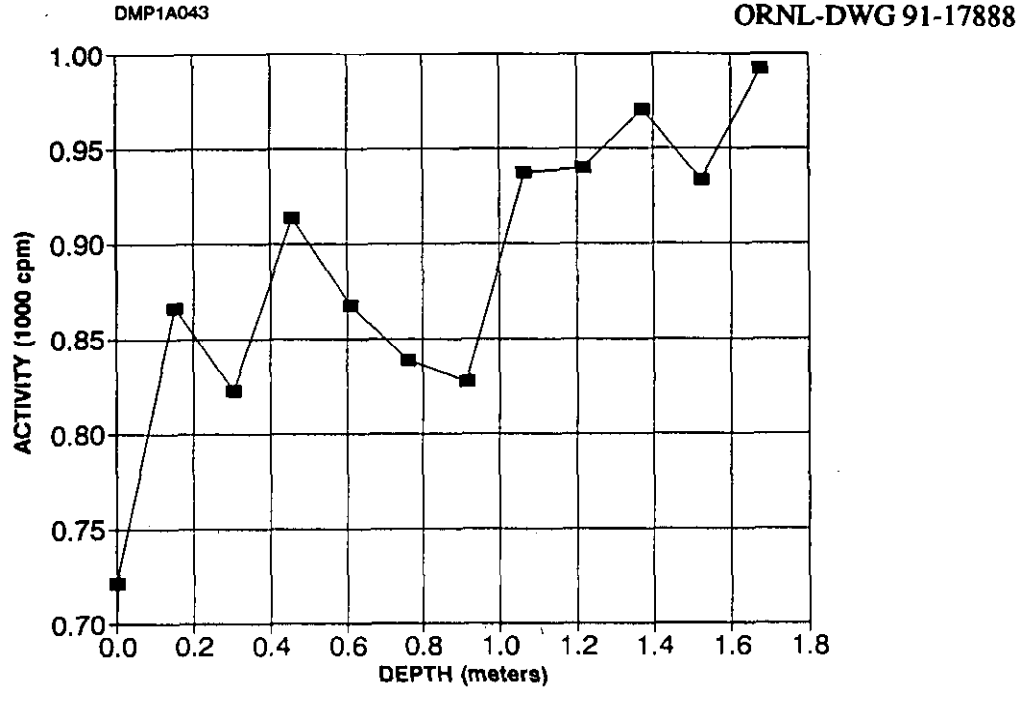
Fig. A.36. Gamma profile of auger hole A43.
