SUBJECT: Authorization for Remedial Action at B&T Metals in Columbus, Ohio

DESIGNATION SUMMARY
FOR THE B&T METALS COMPANY
COLUMBUS, OHIO

Results of the Preliminary Radiological Survey at B&T Metals, 425 West Town Street, Columbus, Ohio (CO001)

RESULTS OF THE PRELIMINARY RADIOLOGICAL SURVEY AT B&T METALS, 425 WEST TOWN STREET, COLUMBUS, OHIO (CO001)

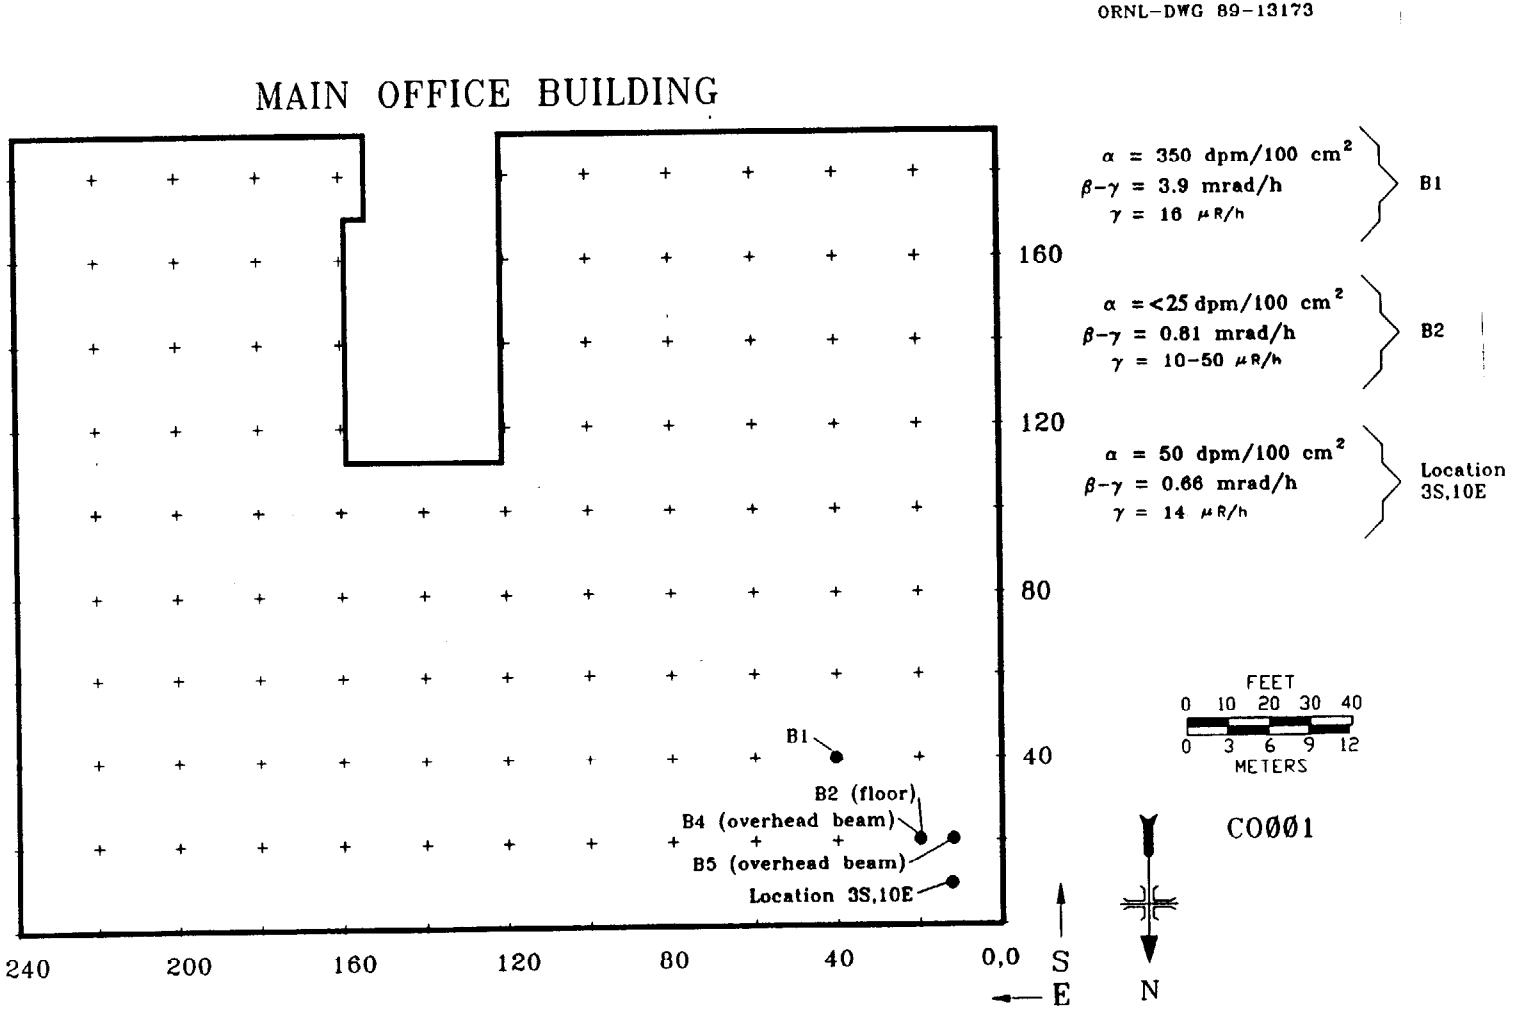
Three areas in the northwest corner of the main office building (the site of the former MED activities) had gamma radiation measurements higher than 12 μR/h (Fig. 4). A crack in the concrete floor showed a gamma level of 14 μR/h. A depression in the floor, filled with a tarlike substance, measured 16 μR/h gamma, and a sump approximately 0.3 × 0.9 m (1 × 3 ft) had gamma levels of 10-50 μR/h. A sample of material from this sump was collected and analyzed for radionuclide content (Table 3, sample B2).

1. three floor locations in the main office building (Fig. 4, locations 3S, 10E; 20S, 20E; and 40S, 40E) (see also Table 4);
2. the drain system beneath the floor of the main office building;
3. the support beams in the main office building (Table 4), where the source of the residual radioactive material appears to be dust from the former uranium extrusion process; and
4. one area outdoors (east of the storage building) where shavings from the former MED operations were reportedly dumped (Fig. 8, locations B9 and B10).

Fig. 4. Grid system, sampling locations, and results of direct radiation measurements at the floor surface inside the main office building at B&T Metals, 425 West Town Street, Columbus, Ohio (CO001).

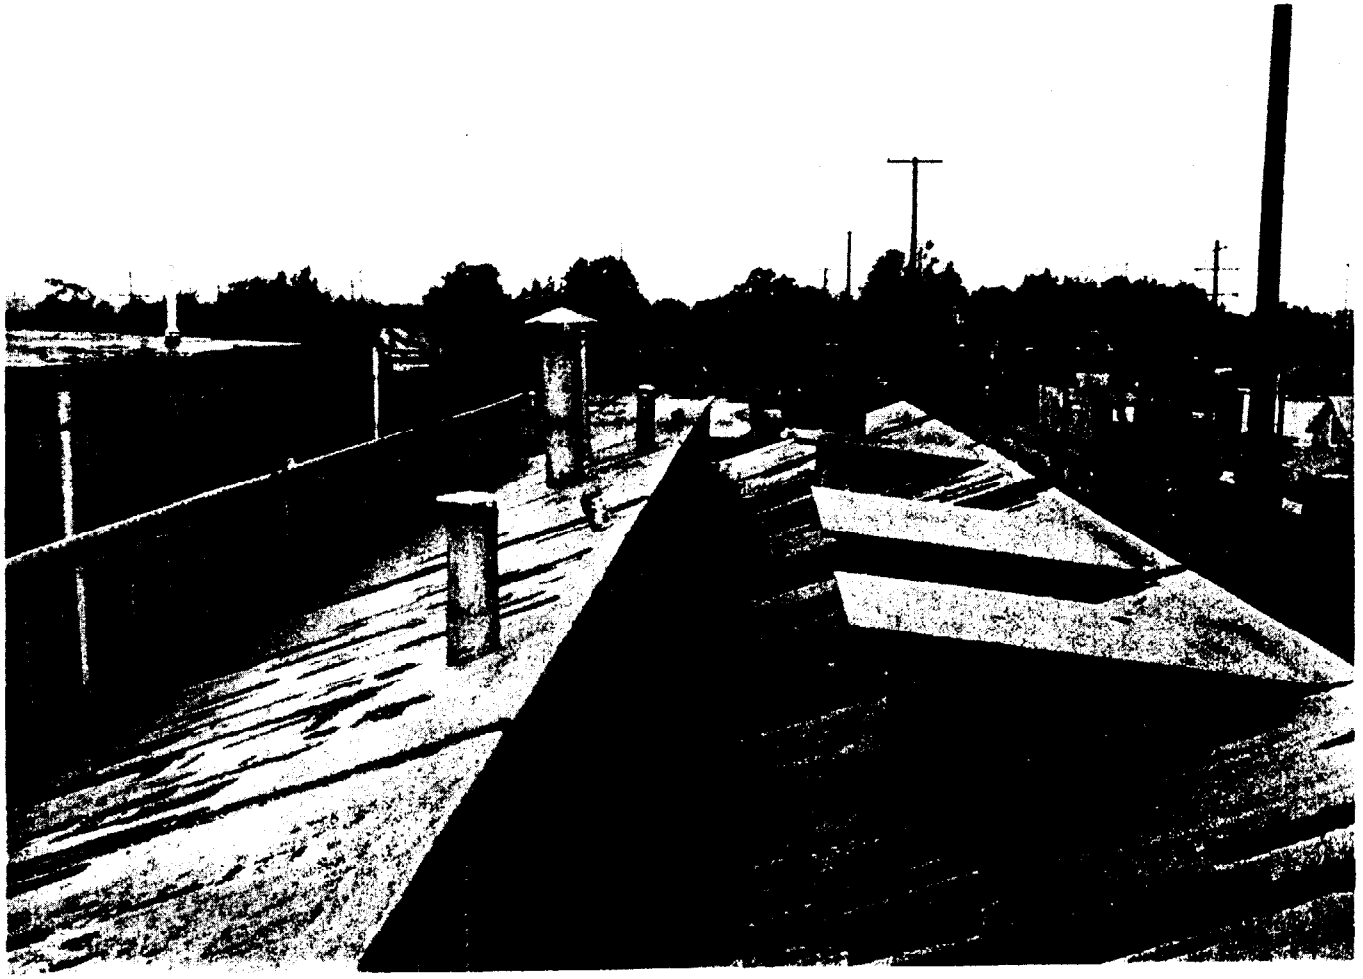
ORNL-PHOTO 3217-89

Thirty-three measurements of direct and transferable radioactivity levels were taken on the roof of the main office building. On the inclined portion of the sawtooth roof (Fig. 6), 29 measurements were taken, and 4 measurements were taken on the level roof of the first-floor annex. Measurements are shown in Table 5. Locations are shown in Fig. 7 (referenced to Fig. 4). All direct alpha measurements are well below DOE guidelines for fixed uranium concentration (Table 1). One direct beta-gamma measurement (location 20S, 2E) was 0.20 mrad/h. Other direct beta-gamma measurements were well below the guideline for surface dose rate averaged over an area ≤ 1 m^2.

Fig. 6. Sawtooth roof over the area where the MED processing took place, looking west, B&T Metals, Columbus Ohio (CO001).

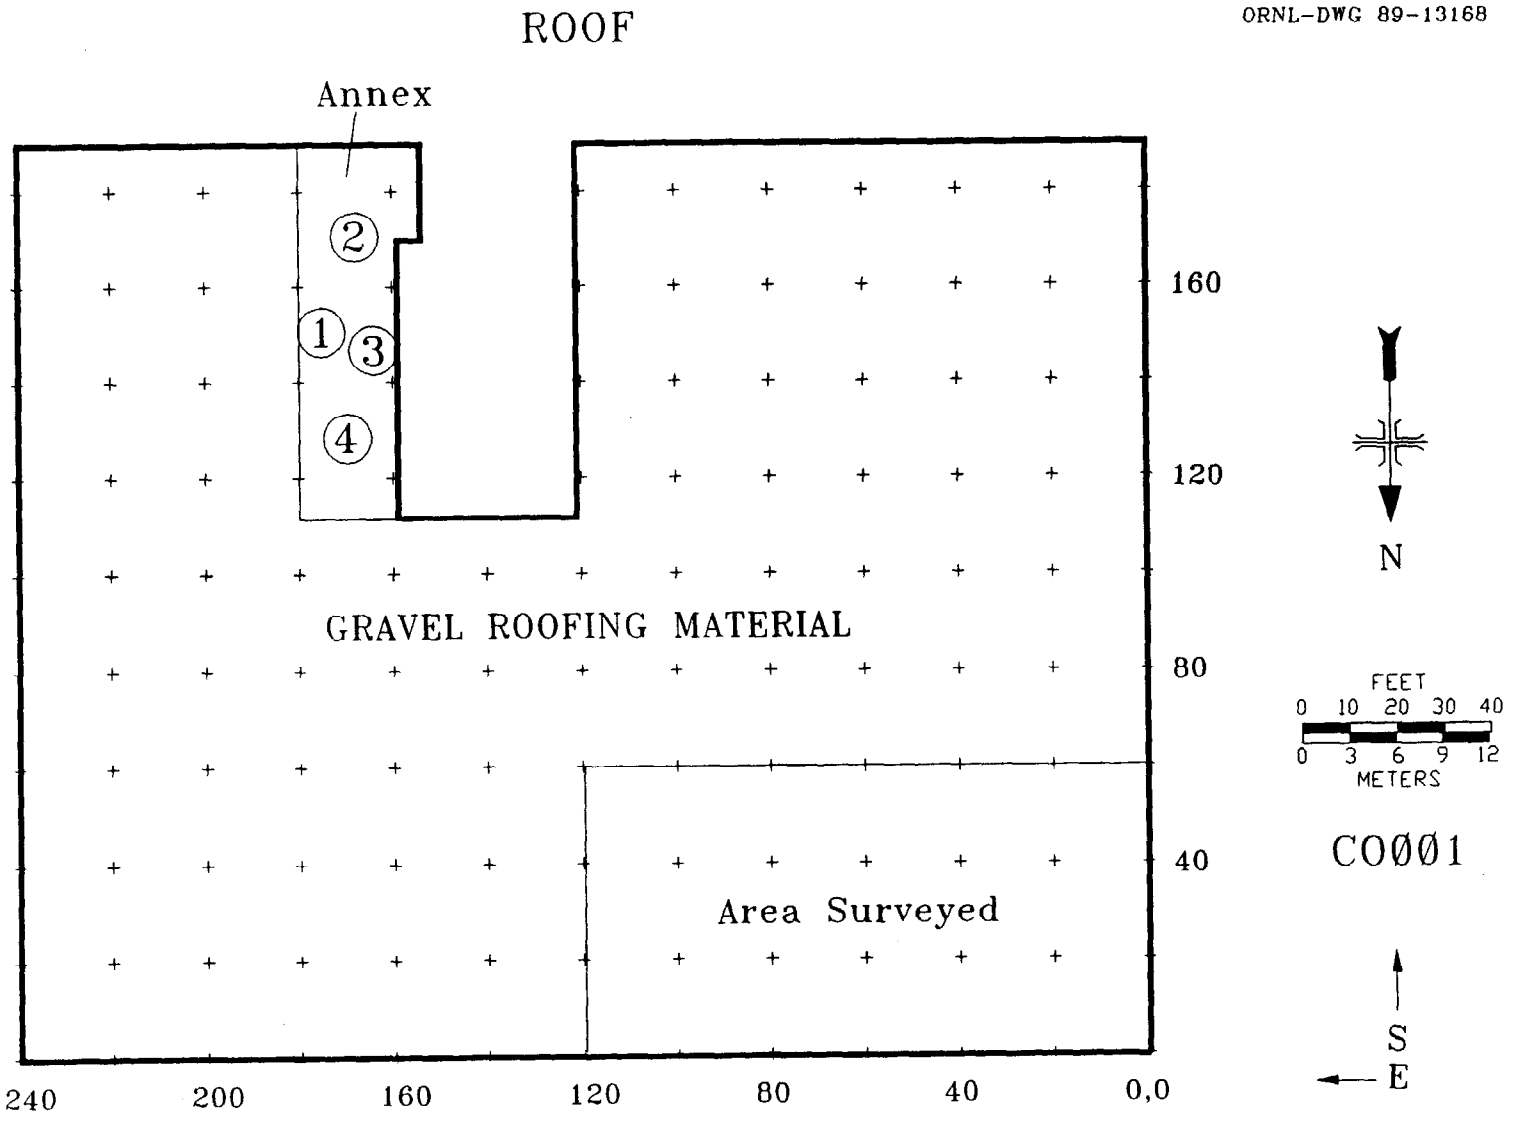
Smear samples were obtained from the roof locations at which direct measurements were taken. Analyses of the smears showed all measurements of transferable alpha and beta-gamma radiation well below DOE guidelines for removable uranium (Table 1).

Fig. 7. Grid system, showing location of roof measurements taken at the main office building, B&T Metals, Columbus, Ohio (CO001).

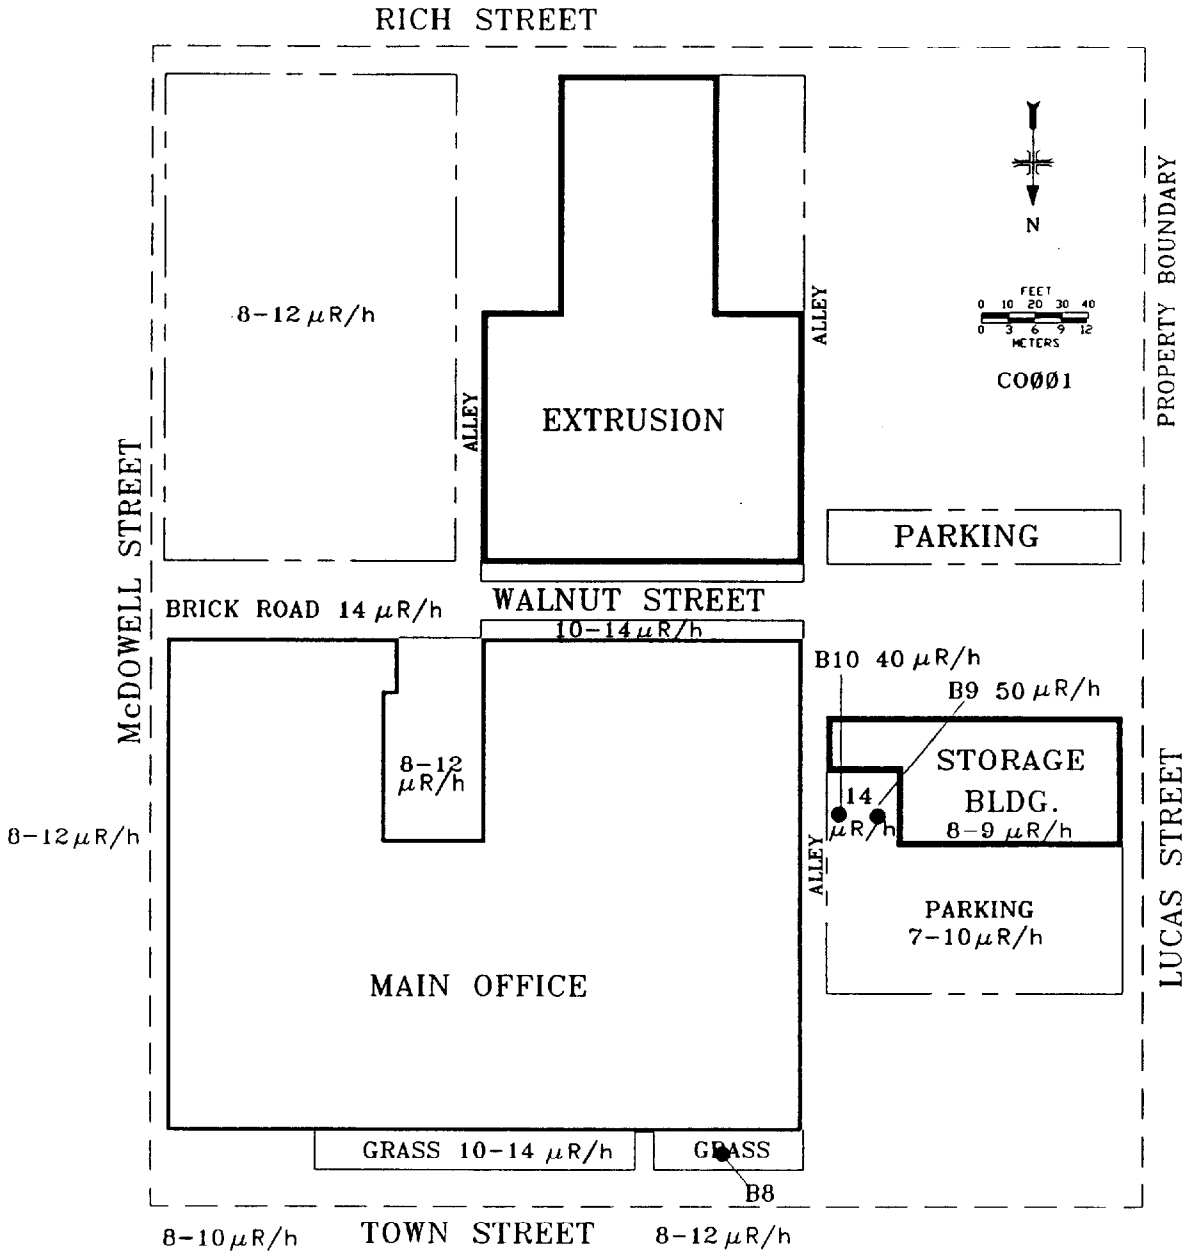
ORNL-DWG 89-13159

Gamma exposure rates measured during a scan of the surface of the property outdoors are shown in Fig. 8. Over the major portion of the property, gamma radiation levels ranged from 7 to 12 μR/h, with measurements of 14 μR/h noted at the brick road behind the main office building, in the grassy area at the front of the building, and in the area west of the building, near the storage building. In the area west of the main office building, where shavings from the MED activities reportedly were dumped, surface gamma exposure rates were 40 and 50 μR/h at sample locations B10 and B9, respectively (Fig. 8).

Biased soil samples were taken from three locations with elevated gamma readings and were analyzed for radionuclide concentrations. Locations of the biased (B) samples are shown on Fig. 8. Results of laboratory analyses for ^{226}Ra, ^{232}Th, and ^{238}U are shown in Table 6. Concentrations of ^{226}Ra and ^{232}Th ranged from 1.4 to 2.1 pCi/g and 0.63 to 1.3 pCi/g, respectively. These values are at or near background soil concentrations for the Columbus, Ohio, area (Table 2) and are well within the DOE guidelines shown in Table 1. Concentration of ^{238}U ranged from 3.5 to 110 pCi/g, with the higher concentrations (67 to 110 pCi/g) found in the two samples (B9 and B10) taken from the area where contaminated shavings were reportedly dumped. These values are higher than typical site-specific uranium guidelines for soil, derived for similar DOE FUSRAP sites.

Fig. 8. Gamma radiation levels (μR/h) at the surface and soil sample locations at B&T Metals, 425 West Town Street, Columbus, Ohio (CO001).
