2020 Annual Inspection and Monitoring Report for the Grand Junction, Colorado, Site

June 2020

U.S. DEPARTMENT OF ENERGY | Legacy Management

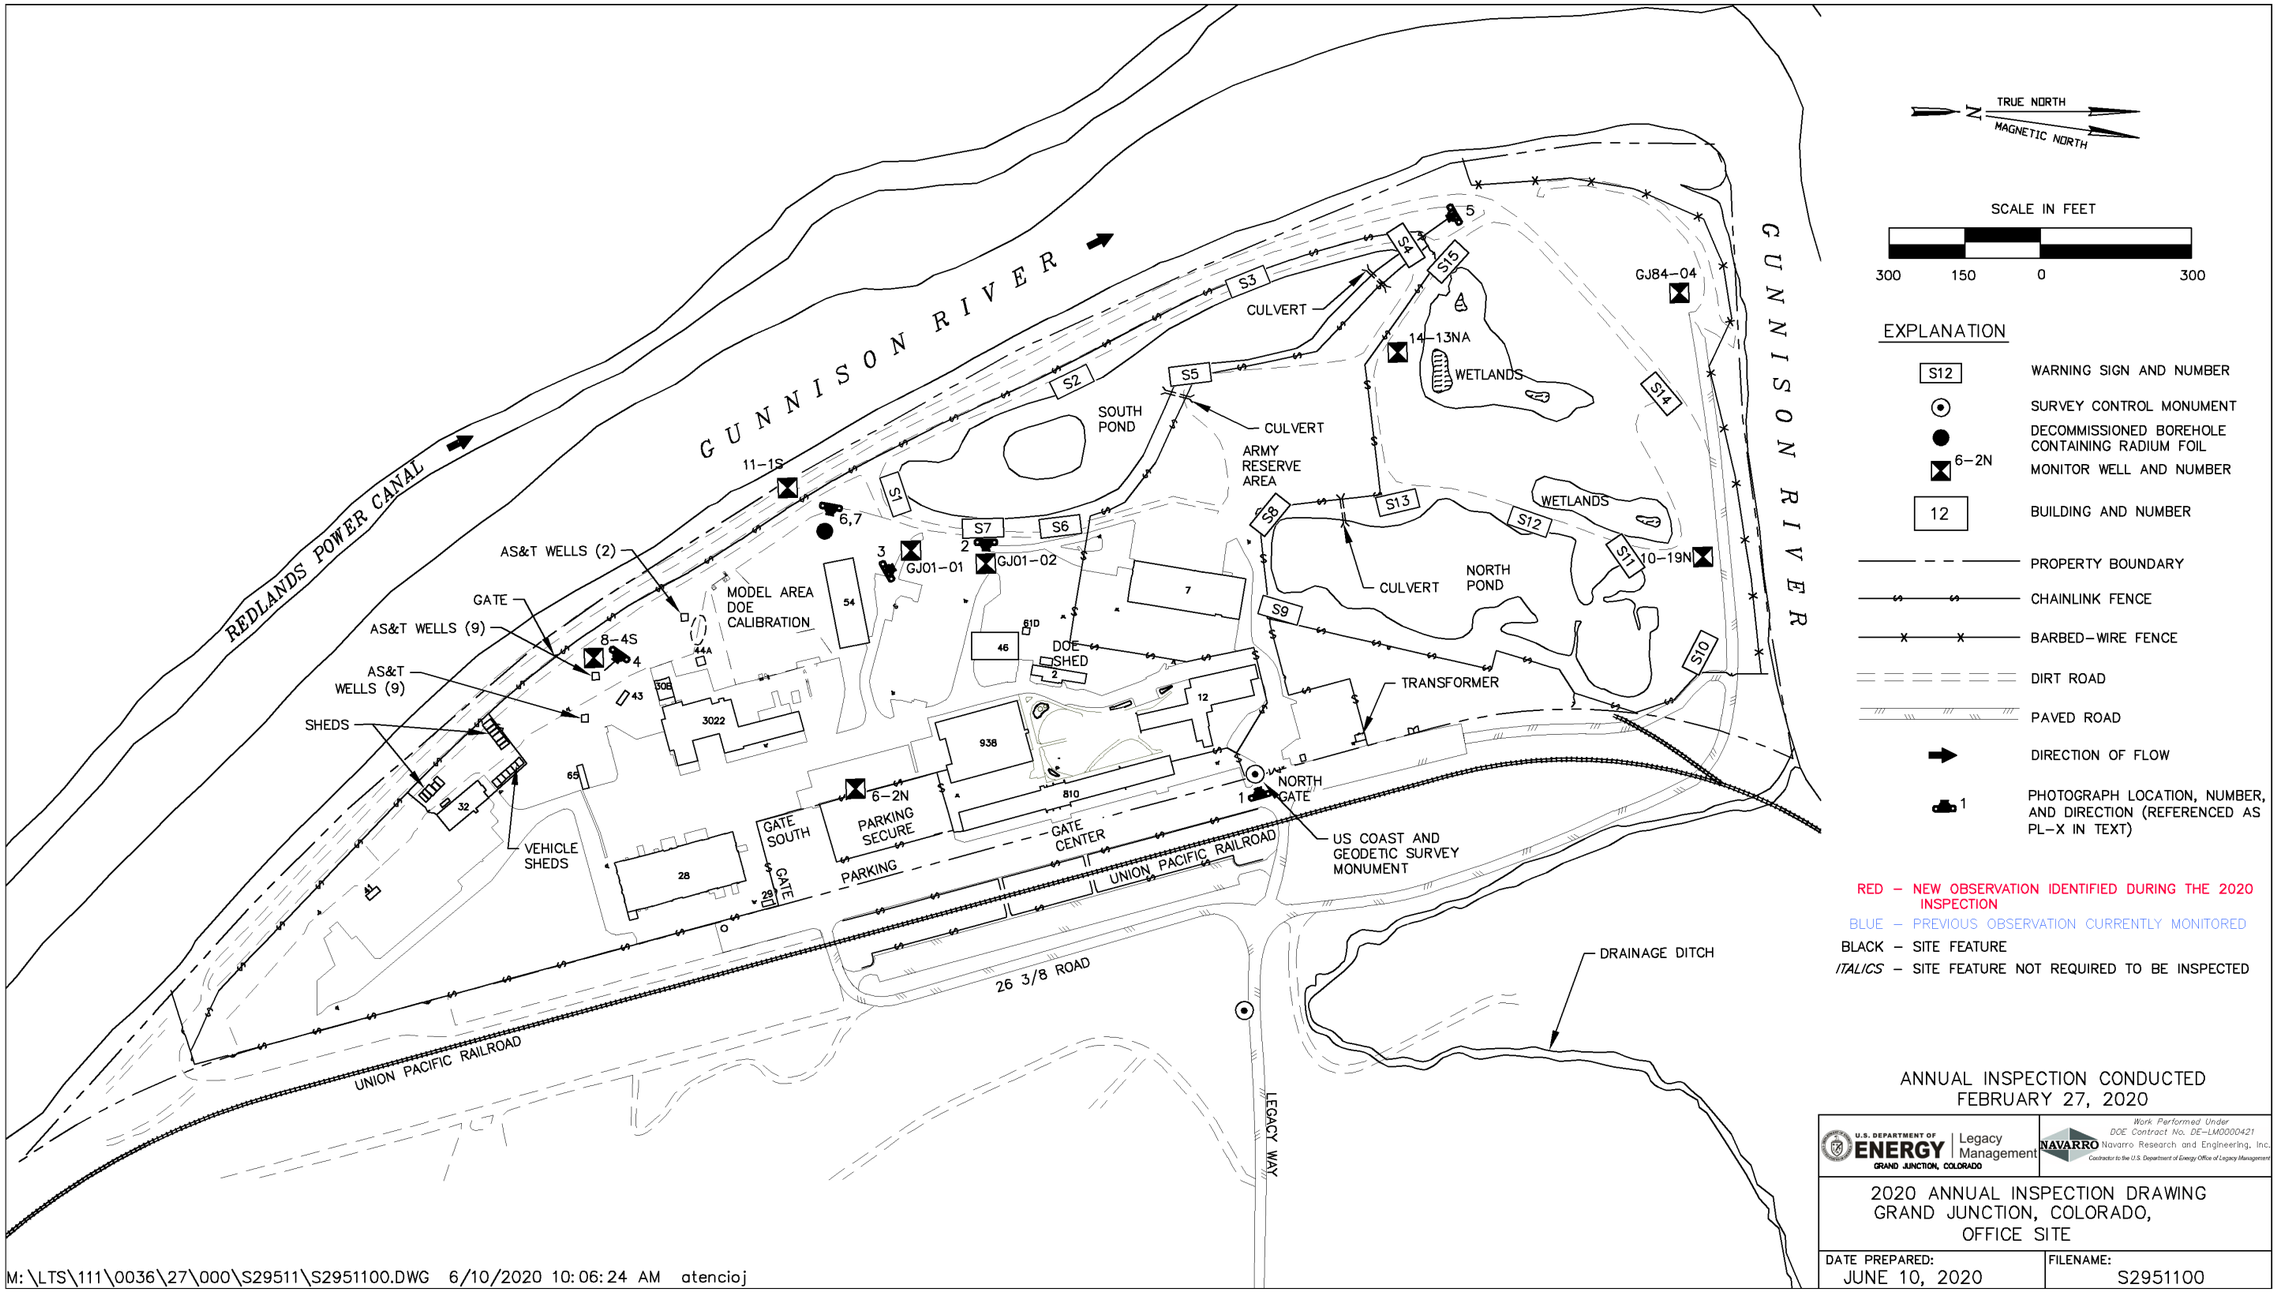
Figure 1. 2020 Annual Inspection Drawing for the Grand Junction, Colorado, Site

Figure 1 shows the locations of site surveillance features. Inspection results and recommended maintenance activities associated with site surveillance features are included in the following subsections.
