LMS/GNO/S31892

2020 Groundwater Monitoring and Inspection Report Gnome-Coach, New Mexico, Site

March 2021

U.S. DEPARTMENT OF ENERGY | Legacy Management

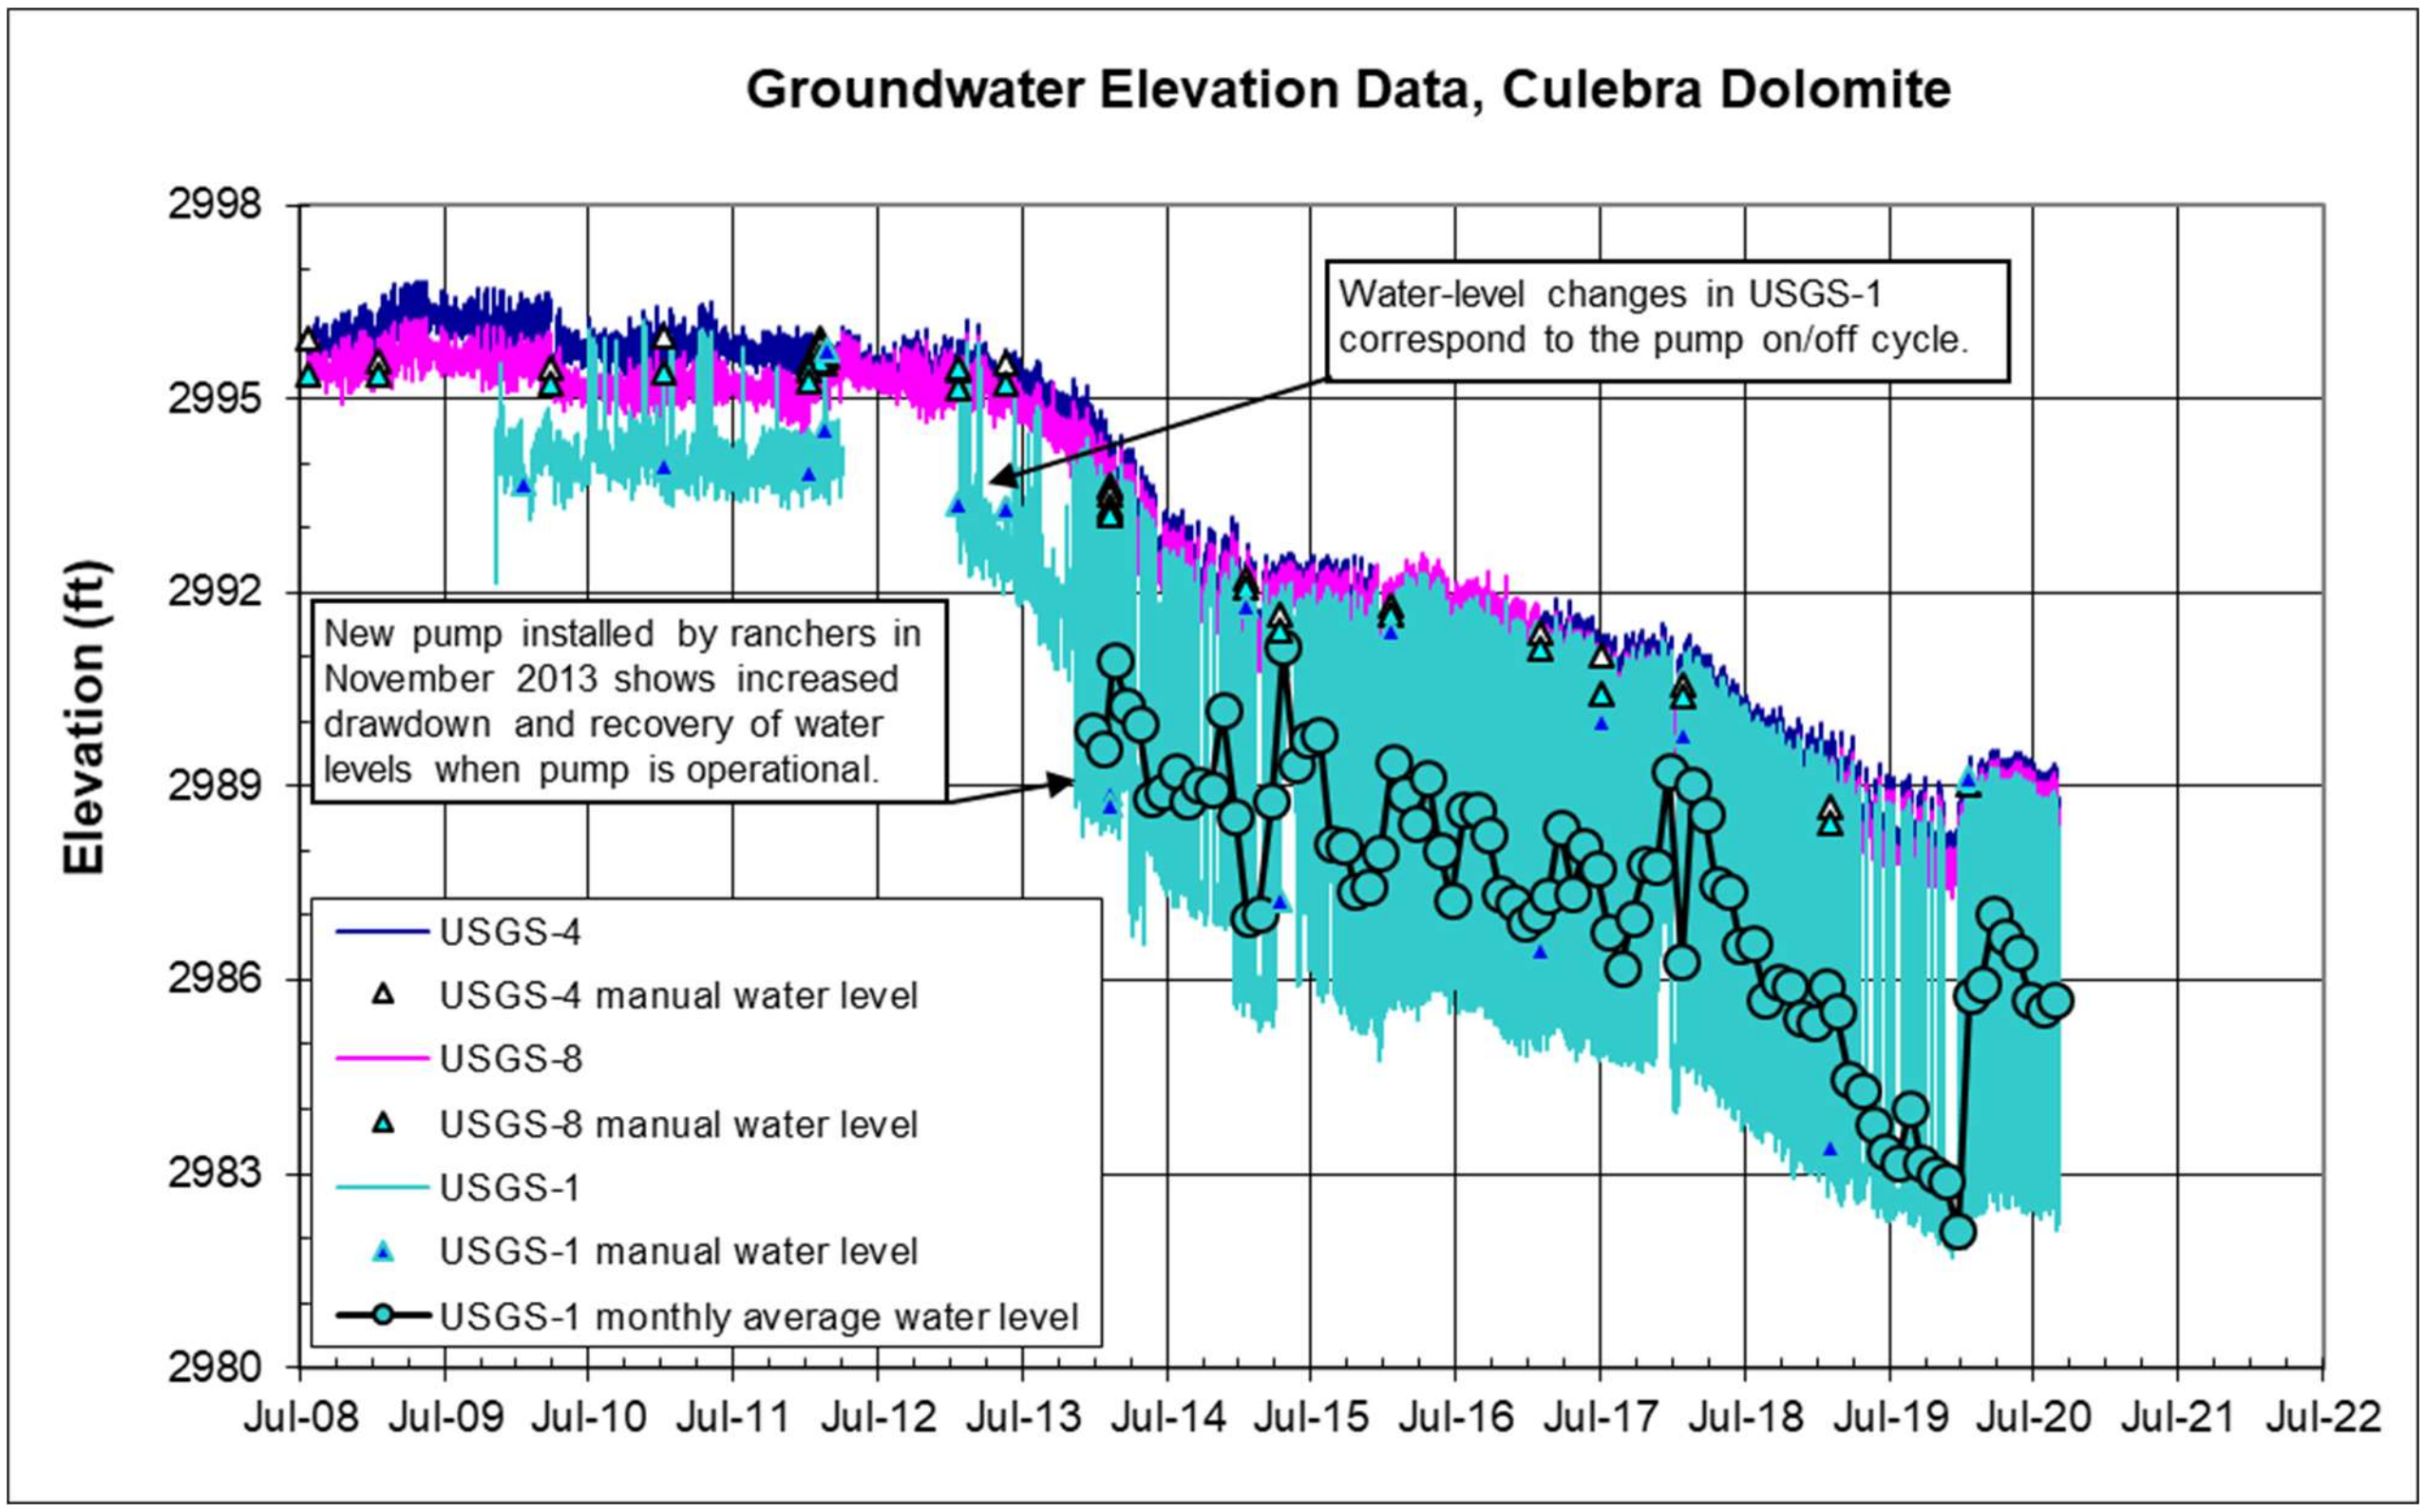
Figure 5. Hydrograph Showing Groundwater Elevations in Culebra Wells

Groundwater elevation data were evaluated with the historical data to assess changes in the groundwater flow system. The hydrographs for wells USGS-1, USGS-4, and USGS-8 (completed in the Culebra Dolomite) are shown in Figure 5. The pump in well USGS-1 cycles on and off to maintain a constant volume in the nearby water tank that supplies water to livestock in the area. The volume of water in the tank is maintained by a float switch, which activates the pump in well USGS-1 to supply water to the tank at a rate of approximately 15 gallons per minute. When the pump cycles on, water levels in USGS-1 drop by approximately 5 ft (Figure 6). The totalizing flow meter installed at this well has been difficult to maintain because the relatively high salt content (total dissolved solids) causes buildup on flow meter parts over time. For this reason, the flow meter is replaced annually during the site inspections. The flow meter was not working at the time of the inspection, and it indicated that only 3000 gallons of water was removed from October 2019 (end of last year's reporting period) through January 28, 2020. A new flow meter was installed during the January inspection and at the end of the reporting period it indicated that more than 6 acre-feet of water had been removed from January 28 through September 11, 2020. Transducer data from well USGS-1 supports the determination that the flow meter failed in the first half of the reporting period, because data indicate that pumping durations were longer during the first half of the reporting period. This is evident in the average monthly groundwater elevation in well USGS-1, which shows that it increased from the lows in December 2019 (Figure 6). Figure 6 is the hydrograph showing groundwater elevations for the Culebra wells during this reporting period.

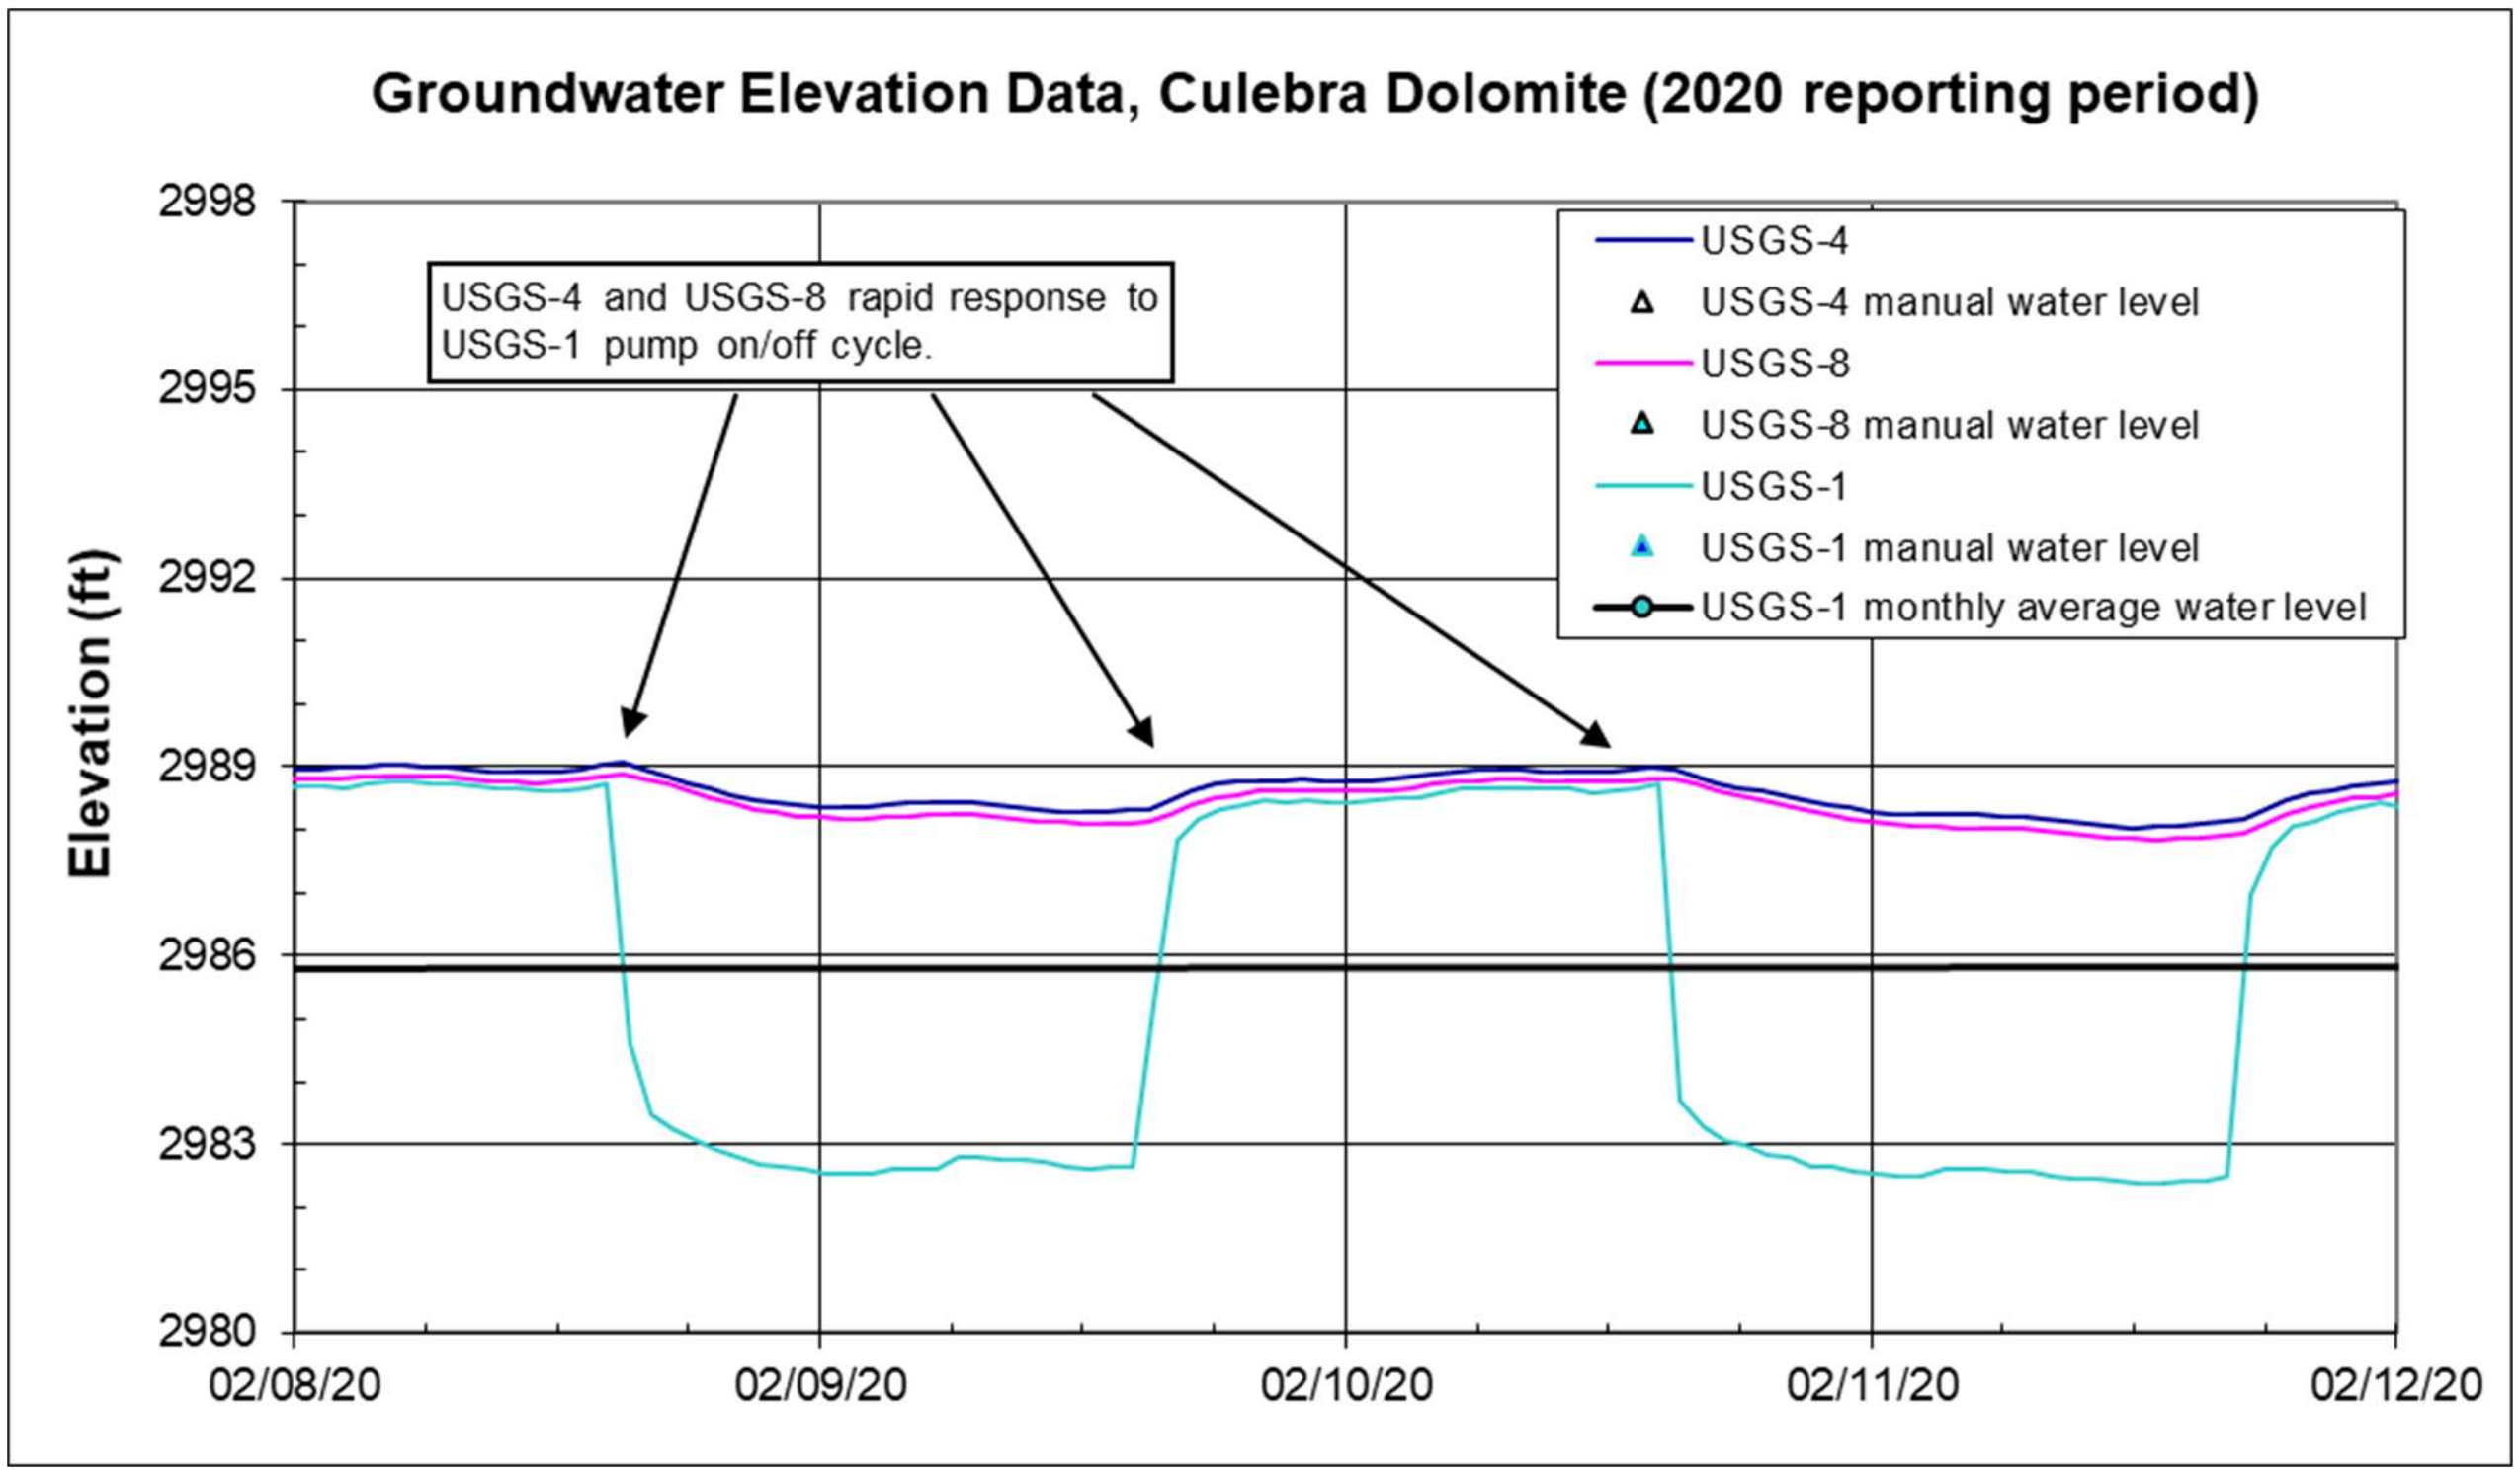
Figure 7. Hydrograph Showing Groundwater Elevation Response in USGS-4 and USGS-8 to Pumping USGS-1

Groundwater elevation data from the Culebra wells continue to support a regional groundwater flow direction that is generally toward the south but is locally influenced by the pumping in well USGS-1. These data also continue to show that pumping in well USGS-1 produces an almost immediate water-level drawdown response in wells USGS-4 and USGS-8 which are about 2350 ft to the northwest (Figure 7). Groundwater elevations have been decreasing in the Culebra wells since monitoring began in 2008 (Figure 5) but have recently shown an increase that started in January 2020. Groundwater elevations increased in the Culebra wells by approximately 1 ft during this reporting period (Figure 6). This is likely the result of the reduced pumping in well USGS-1, and possibly other pumping wells in the area. Historical information on the total gallons removed from this well is limited, because of difficulties with maintaining the flow meter. Since historical data on the total gallons removed from well USGS-1 is limited, it is difficult to attribute the decreasing water levels solely to the pumping at well USGS-1.

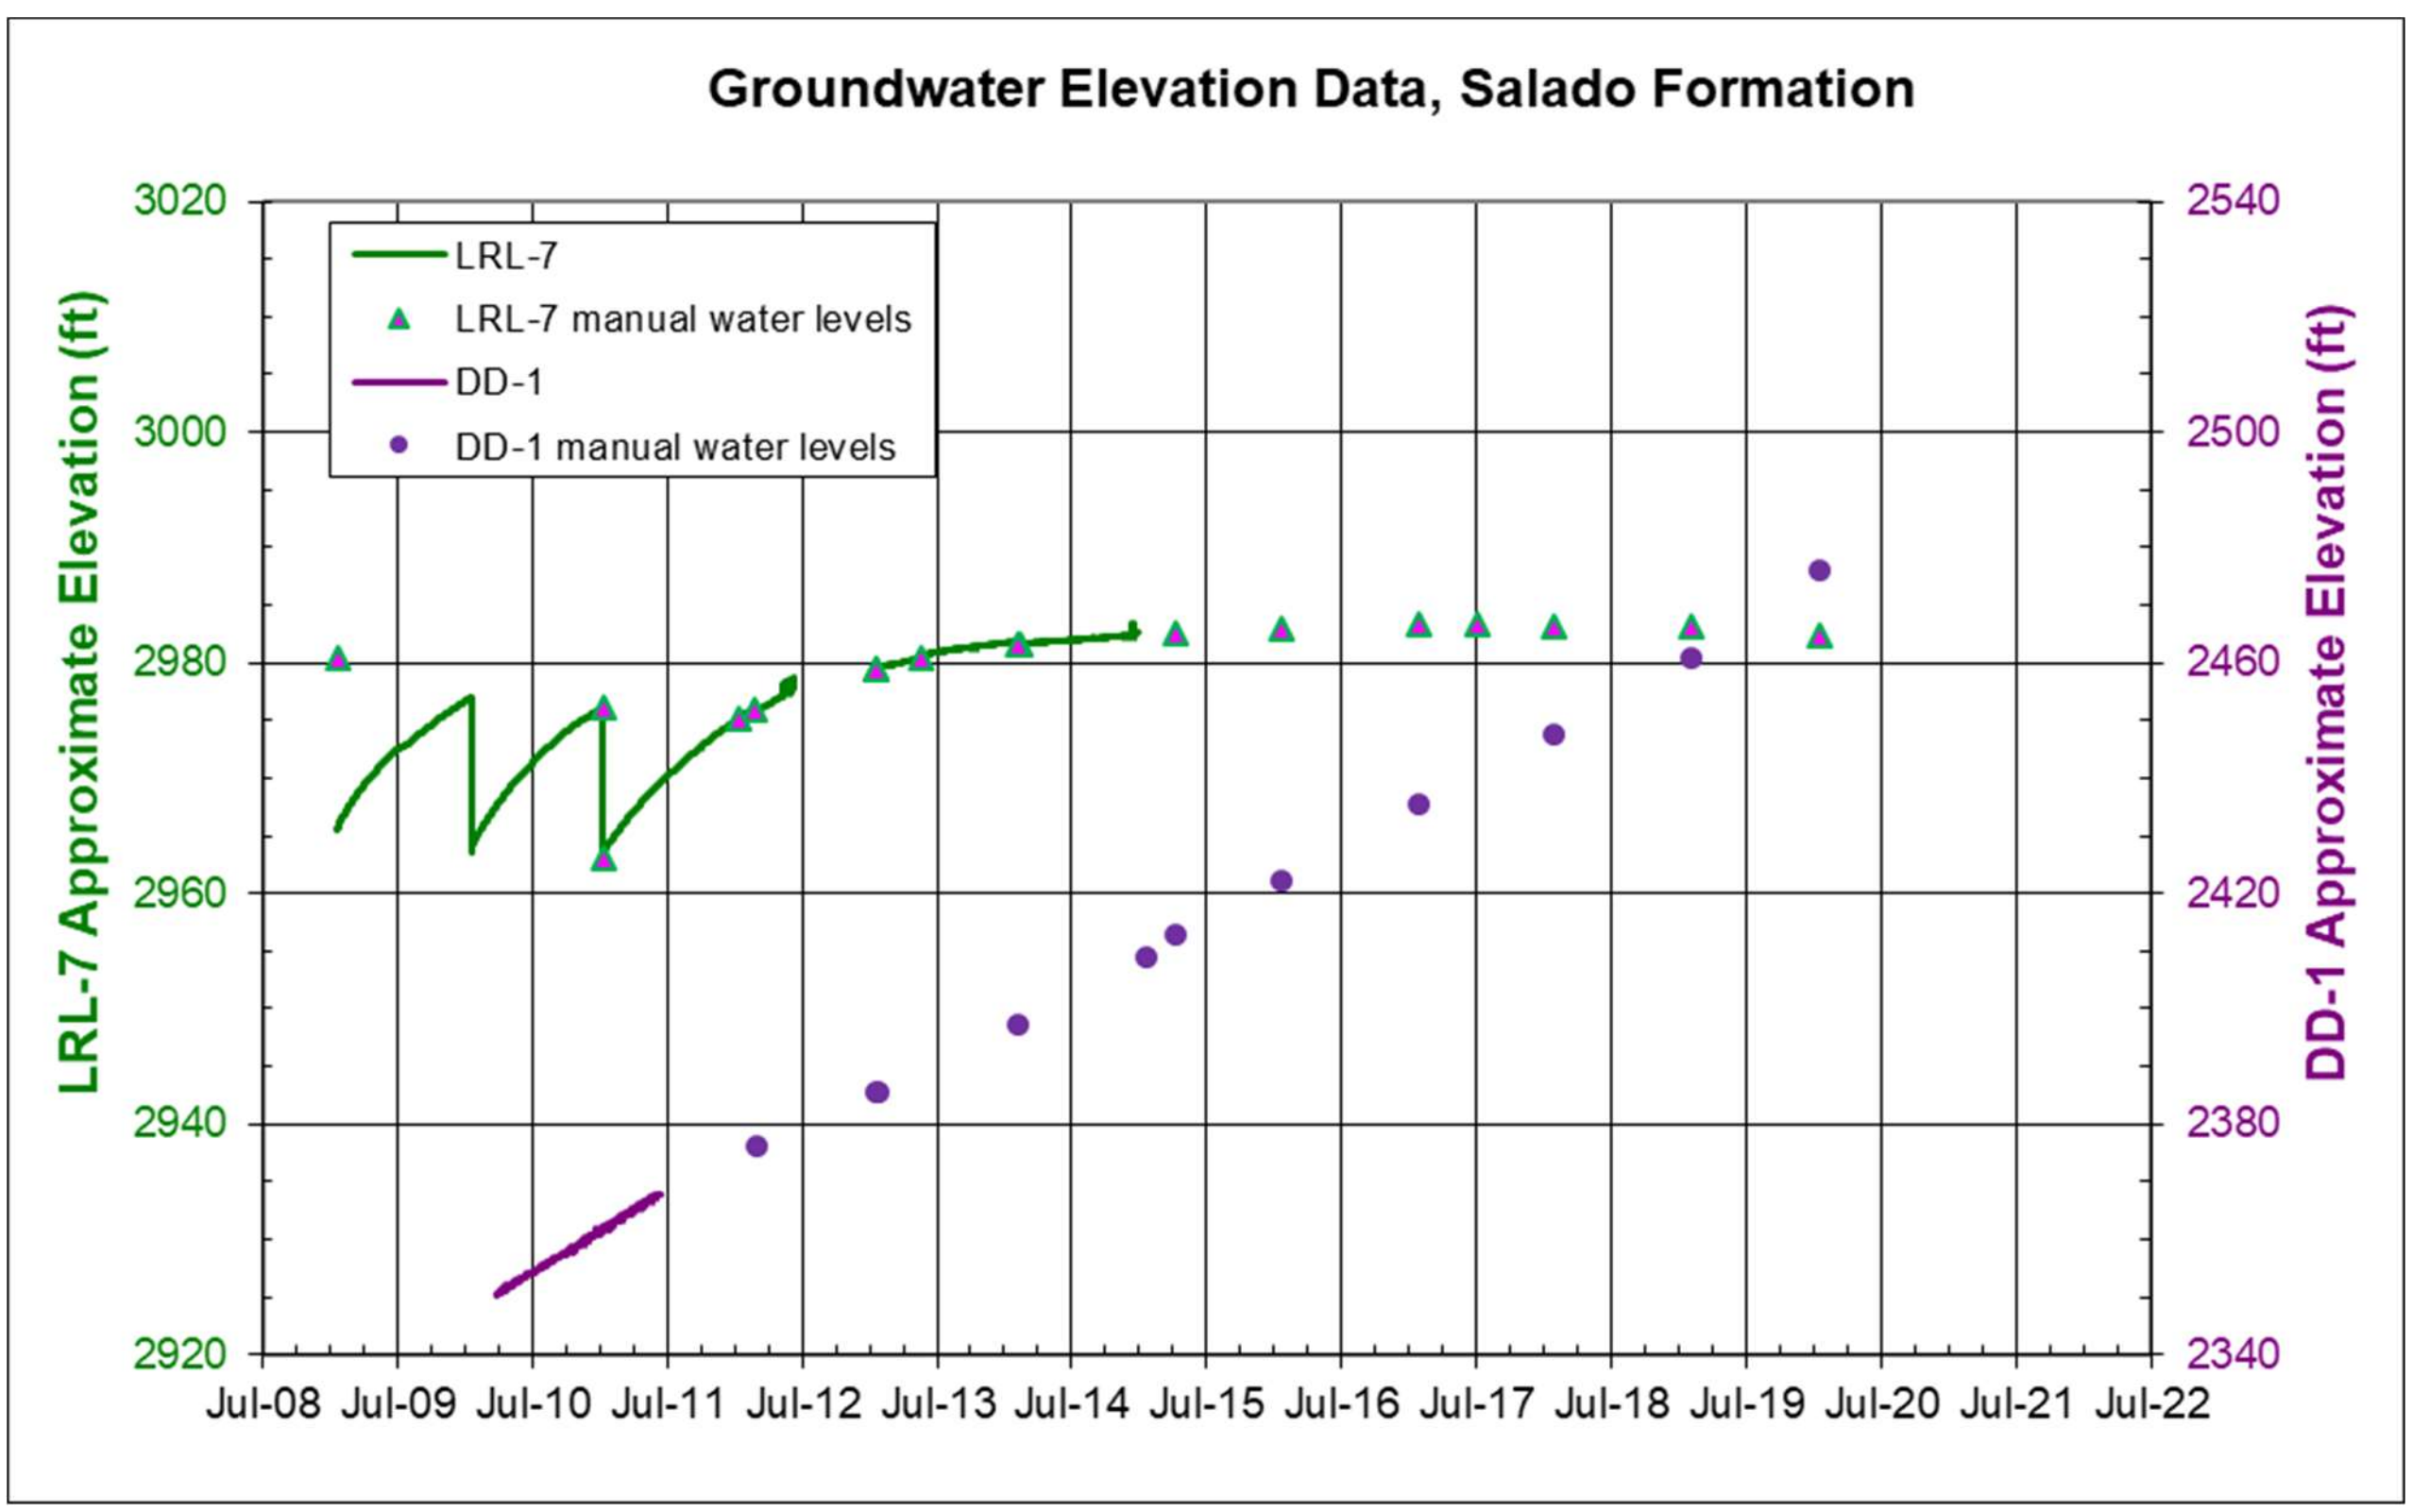
Figure 8. Hydrograph Showing Water Elevations in Reentry Wells DD-1 and LRL-7

Fluid levels in the detonation cavity are monitored by well DD-1 and in the Coach drift by well LRL-7, which are both in the Salado Formation. The hydrograph for wells DD-1 and LRL-7 are shown in Figure 8. The water elevations in these wells are likely not indicative of the Salado Formation, because of their connection to the large unnatural openings and their use for disposal of liquid waste during site cleanup activities in late 1960s and 1970s. Water elevations in well LRL-7 (primary vertical axis) indicate that water levels are no longer rising and have recovered from the last sampling event in January 2011. Water elevations in well DD-1 (secondary vertical axis) indicate that water levels continue to rise in this well at a rate of approximately 10 ft per year. Factors that influence water levels in wells LRL-7 and DD-1 include the slow refilling of the detonation cavity due to limited groundwater flow within the Salado, remnant pressure effects associated with the detonation, the plastic nature of the Salado Formation, and injections of liquefied waste material associated with past disposal activities. Water elevations from wells DD-1 and LRL-7 are approximate because borehole deviation data are not available for these wells (Figure 8).
