LMS/GNO/S31892

2020 Groundwater Monitoring and Inspection Report Gnome-Coach, New Mexico, Site

March 2021

U.S. DEPARTMENT OF ENERGY | Legacy Management

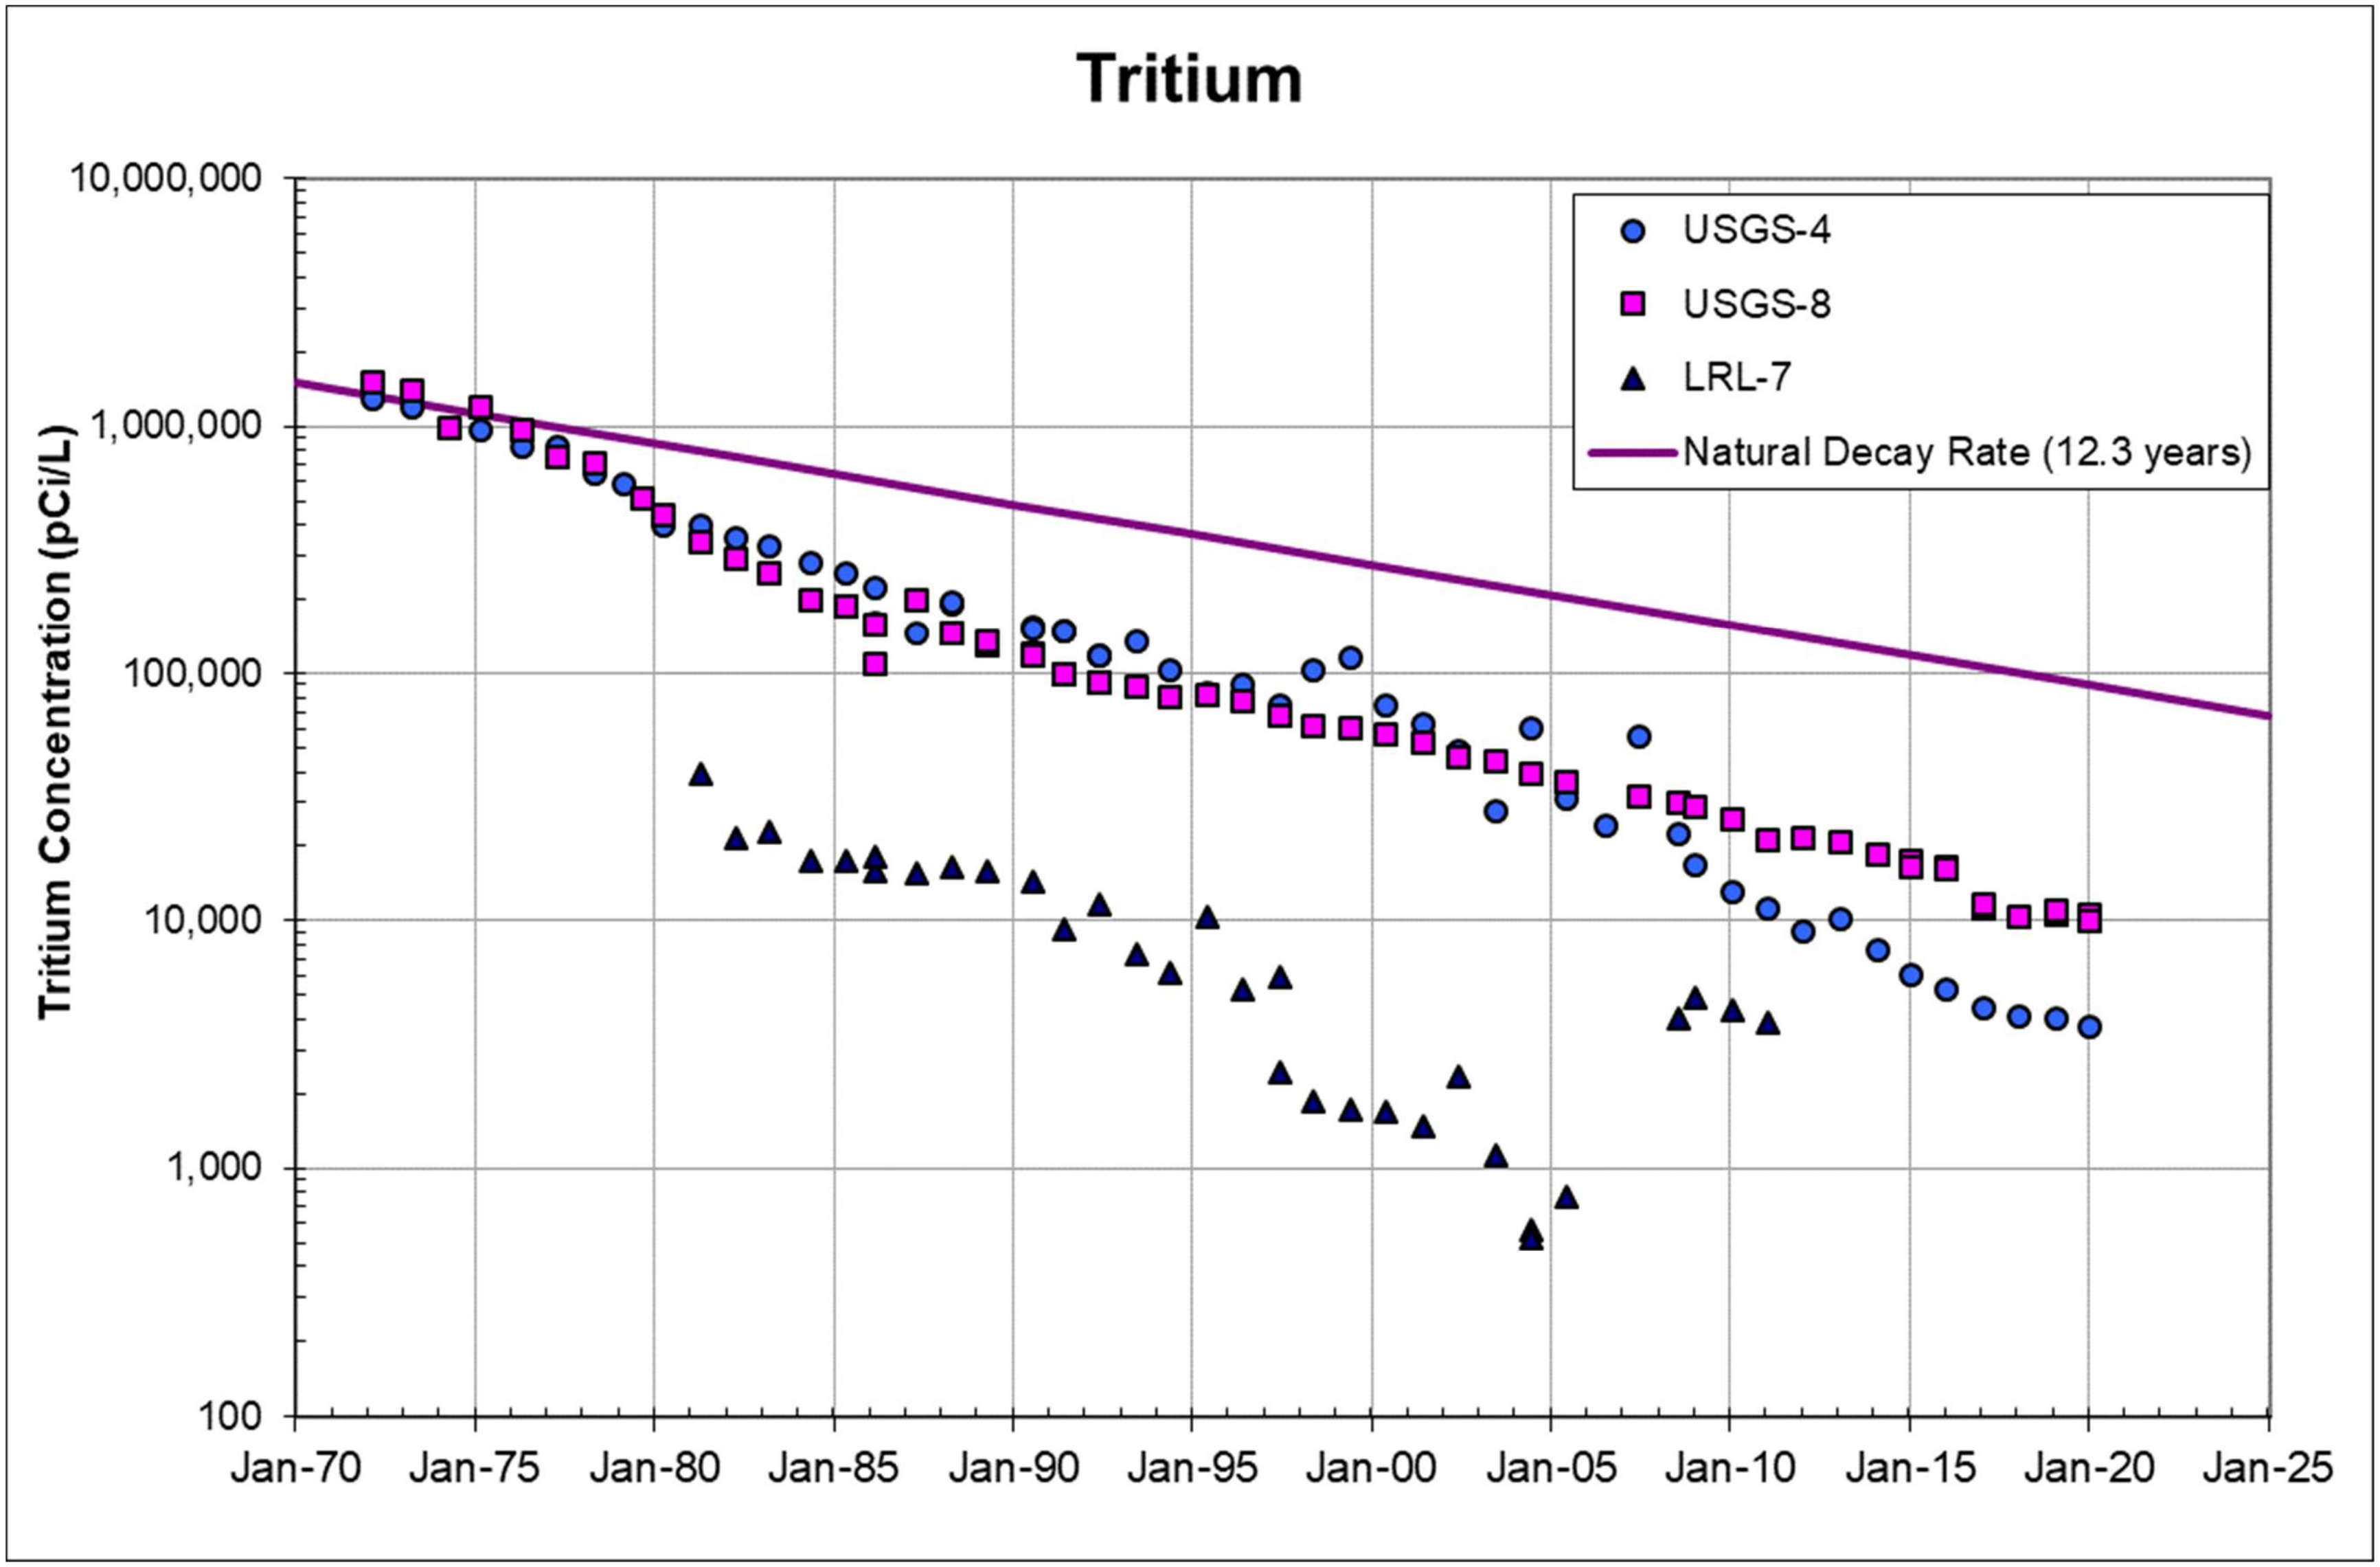
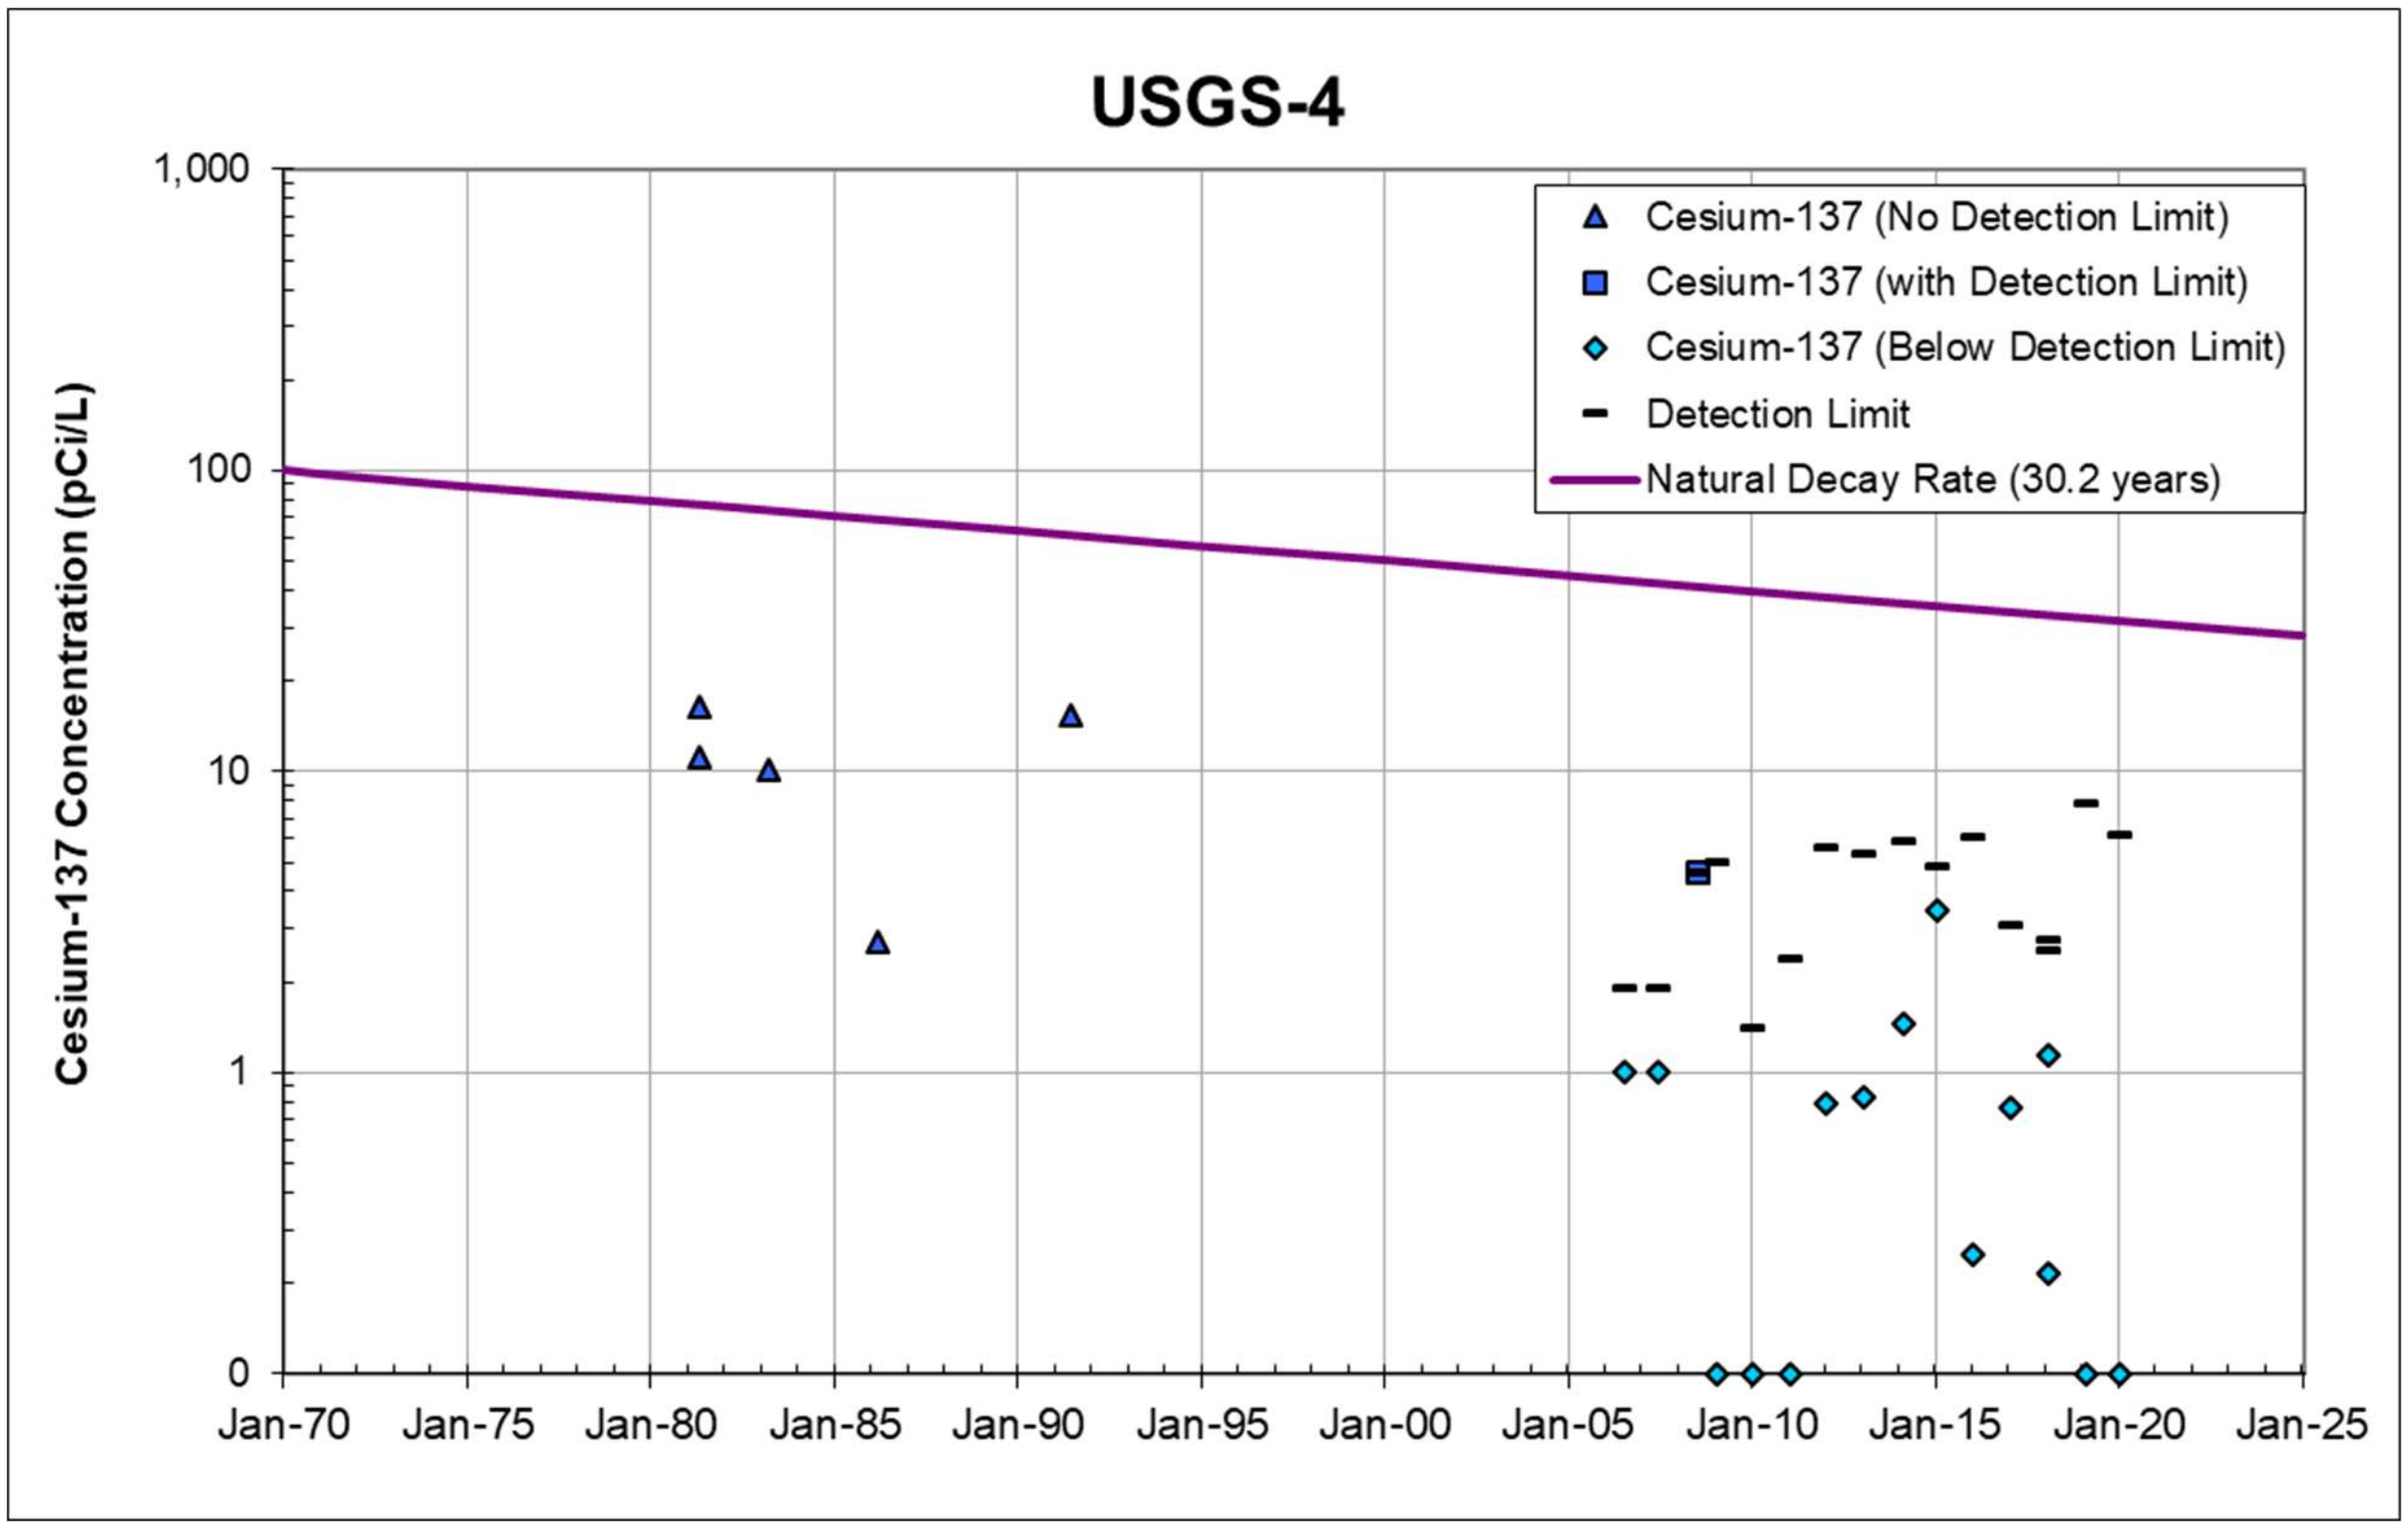
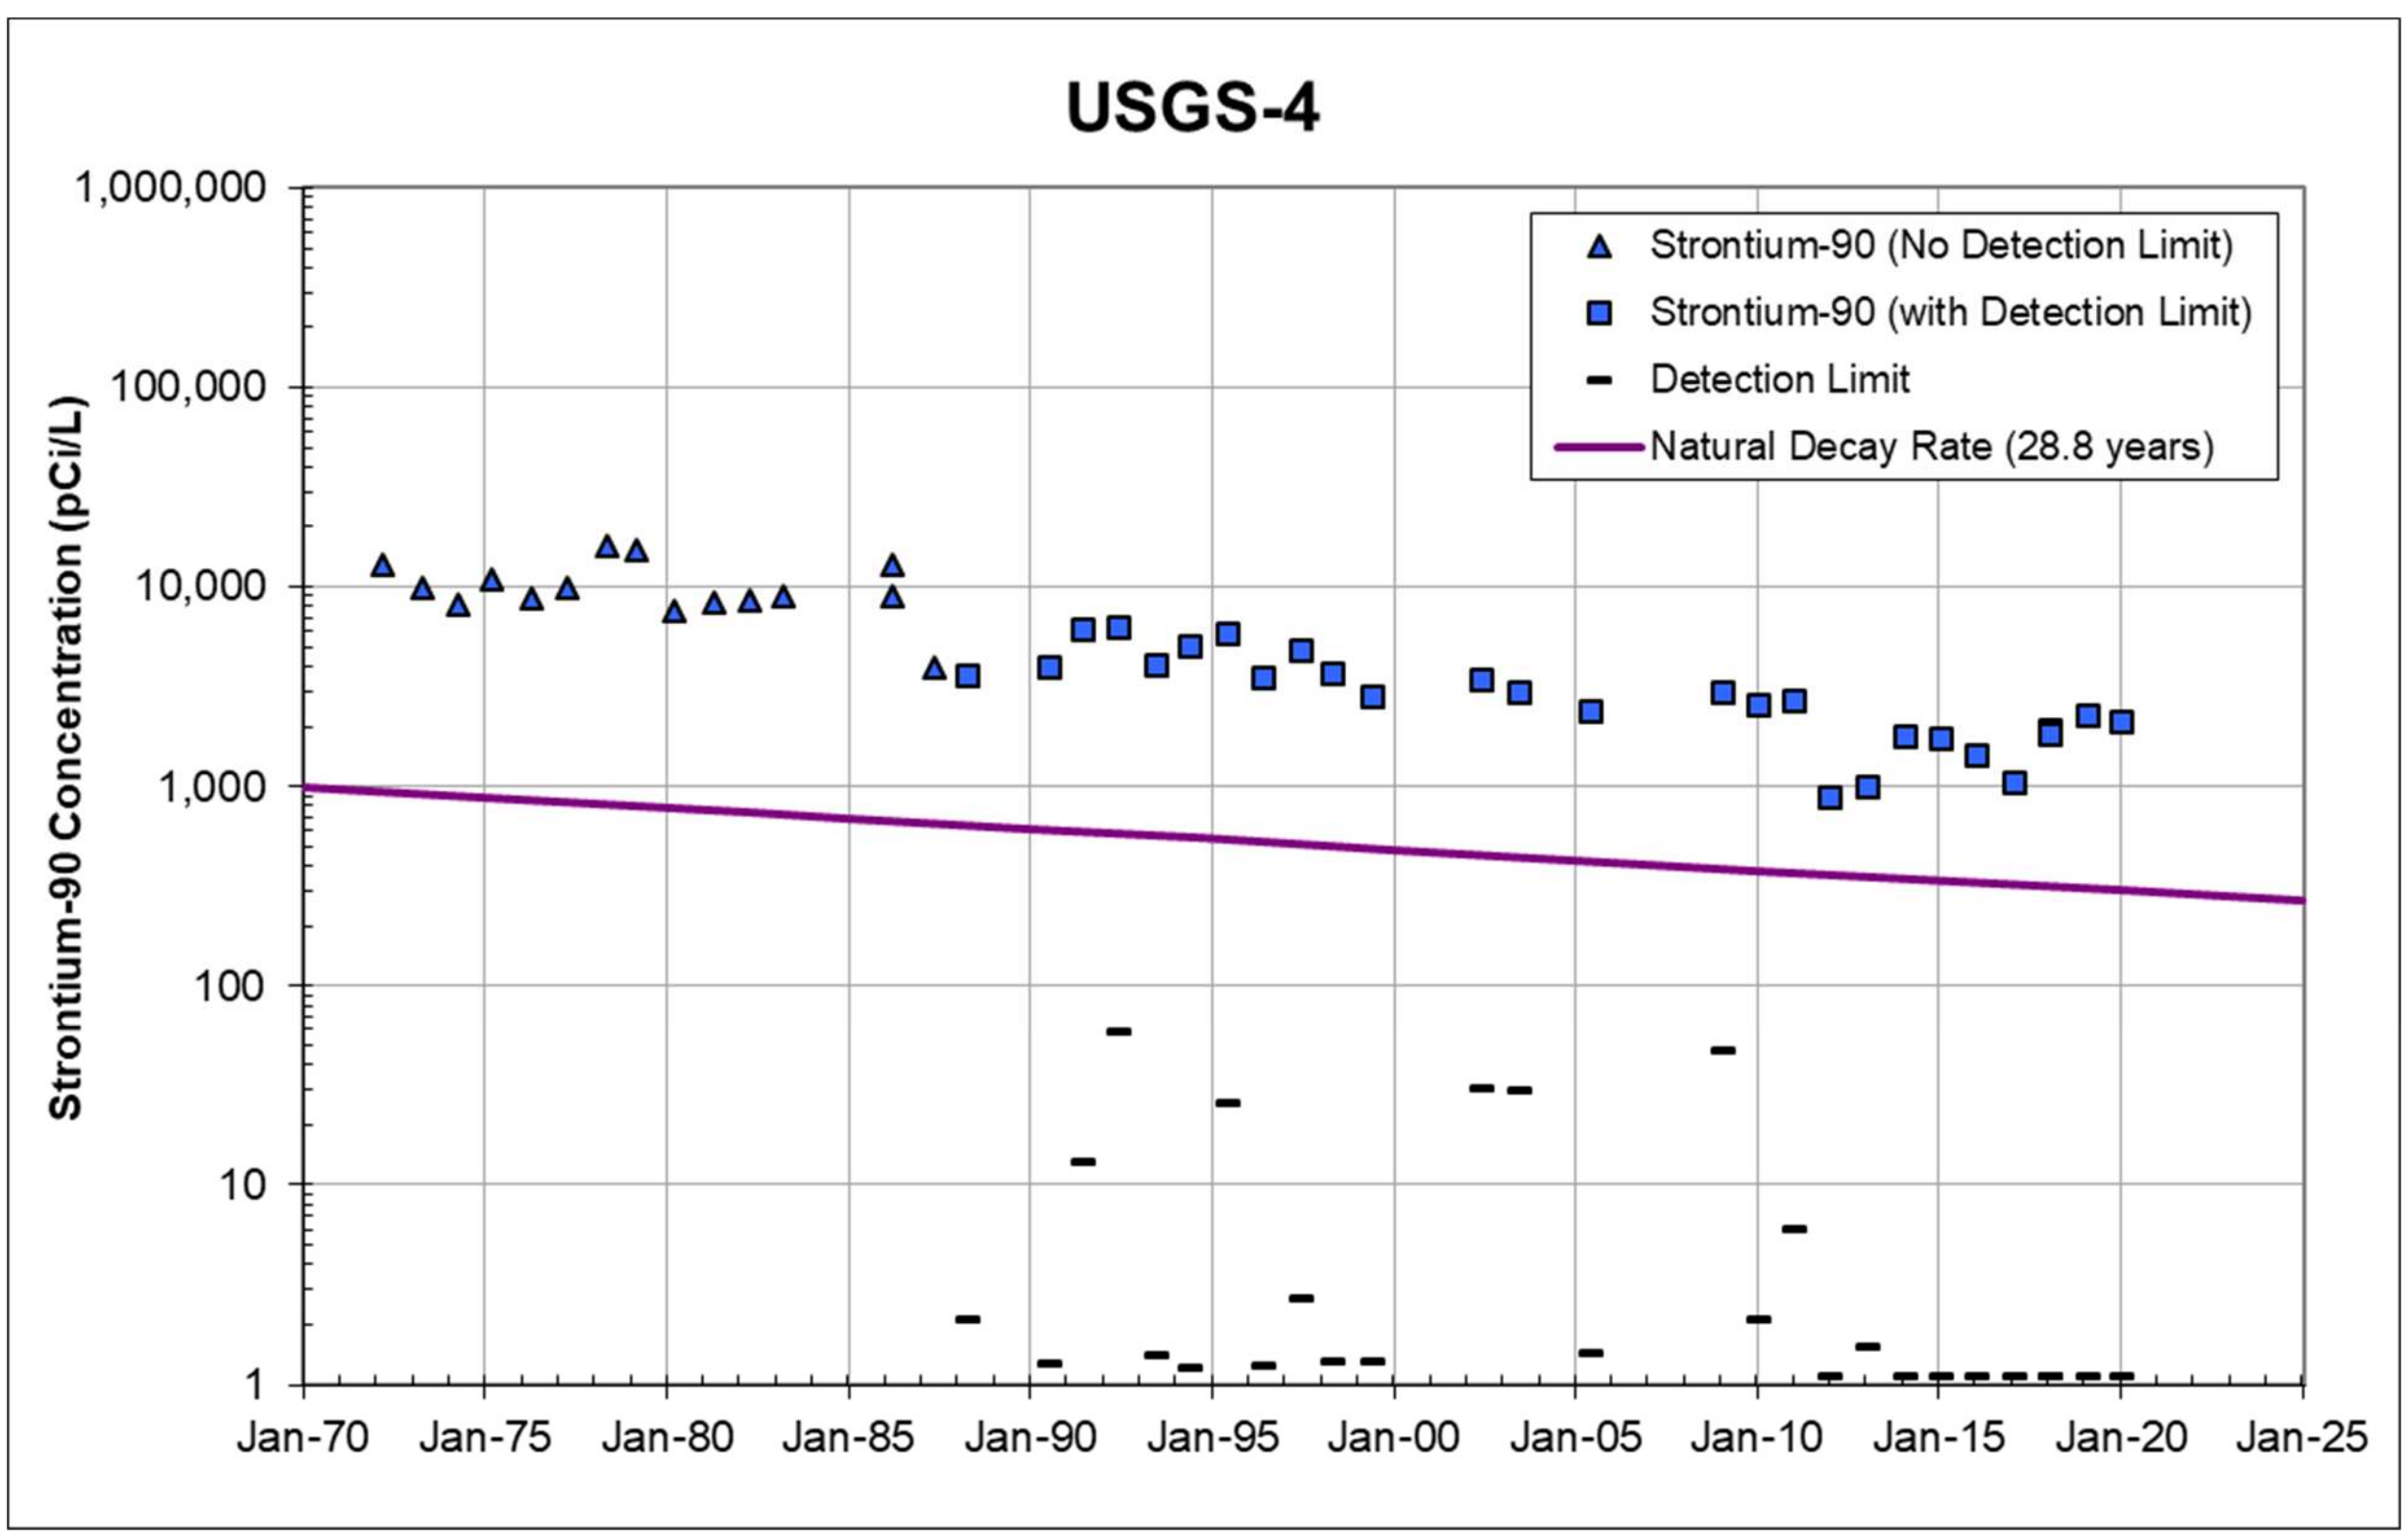
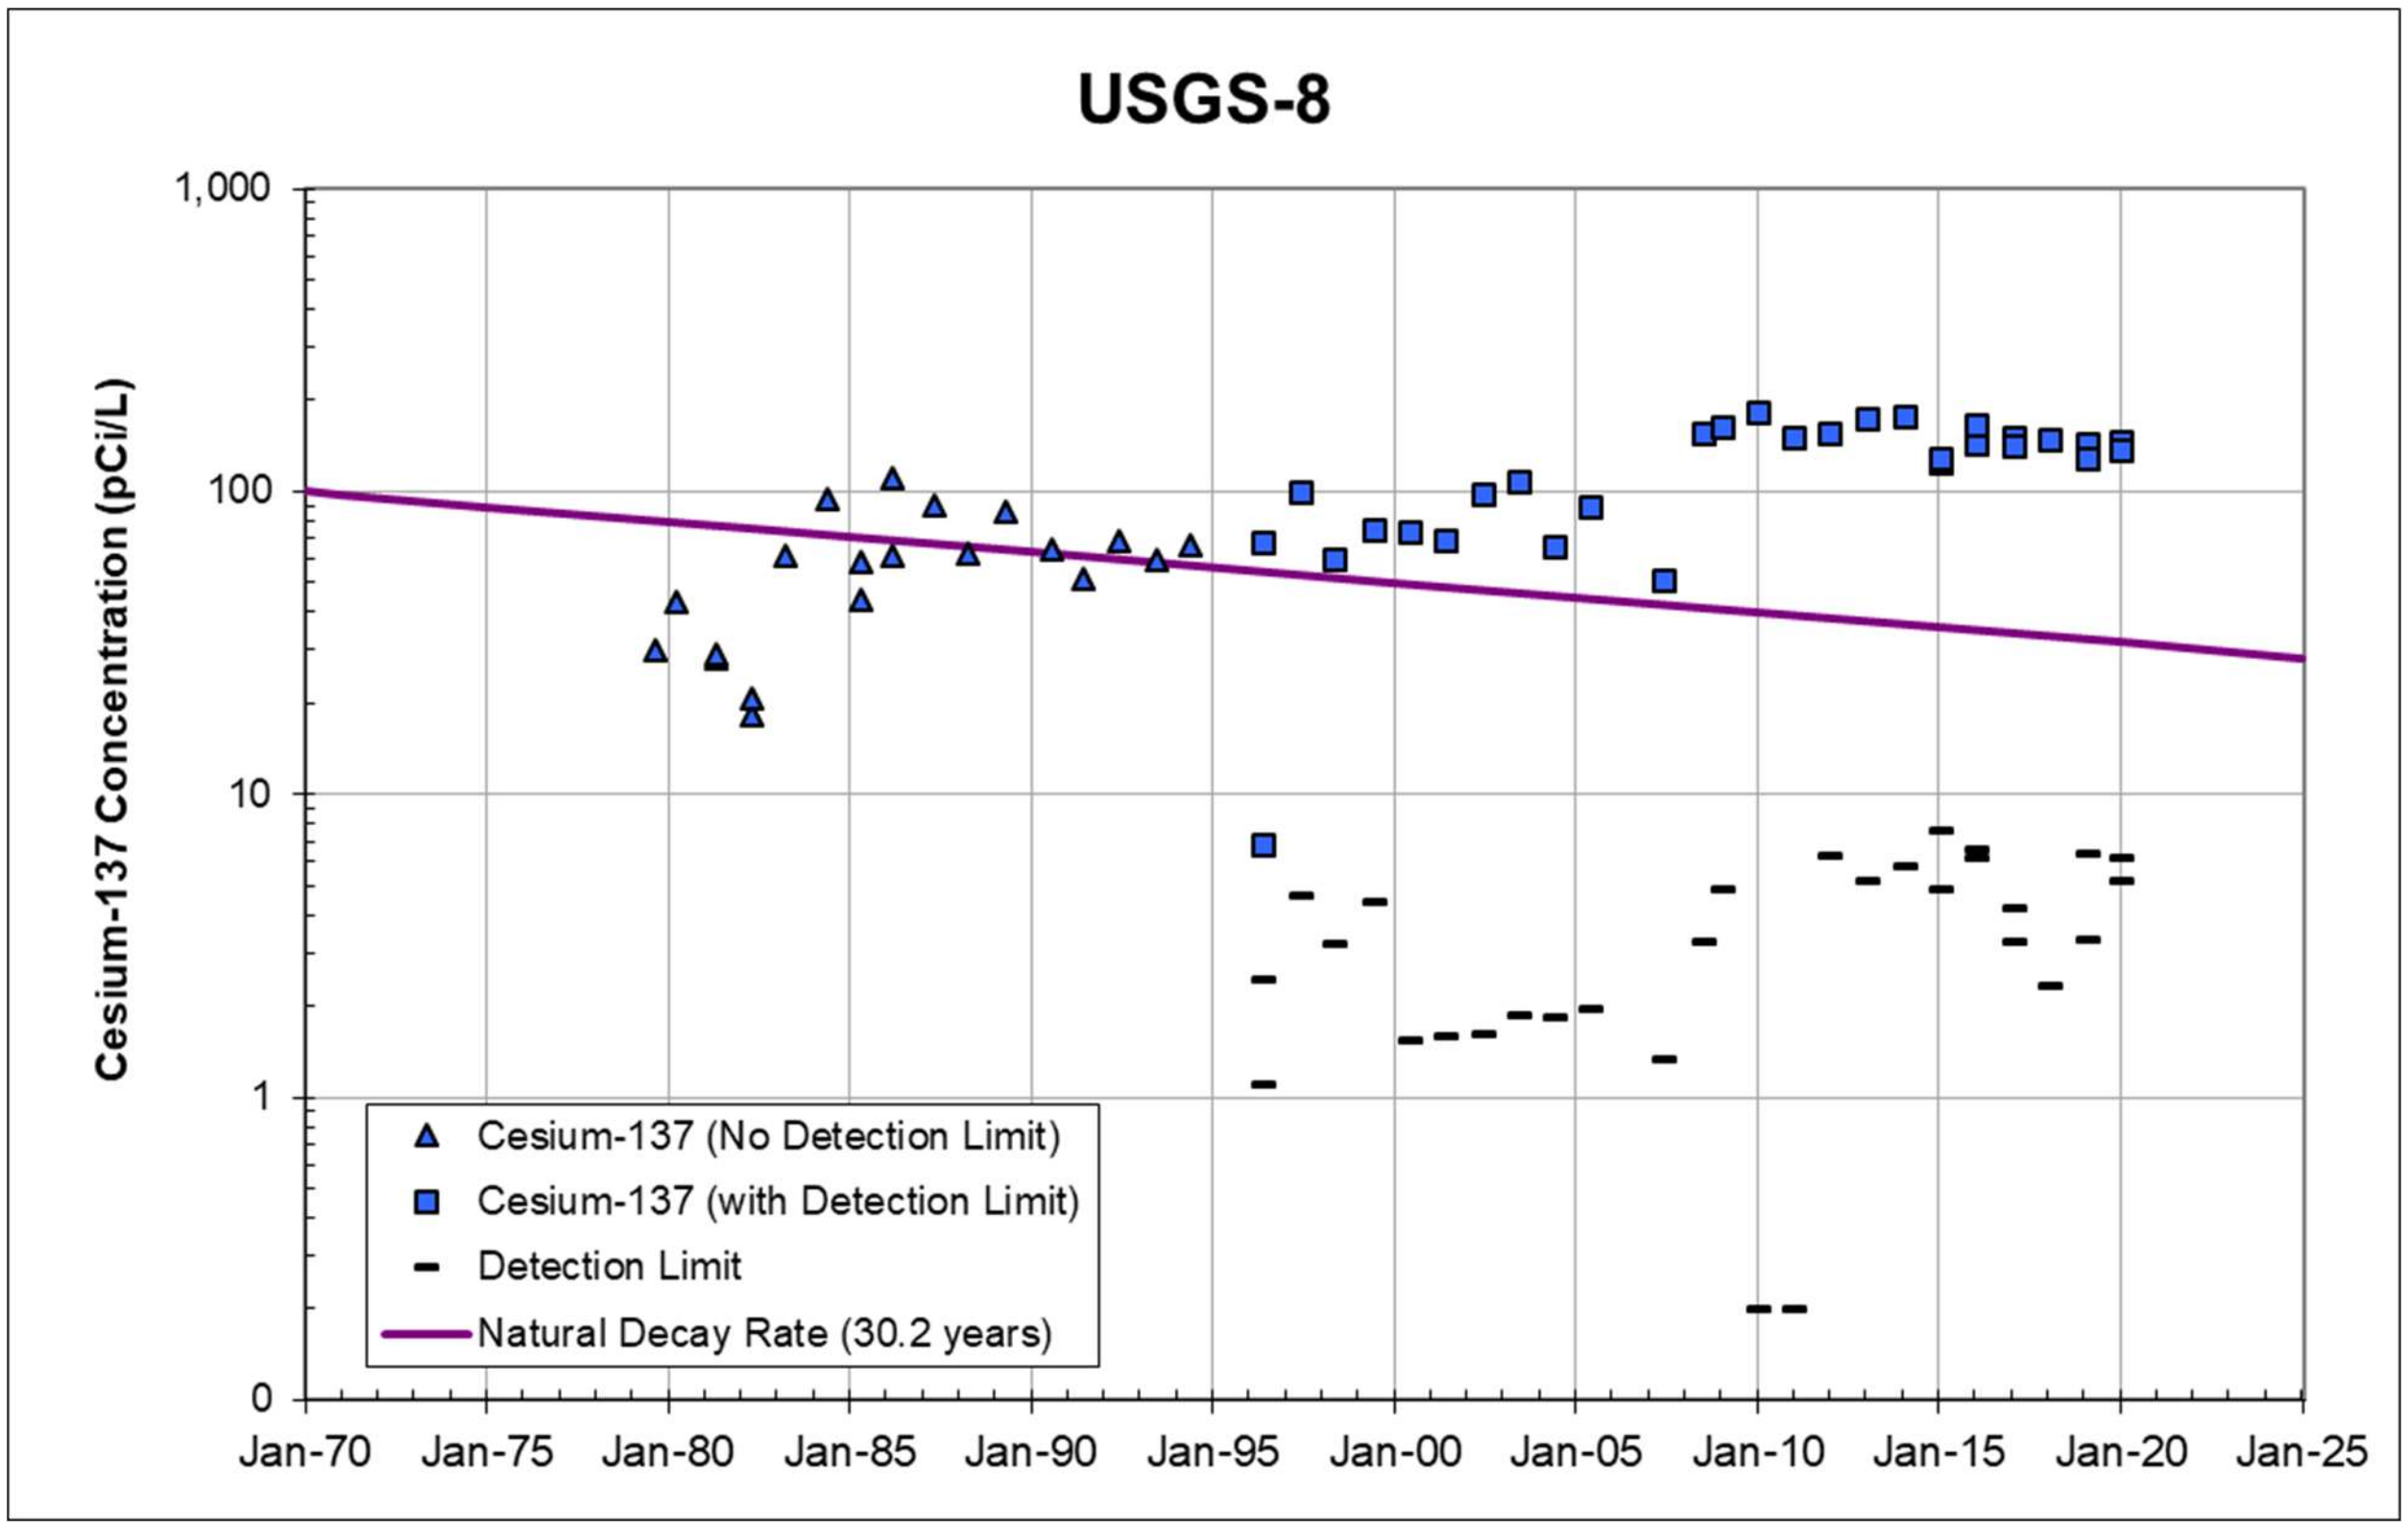
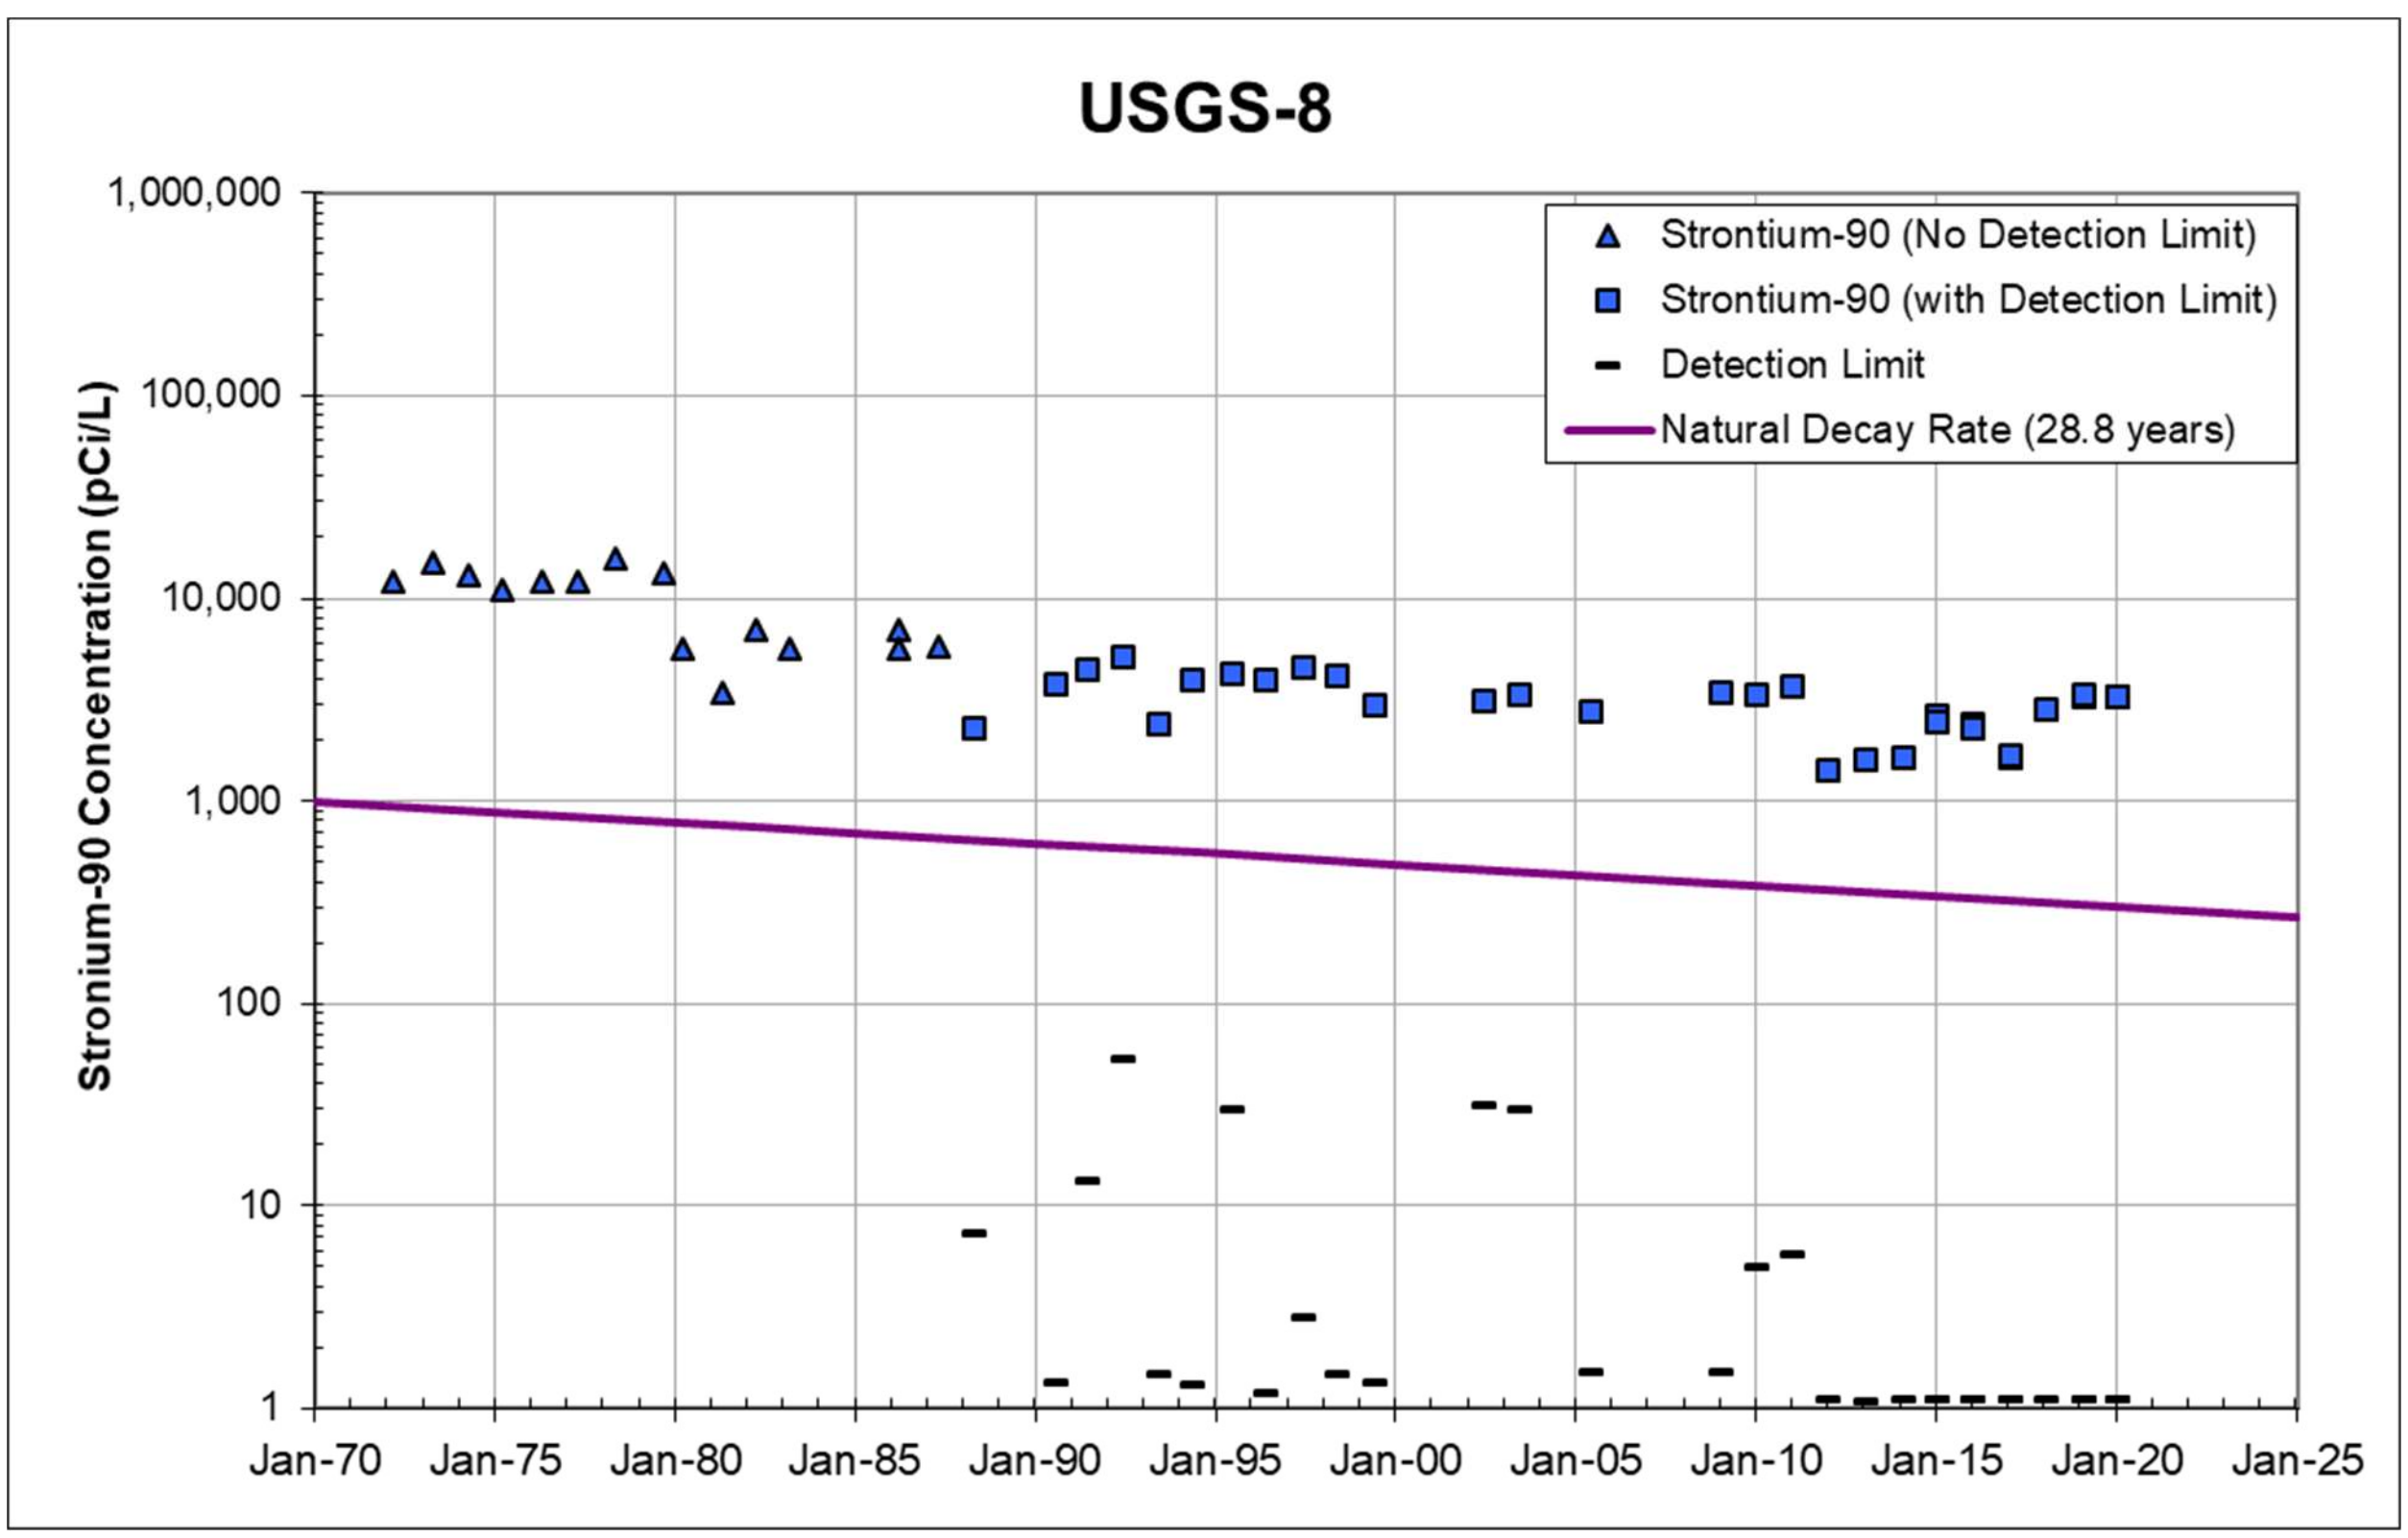
Figures B-1 through B-7 in Appendix B show temporal plots of radionuclide concentrations (1972–2019) in samples collected from wells LRL-7, USGS-4, and USGS-8. Sample results from well USGS-1 are not included because concentrations of tritium (using conventional methods), ^{90}Sr, and ^{137}Cs have not been detected above the laboratory minimum detectable concentration in this well since monitoring began in 1972. The detection of ^{90}Sr in the February 2017 sample collected from USGS-1 was attributed to laboratory contamination (DOE 2018). Concentrations are plotted on a semilogarithmic scale, and all sample results, including nondetects, are plotted. Several results from sampling events before the late 1980s had no reported detection limit, as shown in the charts. For interpretation purposes, relatively high concentrations (i.e., concentrations significantly higher than detection limits associated with subsequent sampling) should be considered detections. The natural decay rates for tritium (12.3-year half-life), ^{90}Sr (28.8-year half-life), and ^{137}Cs (30.2-year half-life) have been included on the charts for reference. The increases in tritium concentrations in samples collected from well LRL-7 (Figure B-1) and ^{137}Cs concentrations in samples collected from wells USGS-8 and LRL-7 (Figure B-4 and Figure B-6) after the 2007 sampling event are attributed to changes in the sampling method. Prior to 2008, EPA collected samples using a depth-specific bailer, and starting in 2008 LM collected samples from dedicated bladder pumps using the low-flow sampling method. Tritium concentrations in samples collected from well USGS-4 (Figure B-1) continue to decrease at a rate that is greater than the natural decay rate for tritium.
