Rocky Flats Environmental Technology Site

PRE-DEMOLITION SURVEY REPORT (PDSR)

Building 771 Area AH (West)

August 10, 2004

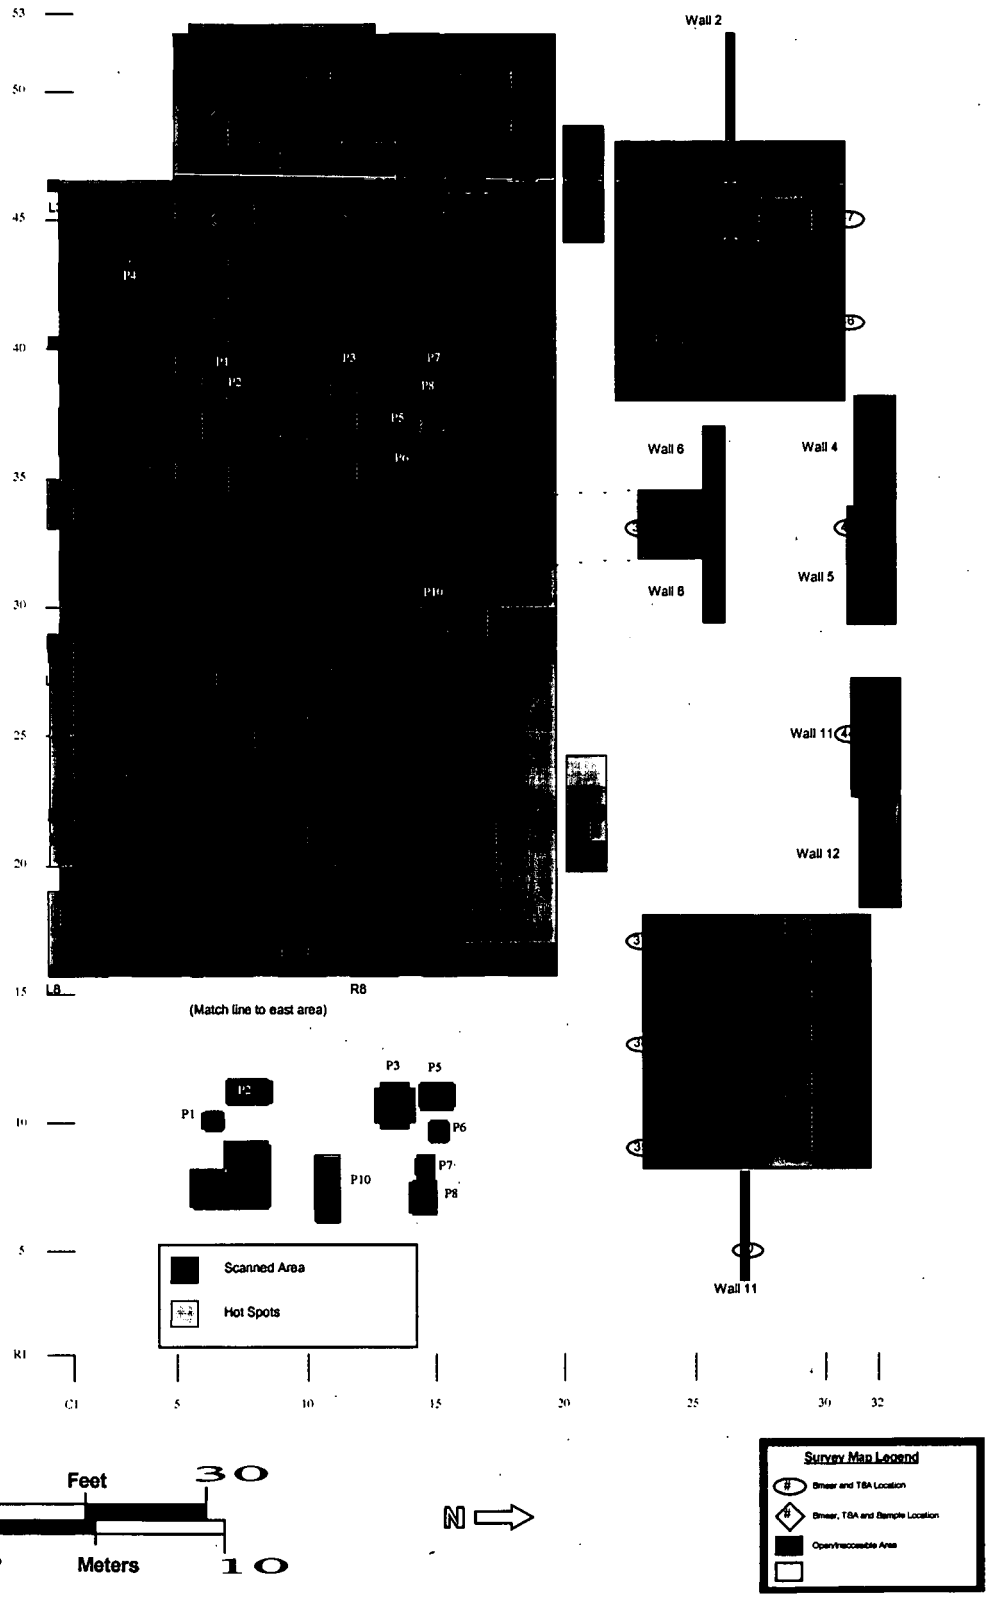
SURVEY UNIT 771038 - MAP 1 OF 2

All scans and surveys in survey unit 771038 were less than the applicable PDS transuranic DCGL values, with the exception of the areas marked in red on the survey unit map. Radiological survey data, statistical analysis results, survey locations, and radiological scan maps for survey unit 771038 are presented in Attachment B, *Survey Unit 771038 Radiological Data Summary and Survey Map.*

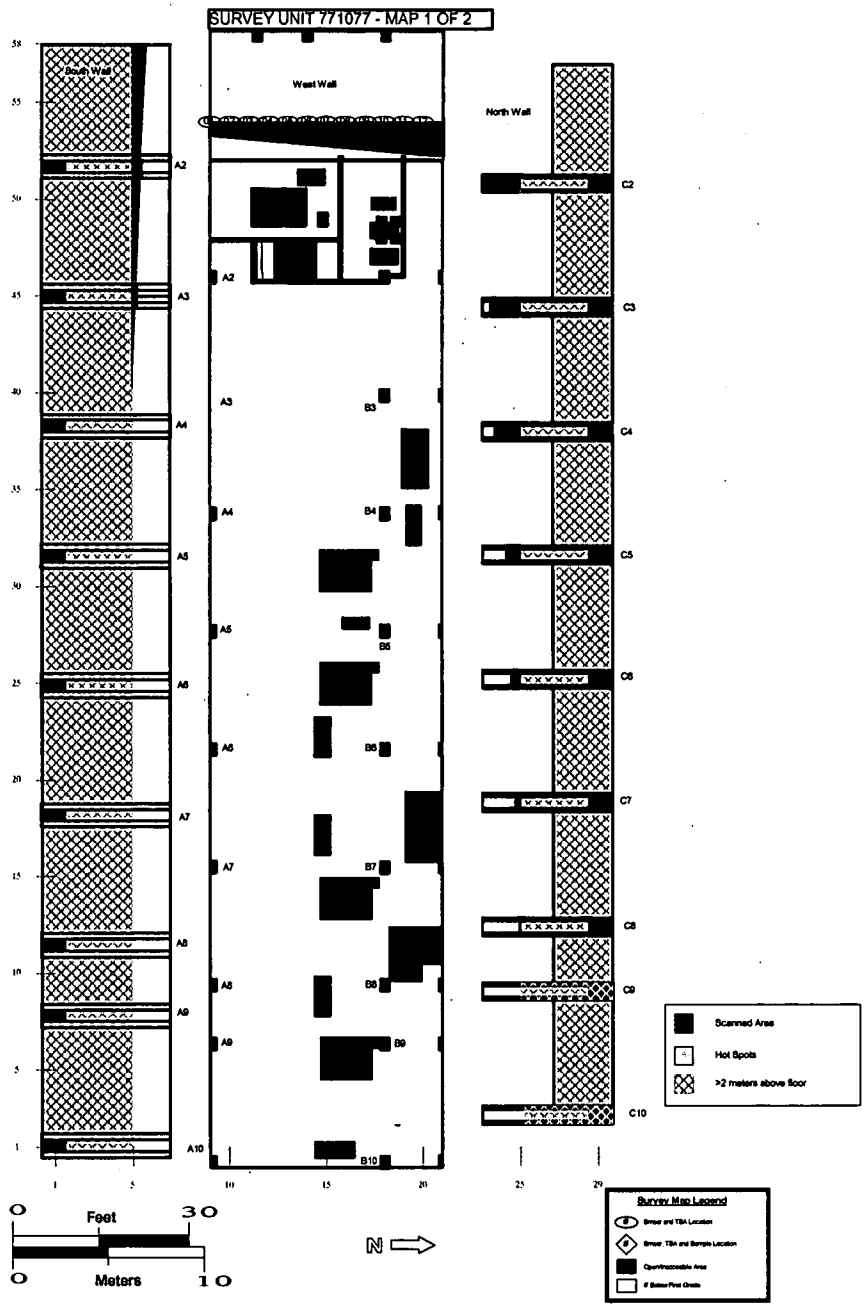
SURVEY UNIT 771077 - MAP 1 OF 2

All scans and surveys in survey unit 771077 were less than the applicable PDS transuranic DCGL values, with the exception of the areas marked in red on the survey unit map. Radiological survey data, statistical analysis results, survey locations, and radiological scan maps for survey unit 771077 are presented in Attachment F, *Survey Unit 771077 Radiological Data Summary and Survey Map*.
