KAISER•HILL
COMPANY

December 4, 2000 00-RF-03237

TRANSMITTAL OF REV 1 PAGE CHANGES TO THE DECOMMISSIONING CLOSEOUT REPORT FOR THE 779 CLOSURE PROJECT- JLS-020-00

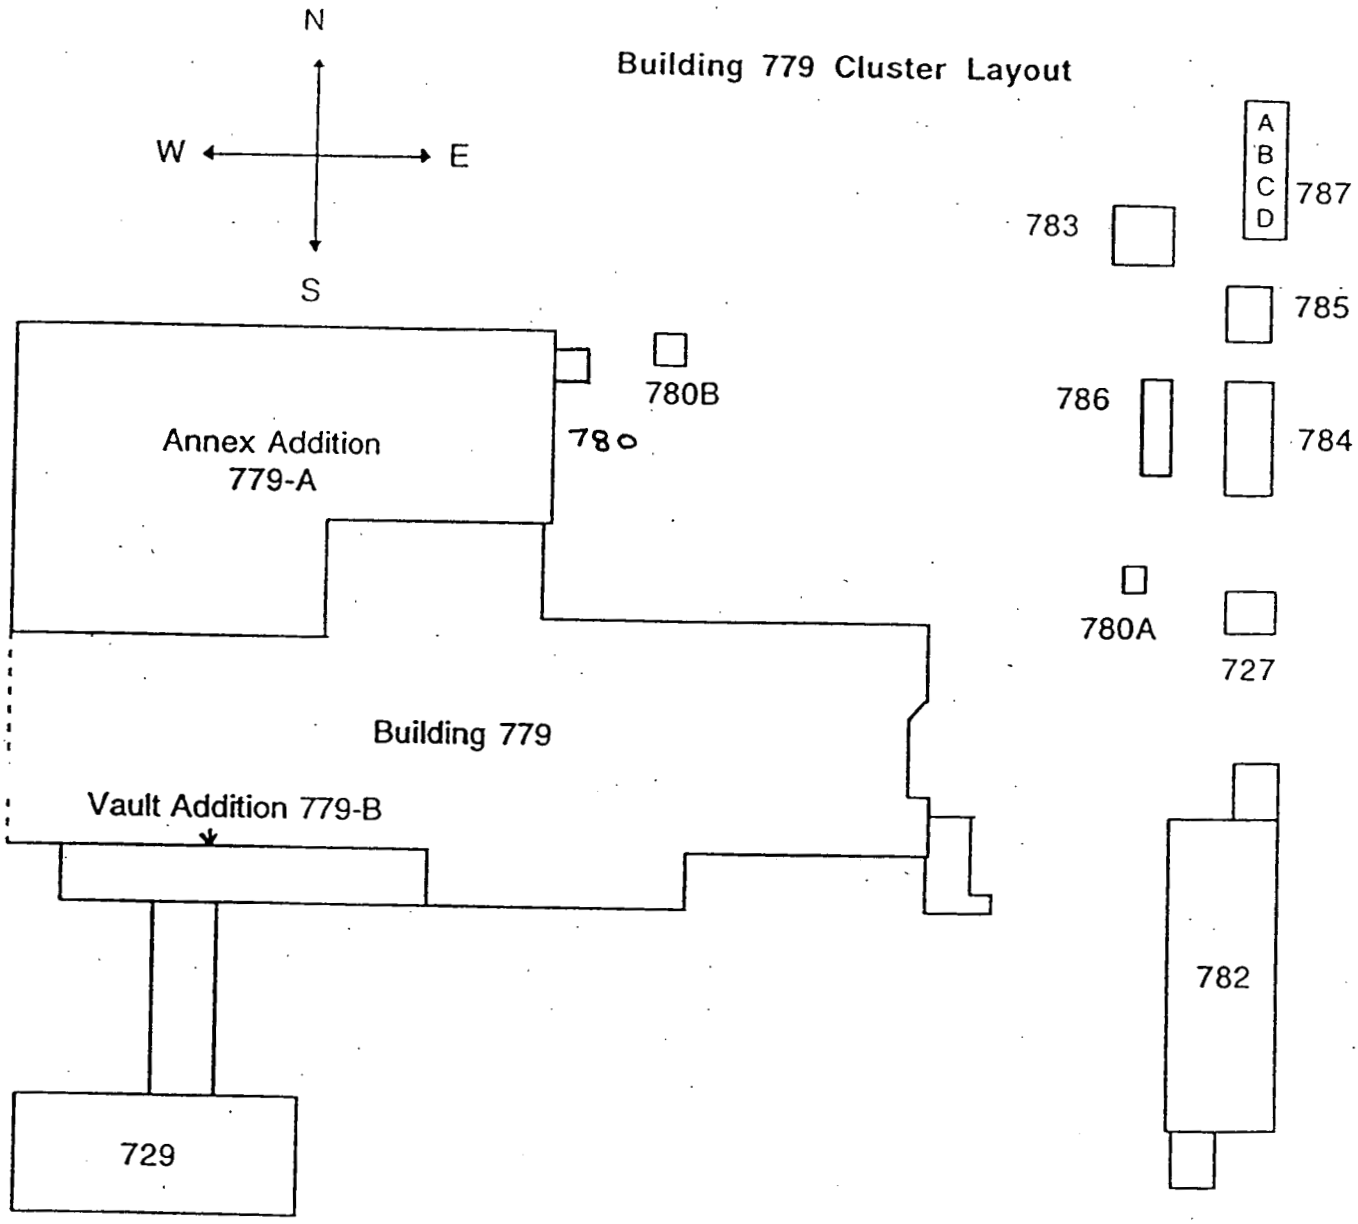
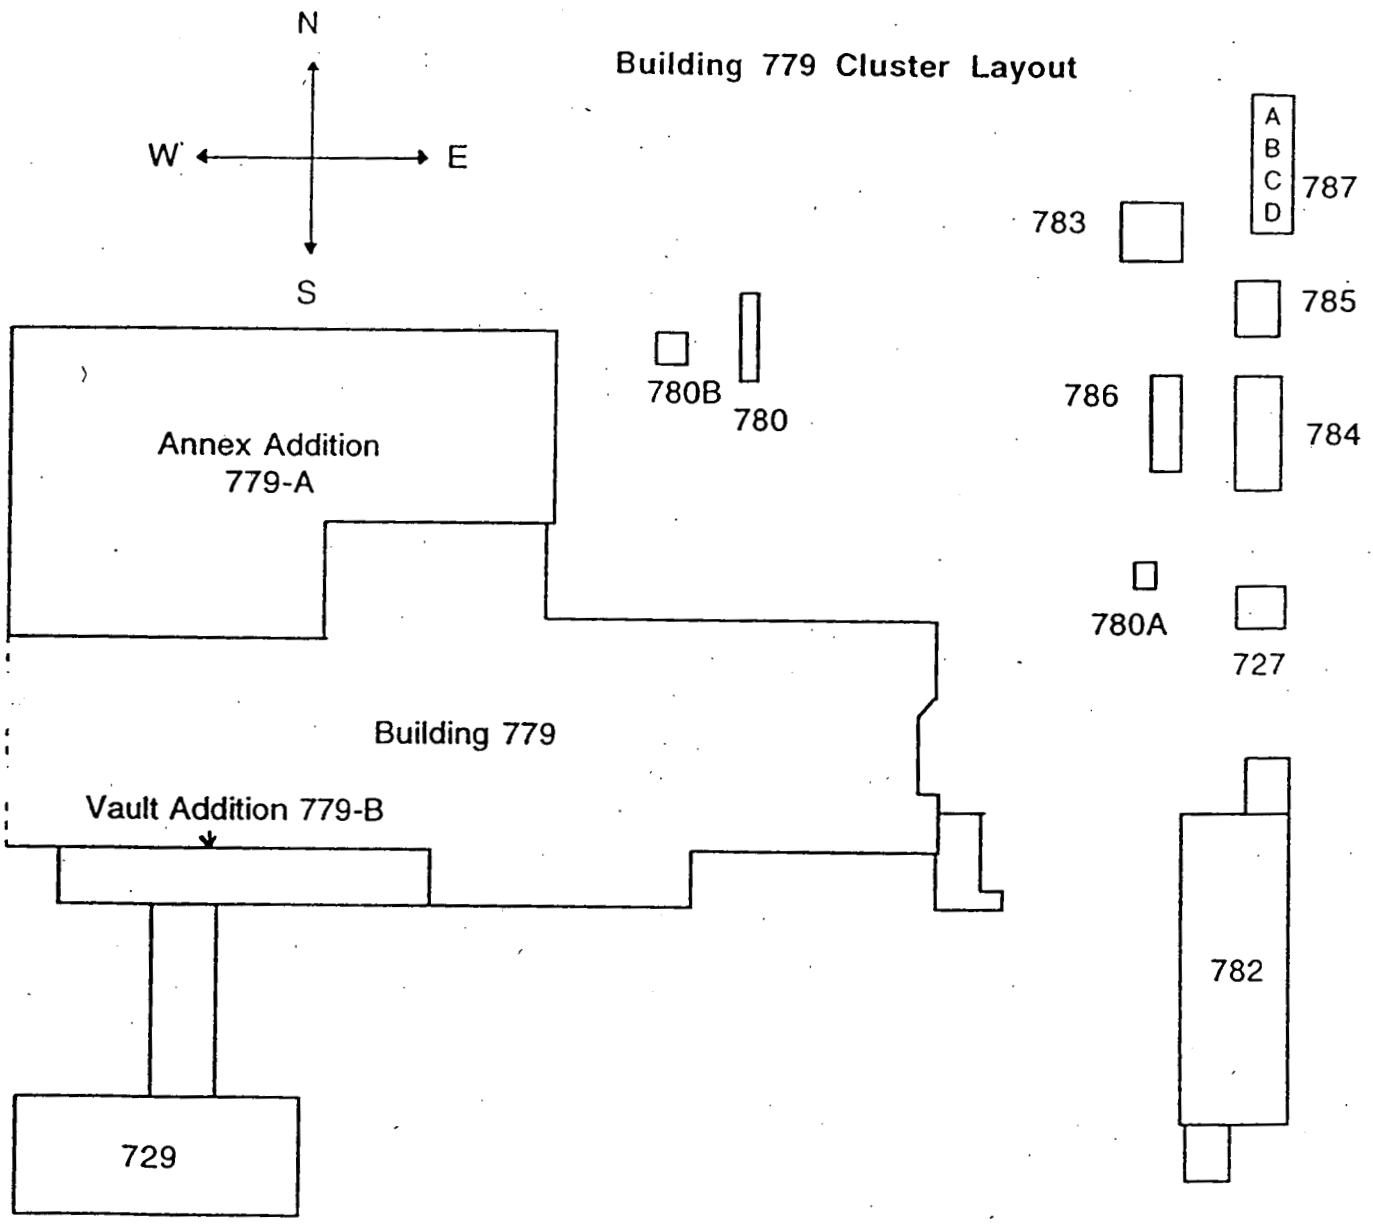
FIGURE 1-1, Building 779 Cluster Layout

Response
A discussion of the B780 slab has been incorporated, including slab dimensions(Page 18). Location of the slab is indicated on Figure 1-1.

The building 780 slab was left in place; its dimensions are 16 feet by 18 feet. Figure 1-1 identifies the location of this slab.

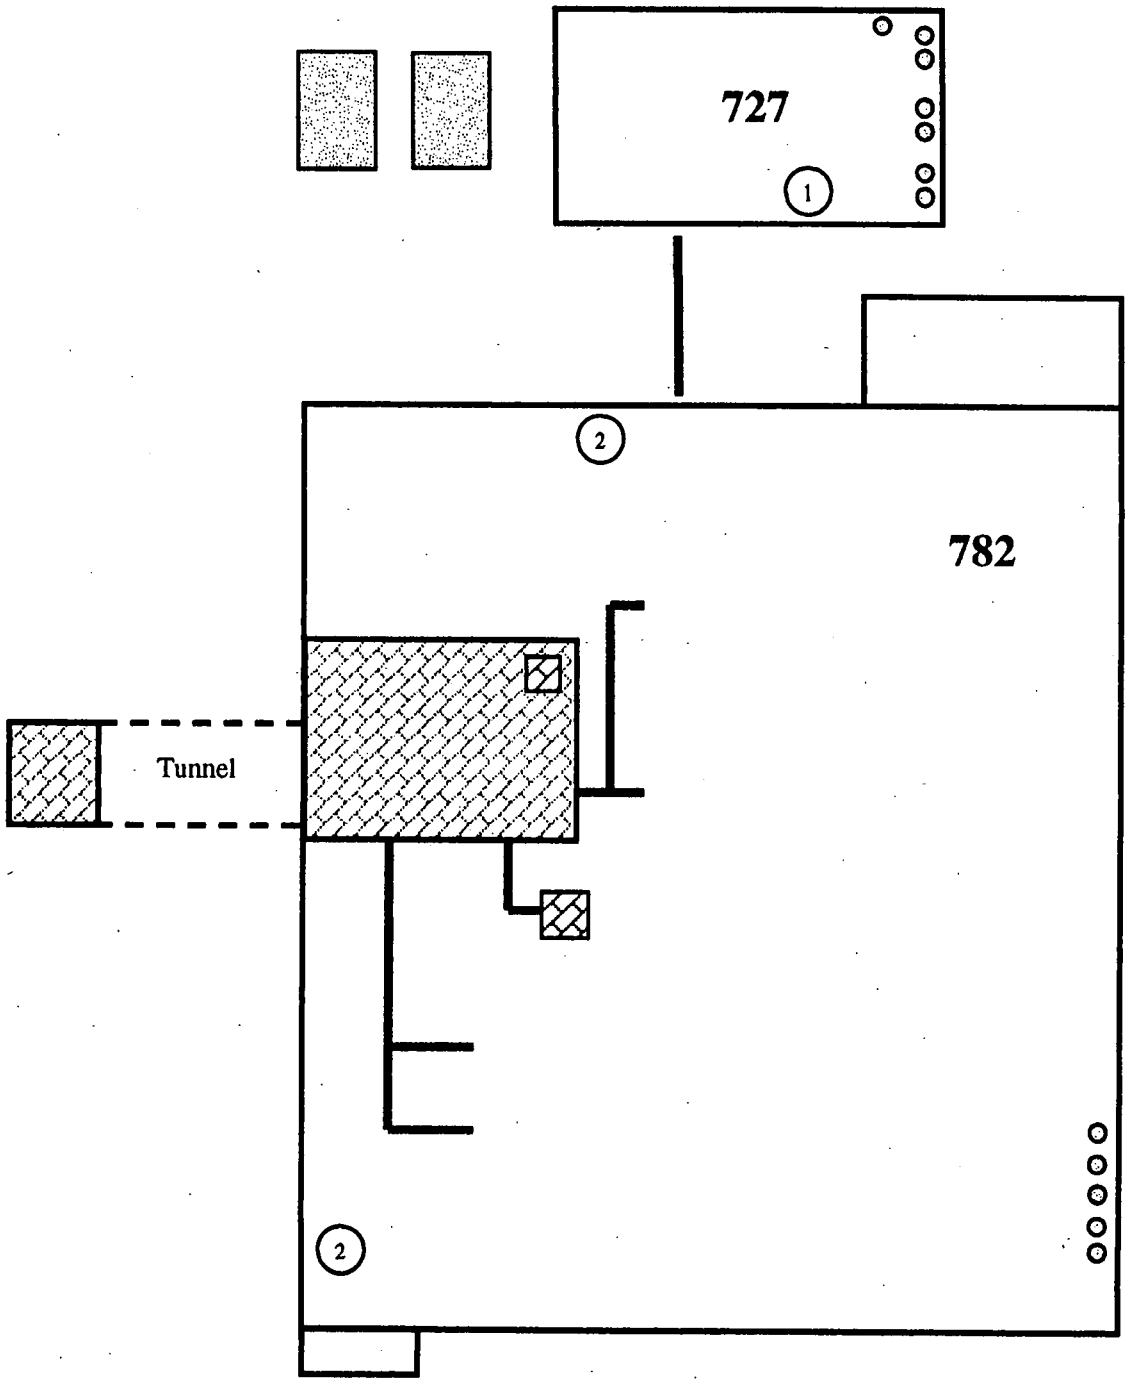
BUILDING 727 and 782 - Slab Details

SLAB DETAILS FOR BUILDINGS 727 AND 782

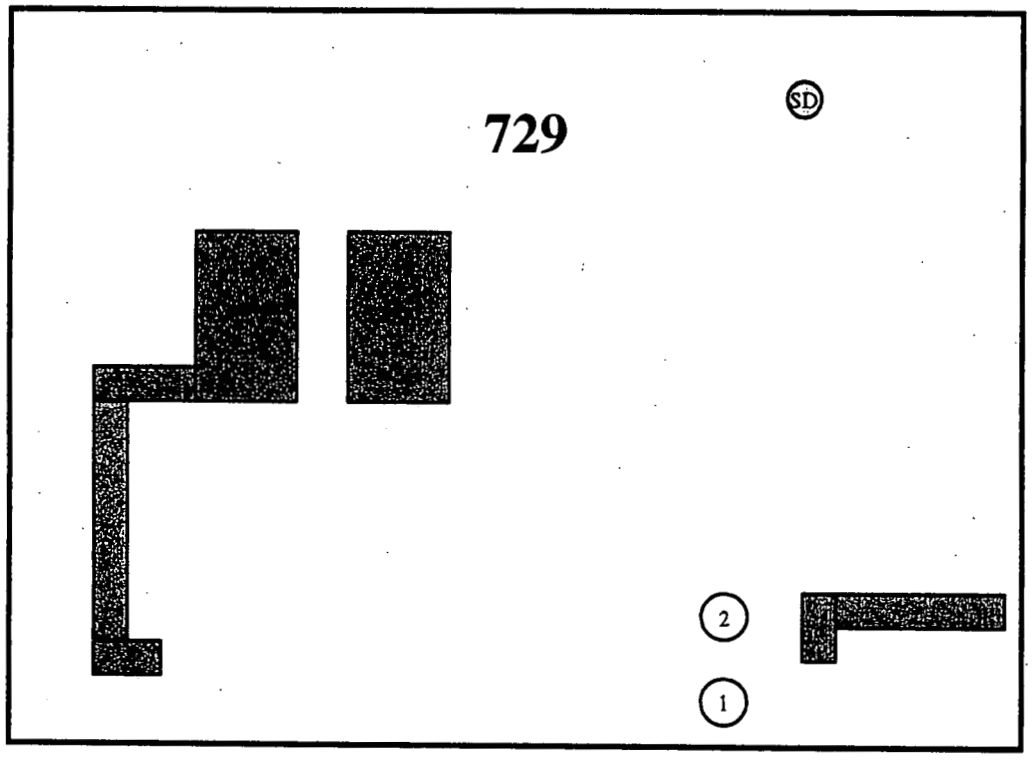
BUIL. .NG 729 - Slab Details

SLAB DETAILS FOR BUILDING 729

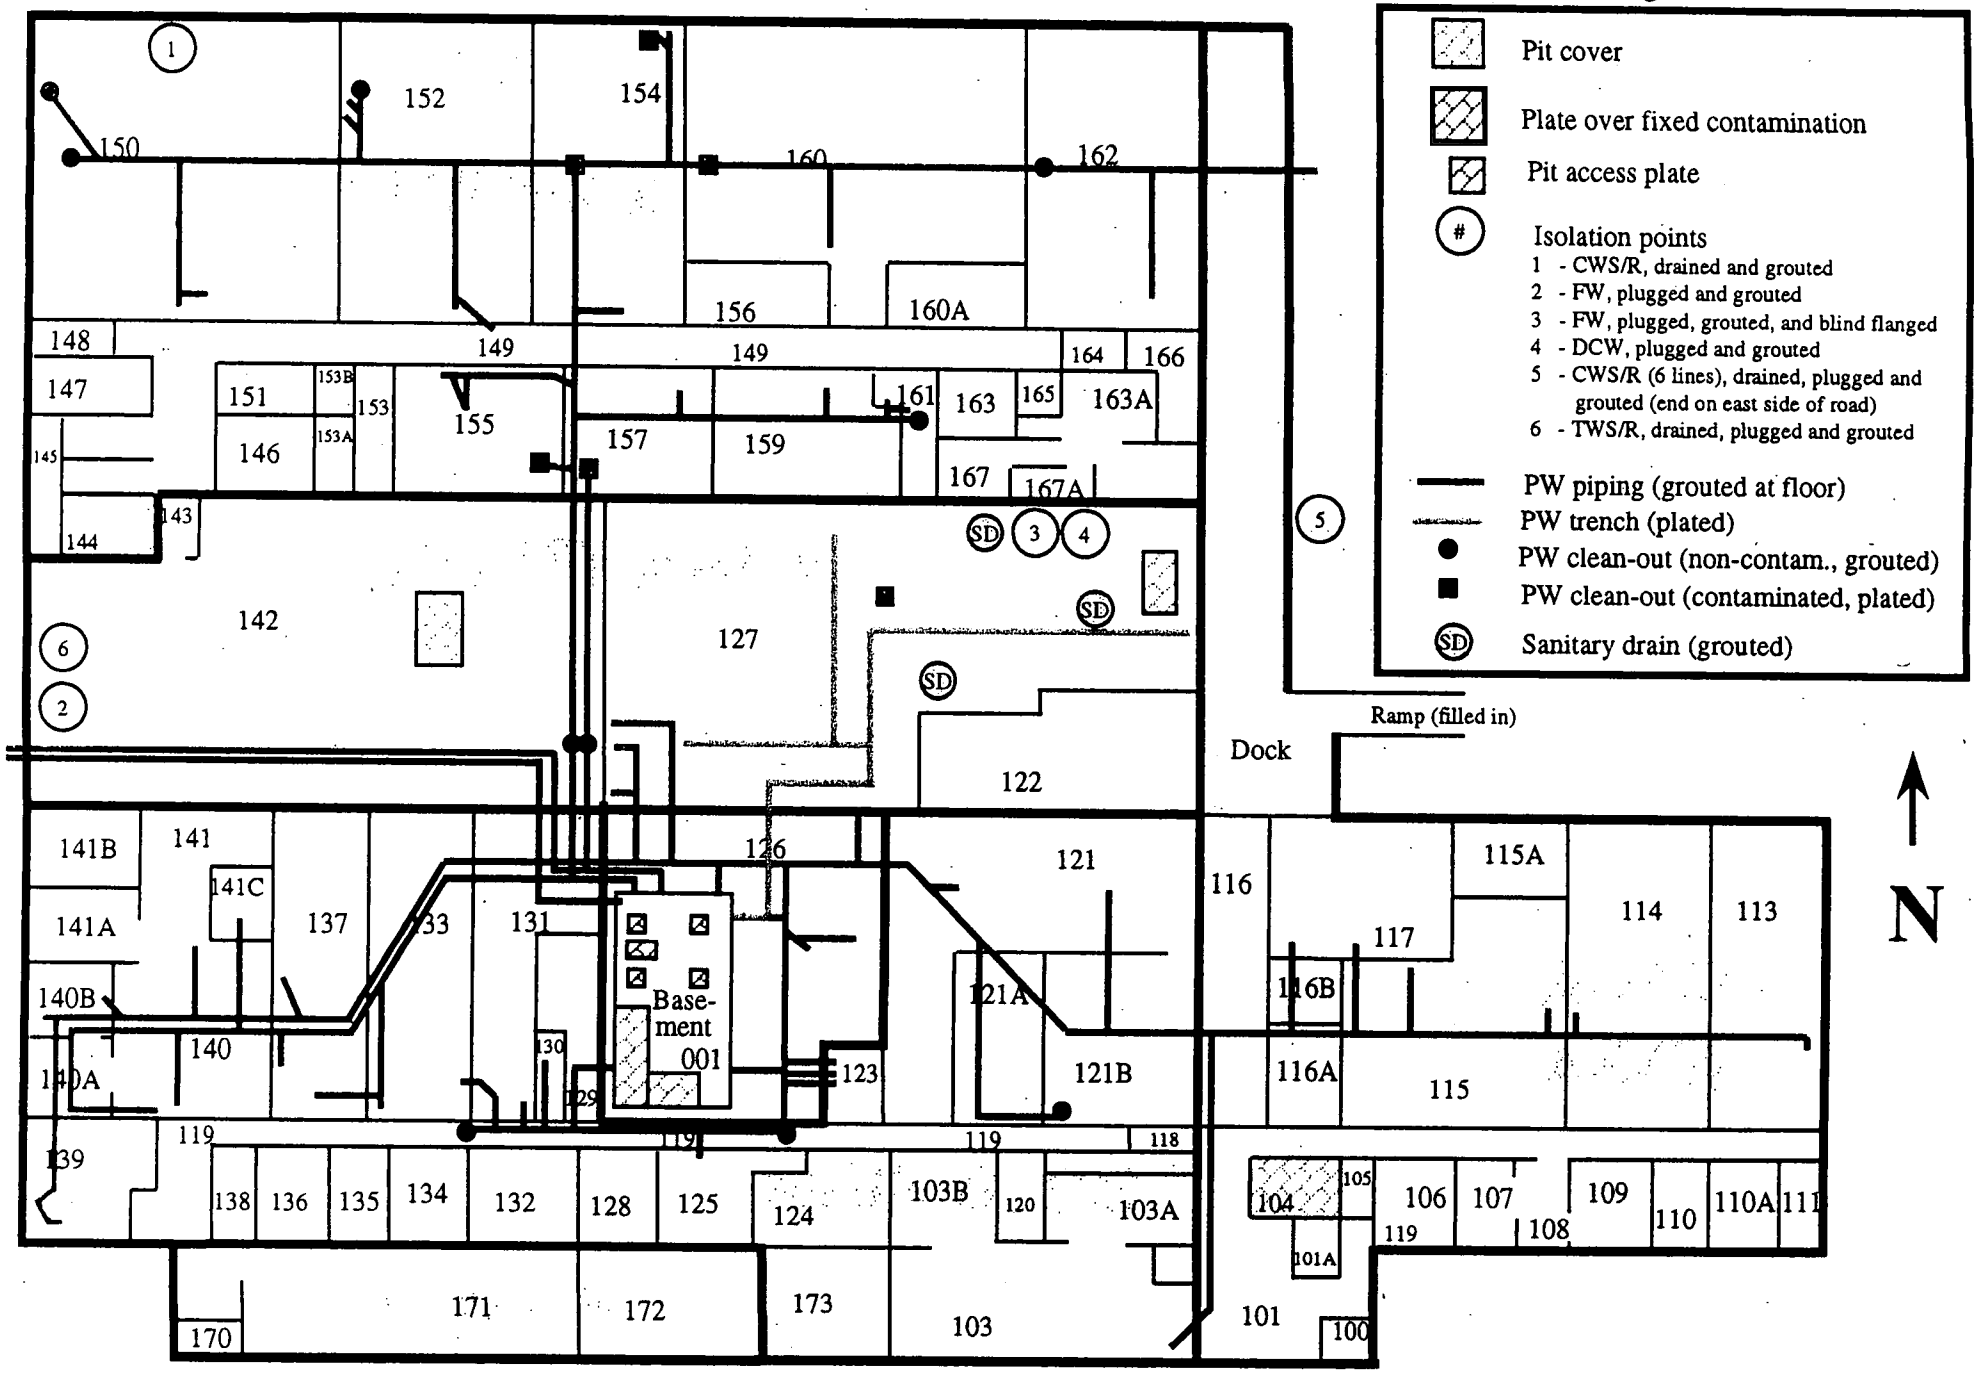
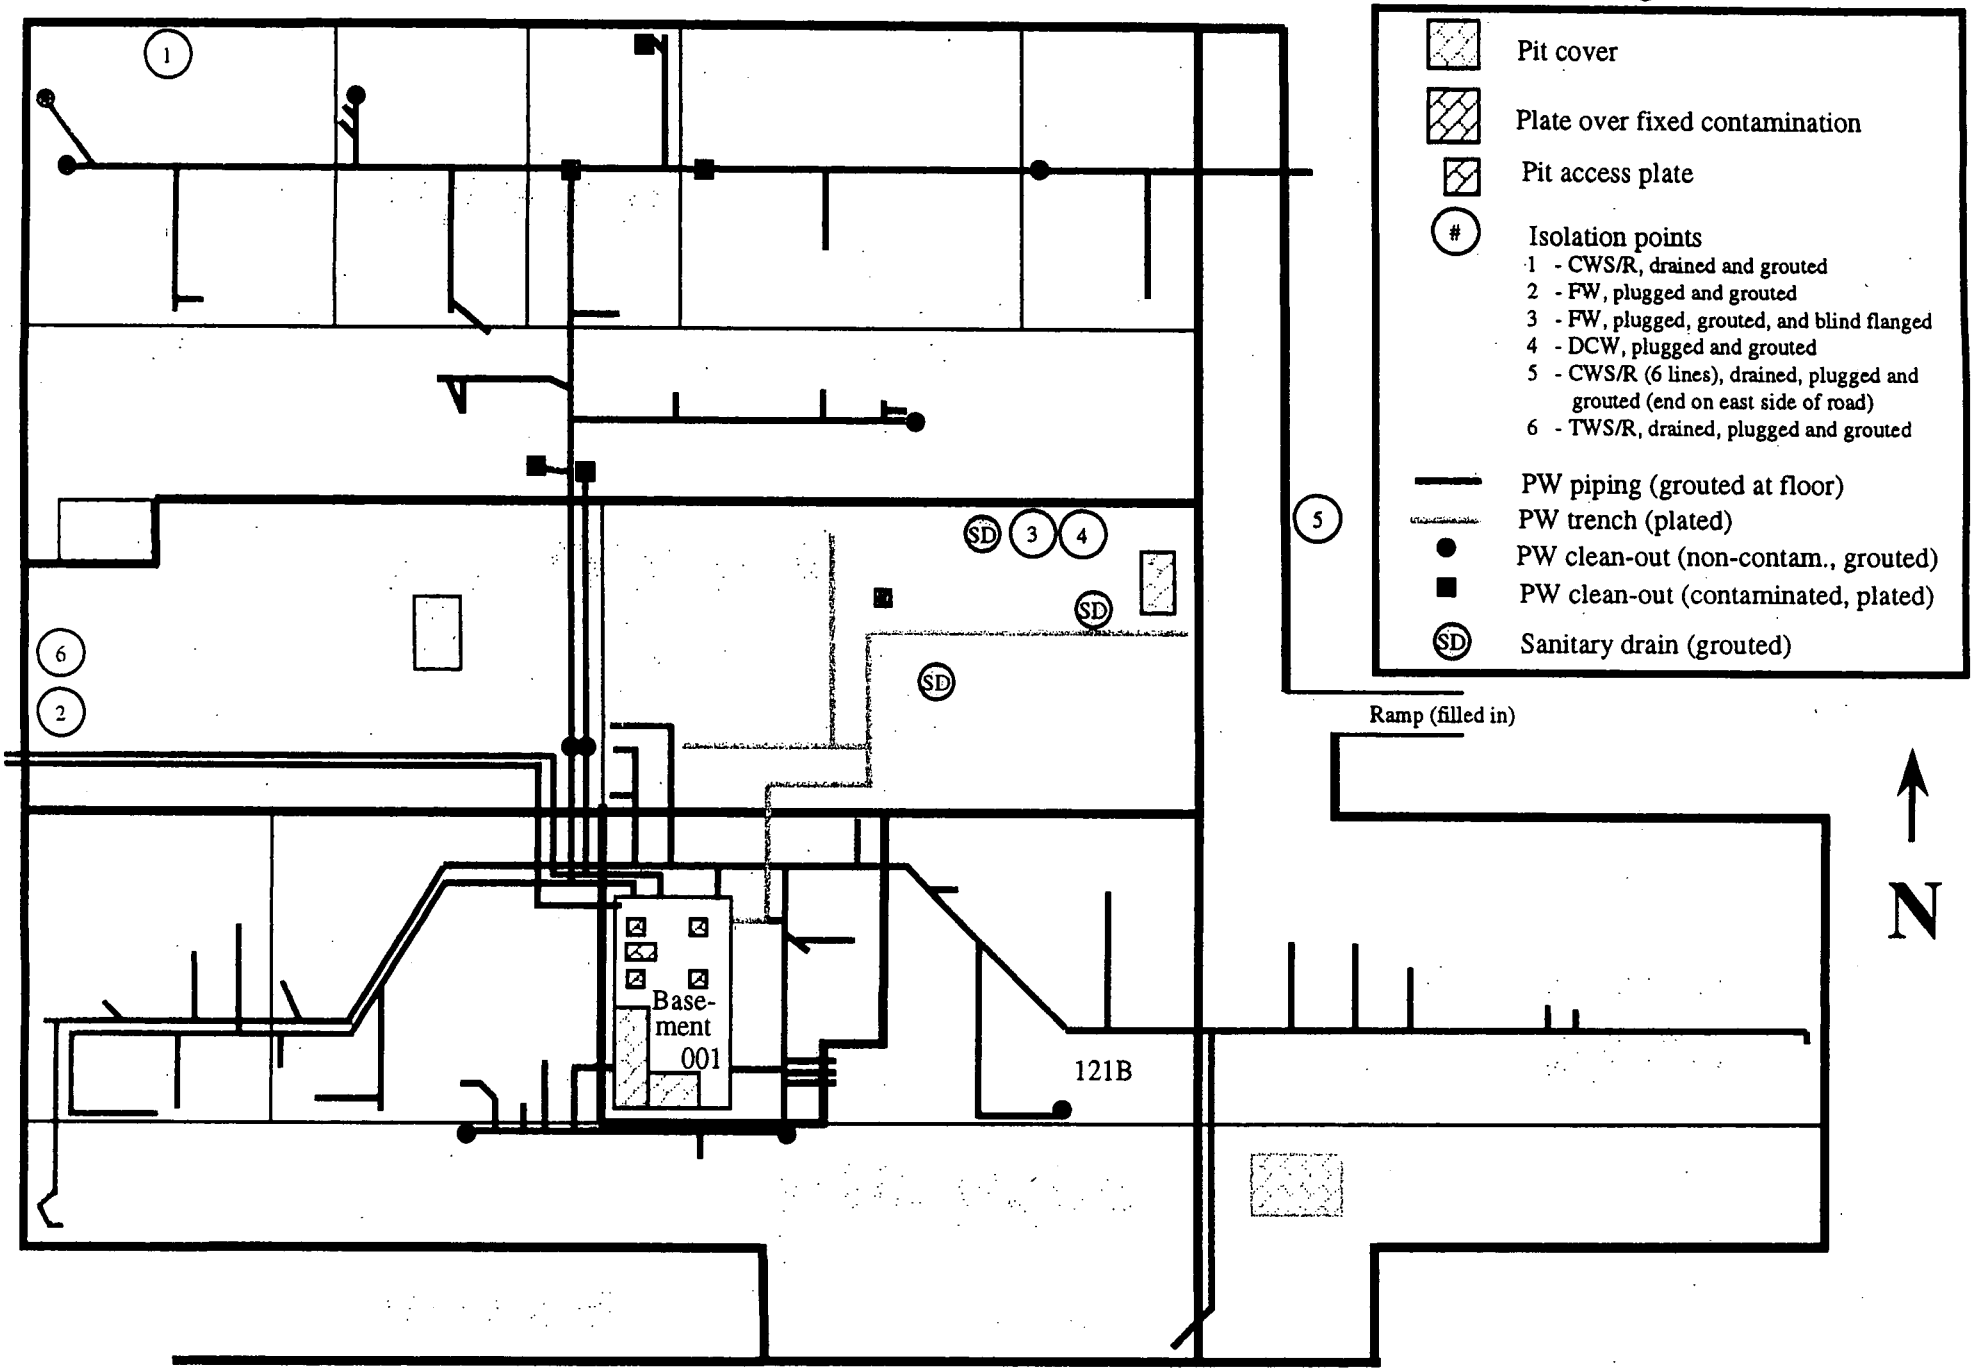
BUILDING 779 FIRST FLOOR - Slab Details

SLAB DETAILS FOR BUILDING 779

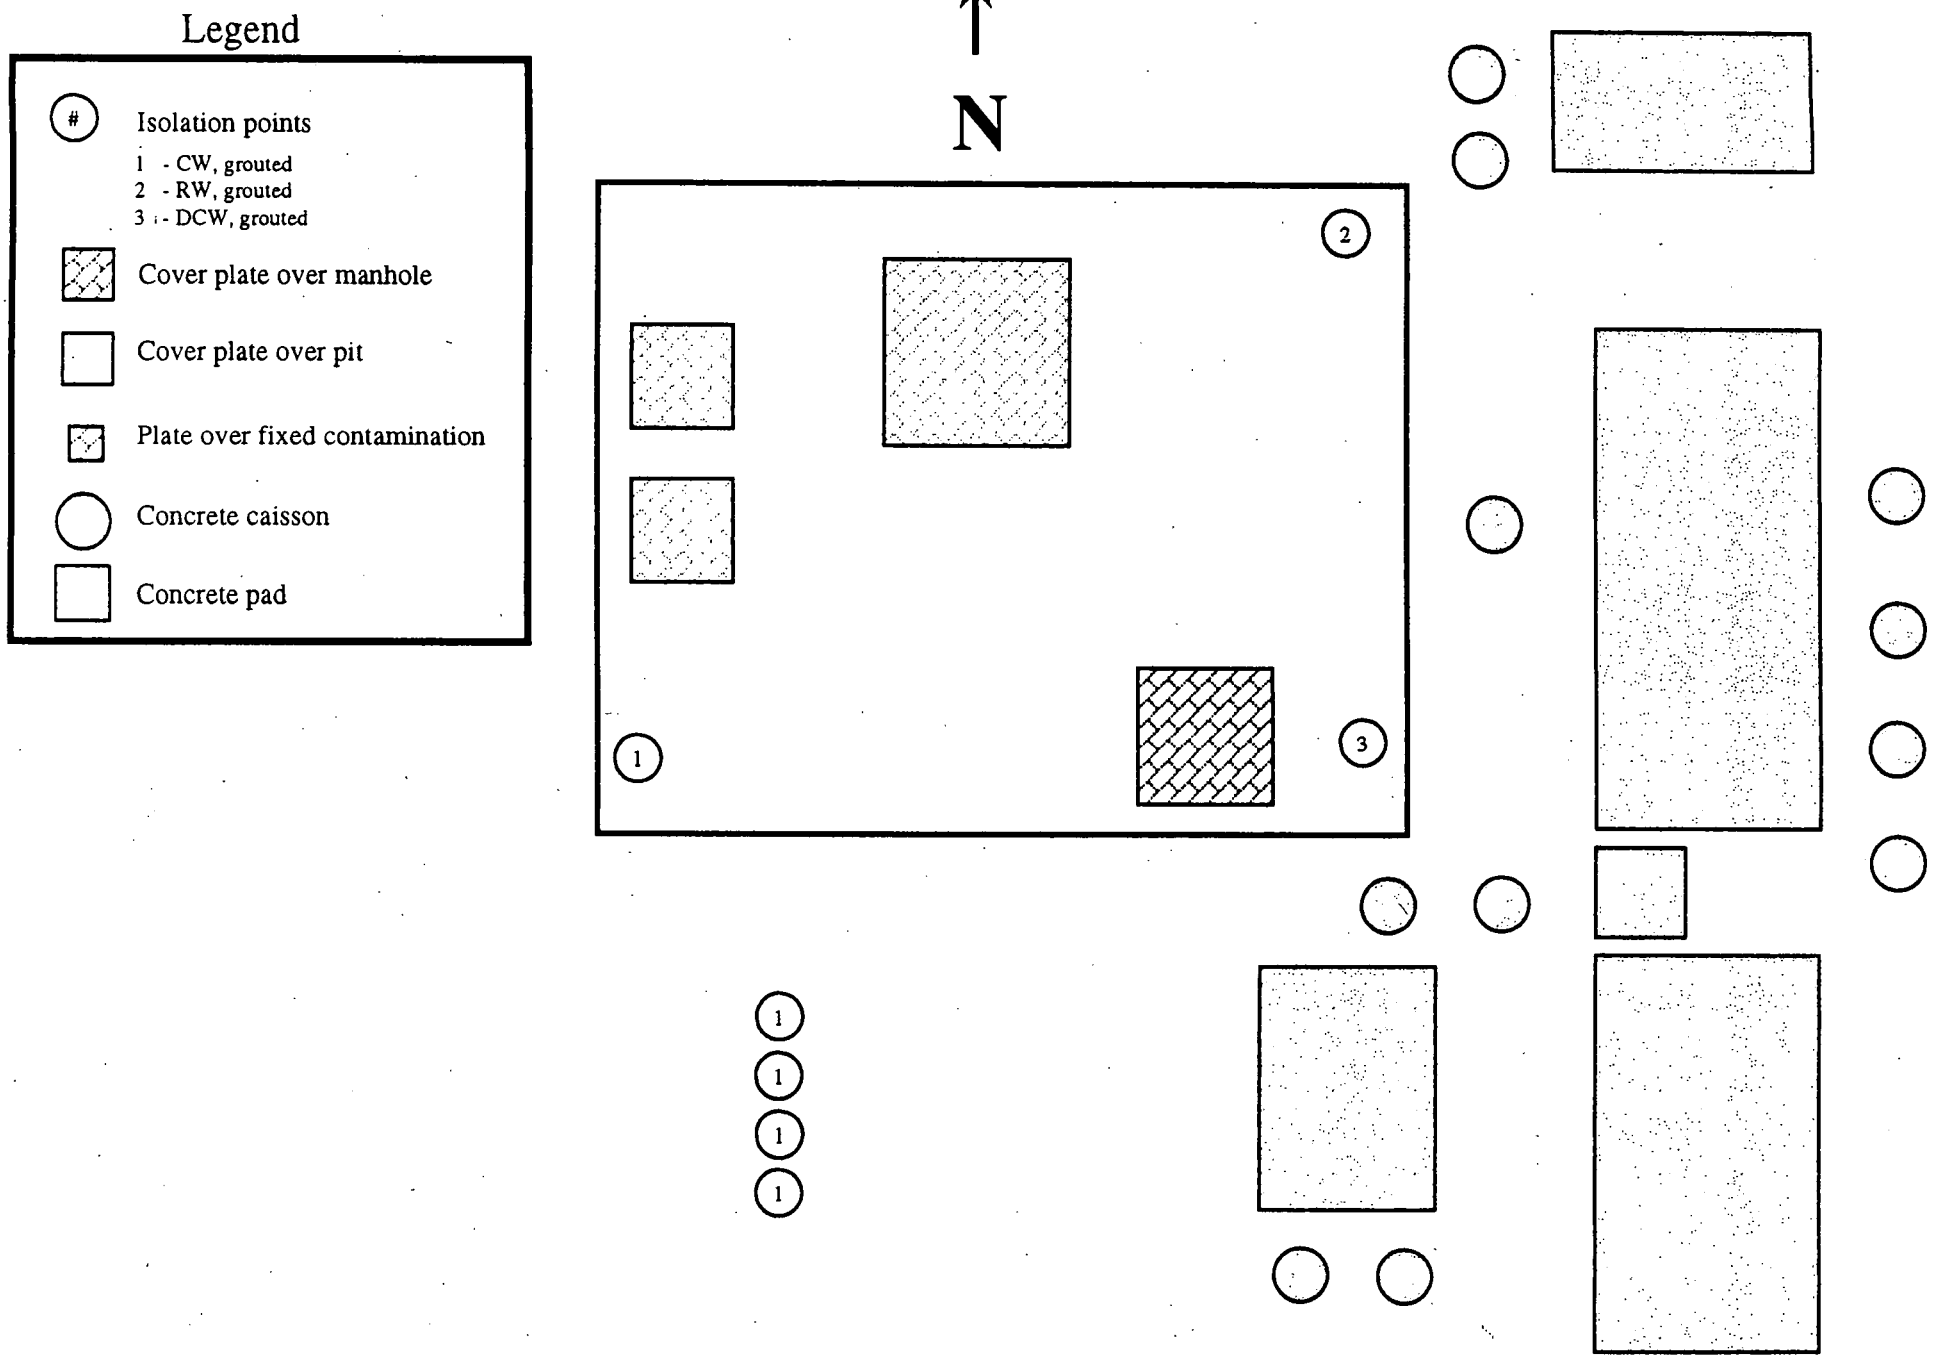
BUILDING 783 - Slab Details

SLAB DETAILS FOR BUILDING 783

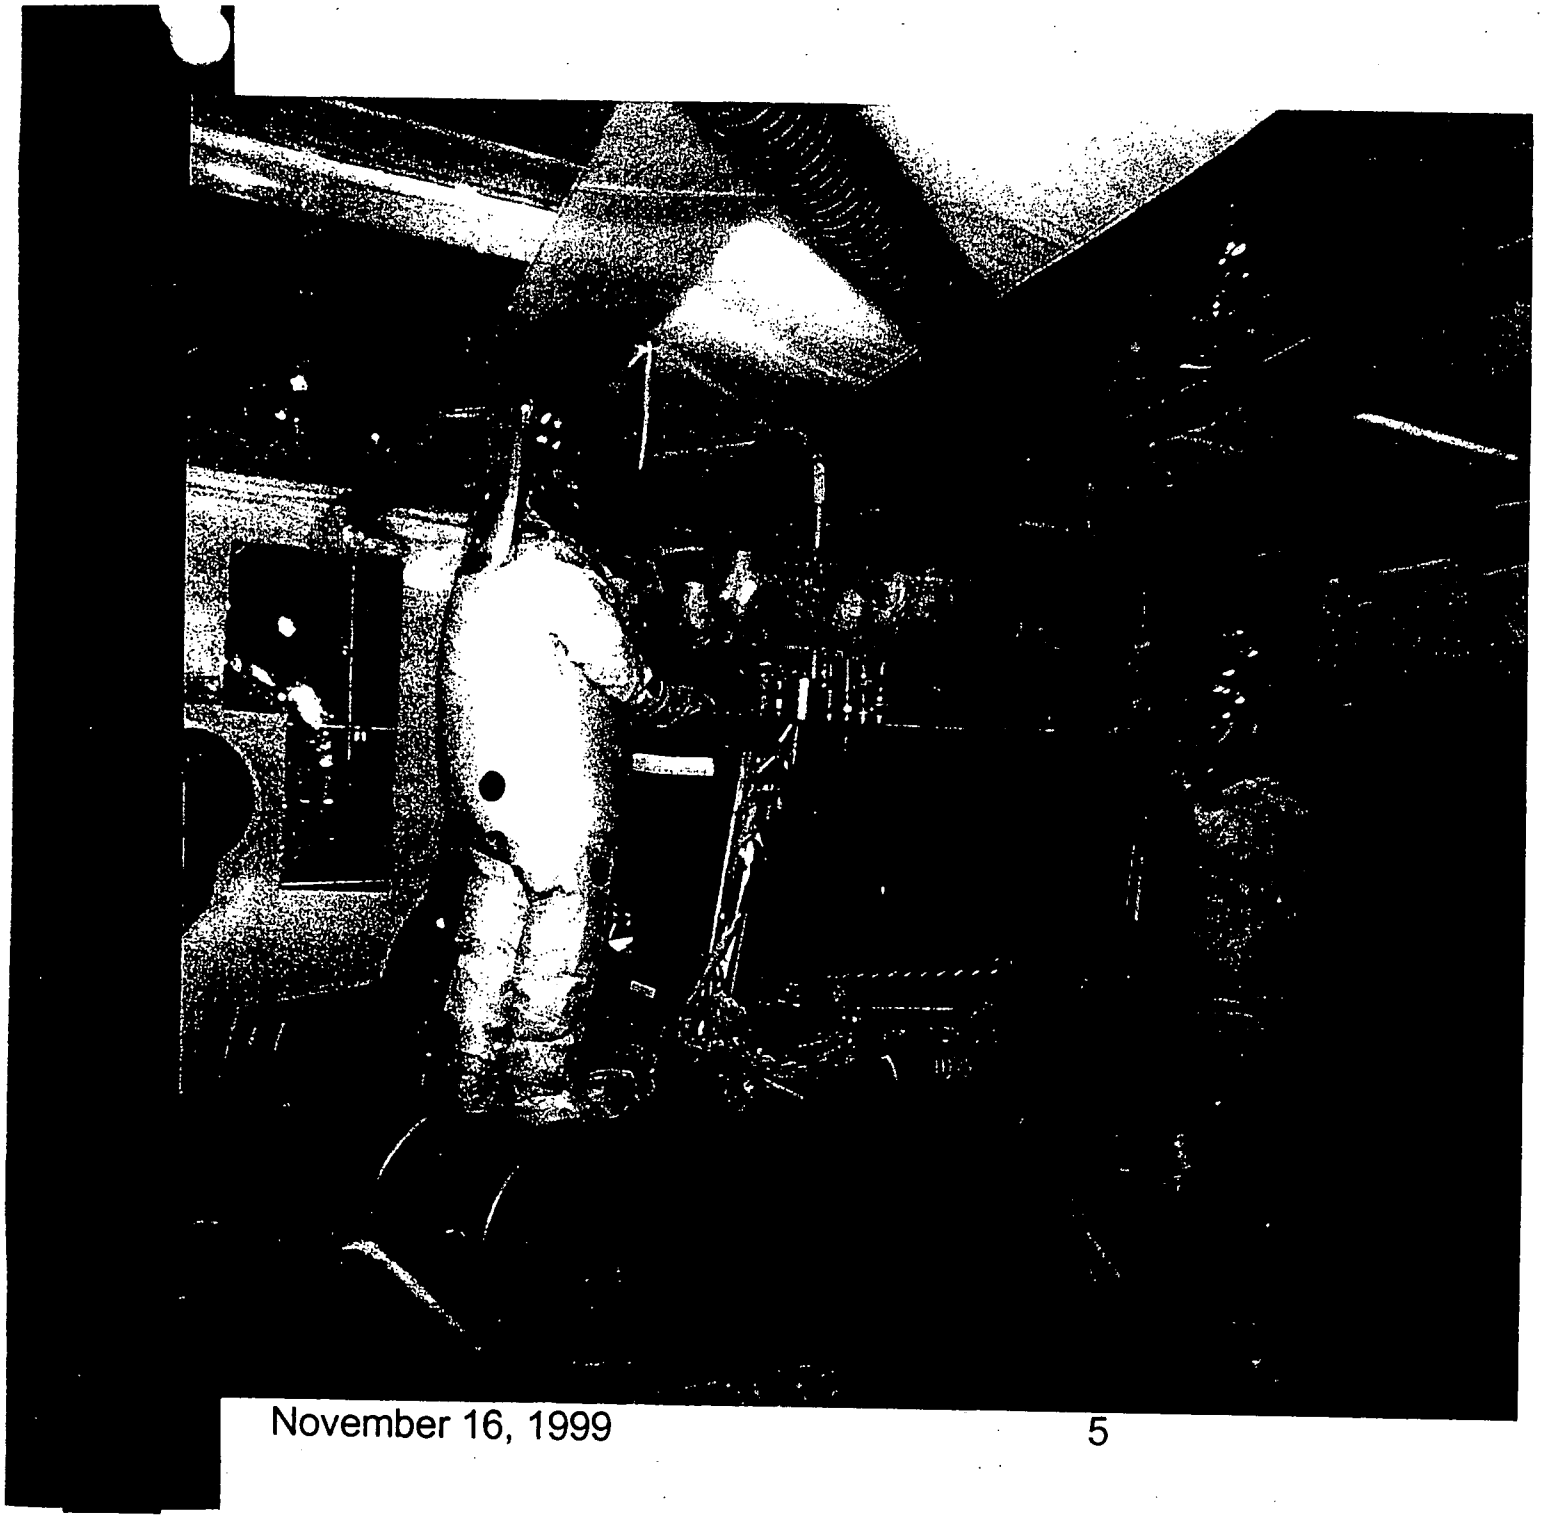
Building 779 - Room 140

Workers Dis-mantling Glovebox in Pre-Fab Tent

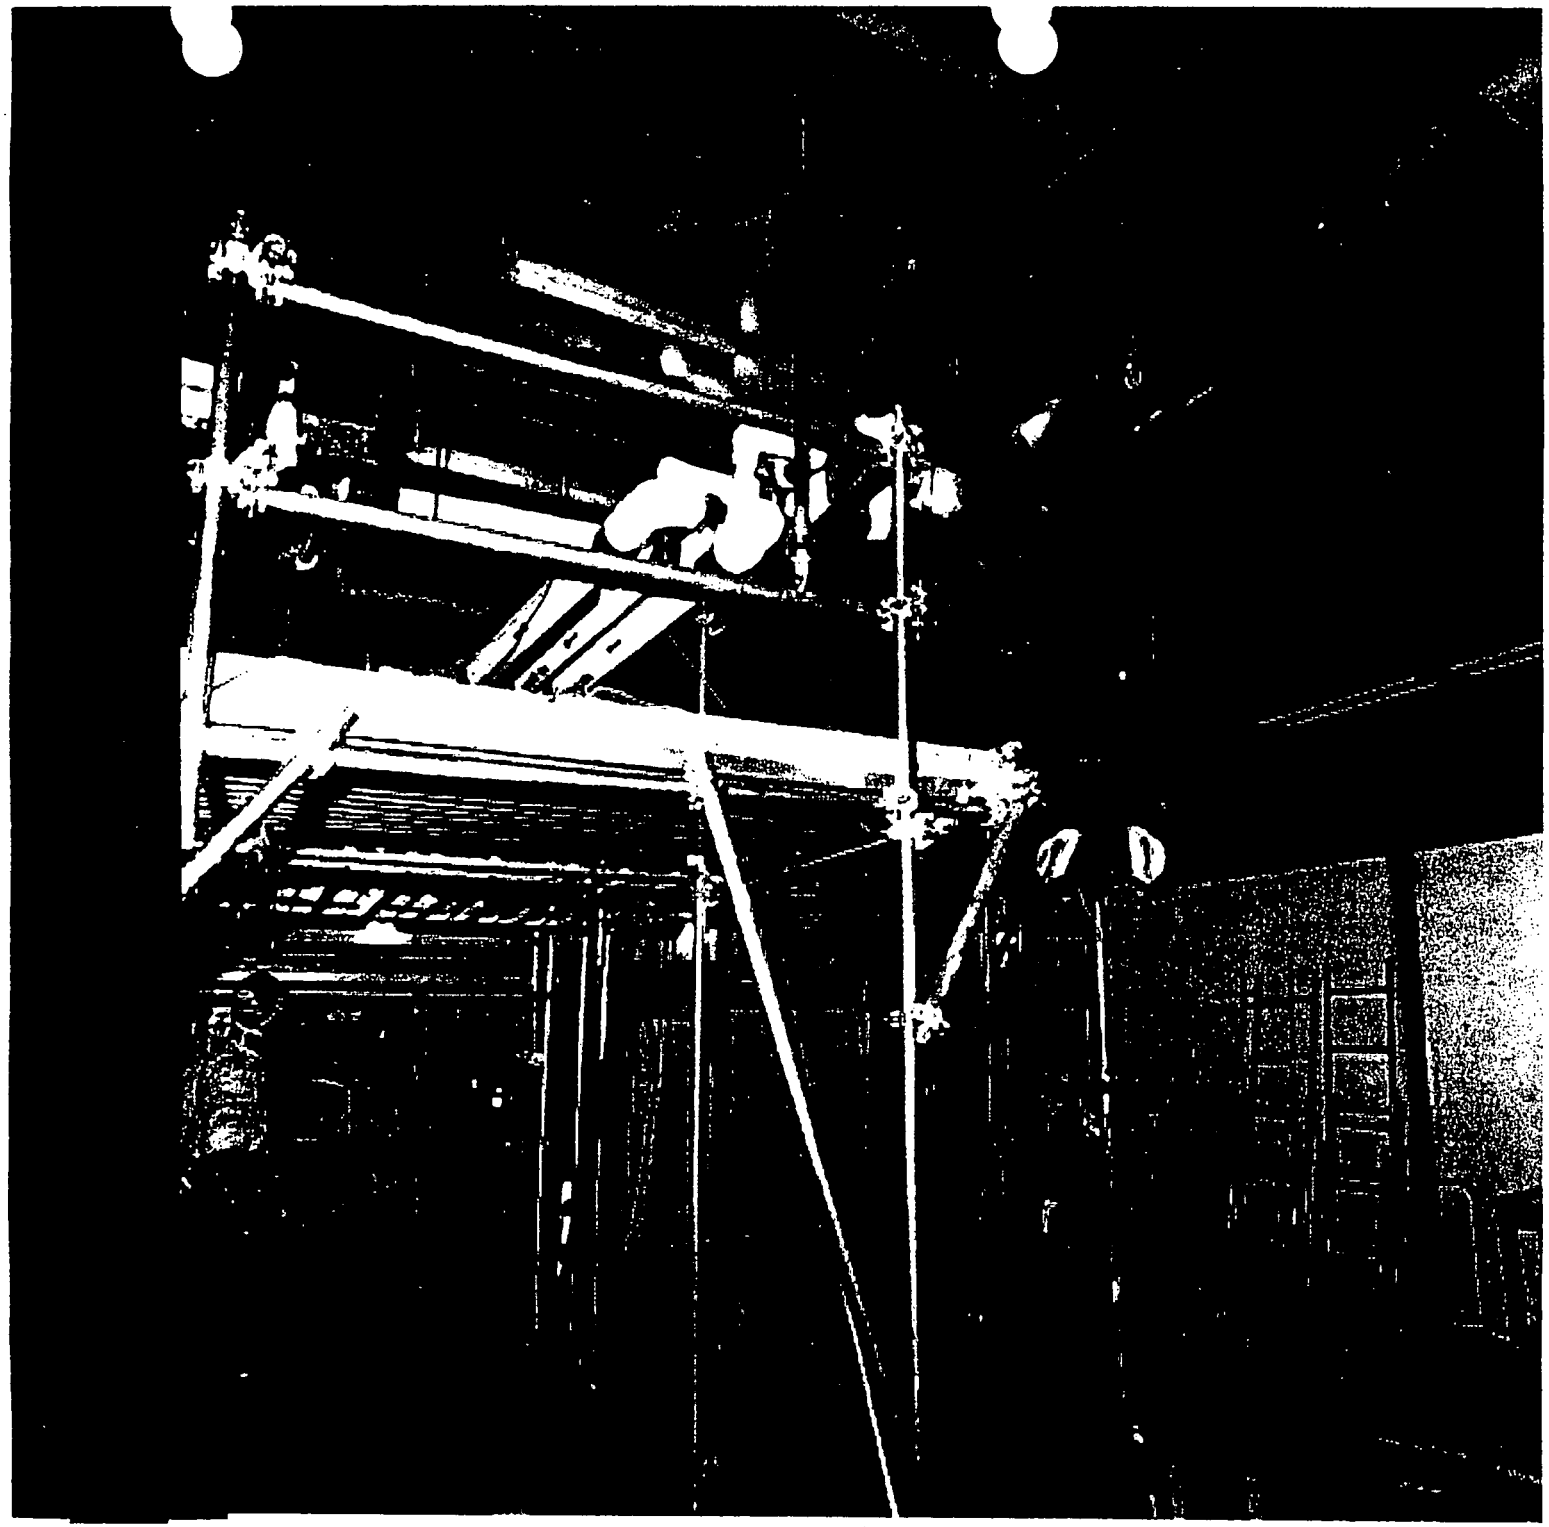
Building 779 - Rooms 146 & 151

Ceiling, Beginning Removal and Walls Gone
