Rocky Flats Environmental Technology Site

PRE-DEMOLITION SURVEY REPORT (PDSR)

BUILDING 771 MAINTENANCE SHOP

June 4, 2003

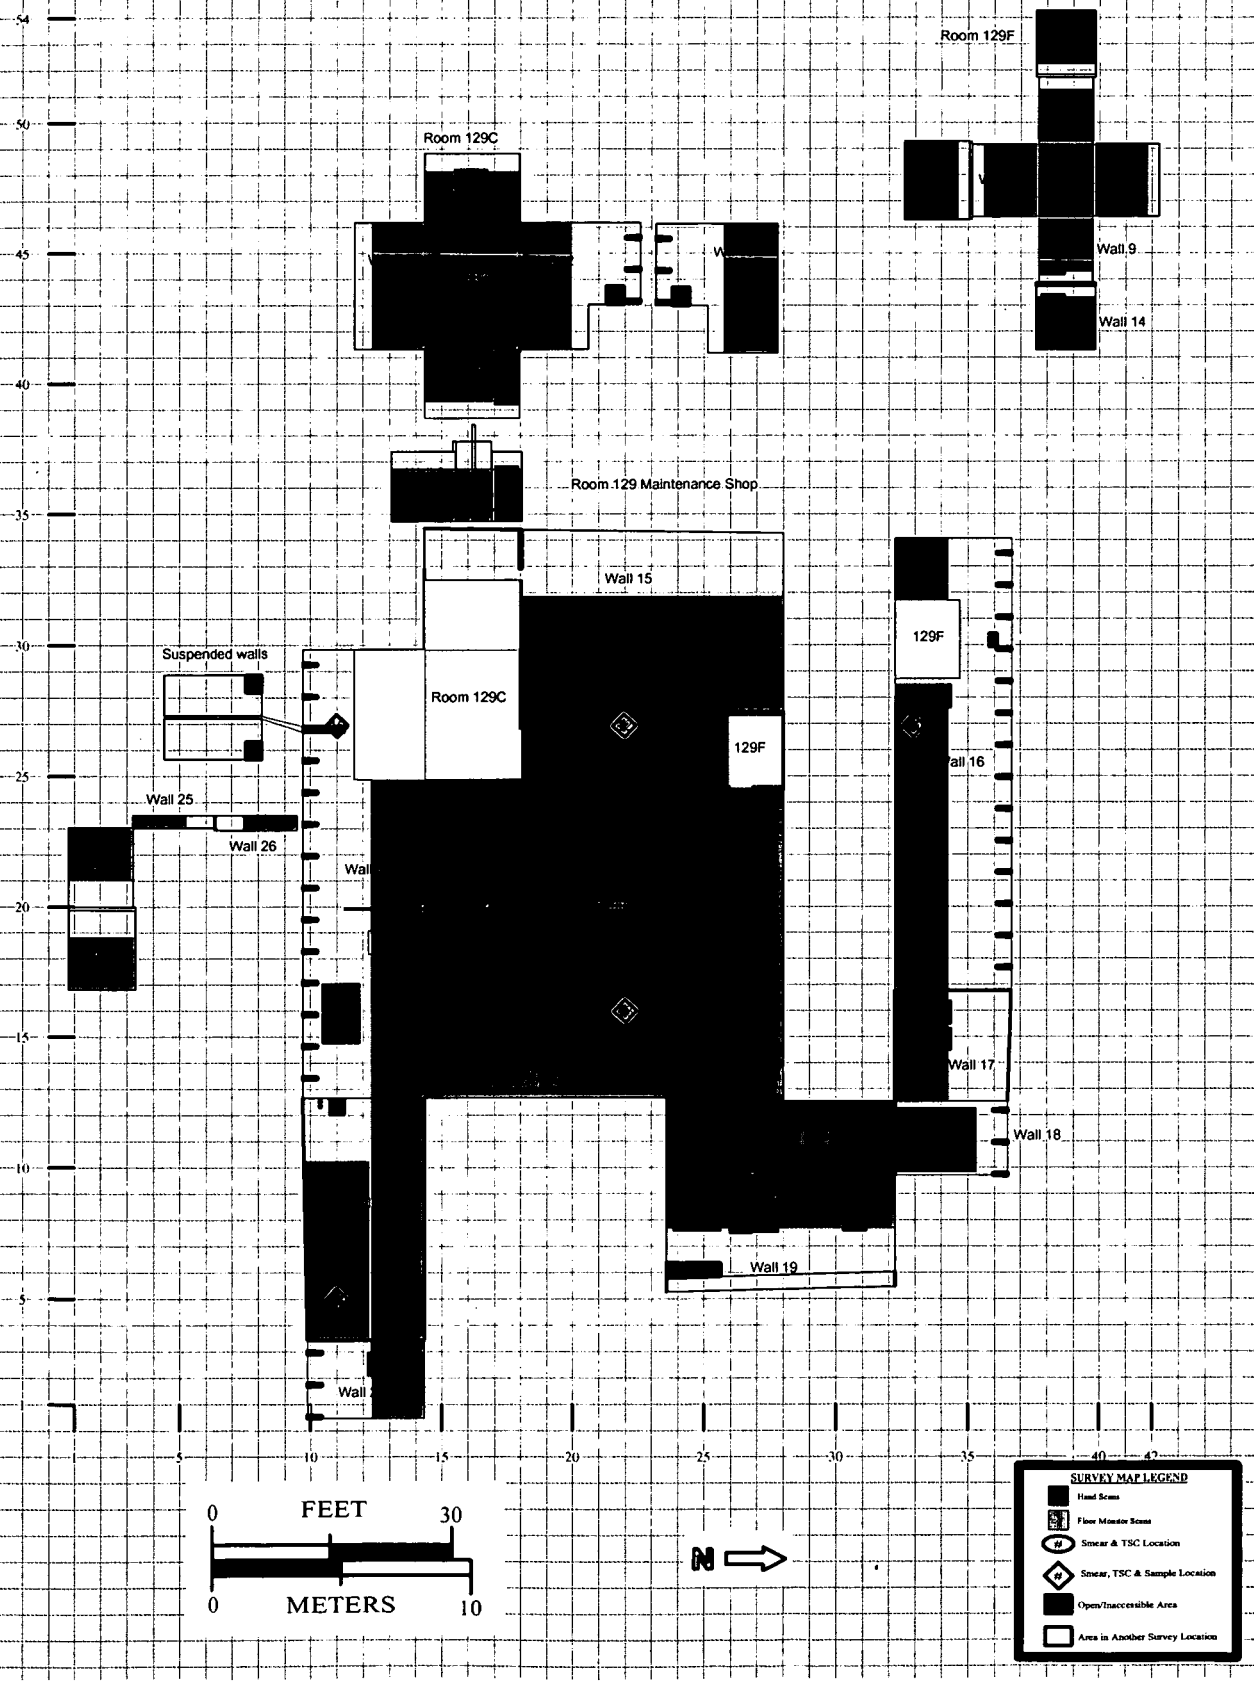
SURVEY UNIT 771031 - MAP 1 OF 3

All scans, surveys, and media sample results in survey unit 771031 were less than the applicable PDS transuranic DCGL values. Radiological survey data, statistical analysis results, survey locations, and radiological scan maps for survey unit 771031 are presented in Attachment B, *Survey Unit 771031 Radiological Data Summary and Survey Map.*

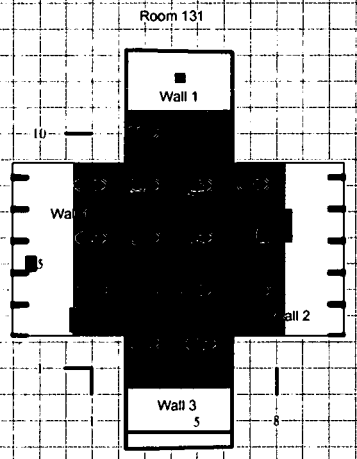
SURVEY UNIT 771081 - MAP 1 OF 1

The floors and lower walls of Room 131 were classified as a MARSSIM Class 1 Survey Unit, due to the identification of several spots of contamination in excess of the DCGLs (identified during initial PDS scans of the Maintenance Shop). A total of 15 random TSA and RSA measurements were taken and scan surveys performed. Surface scan surveys of 100% of the floor/lower wall surfaces (67 m^2) were performed. No media samples were collected, because the paint was removed from the surface prior to PDS.

Fixed radiological contamination up to 891 dpm/100cm^2 was identified in several discrete locations of the floor and one spot on the lower wall of Room 131, including a 26,469 dpm/100cm^2 spot identified inside a trough that had previously been grouted (the grout was removed in order to complete the PDS). An embedded pipe (drain) was physically removed from the trough and PDS follow up scan surveys verified the contamination was removed. All other areas of contamination were remediated by removing the affected area of concrete. The remaining portion of the drain (located in the yard area west of the Room 131) will be removed during slab demolition.

Because the contamination was limited primarily to the floor, the source of the contamination was most likely a liquid spill. Therefore, the upper walls/ceiling of Room 131, which would not have been affected by a liquid spill, was delineated as a separate survey unit (771082).

All other locations and surveys in survey unit 771081 were less than the applicable PDS transuranic DCGL values. Radiological survey data, statistical analysis results, survey locations, and radiological scan maps for survey unit 771081 are presented in Attachment C, *Survey Unit 771081 Radiological Data Summary and Survey Map.*

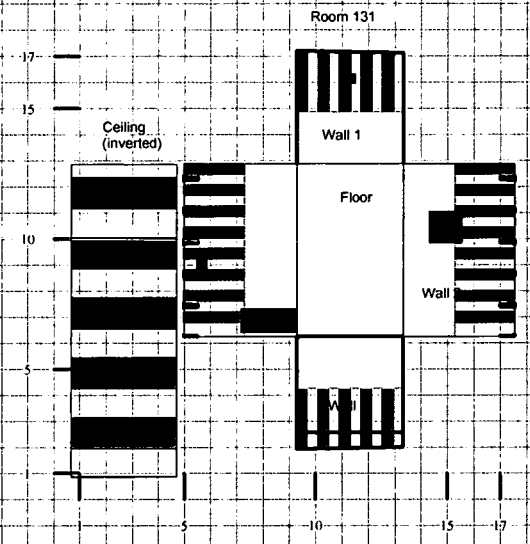
SURVEY UNIT 771082 - MAP 1 OF 1

contamination on the floors/lower wall of the room, although no contamination in excess of the unrestricted release limits was identified on the upper walls during the initial PDS. A total of 15 random TSA and RSA measurements, and 15 media samples were collected. Surface scan surveys of 50% of the upper walls (26 m^2) and ceiling (24 m^2) were also performed.

All scans, surveys, and media samples results in survey unit 771082 were less than the applicable PDS transuranic DCGL values. Radiological survey data, statistical analysis results, survey locations, and radiological scan maps for survey unit 771082 are presented in Attachment D, *Survey Unit 771082 Radiological Data Summary and Survey Map.*

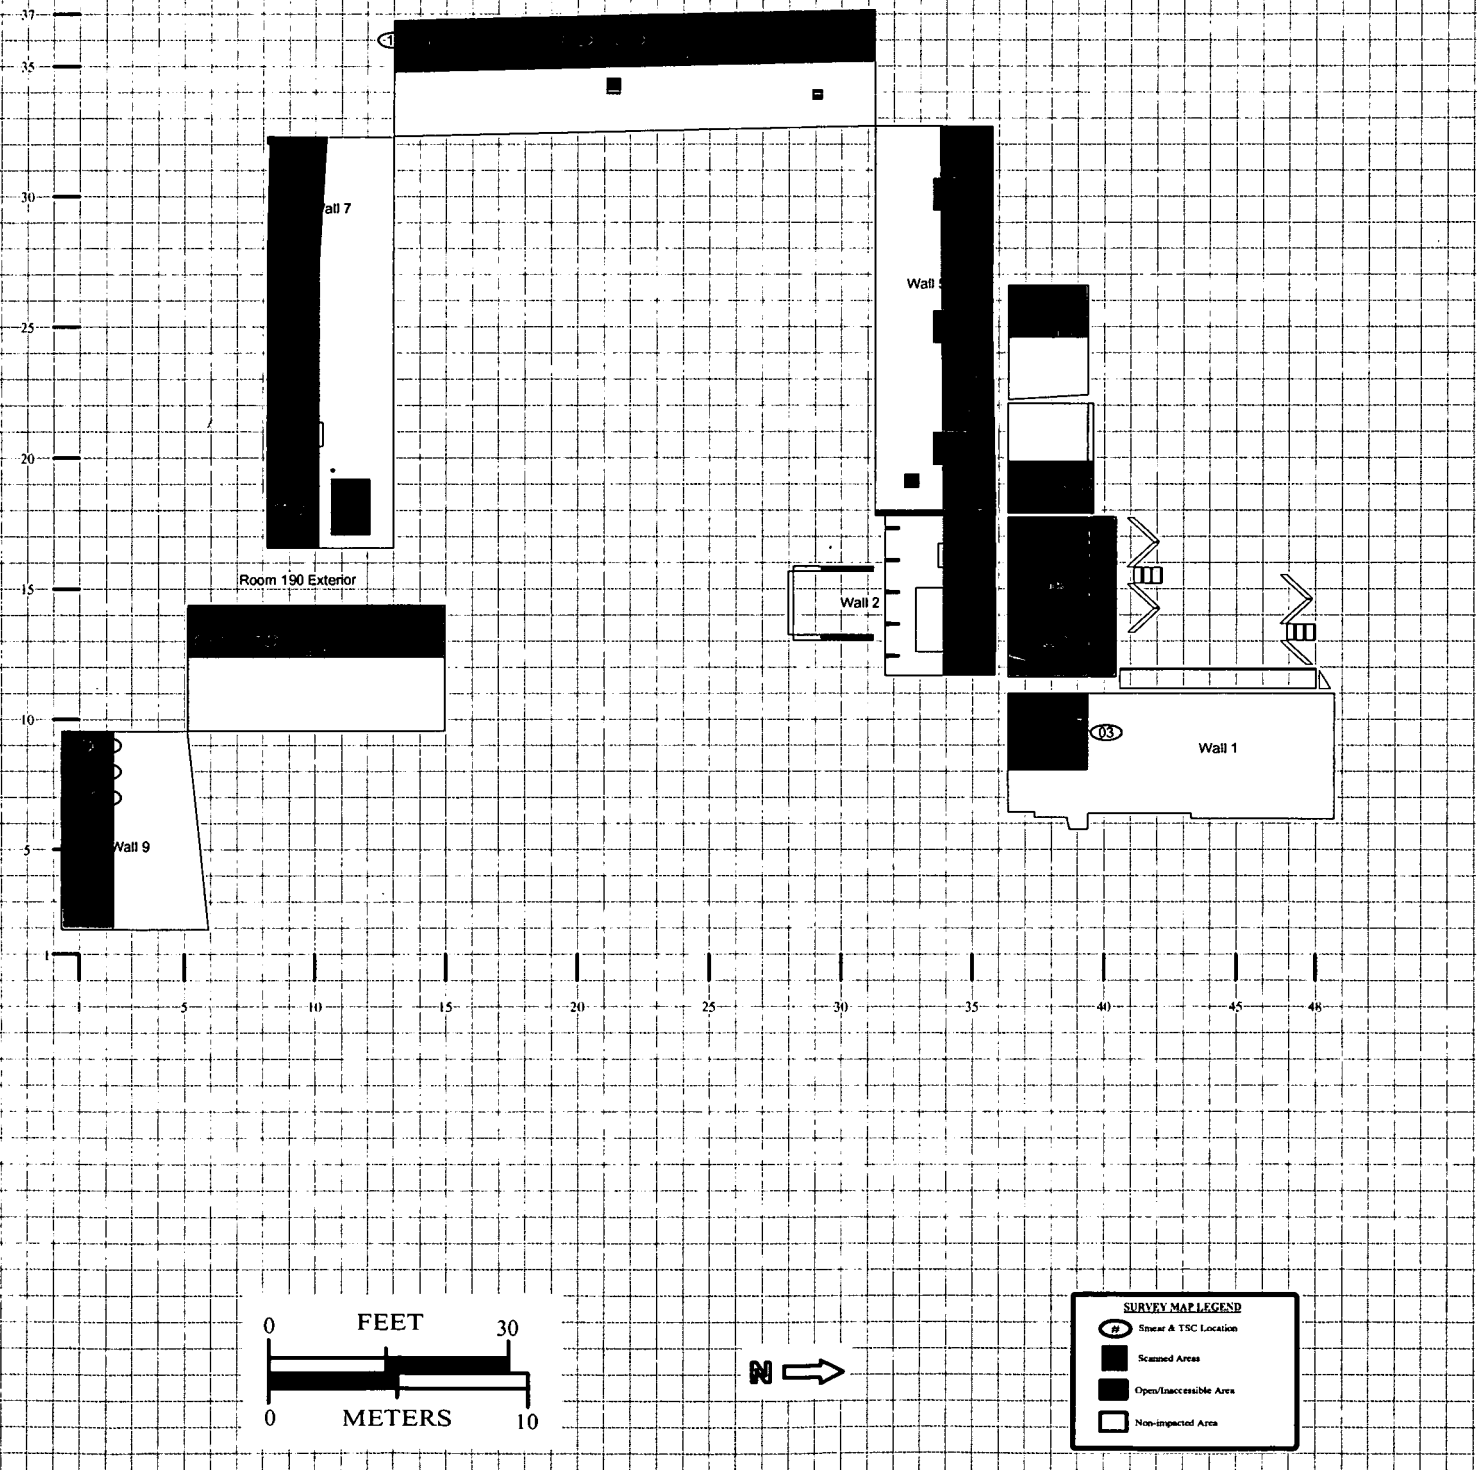
SURVEY UNIT 771068 - MAP 1 OF 1

A total of 15 random TSA and RSA measurements were collected. Surface scan surveys of 100% of the lower walls below 2 meters (~ 165 m^2) were also performed.

A small, discrete area of elevated activity was identified on the lower wall of the Maintenance Shop exterior (~ 4900 dpm/100 cm^2). The concrete surface was scarred in this area, which indicates that the contamination likely originated from a forklift or other piece of equipment. The contamination was remediated, and no additional areas of elevated activity were identified during PDS.
