RF/RMRS-97-124.UN

RECONNAISSANCE LEVEL CHARACTERIZATION REPORT

FOR THE 886 CLUSTER DECOMMISSIONING PROJECT

December 24, 1997
Revision 1

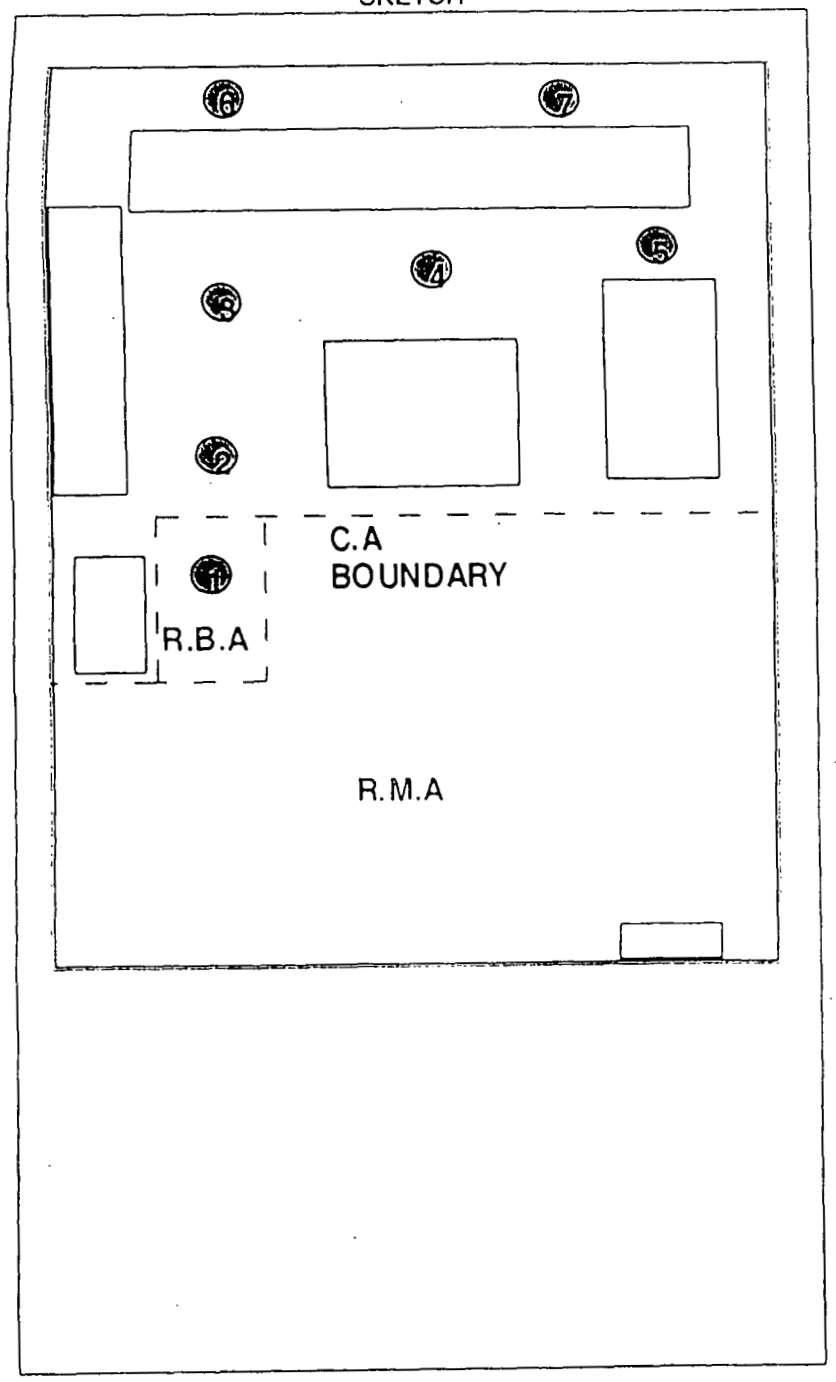
LOG# 886-3W

Swipe #	Location/description	Removable Alpha	Removable Beta/Gamma	Total Alpha 60 sec count	Total Beta/Gamma
1	C.A. FLOOR SURVEY	< 18	< 205		
2	C.A. FLOOR SURVEY	< 18	< 205		
3	C.A. FLOOR SURVEY	< 18	< 205		
4	C.A. FLOOR SURVEY	< 18	< 205		
5	C.A. FLOOR SURVEY	< 18	< 205		
6	C.A. FLOOR SURVEY	< 18	< 205		
7	C.A. FLOOR SURVEY	< 18	< 205

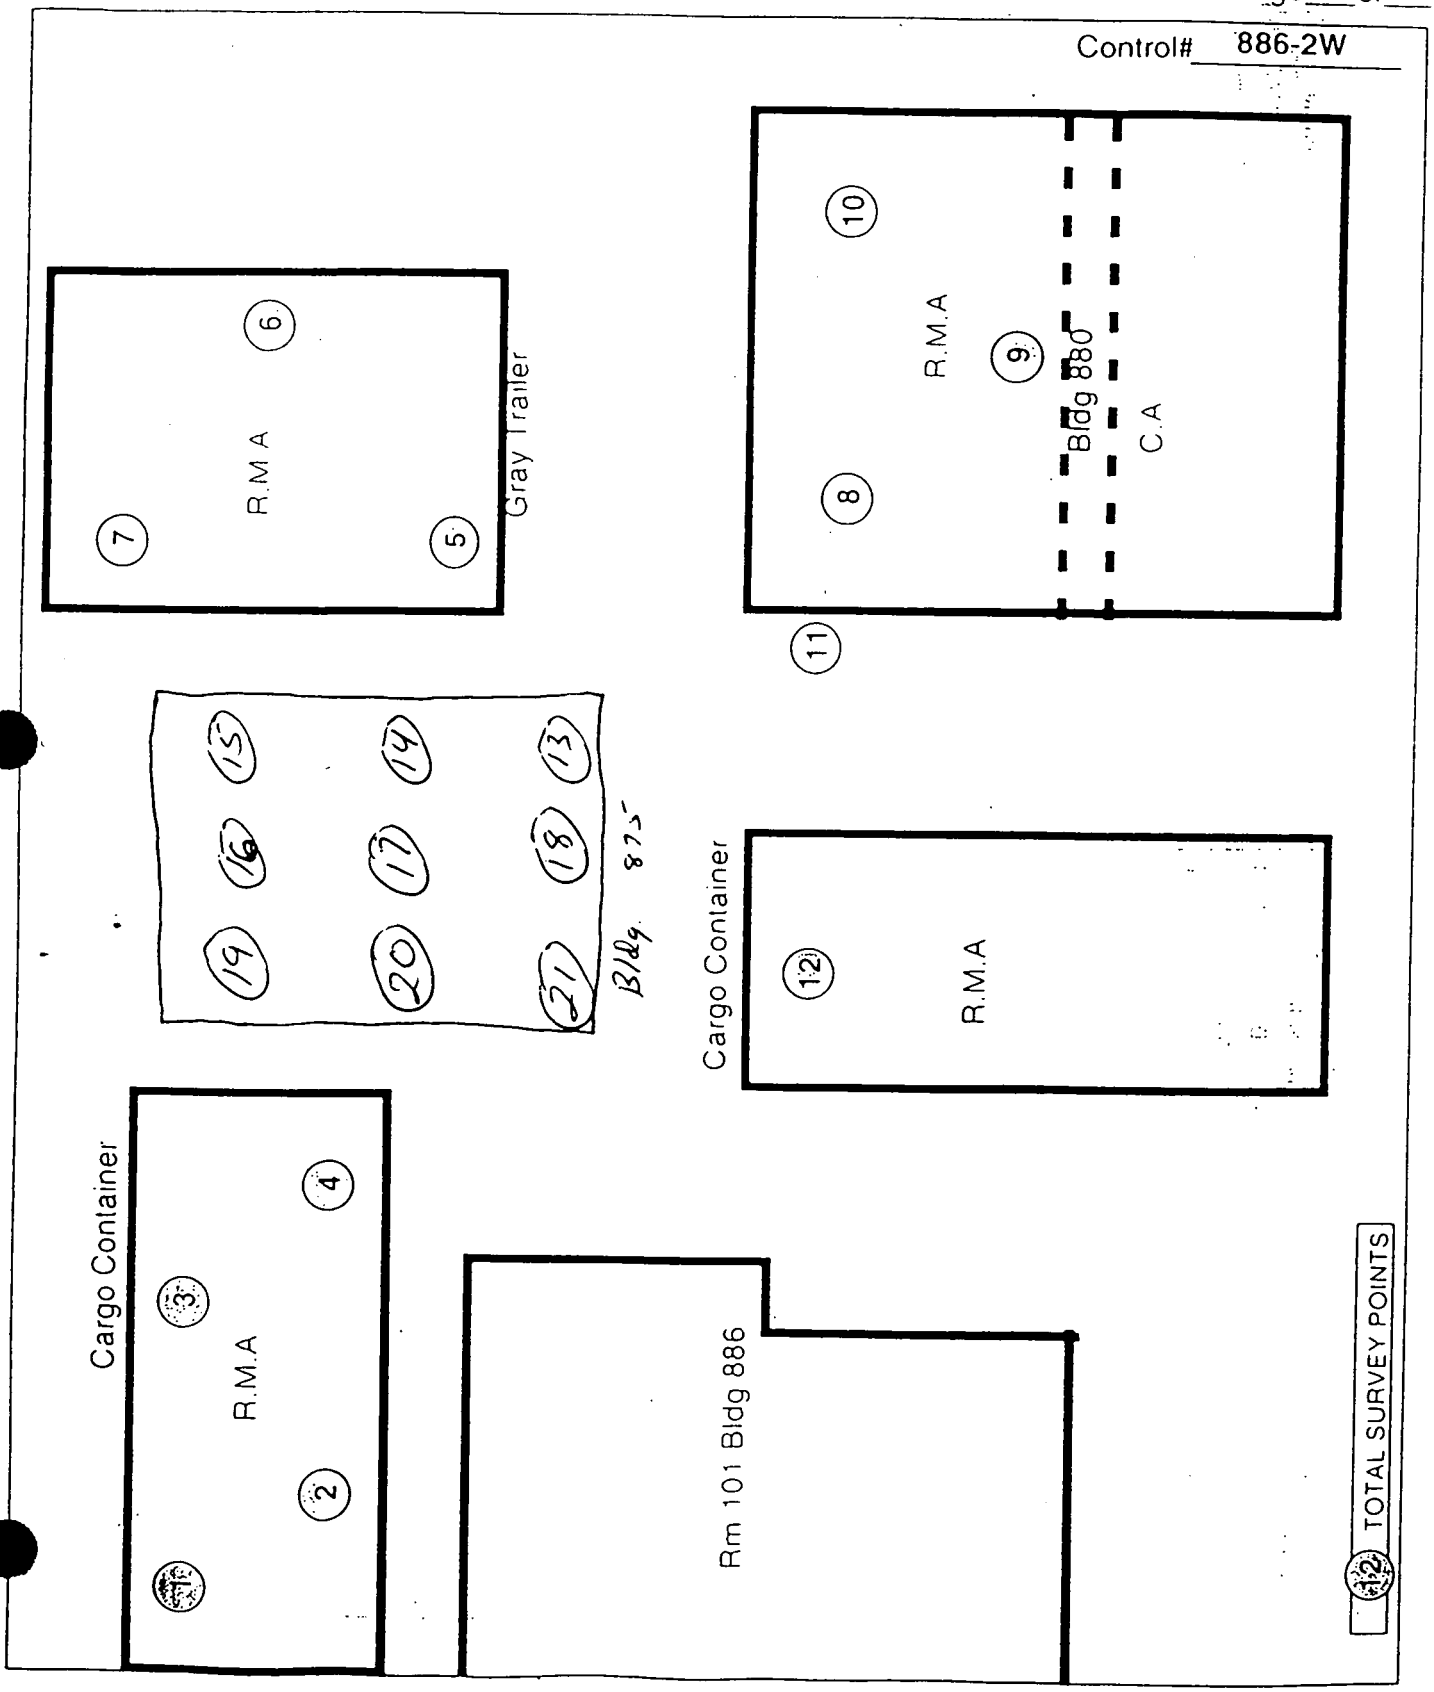
Control# 886-2W

LOG NUMBER:	886-2W
P/WRE _____	ROUTINE X
R.W.P _____	OTHER _____
BUILDING/LOCATION 880/CARGO CONTAIN.	ROOM#: SEE ATTACHED
DATE: 11-6-97	TIME: 1400
ITEM DESCRIPTION:	FLOOR SURVEY OF BLDG. 880
AND TWO CARGO CONTAINER'S AND THE GRAY TRAILER	
R.M.A AREAS ONLY.

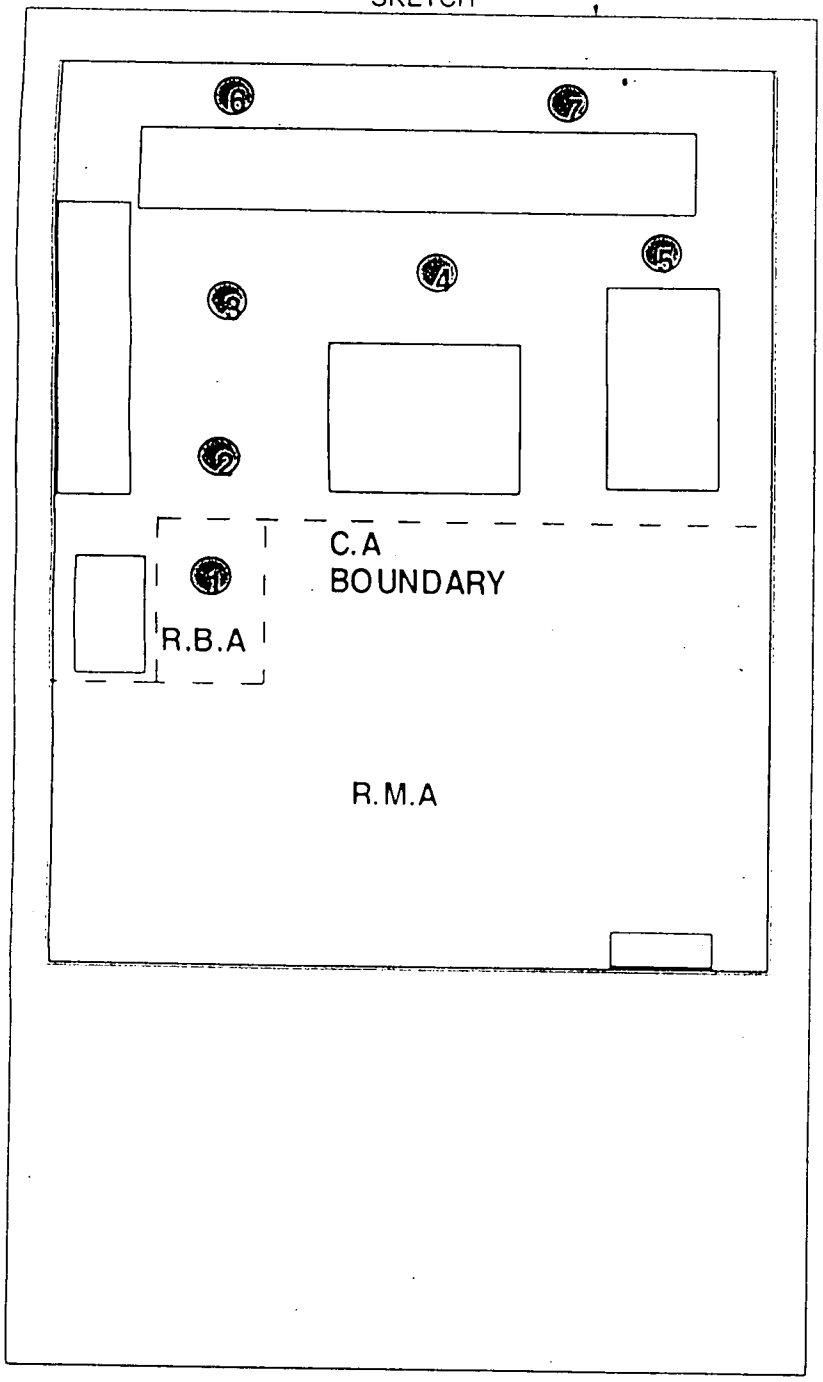
LOG# 8886-3W RADIOLOGICAL OPERATIONS CONTAMINATION SURVEY FORM

Swipe #	Location/description	Removable Alpha	Removable Beta/ Gamma	Total Alpha 60 sec count	Total Beta/ Gamma
1	C.A. FLOOR SURVEY	< 18			
2	C.A. FLOOR SURVEY	< 18			
3	C.A. FLOOR SURVEY	< 18			
4	C.A. FLOOR SURVEY	< 18			
5	C.A. FLOOR SURVEY	< 18			
6	C.A. FLOOR SURVEY	< 18			
7	C.A. FLOOR SURVEY	< 18

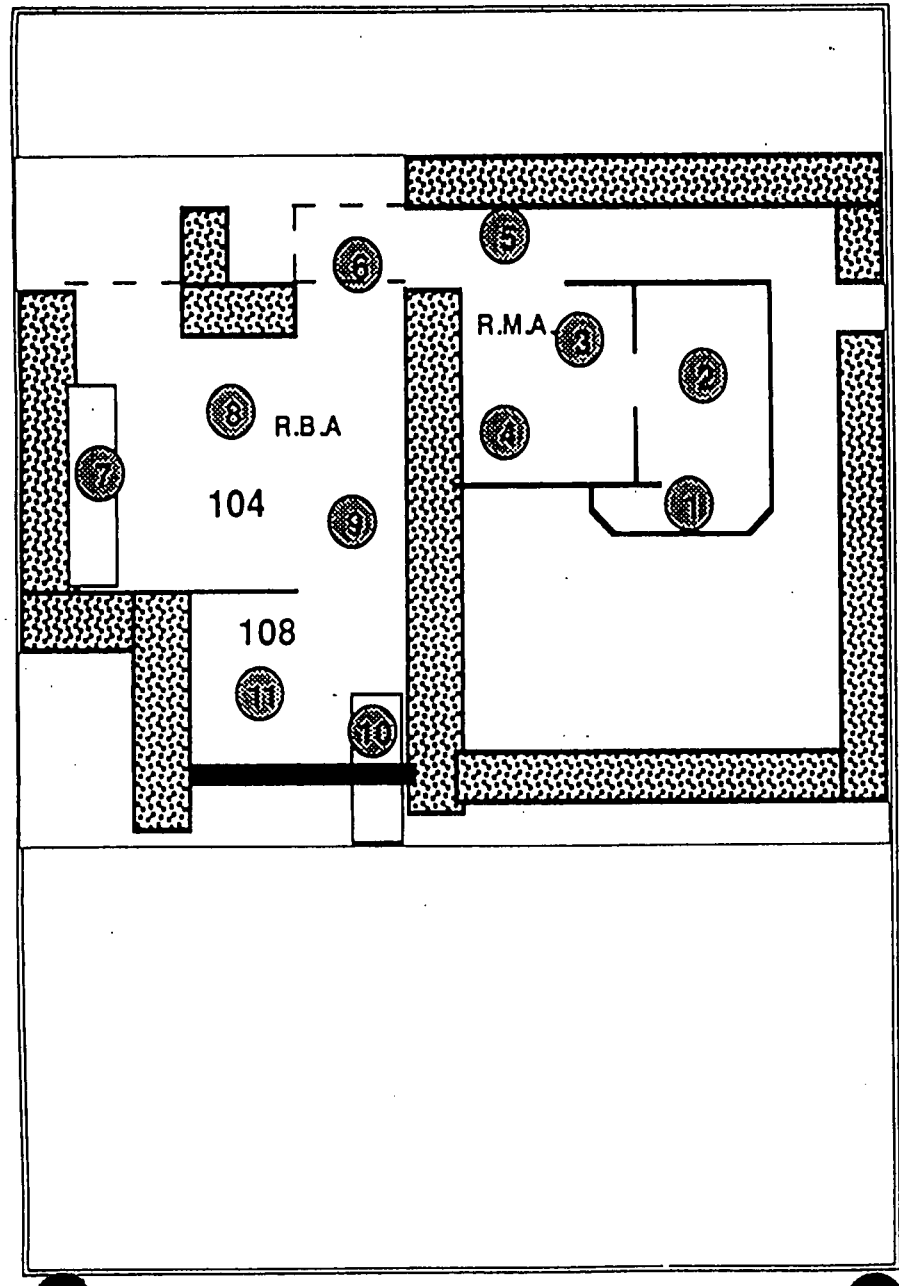
LOG# 886-1D

Swipe #	Location/description	Removable Alpha	Removable Beta/ Gamma	Total Alpha 60 sec count	Total Beta/ Gamma
1	R.M.A CLOTHING AREA	< 18			
2	R.M.A CLOTHING AREA	< 18			
3	R.M.A FLOOR SURVEY	< 18			
4	R.M.A FLOOR SURVEY	< 18			
5	R.M.A FLOOR SURVEY	< 18			
6	R.M.A FLOOR SURVEY	< 18			
7	R.B.A INSTRUMENT TABLE	< 18			
8	R.B.A FLOOR SURVEY	< 18			
9	R.B.A FLOOR SURVEY	< 18			
10	R.B.A TABLE AREA	< 18			
11	R.B.A FLOOR SURVEY	< 18

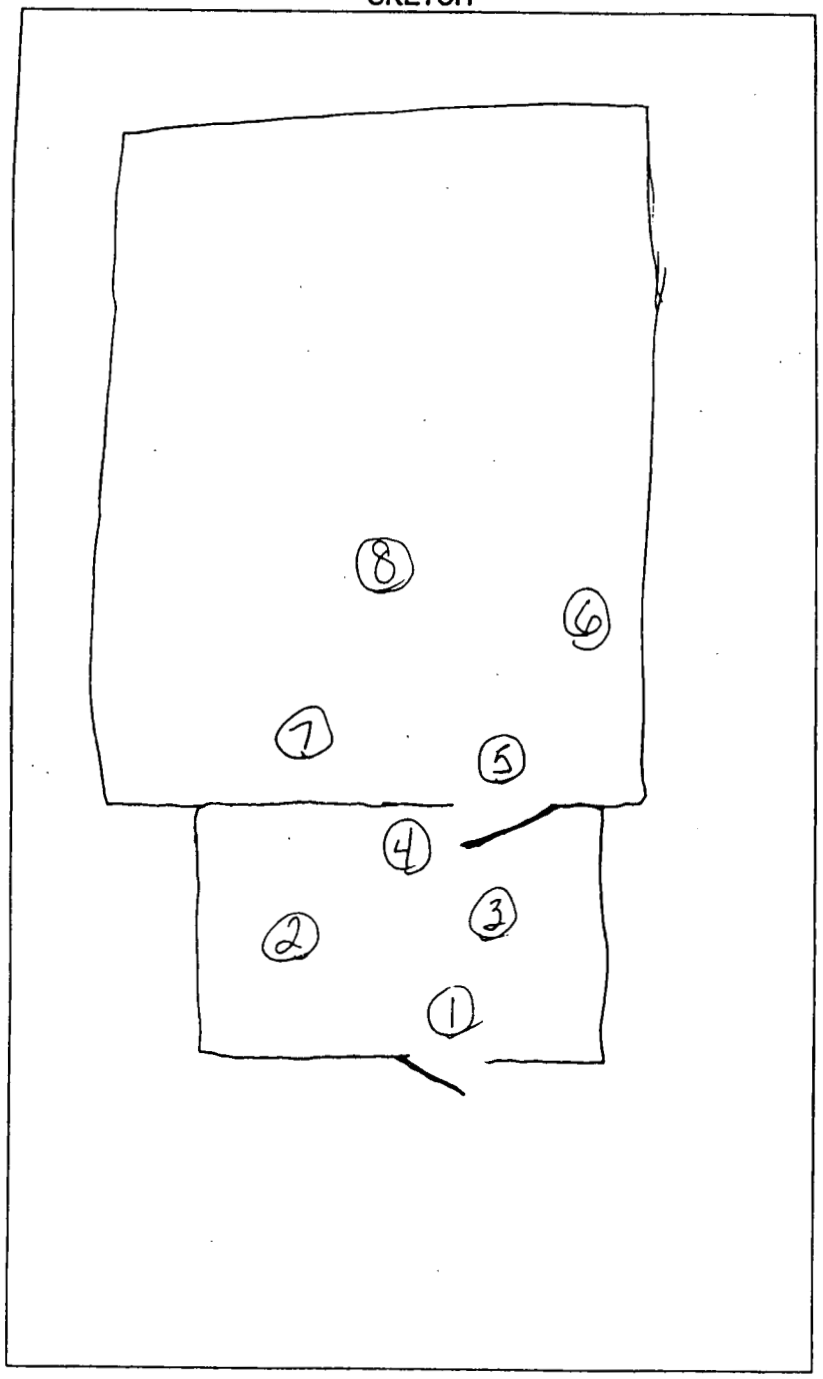
LOG# 96-881-6337 **RADIOLOGICAL OPERATIONS CONTAMINATION SURVEY FORM**

Swipe #	Location/description	Removable Alpha	Removable Beta/Gamma	Total Alpha 60 sec count	Total Beta/Gamma
1	101 / AIRLOCK	2000			
2	101 / AIRLOCK	2000			
3	101 / AIRLOCK	2000			
4	101 / AIRLOCK	2000			
5	101 / DOGHOUSE	20000			
6	101 / DOGHOUSE	24000			
7	101 / DOGHOUSE	28000			
8	101 / DOGHOUSE	4×10^6

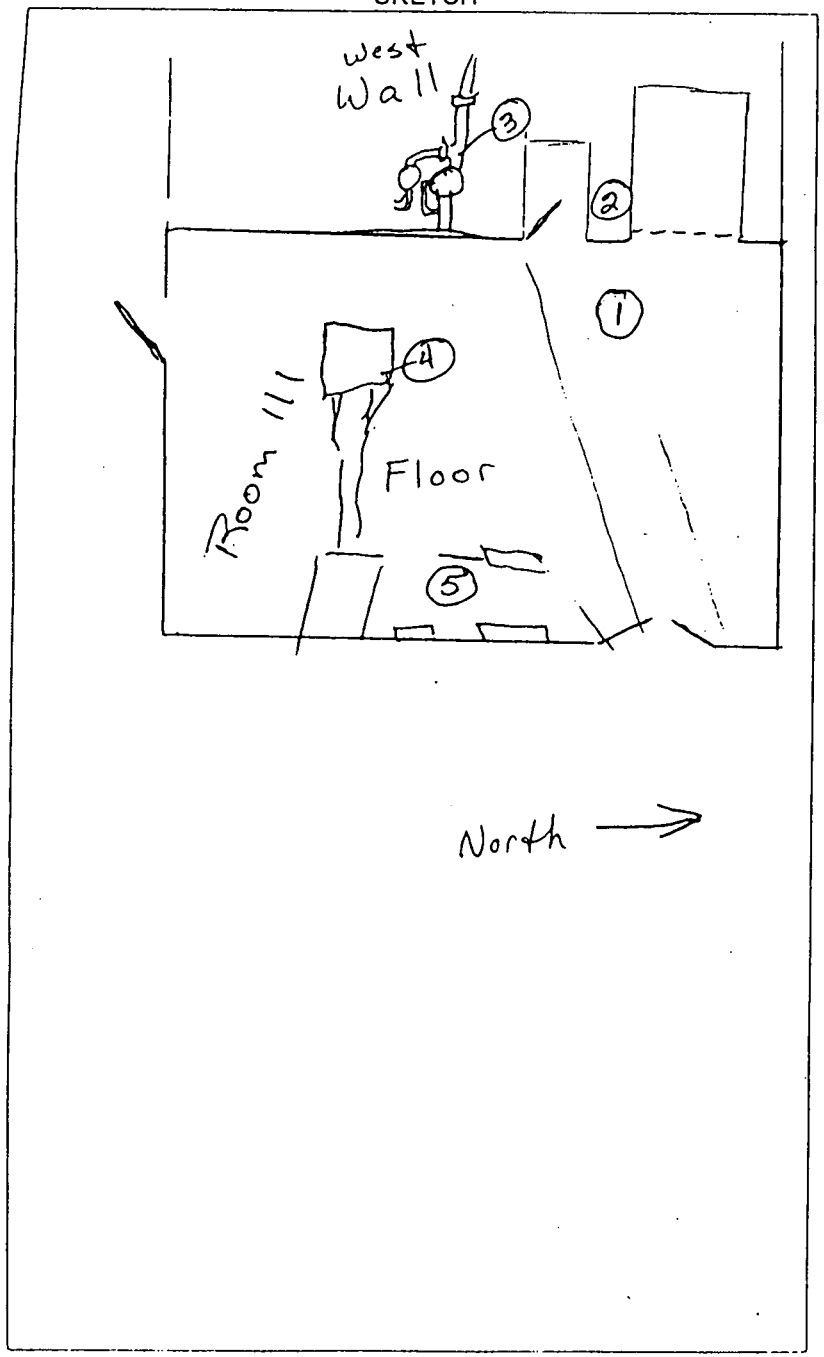
Swipe #	Location/description	Removable Alpha	Removable Beta/Gamma	Total Alpha 60 sec count	Total Beta/Gamma
	Pre				
1	Floor/Stripe	<18	<205	<60	<455
2	Wall by fire Exting.	<18	<205	<60	<455
3	Fire Supression Sys. Pipe	<18	<205	<60	<455
4	Gskt on Veintilation Sys	<18	<205	<60	<455
5	Floor	<18	<205	<60	<455
	Post				
1	Floor/Stripe	Not Sampled			
2	Wall by Fire Exting.	<18	<205	<60	<455
3	Fire Supression Sys. Pipe	<18	<205	<60	<455
4	Gskt on Vent. Sys.	<18	<205	<60	<455
5	Floor	<18	<205	<60	<455
