1.0 Ambrosia Lake, New Mexico, Disposal Site

1.1 Compliance Summary

The Ambrosia Lake, New Mexico, Uranium Mill Tailings Radiation Control Act (UMTRCA) Title I Disposal Site was inspected on March 18, 2021. No changes were observed on the disposal cell or in the associated drainage features. Inspectors identified no immediate maintenance needs and found no cause for a follow-up or contingency inspection.

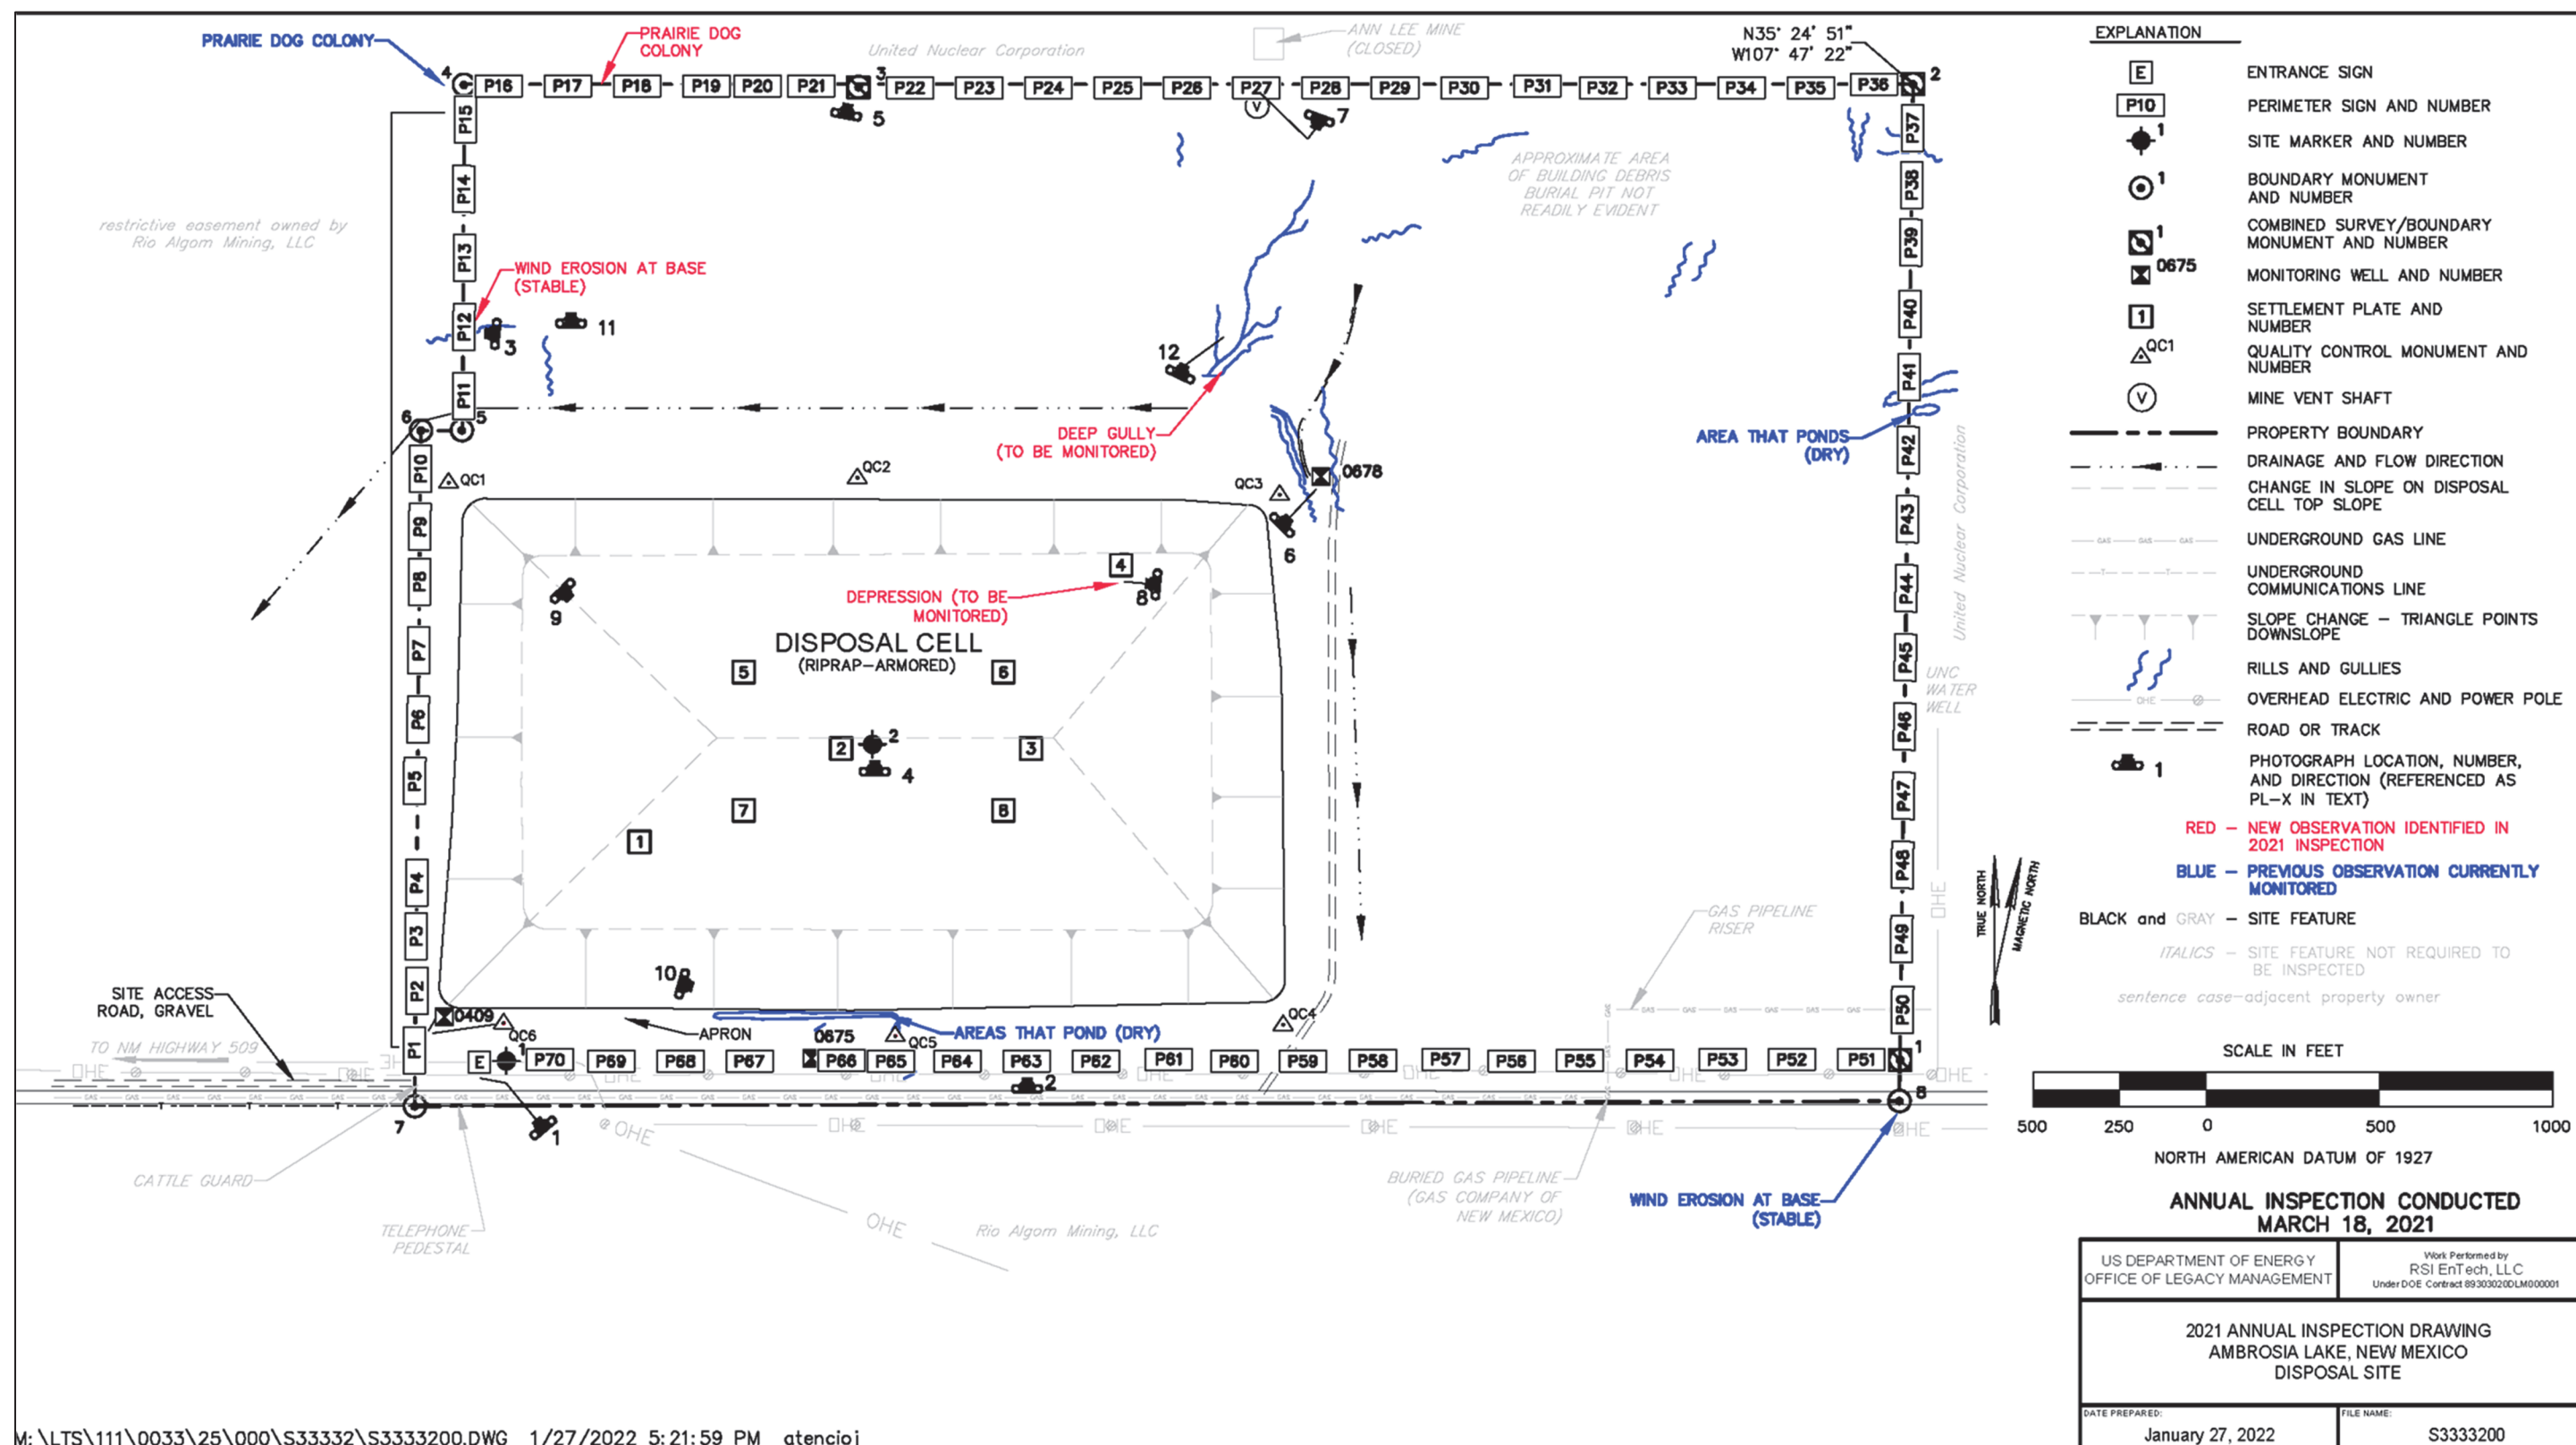
Figure 1-1. 2021 Annual Inspection Drawing for the Ambrosia Lake, New Mexico, Disposal Site

Figure 1-1 shows the locations of site features, including site surveillance features and inspection areas, in black and gray font. Site features that are present but not required to be inspected are shown in italic font. Observations from previous inspections that are currently monitored are shown in blue text, and new observations identified during the 2021 annual inspection are shown in red. Inspection results and recommended maintenance activities associated with site surveillance features are included in the following subsections. Photographs to support specific observations are identified in the text and in Figure 1-1 by photograph location (PL) numbers. The photographs and photograph log are presented in Section 1.10.
