1.0 Ambrosia Lake, New Mexico, Disposal Site

1.1 Compliance Summary

The Ambrosia Lake, New Mexico, Uranium Mill Tailings Radiation Control Act (UMTRCA) Title I Disposal Site was inspected on March 17, 2022. No changes were observed on the disposal cell or in the associated drainage features. Inspectors identified no immediate maintenance needs and found no cause for a follow-up or contingency inspection.

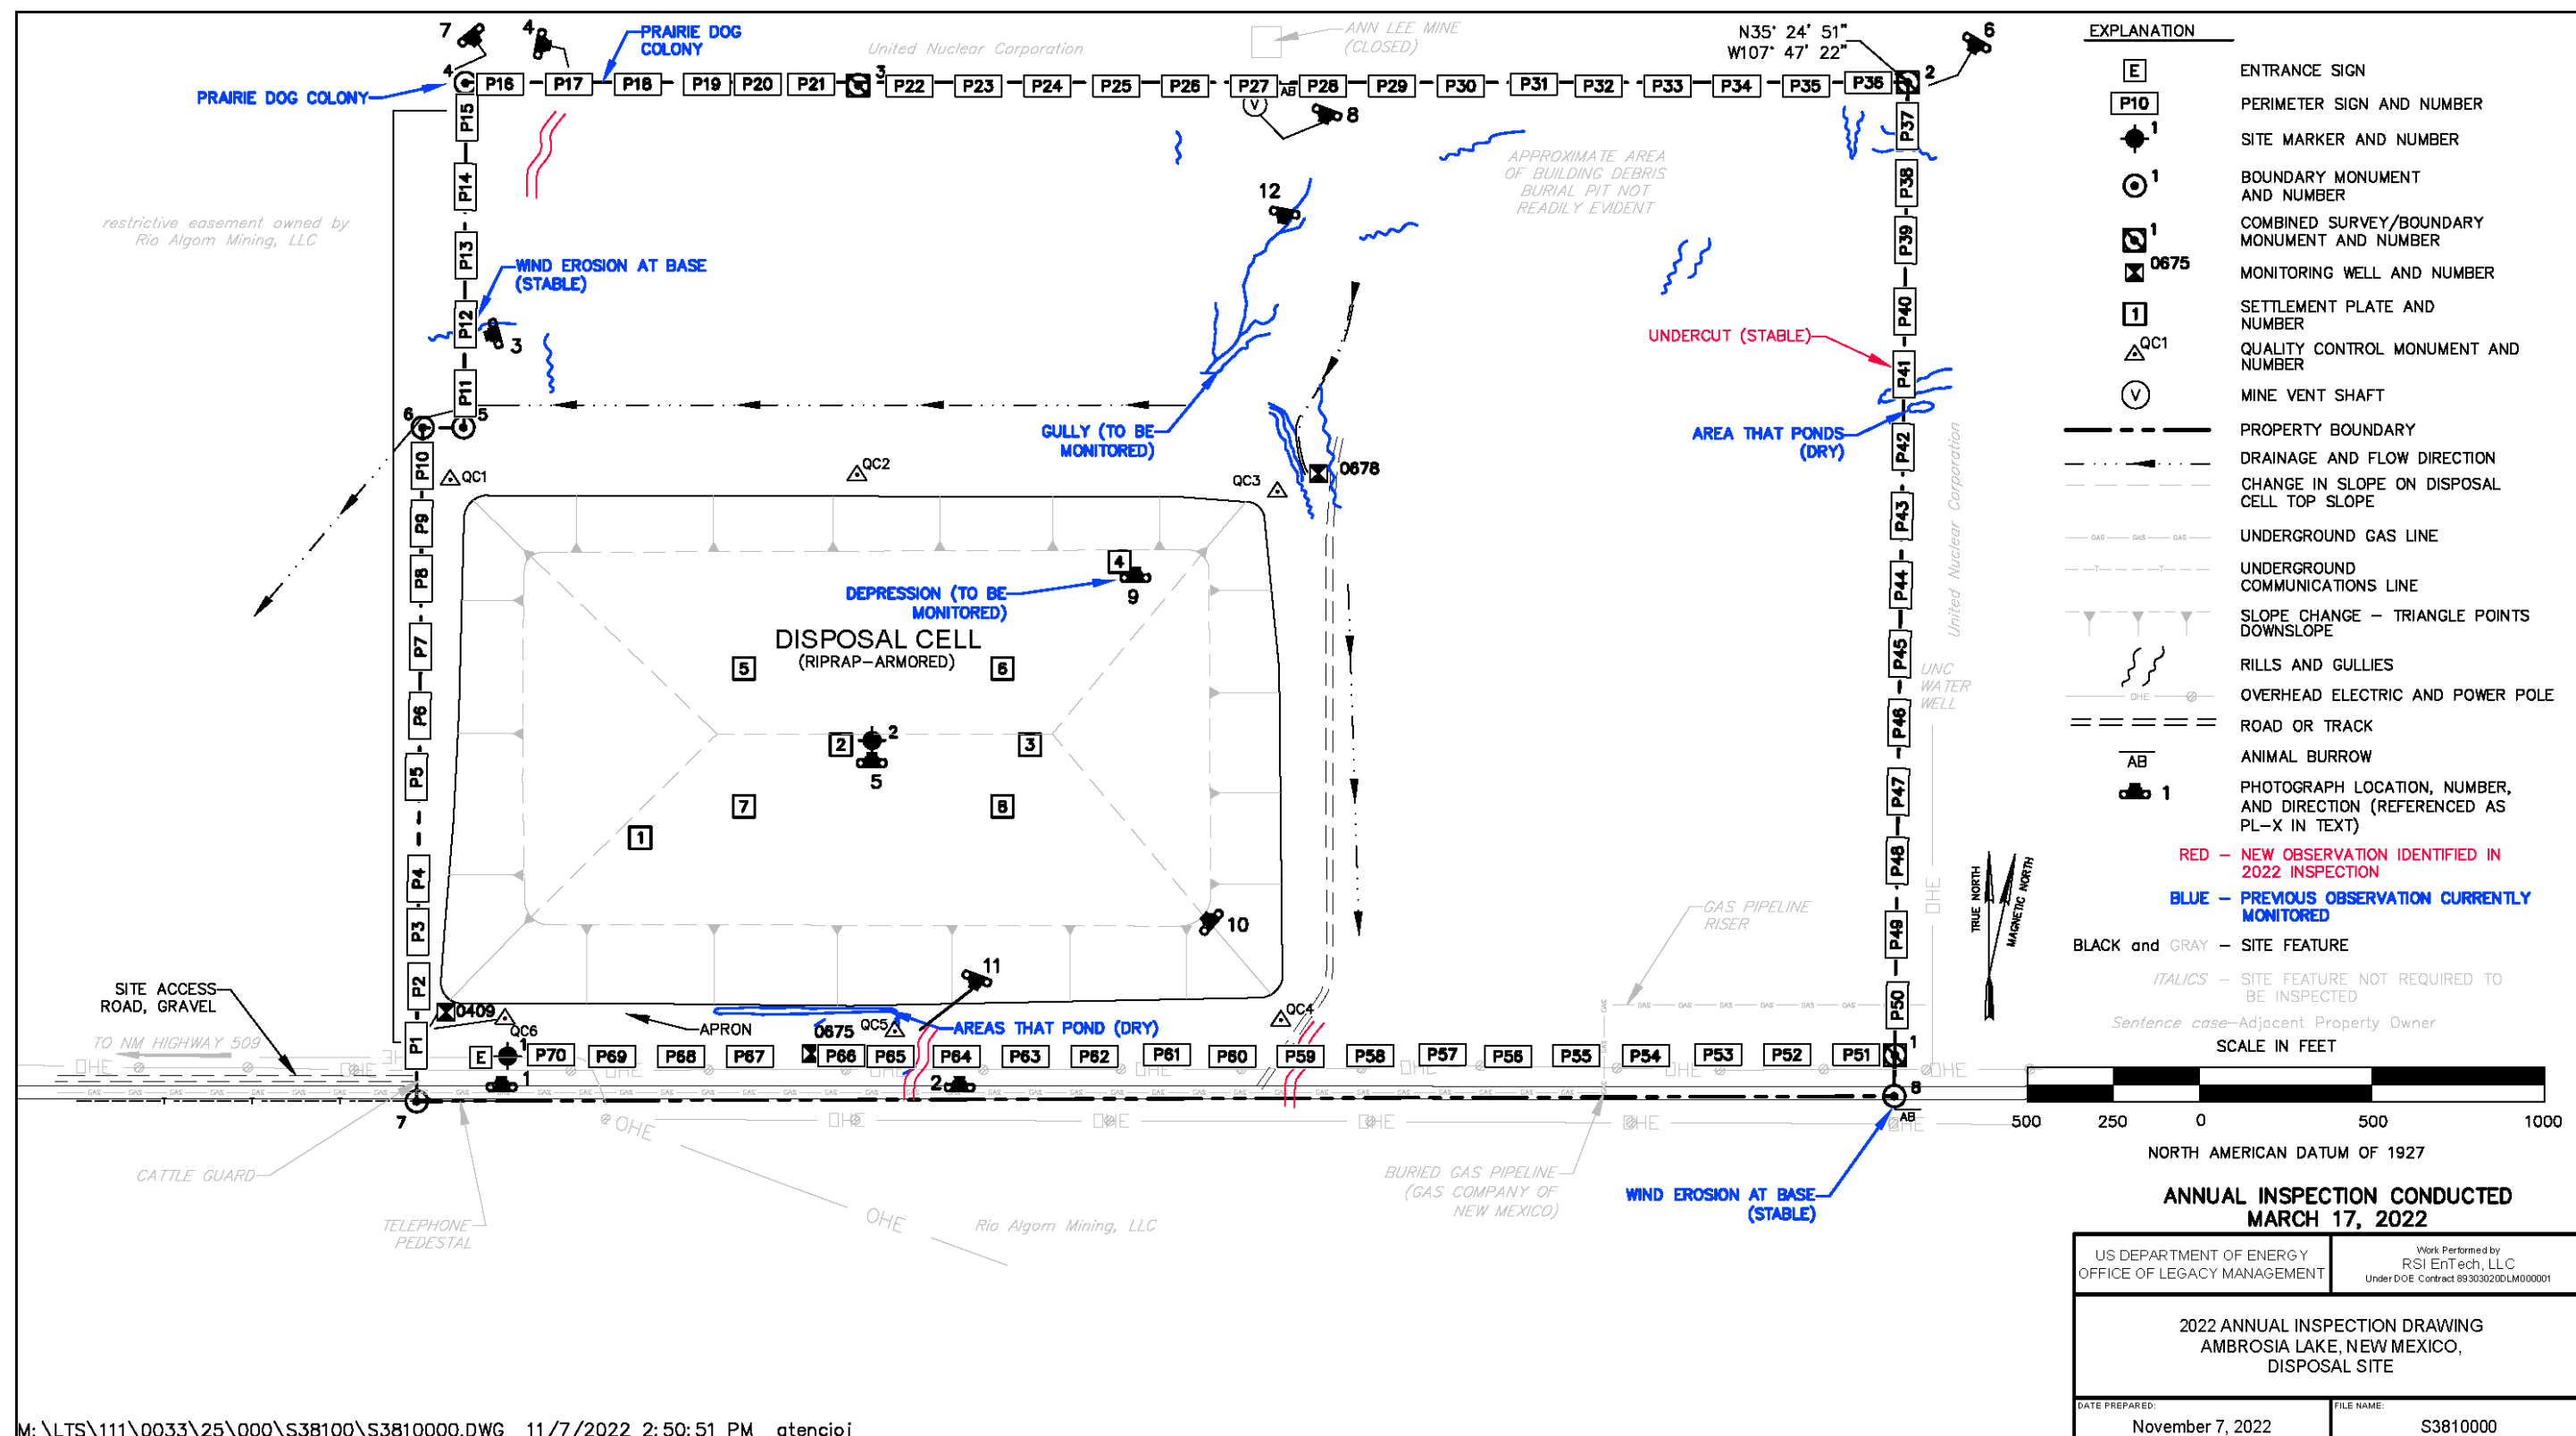
Figure 1-1. 2022 Annual Inspection Drawing for the Ambrosia Lake, New Mexico, Disposal Site

Figure 1-1 shows the locations of site features, including site surveillance features and inspection areas, in black and gray font. Some site features that are present but not required to be inspected are shown in italic font. Observations from previous inspections that are currently monitored are shown in blue, and new observations identified during the 2022 annual inspection are shown in red. Inspection results and recommended maintenance activities associated with site surveillance features are described in the following subsections. Photographs to support specific observations are noted in the text and in Figure 1-1 by photograph location (PL) numbers. The photographs and photograph log are presented in Section 1.10.

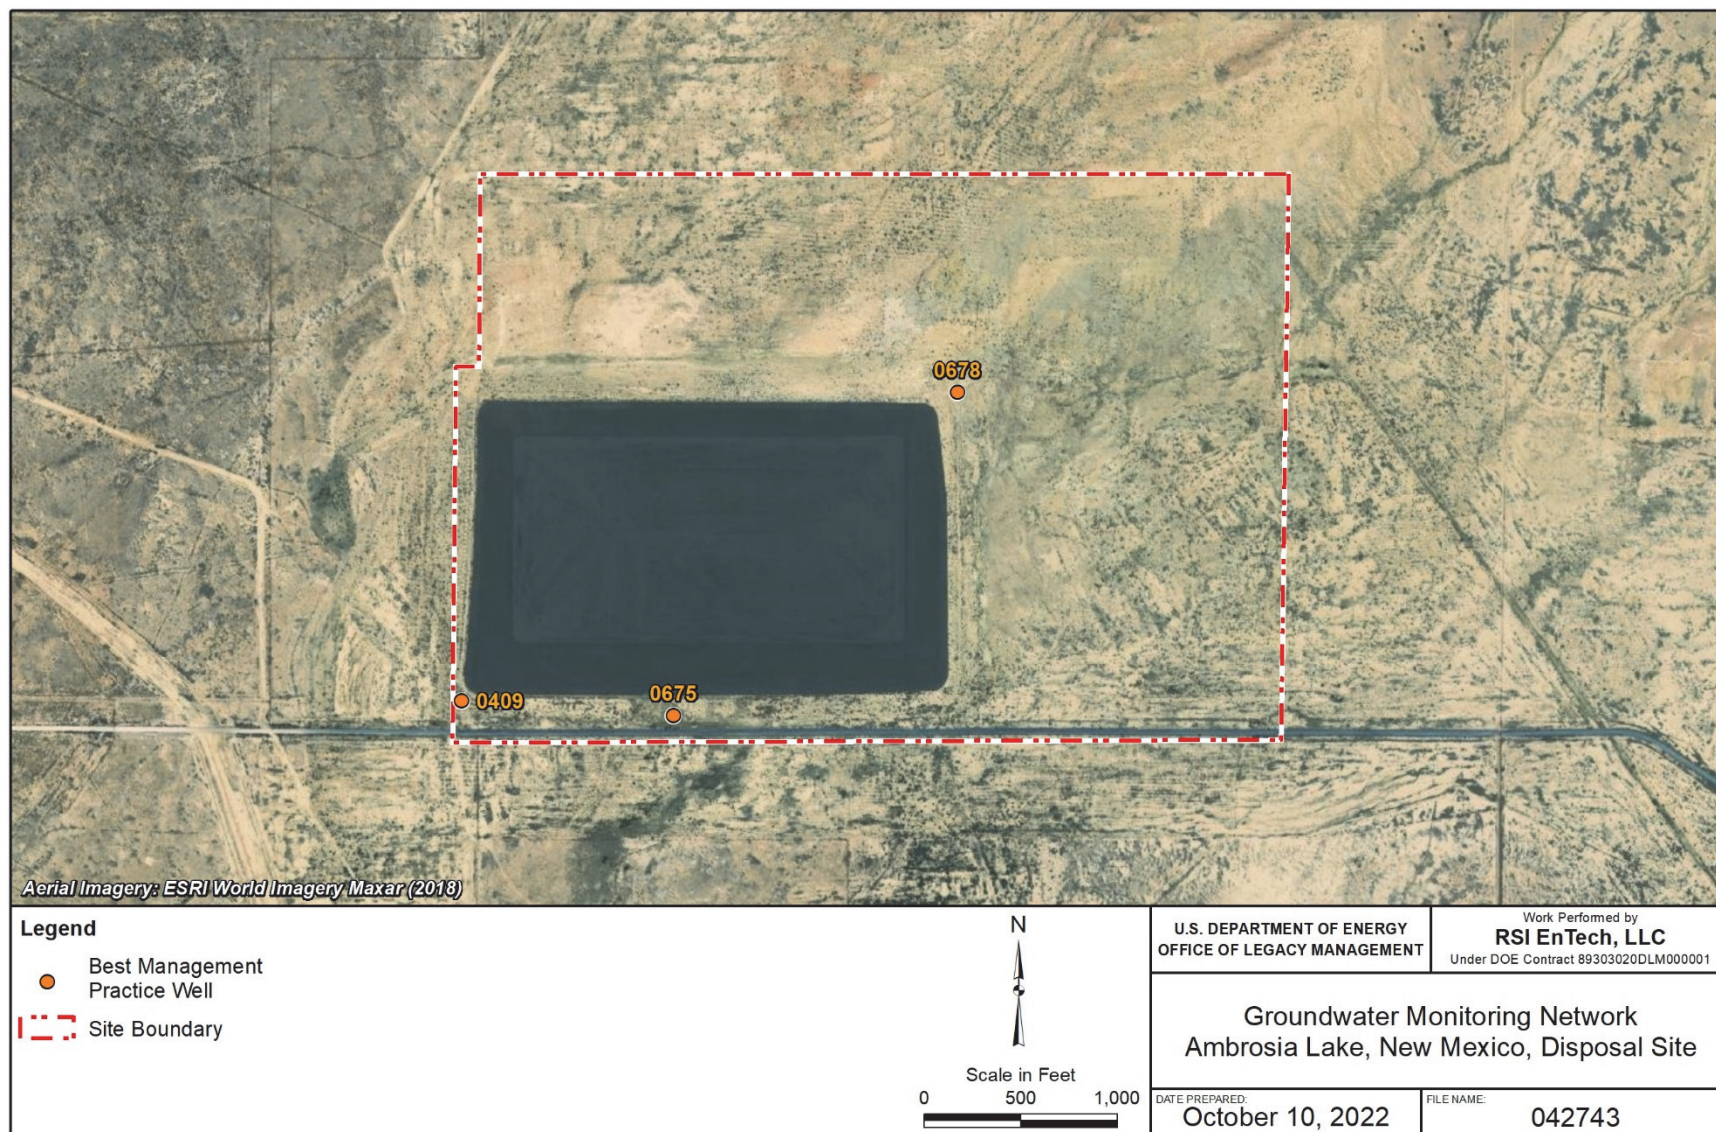
Figure 1-2. Ambrosia Lake, New Mexico, Groundwater Best Practice Monitoring Locations

Well 0675 is completed in weathered Mancos Shale just below its contact with the overlying alluvium, and well 0678 is completed in the Tres Hermanos B Sandstone unit of the Mancos Shale. LM installed well 0409 in May 2011 in support of a regional groundwater investigation being conducted by NMED. Well 0409, on DOE property adjacent to the southwest corner of the disposal cell, is completed in an alluvium-filled paleochannel. The bottom of the well screen is at the contact between the alluvium and the sandstone of the Tres Hermanos Unit C member of the Mancos Shale Formation. Well 0409 is dry, which suggests that alluvial groundwater is not leaving the southwest portion of the site.
