1.0 Ambrosia Lake, New Mexico, Disposal Site

1.1 Compliance Summary

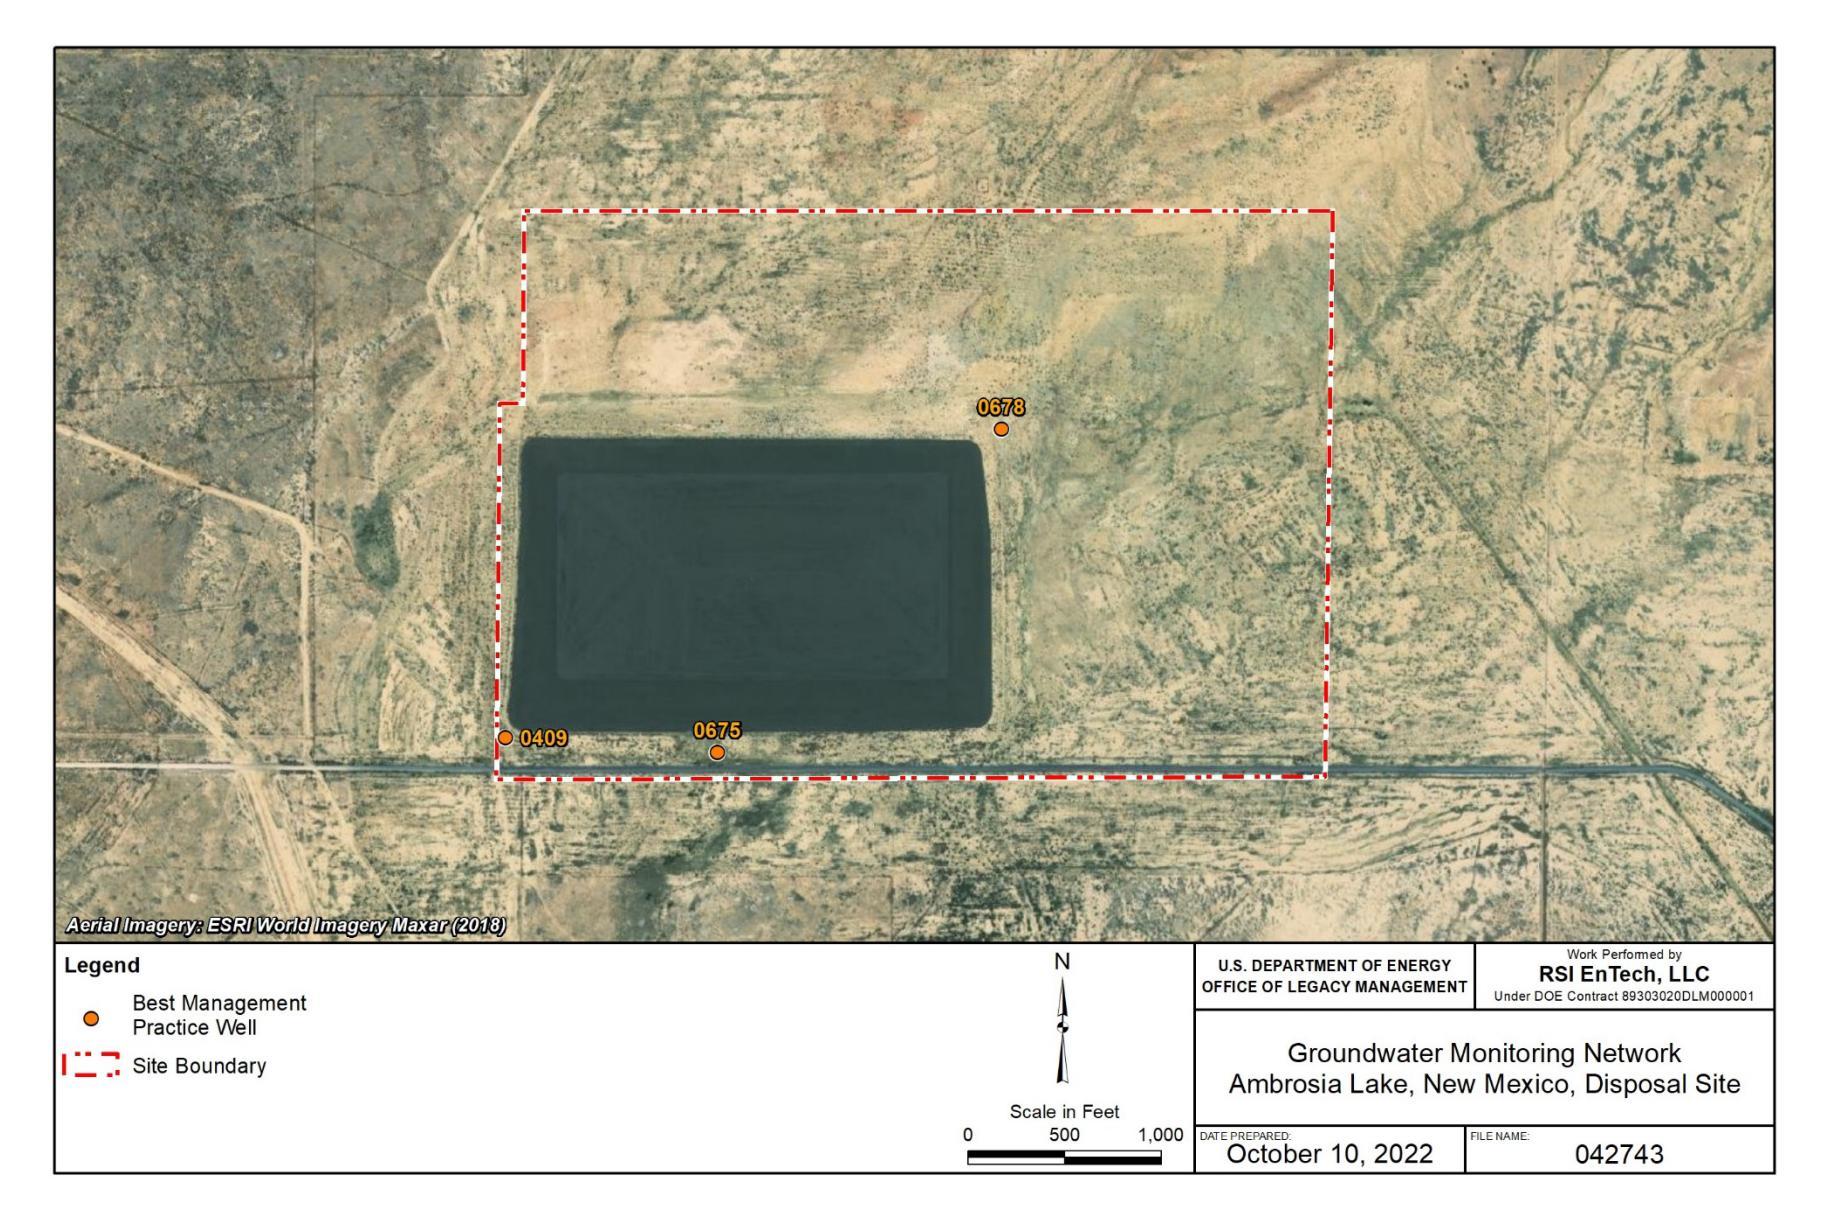
Figure 1-2. Ambrosia Lake, New Mexico, Groundwater Best Practice Monitoring Locations

Well 0675 is completed in weathered Mancos Shale just below its contact with the overlying alluvium, and well 0678 is completed in the Tres Hermanos B Sandstone unit of the Mancos Shale. LM installed well 0409 in May 2011 in support of a regional groundwater investigation being conducted by NMED. Well 0409, on DOE property adjacent to the southwest corner of the disposal cell, is completed in an alluvium-filled paleochannel. The bottom of the well screen is at the contact between the alluvium and the sandstone of the Tres Hermanos Unit C member of the Mancos Shale Formation.

For groundwater elevations, well 0409 has been dry at the time of every sampling event since being installed in 2011. Water-level elevations in well 0675 have fluctuated between 6943.8 and 6953.0 ft since the well was installed in 1989; the lowest water elevations were measured in 2019 and 2022 (Figure 1-3). Over the same duration, water-level elevations in well 0678 have fluctuated between 6764.8 and 6770.8 ft. The vertical hydraulic gradient between the two wells is strongly downward and averages 0.86 ft/ft suggesting that unsaturated conditions potentially exist between the two well screens.
