1.0 Ambrosia Lake, New Mexico, Disposal Site

1.1 Compliance Summary

The Ambrosia Lake, New Mexico, Uranium Mill Tailings Radiation Control Act (UMTRCA) Title I Disposal Site was inspected on March 19, 2024. No changes were observed on the disposal cell or in the associated drainage features. Inspectors identified no immediate maintenance needs and found no cause for a follow-up or contingency inspection.

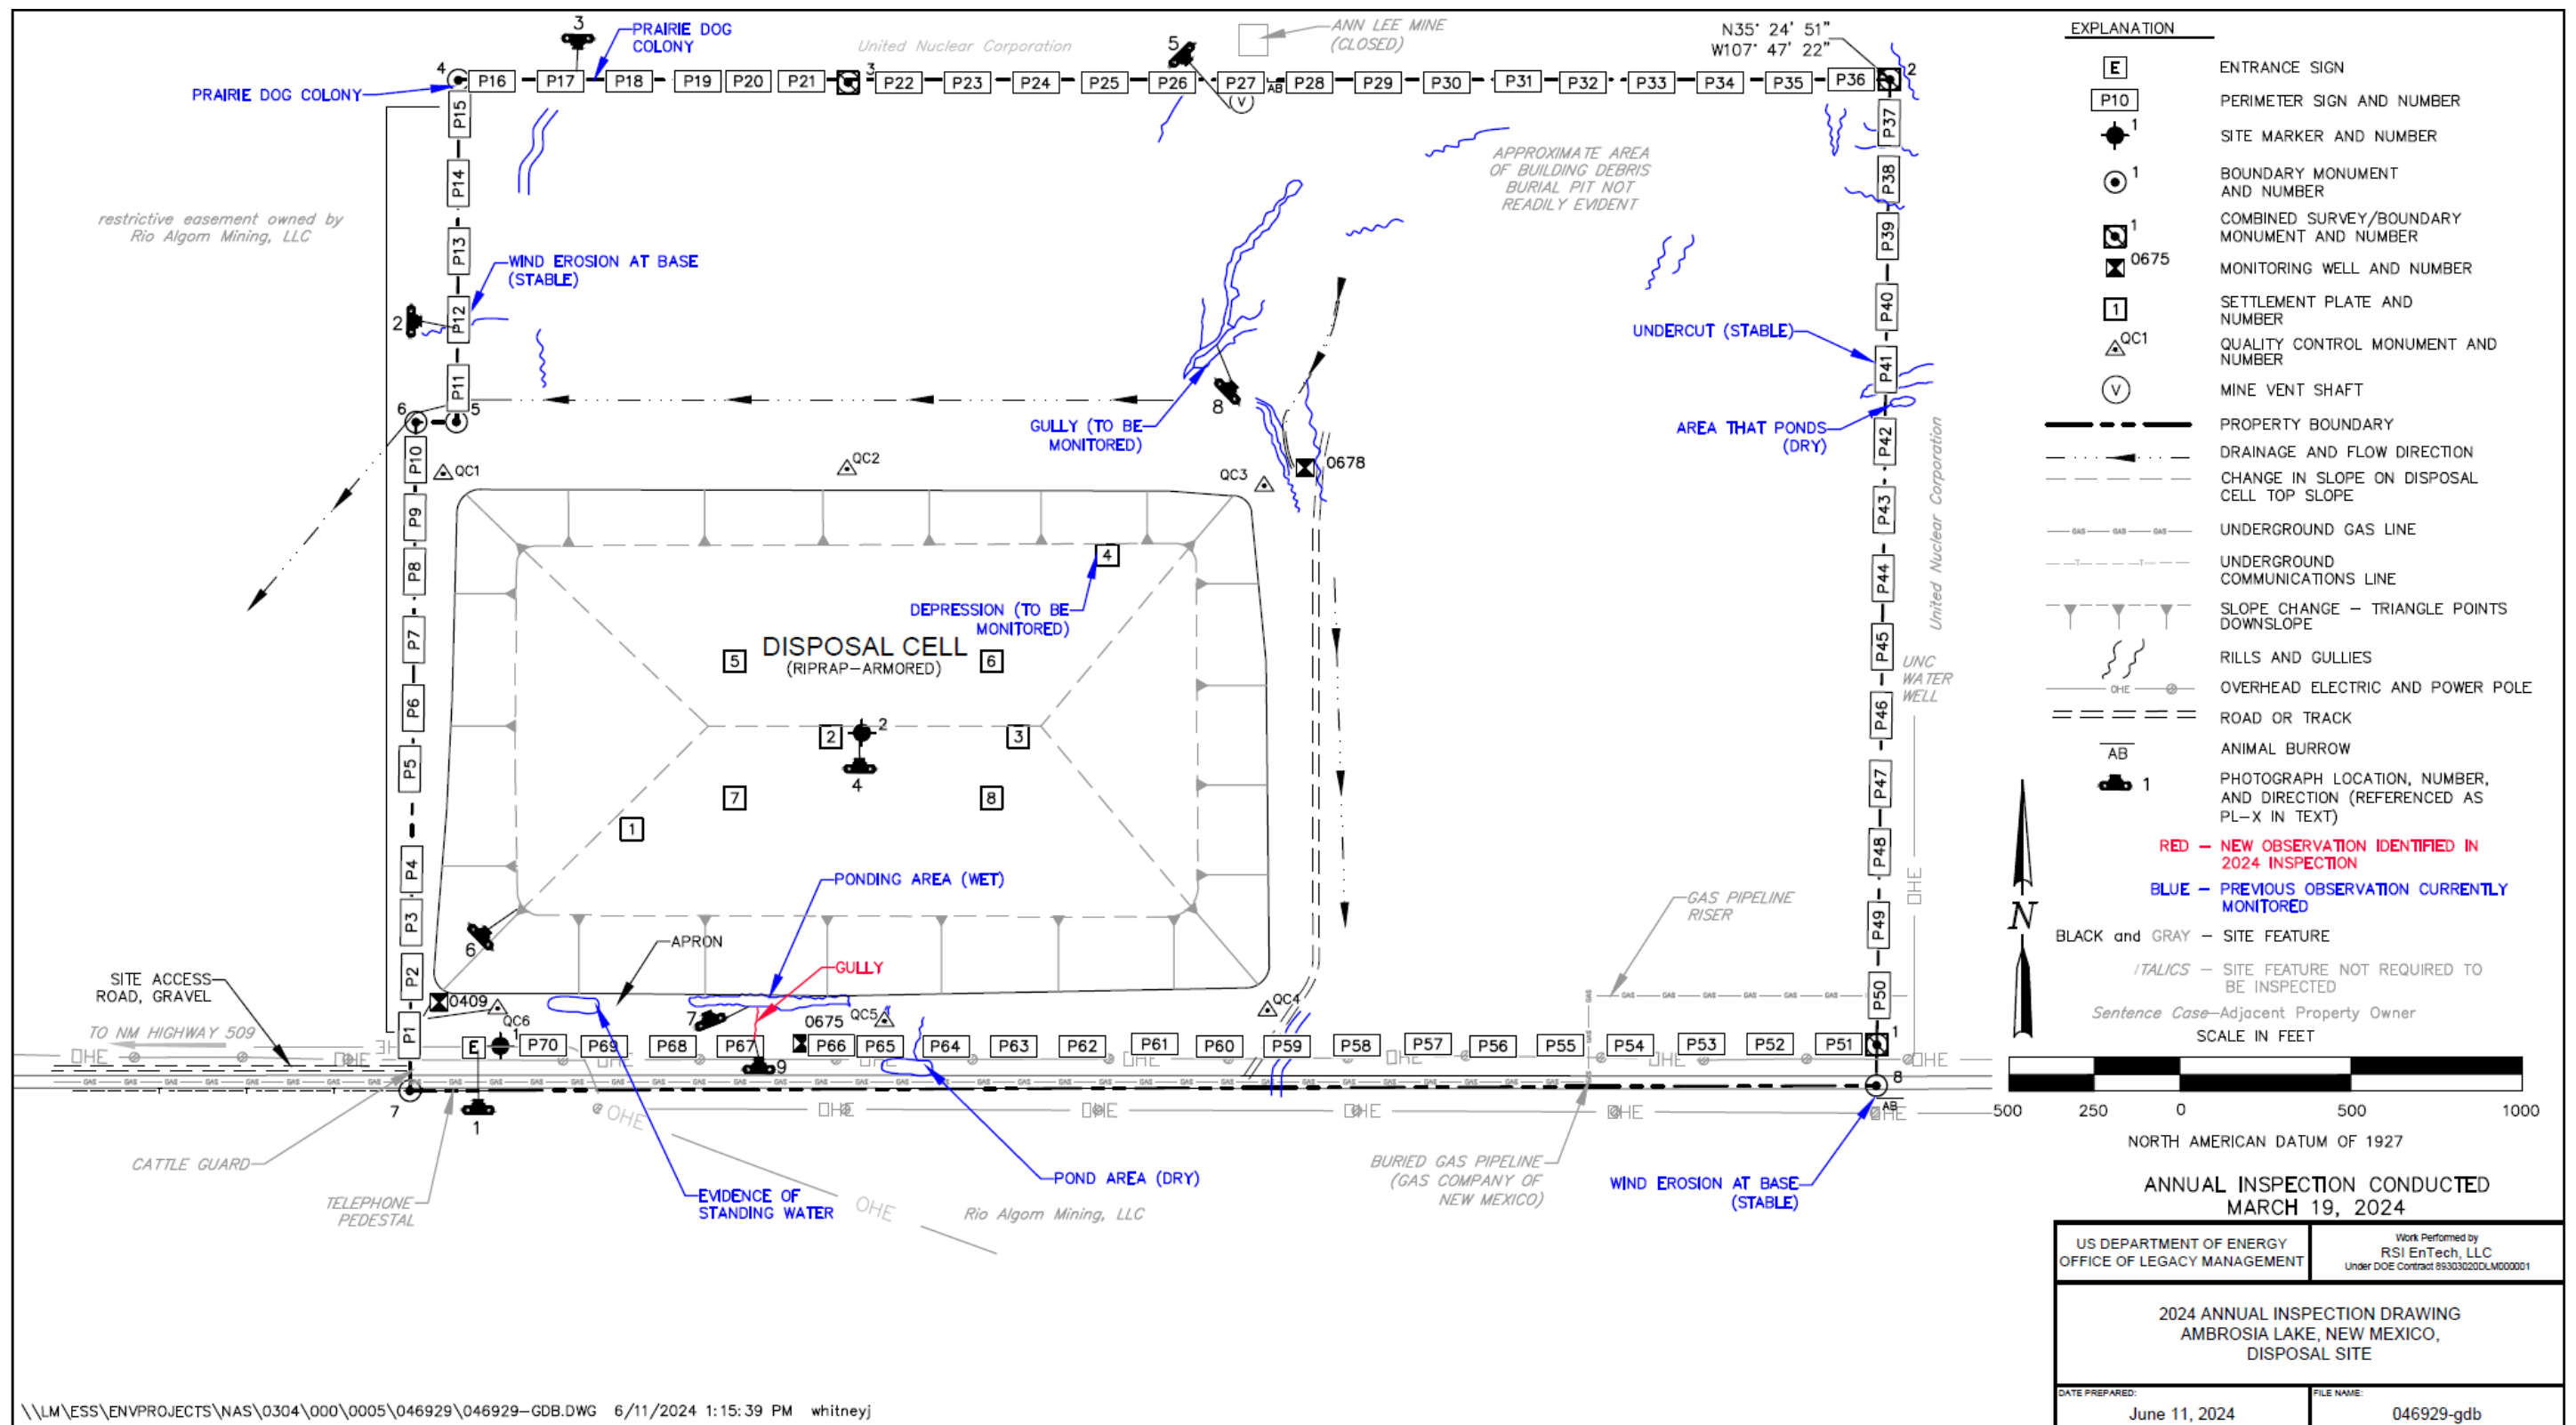
Figure 1-1. 2024 Annual Inspection Drawing for the Ambrosia Lake, New Mexico, Disposal Site

Figure 1-1 shows the locations of site features, including site surveillance features and inspection areas, in black and gray font. Some site features that are present but not required to be inspected are shown in italic font. Observations from previous inspections that are currently monitored are shown in blue, and new observations identified during the 2024 annual inspection are shown in red. Inspection results and recommended maintenance activities associated with site surveillance features are described in the following subsections. Photographs to support specific observations are noted in the text and in Figure 1-1 by photograph location (PL) numbers. The photographs and photograph log are presented in Section 1.10.

The site has two granite site markers. Site marker SMK-1 is just inside the site entrance, and site marker SMK-2 (PL-4) is on the top slope of the disposal cell. No maintenance needs were identified.

A mine vent shaft associated with an abandoned underground mine is within the site boundary in the northern portion of the site (PL-5). Inspectors monitor the condition of the vent to ensure that the closure remains secure. The vent has a spot-welded cover and a casing that rises approximately 3 feet (ft) above the ground. The vent was secure at the time of the inspection. No maintenance needs were identified.

Annual weeds and perennial grasses are sporadically growing on top of the disposal cell (PL-6). In accordance with the LTSP, deep-rooted shrubs are to be removed from the disposal cell cover. No deep-rooted shrubs were noted during the inspection. Weed control is performed as necessary, and the need for weed control will be evaluated again during the next annual inspection.

The basalt riprap-covered side slopes and apron showed no evidence of erosion, settling, slumping, or cracking. Standing water is occasionally observed in a portion of the south apron, and the area was wet during the 2024 inspection (PL-7). An additional ponding area, which was dry, exists south of the current standing water area near the apron and closer to the access road. These locations are in a topographic low spot along the base of the disposal cell, and stormwater runoff collects in these areas. During the 2022 inspection, rilling and erosion were observed on the south side slope near aerial survey quality control monument QC-5. During the 2024 inspection, these features seemed to be stable. Inspectors will continue to monitor this area. No maintenance needs were identified.

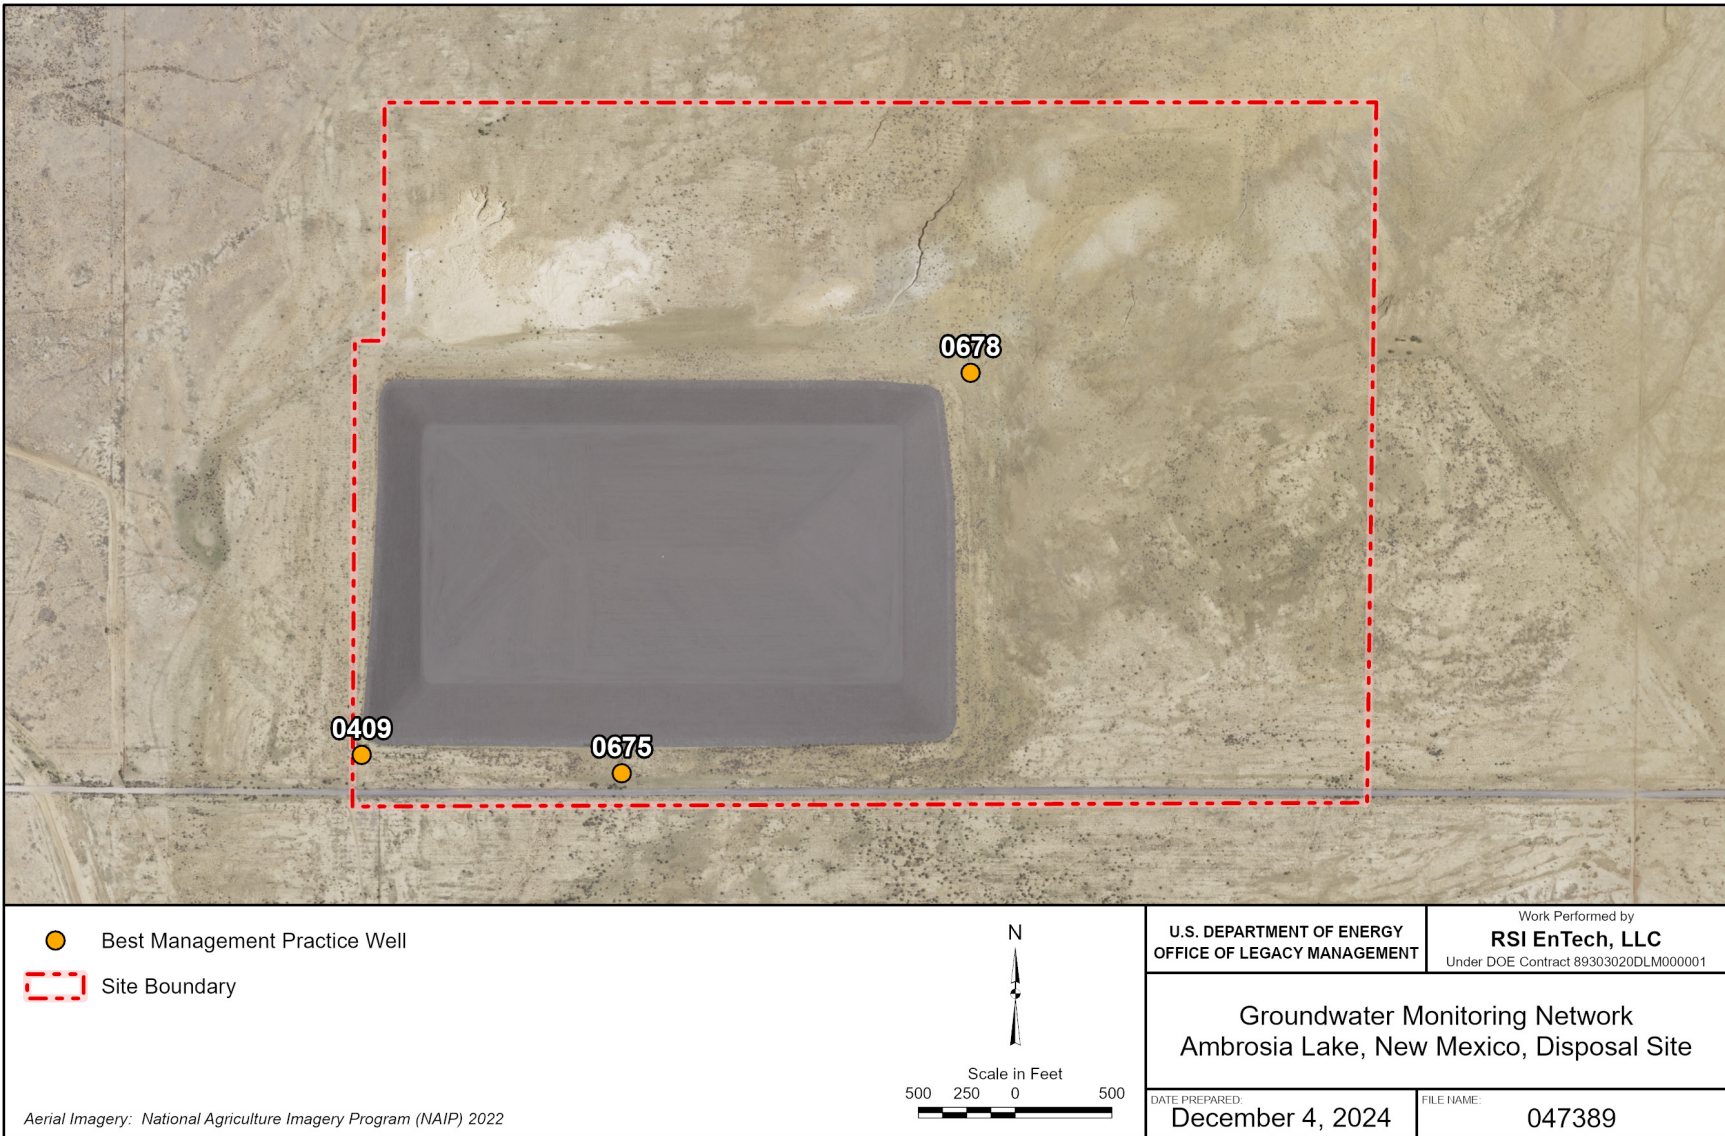
Figure 1-2. Ambrosia Lake Disposal Site Groundwater Best Practice Monitoring Locations

Well 0675 is completed in weathered Mancos Shale just below its contact with the overlying alluvium, and well 0678 is completed in the Tres Hermanos B Sandstone unit of the Mancos Shale. LM installed well 0409 in May 2011 in support of a regional groundwater investigation being conducted by NMED. Well 0409, on DOE property adjacent to the southwest corner of the disposal cell, is completed in an alluvium-filled paleochannel. The bottom of the well screen is at the contact between the alluvium and the sandstone of the Tres Hermanos Unit C member of the Mancos Shale Formation.

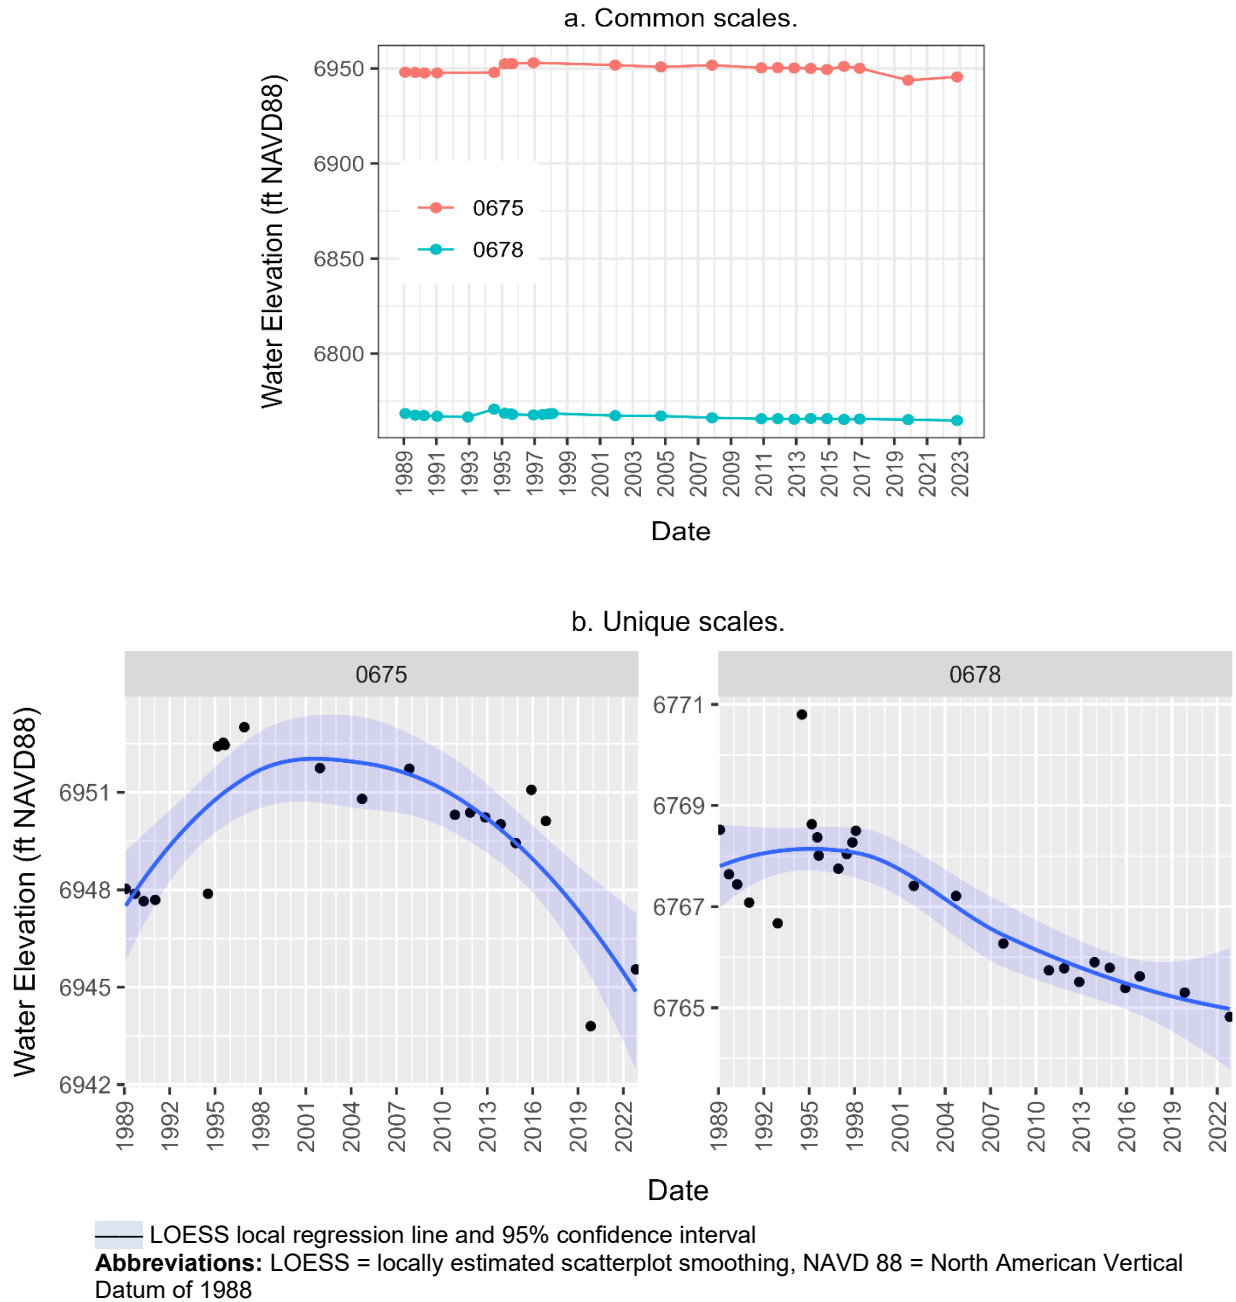
Figure 1-3. Groundwater Elevation Trends in Ambrosia Lake, New Mexico, Disposal Site Monitoring Wells (a: Common Scales, b: Unique Scales)

For groundwater elevations, well 0409 has been dry at the time of every sampling event since being installed in 2011. Water-level elevations in well 0675 have fluctuated between 6943.8 and 6953.0 ft since the well was installed in 1989; the lowest water elevations were measured in 2019 and 2022 (Figure 1-3). Over the same duration, water-level elevations in well 0678 have fluctuated between 6764.8 and 6770.8 ft. The vertical hydraulic gradient between the two wells is strongly downward and averages 0.86 ft/ft suggesting that unsaturated conditions potentially exist between the two well screens.

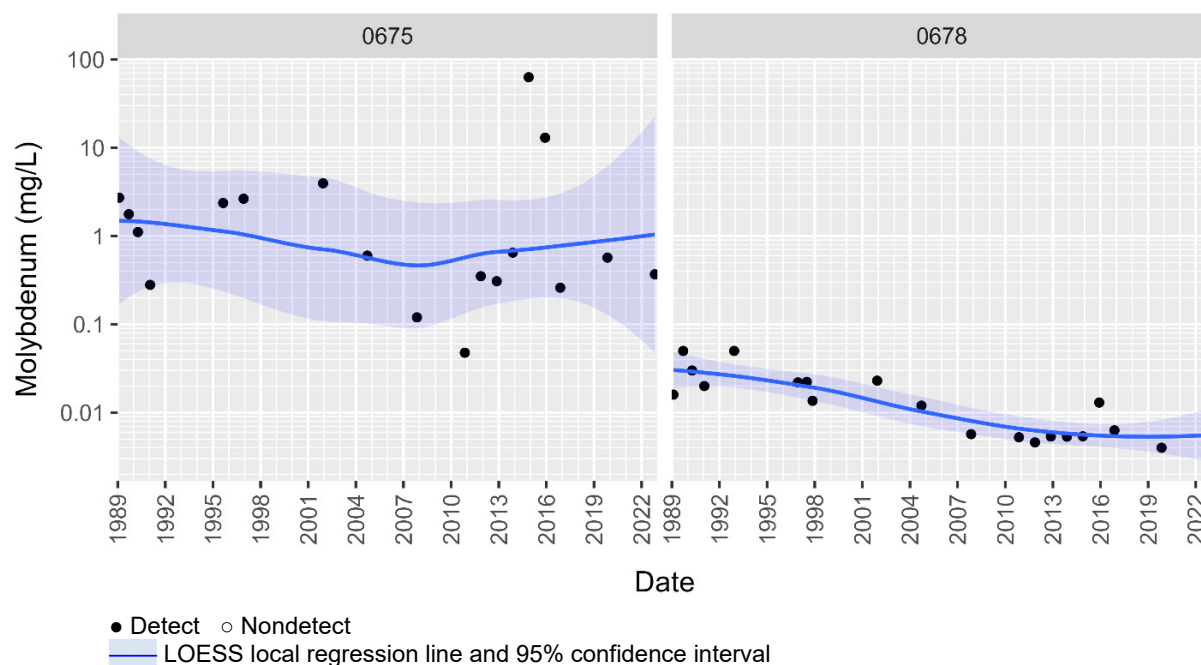
Figure 1-4. Molybdenum Concentrations in Groundwater at the Ambrosia Lake, New Mexico, Disposal Site

Molybdenum concentrations in well 0675, screened in the weathered Mancos Shale, have fluctuated widely at times, ranging from 0.004 milligram per liter (mg/L) to 63.0 mg/L from 1989 to 2022 and averaging about 5 mg/L (Figure 1-4). The highest concentrations were measured in 2014 and 2015 (63.0 and 13.0 mg/L, respectively), but levels have since declined (the most recent result was 0.37 mg/L). Well 0678, screened in the Tres Hermanos B Sandstone unit of the Mancos Shale at an elevation approximately 200 ft deeper than well 0675, historically has had molybdenum concentrations below 0.1 mg/L. The most recent result was below the detection limit (<0.0053 mg/L) (Figure 1-4).

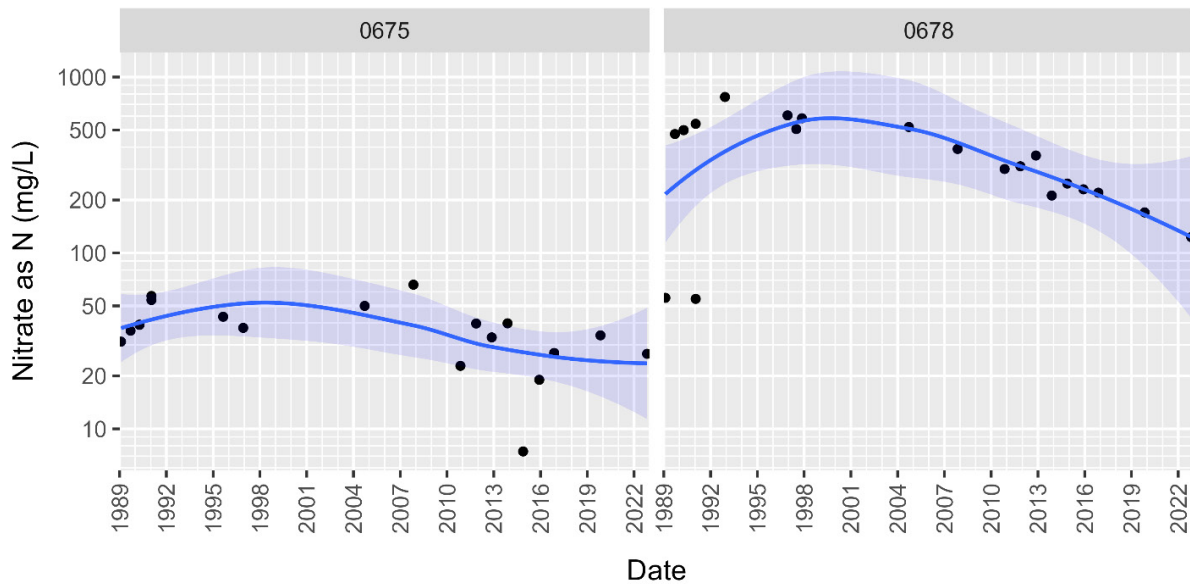
Figure 1-5. Nitrate as N Concentrations in Groundwater at the Ambrosia Lake, New Mexico, Disposal Site

Nitrate as nitrogen (N) concentrations in well 0675 have historically remained below 70 mg/L (Figure 1-5). Nitrate (as N) concentrations in the deeper well (0678) reached a maximum concentration of 770.3 mg/L in 1992 and have steadily decreased to a present-day concentration of 123.0 mg/L (Figure 1-5).

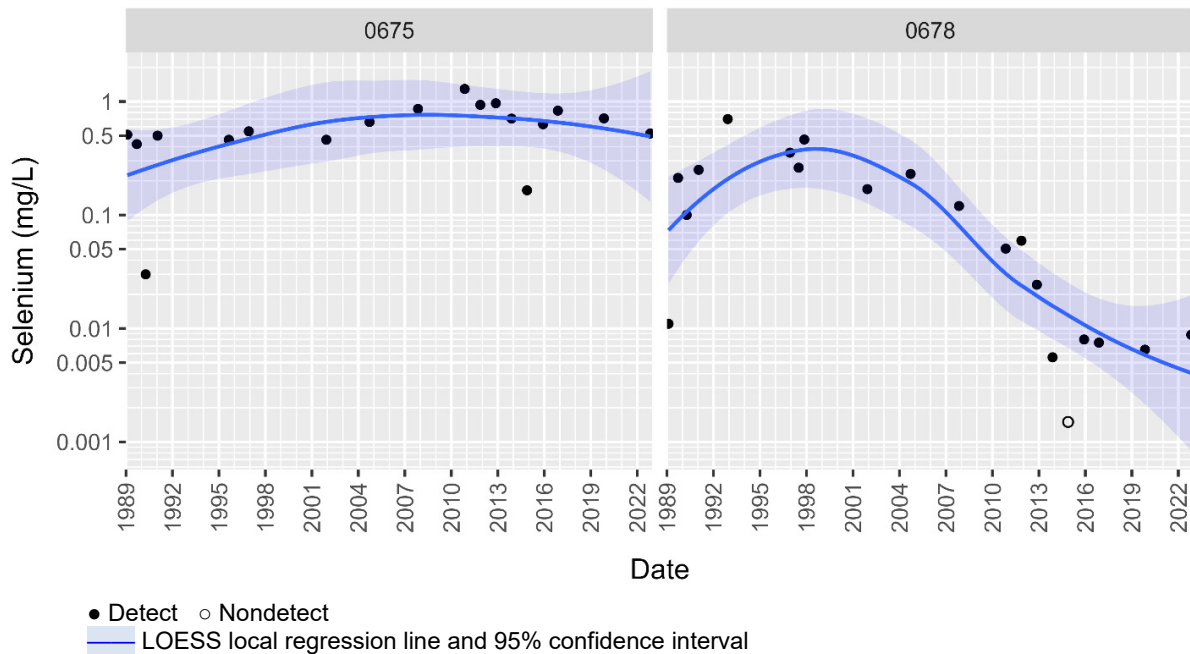
Figure 1-6. Selenium Concentrations in Groundwater at the Ambrosia Lake, New Mexico, Disposal Site

Well 0675 had an initial selenium concentration of 0.51 mg/L. Concentrations trended upward and peaked in 2010 at 1.29 mg/L and then declined to 0.17 mg/L in 2014. The most recent result, 0.52 mg/L, is essentially equivalent to the initial (1989) concentration. Selenium concentrations in the deeper well (0678) reached a peak concentration of 0.7 mg/L in 1992 and have declined to present-day concentrations of less than 0.01 mg/L (Figure 1-6).

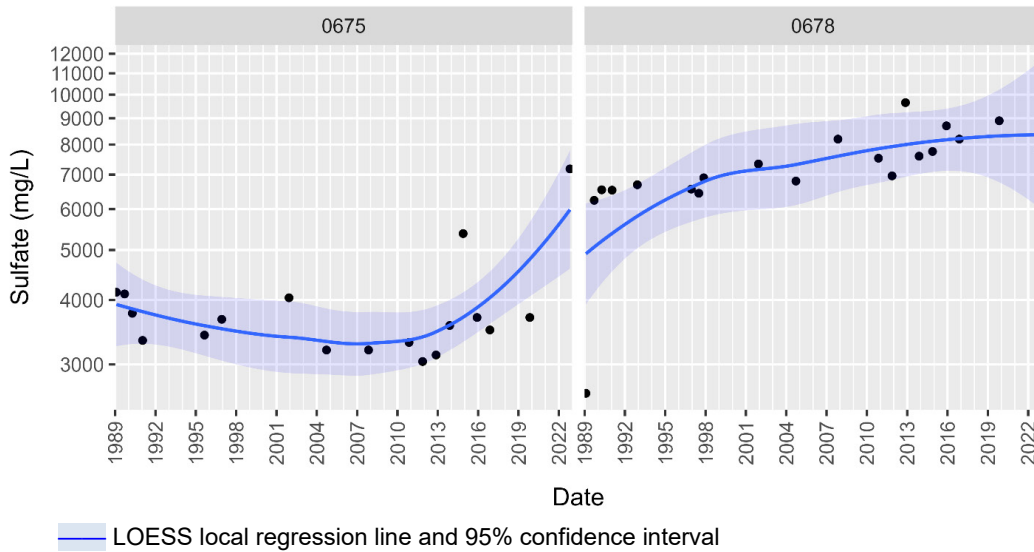
Figure 1-7. Sulfate Concentrations in Groundwater at the Ambrosia Lake, New Mexico, Disposal Site

Historically, sulfate concentrations in well 0675 have generally ranged between 3000 and at or just above 4000 mg/L (Figure 1-7). There are two exceptions: the 2014 measurement (5380 mg/L) and the most recent (2022) result of 7180 mg/L, the maximum sulfate concentration measured in that well. The deeper well (0678) had an initial sulfate concentration of 2638 mg/L; this early measurement is an outlier relative to subsequent results that have exceeded 6000 mg/L. Since September 1989 (6240 mg/L), sulfate concentrations gradually increased to levels between 7000 and 10,000 mg/L (Figure 1-7). The most recent result was 7920 mg/L.

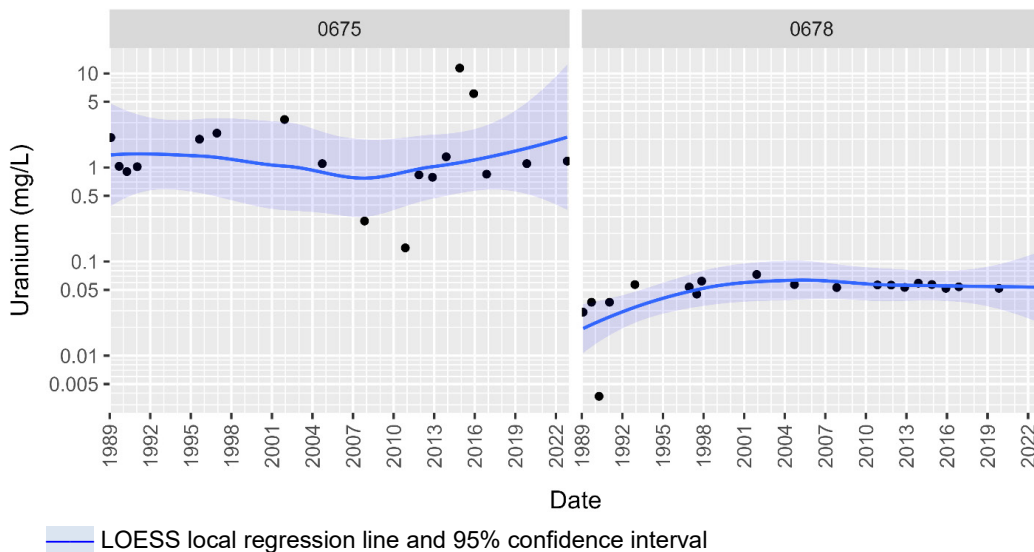
Figure 1-8. Uranium Concentrations in Groundwater at the Ambrosia Lake, New Mexico, Disposal Site

Uranium concentrations in well 0675 ranged from 0.91 to 3.24 mg/L from 1989–2001 and then declined to a low of 0.14 mg/L in 2010 (Figure 1-8). Concentrations then increased to a high of 11.4 mg/L in 2014 and have declined to a present-day concentration of 1.17 mg/L. Uranium concentrations in the deeper well (0678) have historically remained below 0.1 mg/L (Figure 1-8).
